El Vado Dam Rehabilitation Case Study: Coatings & Cathodic Protection

- El Vado Dam is located on the Chama River in north central New Mexico
- Construction completed in 1935 by Middle Rio Grande Conservancy District
- Transferred to BOR in the 1950s
- Cathodic Protection added in the 1980's.
- Faceplate is steel lined and needs new Cathodic Protection system.
- Radial Gate will be newly installed and needs Cathodic Protection.

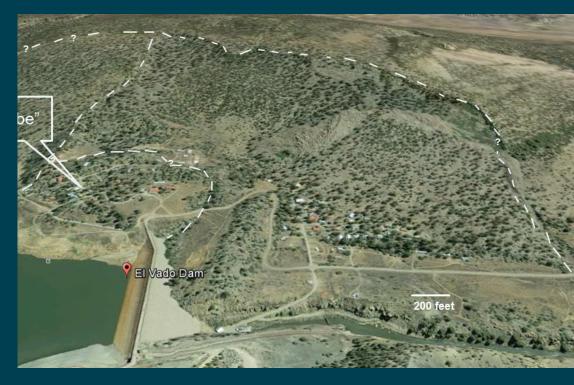
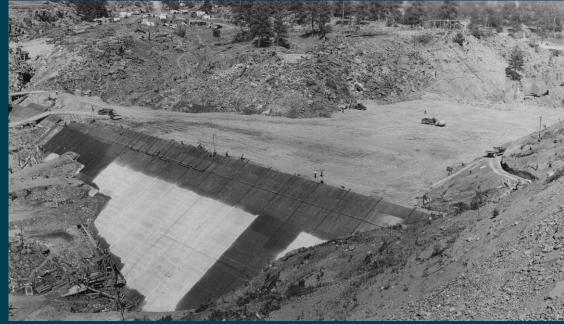
Not the best location for a dam. Geological instability with seepage and erosion issues.

The location is right in the middle of a landslide zone.

A major contributing factor for the rehabilitation work

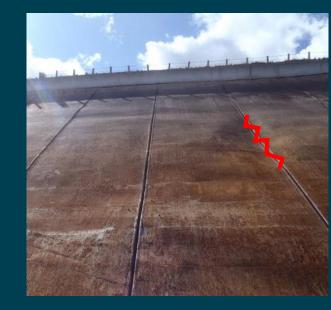
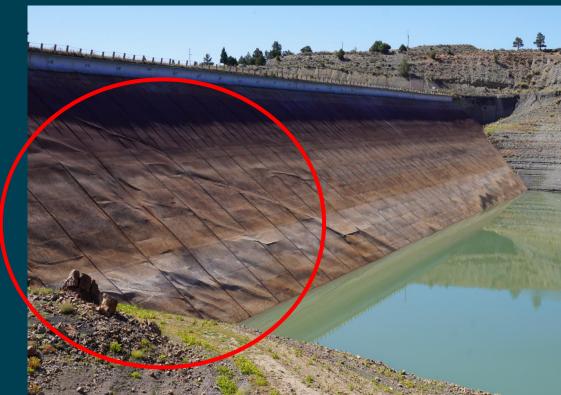
One of the few steel faced rockfill dams in the country.

- Substantial settlement along the dam.
- Expansion joints of faceplate are cracked and allow water to seep through.
- Voids underneath the faceplate.
- Deformations and distress are occurring on the faceplate.

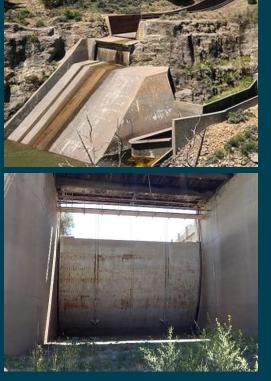
Current Cathodic Protection System:

Faceplate, Steel Spillway, Spillway Radial Gate

- Impressed current cathodic protection (rectifier).
- 2 rectifiers with multiple horizontal anode beds per rectifier on left abutment.
- 3 rectifiers with multiple horizontal anode beds per rectifier on right abutment.
- 8 total horizontal groundbeds

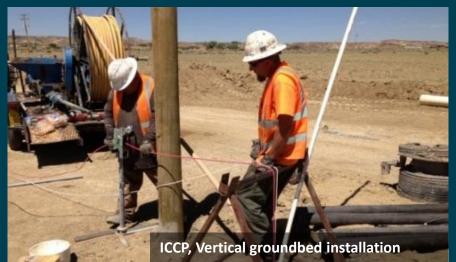
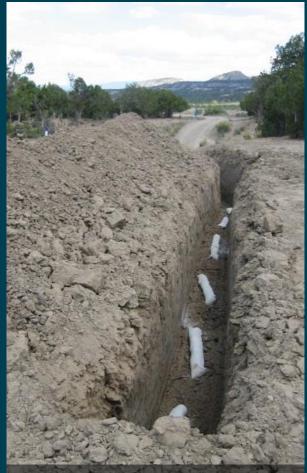
Deep well vs horizontal groundbed

- Less ground taken up, dig down vs. out.
 - Easier to get anode bed remote from structure.
 - Beneficial for limited ROW situations.
- Deep well can be treated like one very large anode with backfill dimensions.
- Can spread out easier to minimize mutual interference.

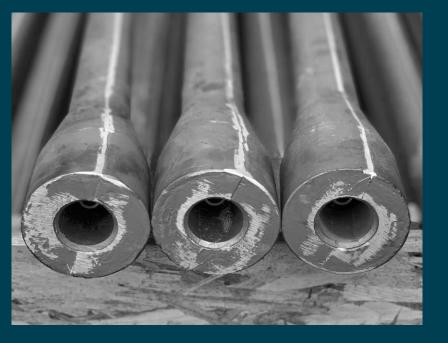
Impressed Current Anodes

Option 1:

High Silicon Cast Iron 12 total anodes per deep well Option 2:

Mixed Metal Oxide 12 total anodes per deep well

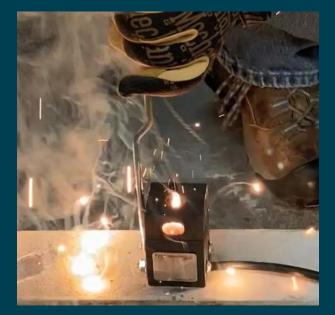
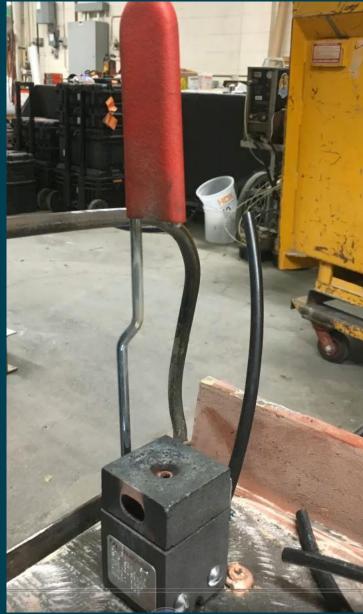
Cable attachments to faceplate

Specific molds-

- Orientation
- Material type for bonding
- Uses powder and lighter for heat source

Bonds CP cable to metallic surface

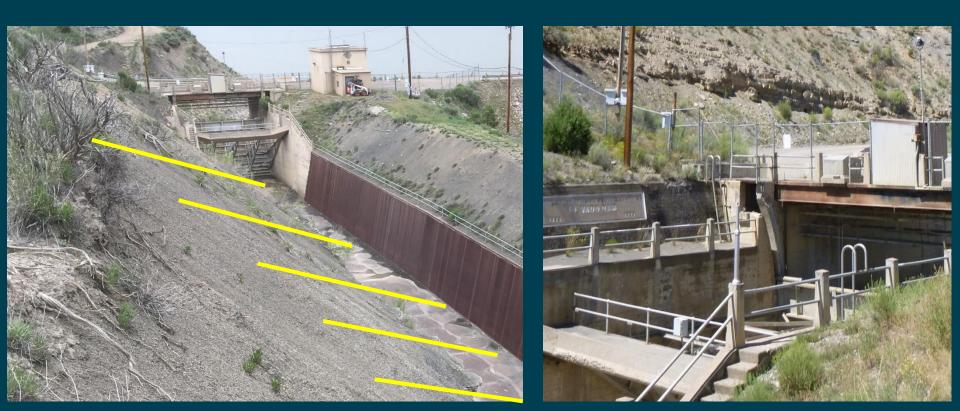
New Spillway & new radial gate

Spillway moving into hillside & widening Spillway steel plating will be encased in concrete - no need for CP

Radial gate coating options:

abrasion resistant epoxy, polysiloxane topcoat
