# Robotic Non-Destructive Inspection of Hydraulic Steel Structures

Dave Tordonato, PhD  
Materials Engineer, Technical Service Center  
[dtordonato@usbr.gov](mailto:dtordonato@usbr.gov), 303-445-2394

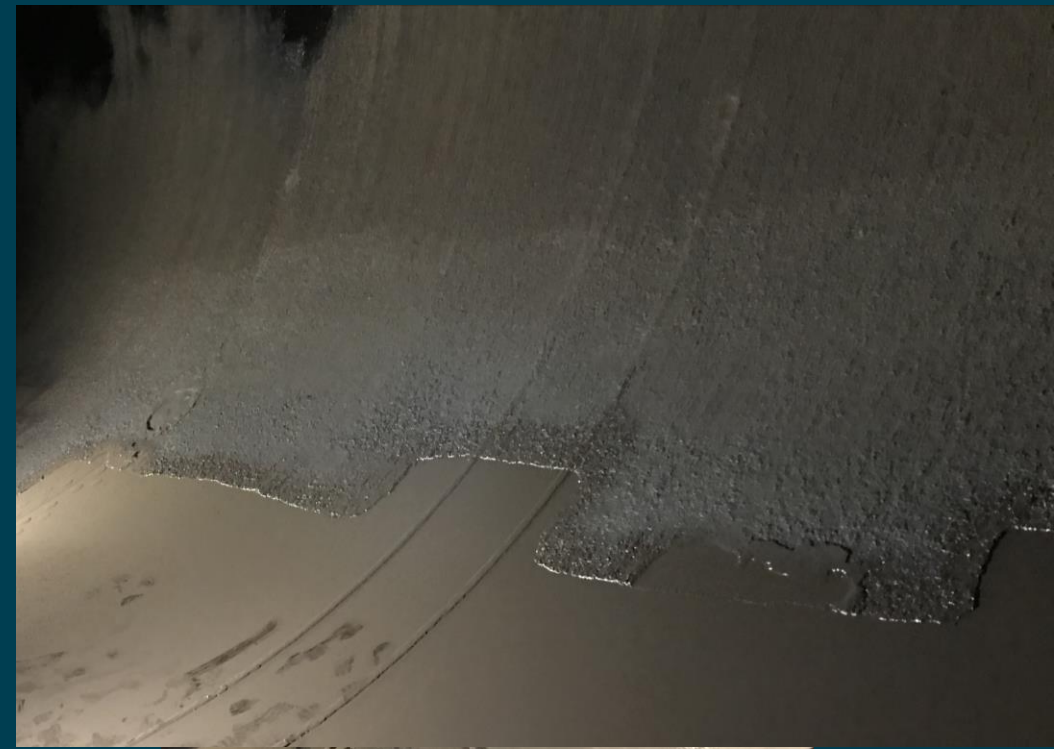
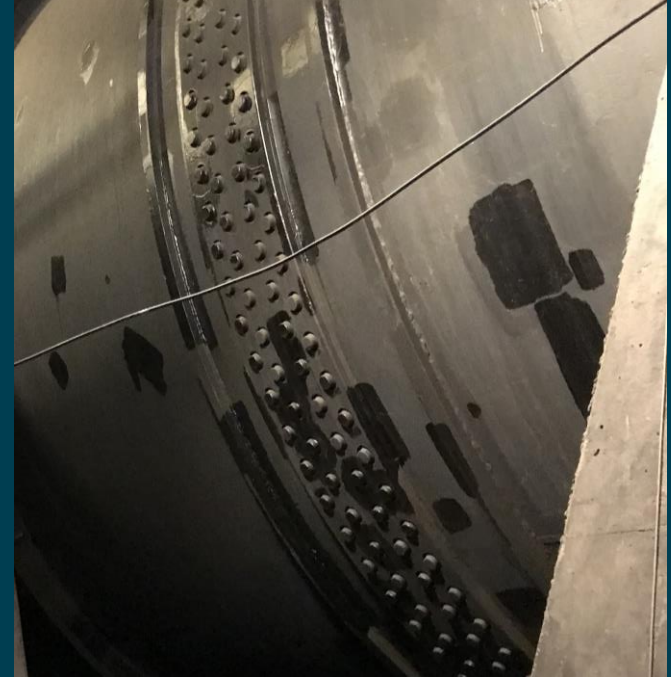
- Facility 1:
  - 25-foot diameter penstock, no slope.
  - Originally coated and lined with coal tar enamel.
  - Accessible from both inside and outside.
  - The exterior coal tar was smoother.
  - Some of the original coating/lining has been spot repaired with a thinner urethane tar material.
  - Large fraction of the upper circumference was already repaired/relined.

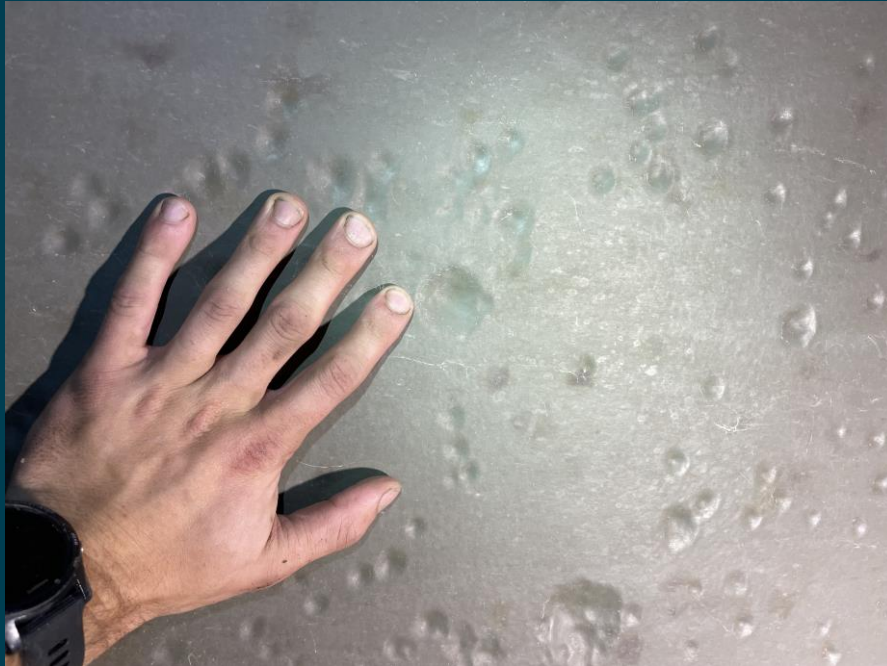
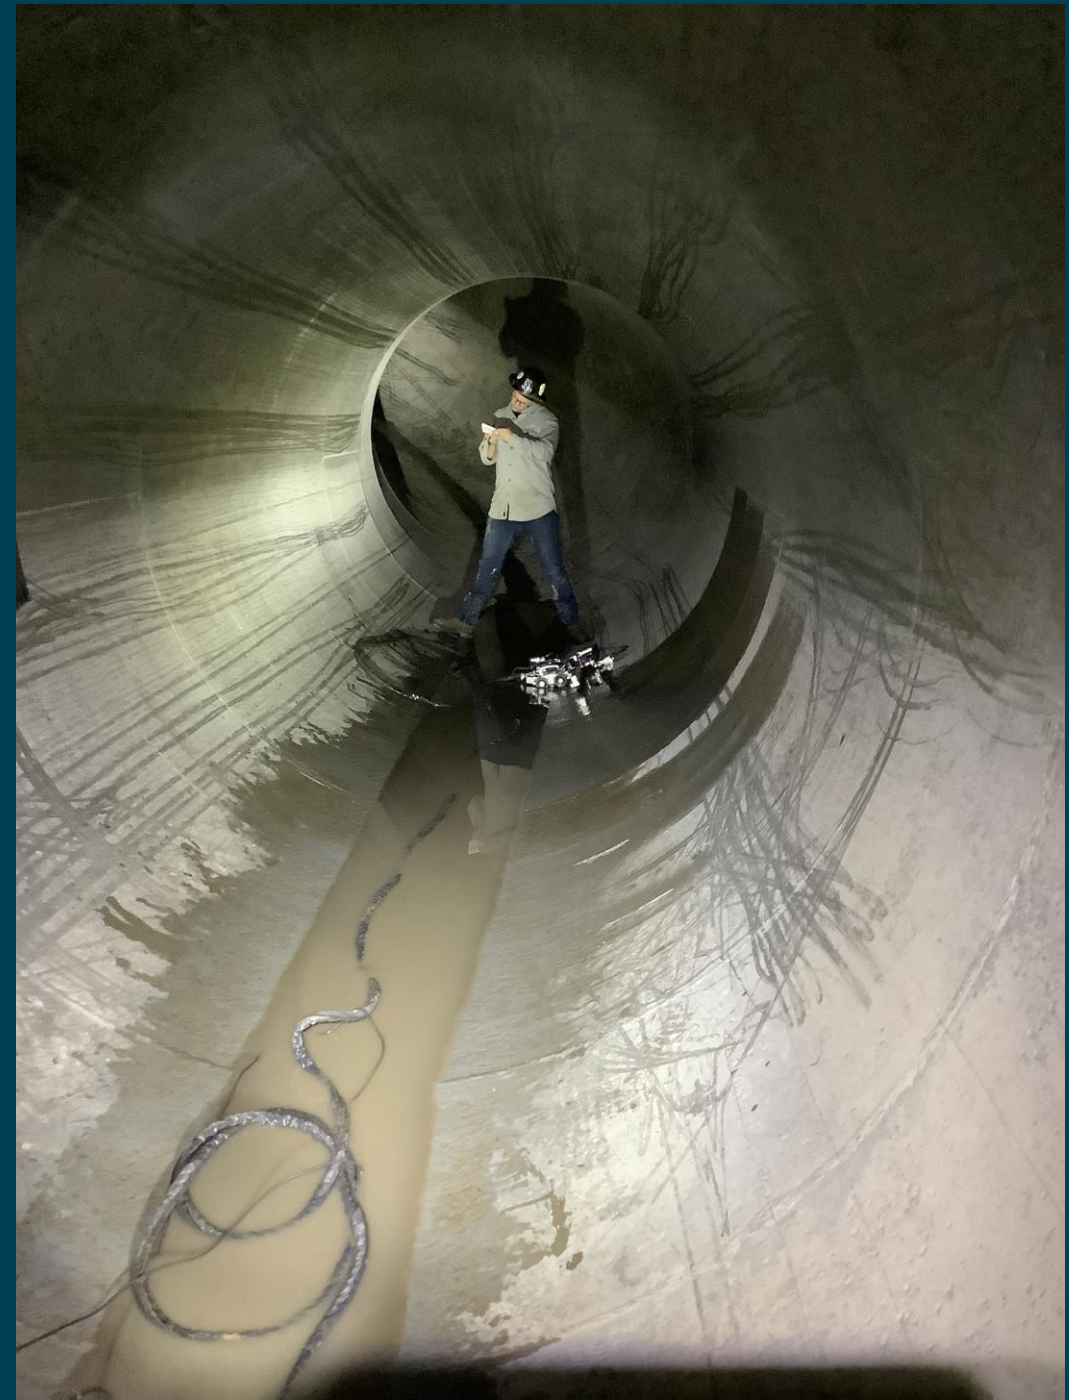
- 96-inch to 108-inch diameter penstock.
- 38-degree slope, requires rope access
- Water and sludge present on the surface
- Relined with epoxy 50-60 mils
- Only accessible from interior
- Prior pitting visible.

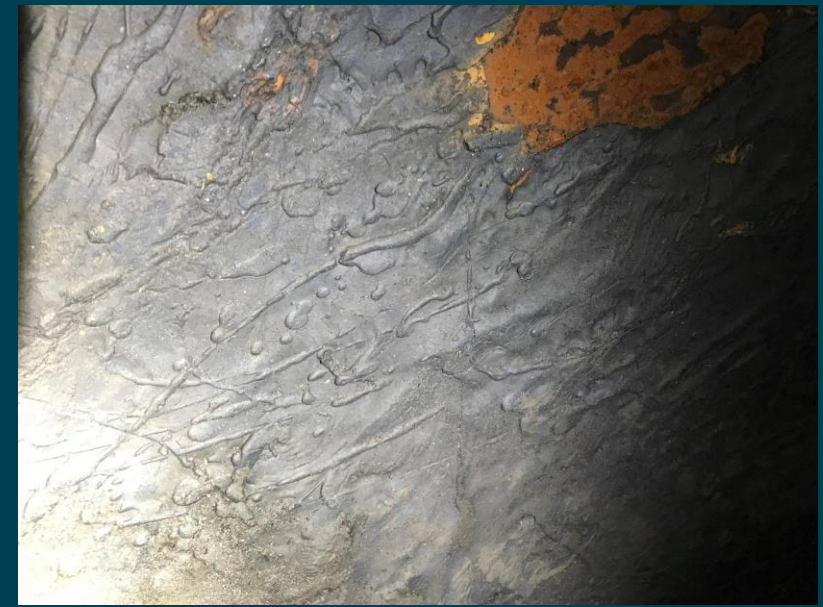
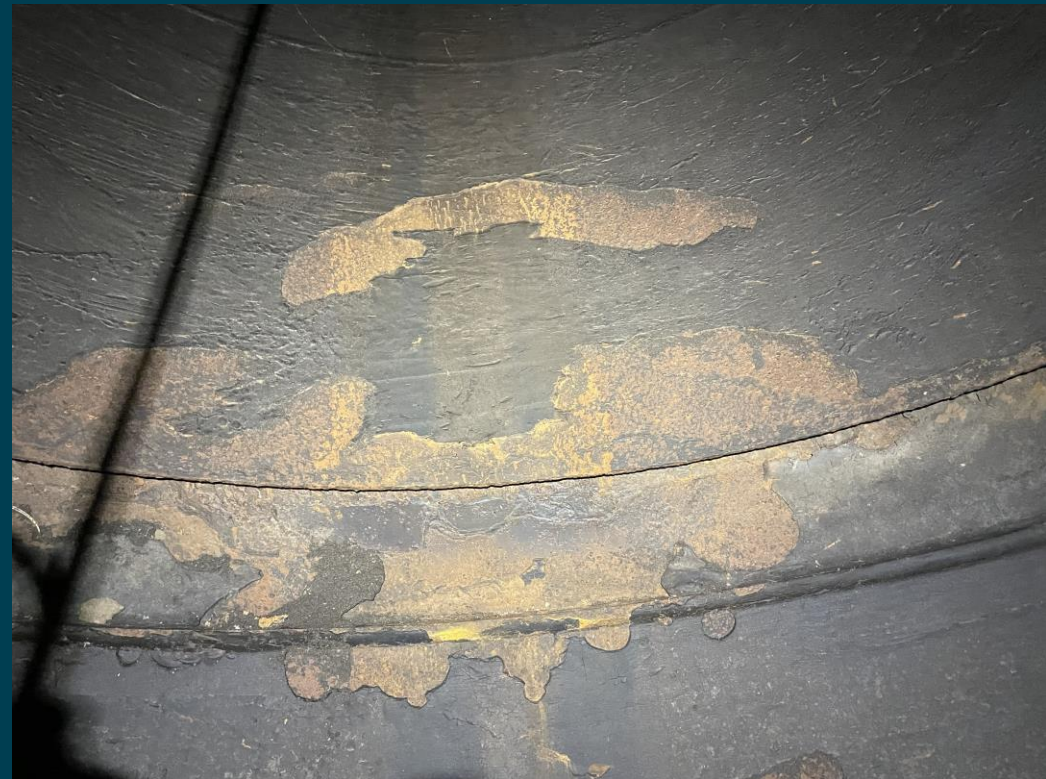
- 96-inch to 60-inch diameter penstock.
- 68-degree slope, requires rope access, dry surfaces
- Original coal tar present in degraded condition
- Accessible from inside only
- 1,000+ feet long (150 feet targeted)

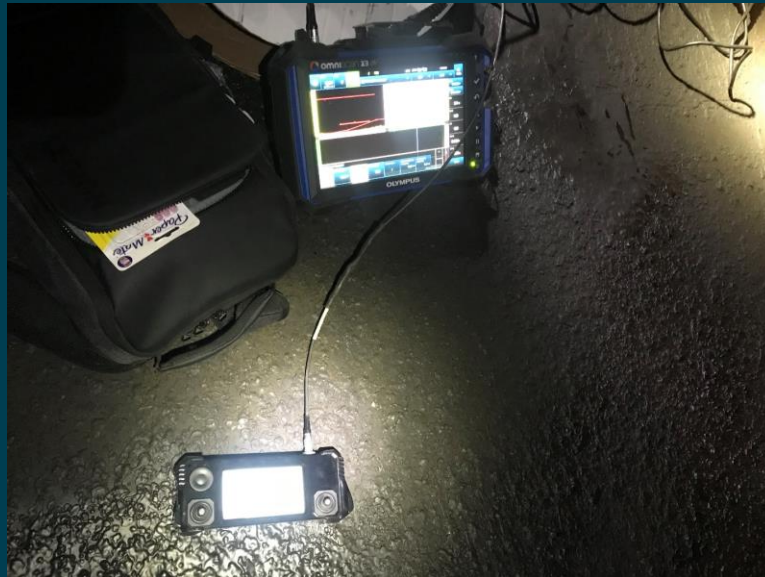
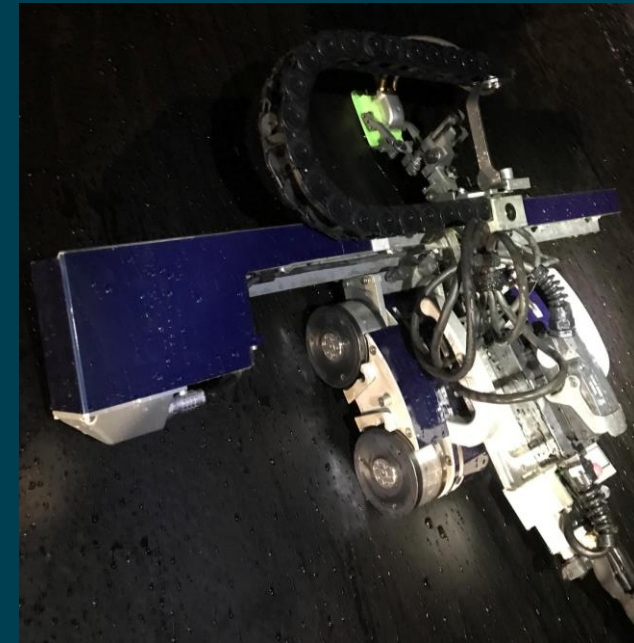
# Results – Facility 1

- RAUT scanning over the spot repaired area (10-14 mils)
- Original CTE too thick and rough to scan
- Rivets, weld seams, and rough lining presented challenges for both driving across and scanning over.
- Performed scanning on one side of the girth seam weld at a time.
- RUG scanning: 945 ft<sup>2</sup>, 8-hour shift

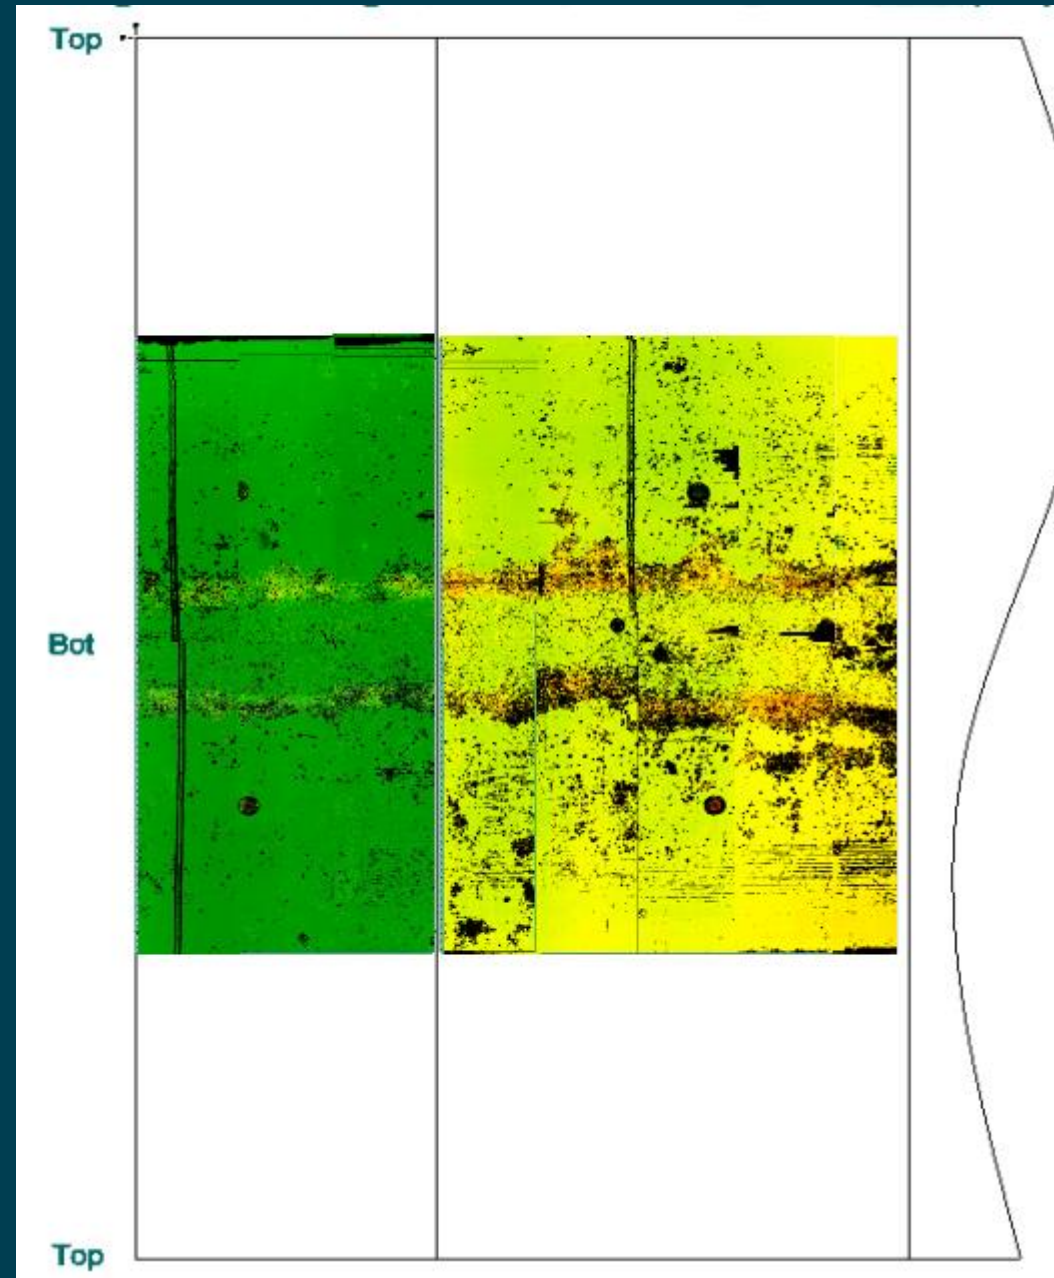
17,488,494 readings taken

185 ft<sup>2</sup>

- The manual UT inspection found a max decrease of **11%** (0.445" with 0.500" nominal).
- Pit gage measurements taken found pits averaged 0.070" with a 0.180" maximum pit depth on 0.500" nominal wall thickness.
- 0.180" deep pit on a 0.500" section would result in 0.320" thickness and **36%** wall loss.
- Both the RUG and RAUT detected lower readings than the manual UT.
- The RUG scanning revealed several low readings:
  - 0.379" in Section 1, flat portion on 96" ID section (**24.2% loss**)
  - 0.366" in Section 2, sloped portion of the 96" ID section (**26.8% loss**)
  - Note: wall loss not provided in the RUG report.
- RAUT results in the flat portion of the pipe were similar with minimum thickness of 0.369" on the flat portion of 96" ID penstock where the reported nominal 0.500" (**26.2% wall loss**).
- It is unclear if RAUT & RUG readings were taken in the pits.
