**ENVIRONMENTAL ASSESSMENT  
WELLSVILLE-MENDON UPPER CANAL PIPELINE  
PROJECT**

**PRO-EA-FY25-044  
JANUARY 2026**

# WELLSVILLE-MENDON UPPER CANAL PIPELINE PROJECT

## PRO-EA-FY25-044

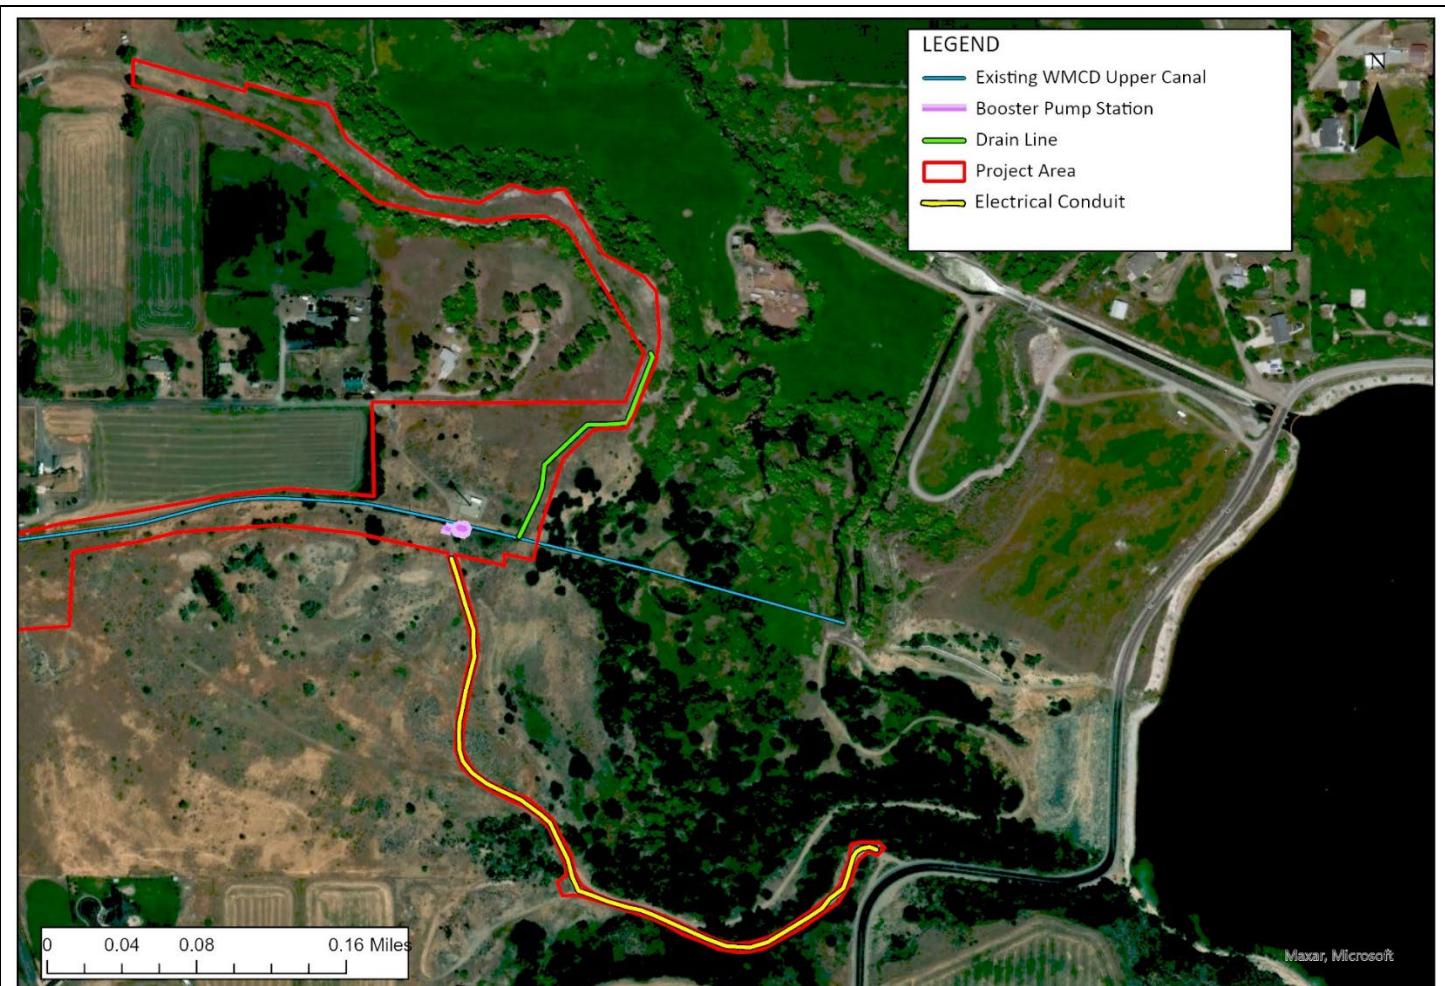
**FIGURE 3 PROPOSED BOOSTER PUMP STATION, DRAIN LINE, & POWER CONDUIT**

Wellsville-Mendon Conservation District  
**Wellsville-Mendon Upper Canal Piping Project Phase II**  
**Proposed Booster Pump Station, Drain Line, & Power Conduit**

The following figures include the project area map, a map of the Proposed Action, and a detailed map of Proposed Action activities near the booster pump station site.

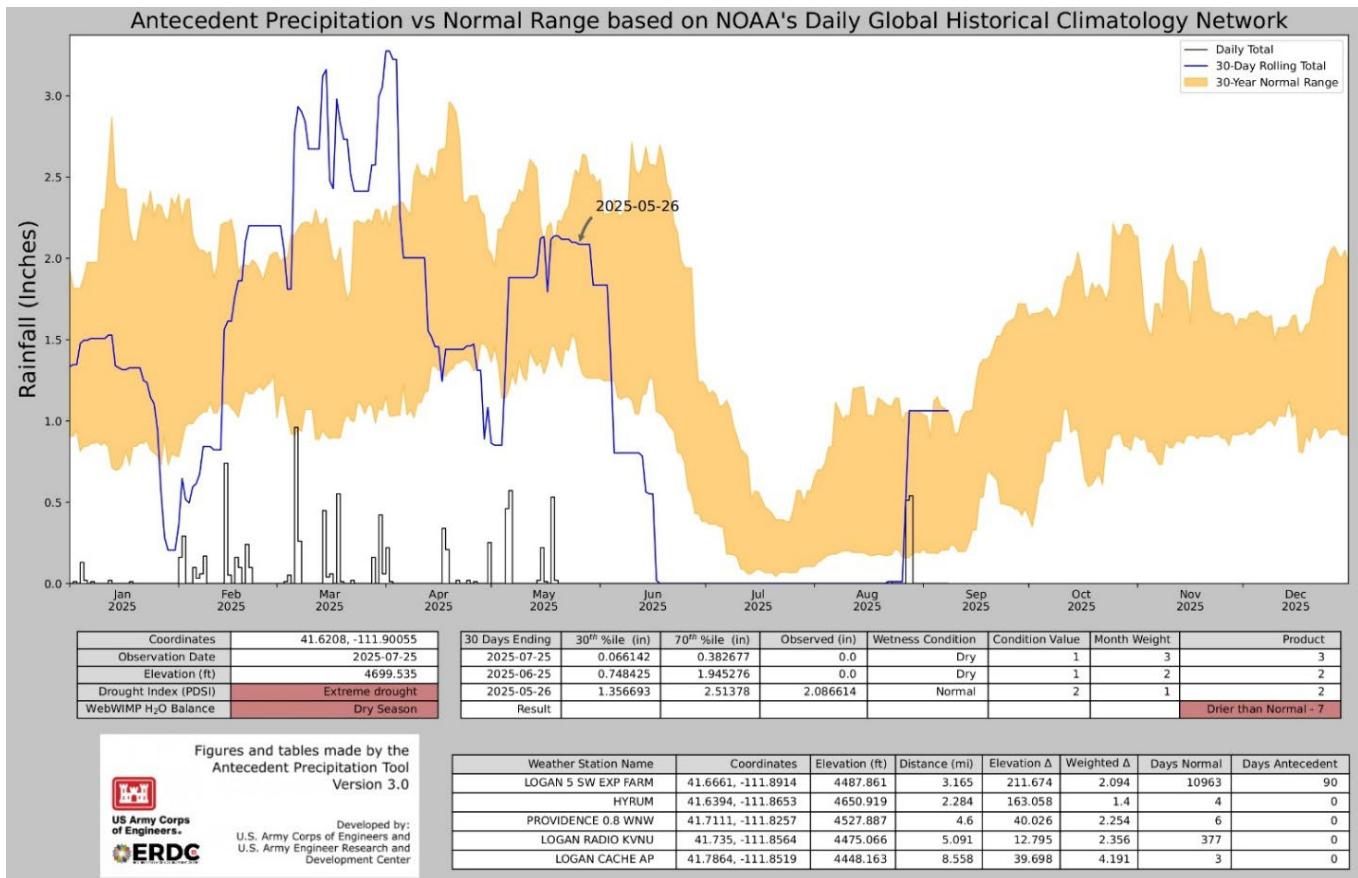
**Figure 1. Antecedent precipitation for the project review area prior to the field survey.**

The weather conditions in the 3 days prior to the field work were hot and dry. The Antecedent Precipitation Tool was run for the project area (Figure 1). The period preceding the field survey was drier than normal (7). The 30-day rolling precipitation total during the winter and early spring was general in the 30-year average range. However, no precipitation was reported beginning in early May through the period preceding the field survey, resulting in the drier than normal condition.

Given that hydrology in the review area is limited to water in the canal, the antecedent precipitation conditions were unlikely to affect the interpretation of the hydrology as it relates to the identification of aquatic resources in the review area.

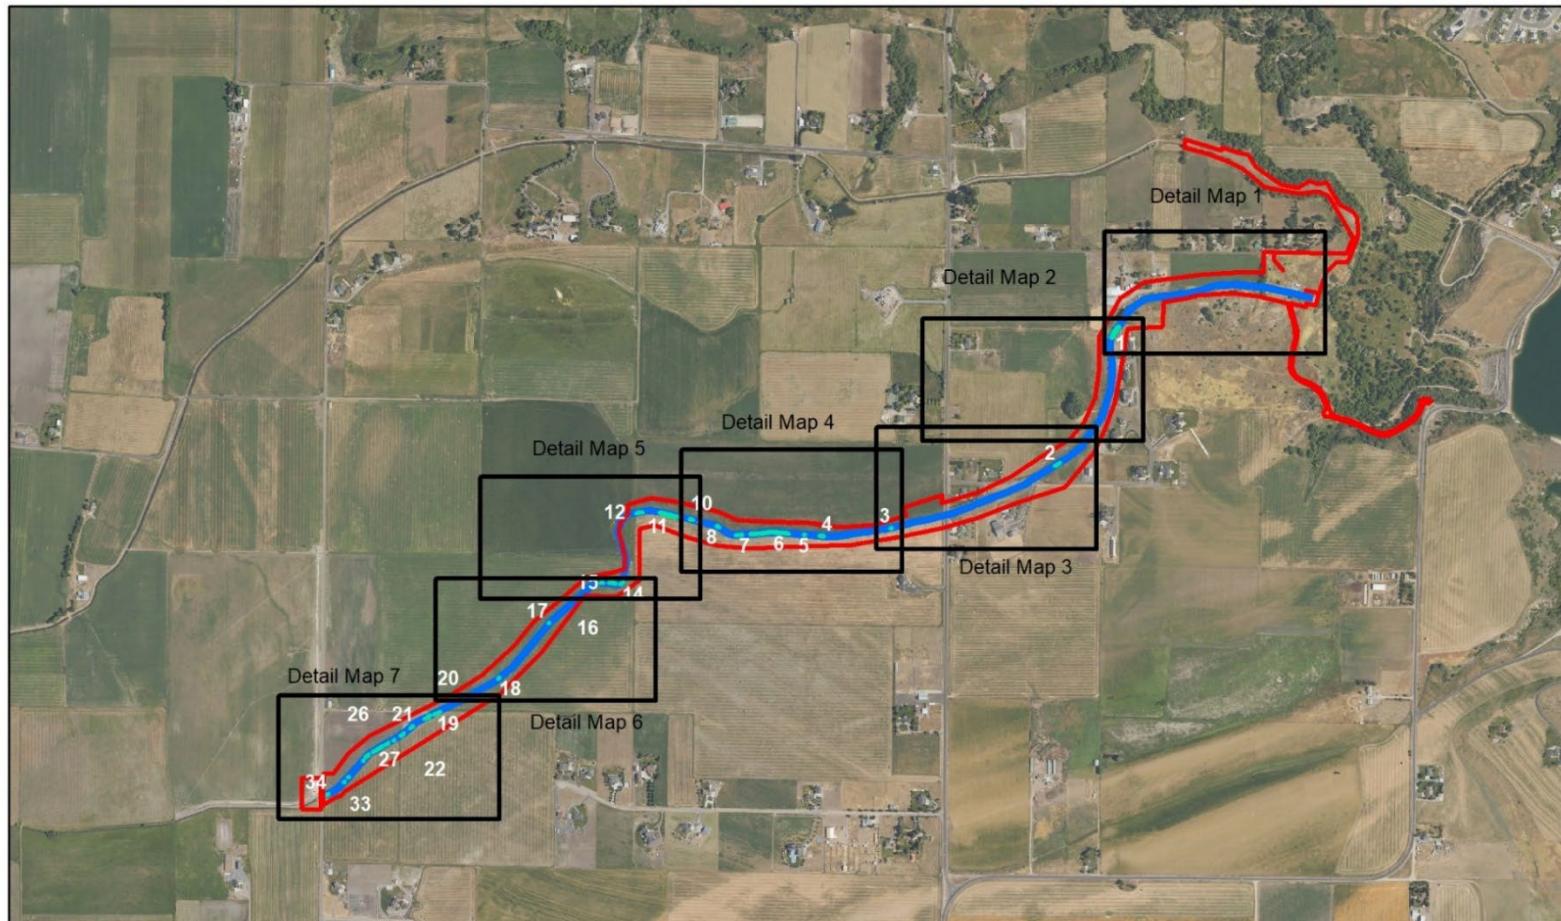
Figure 4. Aquatic resources delineation map of the project review area.

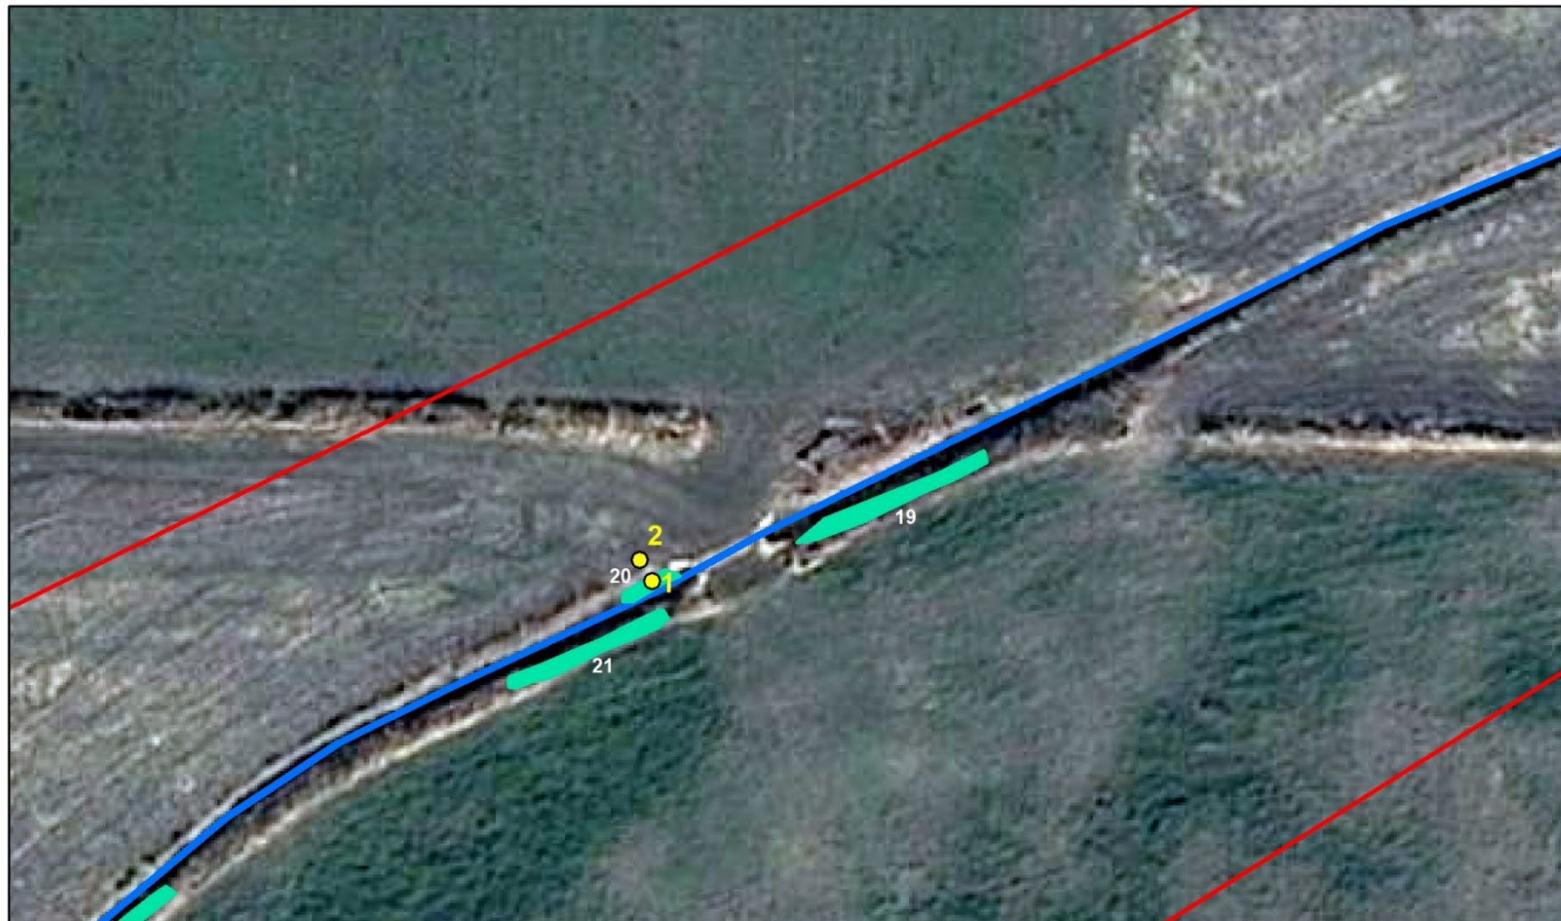
**Figure 5a. Aquatic resources delineation map of the project review area, sample points 1 and 2.**

The soil profile description for the soils in the sample points SP1 and SP3 were 10YR 3/1 with no observed redox features, clay (Appendix E). Soils were saturated and thus met the criteria of a hydric soil (... a soil that formed under conditions of saturation, flooding, or ponding long enough during the growing season to develop anaerobic conditions in the upper part- Field Indicators of Hydric Soils in the United States A Guide for Identifying and Delineating Hydric Soils, Version 8.0, 2016.). However, hydric soil field indicators were not observed. Repeated excavation/maintenance could limit the potential development of hydric soil indicators.

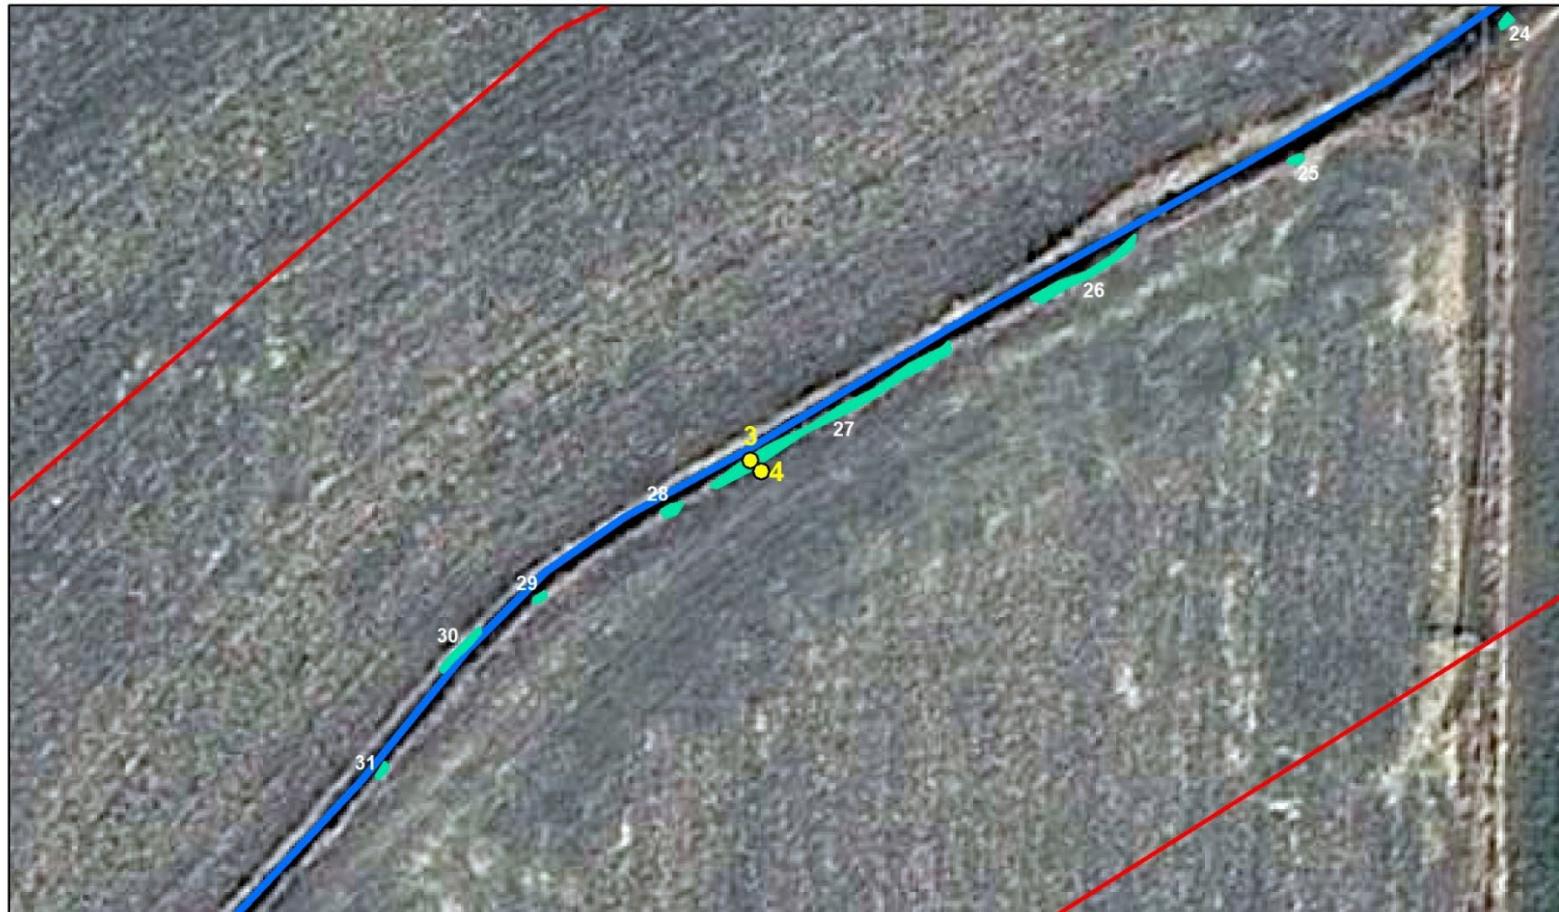
**Figure 5b. Aquatic resources delineation map of the project review area, sample points 3 and 4.**

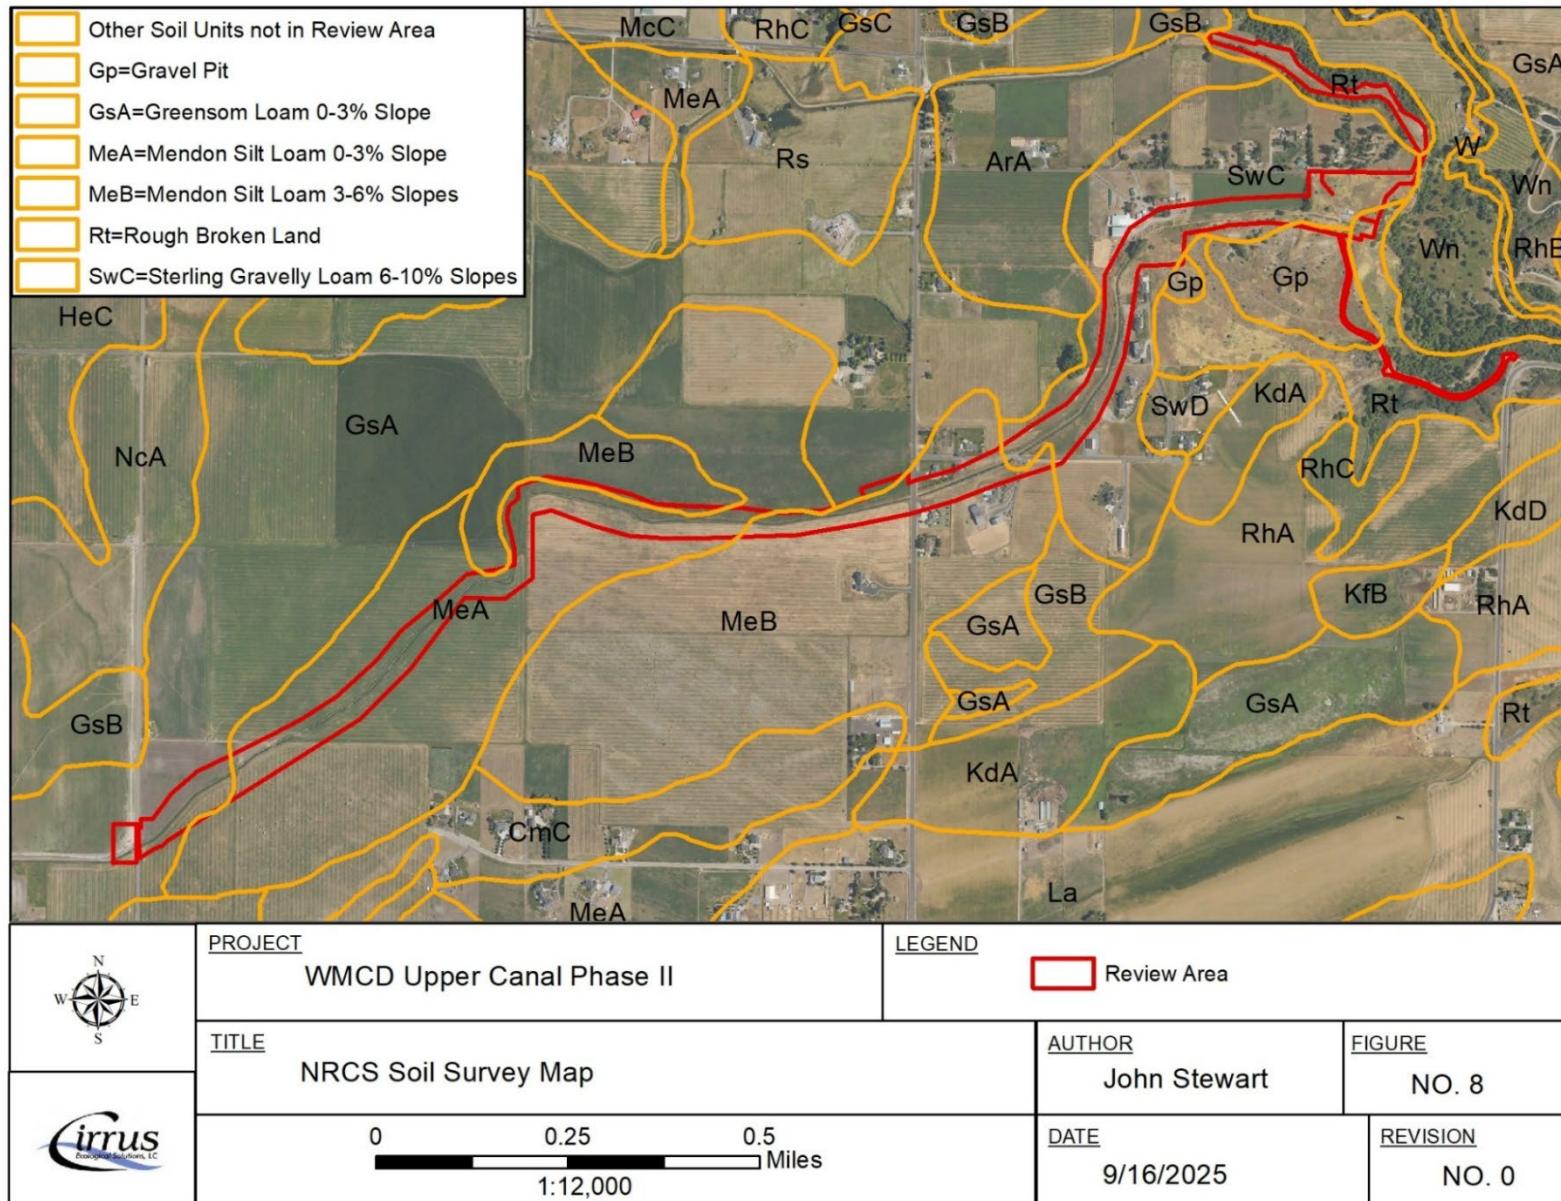
Figure 8. Natural Resources Conservation Services soil survey map of the project review area.

Soils data from the Web Soil Survey (<https://websoilsurvey.nrcs.usda.gov/app/>) was obtained for the project area (Figure 8, Appendix D). The primary soil map units in the review are Mendon Silt Loam, 0 to 3 Percent Slopes, Mendon Silt Loam, 3 to 6 Percent Slopes, Sterling Gravelly Loam, 6 to 10 Percent Slopes, Greenson Loam, 0 to 3 Percent Slopes, Gravel Pit, and Rough Broken. Only the Greenson Loam is listed as a hydric soil. Due to the absence of hydrology except within the lower canal profile, soils in the review area do not meet the definition of a hydric soil.

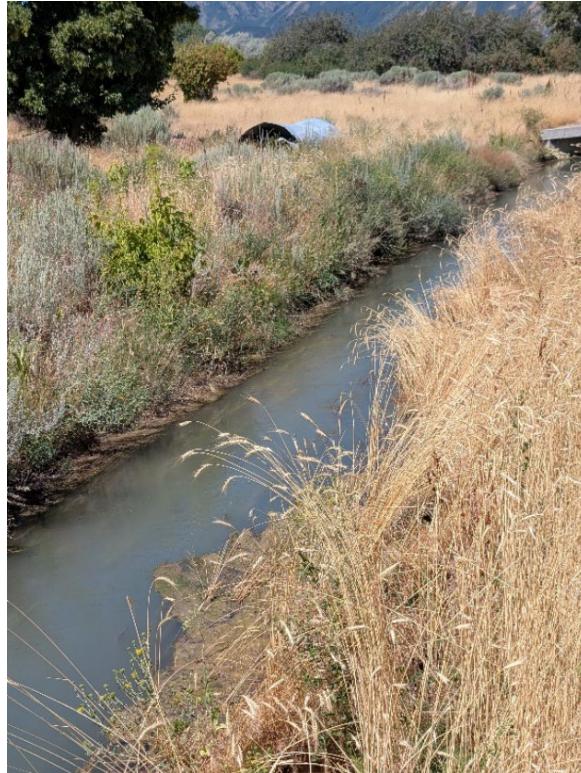
**Photo 1.** East end of canal just below the discharge to the canal, looking west.

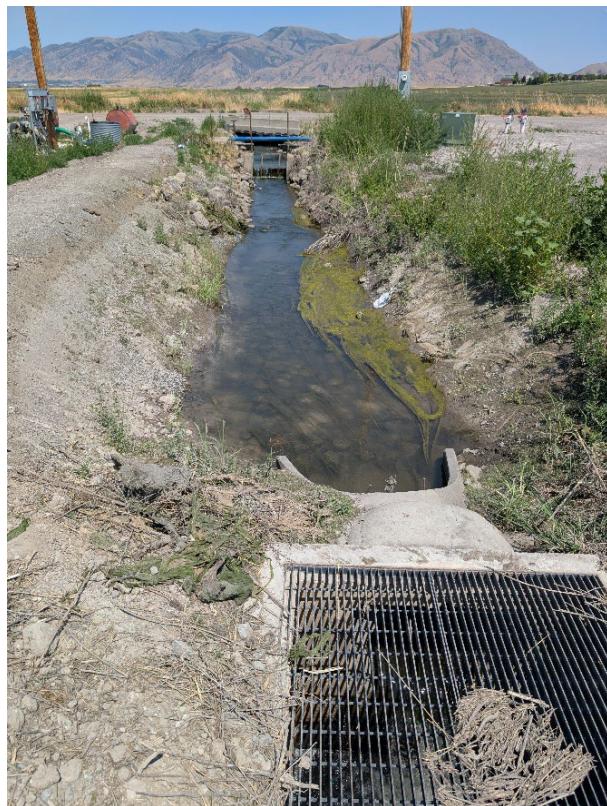
**Photo 12. Looking east at the west end of the canal, showing the connection with the Phase I pipeline.**
