**LEVEL II DOCUMENTATION OF
A PORTION OF THE NORTH DELTA CANAL (5DT1738.6),
DELTA COUNTY, COLORADO**

Jonathon C. Horn
Principal Investigator

Alpine Archaeological Consultants, Inc.
PO Box 2075
Montrose, Colorado 81402

January 2020

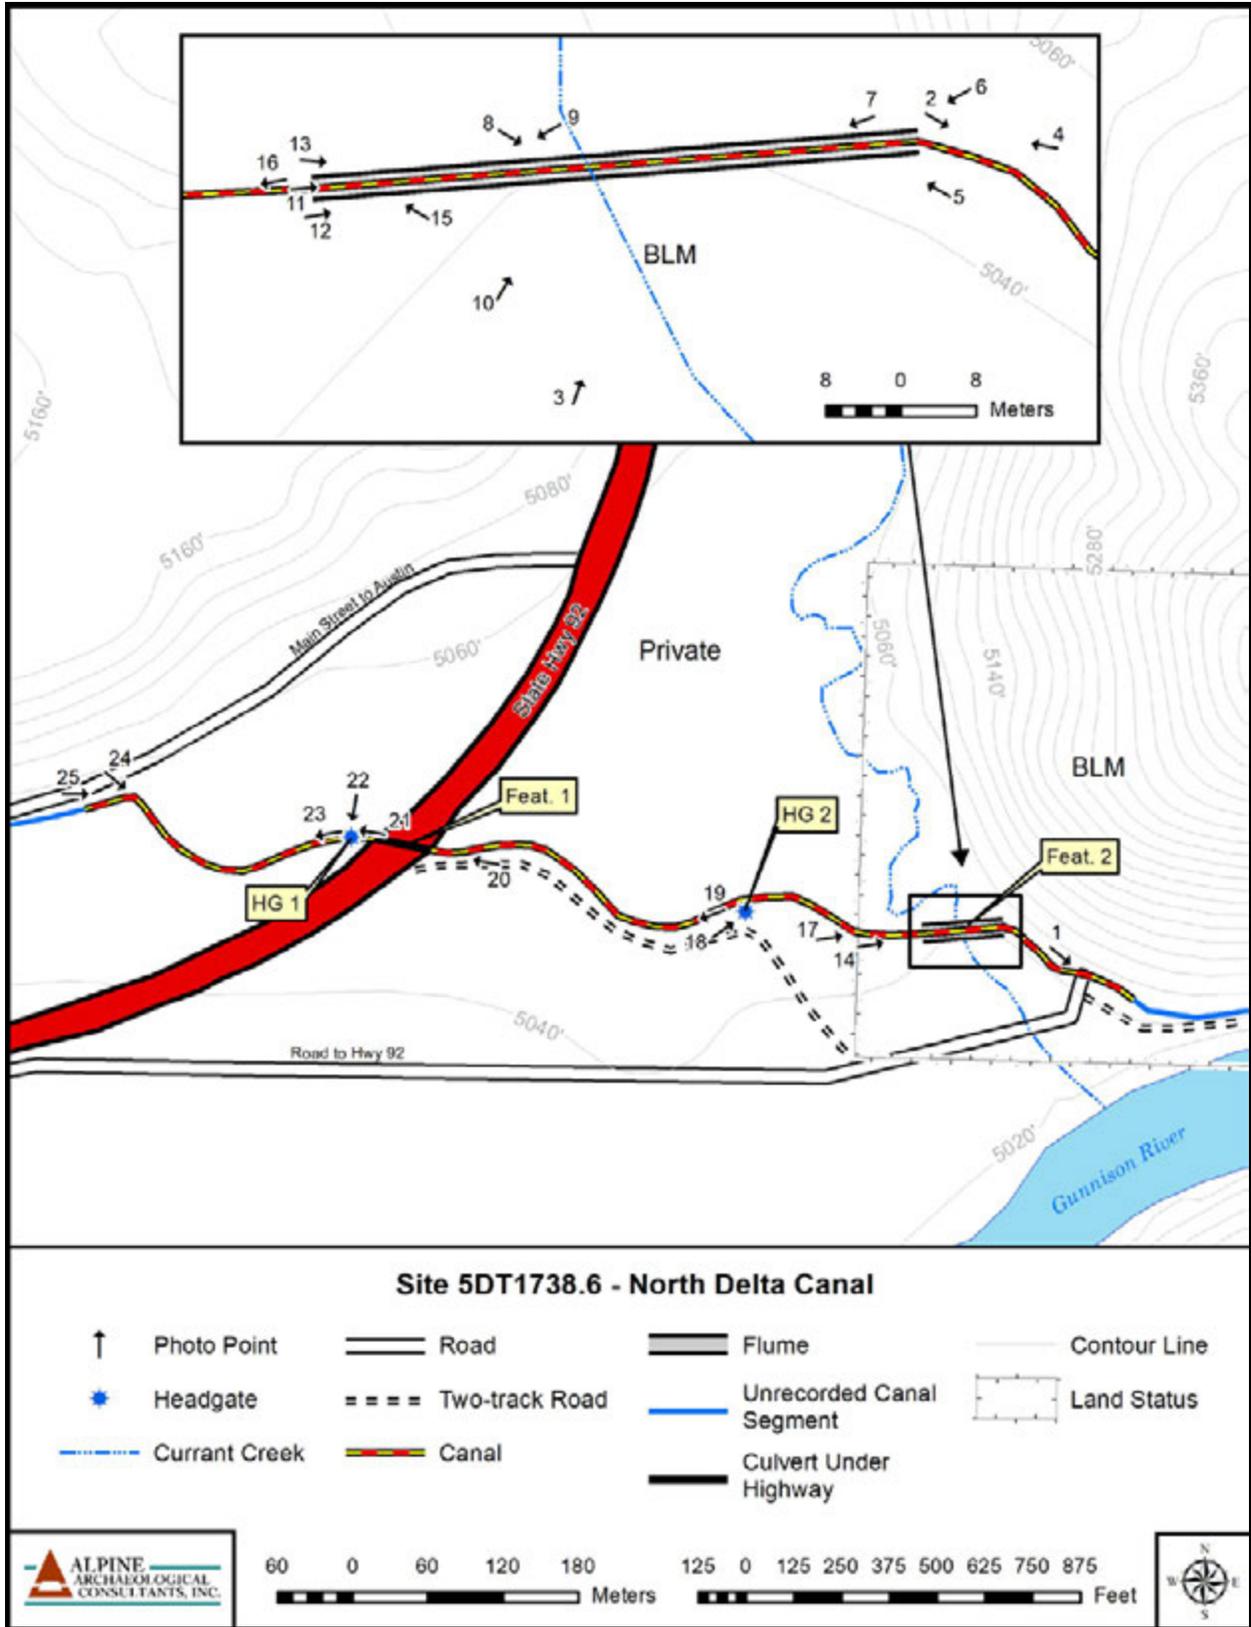
Map 2.

Map 3: Plan map of the documented segment of the North Delta Canal showing photographic points.

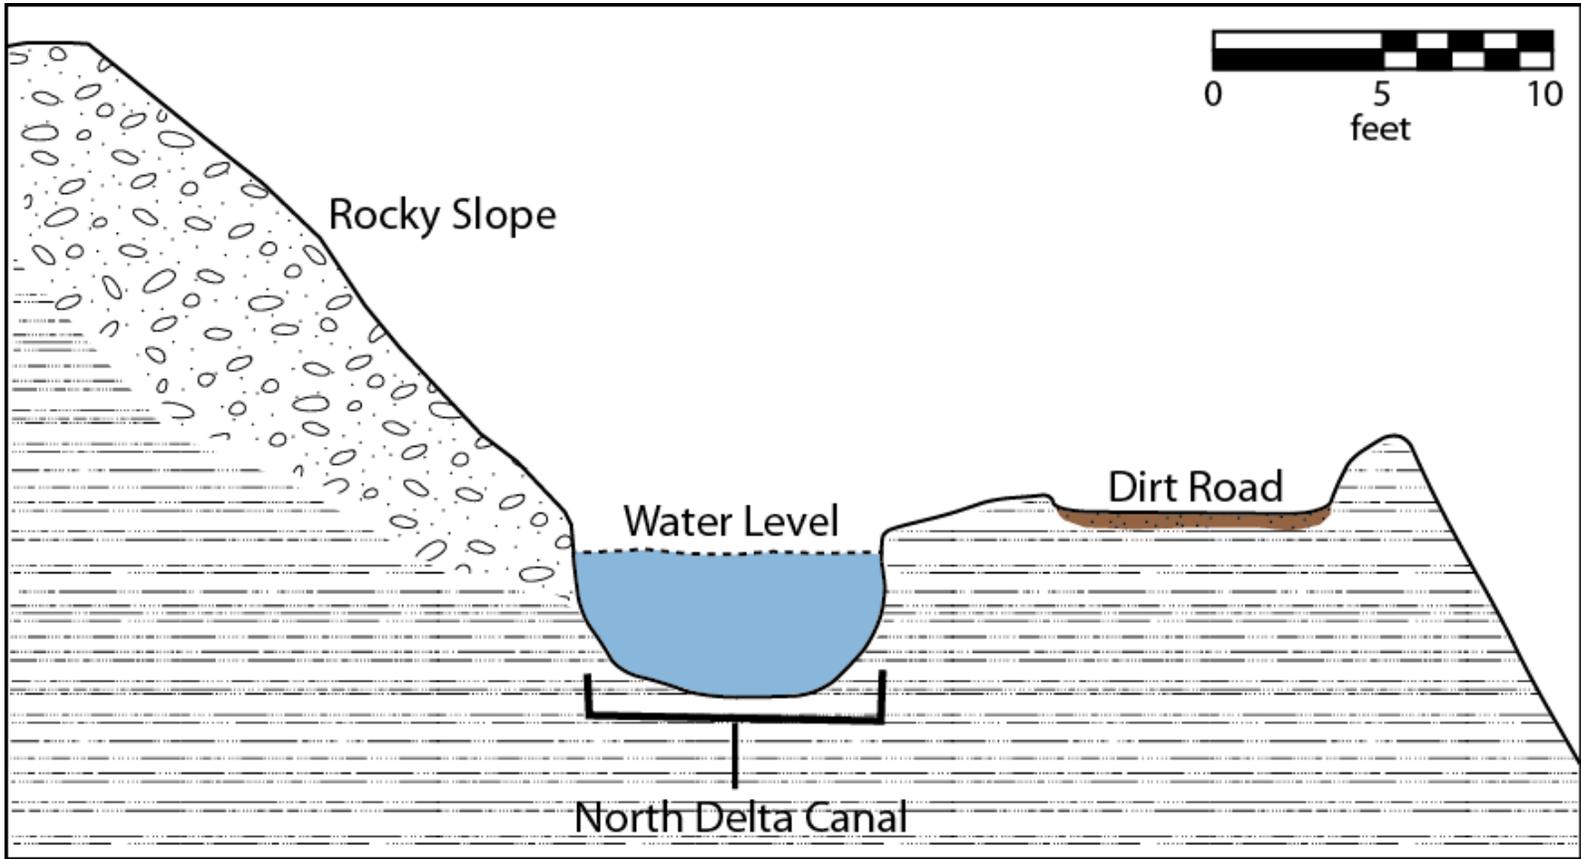
Map 3.

Map 4: Profile drawing of typical canal cross-section.

The 0.57-mile-long documented segment of the North Delta Canal (5DT1738.6) begins about 200 ft. north of the Gunnison River about 2.5 miles west of its headgate. The documented segment runs generally east to west, crosses State Highway 92, and terminates just east of Austin, Colorado. The segment is an earthen ditch about 10 ft. wide and 3 ft. deep cut into Mancos Shale hills on its eastern portion and passing through agricultural land on its western portion. The most notable element of the canal is a 190-ft.-long flume across Currant Creek. Two-track roads about 8 ft. wide are built on the top of the cut-and-fill spoil side of the canal along the southern side of the canal on both sides of the flume east of State Highway 92. No road follows the canal segment west of State Highway 92. Two headgates are on the southern side of the canal, and the canal passes through a modern concrete culvert beneath State Highway 92.

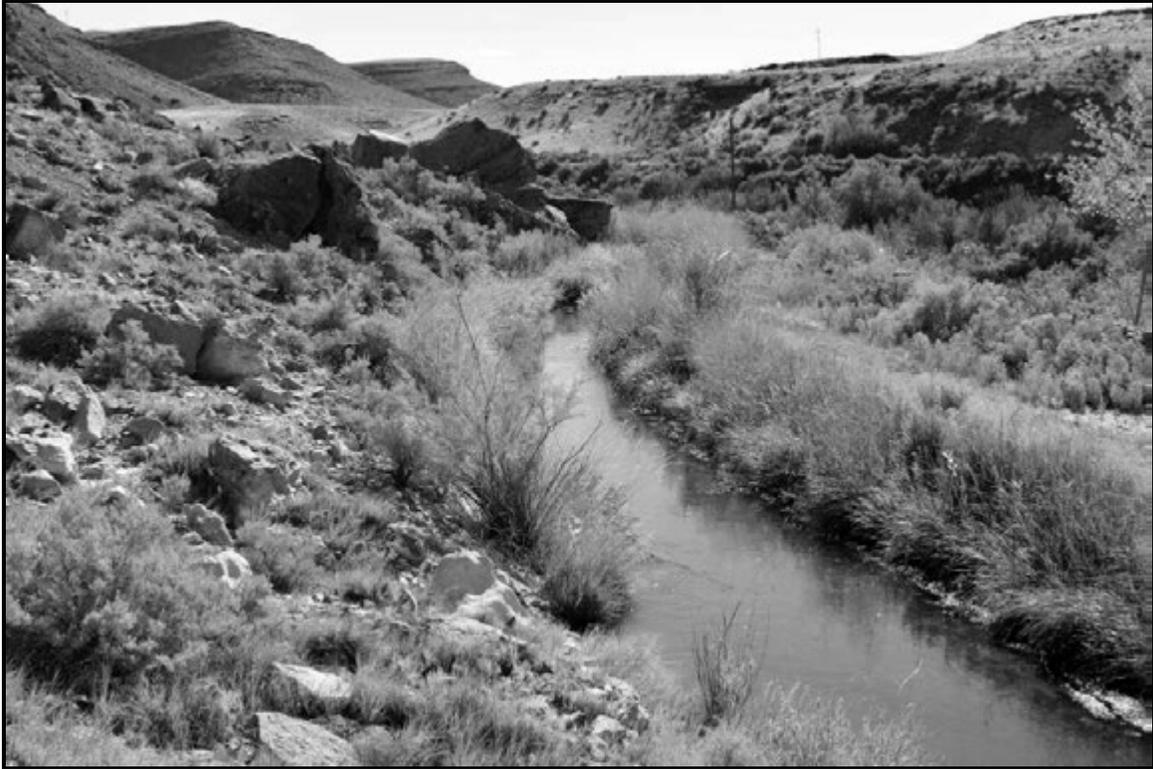
5DT1738.6
Photograph No. 1

Photograph 1. Looking upstream to the southeast along the easternmost section of the documented portion of the North Delta Canal.

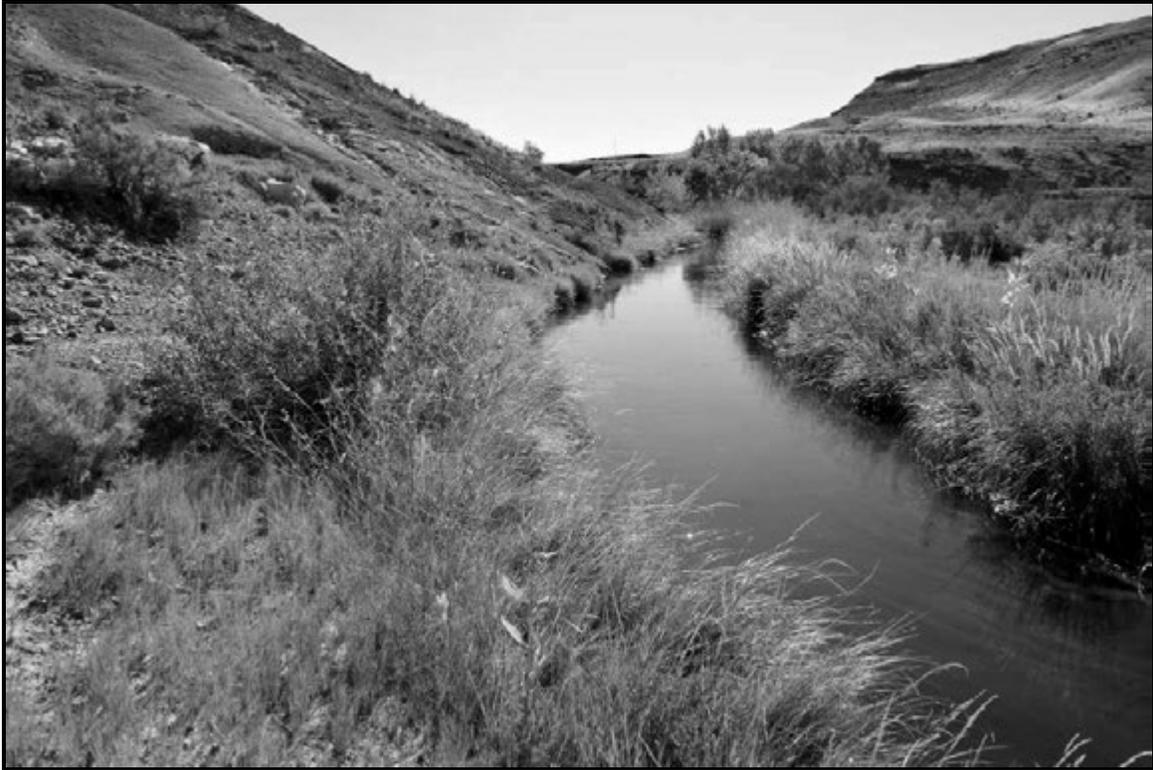
5DT1738.6
Photograph No. 2

Photograph 2. North Delta Canal immediately upstream of the flume across Currant Creek. View is to the east-southeast.

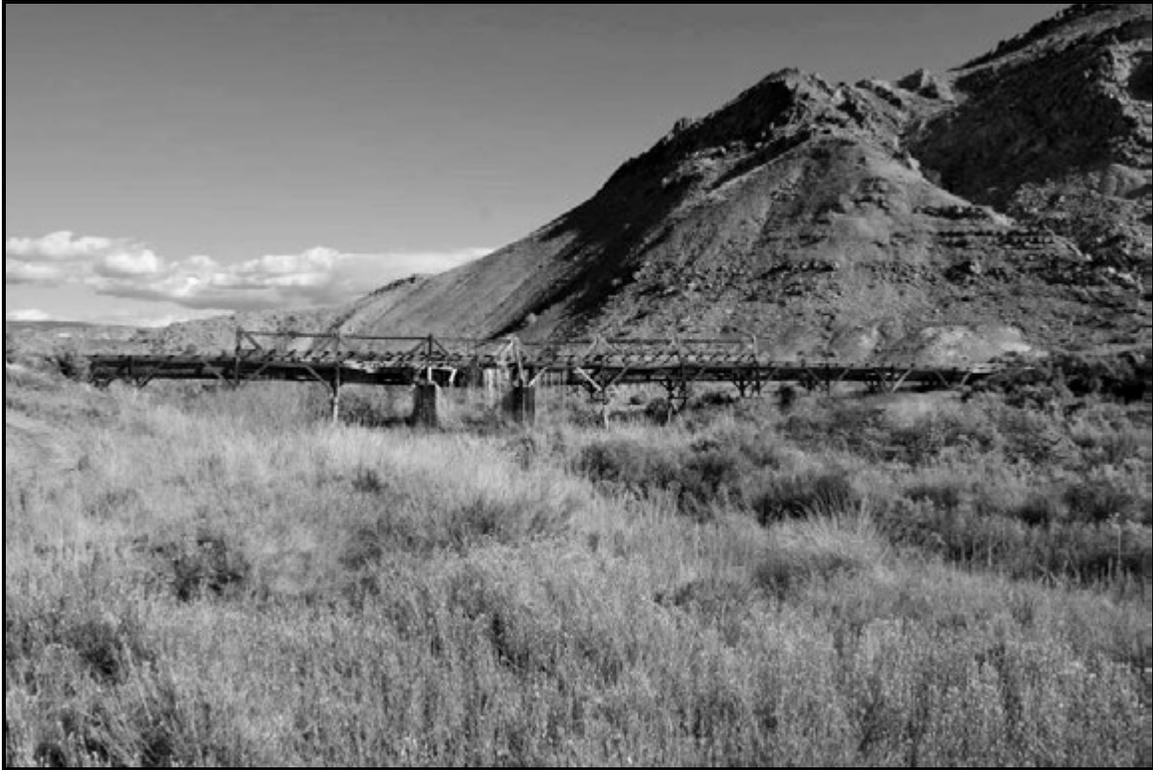
5DT1738.6
Photograph No. 3

Photograph 3. The flume crossing Currant Creek on a trestle, looking north-northeast.

The 190-ft.-long flume over Currant Creek (Feature 2) is supported by a wooden trestle and two concrete piers. Three trestle bents are on the western end of the flume, the two concrete piers are on the west-central portion, and seven trestle bents are on the eastern end, which is built on a more gradual slope than the western end. The trestle bents are spaced at 16-ft. intervals and constructed of 6-x-6-in. post legs set on pyramidal concrete piers. The heights of the trestles vary from 2–10 ft. tall, depending on the topography, and are a maximum of 10 ft. wide. The legs slope slightly inward, are supported by 3-x-6-in. horizontal and diagonal braces, and are secured with ½-in.-diameter square-headed bolts, cast-iron collar washers, and square nuts. The two mid-span

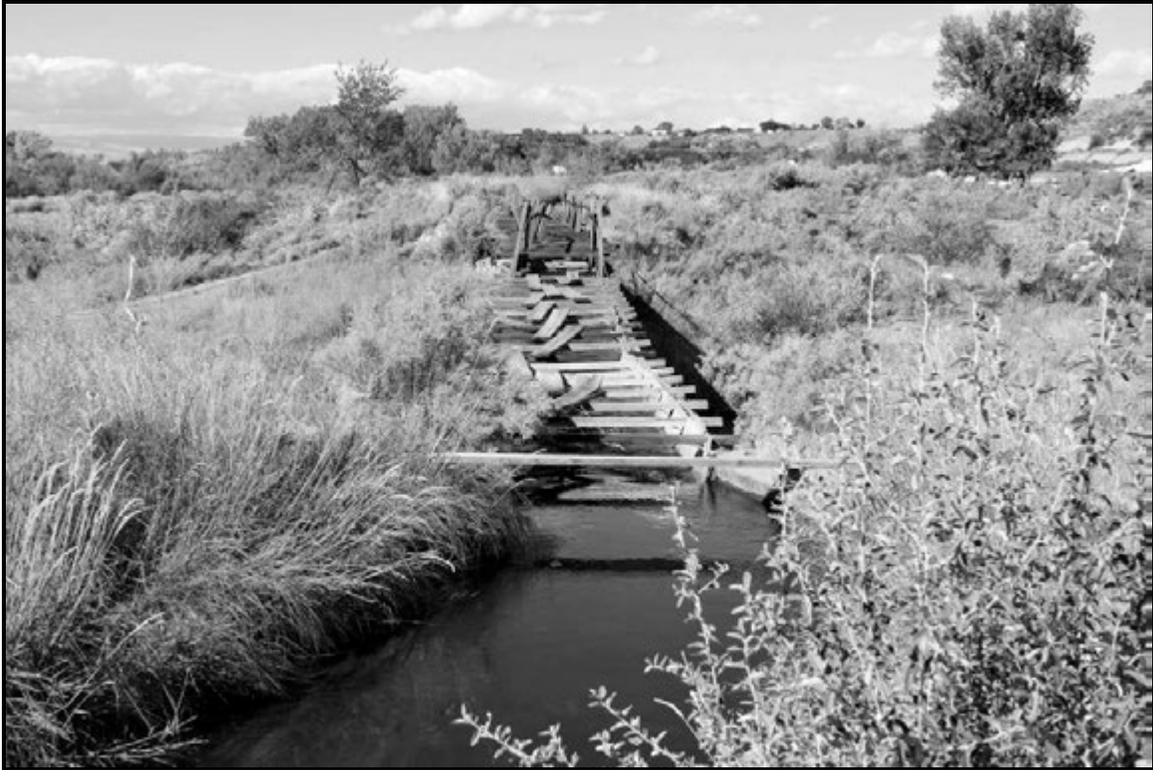
5DT1738.6
Photograph No. 4

Photograph 4. Looking downstream to the west across the top of the flume over Currant Creek. Note the concrete entry structure angling inward to the flume entry.

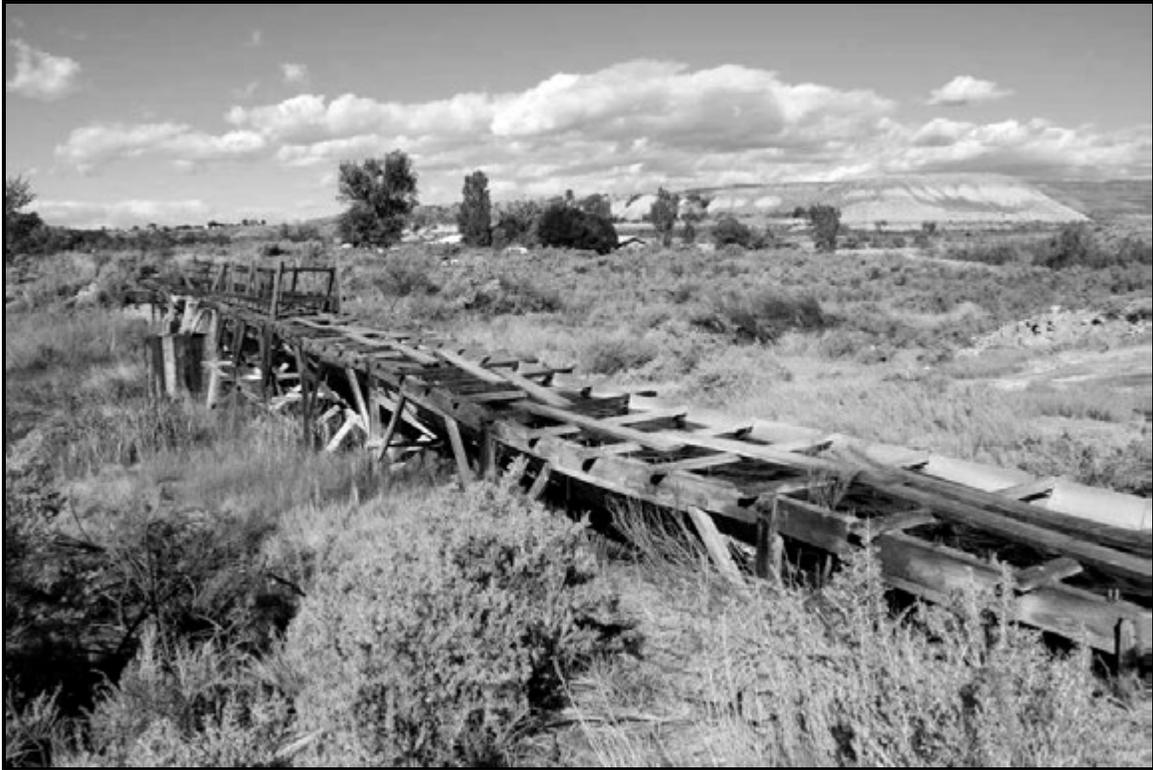
5DT1738.6
Photograph No. 5

Photograph 5. Southern side of the flume on a trestle across Currant Creek, looking west-northwest.

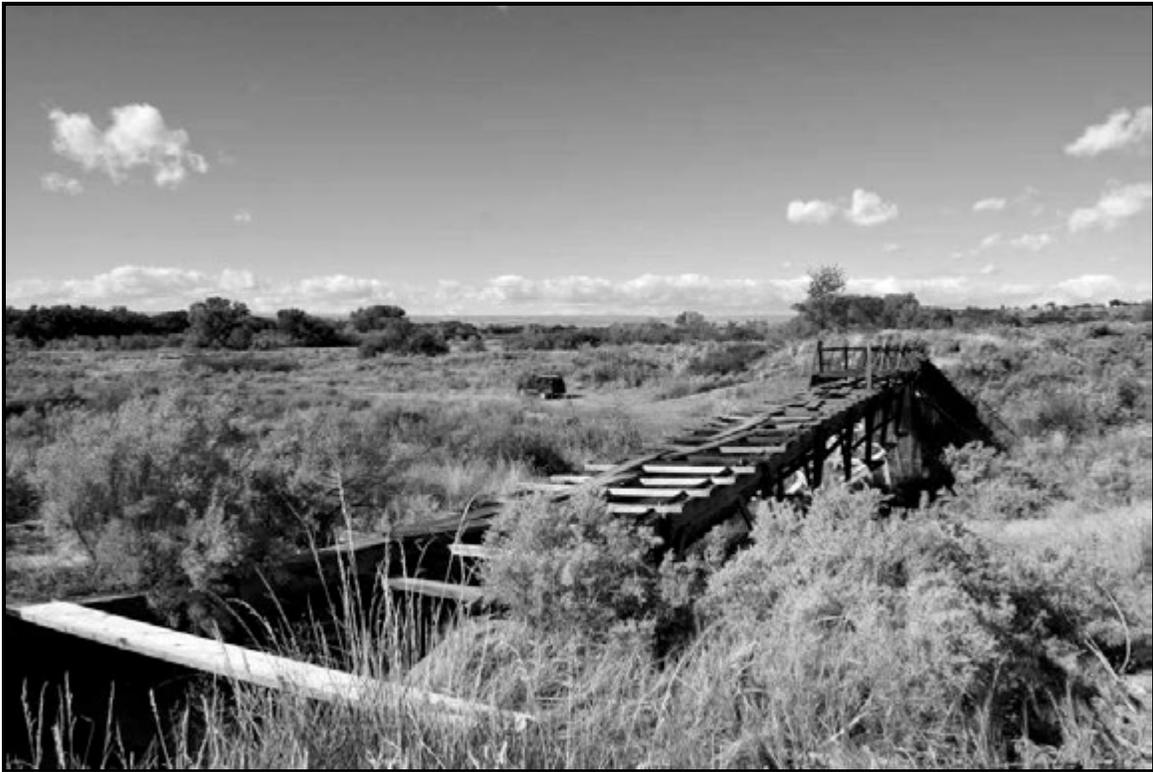
5DT1738.6
Photograph No. 6

Photograph 6. Northern side of the flume on a trestle across Currant Creek. View is to the west-southwest.

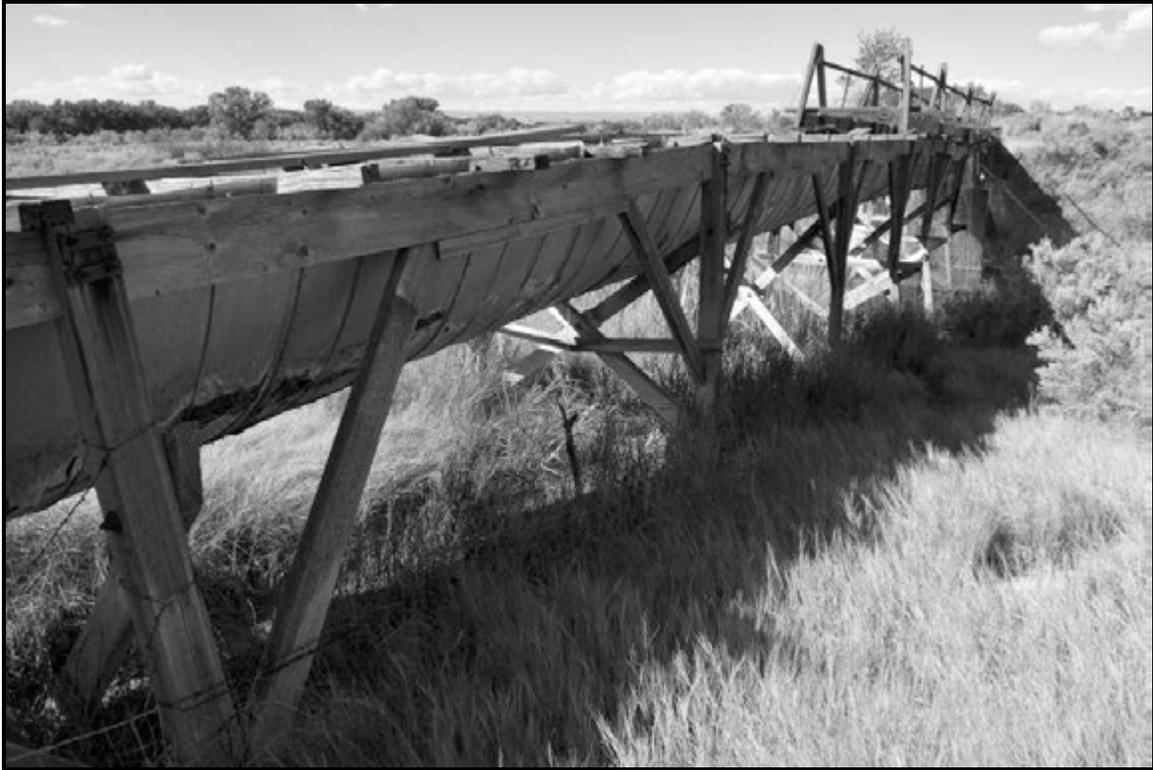
5DT1738.6
Photograph No. 7

Photograph 7. Eastern end of the northern side of the flume across Currant Creek, looking west-southwest. Note the recently reinforced section of the flume in the distance.

concrete piers are of relatively recent installation and measure 2 x 14 ft. and 2 x 16 ft., respectively, and are 10 ft. tall. These were poured around makeshift wooden angle braces on the northern side of the flume that were installed to prevent the flume from collapsing. The top sides of the 8-ft.-wide semicircular sheet-metal flume are attached with iron brackets to 4-x-10-in. stringers laid on edge; 3-x-4-in. board crosspieces span the top of the flume every 3 ft., providing additional support. The stringers are supported by the tops of the trestle legs, diagonal 3-x-6-in. angle braces extending upward from the legs, and wooden posts and angle braces extending upward from the tops of the concrete piers. The deteriorating condition of the trestle required the recent addition of bracing above the central portion of the flume that extends above two of the trestle bents on the western end, the two concrete piers, and three trestle bents on the eastern end, covering a distance of 96 ft. Laid on top of the stringers are 2-x-8-in. planks set on edge that are spanned by 3-x-3-in. crosspieces through which eyebolts are attached near the ends that allow the attachment of sections of $\frac{3}{8}$ -in.-diameter wire rope that are slung beneath the sheet metal flume and secure horizontal sections of 2-x-4-in. boards along the sides and bottom of the flume. The new construction includes upright 3-x-6-in. posts that extend above each trestle bent and the two concrete piers to which paired 2-x-6-in. board diagonal braces are attached with bolts. A rather insubstantial 2-x-4-in. board railing is attached between the uprights. The flume itself is 8-ft.-diameter, semi-circular galvanized sheet metal cut into 4-ft.-long sections that are ribbed every 16 in. Flume sections are screwed together from the inside. Additional projecting screws suggest that the interior has been lined with added sections of sheet metal. Concrete entry and exit structures on the eastern and western ends of the flume are identical. These have 7-in.-thick poured concrete walls that form 8-ft.-wide channels at the connections to the ends of the flume. Extending at right angles into the banks at the flume connections are 7½-ft.-long wing walls. From the flume connections, the channels have 8-ft.-long long walls that flare outward to about 12 ft. wide that terminate in 4-ft.-long wing walls that extend at right angles into the banks. The entry structure walls on the eastern end of the flume are mostly obscured by soil and vegetation; the exit structure walls on the western end of the flume are more visible. Beneath the western end of the flume, an earlier exit structure/headwall can be seen. This is constructed of poured concrete, is about 14 ft. wide, and has diagonal wing walls extending into the banks on both sides; it now serves as a retaining wall supporting the slope beneath the western end of the flume.

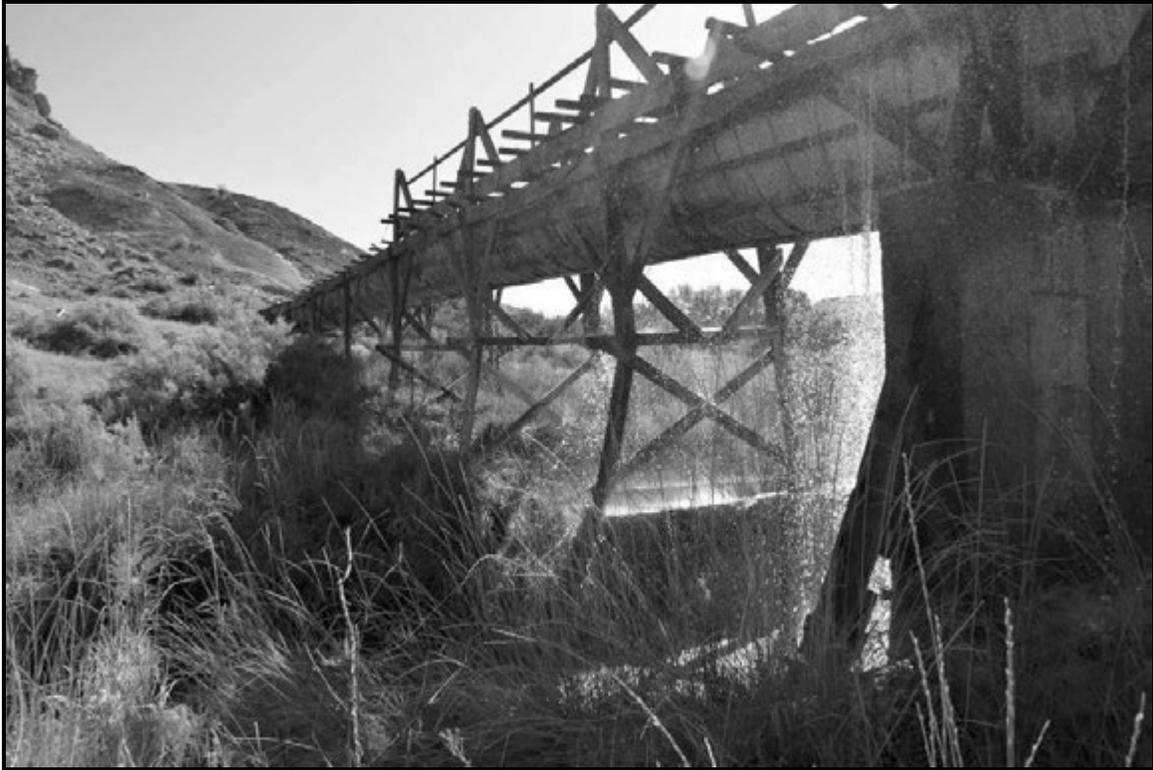
5DT1738.6
Photograph No. 8

Photograph 8. Looking east-southeast at the underside of the eastern portion of the northern side of the flume on a trestle crossing Currant Creek.

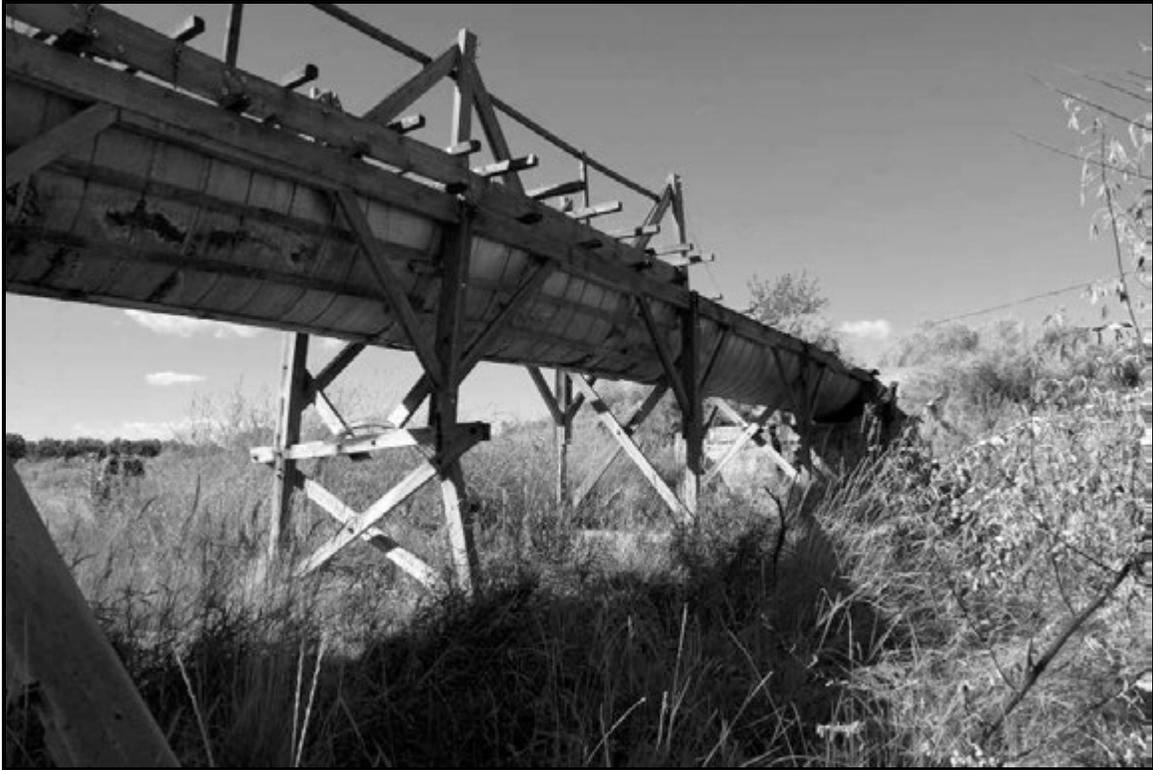
5DT1738.6
Photograph No. 9

Photograph 9. Underside view of the western end of the northern side of the flume on a trestle crossing Currant Creek. View is to the west-southwest. Note the typical trestle supports with recent reinforcement above.

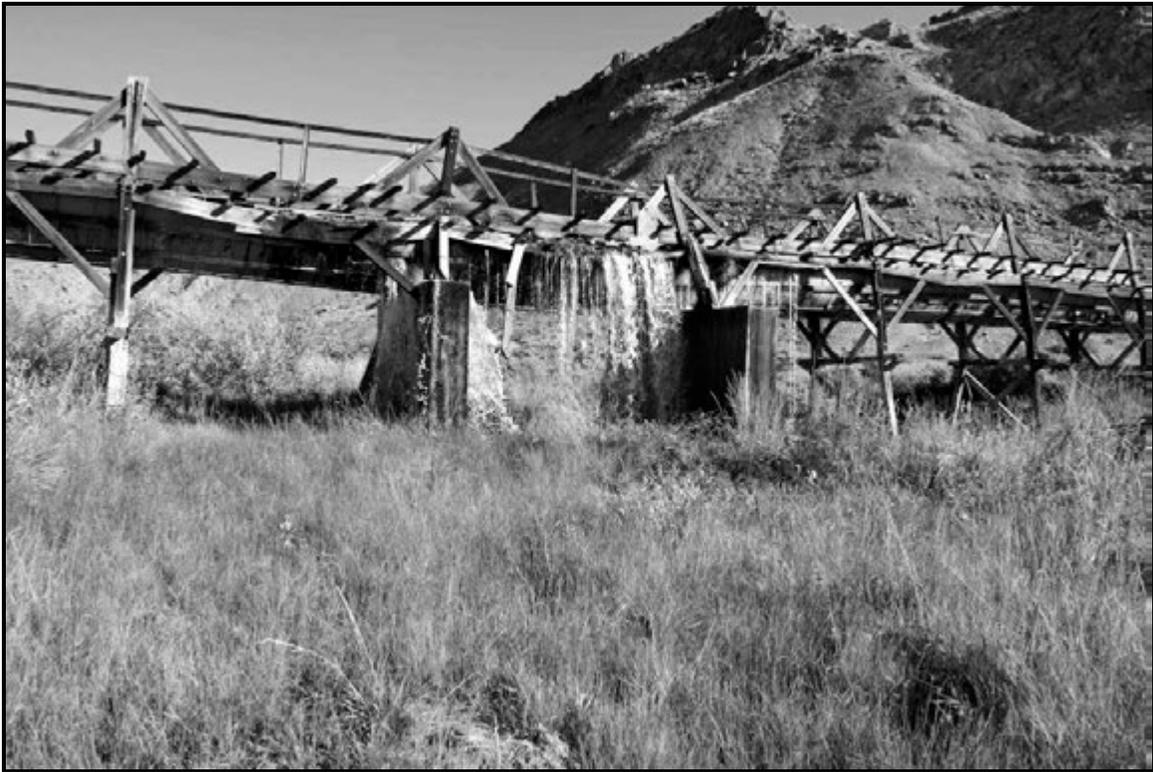
5DT1738.6
Photograph No. 10

Photograph 10. Detail of the central spans of the flume crossing Currant Creek. View is to the north-northeast. Note the extensive water leaking from the flume.

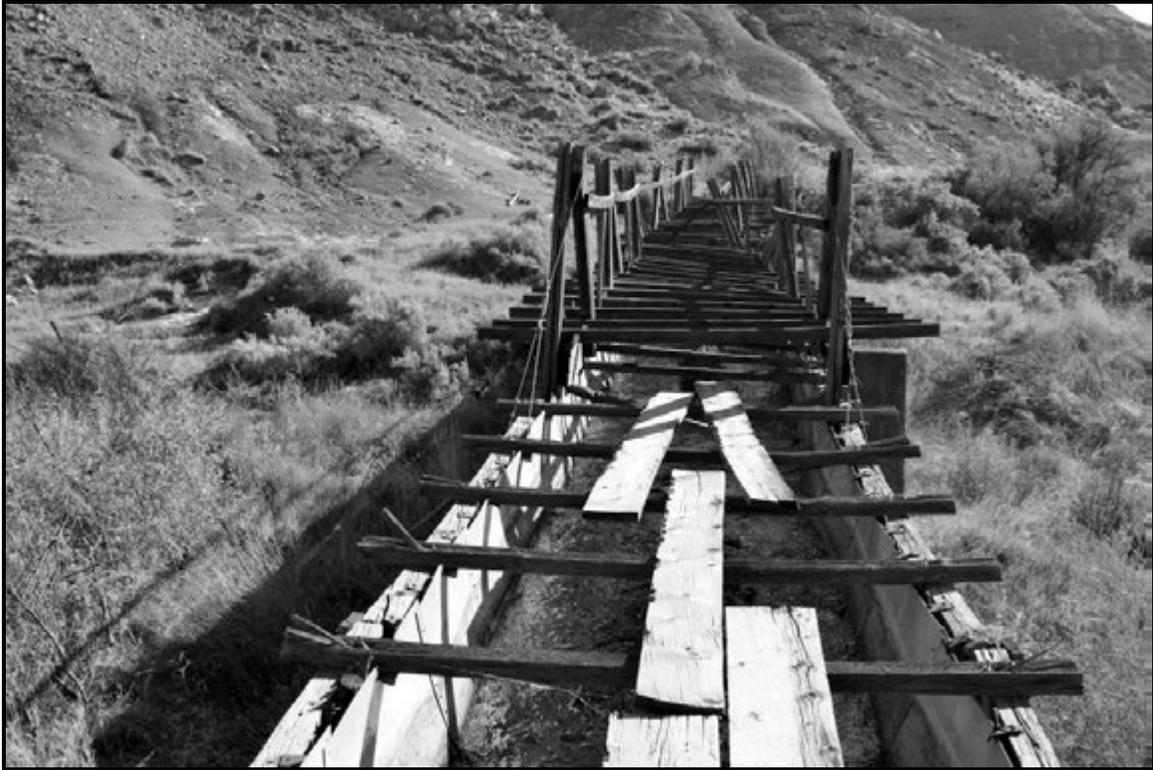
5DT1738.6
Photograph No. 11

Photograph 11. The flume crossing Currant Creek, looking upstream to the east.

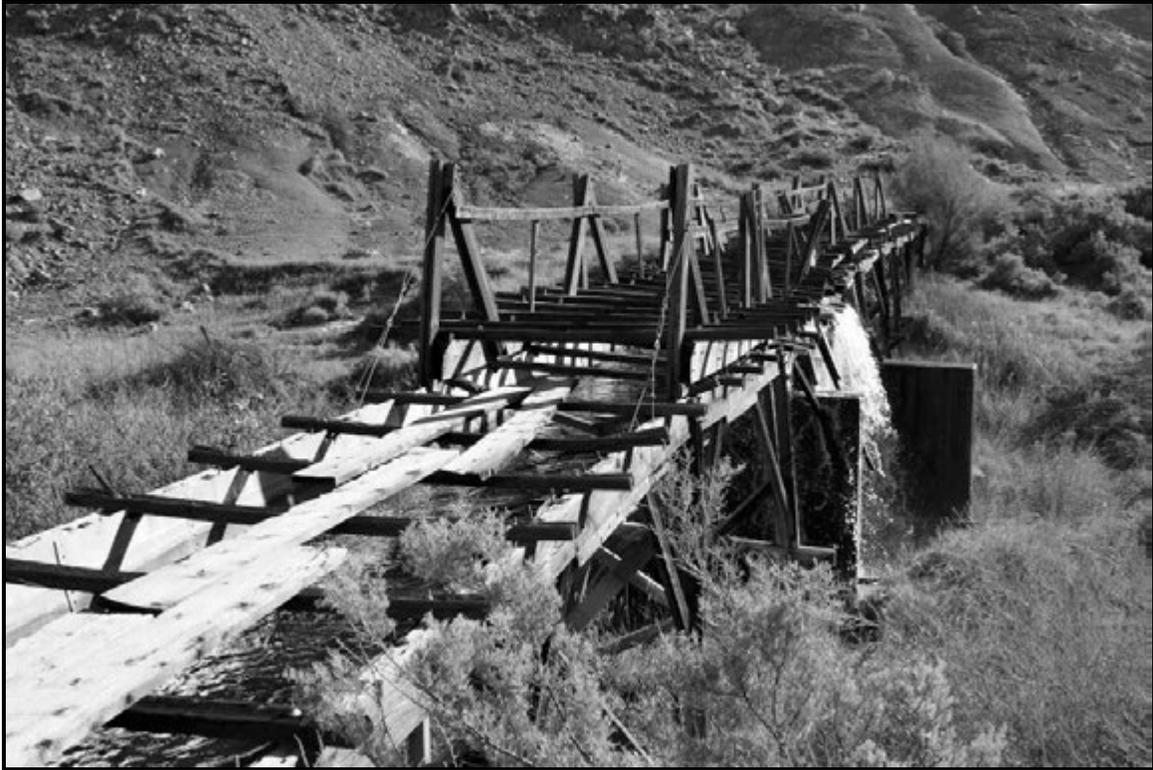
5DT1738.6
Photograph No. 12

Photograph 12. Looking east along the southern side of the flume on a trestle across Currant Creek. Note the water spilling from the flume between the two concrete piers.

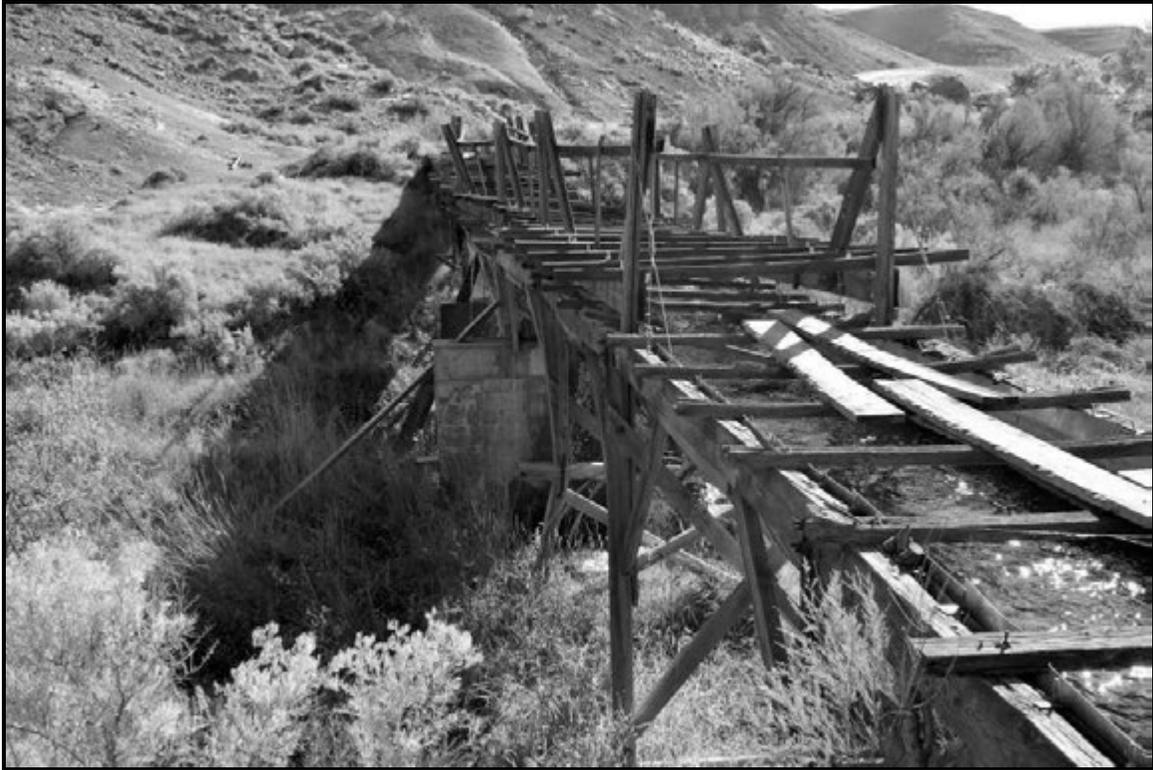
5DT1738.6
Photograph No. 13

Photograph 13. The northern side of the flume crossing Currant Creek on a trestle. View is to the east.

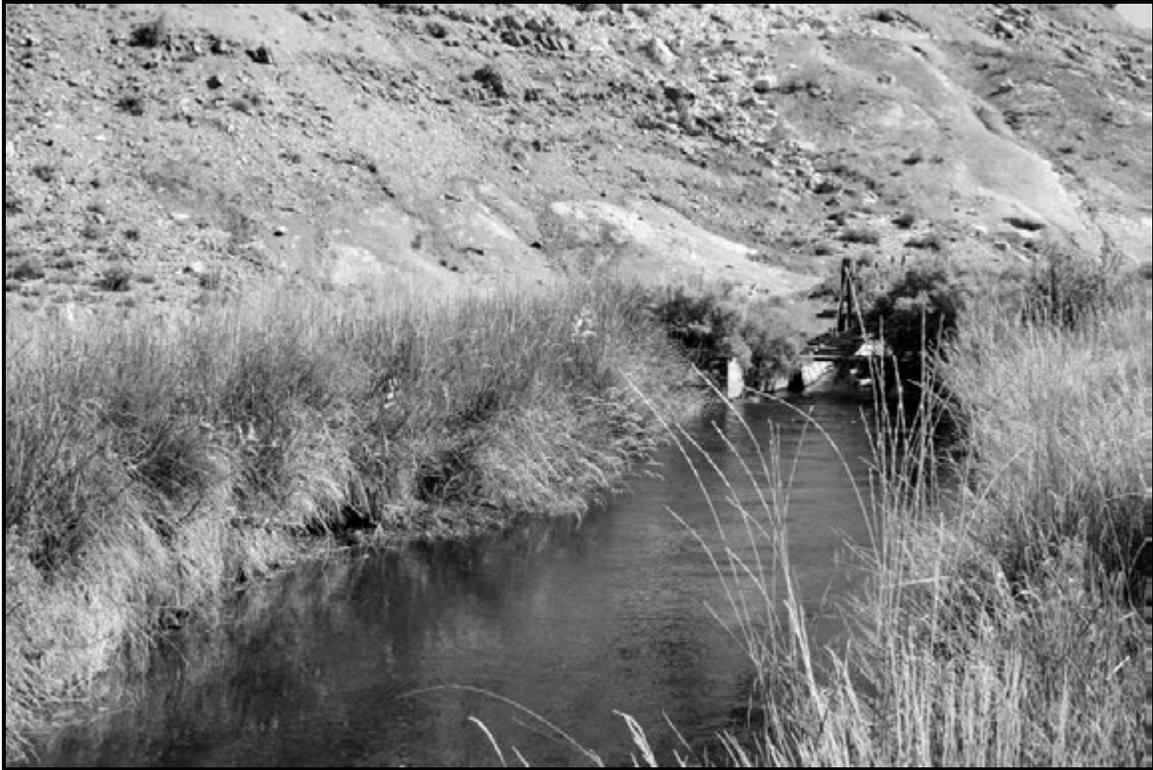
5DT1738.6
Photograph No. 14

Photograph 14. North Delta Canal with the concrete exit structure on the western end of the flume across Currant Creek in the distance. View is to the east.

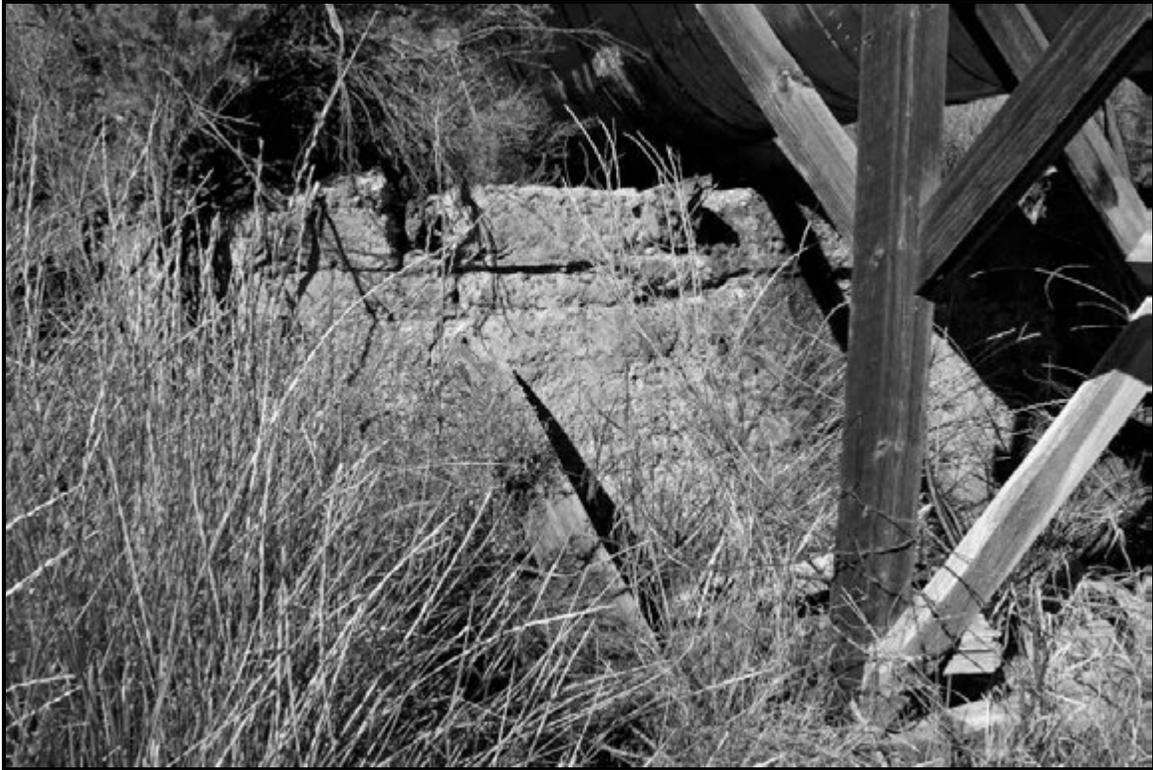
5DT1738.6
Photograph No. 15

Photograph 15. Former western concrete abutment of an earlier version of the flume across Currant Creek, looking west-northwest.

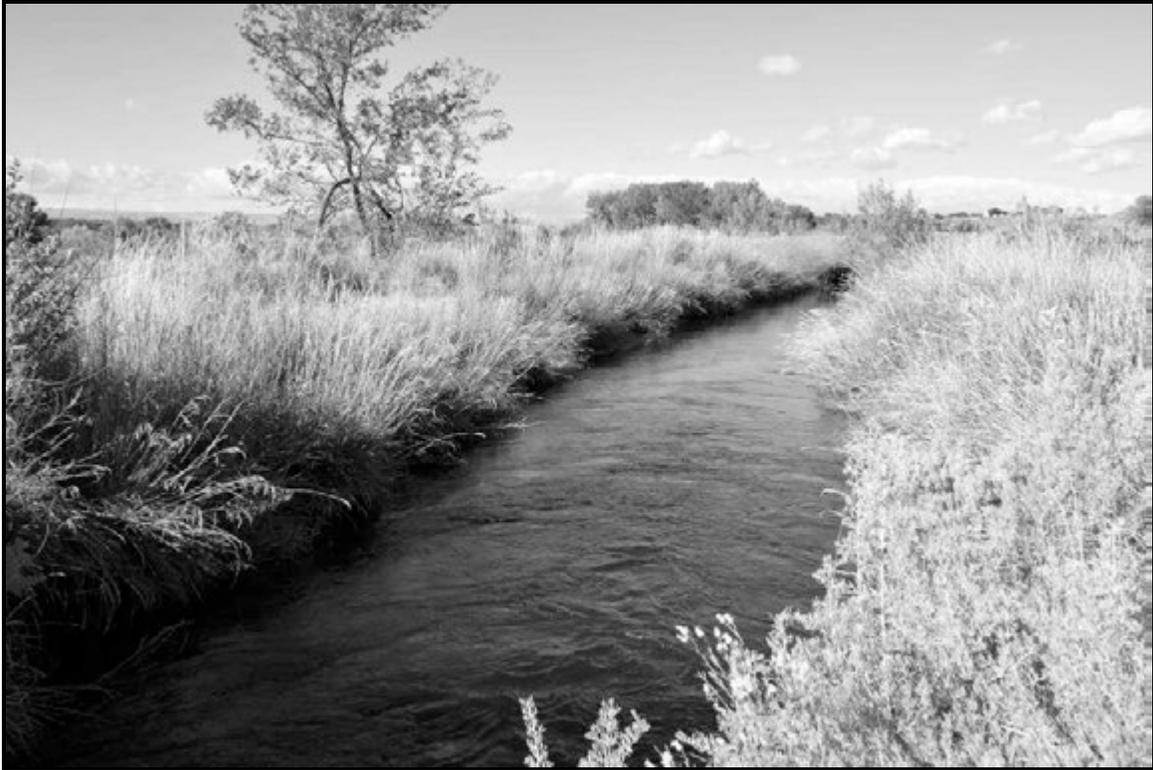
5DT1738.6
Photograph No. 16

Photograph 16. Looking downstream to the west at the North Delta Canal below the flume crossing of Currant Creek.

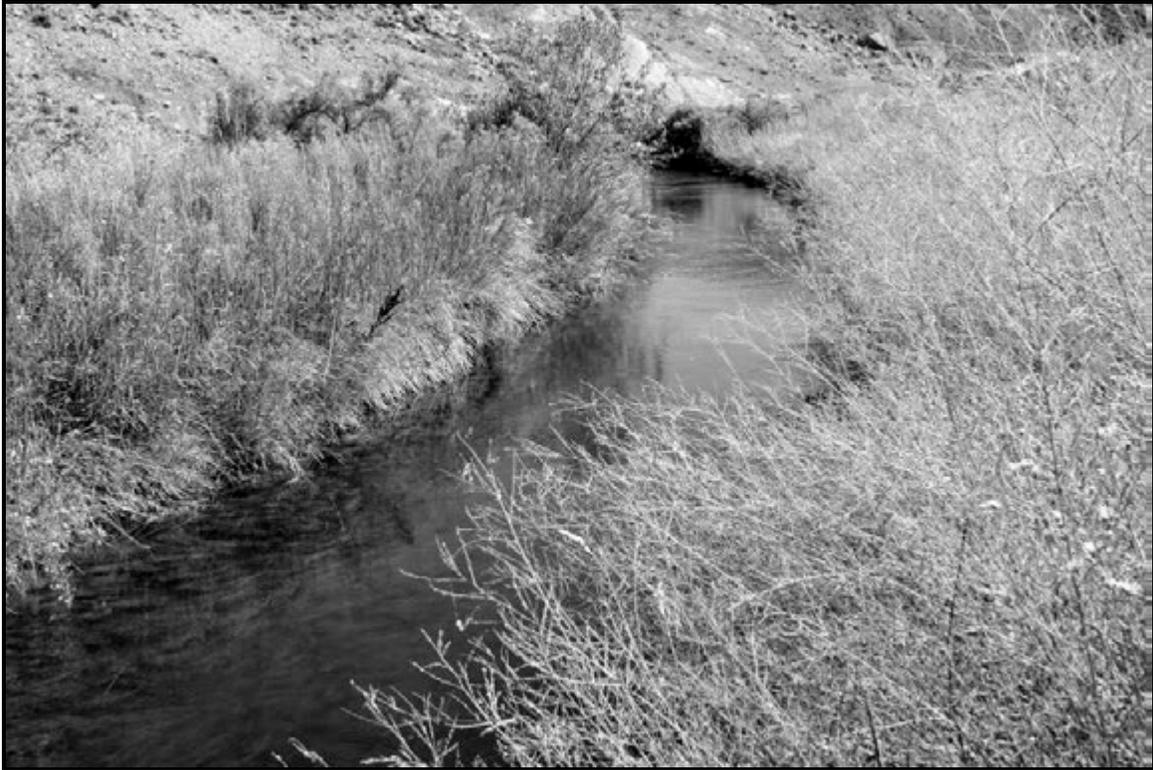
5DT1738.6
Photograph No. 17

Photograph 17. Looking upstream to the east immediately west of the flume crossing Currant Creek.

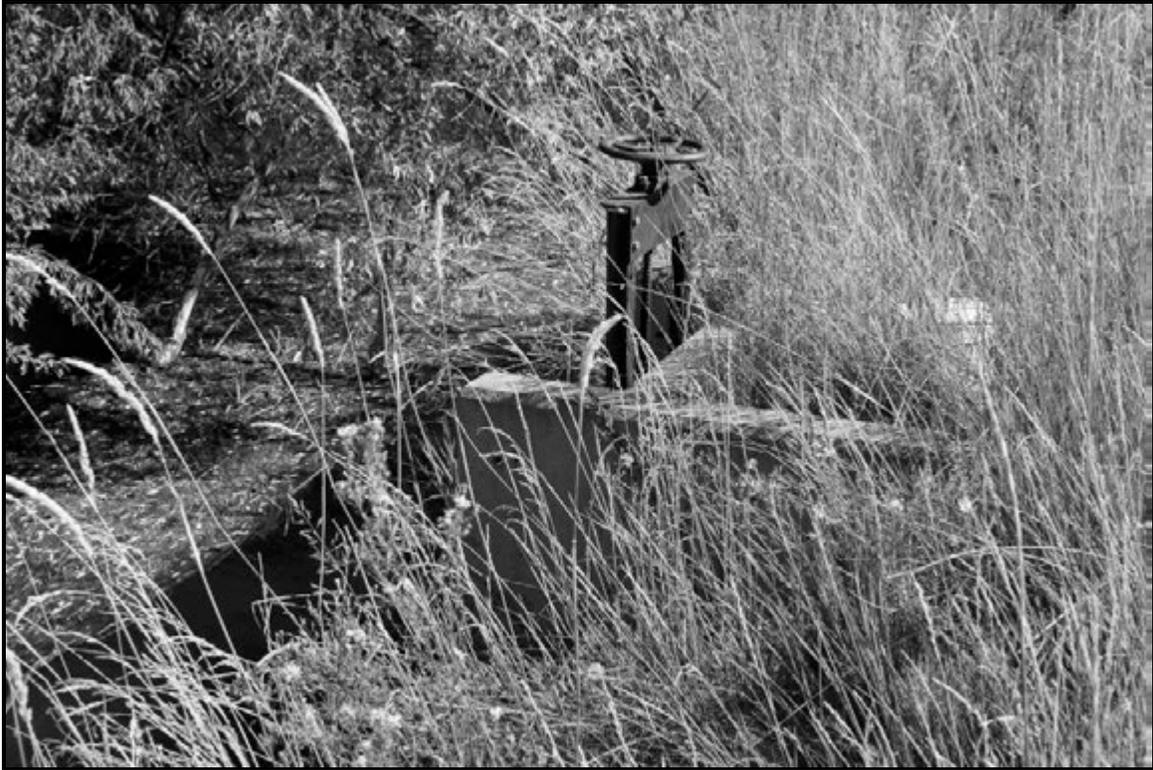
5DT1738.6
Photograph No. 18

Photograph 18. Headgate 2 on the southern bank of the North Delta Canal, looking northeast. This is a modern H-shaped concrete structure with a lift gate attached.

About 450 ft. west of the flume is a modern headgate on the southern side of the canal (Headgate 2). It is a 16-in.-wide, bolted, angle-iron gate frame with a 10-in.-diameter handwheel on $\frac{7}{8}$ -in.-diameter threaded stem that opens into a buried pipe for which an 8-in.-diameter PVC vent pipe extends above the ground immediately south of the headgate. The gate frame is mounted to an H-shaped concrete headgate structure. The 6-ft.-tall, 4-ft.-wide structure has 6-in.-thick concrete walls with 4-ft.-long sidewalls that project 1 ft. into the canal. The handwheel is marked "WATERMAN." The headgate was manufactured by Waterman Industries of Exeter, California. Waterman was founded by W. A. Waterman in 1912 to supply water-control products to the Central Valley of California. They expanded their scope to the western United States after 1953 and internationally after 1963. It was acquired by McWayne, Inc. in 2018 (Waterman Valve, LLC 2018).

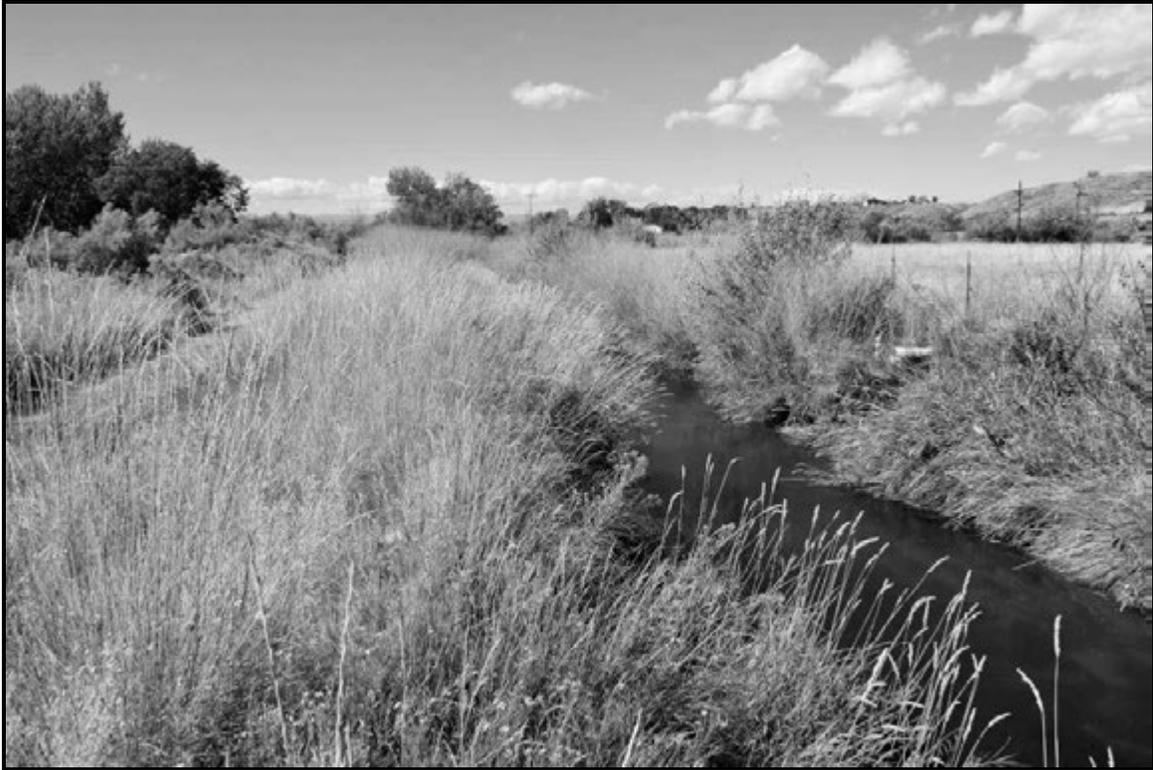
5DT1738.6
Photograph No. 19

Photograph 19. Looking west along the central portion of the North Delta Canal west of Headgate 2.
