**LEVEL II DOCUMENTATION OF
A PORTION OF THE NORTH DELTA CANAL (5DT1738.6),
DELTA COUNTY, COLORADO**

Jonathon C. Horn
Principal Investigator

Alpine Archaeological Consultants, Inc.
PO Box 2075
Montrose, Colorado 81402

January 2020

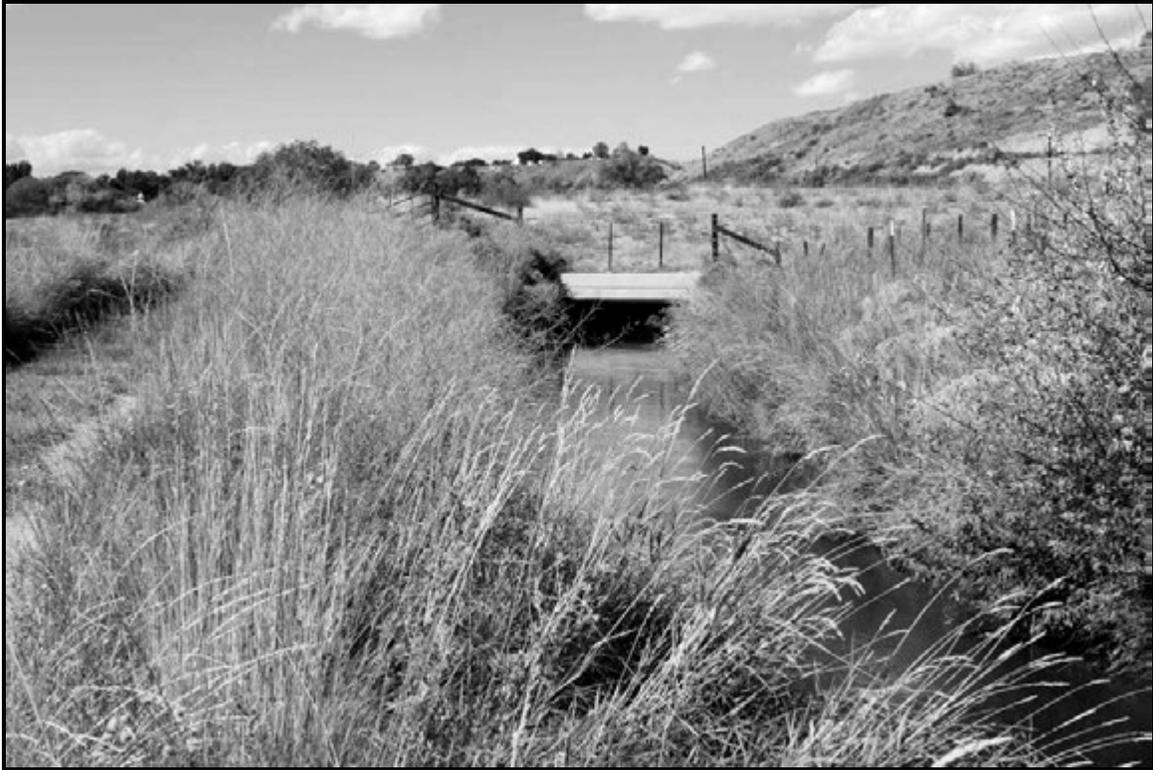
5DT1738.6
Photograph No. 20

Photograph 20. North Delta Canal entering the modern concrete culvert beneath State Highway 92. View is to the west-southwest.

Farther west, the canal passes beneath State Highway 92 in a modern 128-ft.-long concrete culvert with a rectangular 10-ft.-wide, 4-ft.-tall opening with headwalls that extend 1½ ft. above the culvert opening (Feature 1). It has 45 degree, 1-ft.-thick wing walls that enter the canal banks on each end. The wing walls at the entry on the eastern end are 6 ft. long on the northern side and 22 ft. long on the southern side. At the exit on the western end, the wing walls are both about 9 ft. long.

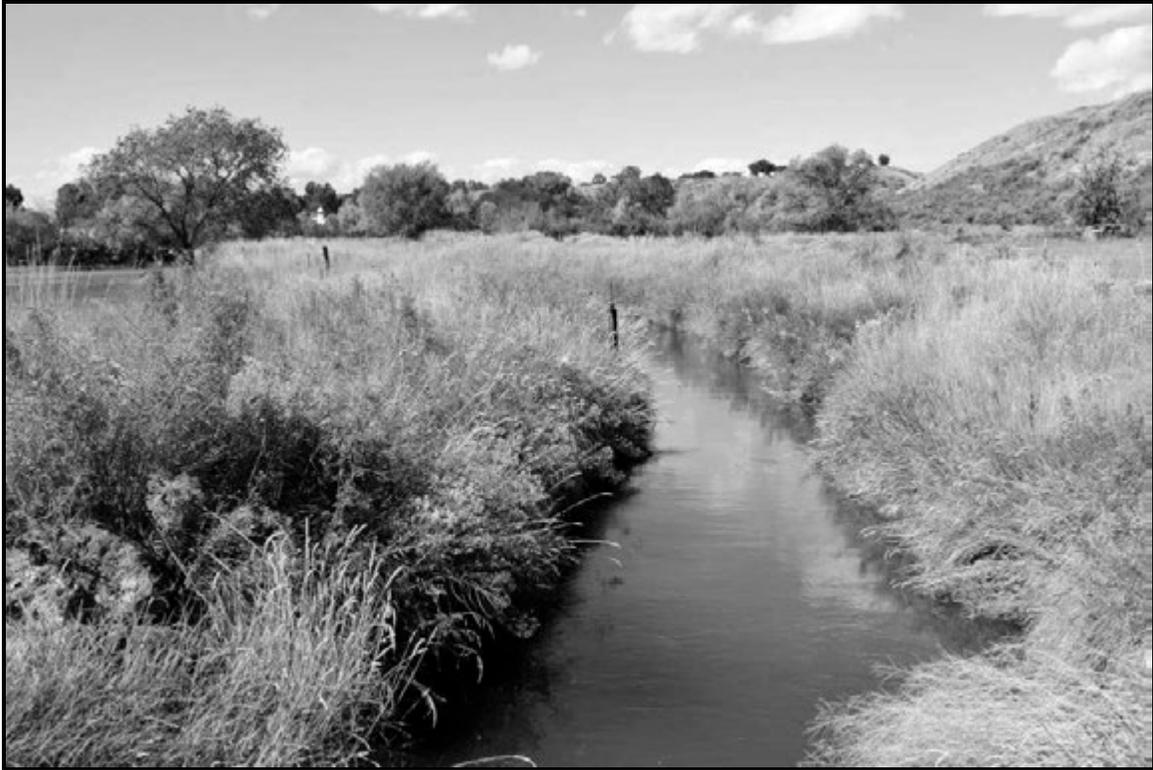
Photograph 21. Looking west at the North Delta Canal west of State Highway 92. Note Headgate 1 on the southern bank of the canal at the center of the photograph.

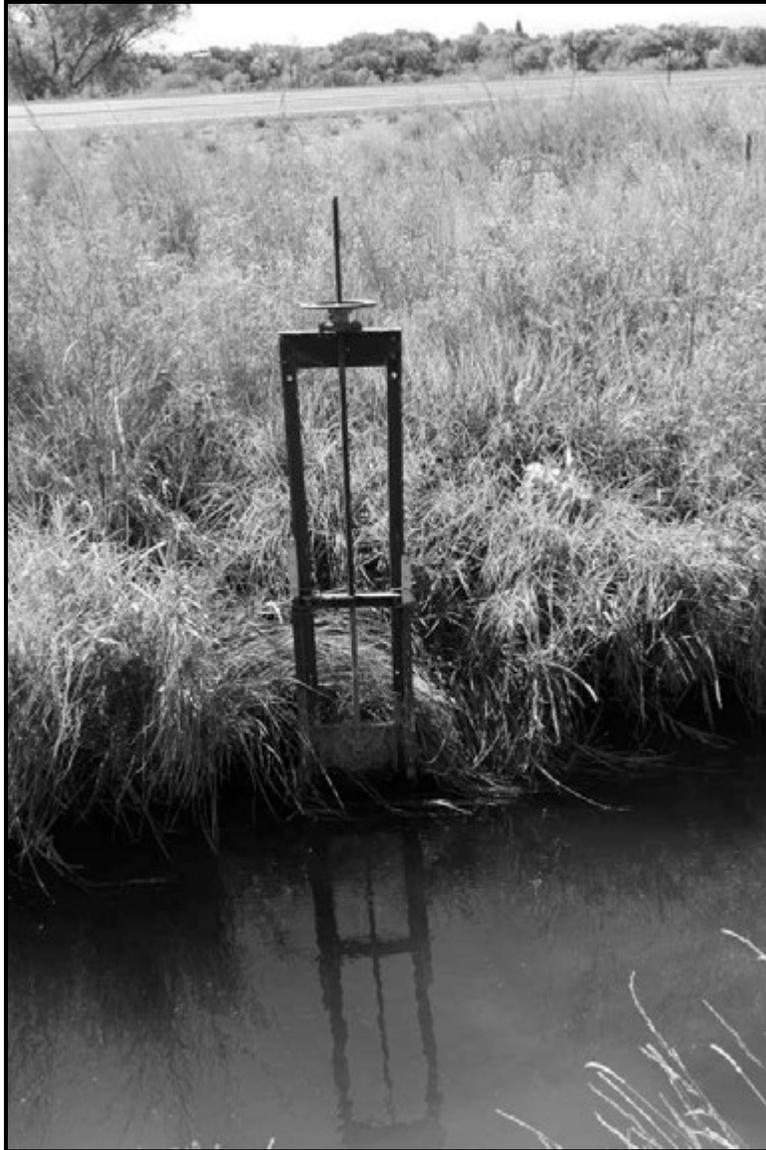
5DT1738.6
Photograph No. 22

Photograph 22. Headgate 1 on the southern side of the North Delta Canal. View is to the south with State Highway 92 in the background.

About 50 ft. west of the culvert beneath State Highway 92 is a second modern headgate on the southern side of the canal (Headgate 1). Like Headgate 2, it is a 16-in.-wide, bolted, angle-iron gate frame with a 10-in.-diameter handwheel on $\frac{7}{8}$ -in.-diameter threaded stem that opens into a buried pipe. It stands about 5 ft. above the ground and does not have an evident concrete headgate

structure in association. The handwheel is marked "WATERMAN" and the stem collar is marked "W-1426-02-01," indicating that the headgate was also manufactured by Waterman Industries.

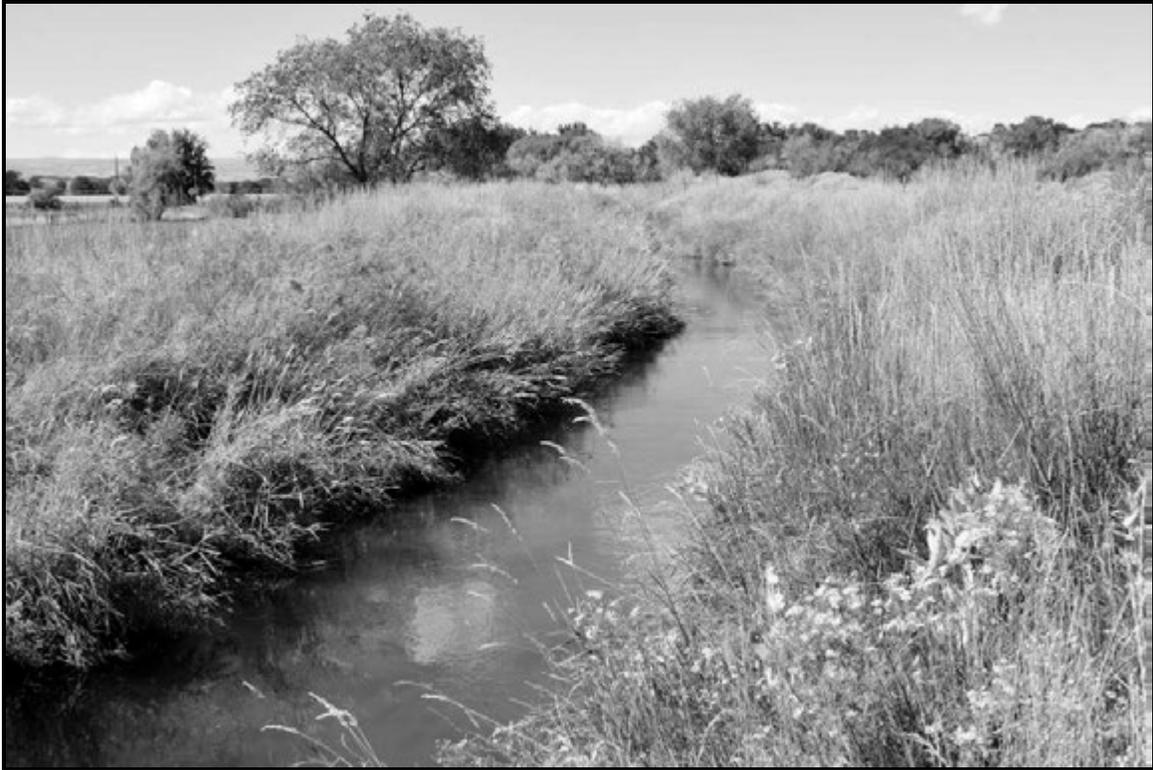
5DT1738.6
Photograph No. 23

Photograph 23. The North Delta Canal downstream, looking west of Headgate 1.

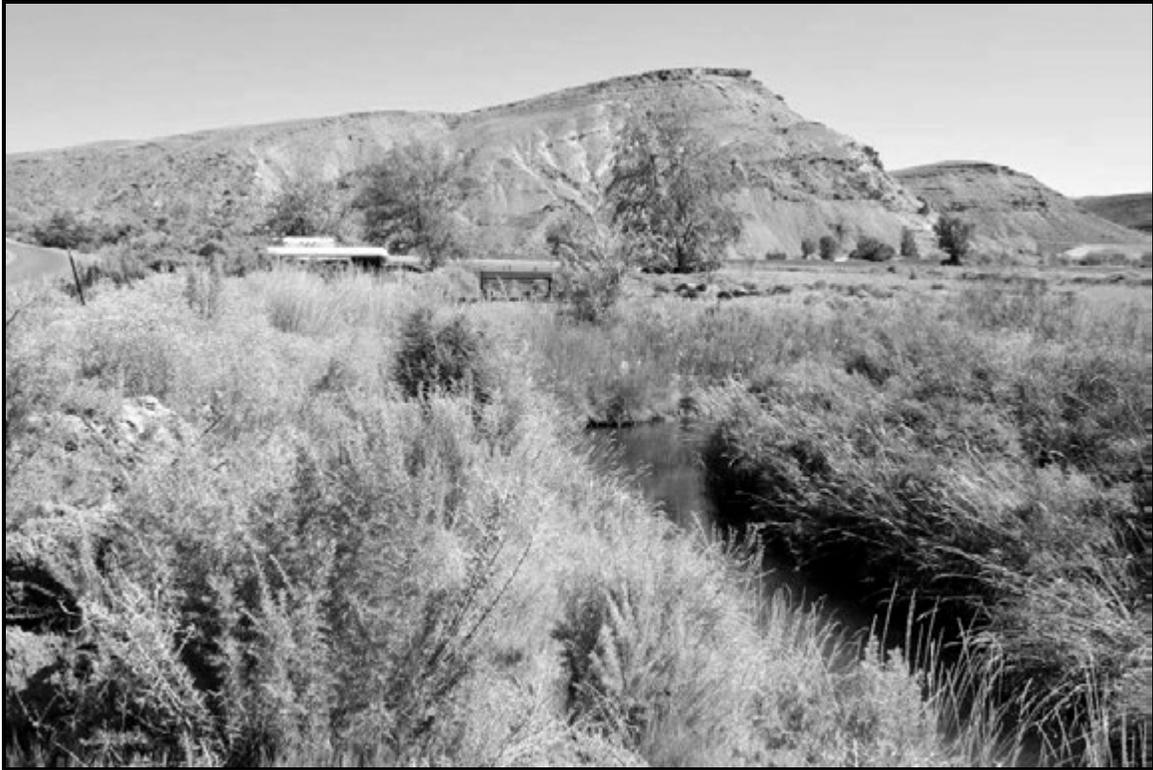
5DT1738.6
Photograph No. 24

Photograph 24. Looking southeast at the western end of the documented segment of the North Delta Canal.

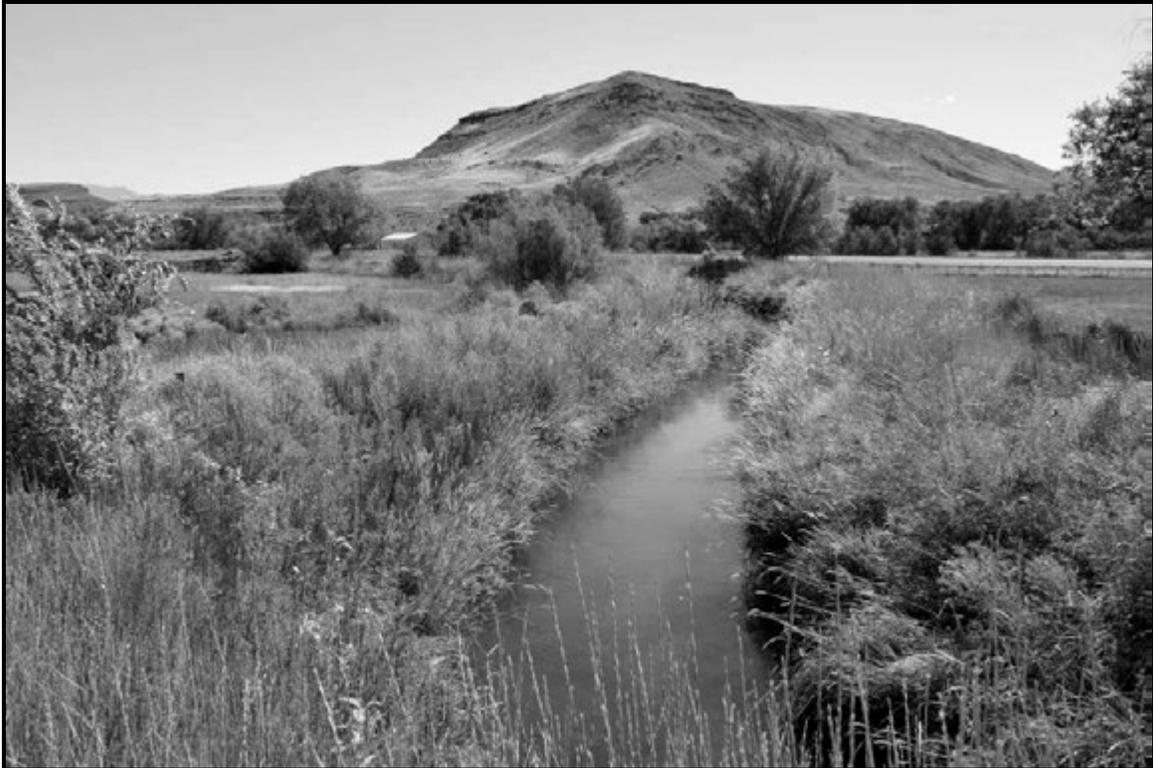
5DT1738.6
Photograph No. 25

Photograph 25. Western portion of the North Delta Canal with State Highway 92 in the distance. View is to the east.
