# **Level II Historic Documentation of the Aspen Canal (5DT1584) Delta County, Colorado OAHP #DT.R.R32**

JoAnne Young

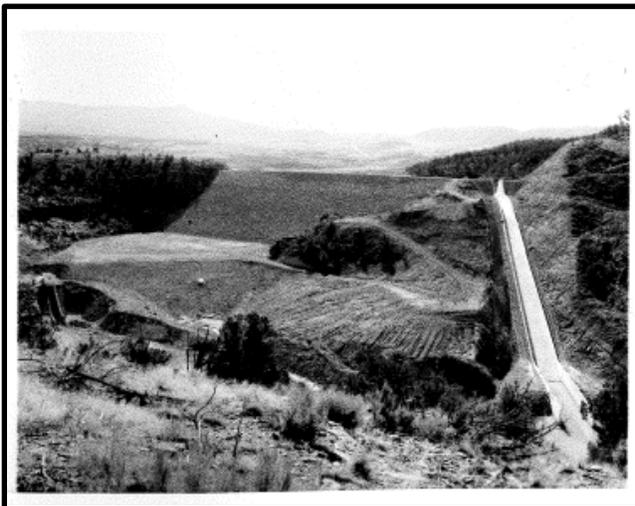
**Figure 1. Aerial photograph of Crawford Dam – the dam, the dam spillway (right in photo), and its outlet works upon completion, Delta County, Colorado. Photo credit: Reclamation by J.D. Wright, November 1, 1962.**

Crawford Dam is an earthfill structure, 162 feet high by 580 feet long with a volume of 1,006,00 cubic

yards. The uncontrolled overflow spillway is on the left abutment of the dam and has a design capacity of 1,400 cfs. The outlet works in the right abutment carries water through a 34" diameter steel pipe controlled by four 2.25' square high-pressure gates. Construction of the 14,395 af Crawford Reservoir formed by Crawford Dam covers a surface area of 406 acres.

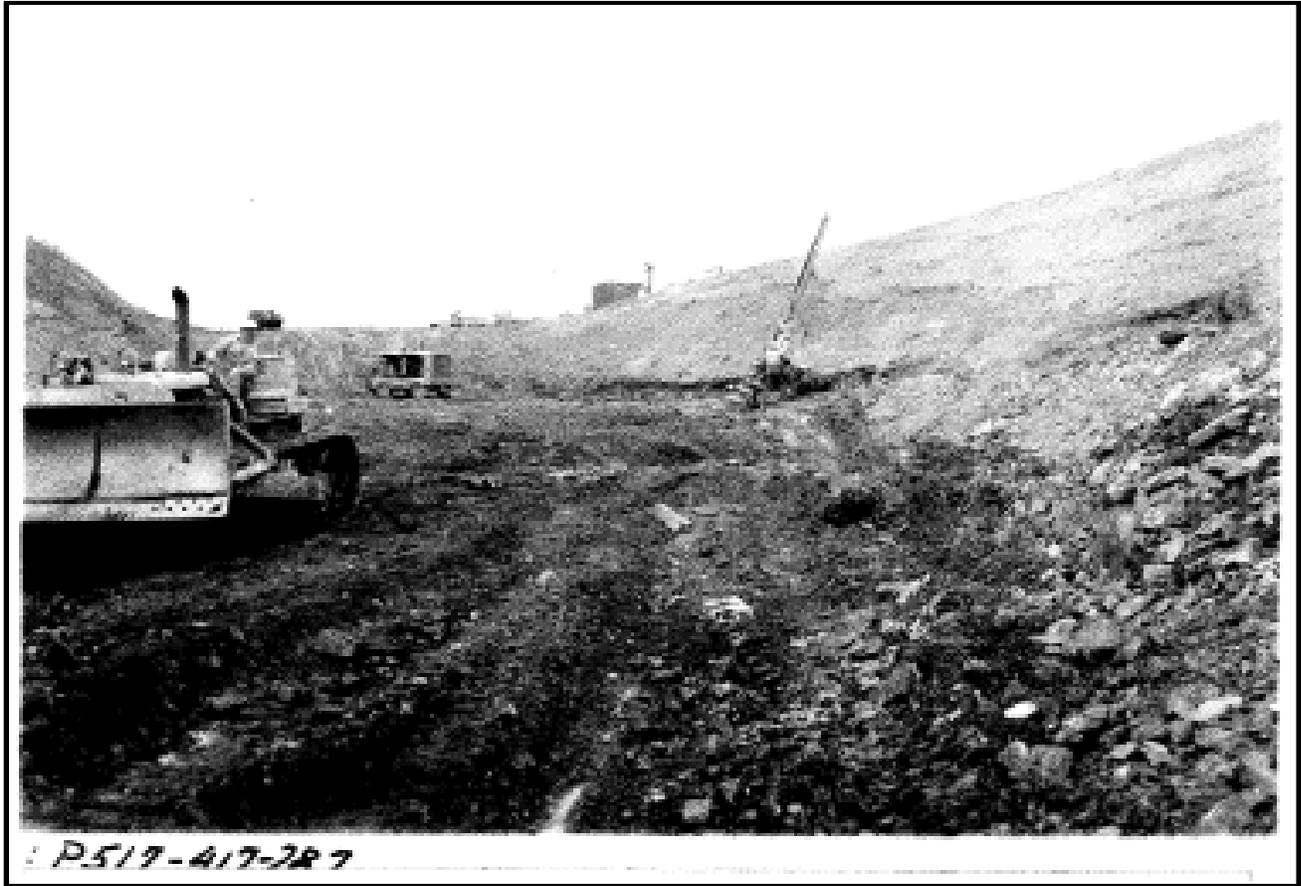
**Figure 2. Overview of Aspen Canal Construction- looking downstream at air track rig drilling rock at Station 84 + 50. Work by Dan Hayes, subcontractor for Riverside Corporation, on September 29, 1961. Photo credit: Reclamation photo by E. J. Peterson.**

mechanized equipment was used to build the canal. Canal excavation was accomplished using Koehring dragline excavators, Bantam backhoes, air track drilling rigs, DW-21 scrapers, and D-7 bulldozers. T30 tractors and tamping rollers were used to spread and compact the canal's earthen lining, respectively. The earth-lined Aspen Canal begins from a buried siphon pipe (fabricated by United Pipe Corporation of Pleasant Grove, Utah) extending from the north end of the dam. The canal stretches northerly for a length of 5.8 miles, feeding private ditches and small creeks from which users draw their supply. The canal itself has a bottom width of +/- 10 feet and an initial capacity of 125 cu-ft-sec. A few short stretches of the canal are underground to accommodate steeper slopes and as pipe crossings beneath roads. All construction of these features was completed in 1962 (Latousek 1995).

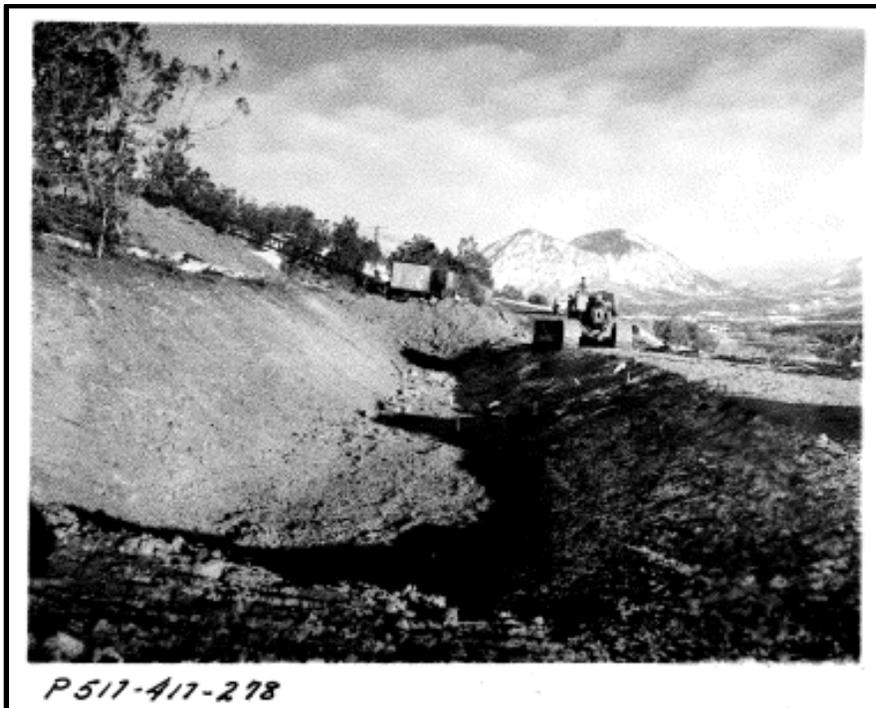
Figure 4. Aspen Canal Construction Underway- uphill slope (on left) is a flank of Youngs Peak. Berm on right is levelled by a dozer (center of photo) and later utilized as the canal's two-track access and maintenance road. Snow-capped Elk Mountains shown in background in Delta County, Colorado.

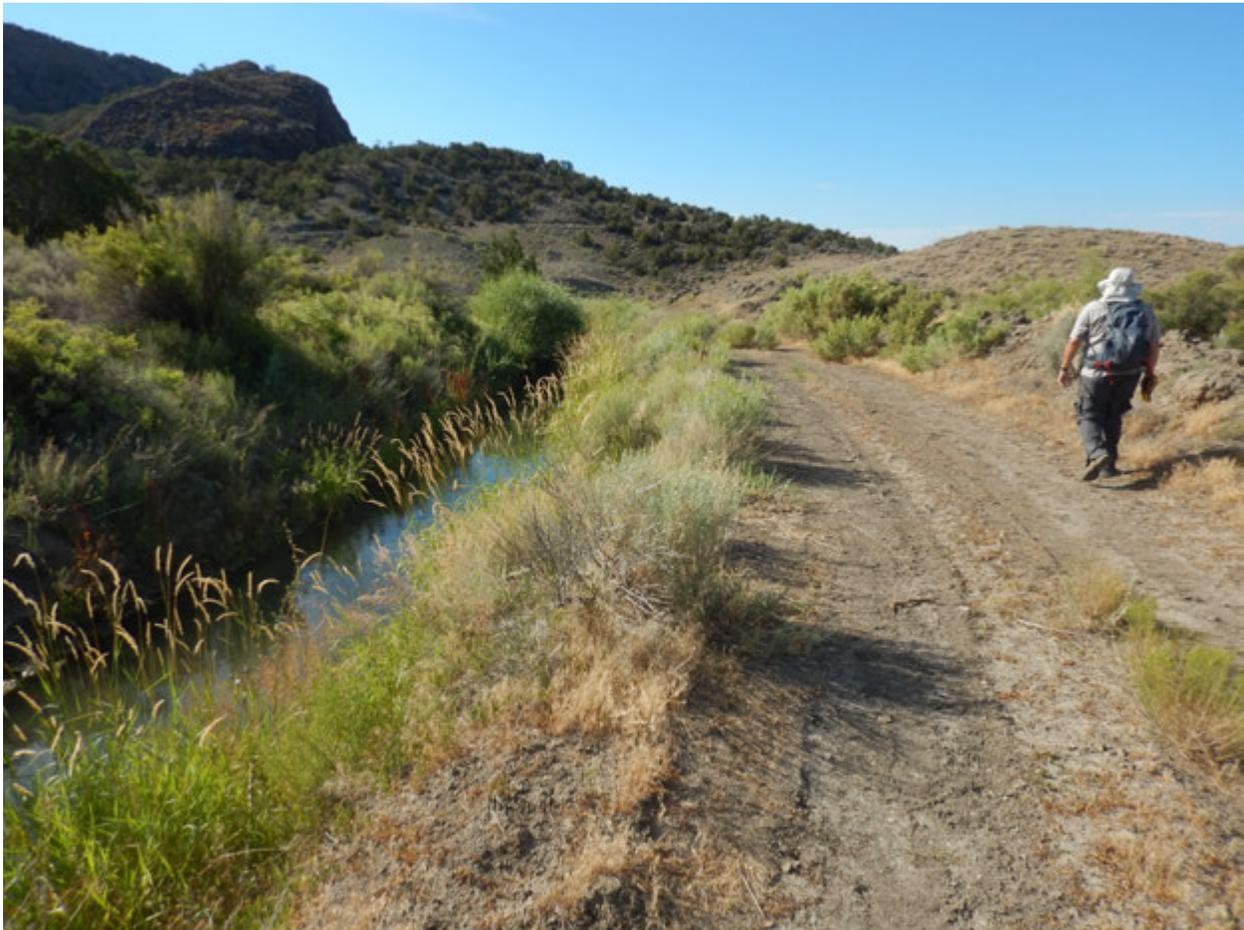
**Figure 12. Overview of a Segment of the Aspen Canal- western flank of Youngs Peak on left. Maintenance and access two-track road (right) parallels canal. Reclamation archaeologist, Steve Manion, pictured, July 2018.**

Today, vegetation on site varies along the canal but is dominated by open pinyon-juniper woodlands and open sagebrush and greasewood parks with an understory of grasses. Slope on site is frequently 0-3 degrees. Soils are dominated by shale loams which are loose and largely unconsolidated. These sediments are subject to regular erosion into the canal, resulting in frequent canal maintenance. Typically, one side of the ditch utilizes the natural contour of the hillside slope and the opposite, outside wall of the ditch is an earthen berm. This berm is utilized as a two-track access and maintenance road for the canal. It is bladed and regularly maintained, is approximately 8 feet wide, and forms the outside wall of the canal.

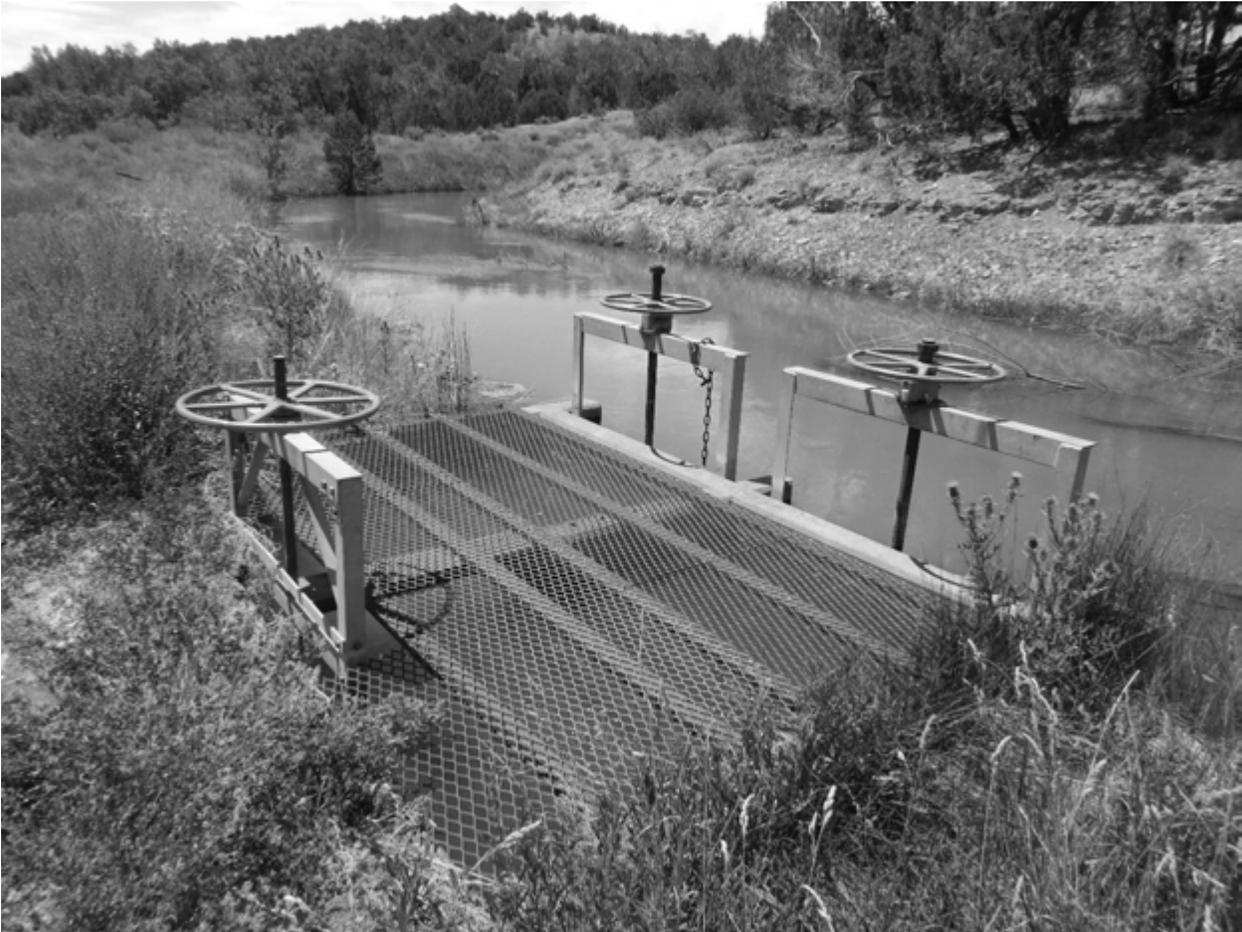
5DT1584—Aspen Canal  
Photograph 1.

Photo #	Description	Facing
1	A set of three constant head orifice turnout gates with 18" diameter cast iron handwheels. Metal grate provides decking across top.	W
2	Cast concrete baffled stilling basin with flare downstream of corrugated shelter house in background.	ESE
3	Corrugated steel shelter house, approximately 6' tall X 4' diam., mounted atop subsurface stilling well (not visible). Precast concrete siphon inlet in foreground.	ENE
4a	Constant head orifice turnout with two 12" cast iron hand wheels	SE
4b	Two 12" handwheels with view of two measuring gages set on interior walls of concrete constant head orifice turnout structure. Two pieces of milled lumber decking used across top of structure.	Detail
5a	Timber operating bridge and smooth metal overchute pipe spanning Aspen Canal. Steve Manion, Reclamation archaeologist pictured (right).	SE
5b	Timber operating bridge spanning Aspen Canal (opposite view of 5a).	NW

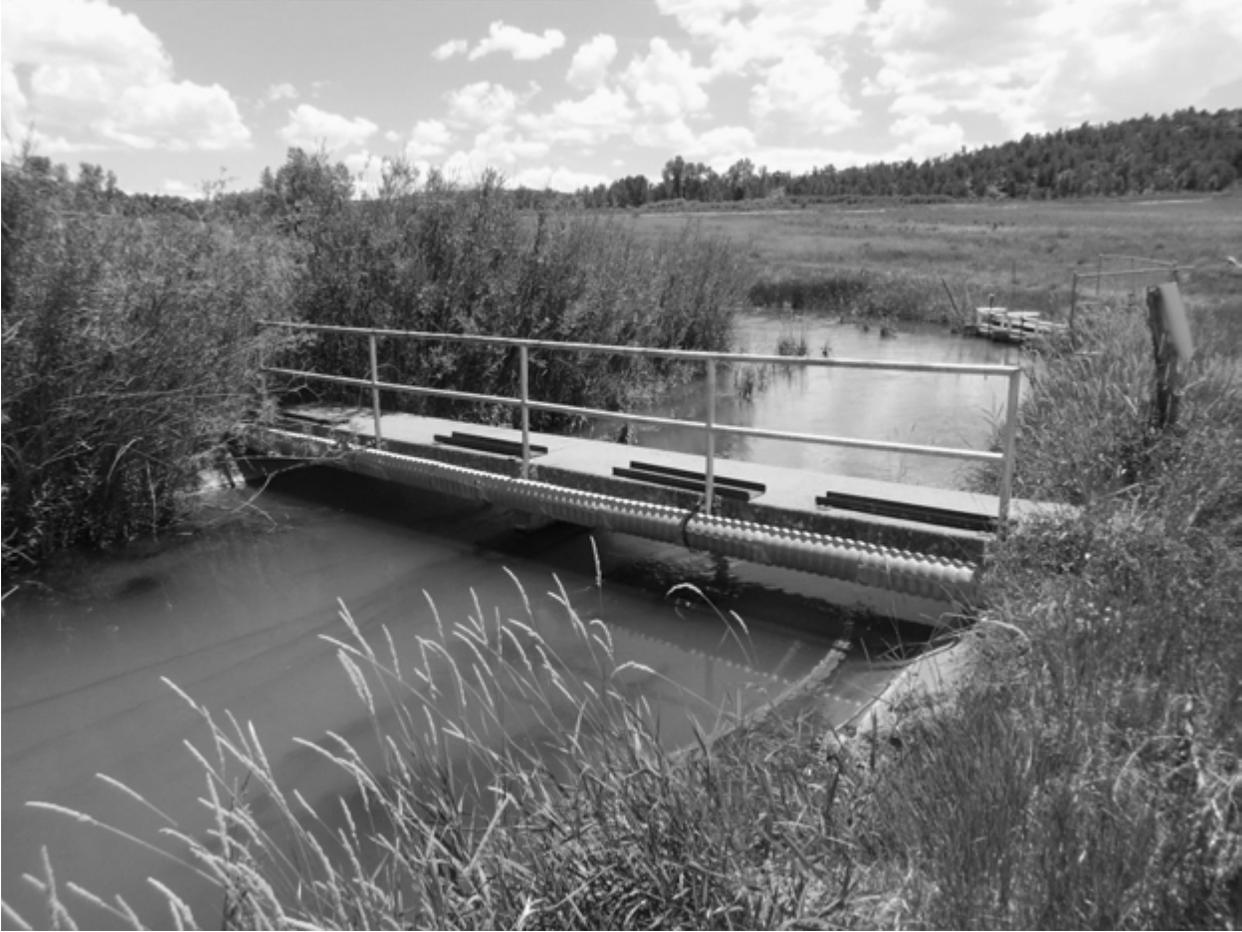
**5DT1584—Aspen Canal**  
**Photograph 6.**

6	Precast concrete check drop structure with access bridge and cast metal handrail. Corrugated overchute pipe attached to bridge.	SE
7	Two parallel sets of lateral constant head orifice turnout gates with 18"-21" diameter cast iron handwheels (foreground) with a check inlet structure (background). Footbridge with precast concrete deck with a cast metal handrail constructed on top of a check inlet structure. Western flank of Youngs Peak in background.	N
8a	Wood plank footbridge spanning canal used as a flow gaging station. Concrete stilling basin with milled wood cover (right of footbridge).	W
8b	Detail of wood plank footbridge spanning canal used as a flow gaging station. Metal pipe attached to exterior of footbridge decking. Concrete stilling basin with milled wood cover (right of footbridge).	W
9	Detail of cast concrete pipe shelter house with milled wood cover. Subsurface stilling well and inlet pipe (beneath shelter house, not visible).	W

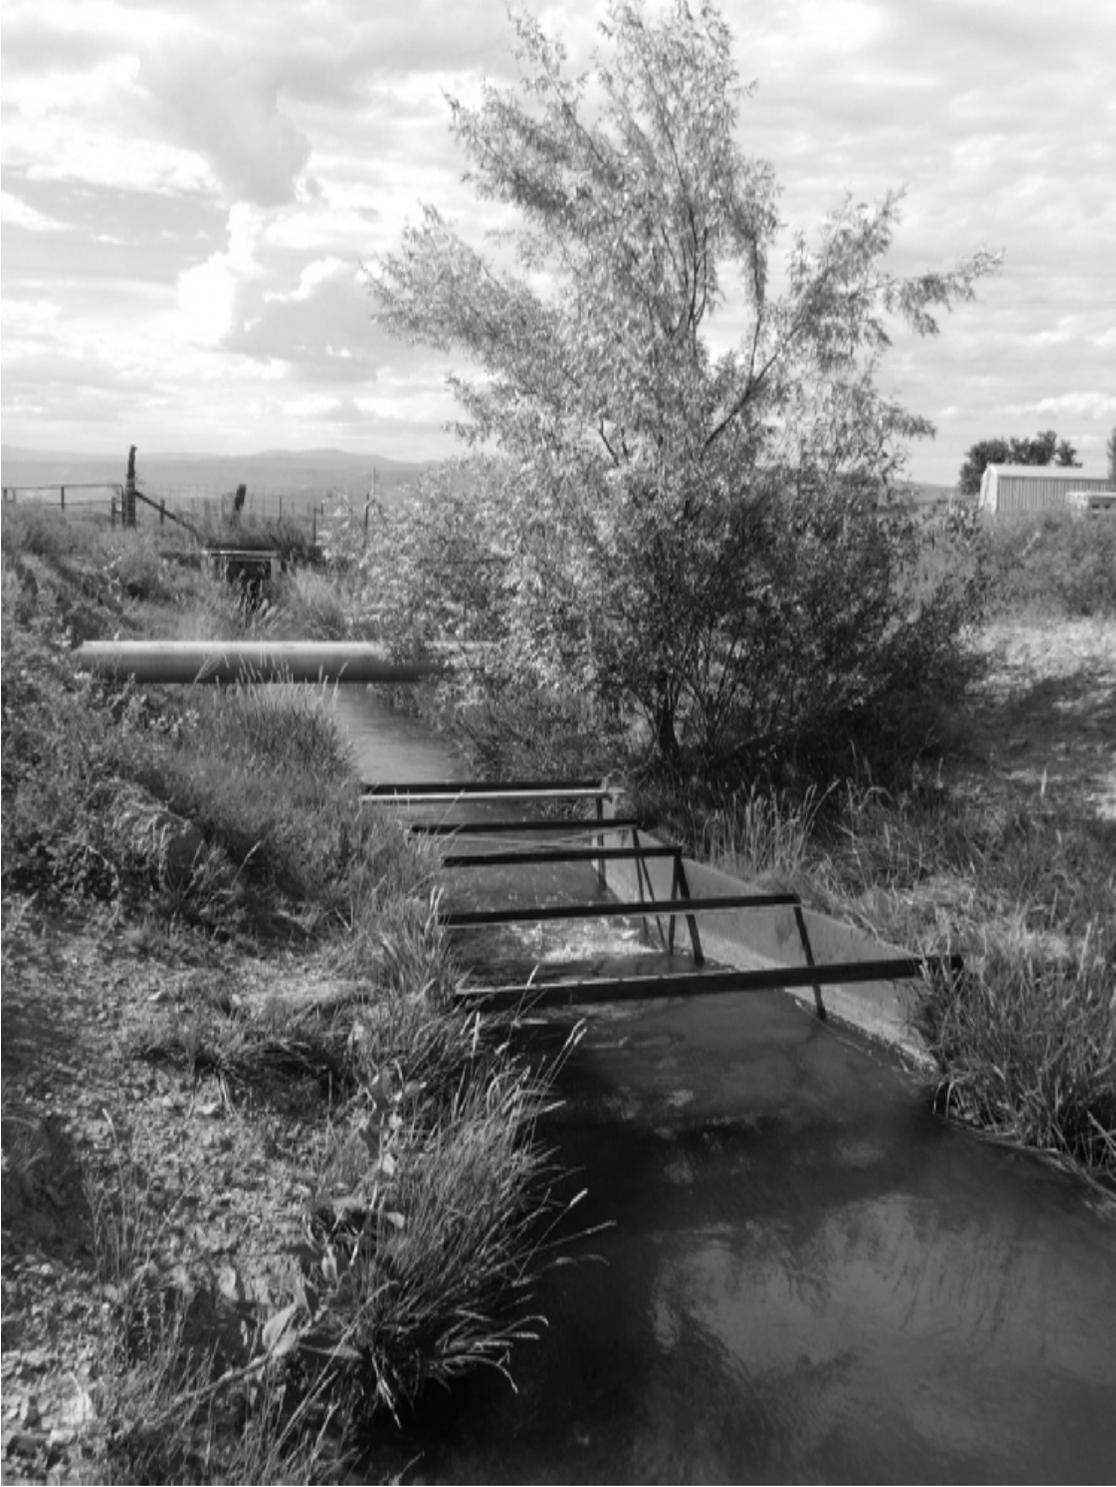
5DT1584—Aspen Canal  
Photograph 10.

10	Metal Parshall flume. Pictured in background are a smooth metal overchute pipe and precast concrete drop inlet with angle iron frame, including milled wood decking.	N
11	Cast concrete constant head orifice turnout with cast iron handwheel (foreground) with precast concrete drop inlet with angle iron frame including	N

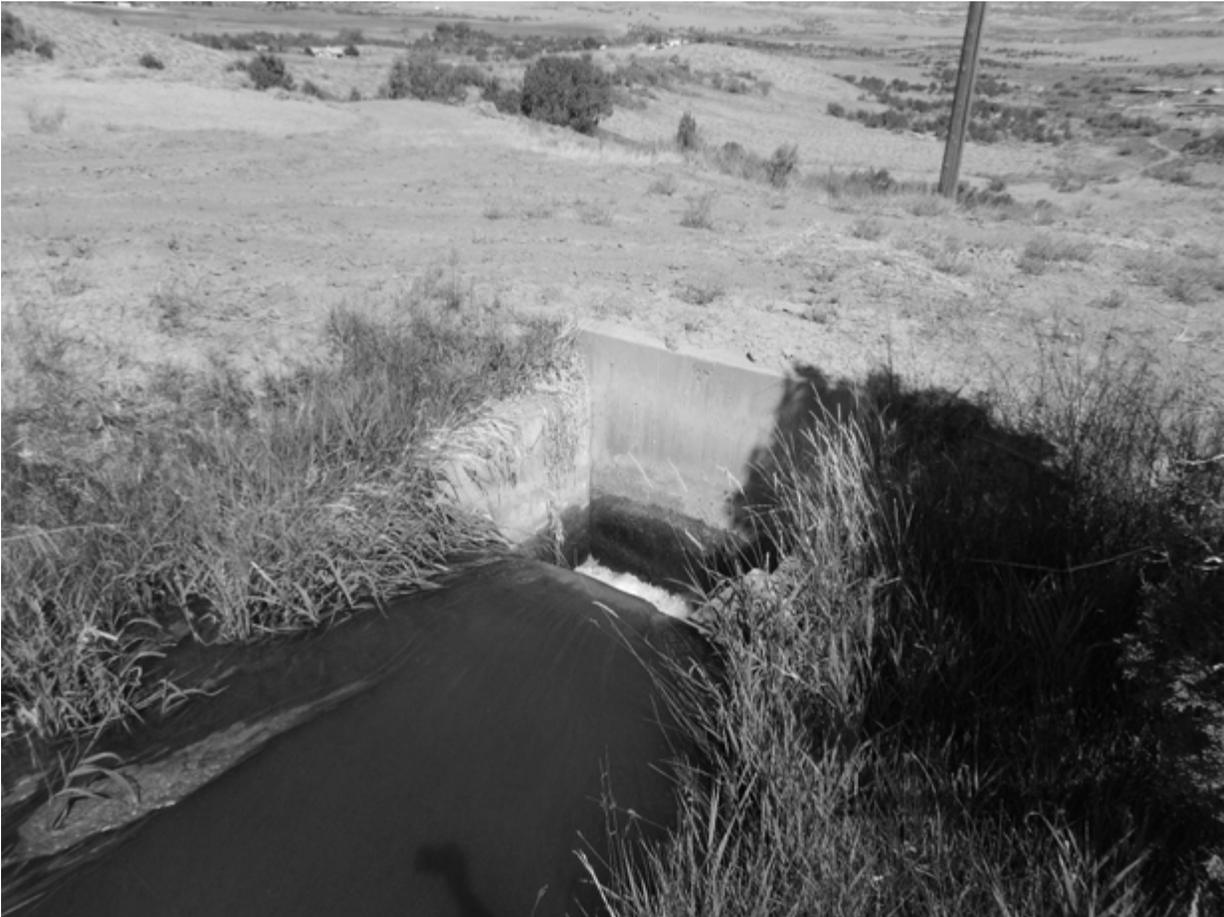
5DT1584—Aspen Canal  
Photograph 19.

18	Corrugated overchute pipe spans Aspen Canal.	SE
19	Precast concrete pipe drop inlet conveys water into buried pipe crossing beneath canal access road.	NE
20	Buried pipe drop (background upslope) flows downslope to a rectangular, inclined, precast concrete drop spillway with baffled stilling basin and flare.	SSE
21	Precast concrete culvert pipe with flare.	W
22	Overview of Aspen Canal. West flank of Youngs Peak (left), canal with two-track canal access road (right). Steve Manion, Reclamation archaeologist pictured (right).	S
23a	Fence crossing panel spans Aspen Canal.	E
23b	Fence crossing panel spans Aspen Canal (opposite view).	NW
24	Precast concrete culvert pipe with flare.	W
25a	Timber operating bridge.	NW
25b	Timber operating bridge (alternate view).	N
26	Gate with fence crossing panel which spans Aspen Canal.	NE
27	Precast concrete pipe culvert.	SW
28	Precast concrete check and drop structure with milled lumber decking and cast metal handrail.	W

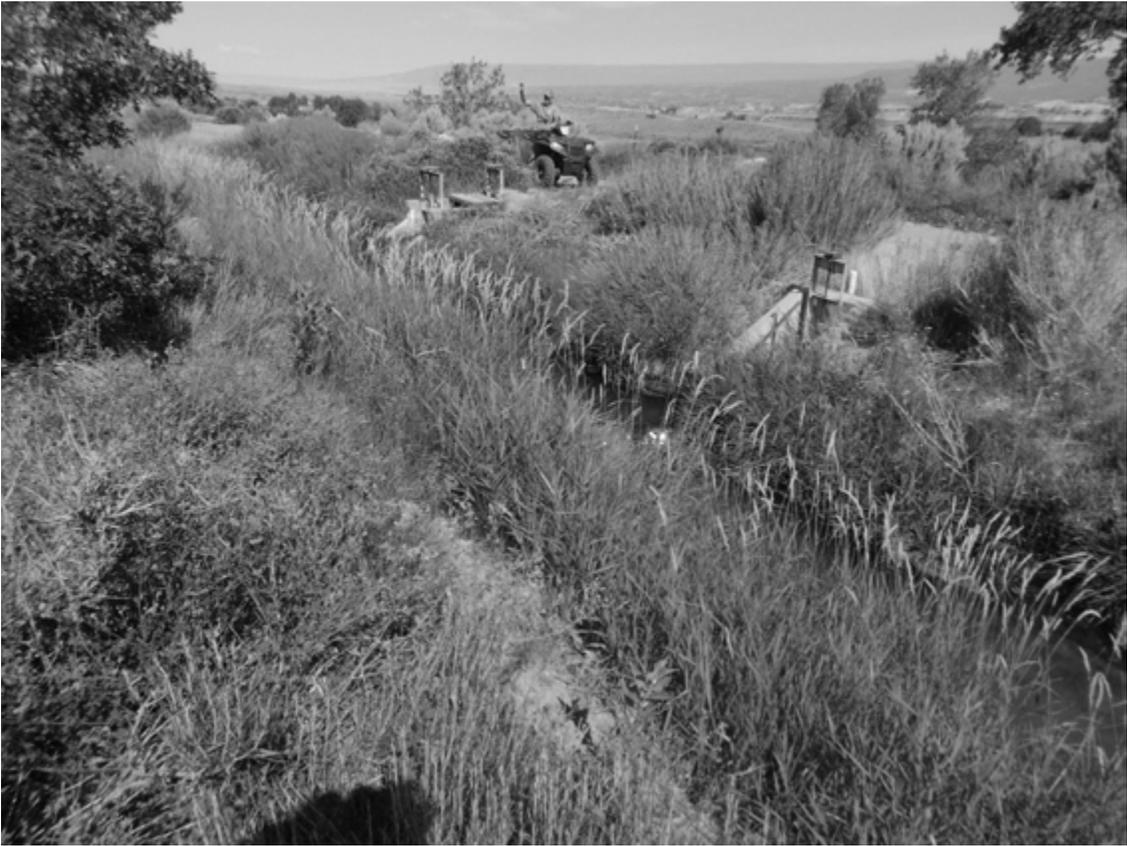
5DT1584—Aspen Canal  
Photograph 29.

29	One set of two constant head orifice turnouts (background) and one single constant head orifice turnout gate (foreground), each with cast iron handwheels set in concrete box structures, located on canal's north edge. Local landowner on ATV driving on canal access road (top center).	NE
30	Concrete deck above concrete check and drop structure. Canal access road on right.	W
31	Concrete deck above concrete check and drop structure Canal access road on right. Single constant head orifice head turnout and smooth pipe overchute pipe in background.	W
32	Precast concrete culvert pipe with flare.	NE
33	Precast concrete culvert pipe with flare.	WNW
34	Two parallel constant head orifice turnouts with cast iron handwheels and milled lumber decking. Drop inlet with angle iron housing and milled lumber decking on top.	E

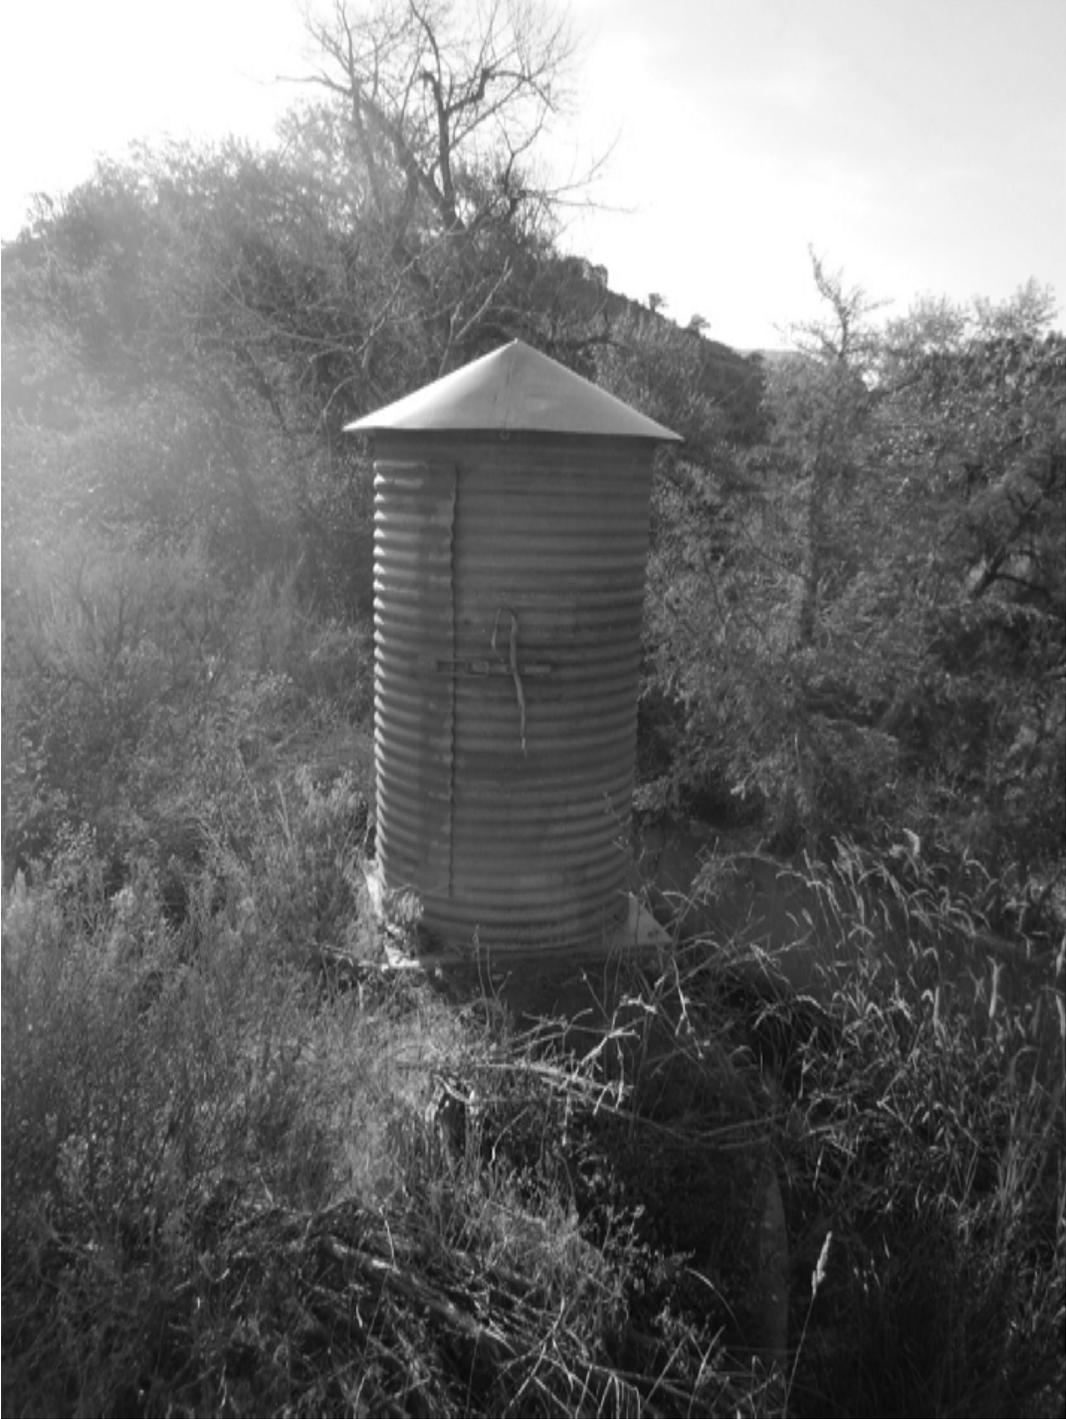
5DT1584—Aspen Canal  
Photograph 35.

35	Corrugated steel shelter house, approximately 6' tall X 4' diam., bolted on top of subsurface stilling well. Precast concrete siphon inlet (foreground) at NE end of Aspen Canal near juncture with Cottonwood Creek.	E
----	---	---
