Level II Documentation of the Ratliff and Root Ditch (5MT23092), Montezuma County, Colorado

(OAHP # MT.R.R142)

OAHP Project Number: MT.R.R142

October 5, 2020

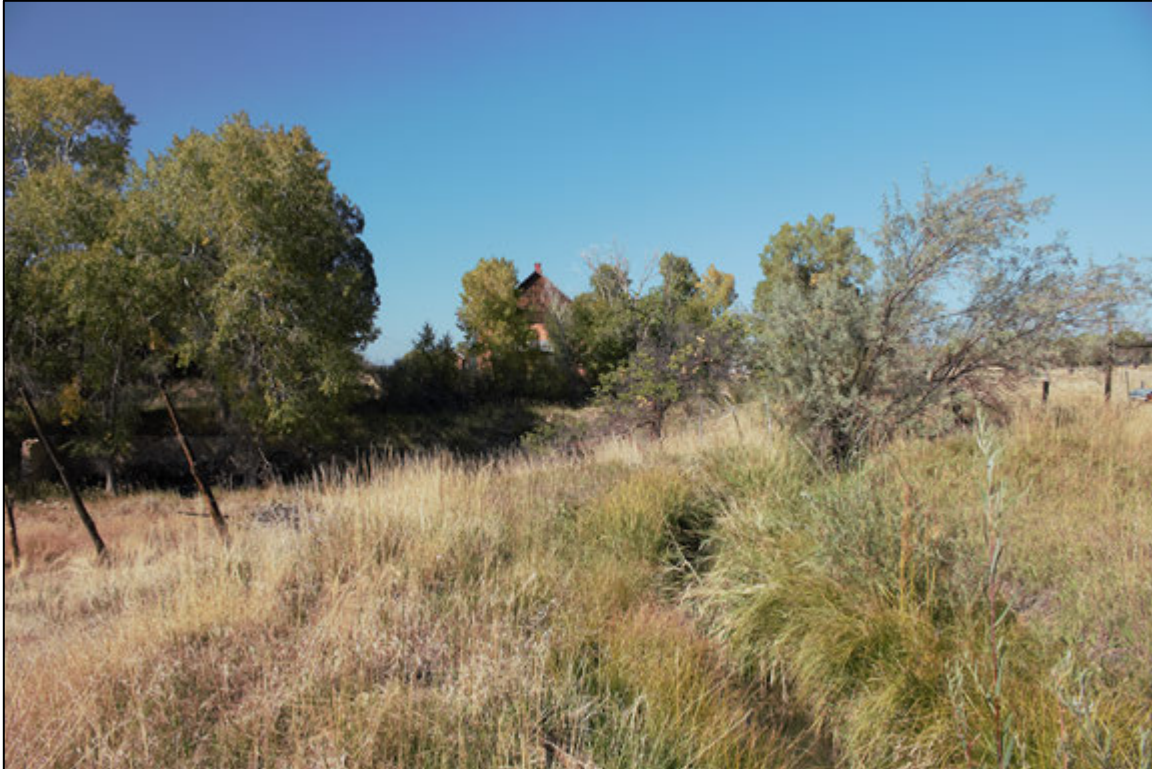
Figure 10. The Ratliff and Root Ditch in the foreground with the Joseph S. Smith homestead in the background.

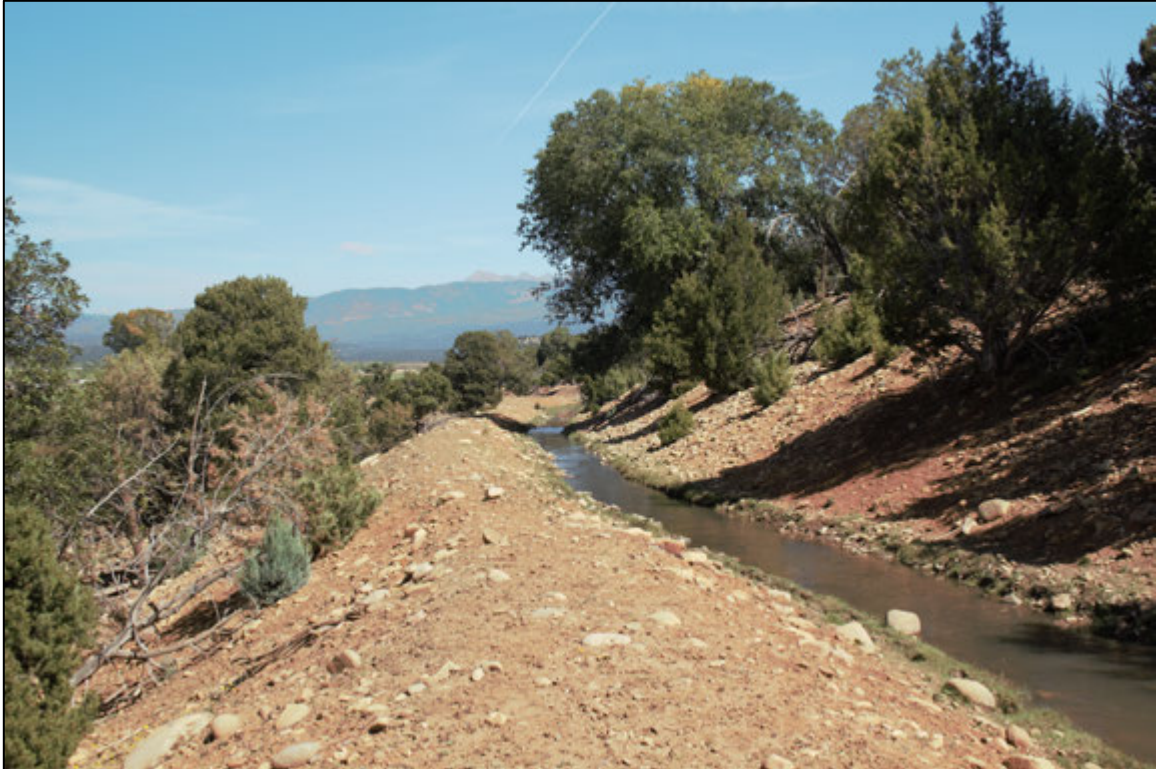
Figure 11. A heavily engineered section of the Ratliff and Root Ditch on a steep escarpment east of its crossing with Montezuma County Road 41.

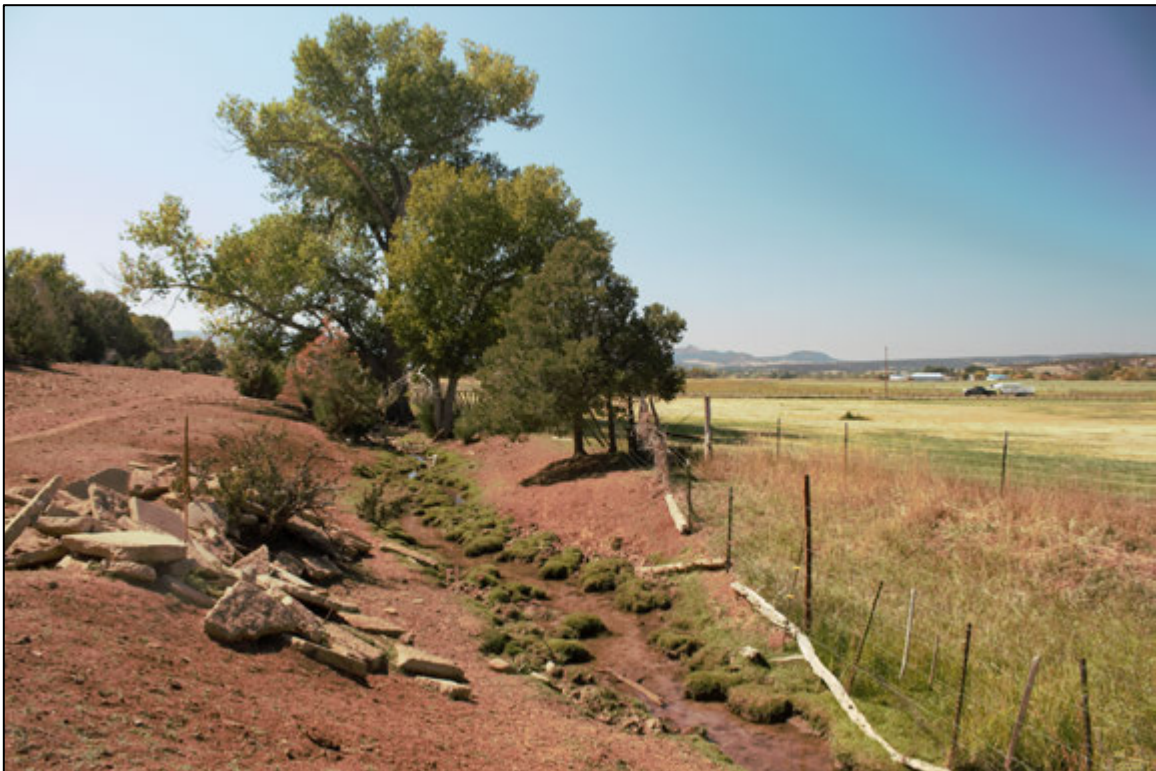
Figure 12. Overview of a large lateral ditch (previously recorded as 5MT23519.1) off of the Root Ratliff Ditch.

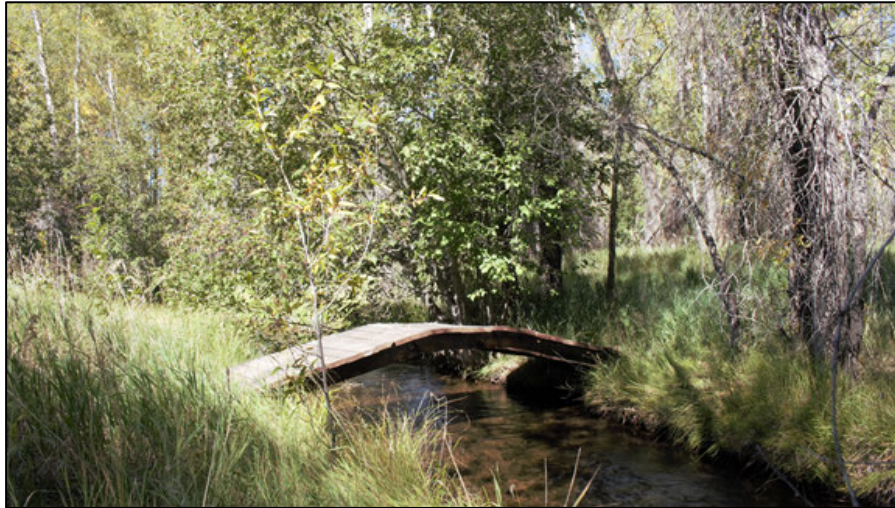
Figure 13. Example of a modern footbridge across the Ratliff and Root Ditch.

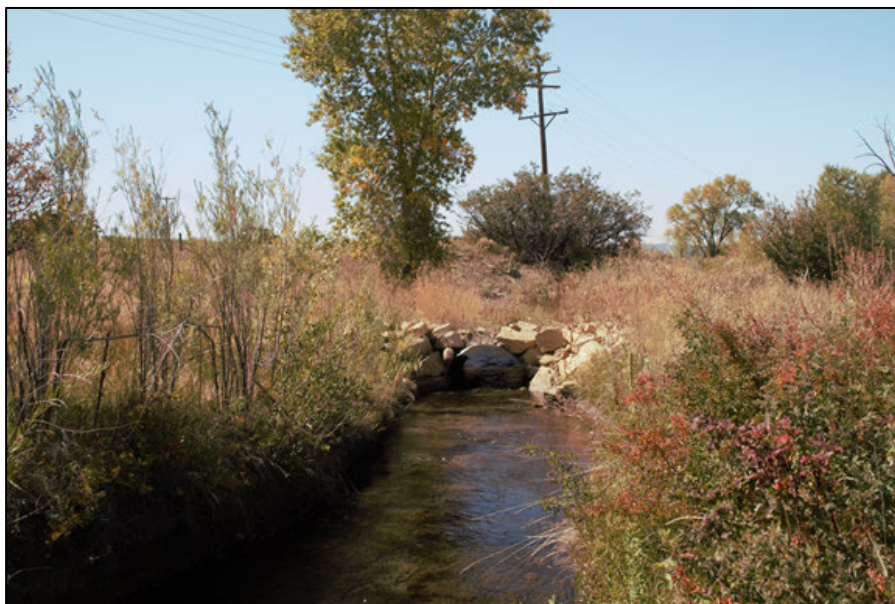
Figure 14. Example of a modern 2 foot in diameter corrugated metal culvert along the Ratliff and Root Ditch.

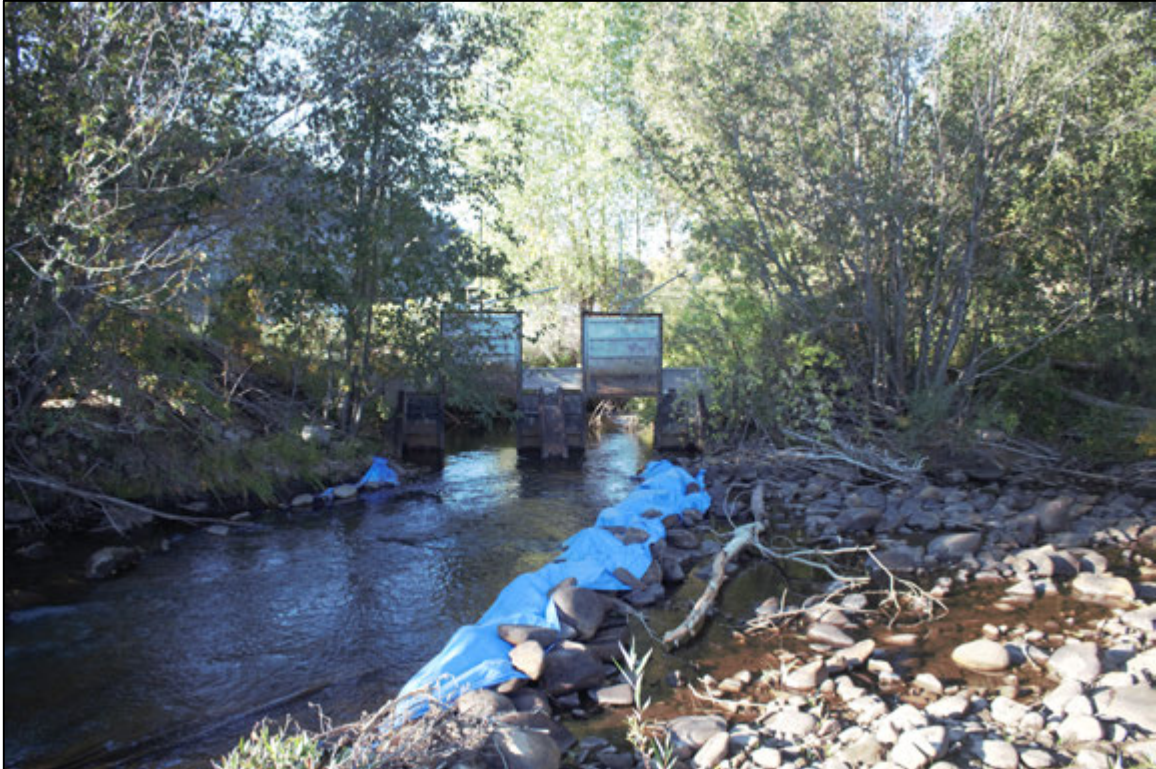
The intake superstructure is built of formed concrete. Six perpendicular pillars were mounted into the ditch opening. The three upstream pillars are 12" wide and stand 4'4" tall above the water line. The north face of the pillars angle back towards the superstructure at a 45 degree angle and the angled face is armored with ½" thick metal plates. Metal brackets are mounted along the outside edge of the outer angled pillars, likely to support additional wood or metal diversion plates during flooding events. The three downstream pillars are also 4'4" high but only 10" wide. The center pillar is 4' long while the side pillars are 6' long, L-shaped, and built into the east and west banks of the opening to reduce their erosion. The ditch intake gap is bridged by a 12x12" formed concrete beam that ties together all but the central upstream concrete pillar. Additional 5' long concrete wings extend off the east and west ends of this beam into the adjacent river bank to provide additional support to the superstructure.

The intake gates were mounted on the river (north) face of the superstructure. The gates are mounted in vertical metal frames measuring 8' high and 3'6" wide. The metal frames are 2" wide and bolted to the concrete pillars with 1" square concrete bolts. The gates measure 3 by 6' with metal panels mounted on their north face and steel panels on their south face. Stacked metal plates mounted on the north face of the concrete pillars block the flow of the intake ditch on either side and between the gates. The gates are raised and lowered with a rudimentary lever system. A vertical pole is mounted into the center of each gate and screwed into a plate on the south face. This pole extends through the top of the metal gate frame and a 6" tall bracket welded to the frame. Mounted to each bracket is a 3'6" long handle attached to the pole by a swivel lever below the handle. The gate levers are accessed via a 12' long and 2' wide metal grate walkway mounted to the tops of the concrete pillars on the south side of the gates.

Figure 15. Overview of the Ratliff and Root Ditch intake gates (Feature 1) facing south.

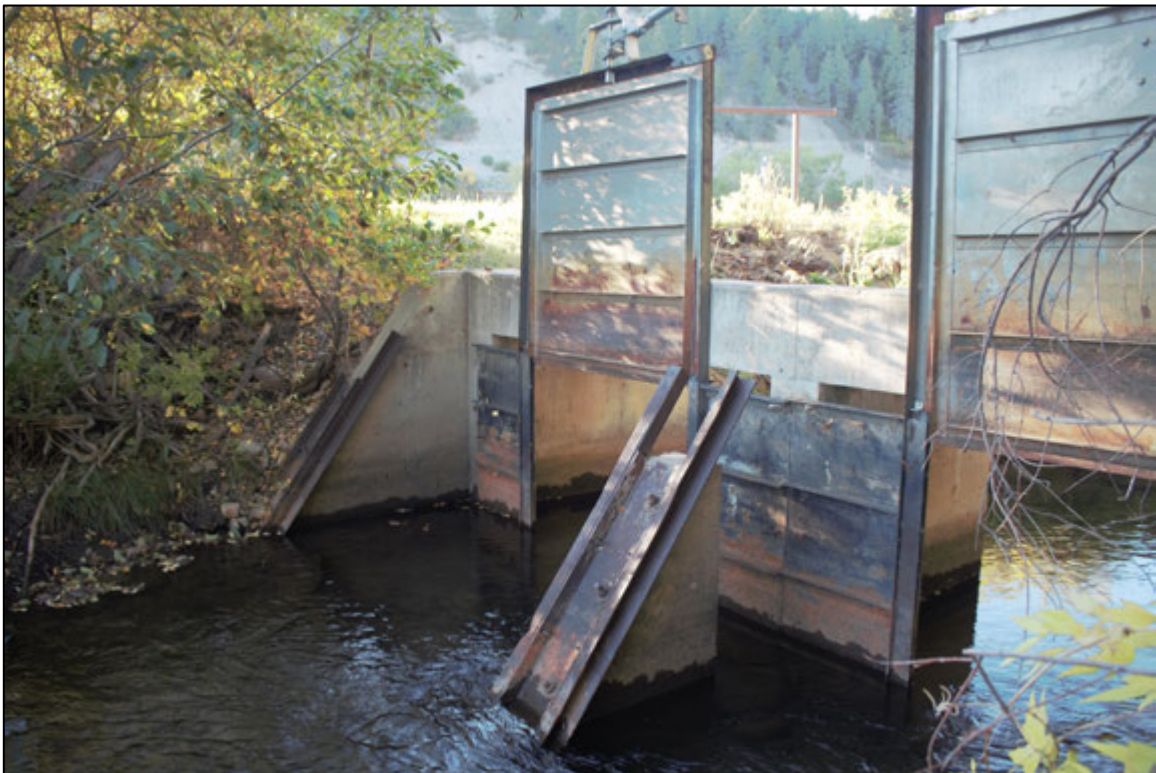
Figure 16. Closeup of the angled pillars on the north face of the Feature 1 facing southeast.

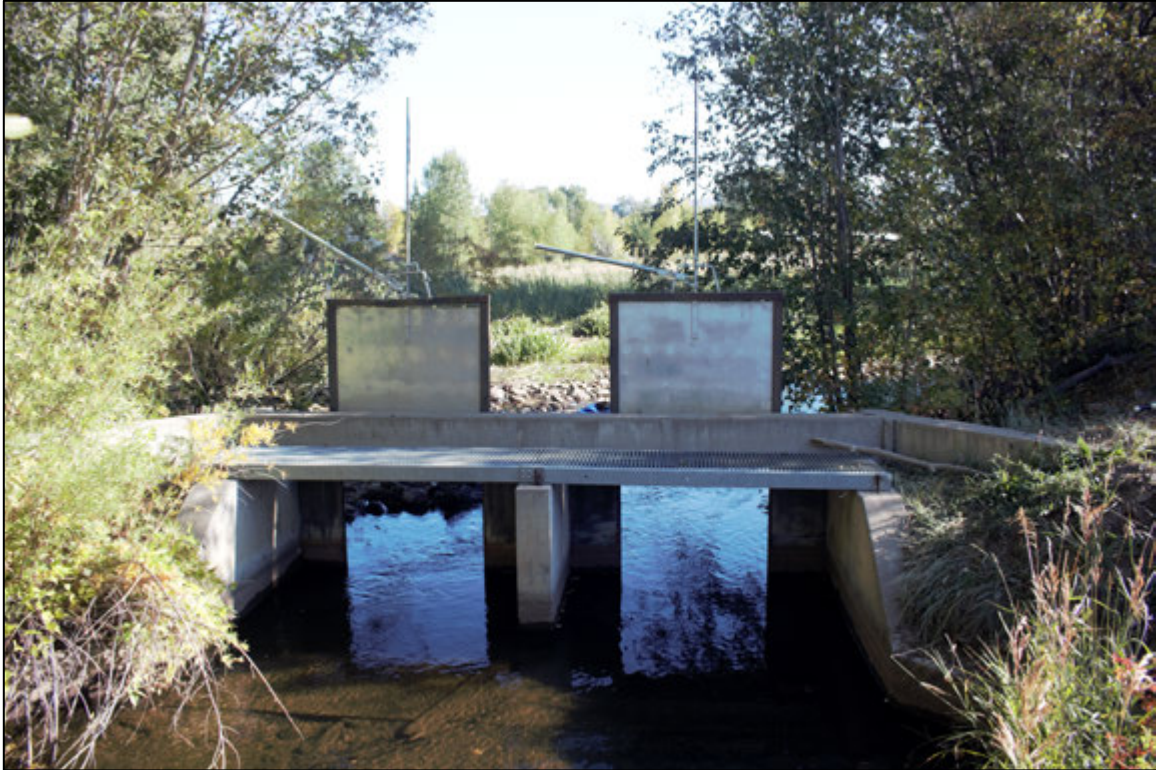
Figure 17. South elevation of Feature 1 facing north.

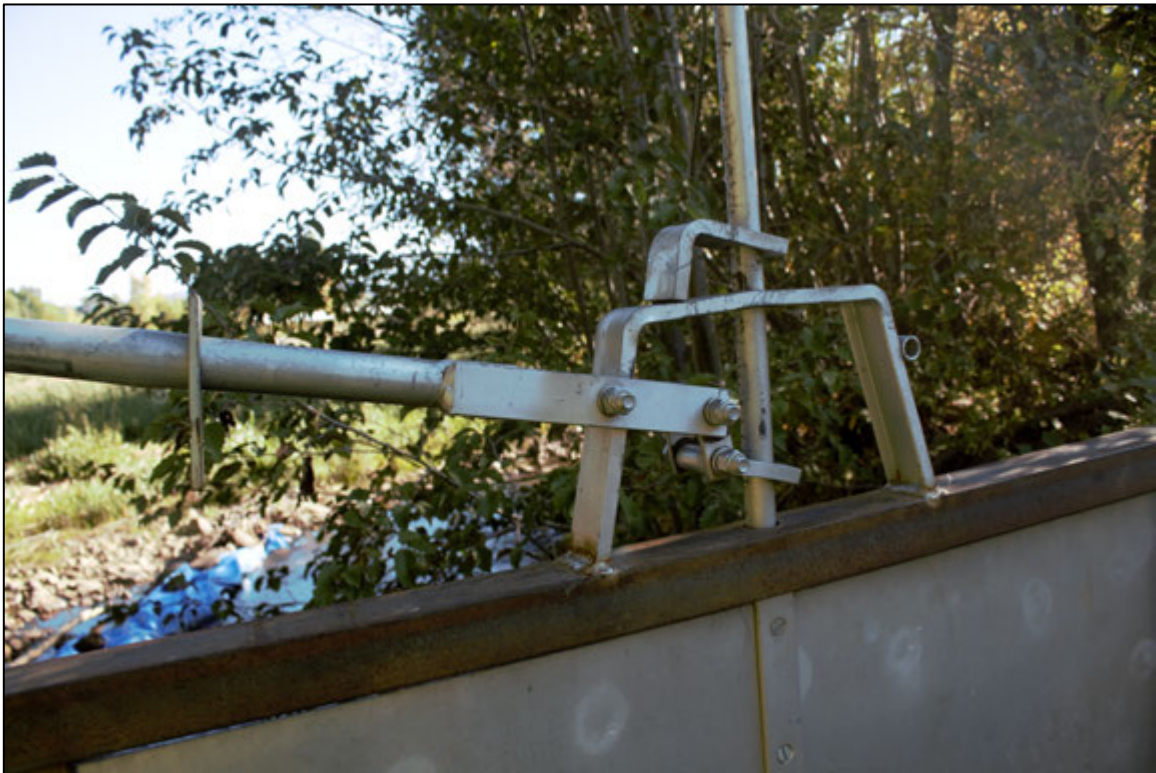
Figure 18. Closeup of the gate lever system in Feature 1. View to the northeast.

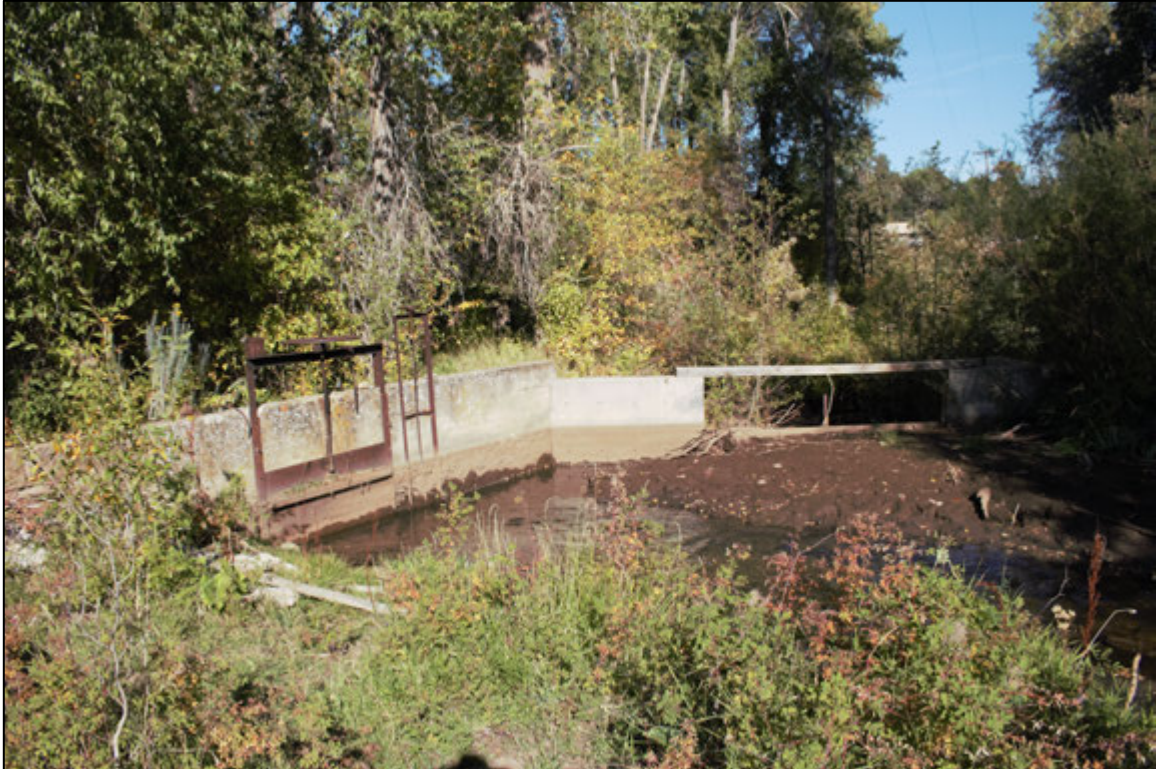
Feature 2 is the main headgate to the Ratliff and Root Ditch located about 110' west-southwest from Feature 1. The structure is built of two formed concrete wings. The south wing, which houses the headgate, was constructed in the mid-twentieth century based on a date stamp of "1948" inscribed on the top of the concrete wall. The northeast wing, which controls overflow back to the Mancos river, was added recently with a date stamp of "2007" similarly inscribed on the top of the wall. Both wings are 10" thick formed concrete standing approximately 6' tall.

Figure 22. Overview of Feature 2 facing north-northwest.

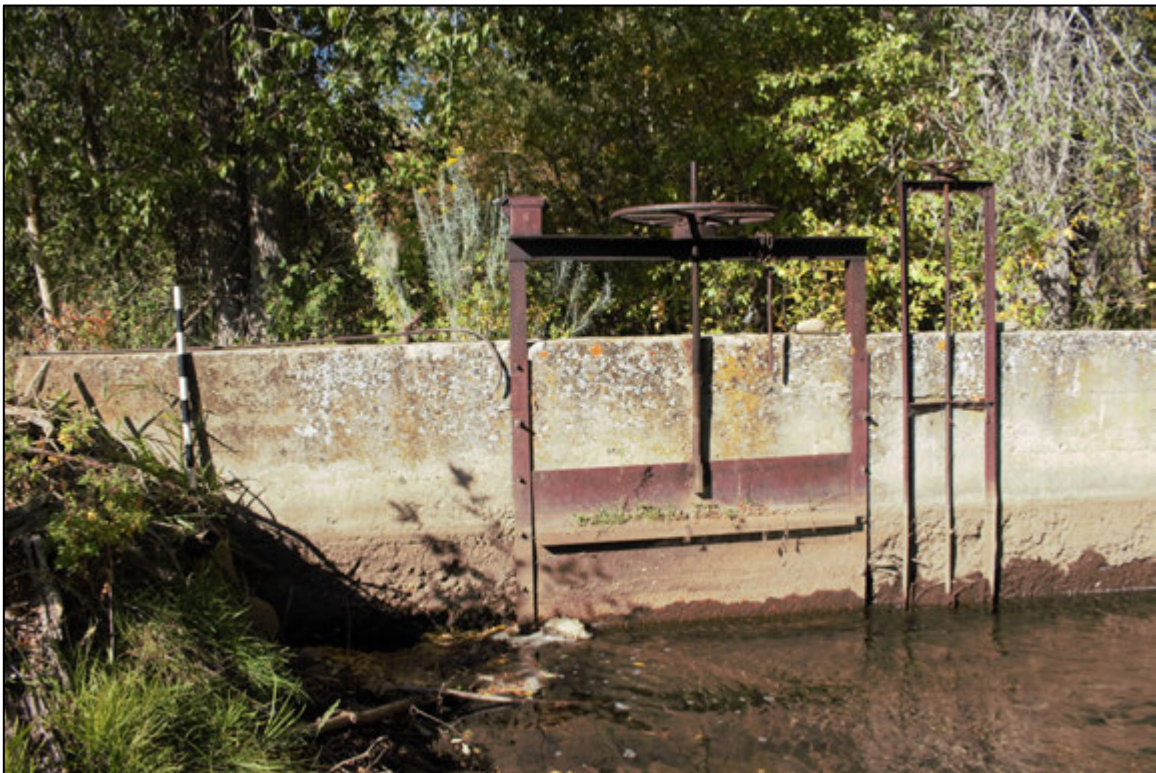
Two headgates, one large and one small, are mounted into the south concrete wall. The large headgate is a 4' by 4' rectangular metal sheet mounted into a metal bracket frame bolted to the concrete wall. The gate is controlled by a 30" hand wheel stamped with the makers mark "Thompson P & S CO Denver 2155c". The wheel is locked in place with a chain and padlock. The smaller gate is mounted into a 18" wide frame 6" north of the larger headgate. The smaller headgate is controlled by a 10" diameter hand wheel which opens a circular 18" diameter metal grate. The large headgate opens directly into an 8'6" long and 2' wide rectangular inclined formed concrete drop spillway. The smaller headgate must add water to the spillway through an unseen concrete culvert. The end of the spillway flares out to a 5' by 5' stilling basin before it retracts to the standard 3' wide ditch.

Figure 23. East elevation of the headgates in Feature 2. View to the west.

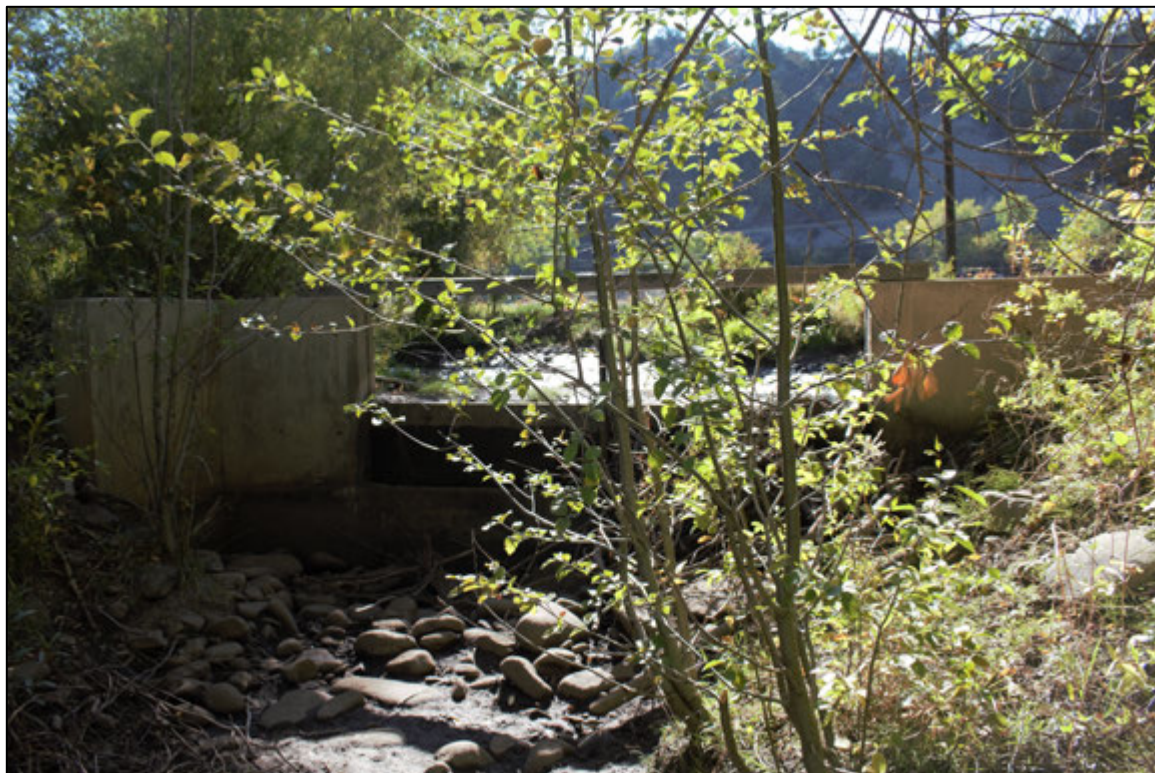
The lower 4' of the northeast wing of the feature impounds sediment and water to channel into the adjacent headgates. An 8' wide gap in the upper 2' of the barrier provides an overflow outlet that pours over the dam into a swale that leads northwest, back to the Mancos River.

Figure 24. West elevation of the overflow spillway in Feature 2. View to the southwest.

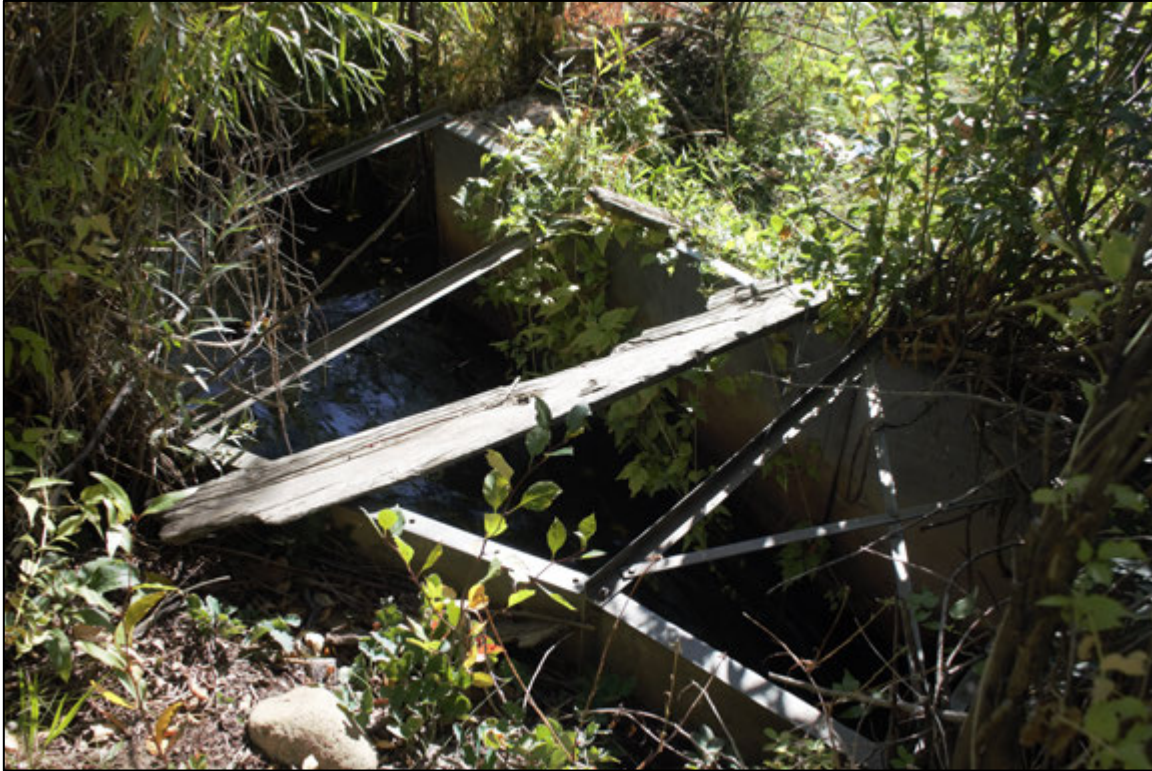
Feature 3 is a prefabricated Parshall Flume 173' west-southwest of the Feature 2 Main Headgate. The flume is 11'4" long and constructed of 3' by 3' sheet metal riveted together to form an hourglass shape. The flume opening is 5'6" wide and restricts to a 3'6" wide central shoot where the bottom drops 6" in just a couple of feet. A flow gauge ruler in cubic inches and feet is glued to the interior north face of the flume near the intake. A series of seven cross beams keep the flume from flexing. The Parshall Flume is held in place by 10" thick formed concrete buttresses mounted perpendicularly into the flume banks at all four corners.

Figure 26. Overview of the Parshall Flume in Feature 3. View to the southeast.

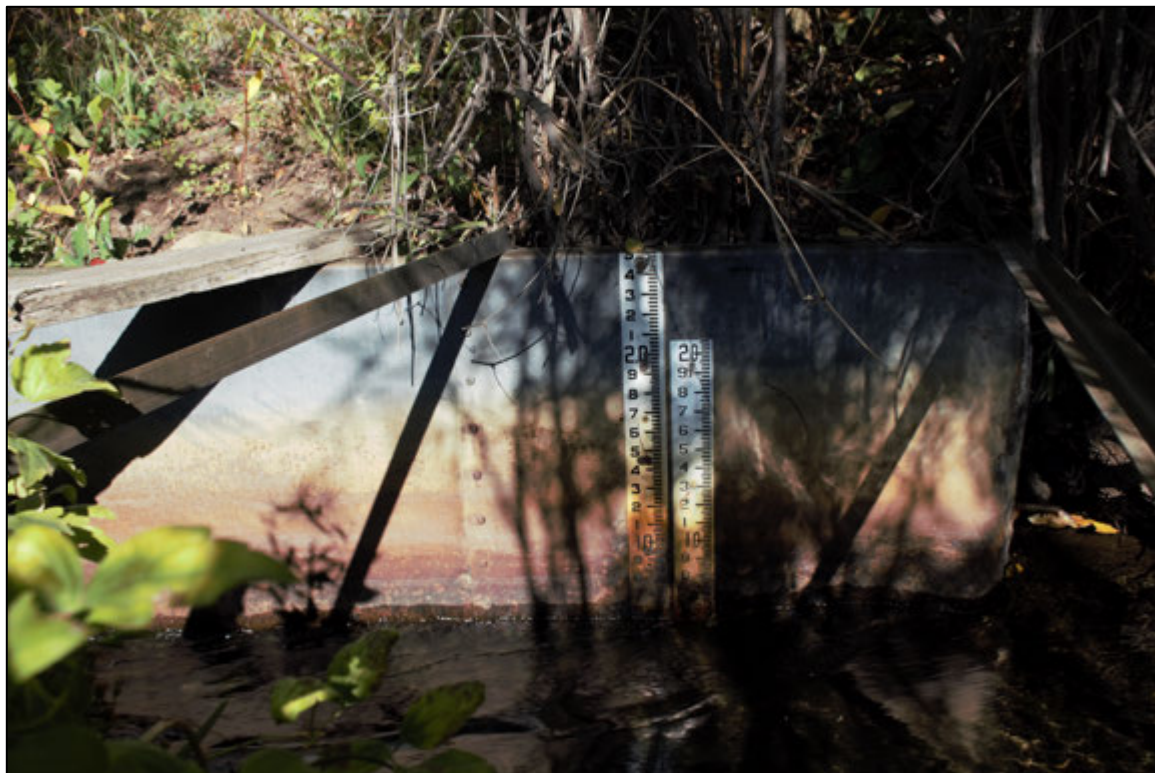
Figure 27. Gauge rulers on the north interior face of the Parshall Flume in Feature 3.

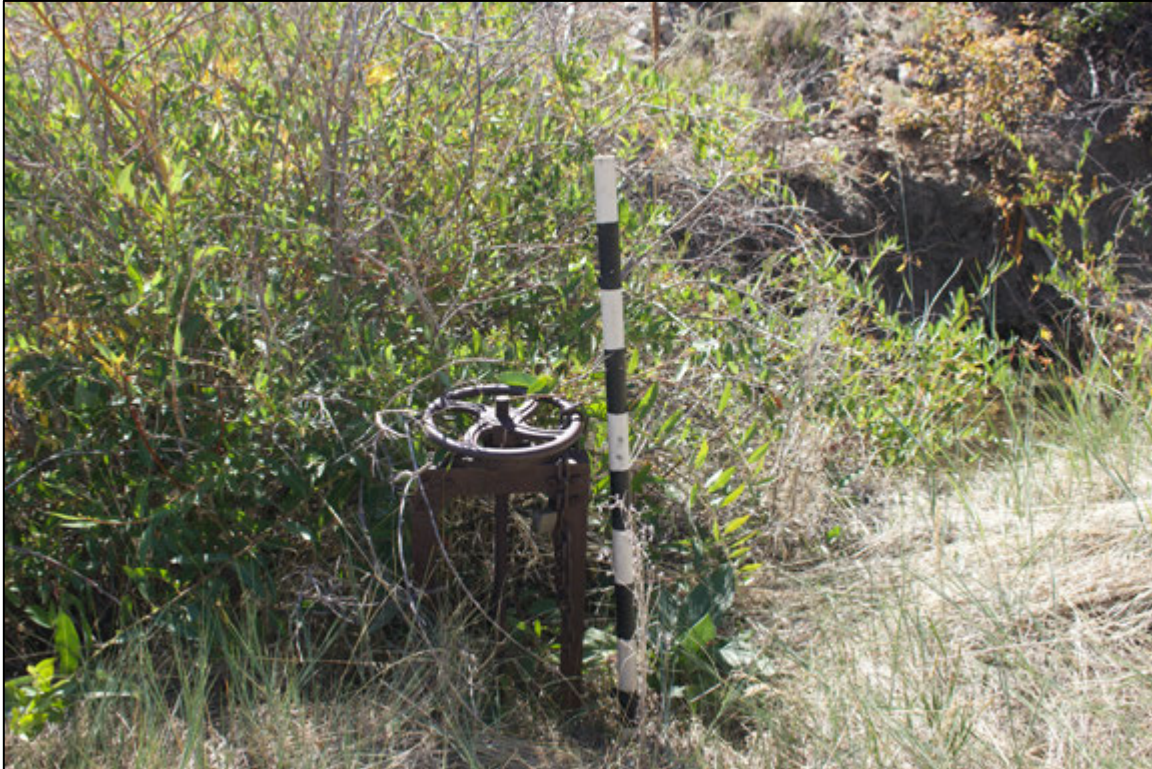
Feature 3 is a defunct lateral headgate on the northeast side of the Ratliff and Root Ditch, 430' before it crosses U.S. Highway 160. The rectangular headgate frame is built of 3" wide metal plates bolted together to create a rectangular frame. The handwheel shaft is mounted through the top of the frame and controlled by a 10" wheel. Only the upper 2' of the headgate is currently visible. The actual gate inside the ditch has been buried by sediment. Likewise, there is no evidence of the headgate culvert or associated ditch that was fed by the headgate.

Figure 29. Feature 4 headgate with hand wheel facing south.

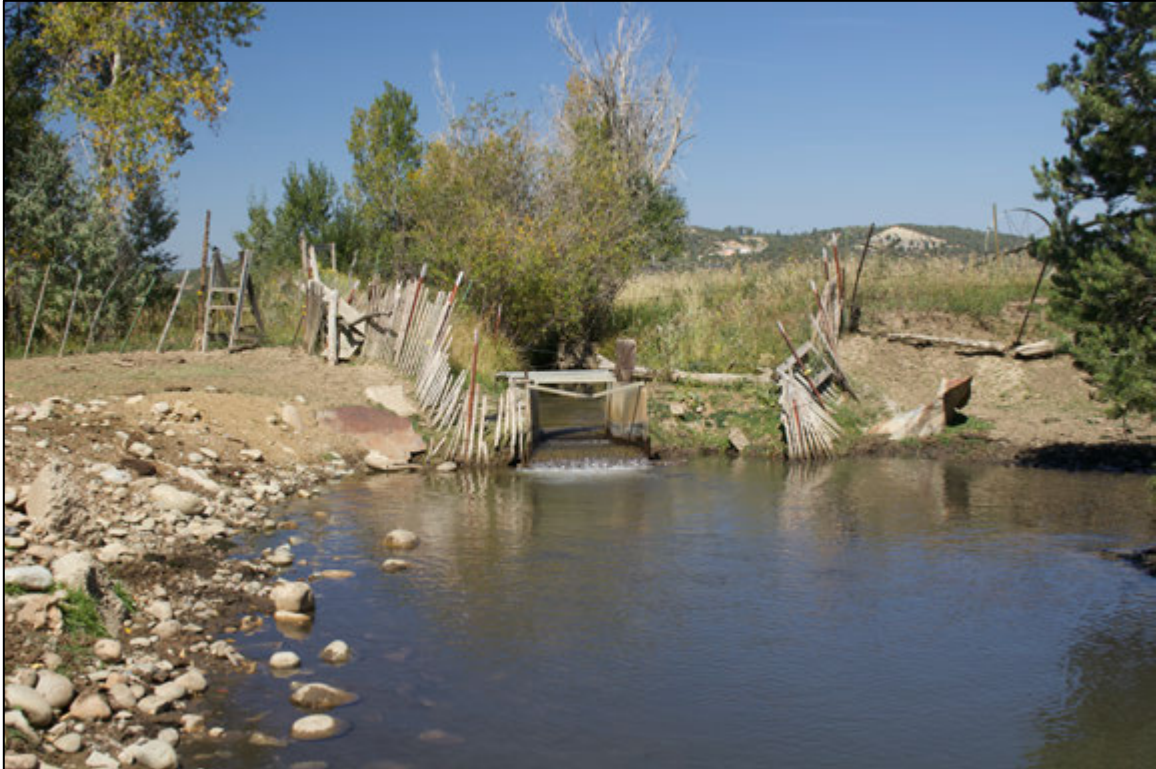
Feature 6 is a Parshall Flume installed north-south along the main Ratliff and Root Ditch 60' south of Feature 7, the headgate for a major lateral ditch. Like Feature 3, the flume 11'4" long and is constructed of 3' by 3' sheet metal riveted together to form an hourglass shape. The flume opening is 5'6" wide and restricts to a 3'6" wide central shoot where the bottom drops 6" in just a couple of feet. A flow gauge ruler in cubic inches and feet is glued to the interior west face of the flume near the intake. A series of seven cross beams keep the flume from flexing. The flume is held in place by a short 10" thick formed concrete buttresses off the northwest corner, three metal t-posts sunk along its west side, and a 8" diameter post mounted on the east side of the flume and tied to it with bailing wire. The flume exits into a shallow 14' in diameter stilling pond which opens into the standard 3' ditch off its south side.

Figure 30. Overview of the Parshall Flume in Feature 5 facing north.

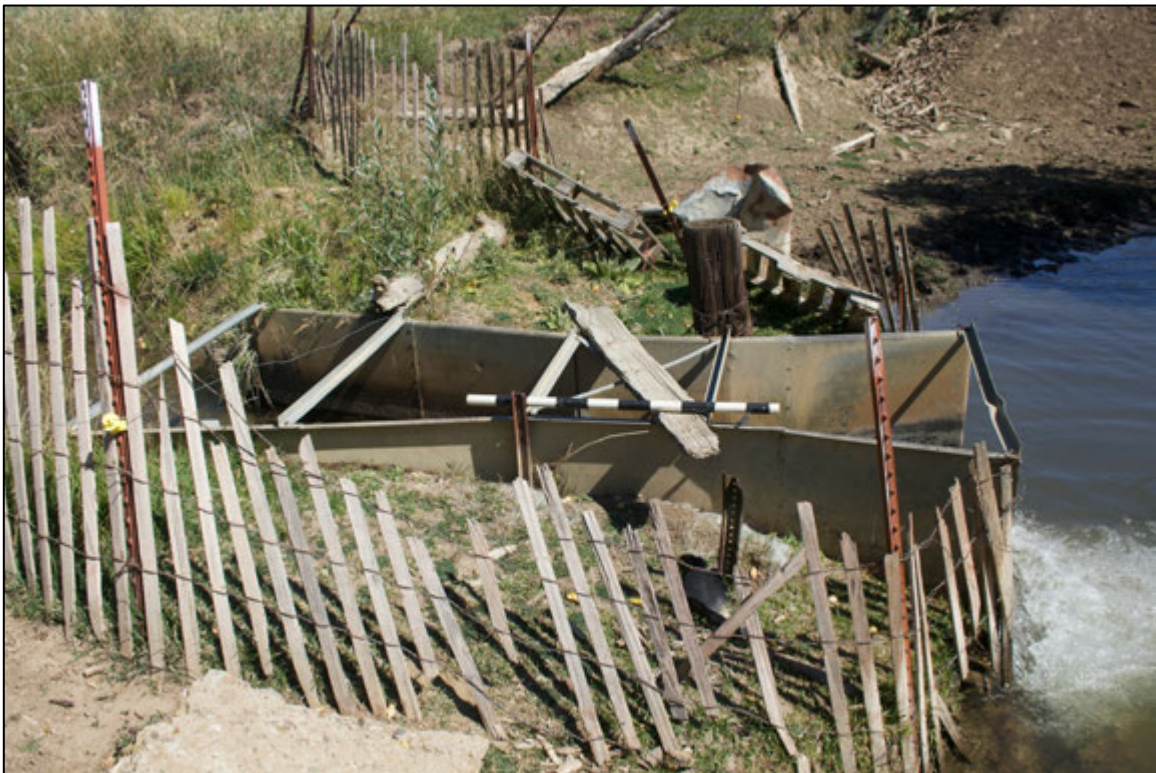
Figure 31. Overview of the Parshall Flume in Feature 5 facing east.

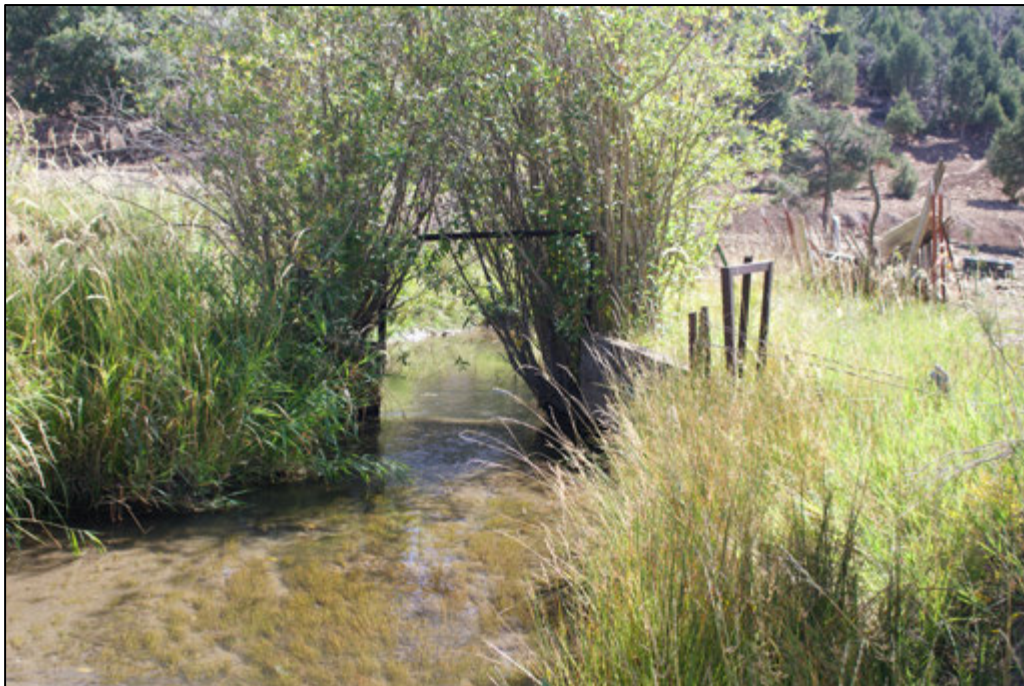
A prefabricated Parshall Flume is mounted in the lateral ditch at the end of the concrete spillway. The flume is slightly smaller than the flumes in Features 3 and 5. The flume is 9' long a 2'8" opening on the east side and 2' opening to the west where it exits directly into the lateral ditch. Like the main Ratliff and Root Ditch, this lateral is 3' wide but is about half as shallow at about 1'6" deep.

Figure 32. Overview of Feature 6 facing south.

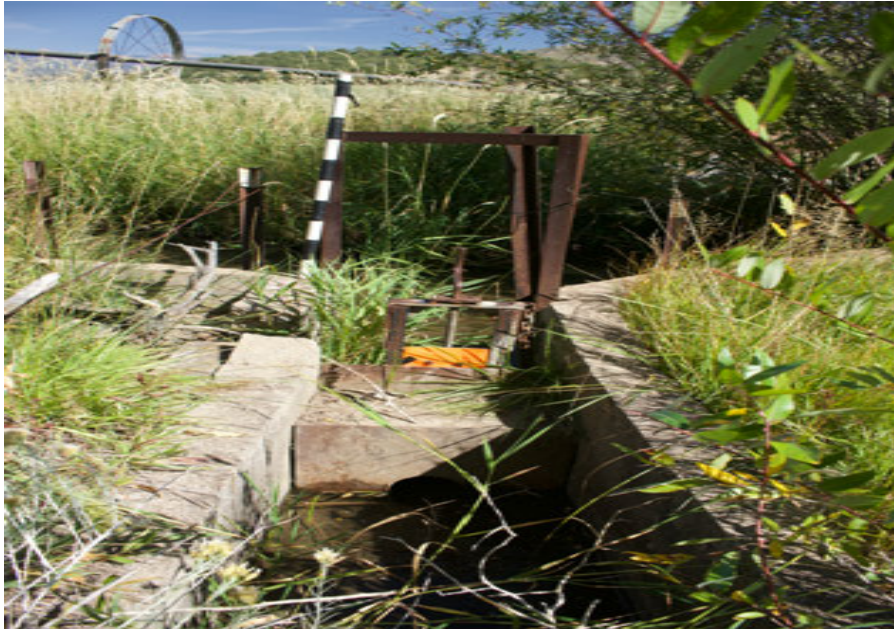
The lateral ditch headgate is mounted into the concrete stem wall on the east bank of the Ratliff and Root Ditch. A 20" gap in the stem wall is framed with L-shaped brackets that support a 6" iron hand crank that lifts and lowers a 10" metal gate. The headgate frame is stamped with a certification mark, "MFGBY AWEPRITCW MANCOS CO 1969". Behind the gate is a trapezoidal custom built metal box measuring 12" deep, 8" long, and 17" to 22" wide. A 6" diameter open pipe runs through the center of box which controls the maximum flow of water into the lateral ditch. The flow control box is mounted in and opens into a 6'2" long and 2' deep concrete spillway.

Figure 33. West elevation of lateral headgate in Feature 6.

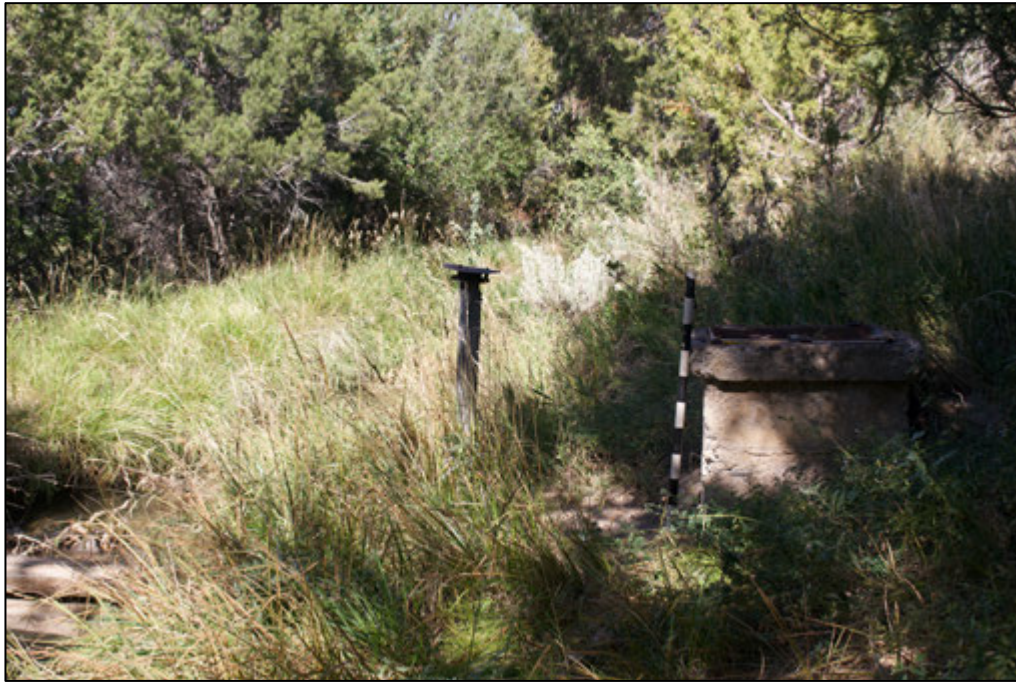
Feature 7 is a historic stilling well along the central portion of the Ratliff and Root Ditch. The well was built on the uphill (east) side of the ditch between two historic homesteads (5MT23521 and 5MT23084). The 5MT23084 property was patented by Joseph Smith in 1889 who owned the property during the construction and early use of the Ratliff and Root Ditch. The 5MT23521 property was patented by one of the namesakes of the ditch, Almarian Root in 1882. The stilling well could have been used for domestic water by either party.

The stilling well is a 20" by 32" rectangular vertical well built into the slope 10' east of the Ratliff and Root Ditch. A 8" thick lip was added to the top of the well to support the frame of a hinged wooden framed screen with a clasp now locked with a keyed padlock. The well stands 2'4" above the modern ground surface and extends about 3' below ground.

Figure 36. Overview of Feature 7 facing northeast.

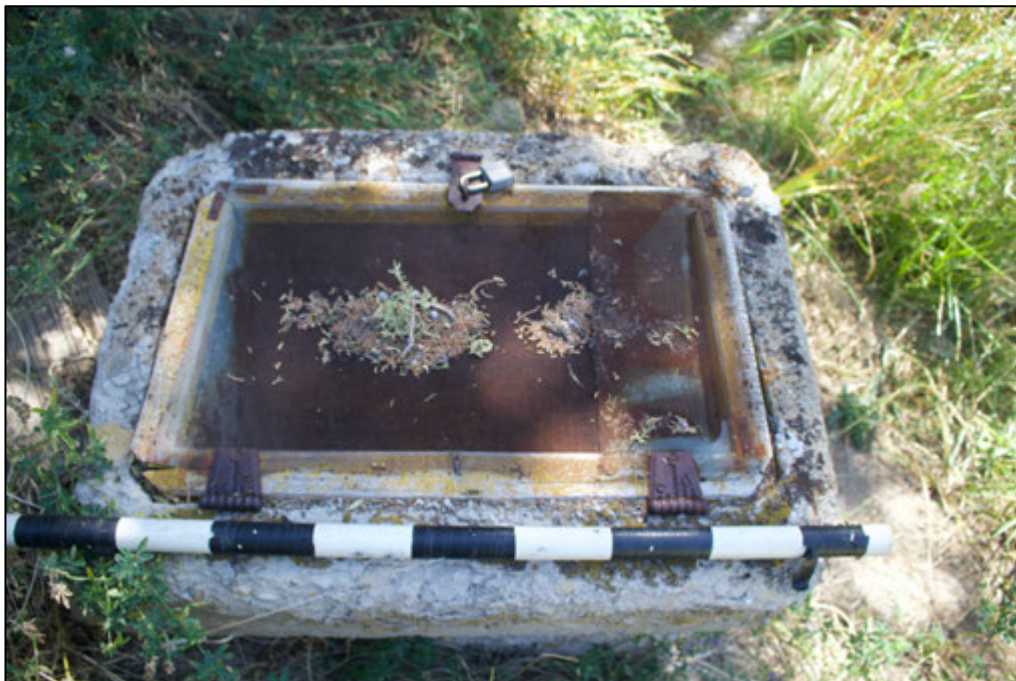
Figure 37. Closeup of the hinged screen over the stilling well in Feature 7. View to the southwest.

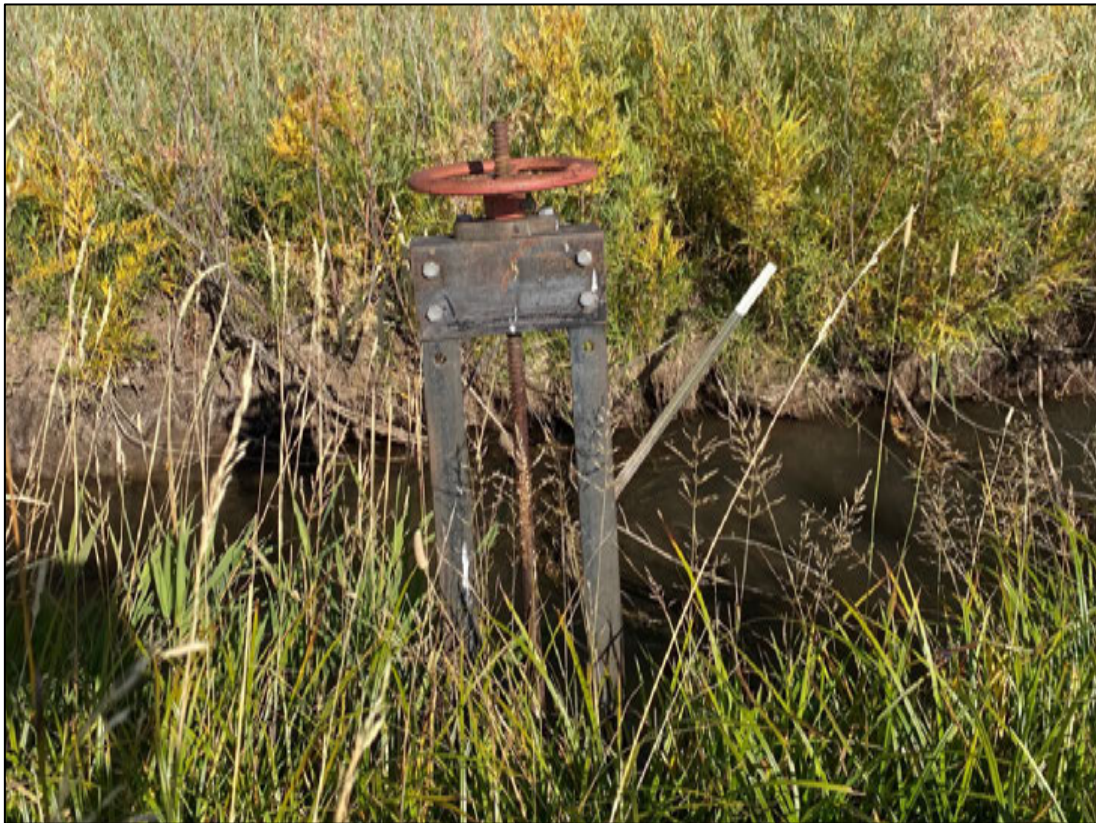
Figure 38. Closeup of the headgate in Feature 8 facing east.

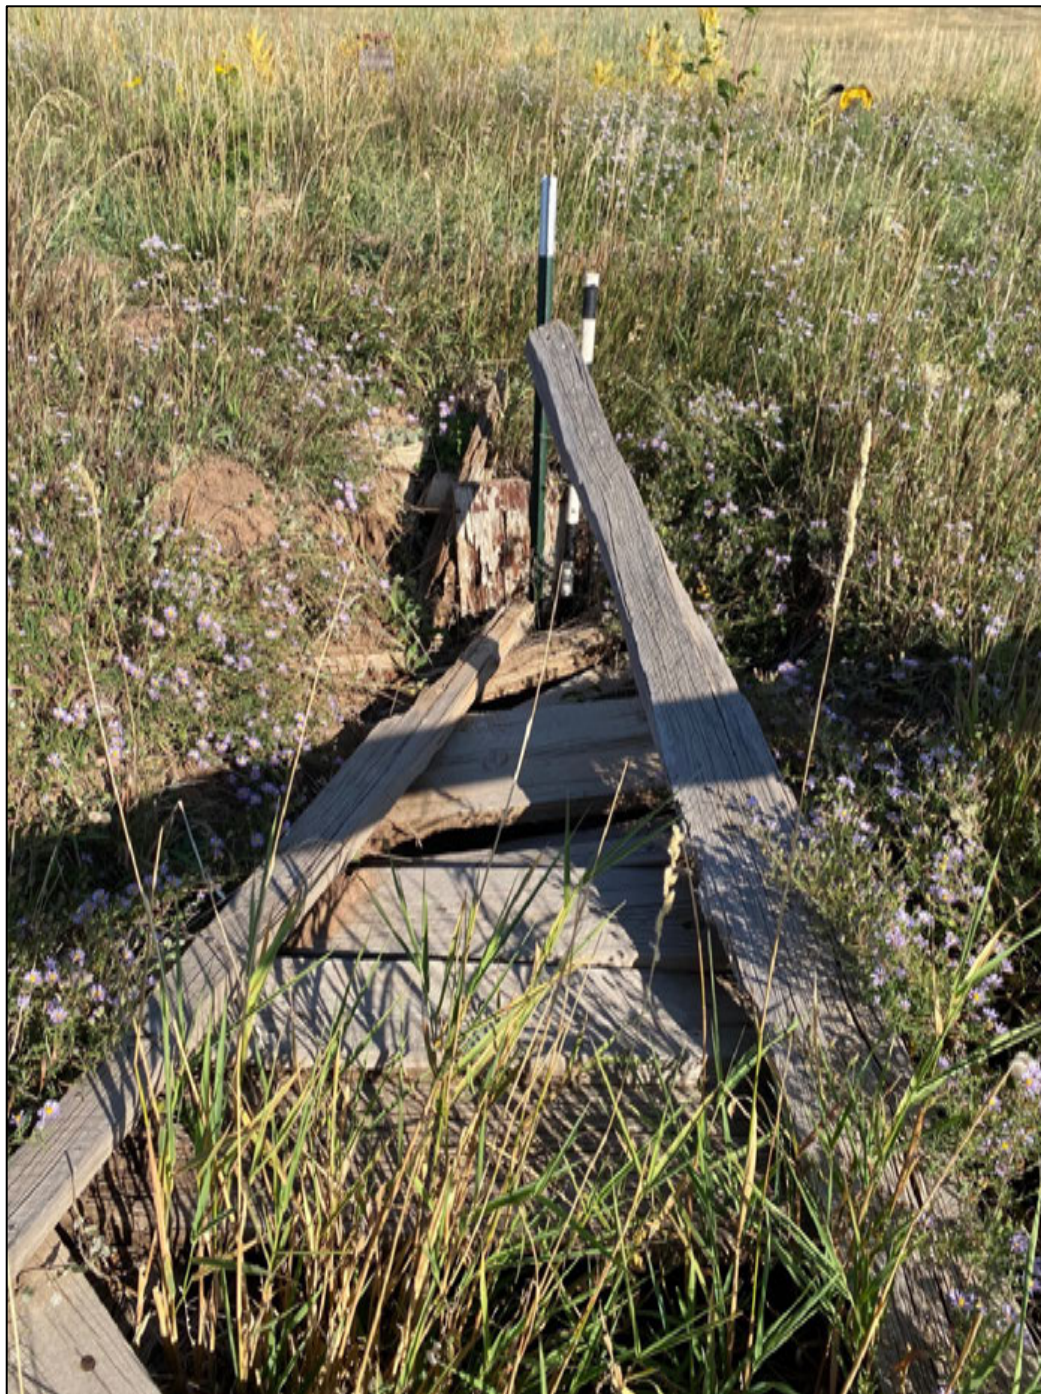
A formed 2' square concrete culvert runs through the 6' wide and 4' high berm on the downhill west side of the ditch. The culvert exits the berm into a 3'6" deep and 2'3" wide and 5' long stilling basin covered by rough cut boards. The ditch continues into a 9' long hourglass shaped Parshall Flume exactly like the one found in Feature 6. The flume opening on the east side is 2'8" and is 2' wide as it exits to the west directly into the lateral ditch.

*Figure 39. Closeup of the western face of the culvert and the boarded over stilling chute in Feature 8.
View to the east.*
