Level II Documentation of the Ratliff and Root Ditch (5MT23092), Montezuma County, Colorado

(OAHP # MT.R.R142)

OAHP Project Number: MT.R.R142

October 5, 2020

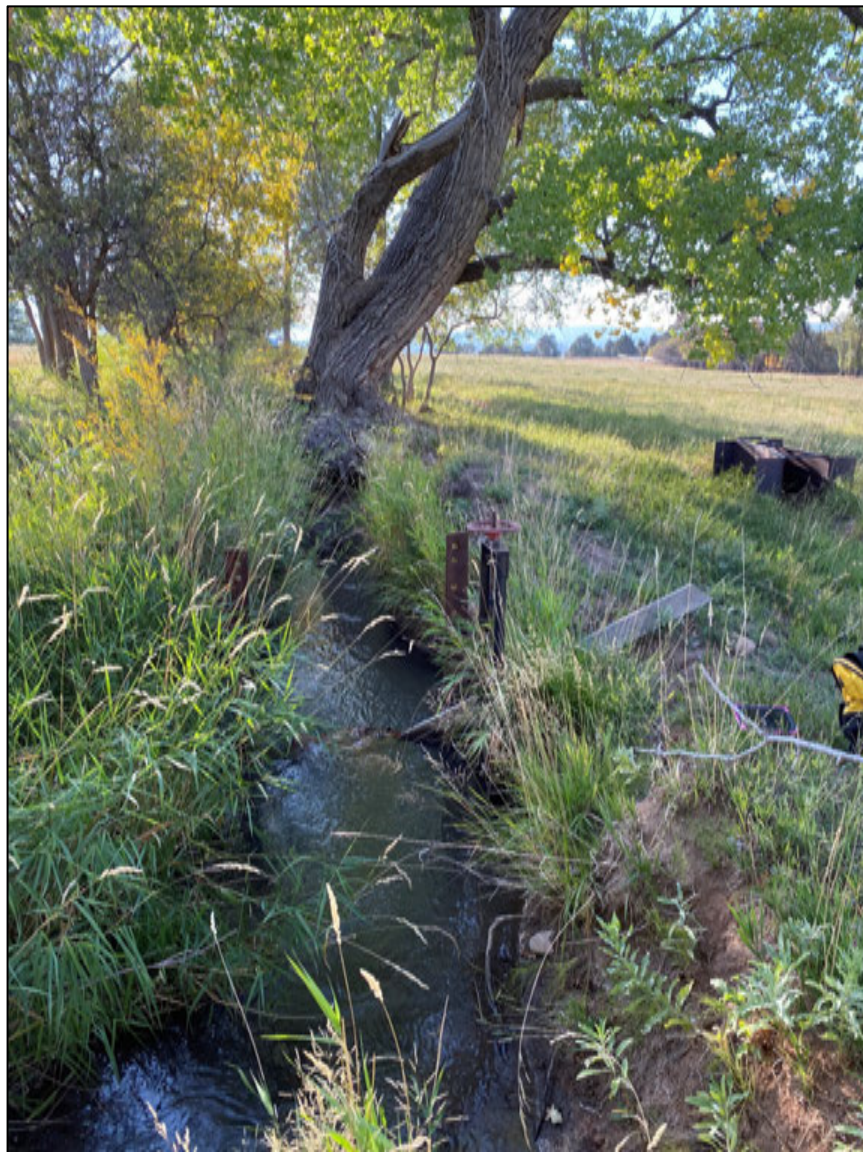
Figure 41. Overview of Feature 9 facing west-northwest.

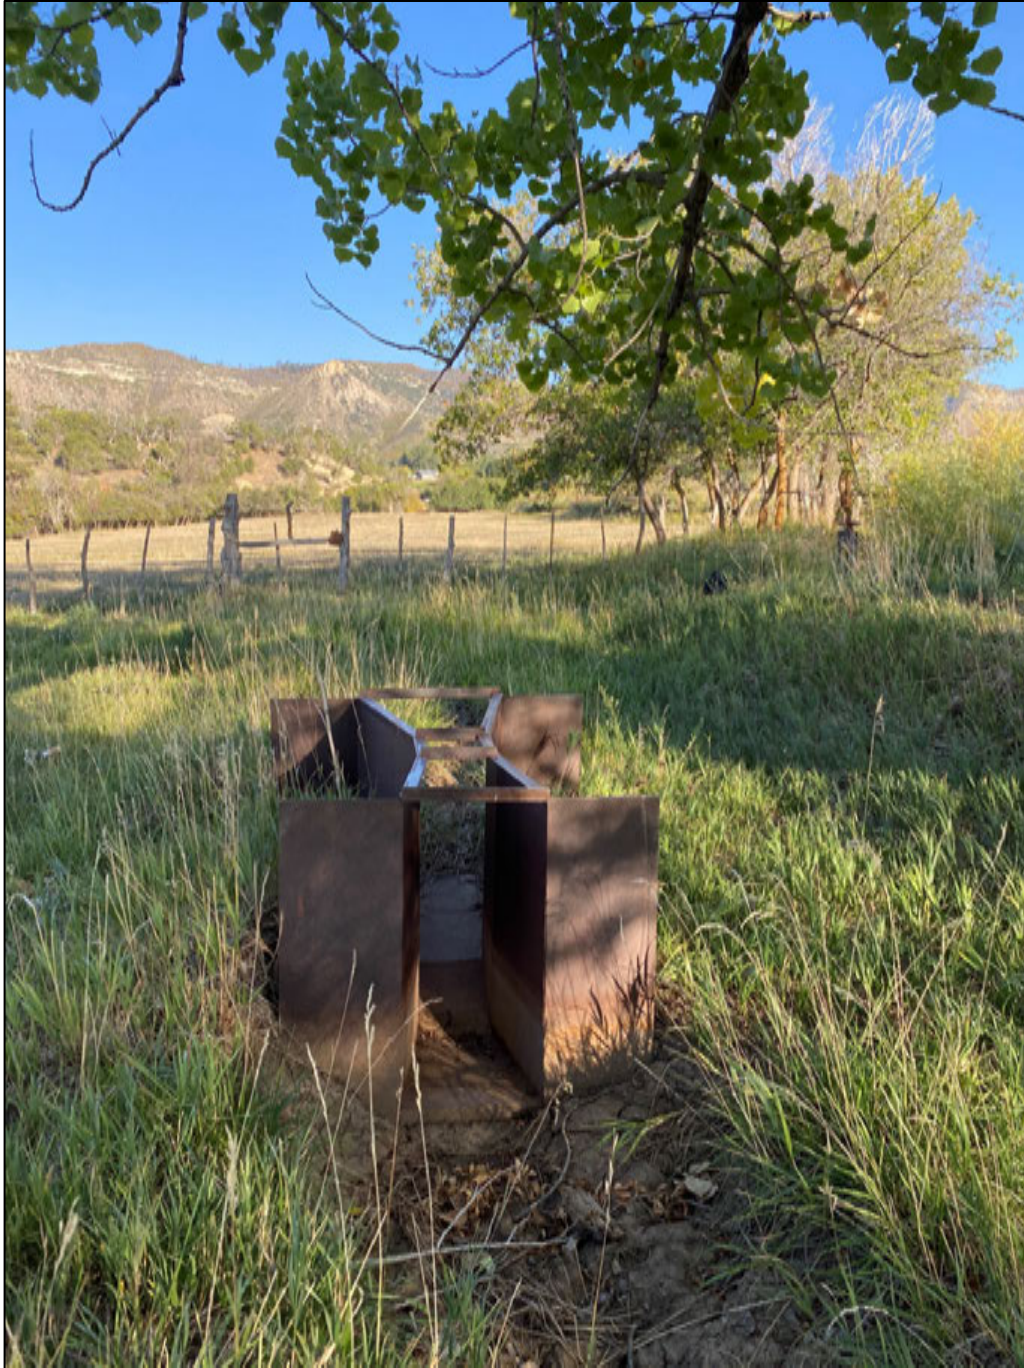
A PVC culvert directs the water from the headgate under the downslope berm to the north to the mouth of the ditch 12' to the north. Three feet down the ditch is a Parshall Flume, slightly smaller than others used along the Ratliff and Root Ditch system. The metal flume measures 5'4" long with 39" intake and 33" wide outake into a 2' wide lateral ditch that runs to directly west.

Figure 42. Closeup of the Parshall Flume in Figure 9.

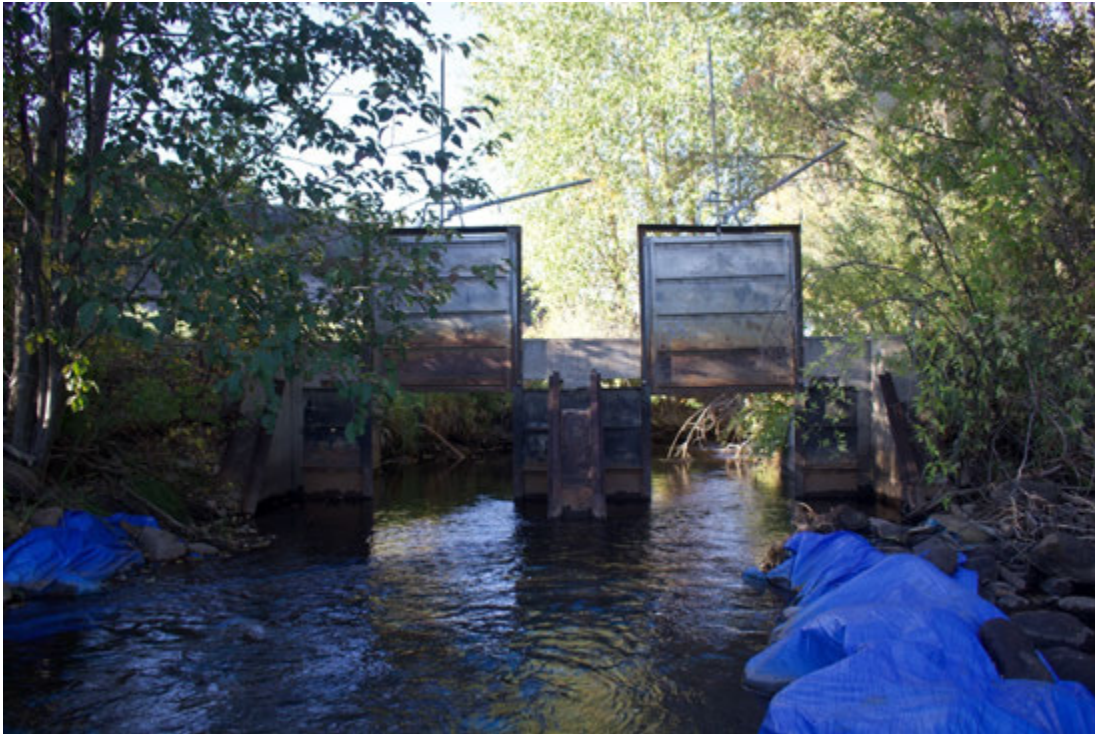
Image Number 5631 A photograph showing a closeup of Feature 1, the Ratliff and Root irrigation ditch intake gate's north elevation, facing south.

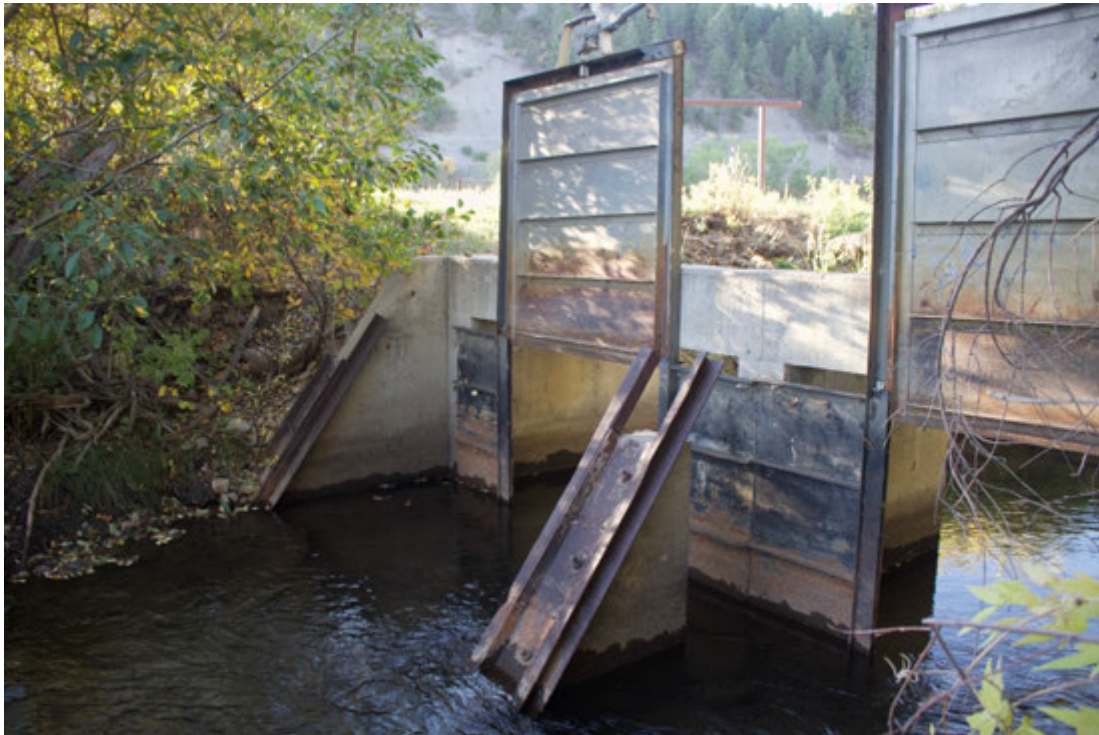
Image Number 5632 A photograph showing a closeup of Feature 1, the Ratliff and Root irrigation ditch intake gate's southeast corner of the north elevation, facing southeast.

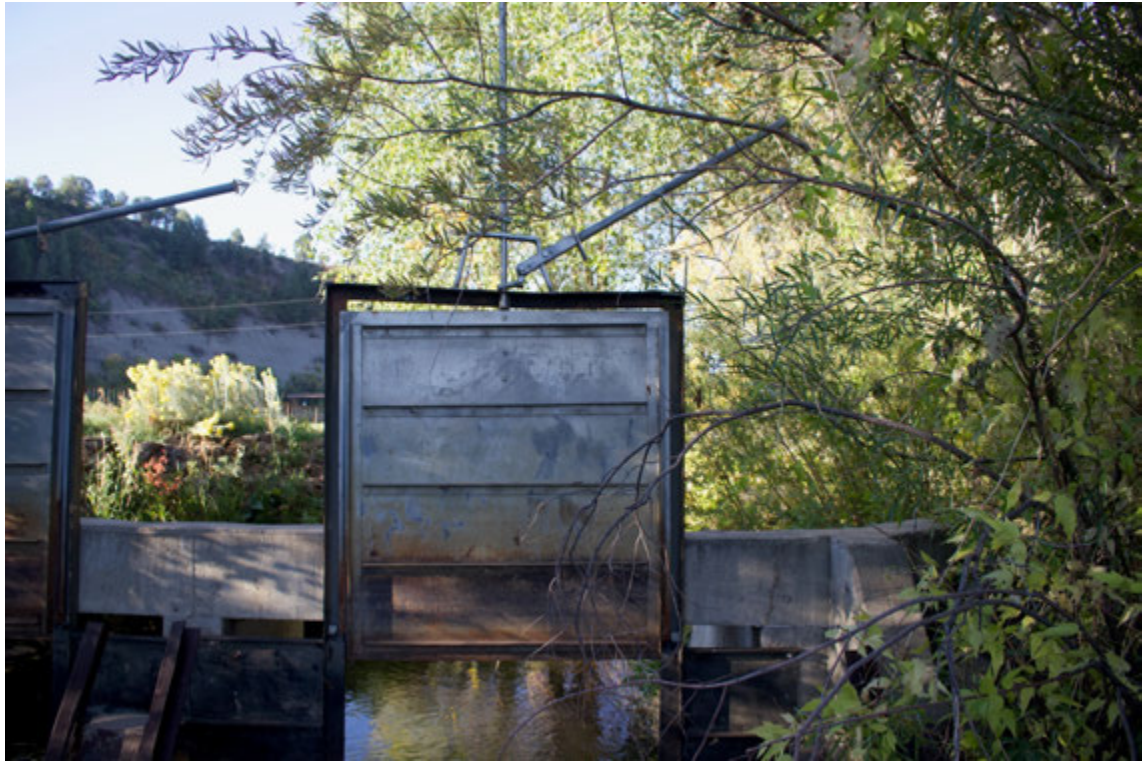
Image Number 5633 A photograph showing a closeup of Feature 1, the Ratliff and Root irrigation ditch intake's west gate, facing south.

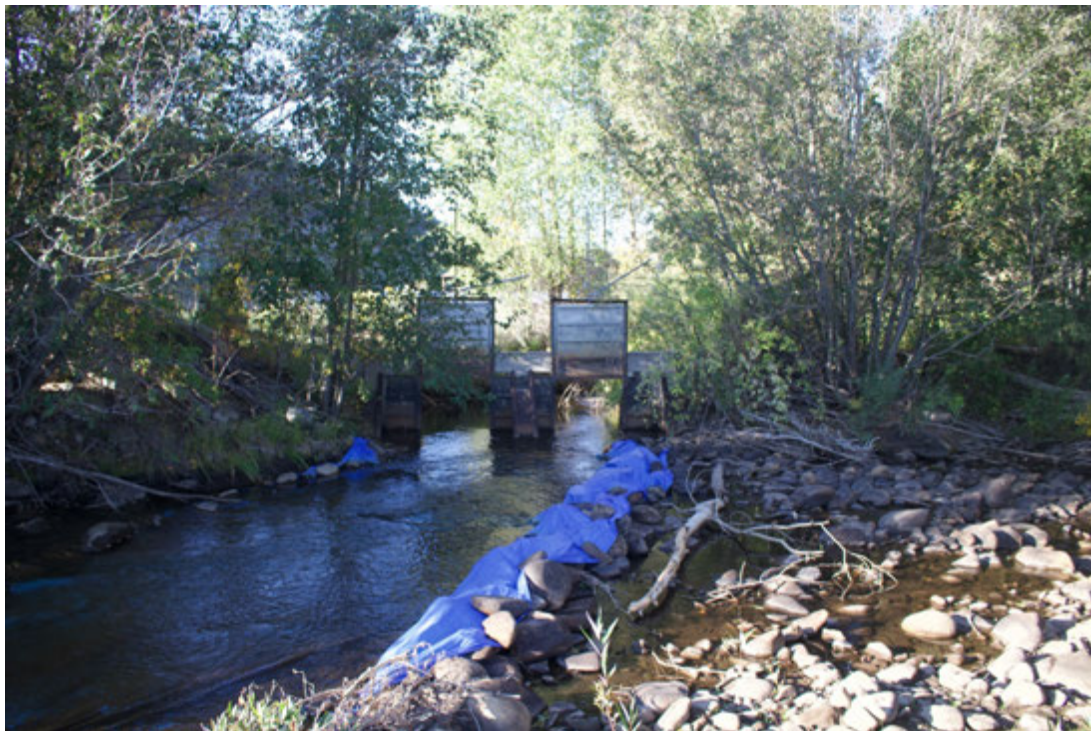
Image 5634 A photograph showing an overview of Feature 1, the Ratliff and Root irrigation ditch intake's Mancos River diversion berm and the intake gate in the background, facing south.

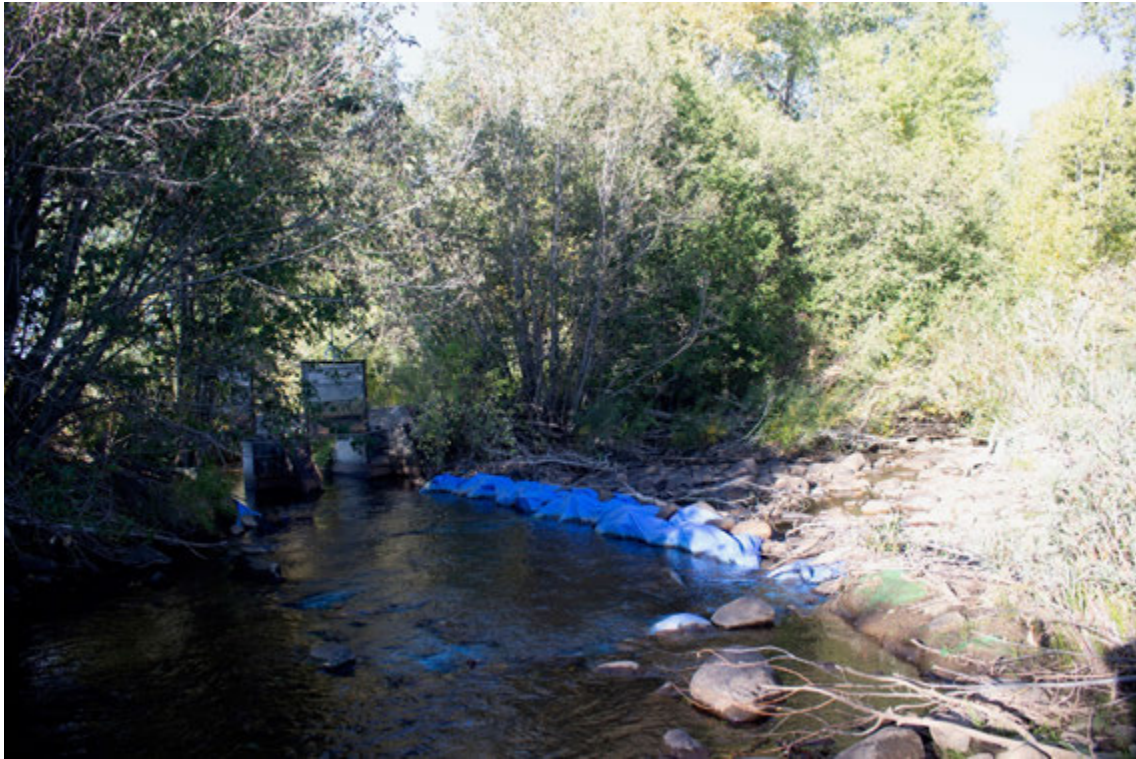
Image Number 5635 A photograph showing an overview of Feature 1, the Ratliff and Root irrigation ditch intake's Mancos River diversion berm and the intake gates on the left, facing southwest.

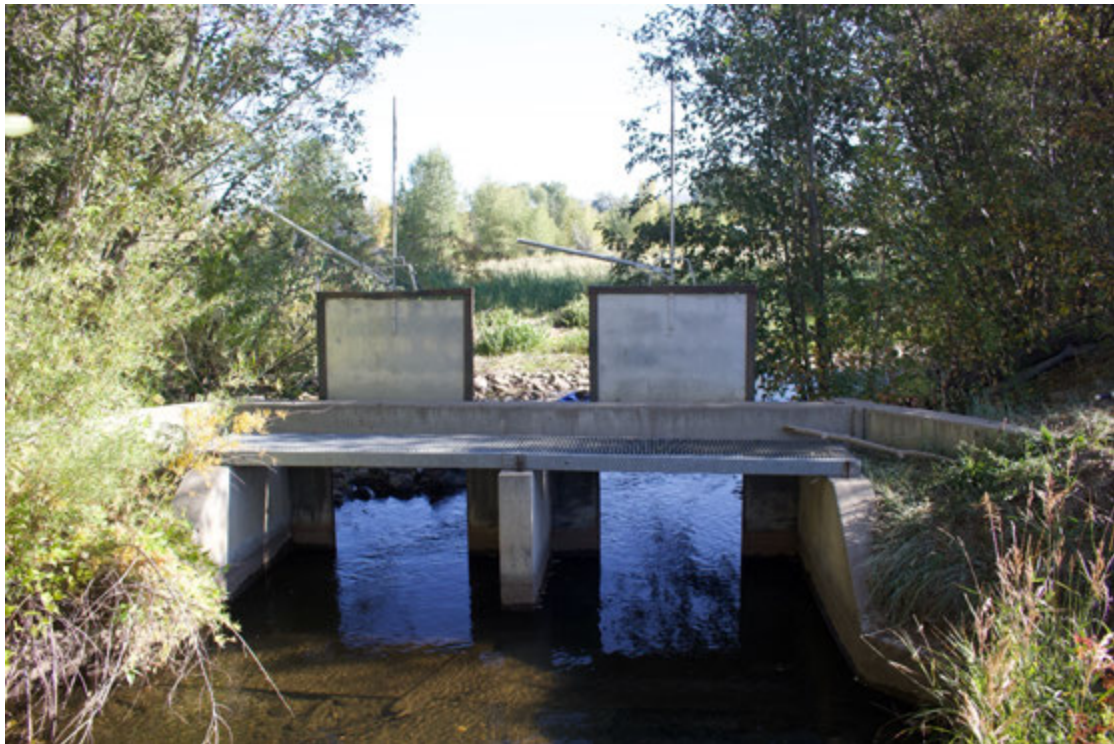
Image Number 5636 A photograph showing a closeup of Feature 1, the Ratliff and Root irrigation ditch intake's south elevation, facing north.

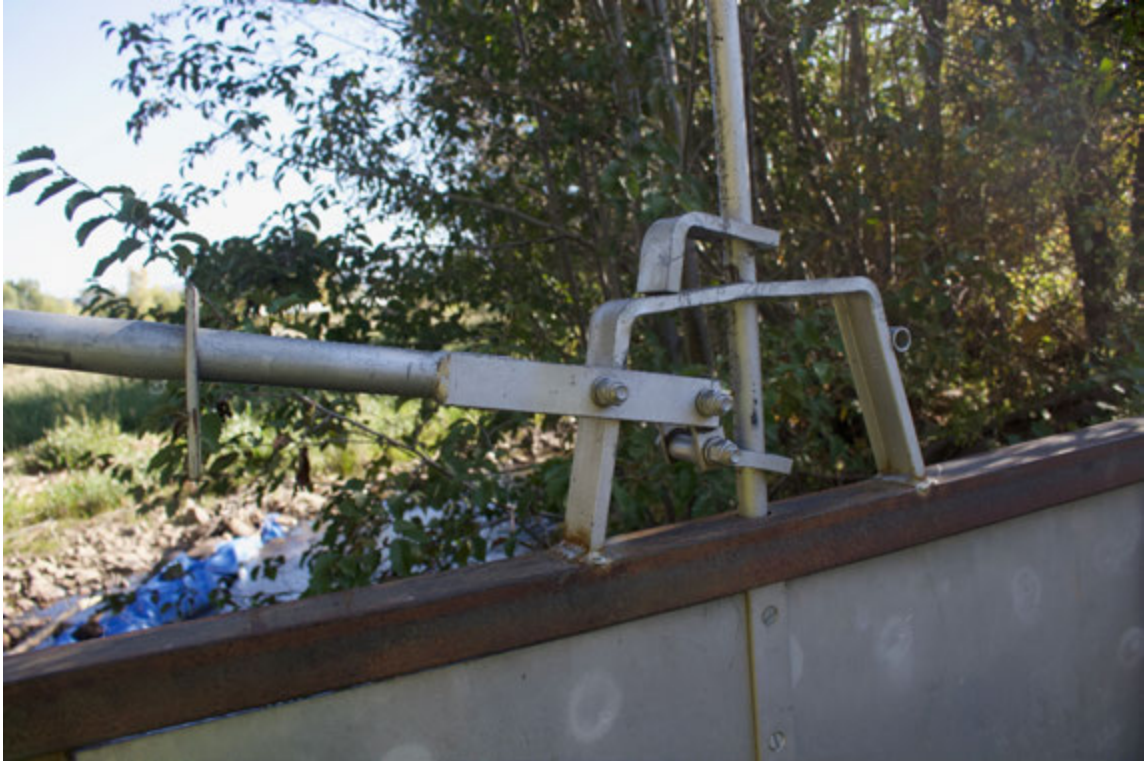
Image Number 5637 A photograph showing a closeup of Feature 1, the Ratliff and Root irrigation ditch intake's gate lever, facing northeast.

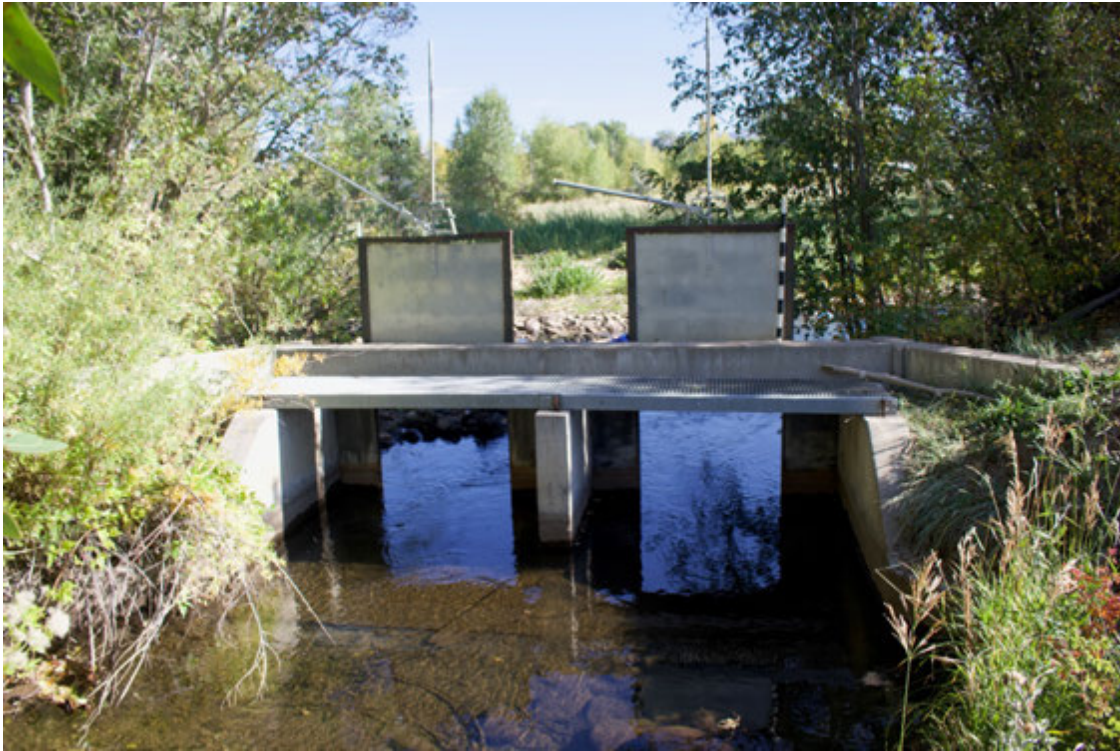
Image Number 5639 A photograph showing a closeup of Feature 1, the Ratliff and Root irrigation ditch intake's south elevation with scale, facing north.

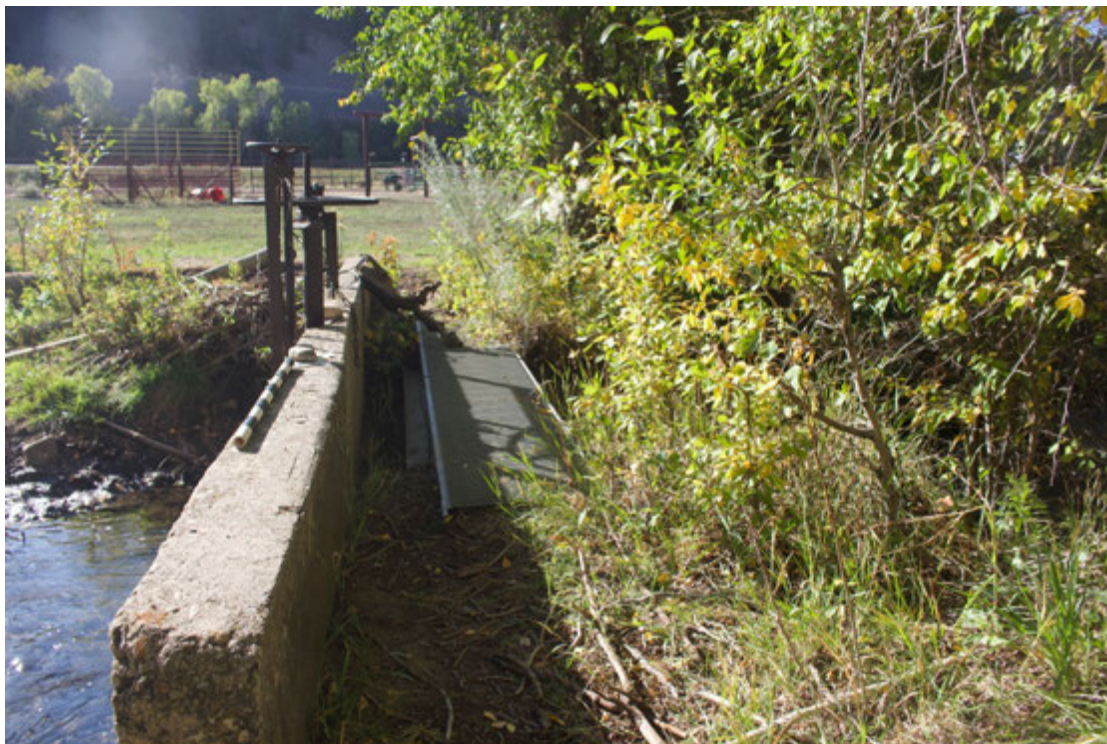
Image Number 5640 A photograph showing a closeup of Feature 2, the Ratliff and Root irrigation ditch's main headgate, facing south.

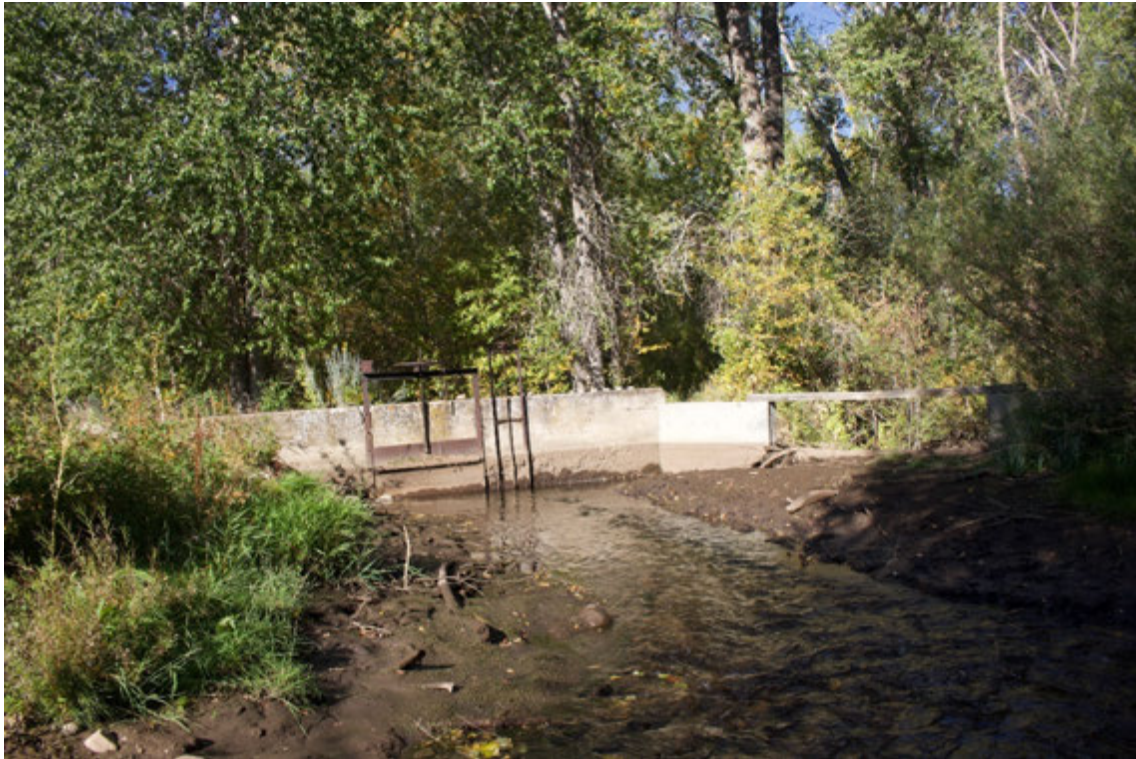
Image 5641 A photograph showing a closeup of Feature 2, the Ratliff and Root irrigation ditch main headgates to the left and overflow channel to the right, facing northwest.

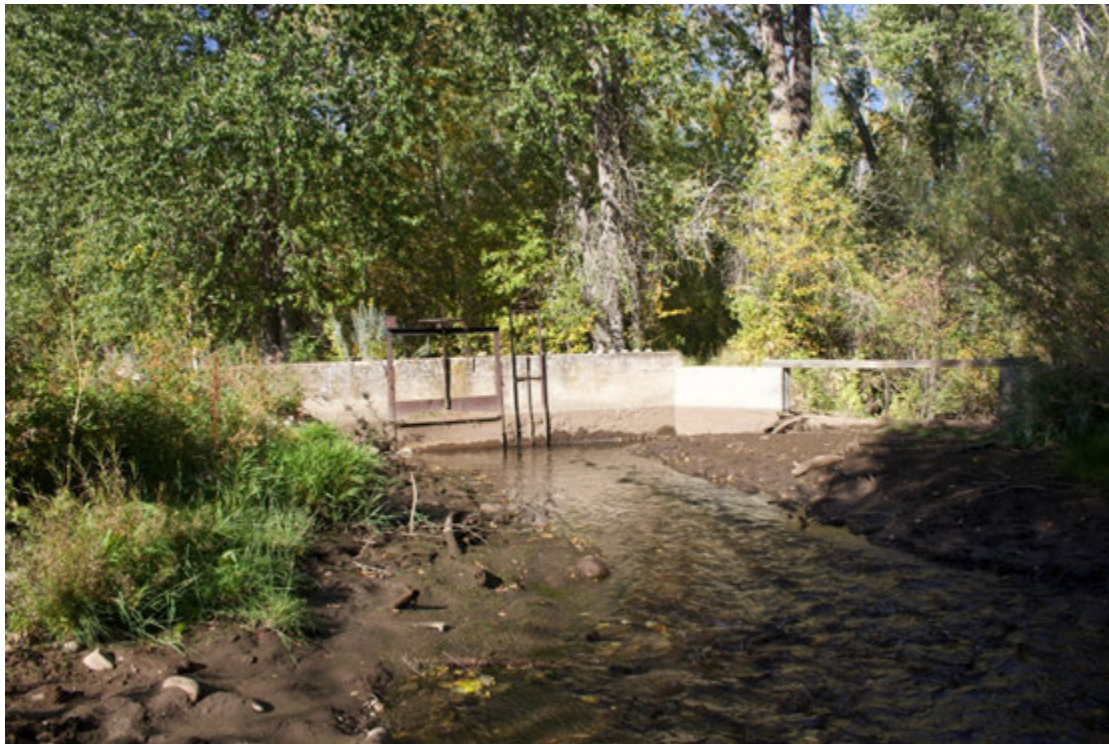
Image Number 5642 A photograph showing a closeup of Feature 2, the Ratliff and Root irrigation ditch main headgates' east elevation, facing northwest.

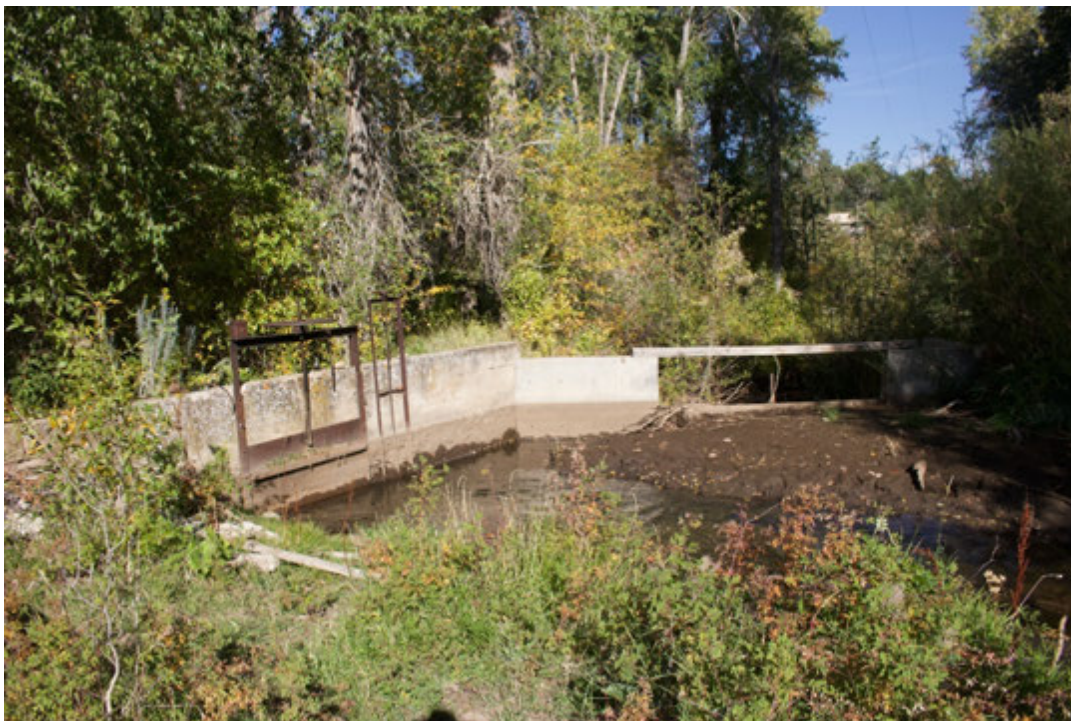
Image Number 5643 A photograph showing a closeup of Feature 2, the Ratliff and Root irrigation ditch main headgates' northeast elevation, facing north.

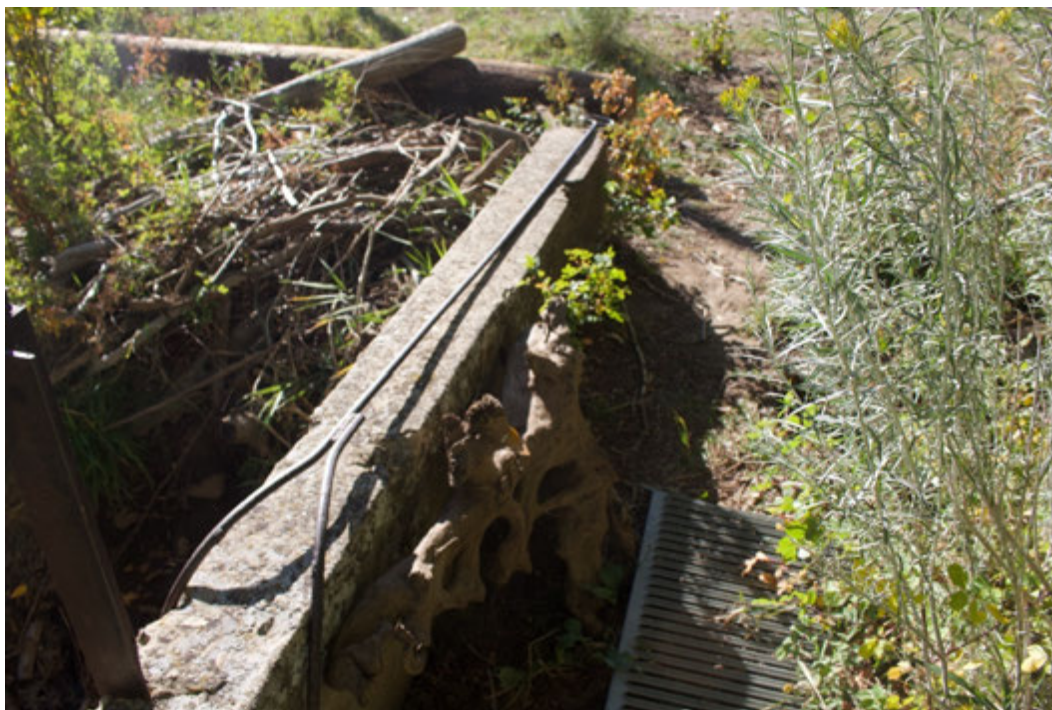
Image Number 5644 A photograph showing a closeup of Feature 2, the Ratliff and Root irrigation ditch main headgates' forked gate cleaning tool, facing south.

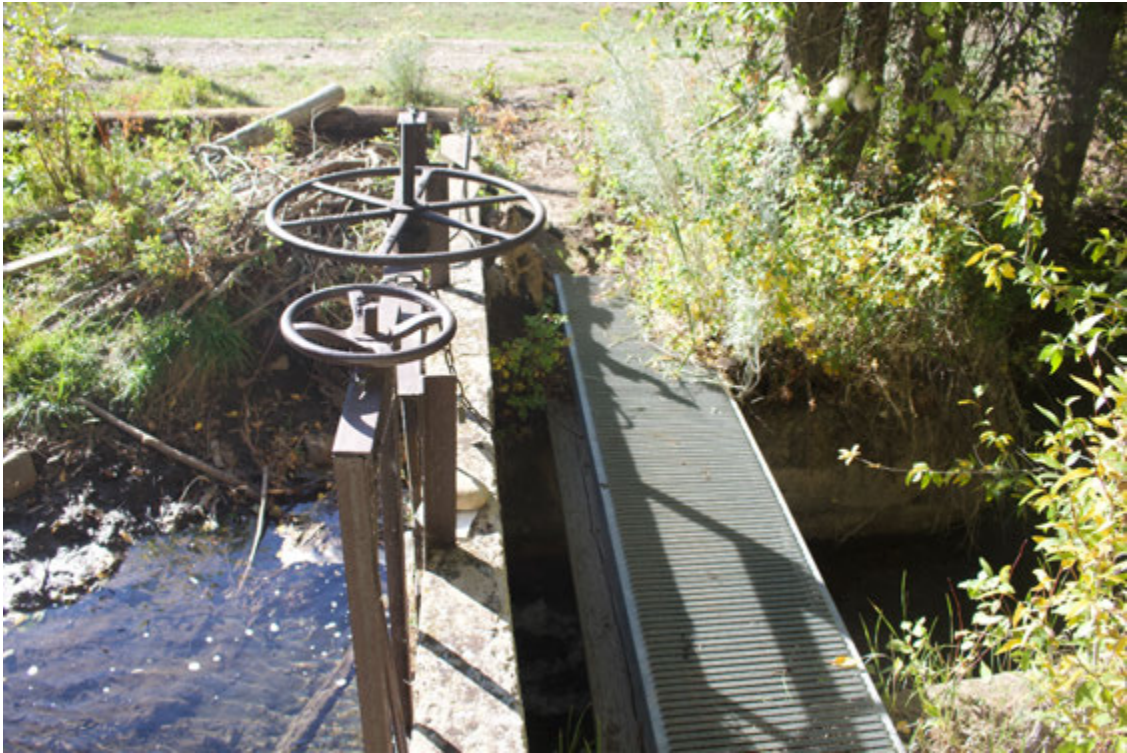
Image Number 5645 A photograph showing a closeup of Feature 2, the Ratliff and Root irrigation ditch main headgates' access and handwheels, facing south.

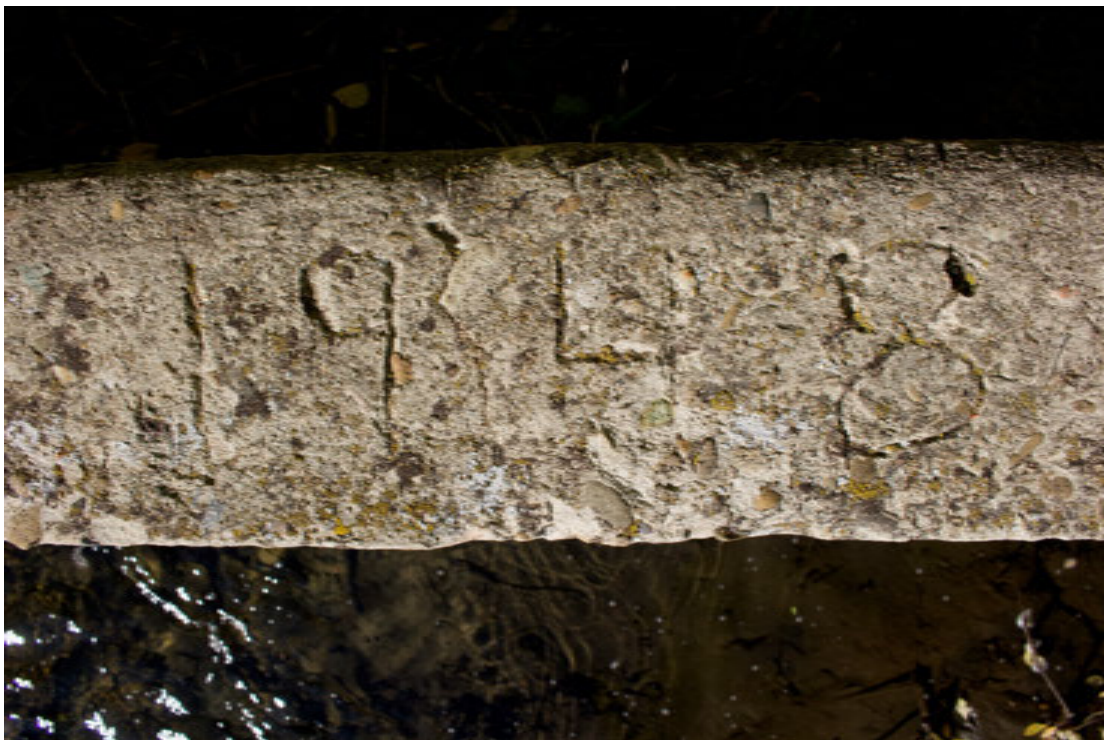
Image Number 5646 A photograph showing a closeup of a 1948 inscription on the formed concrete in the south segment of Feature 2, the Ratliff and Root irrigation ditch main headgates, facing south.

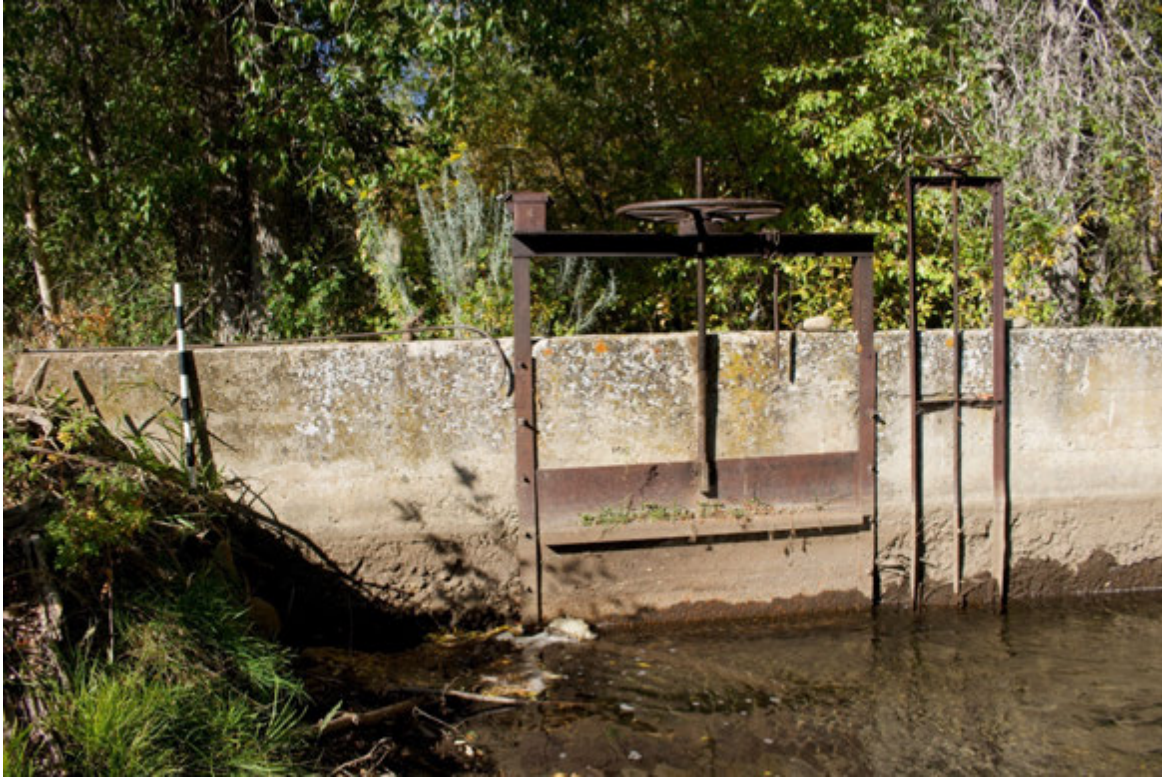
Image Number 5647 A photograph showing a closeup of Feature 2, the Ratliff and Root irrigation ditch main headgates' east elevation, facing west.

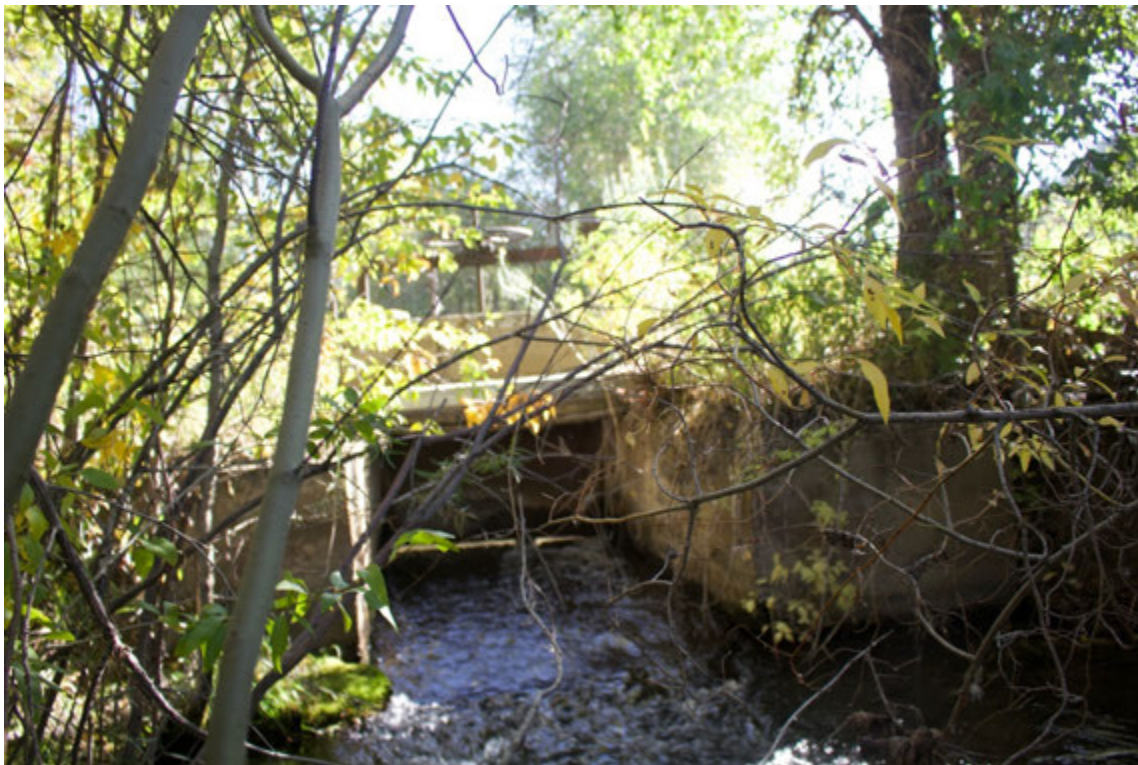
Image Number 5648 A photograph showing a closeup of Feature 2, the Ratliff and Root irrigation ditch main headgates' west elevation, facing east.

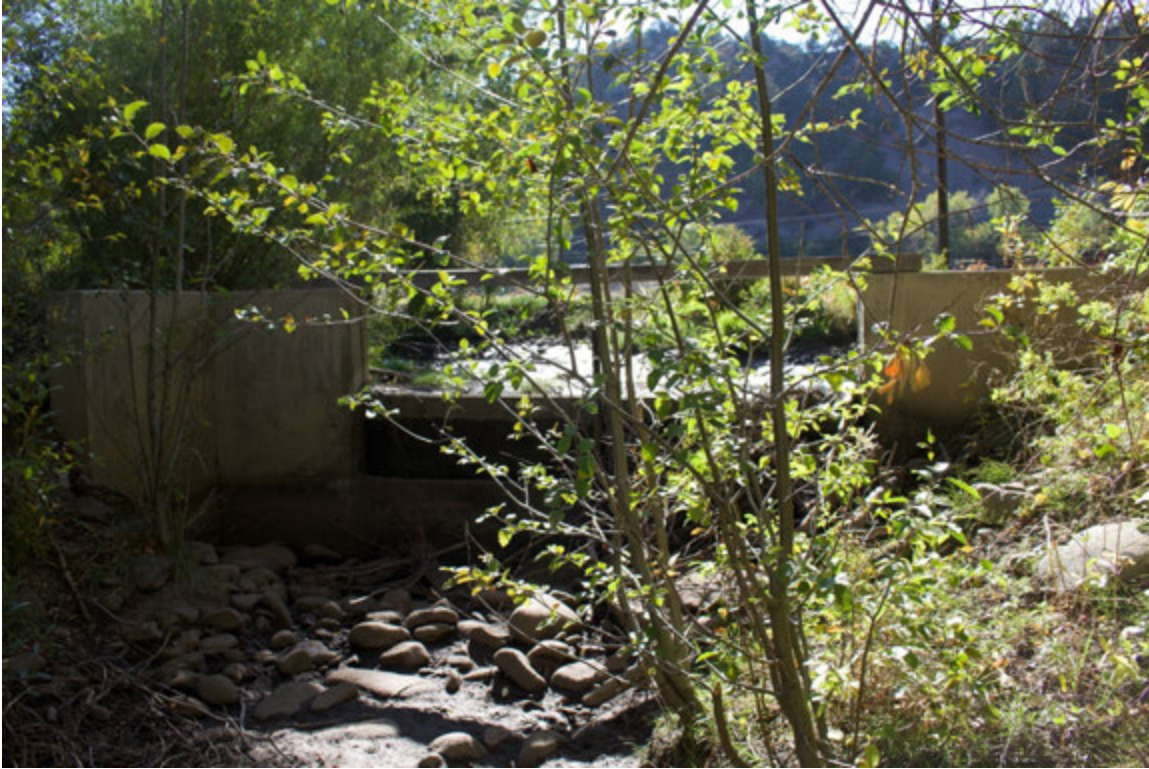
Image Number 5649 A photograph showing a closeup of Feature 2, the Ratliff and Root irrigation ditch main headgates' west elevation, facing east.

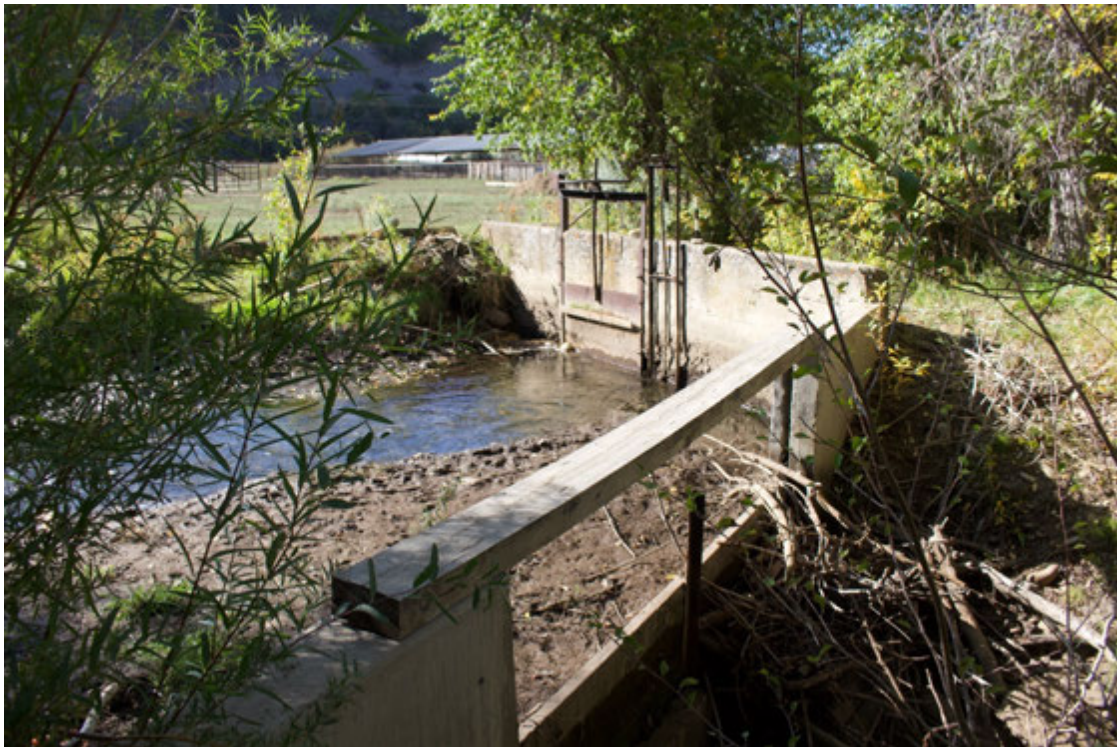
Image Number 5650 A photograph showing an overview of Feature 2, the Ratliff and Root irrigation ditch main headgates with Feature 1, the Ratliff and Root irrigation ditch's main intake in the background and Feature 2's overflow gate in the foreground, facing south.

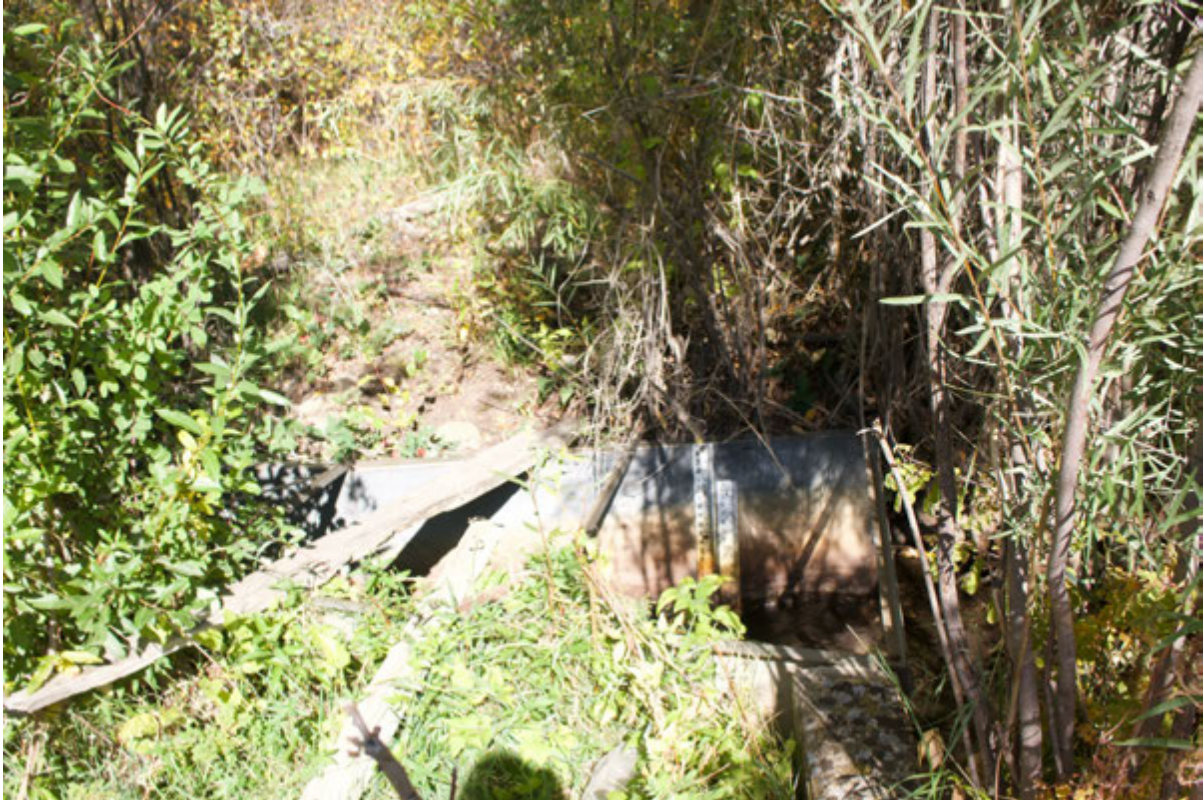
Image Number 5651 A photograph showing a closeup of Feature 3, the Ratliff and Root irrigation ditch Parshall Flume, facing north.

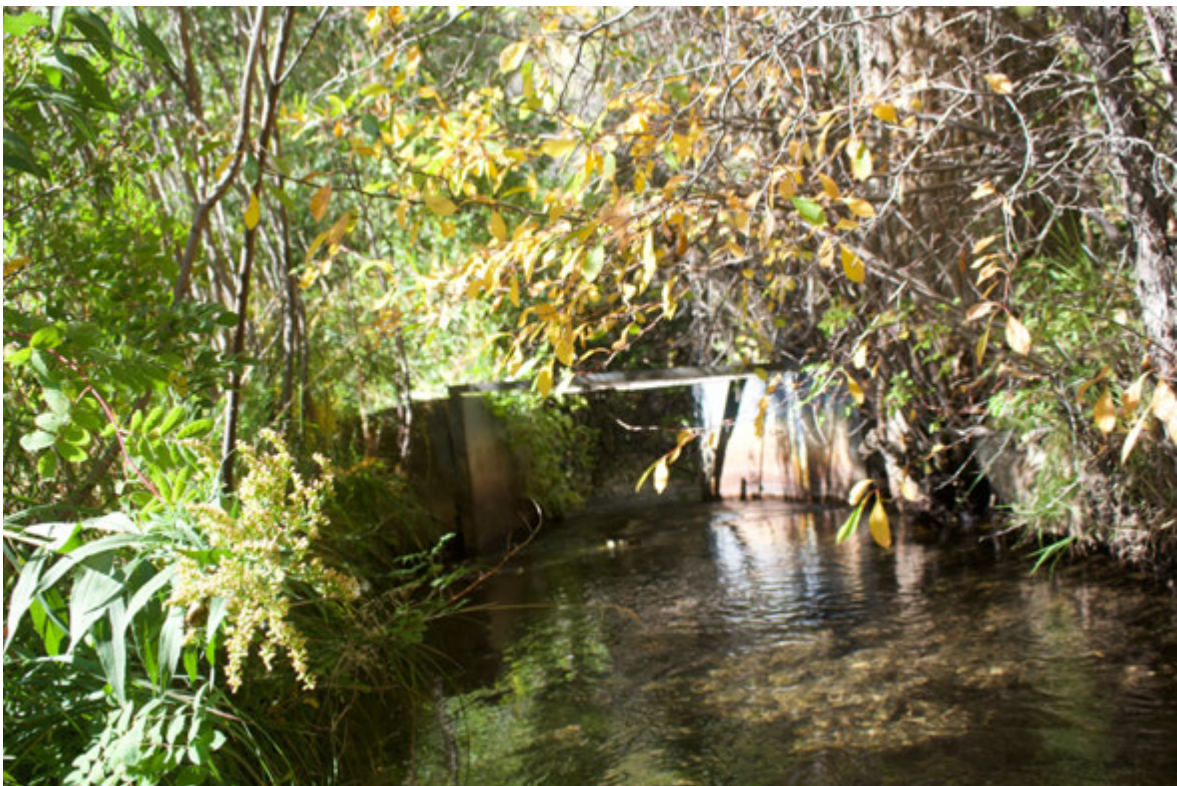
Image Number 5652 A photograph showing a closeup of Feature 3, the Ratliff and Root irrigation ditch Parshall Flume's east elevation, facing west.

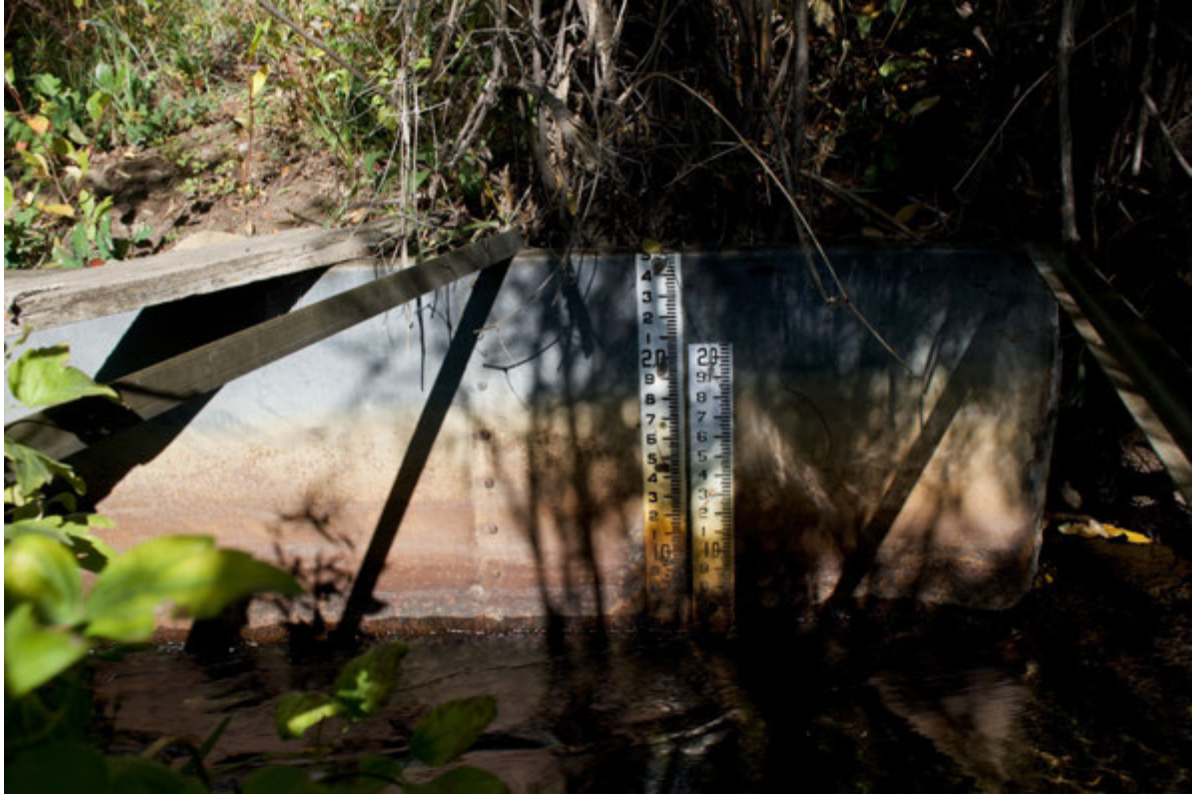
Image Number 5653 A photograph showing a closeup of Feature 3, the Ratliff and Root irrigation ditch Parshall Flume's flow rulers on the interior of the flume, facing north.

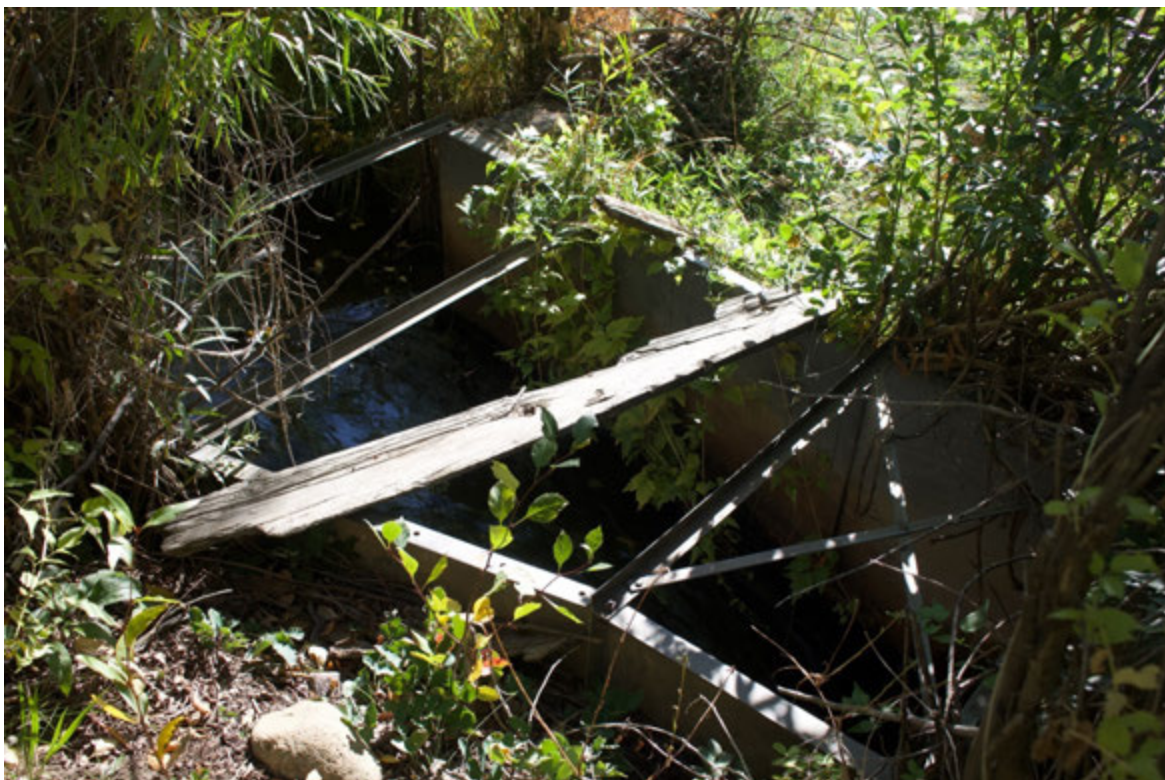
Image 5654 A photograph showing a closeup of Feature 3, the Ratliff and Root irrigation ditch Parshall Flume with lumber laying across top and utilized as a footbridge, facing southeast.
