Level II Documentation of the Ratliff and Root Ditch (5MT23092), Montezuma County, Colorado

(OAHP # MT.R.R142)

OAHP Project Number: MT.R.R142

October 5, 2020

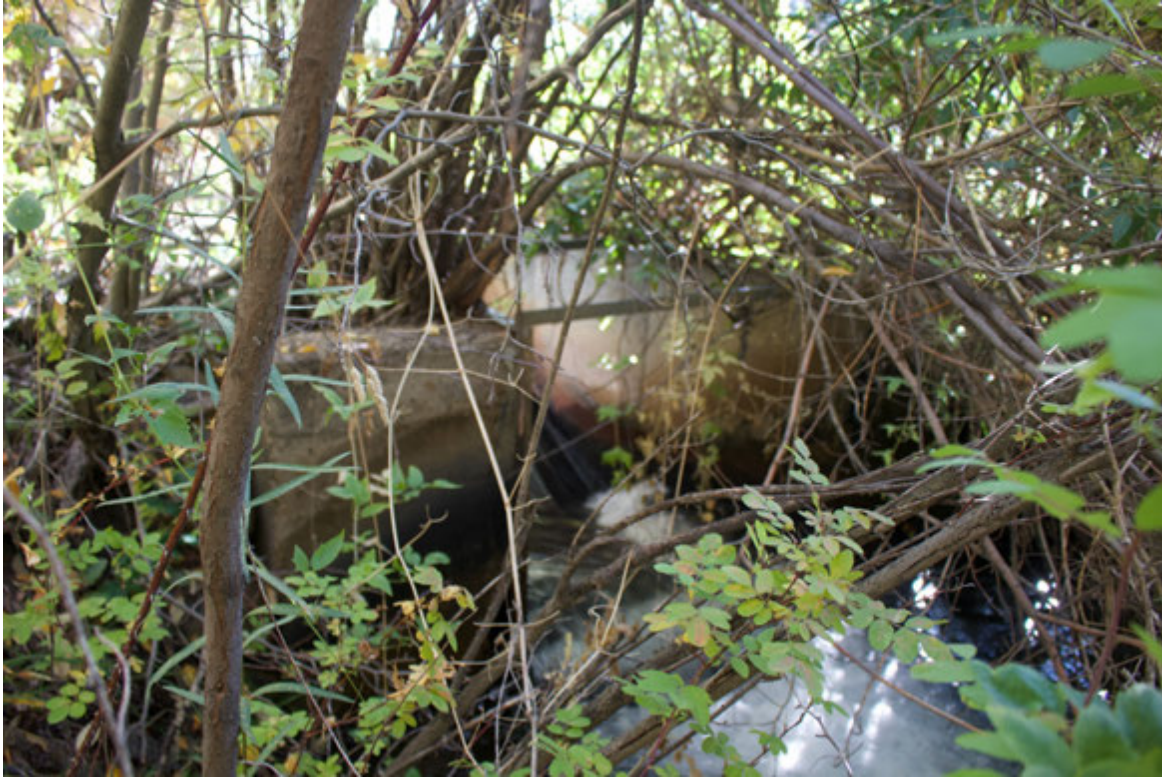
Image Number 5655 A photograph showing a closeup of Feature 3, the Ratliff and Root irrigation ditch Parshall Flume's west elevation, facing southeast.

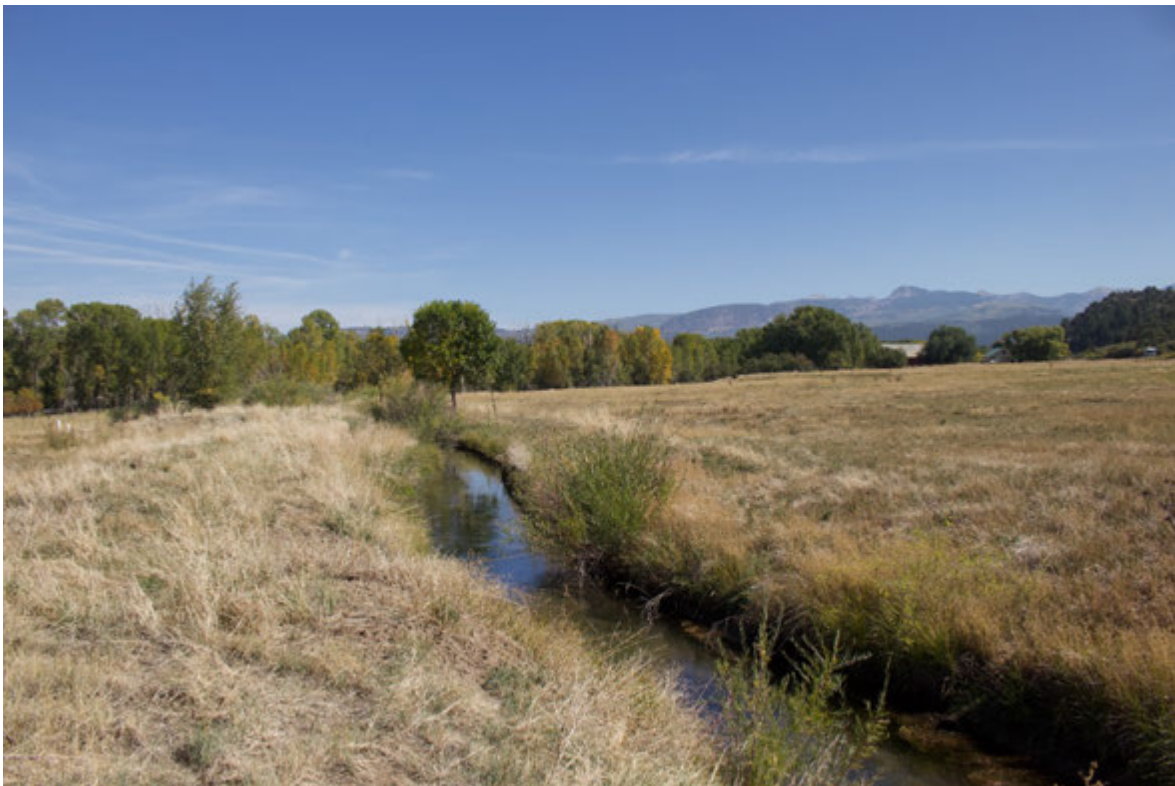
Image Number 5656 A photograph showing the Ratliff and Root irrigation ditch's northeast end site overview in pastureland, facing east.

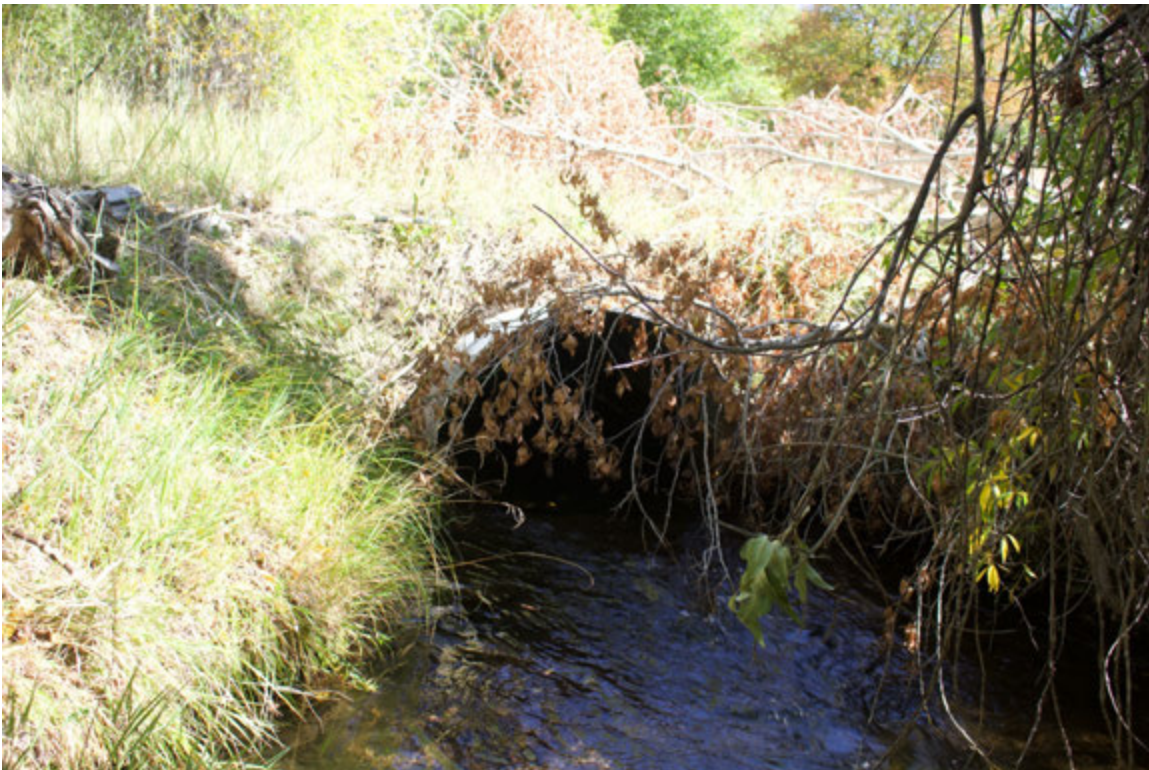
Image Number 5658 A photograph showing a modern 24" culvert along the Ratliff and Root irrigation ditch, facing southeast.

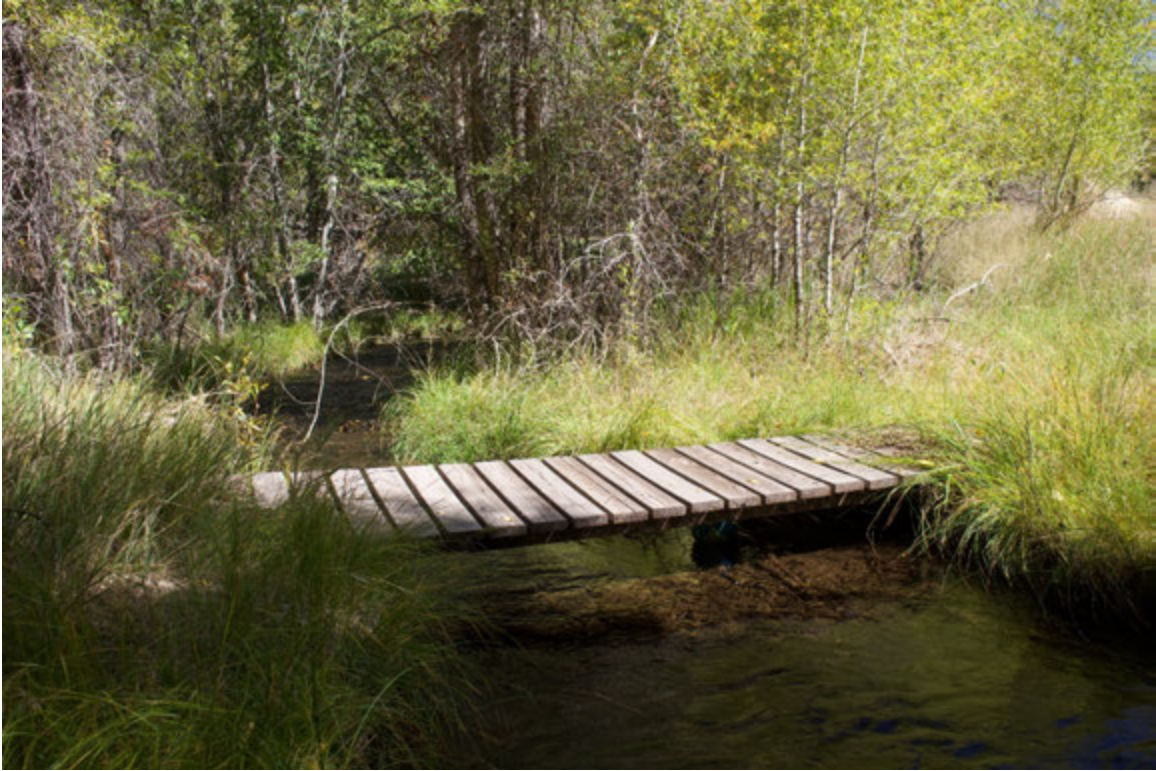
Image Number 5659 A photograph showing a closeup of a footbridge crossing the Ratliff and Root irrigation ditch, facing east.

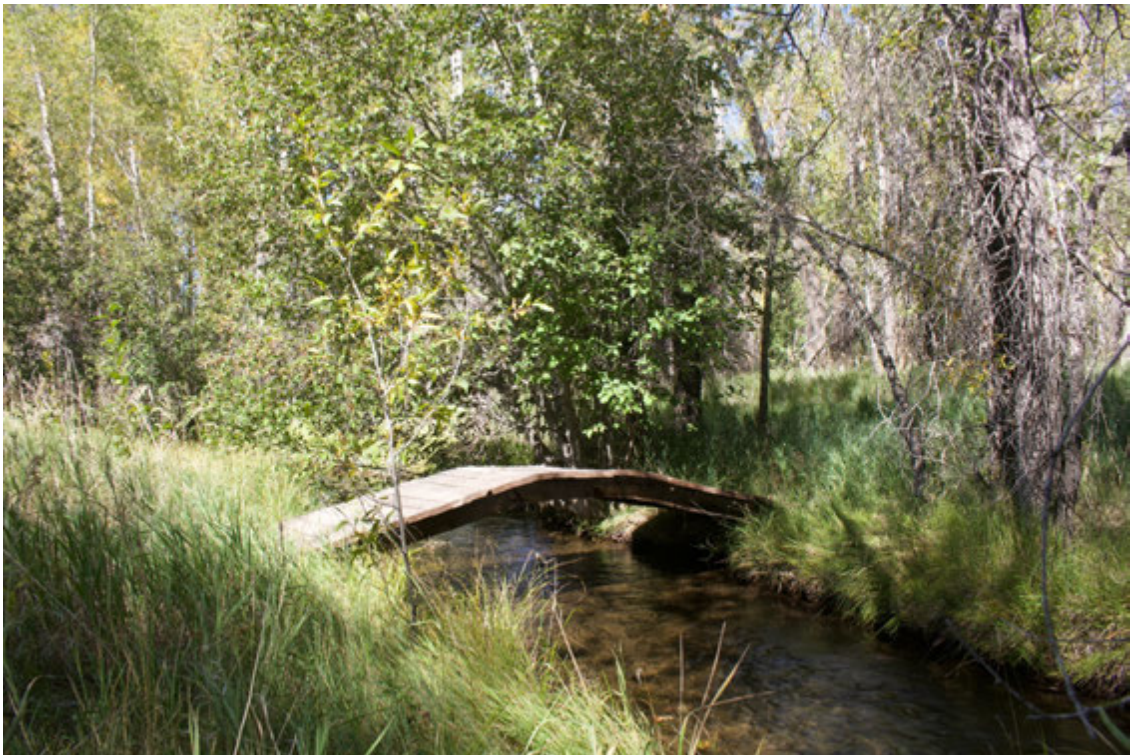
Image Number 5661 A photograph showing a closeup of a footbridge crossing the Ratliff and Root irrigation ditch, facing northwest.

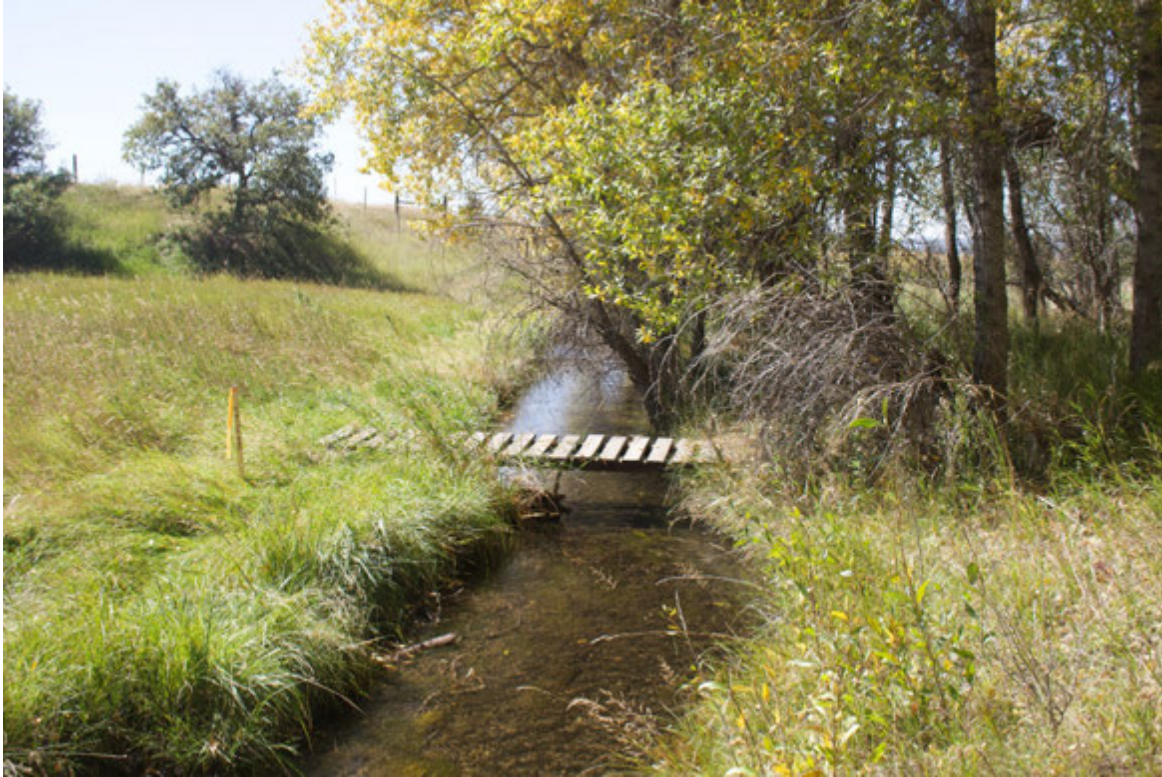
Image Number 5662 A photograph showing a closeup of a footbridge crossing the Ratliff and Root irrigation ditch, facing west.

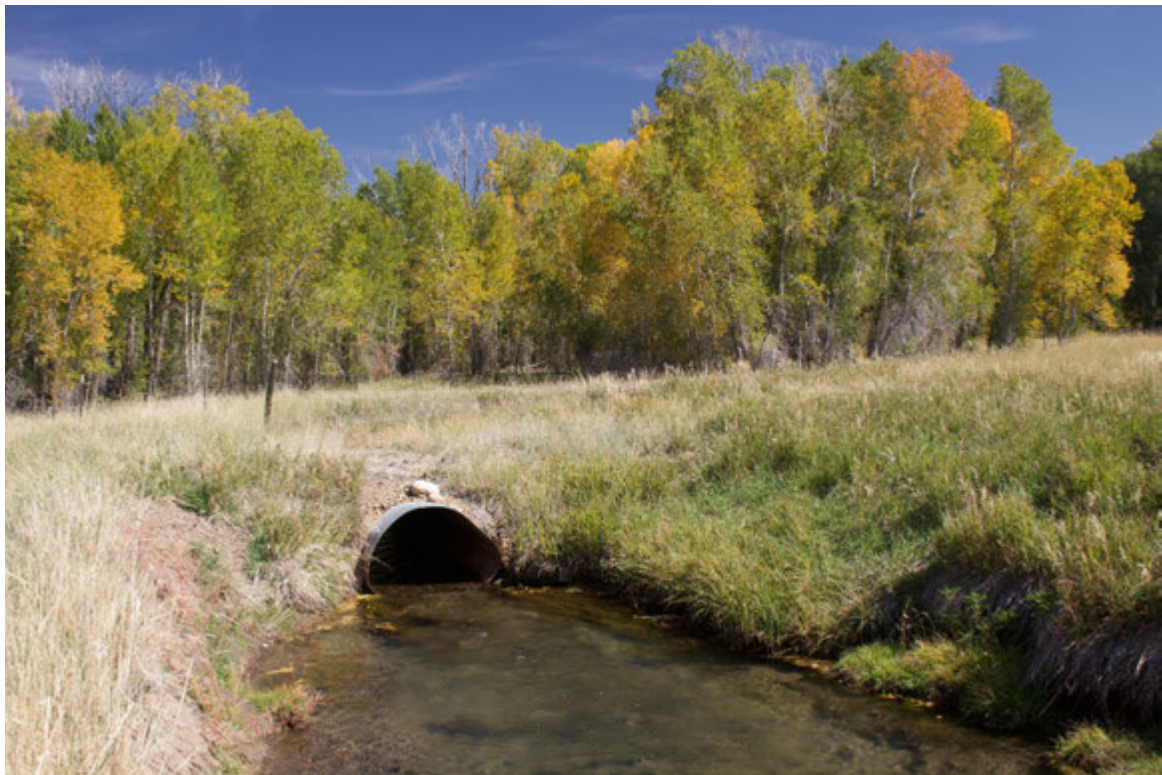
Image Number 5663 A photograph showing a closeup of the modern 24" culvert along the Ratliff and Root irrigation ditch, facing west.

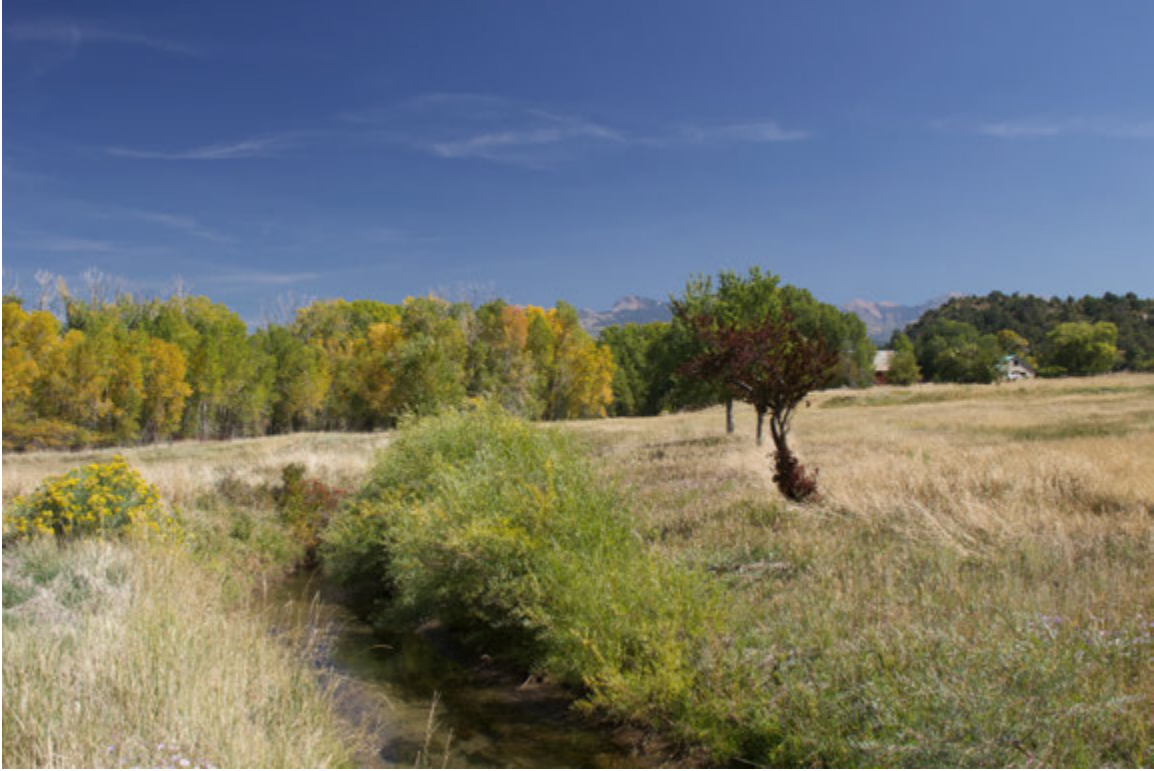
Image Number 5664 A photograph showing an overview of the northeast section of the Ratliff and Root irrigation ditch, facing east.

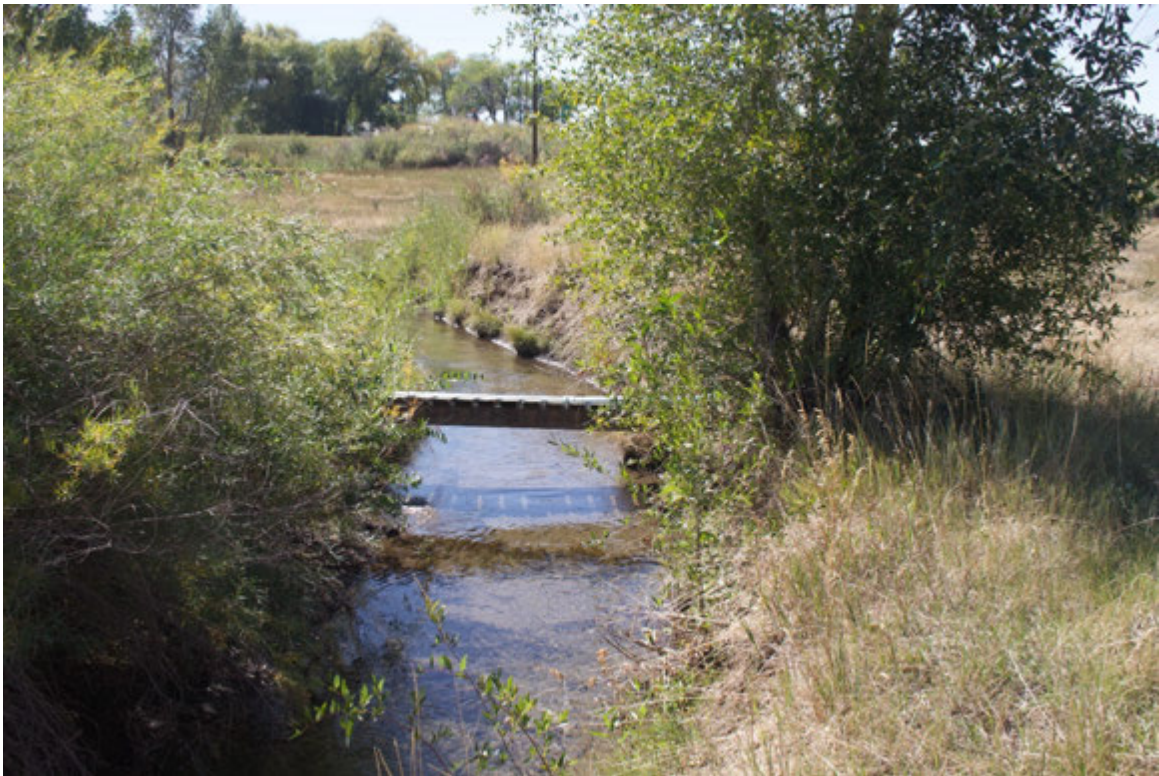
Image Number 5665 A photograph showing a closeup of a footbridge crossing the Ratliff and Root irrigation ditch, facing southwest.

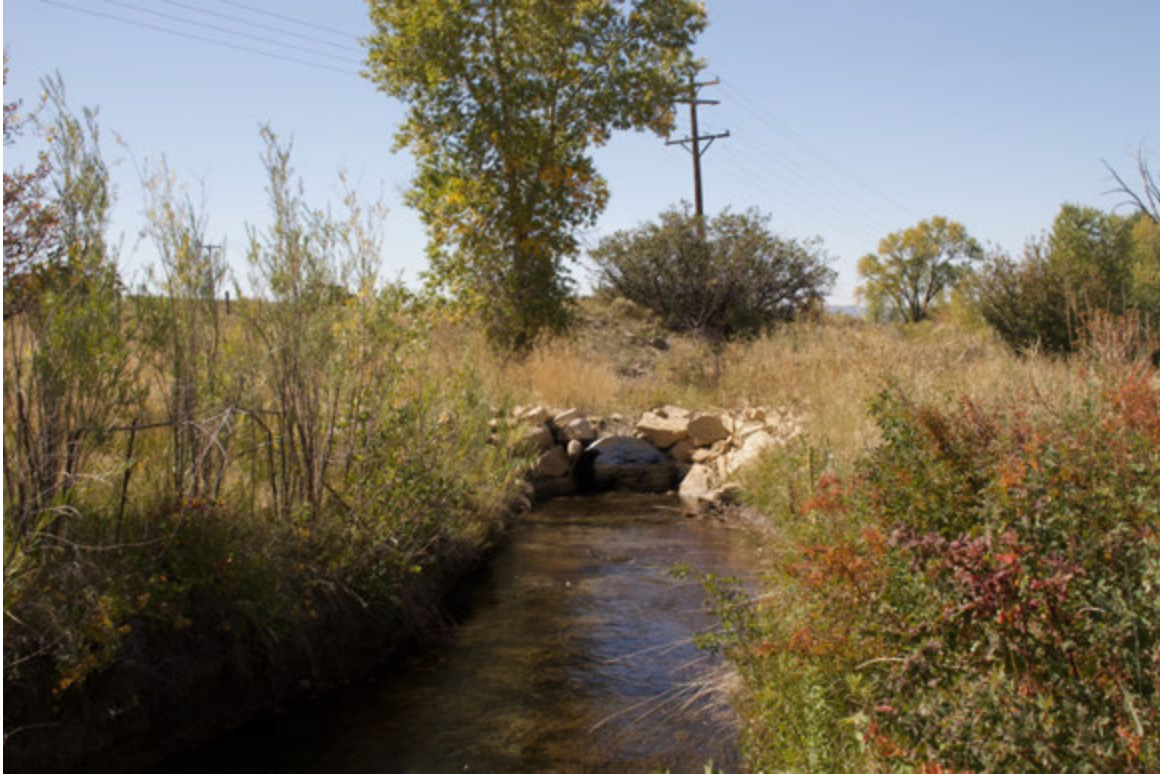
Image Number 5666 A photograph showing a closeup of a modern 24" culvert along the Rattliff and Root irrigation ditch, facing southwest.

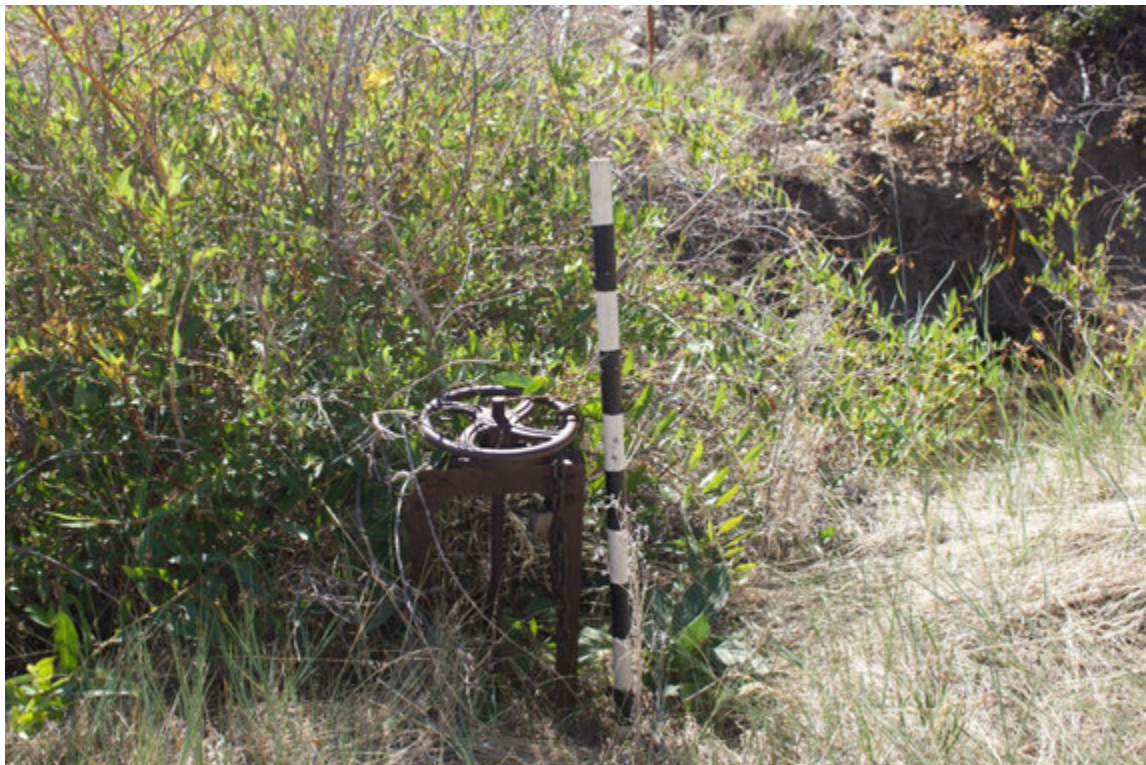
Image Number 5667 A photograph showing a closeup of Feature 4, the Rattliff and Root irrigation ditch lateral headgate's north elevation, facing south.

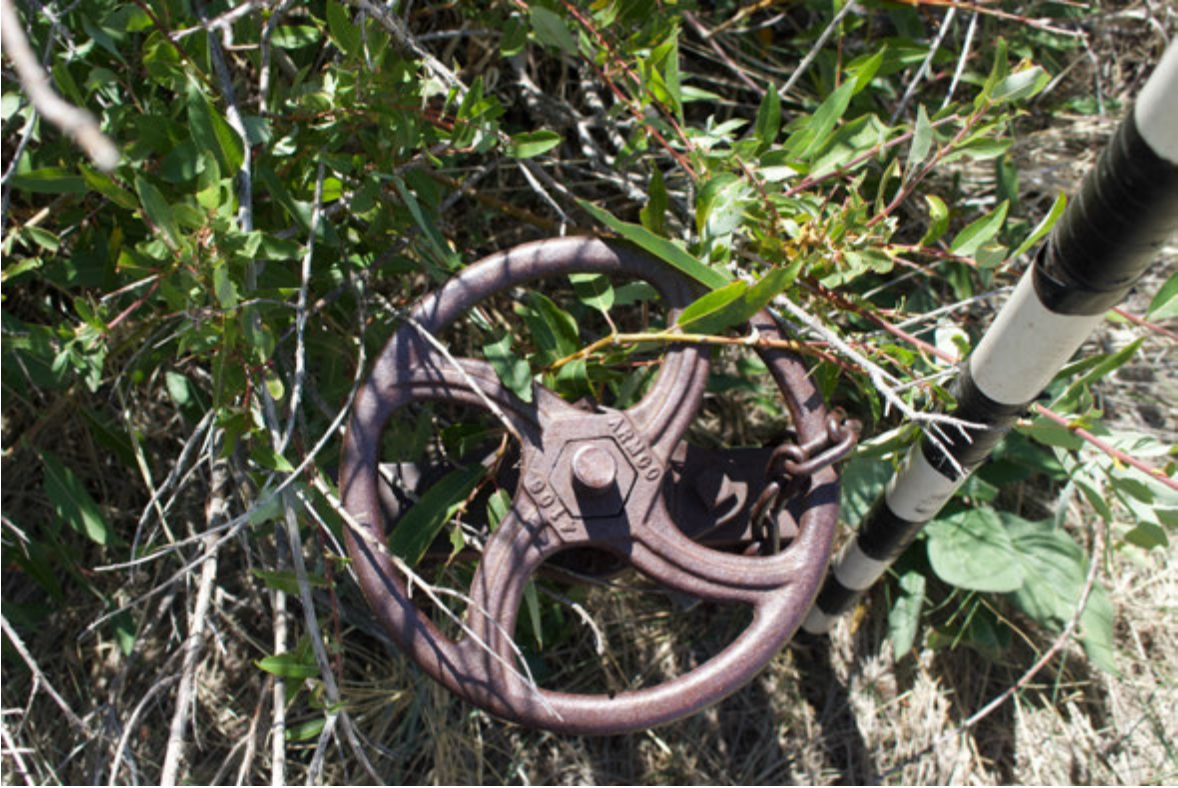
Image Number 5668 A photograph showing a closeup of Feature 4, the Ratliff and Root irrigation ditch lateral headgate, facing south.

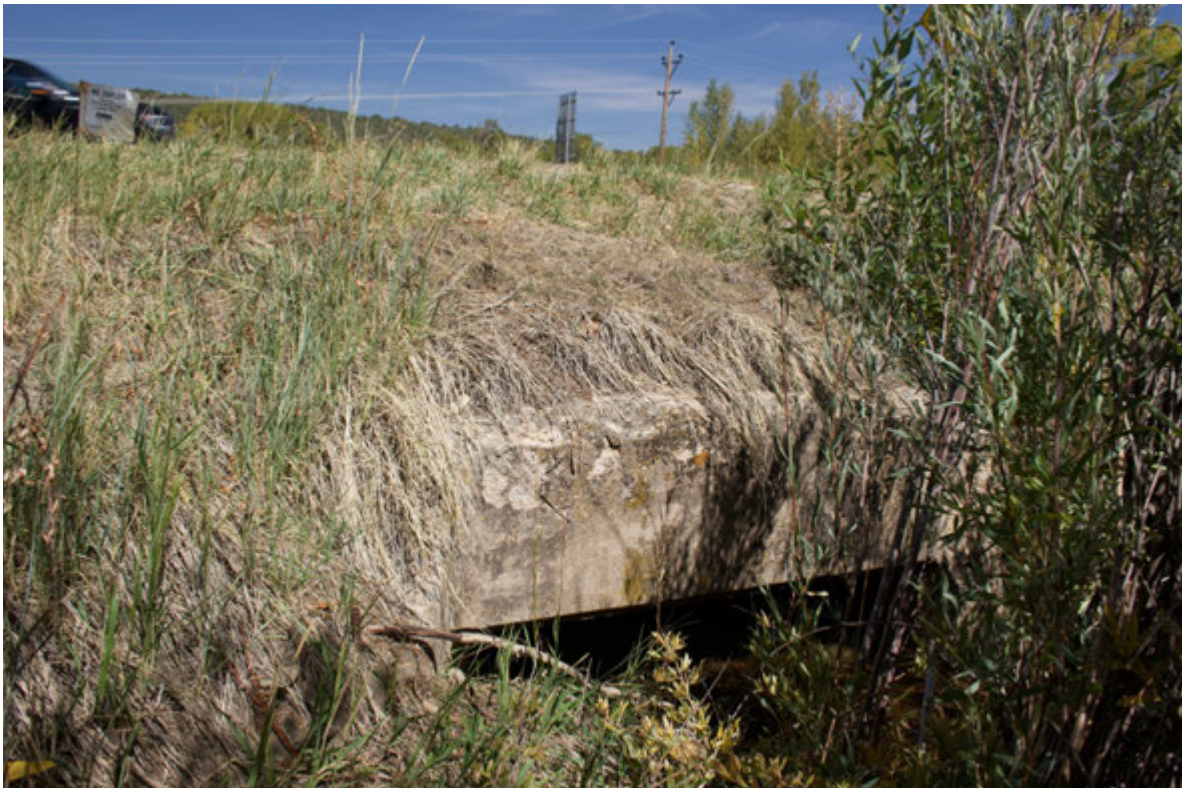
Image Number 5671 A photograph showing a closeup of concrete formed culvert under U.S. Highway 160 along the Ratliff and Root irrigation ditch, facing northeast.

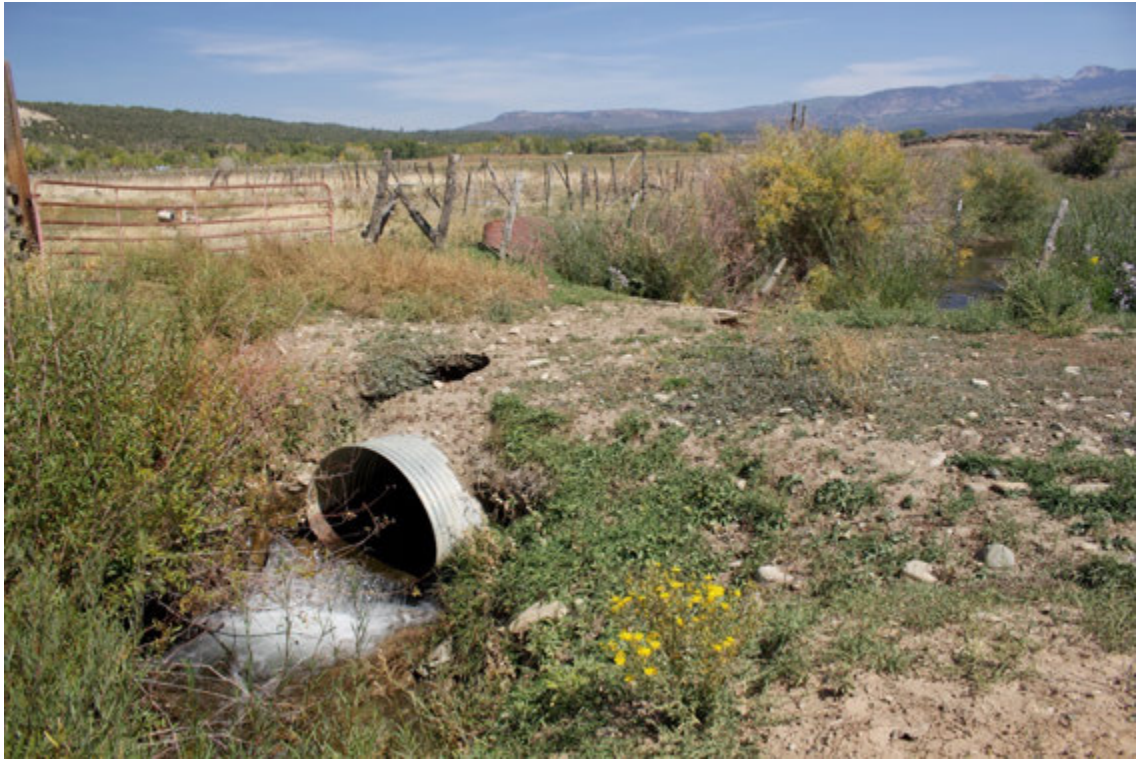
Image Number 5672 A photograph showing a closeup of a modern 24" culvert along the Ratliff and Root irrigation ditch, facing east.

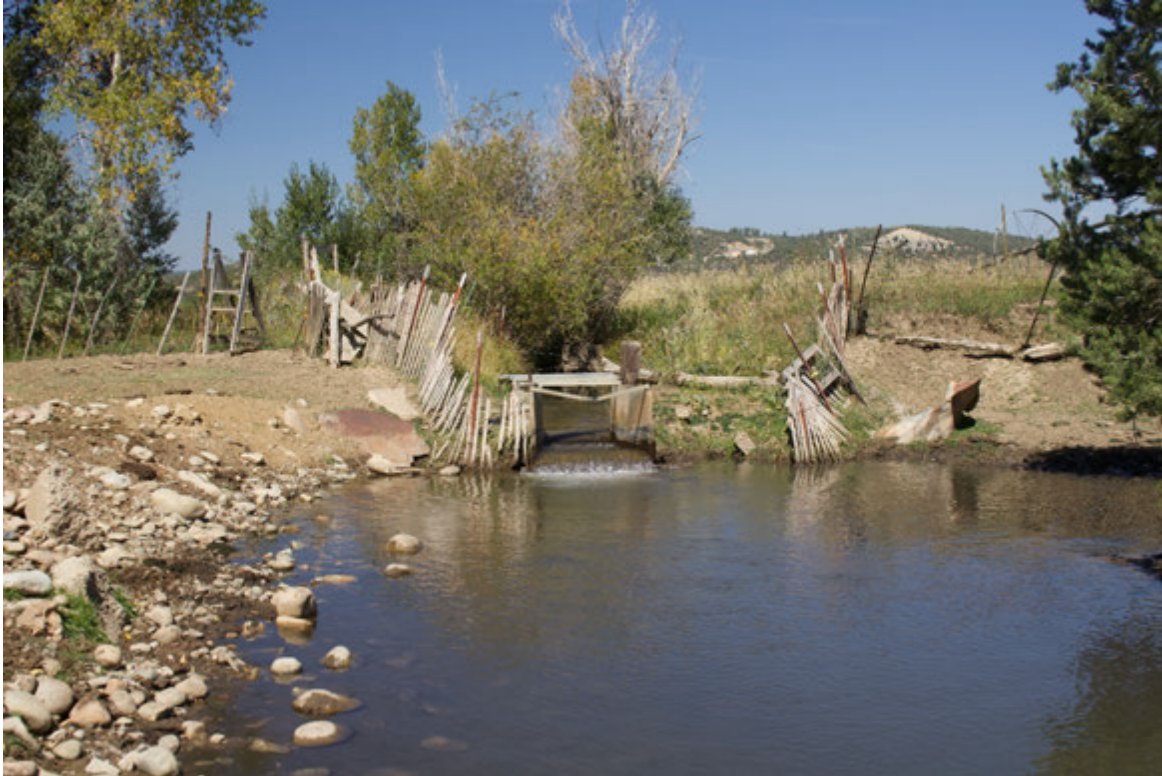
Image Number 5678 A photograph showing an overview of Feature 5, the Ratliff and Root irrigation ditch Parshall Flume No. 2, facing north.

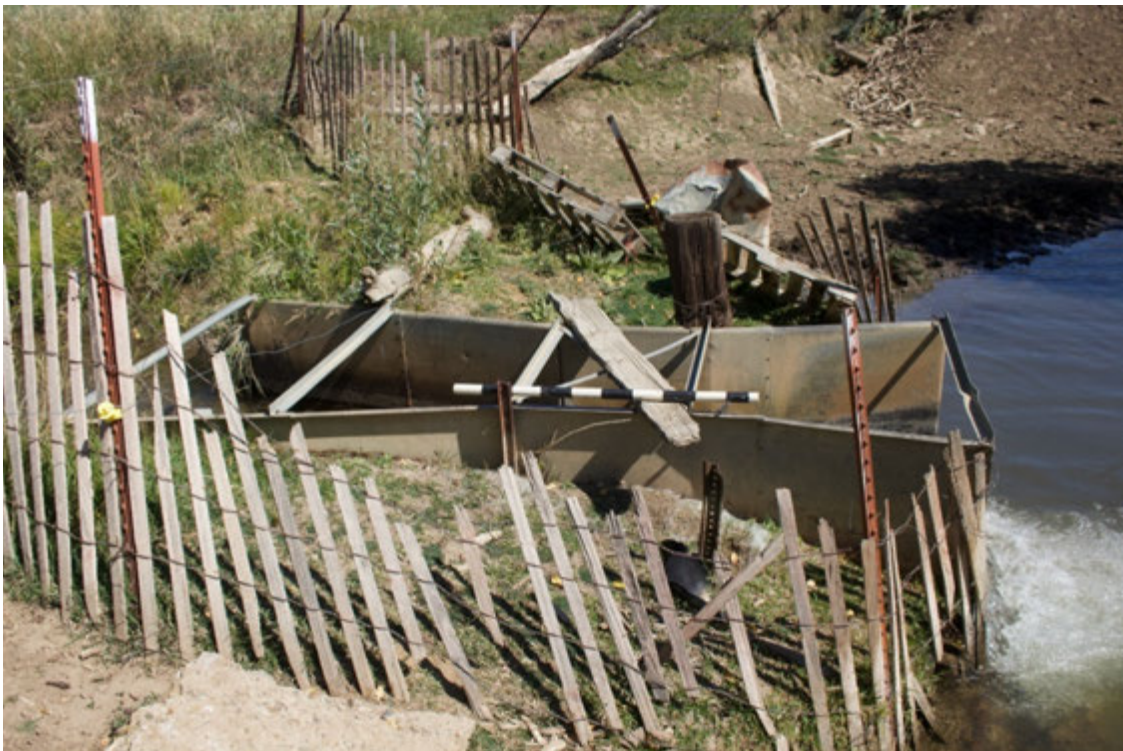
Image Number 5679 A photograph showing a closeup of Feature 5, the Ratliff and Root irrigation ditch Parshall Flume No. 2, facing west.

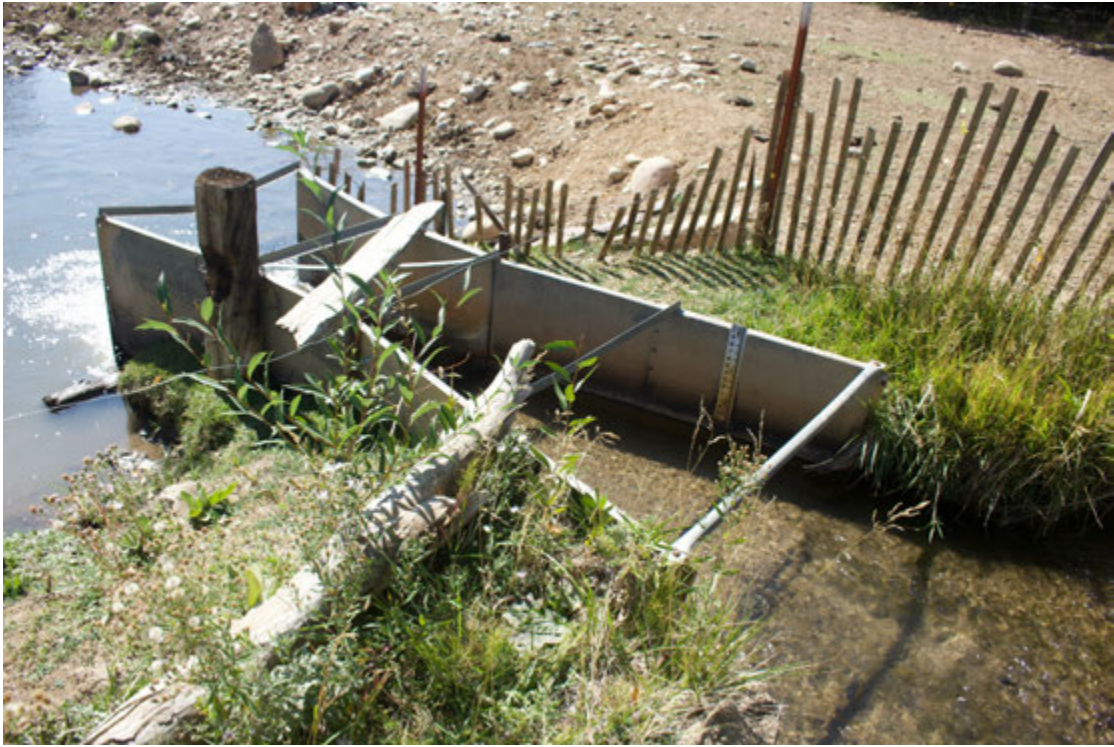
Image Number 5680 A photograph showing a closeup of Feature 5, the Ratliff and Root irrigation ditch Parshall Flume No. 2, facing southwest.

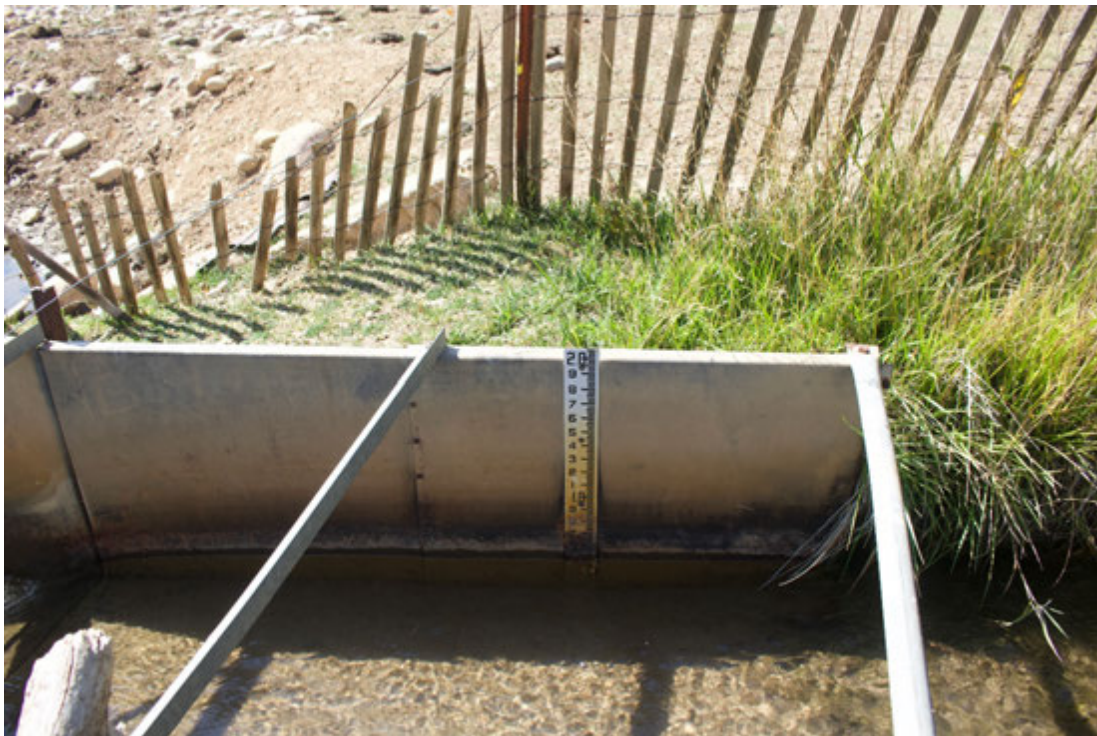
Image Number 5681 A photograph showing a closeup of Feature 5, the Ratliff and Root irrigation ditch Parshall Flume No. 2 water flow gauge, facing west.

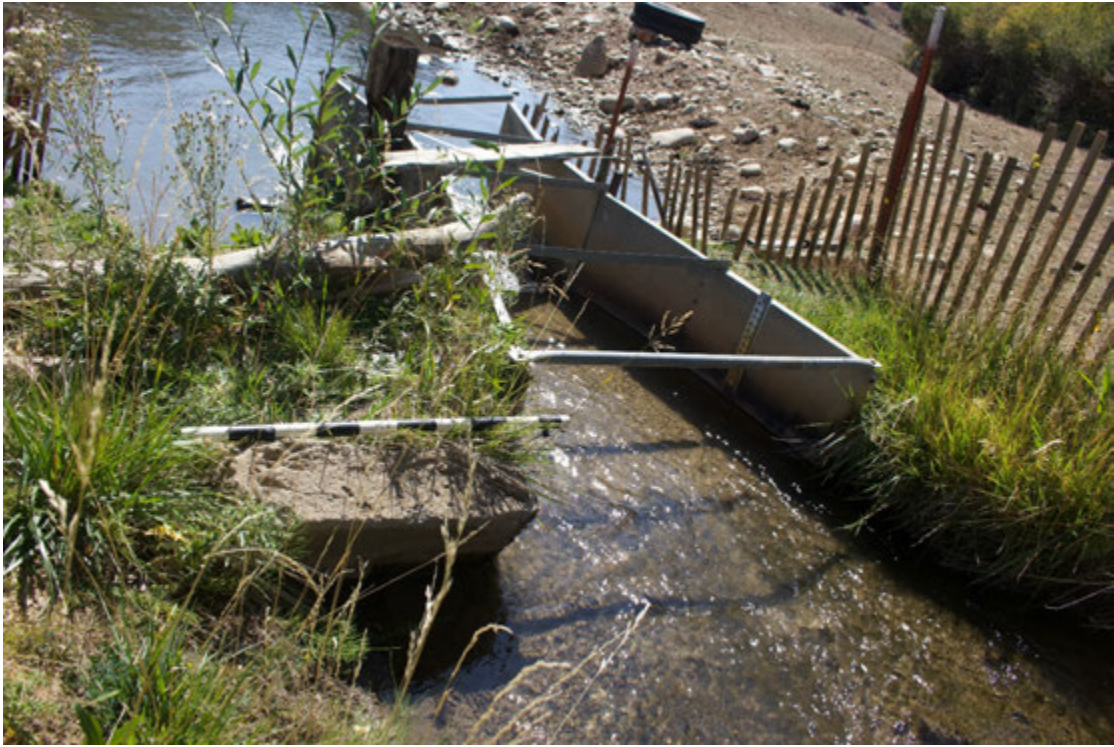
Image Number 5682 A photograph showing a closeup of Feature 5, the Ratliff and Root irrigation ditch Parshall Flume No. 2, facing southeast.

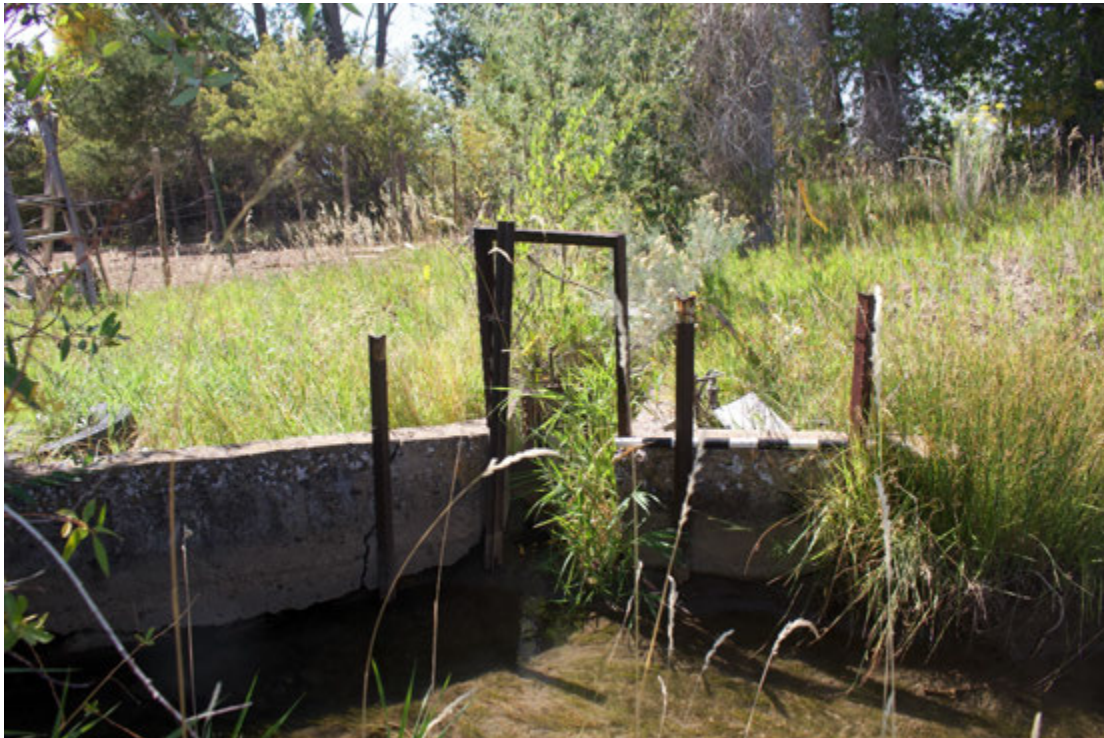
Image Number 5683 A photograph showing a closeup of Feature 6, the Ratliff and Root irrigation ditch lateral ditch impound and headgate, facing west.

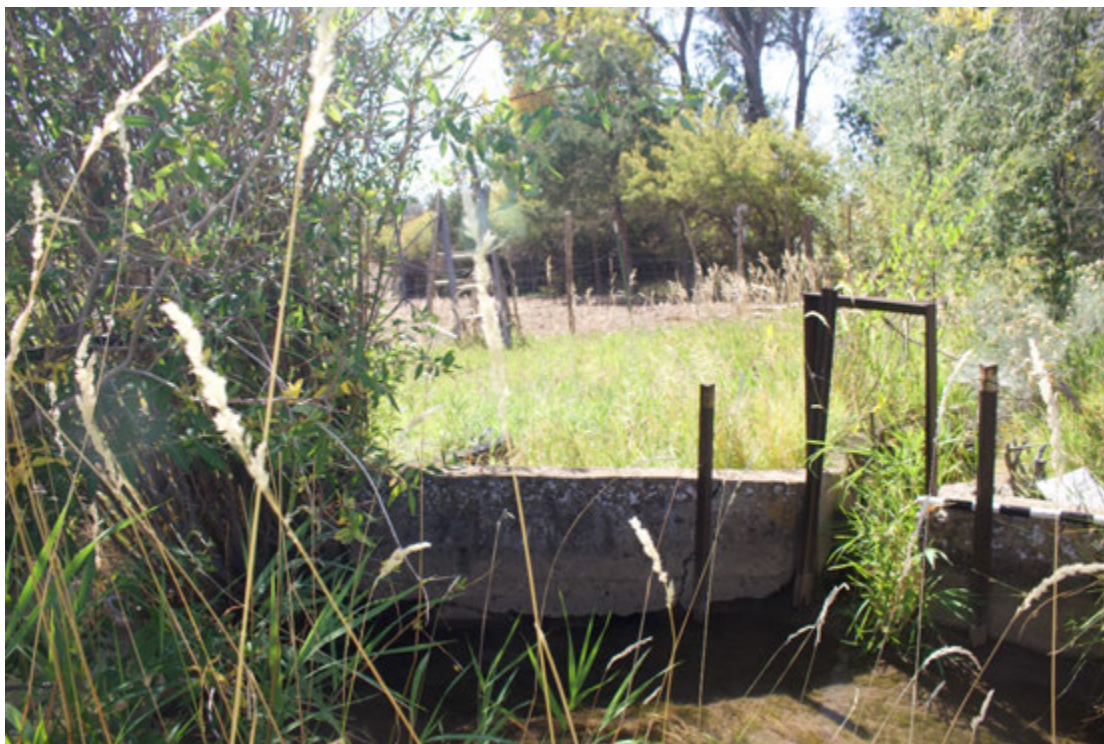
Image Number 5684 A photograph showing a closeup of Feature 6, the Ratliff and Root irrigation ditch lateral ditch impound and headgate, facing southeast.

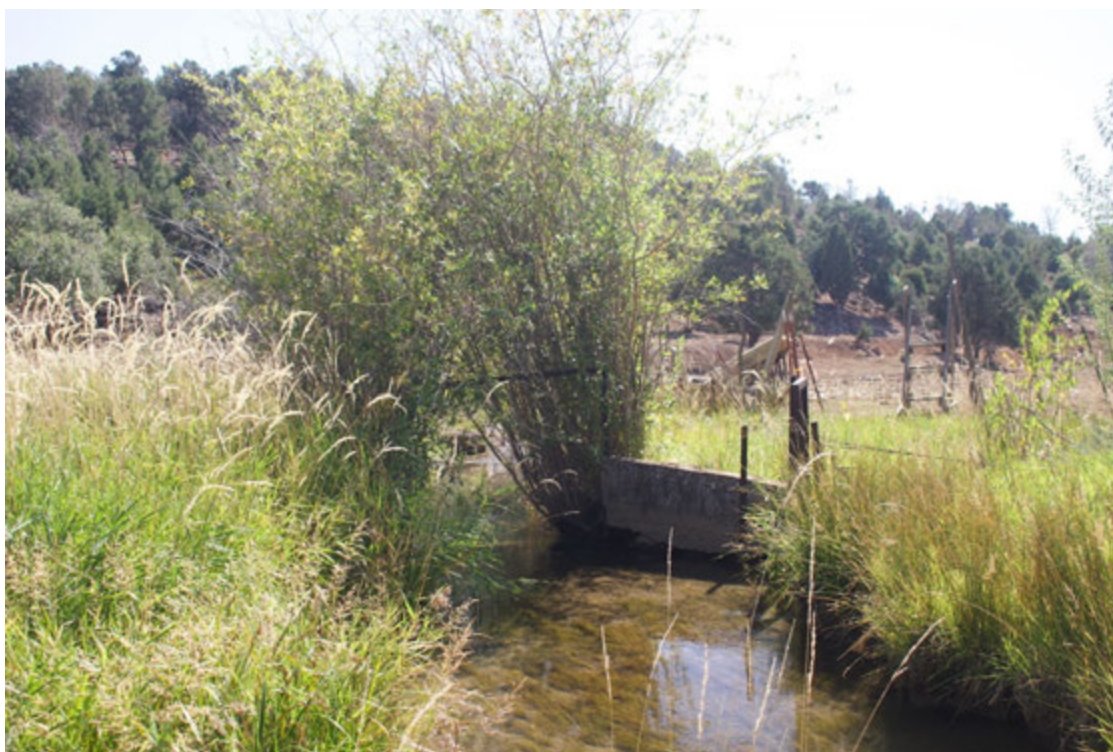
Image Number 5685 A photograph showing an overview of Feature 6, the Ratliff and Root irrigation ditch lateral ditch impound and headgate with the main ditch opening to the left and lateral headgate to the right, facing south.

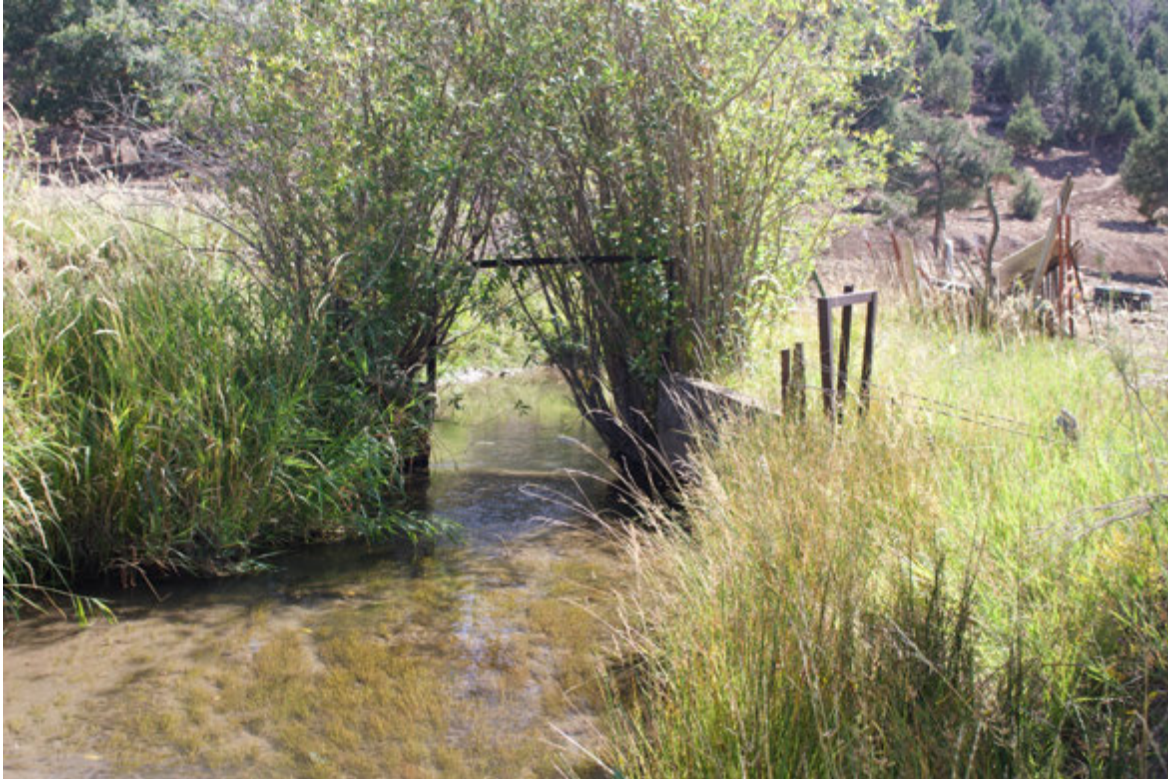
Image Number 5686 A photograph showing a closeup of Feature 6, the Ratliff and Root irrigation ditch lateral ditch impound and headgate, with main ditch opening to the left and lateral headgate to the right, facing south.

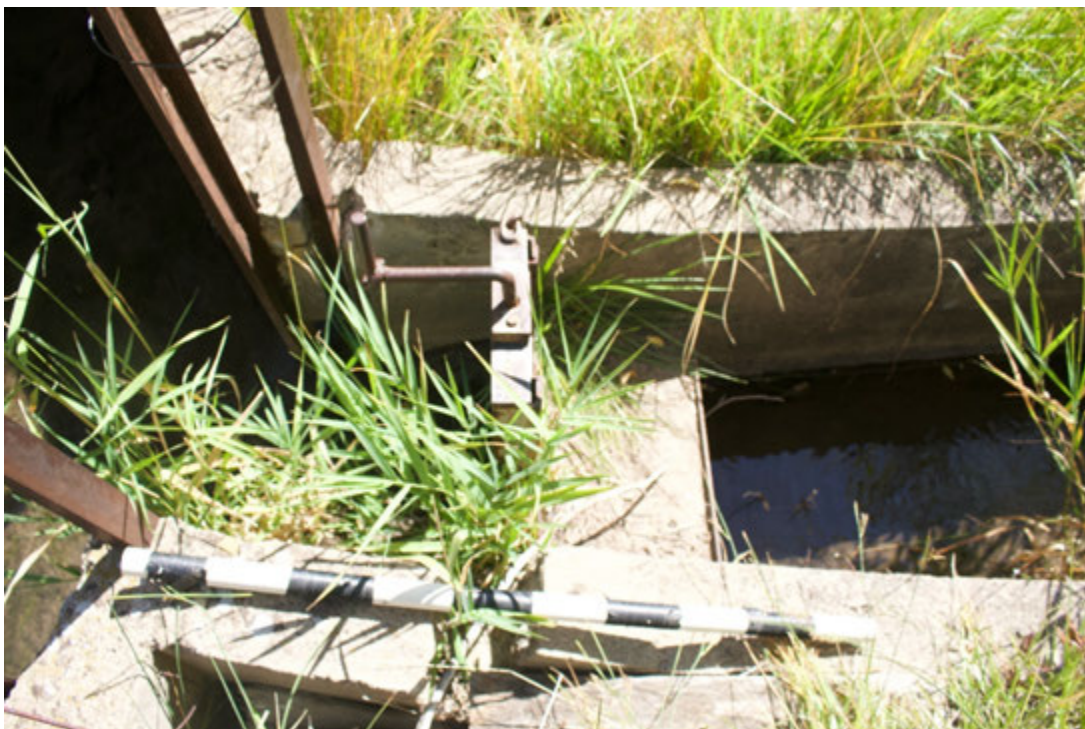
Image Number 5687 A photograph showing a closeup of Feature 6, the Ratliff and Root irrigation ditch lateral ditch impound and headgate, facing south.

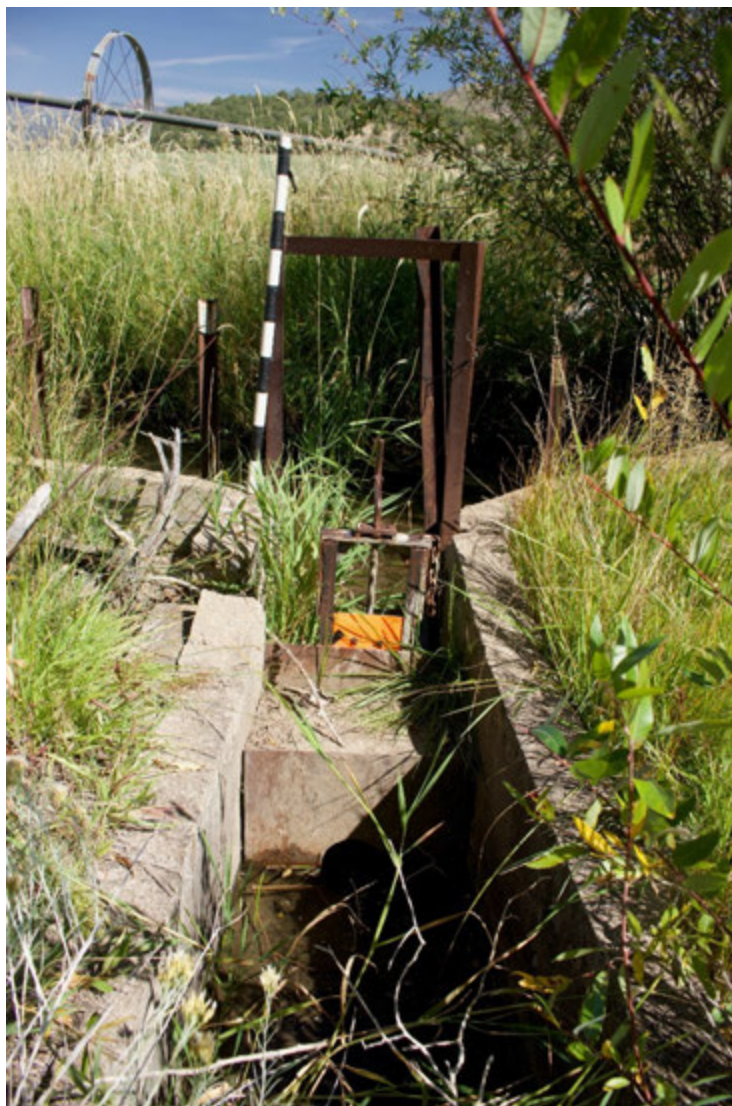
Image Number 5688 A photograph showing a closeup of Feature 6, the Ratliff and Root irrigation ditch lateral ditch impound and headgate's west elevation, facing south.
