Level II Documentation of the Ratliff and Root Ditch (5MT23092), Montezuma County, Colorado

(OAHP # MT.R.R142)

OAHP Project Number: MT.R.R142

October 5, 2020

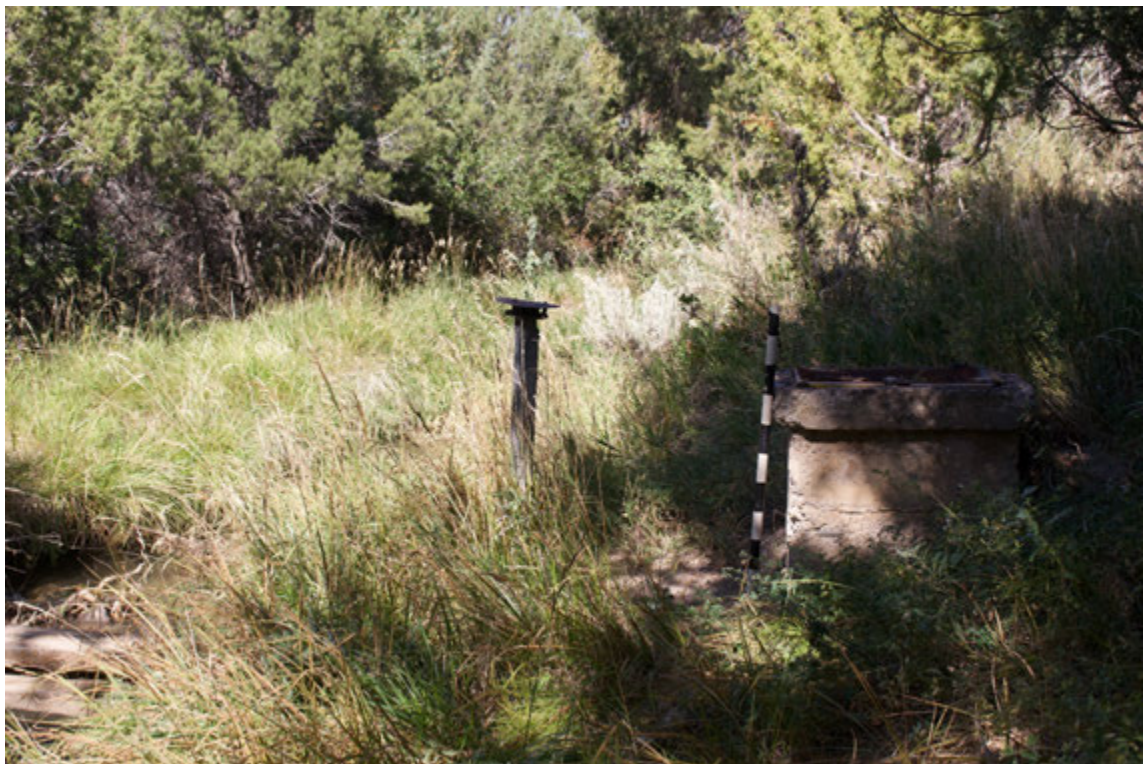
Image Number 5690 A photograph showing a closeup of Feature 7, the Ratliff and Root irrigation ditch stilling well, facing northeast.

A low damn of loose rocks runs across the Ratliff and Root Ditch just upstream of the well, impounding about 6" of water and directing it into a siphon culvert inlet on the east bank. Today the culvert is only discernable as a 4" gap in the bank. Despite being overgrown and nearly obscured, this culvert must be intact because it is still carrying water to the stilling well.

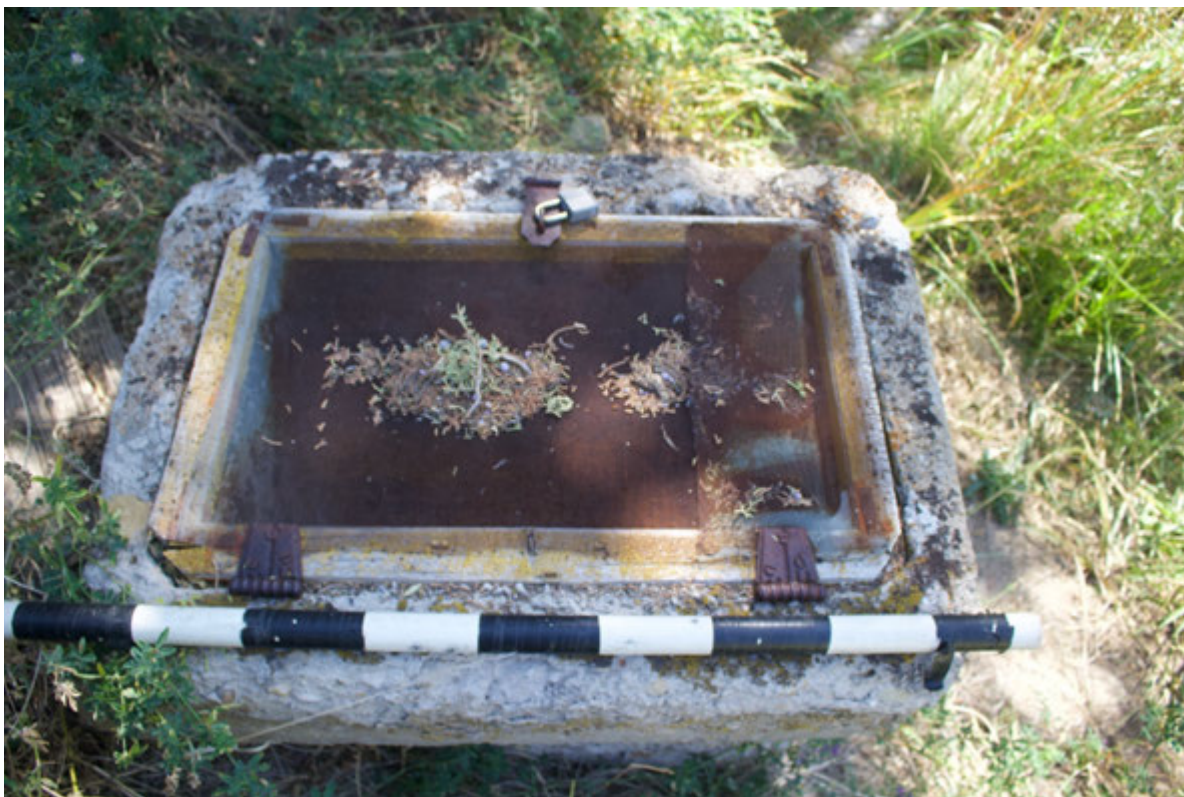
Image Number 5691 A photograph showing a closeup of the top of Feature 7, the Ratliff and Root irrigation ditch stilling well, facing south.

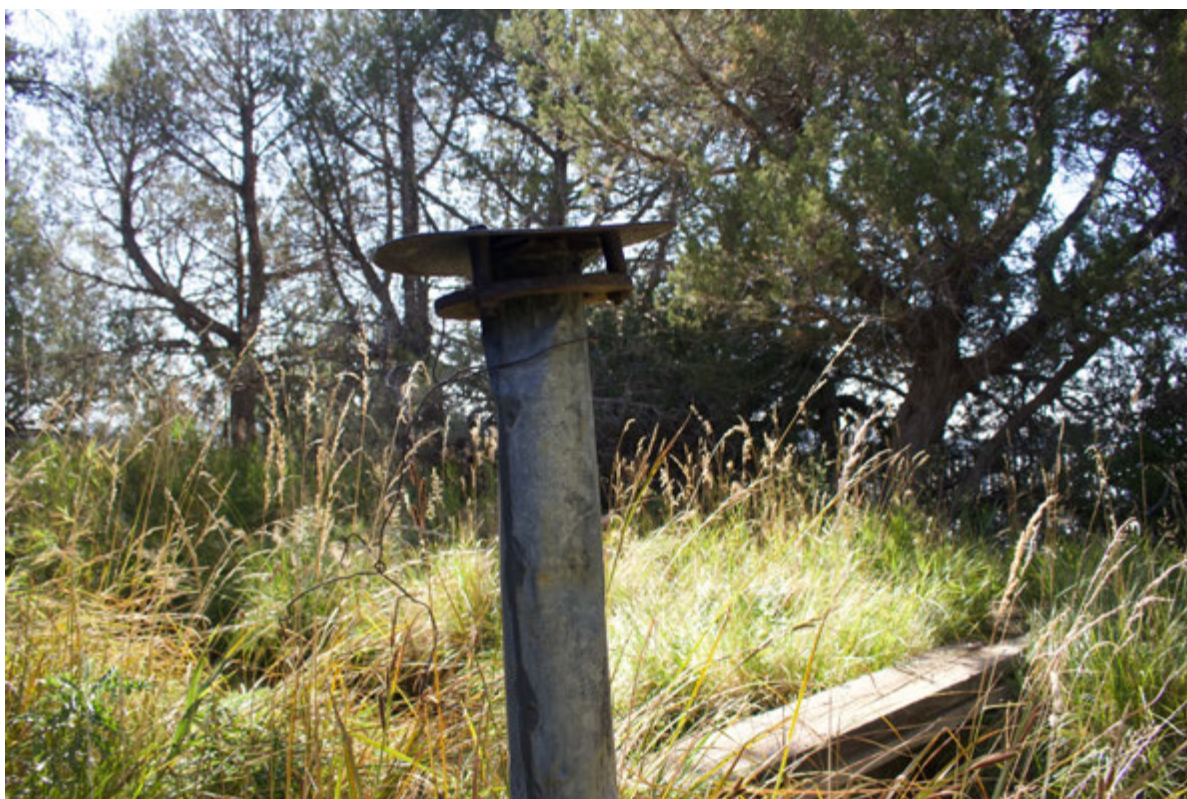
Image Number 5692 A photograph showing a closeup of the mount post of Feature 7, the Ratliff and Root irrigation ditch stilling well, facing southwest.

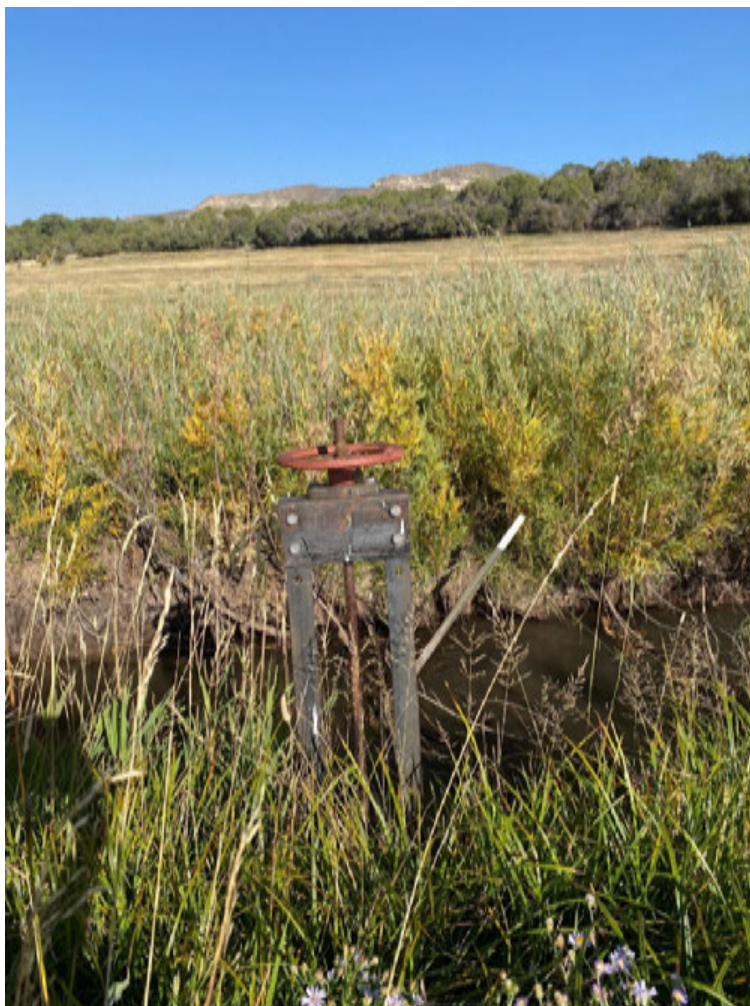
Image Number 5696 A photograph showing a closeup of Feature 8, the Ratliff and Root irrigation ditch lateral ditch headgate's west elevation, facing east.

A formed 2' square concrete culvert runs through the 6' wide and 4' high berm on the downhill west side of the ditch. The culvert exits the berm into a 3'6" deep and 2'3" wide and 5' long stilling basin covered by rough cut boards. The ditch continues into a 9' long hourglass shaped Parshall Flume exactly like the one found in Feature 6. The flume opening on the east side is 2'8" and is 2' wide as it exits to the west directly into the lateral ditch.

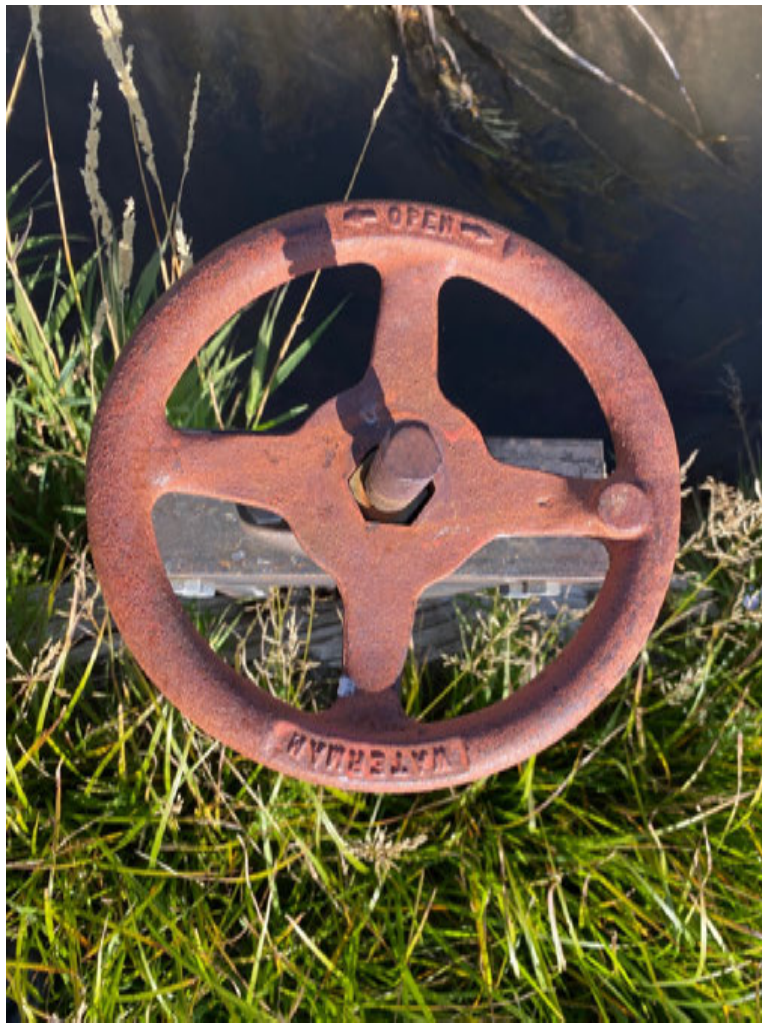
Image Number 5697 A photograph showing a closeup of the handwheel for Feature 8, the Ratliff and Root irrigation ditch lateral ditch headgate, facing east.

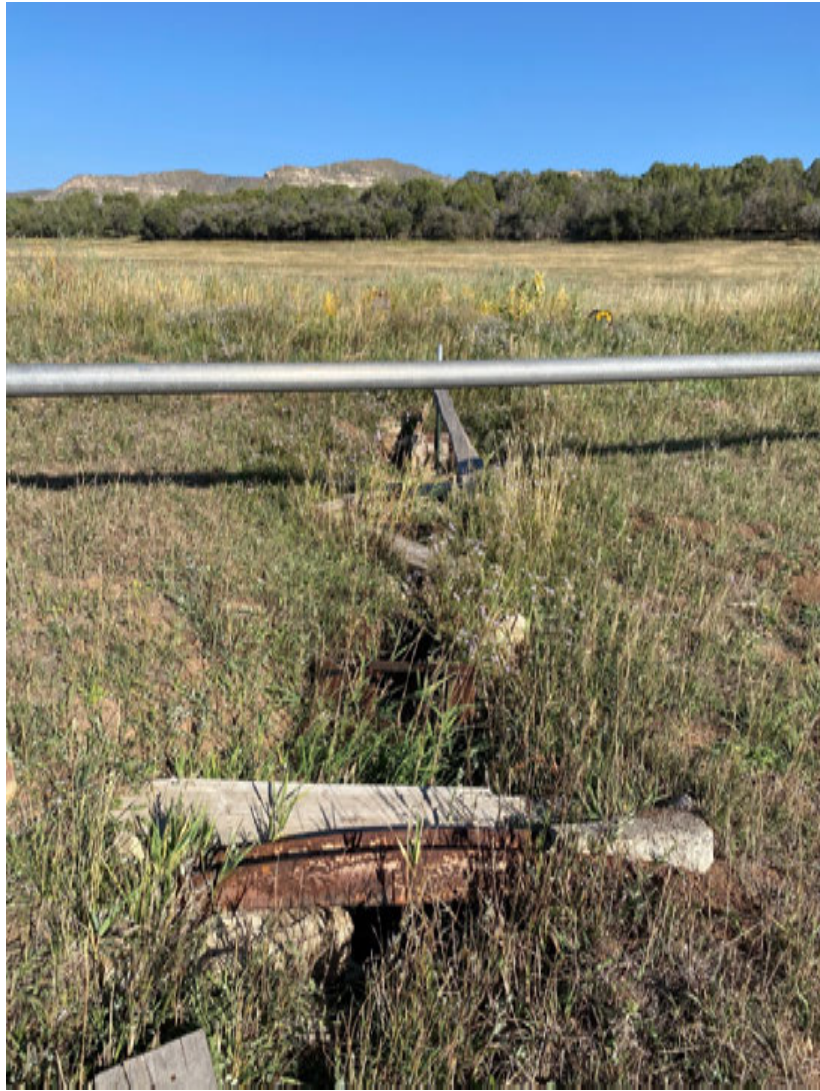
Image Number 5698 A photograph showing a closeup of the west side of Feature 8, the Ratliff and Root irrigation ditch lateral ditch headgate, facing east.

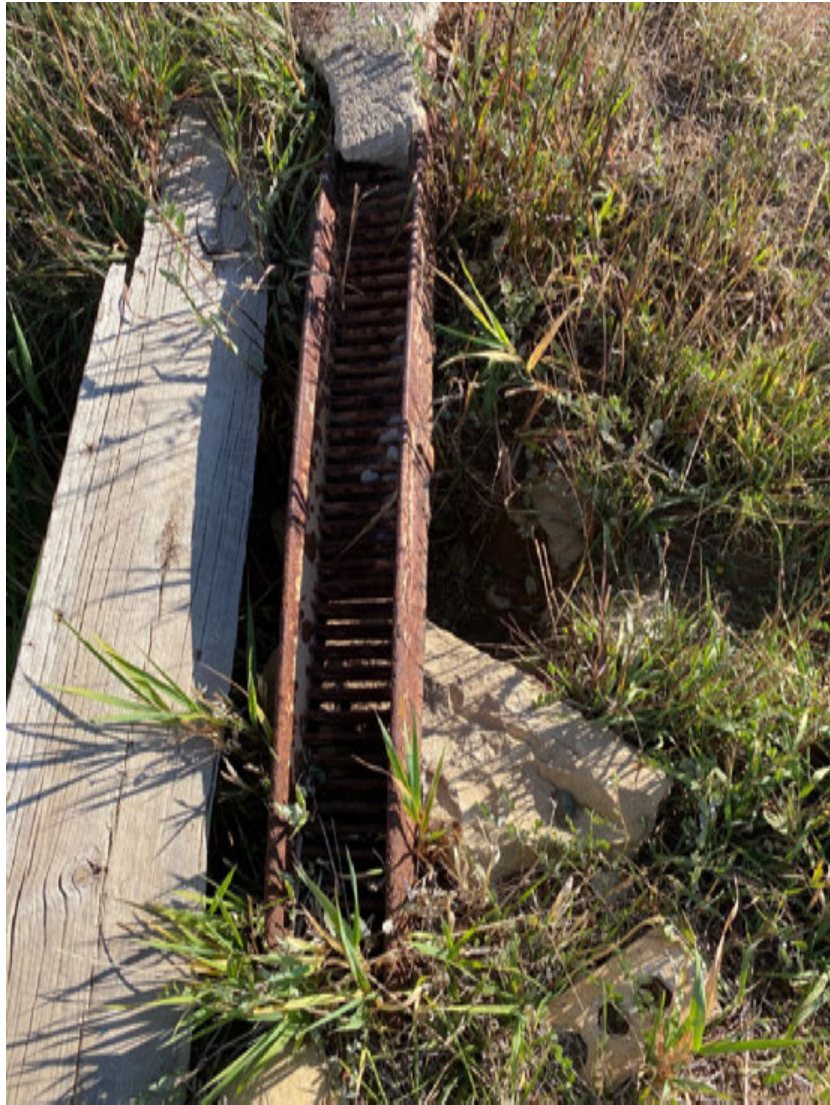
Image Number 5699 A photograph showing a closeup of the west end of Feature 8, the Ratliff and Root irrigation ditch lateral ditch headgate, facing south.

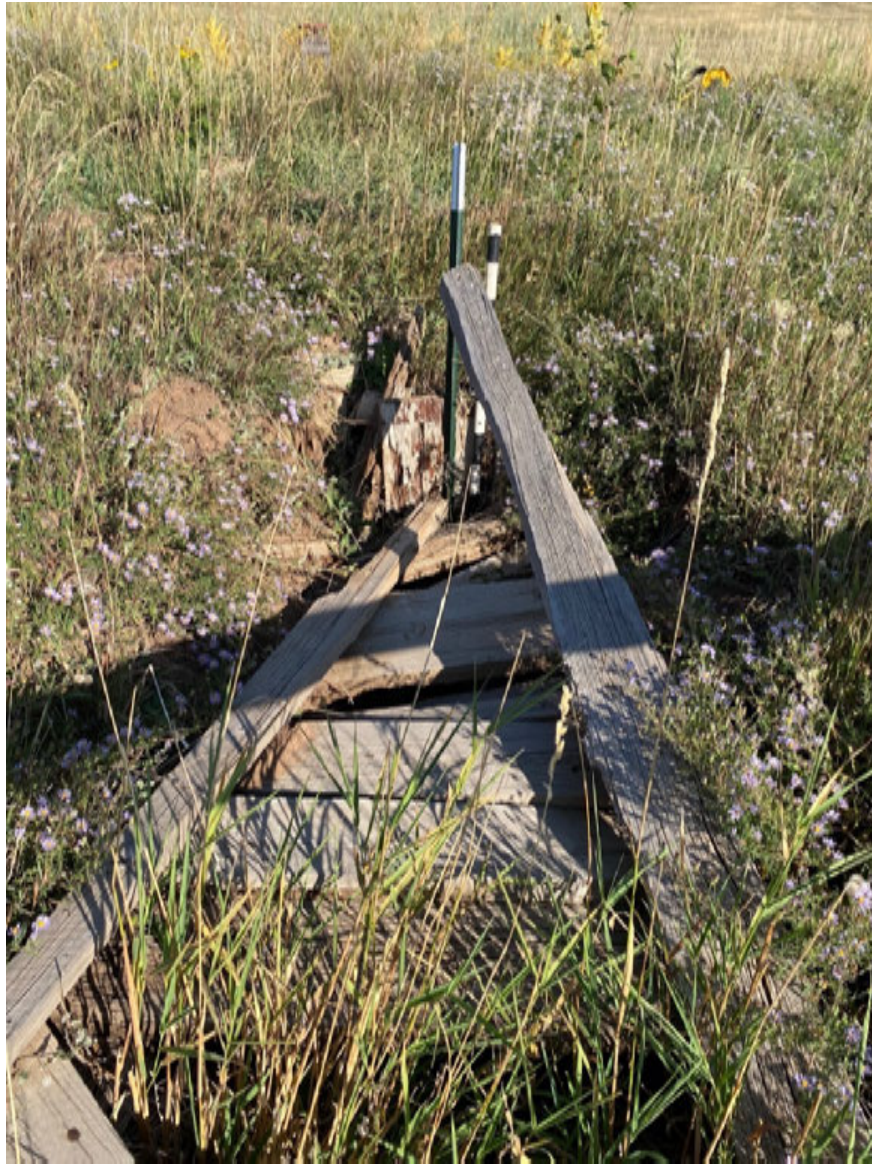
Image Number 5700 A photograph showing the west elevation of the concrete line culvert (covered by the board) in Feature 8, the Ratliff and Root irrigation ditch lateral ditch headgate. The boards in the foreground cover a stilling chute before a Parshall Flume, facing west.

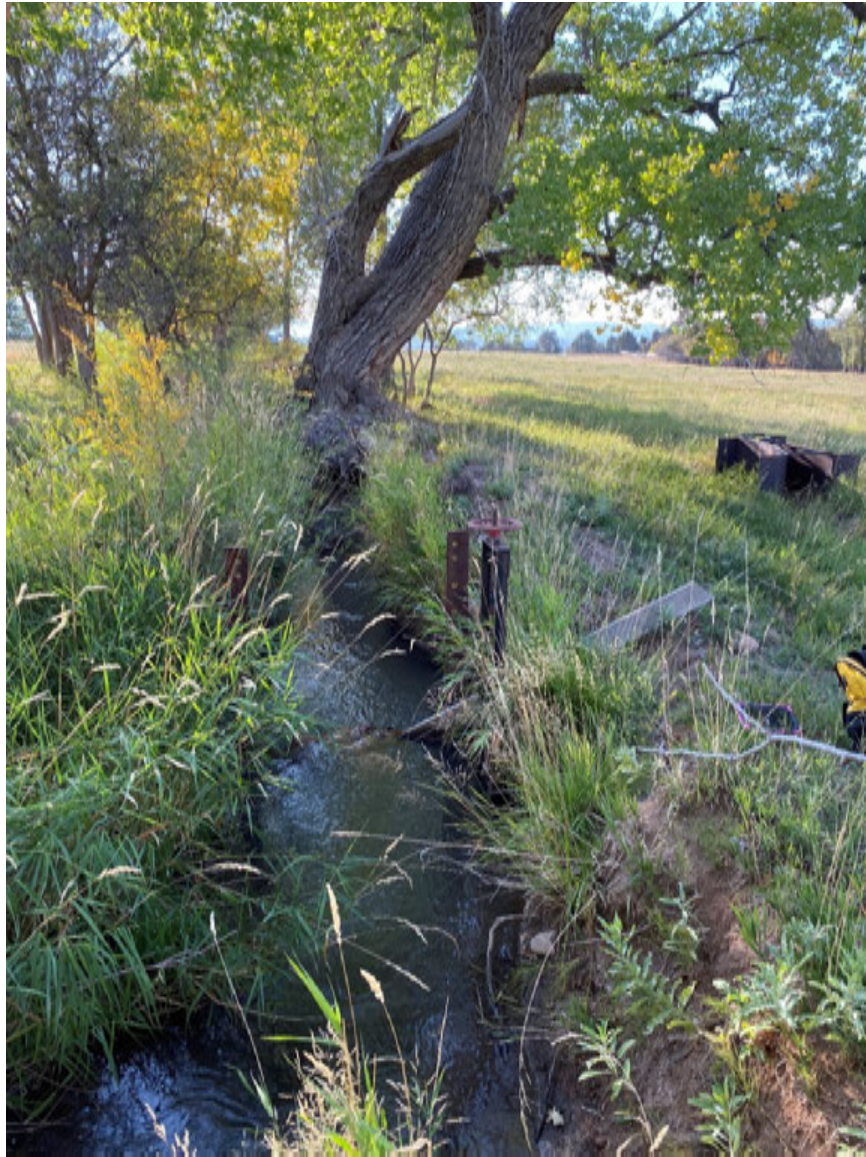
Image Number 5701 A photograph showing an overview of Feature 9, the Ratliff and Root lateral ditch headgate, facing west.

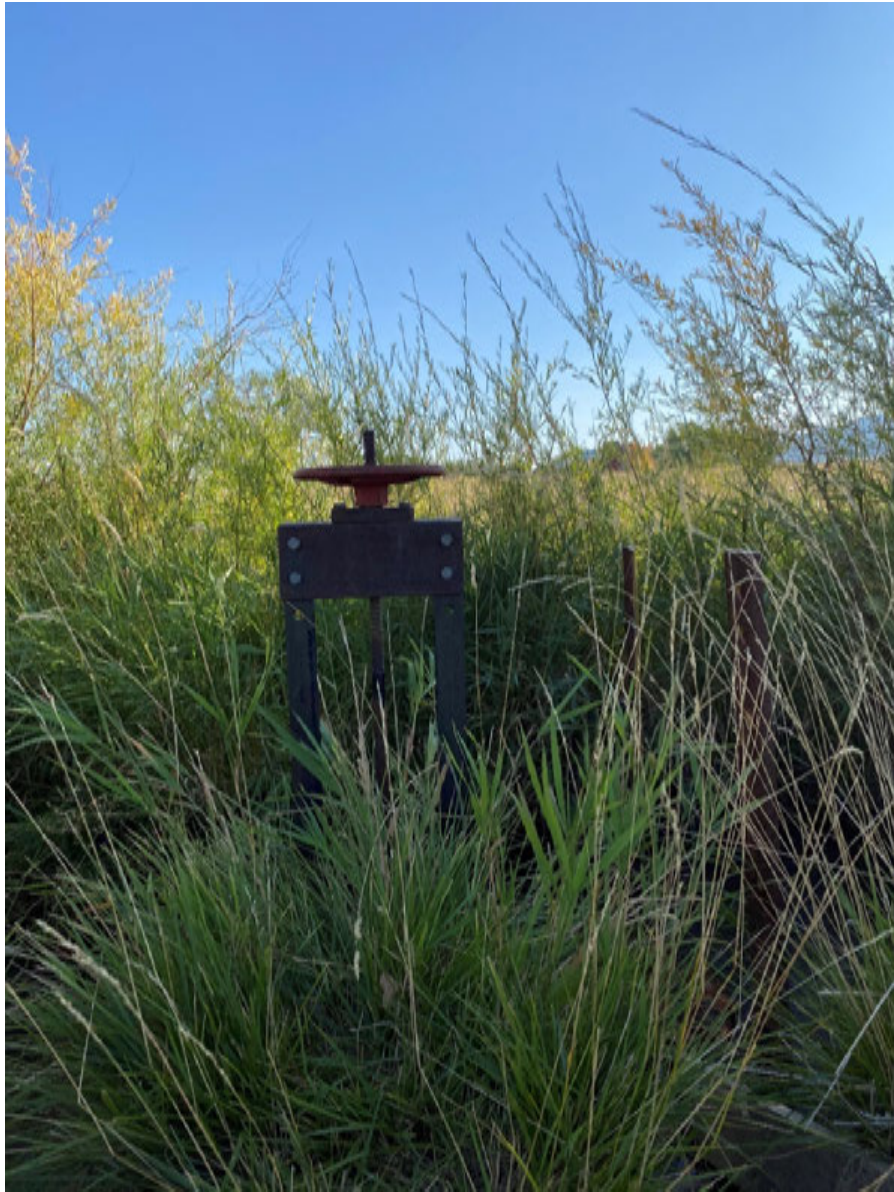
Image Number 5702 A photograph showing a closeup of the north elevation of Feature 9, the Ratliff and Root irrigation ditch lateral headgate, facing south.

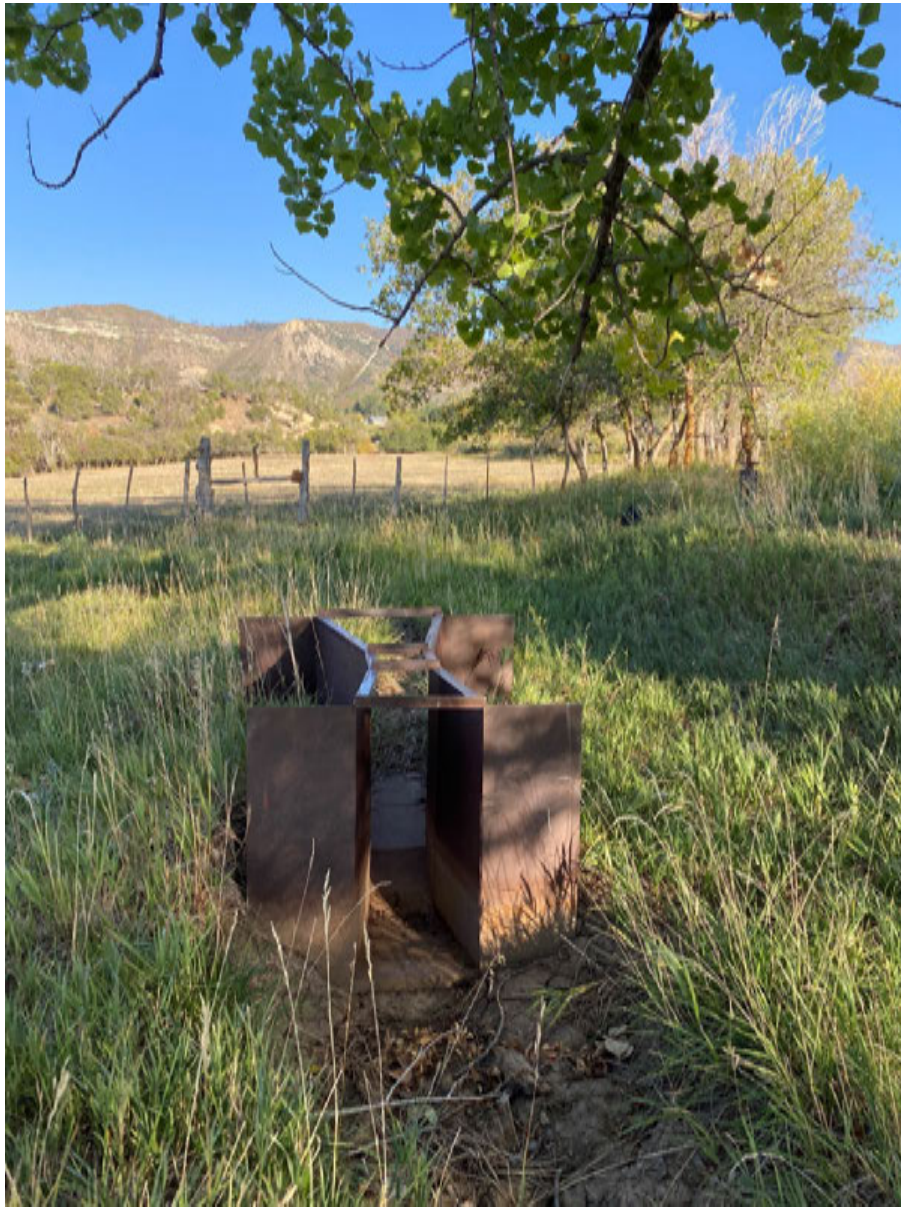
Image Number 5703 A photograph showing a closeup of the Parshall Flume in Feature 9 of the Ratliff and Root irrigation ditch, facing east.
