Calendar Year 2018 Report to the Rio Grande Compact Commission

U. S. Department of the Interior
Bureau of Reclamation
Albuquerque Area Office
Albuquerque, New Mexico

March 2019

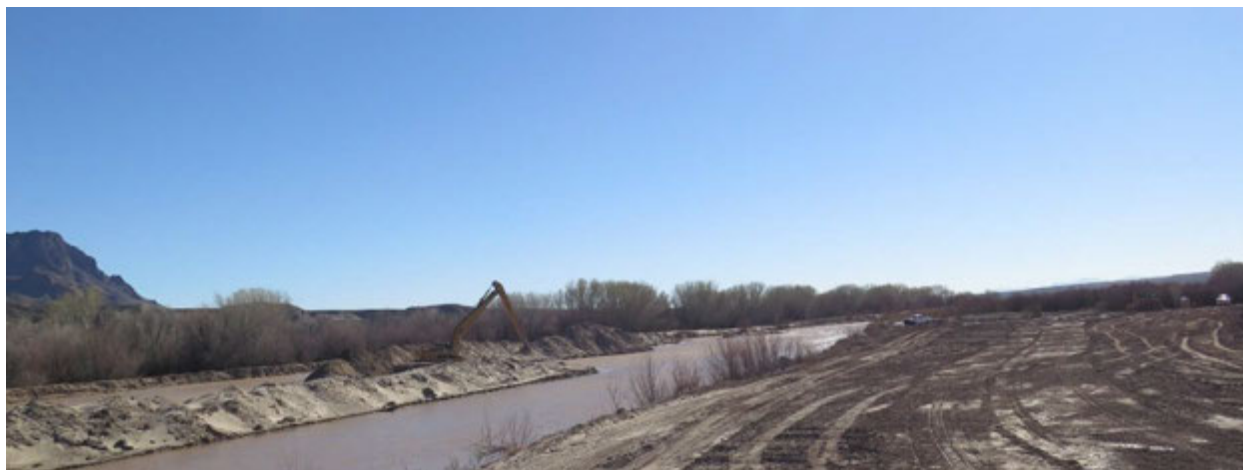
Photo 1: Delta Channel Maintenance (Armstrong, March 2018)

The maintenance work performed along the Delta Channel in 2018 extended from River Mile (RM) 47.5 upstream to approximately RM 52. Reclamation conducted maintenance of the Delta Channel from February through April 2018. Maintenance work included in-channel excavation, sandbar de-vegetation, mowing, and road grading.

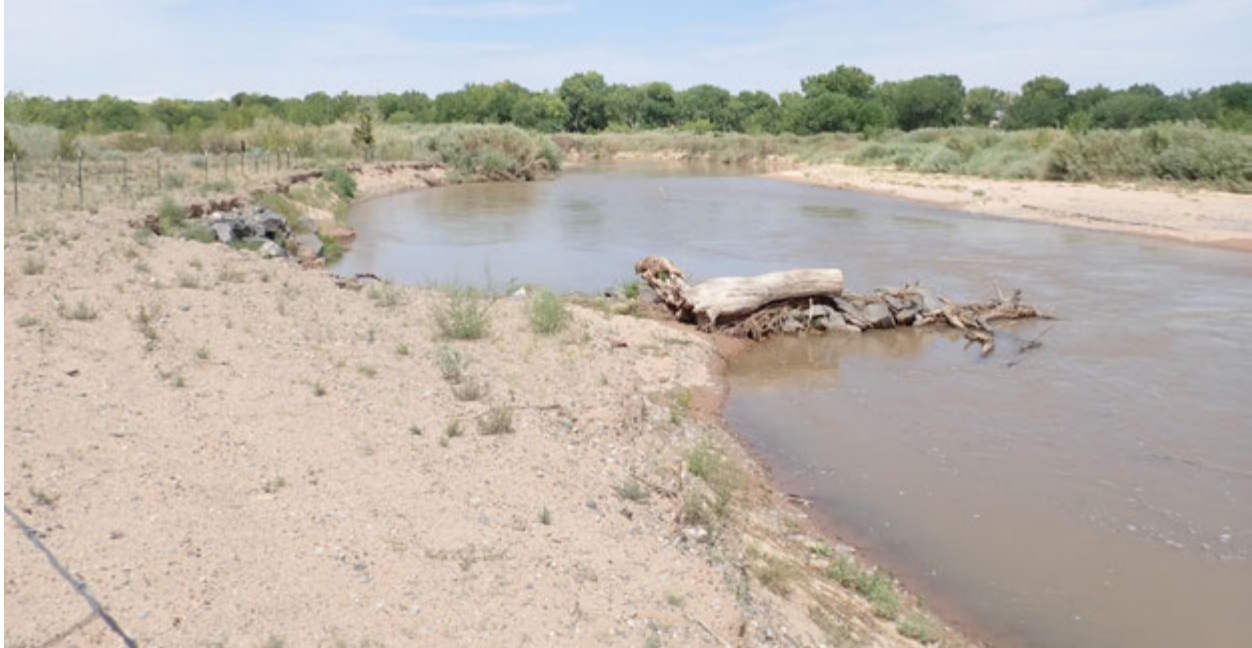
Photo 2: View looking downstream at the Sandia Priority Site. The riprap along the bankline was buried in place during the 2017 repairs but exposed through bank erosion during the 2017 spring runoff (8/17/2018)

In January 2016, the Pueblo of Sandia contacted Reclamation regarding new erosion along the east bankline at the site. Reclamation monitored during the 2016 spring runoff and saw 30 to 40 feet of erosion. As a result, Reclamation sought and received approval from the Pueblo's tribal council to strengthen the bankline at the bendway weirs. Reclamation crews performed repair work at this location in March and April 2017.

An investigation to evaluate the specific geomorphic and hydraulic conditions that led to the 2016 spring runoff bank erosion was completed in August 2018. Reclamation is currently planning adaptive maintenance work at the site as part of a longer-term repair project.

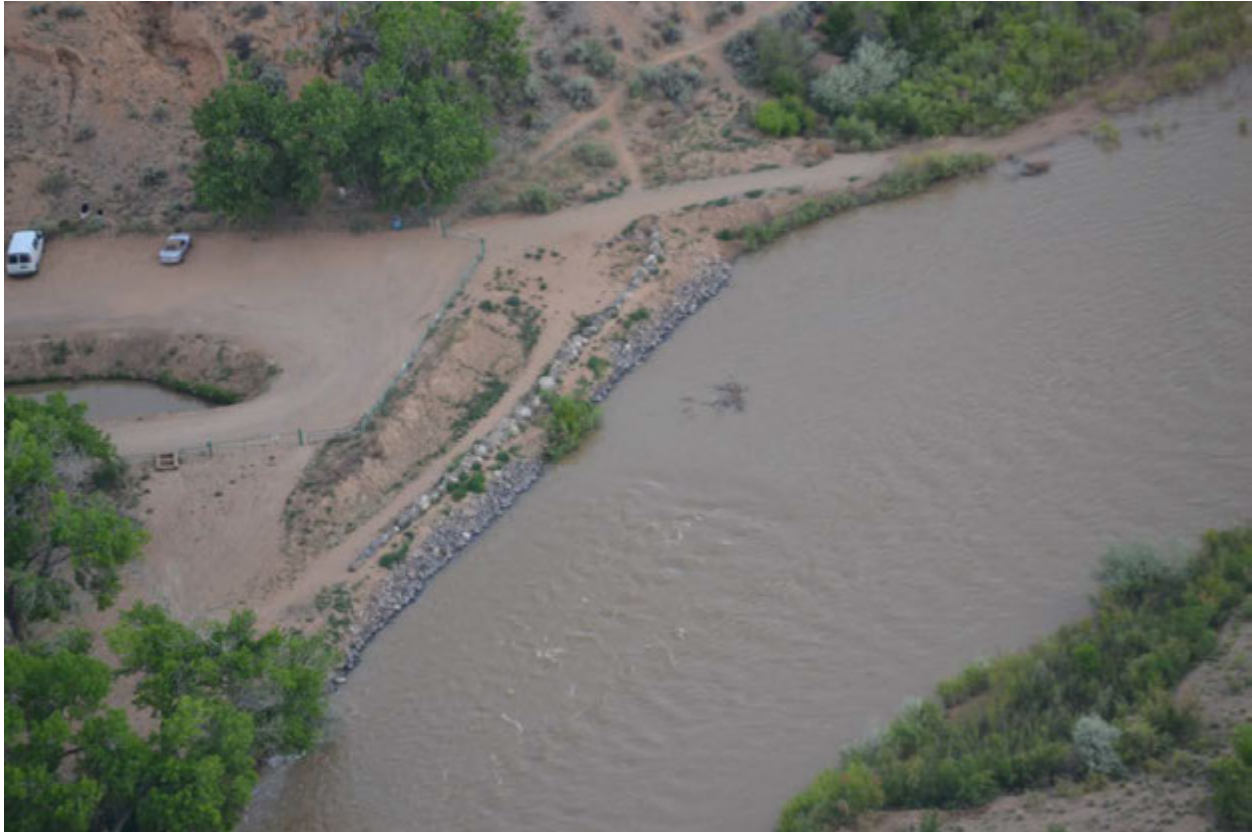
Photo 3: View looking downstream at the Corrales Siphon and the 2016 riprap protection placed downstream of the siphon

The Corrales Siphon is in Corrales, NM, just north of Albuquerque, at RM 199.7 and about 700 feet downstream of the Arroyo de la Barranca confluence. The siphon was constructed in the early 1930s by the MRGCD to provide irrigation water to the Corrales Main Canal. During river reconnaissance in 2012, Reclamation discovered that degradation in the area had exposed the siphon to the current. MRGCD requested emergency technical assistance and construction support from Reclamation to temporarily protect it during the 2016 runoff.

Reclamation and MRGCD collaborated on a short-term project that placed riprap in the scour hole downstream of the exposed siphon. Approximately 1,800 cubic yards of riprap were placed upstream and downstream of the siphon along the west bankline.

The scour hole and exposed part of the siphon have moved away from the west bank toward the center of the river channel. New developments caused by geomorphic responses to the temporary repair will continue to be monitored by Reclamation. MRGCD will be working on a longer-term solution beyond the 2016 temporary protection of the Siphon location and Reclamation is awaiting further information about their proposed project.

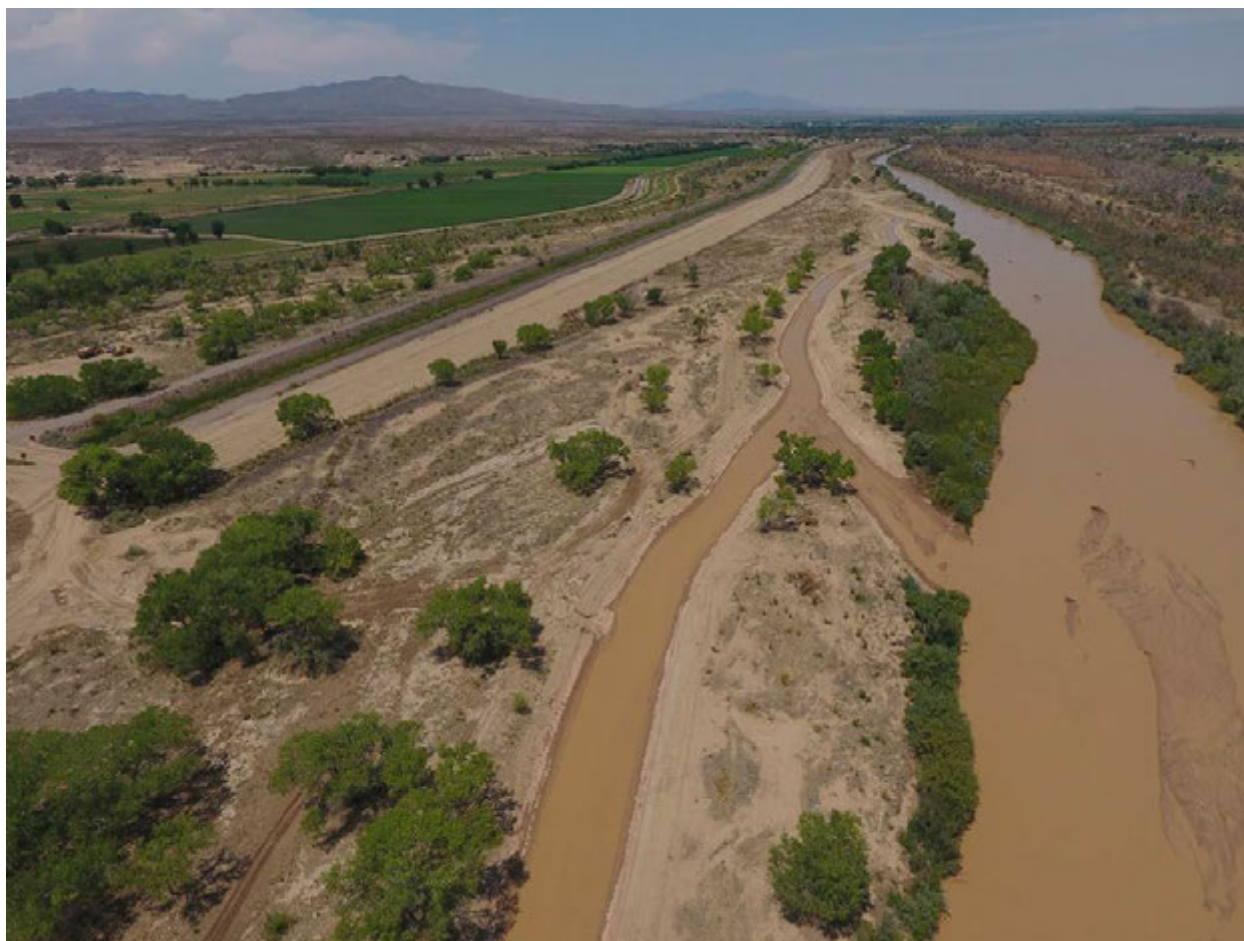
Photo 4: Escondida side channel project at post-monsoonal conditions (7/30/2018)

The habitat restoration work at the Escondida burn scar involved lowering the Arroyo de la Parida delta and an abandoned side channel. Approximately 1.8 acres of the arroyo delta was lowered to the 300 cfs inundation design level. Cut banks were also sloped to encourage growth of riparian vegetation.

Downstream of the arroyo work, a side channel was also constructed to create a flow-through channel at 2,000 cfs. Three outlets were also added along the side channel which, along with the original inlet and outlet, will function as backwaters at the 300 cfs inundation design water surface level.

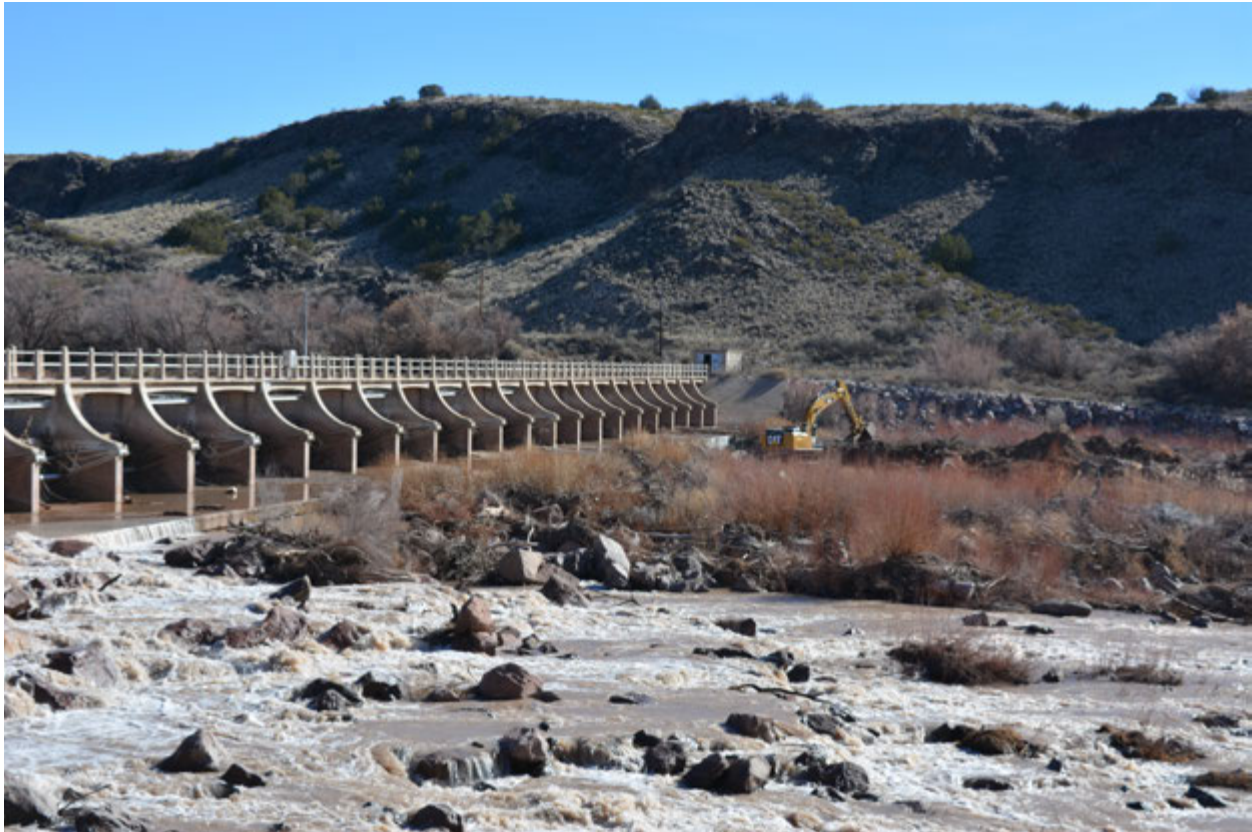
Photo 5: Construction work has begun to rehabilitate the rock ramp below San Acacia Diversion Dam's concrete apron to create a 10% design slope on the ramp as it transitions from the dam's headworks onto the downstream river channel (flow about 500 cfs; January 2019)

The riprap covered ramp downstream of the San Acacia Diversion Dam just north of Socorro, NM, was rehabilitated by Reclamation in the late 1980s. A multitude of high flow events have progressively displaced much of the ramp downstream. This has resulted in some exposure of the dam's apron and presents challenges to upstream fish movement at the dam when it is unchecked outside of irrigation season. At the request of Reclamation's partner MRGCD, Reclamation is providing design and construction support to rehabilitate the ramp to facilitate future fish passage efforts at this location. This project's goal is to renovate the ramp by providing a 10% design slope comprised of 3 to 4-foot nominal riprap and to see if local fish species can traverse the ramp to the dam's apron while also providing protection to the exposed apron toe. The Socorro Field Division is responsible for the construction of the renovated ramp and this project is being closely coordinated with both the MRGCD and NMISC.

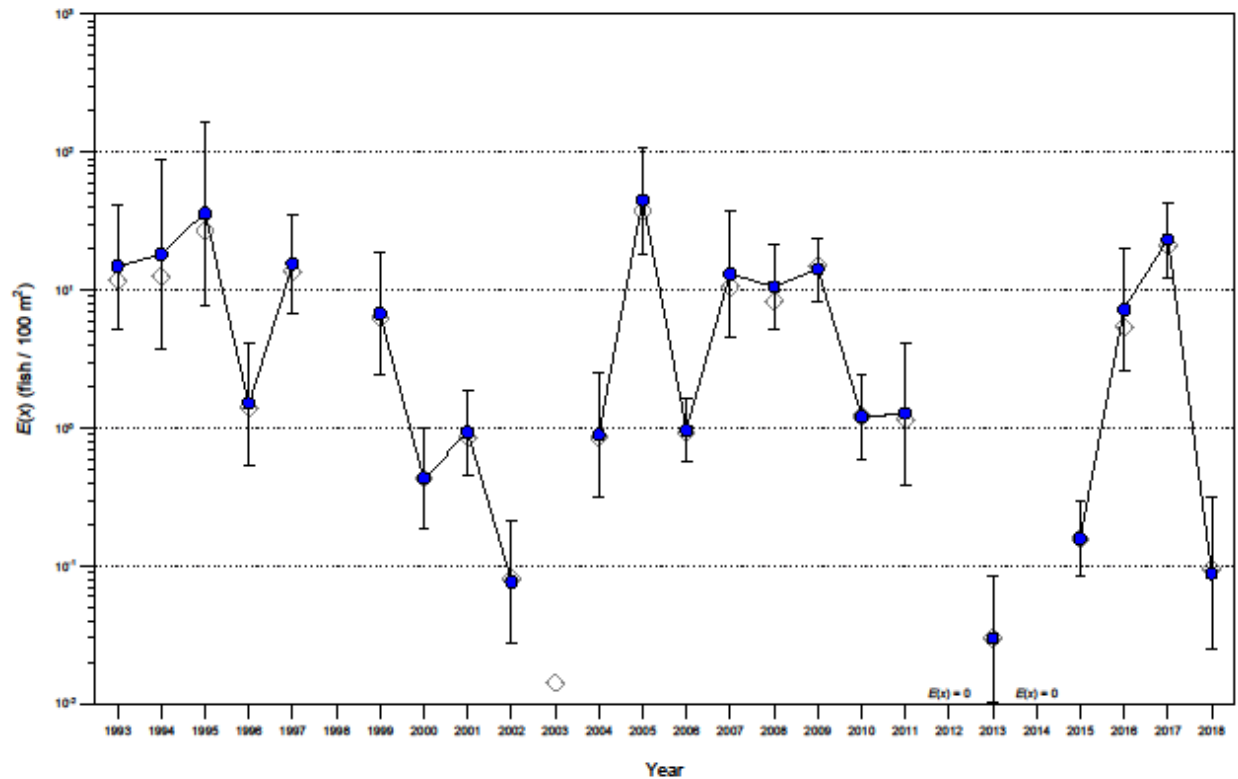
Figure 5: October silvery minnow density estimates ($E(x)$) for 1993–2018 from American Southwest Ichthyological Researchers. Solid circles indicate estimates, hollow circles represent simple estimates using methods of moments, and bars represent 95% confidence intervals.

CPUE of silvery minnow during October 2018 was substantially lower than October estimates from recent years' monitoring (Dudley and Platania, 2018; Figure 5). During October 2018, a total of 10 silvery minnow were collected from the 20 standard long term monitoring sites. The species was present at four of 20 monitoring sites, and was collected in seven of 309 seine hauls that yielded fish (Dudley and Platania, 2018). All silvery minnow collected in October 2018 were unmarked and presumably naturally spawned fish. In addition, three age classes of silvery minnow were present; however, rather than a majority of the fish being young of year, eight of the 10 fish collected from standard monitoring sites were older age 1+ fish that were presumably spawned in 2017 or 2016. The results from October 2018 monitoring suggest that 2018 spring runoff flows were insufficient for successful silvery minnow spawning and recruitment.

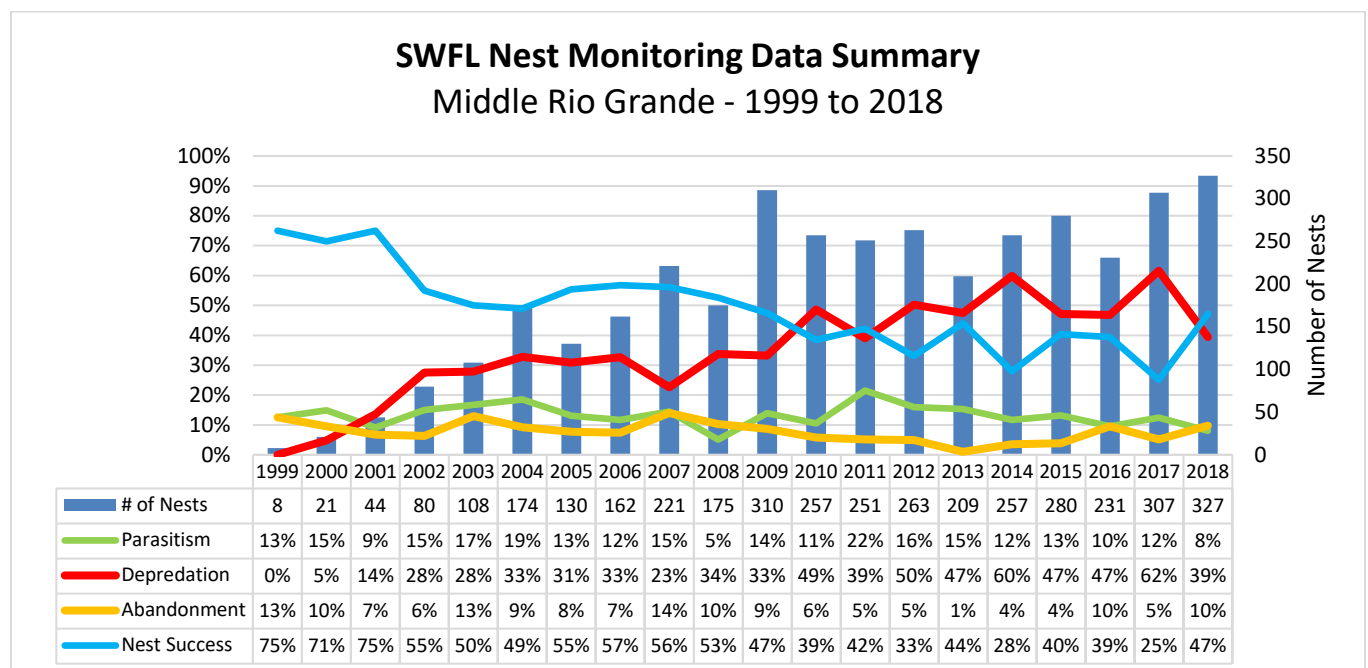
Figure 6: Summary of flycatcher nesting in the Middle Rio Grande from 1999 to 2018

Nest success in the Middle Rio Grande rebounded to 47 percent in 2018 following a study period low of 25 percent observed in 2017 (Figure 6).

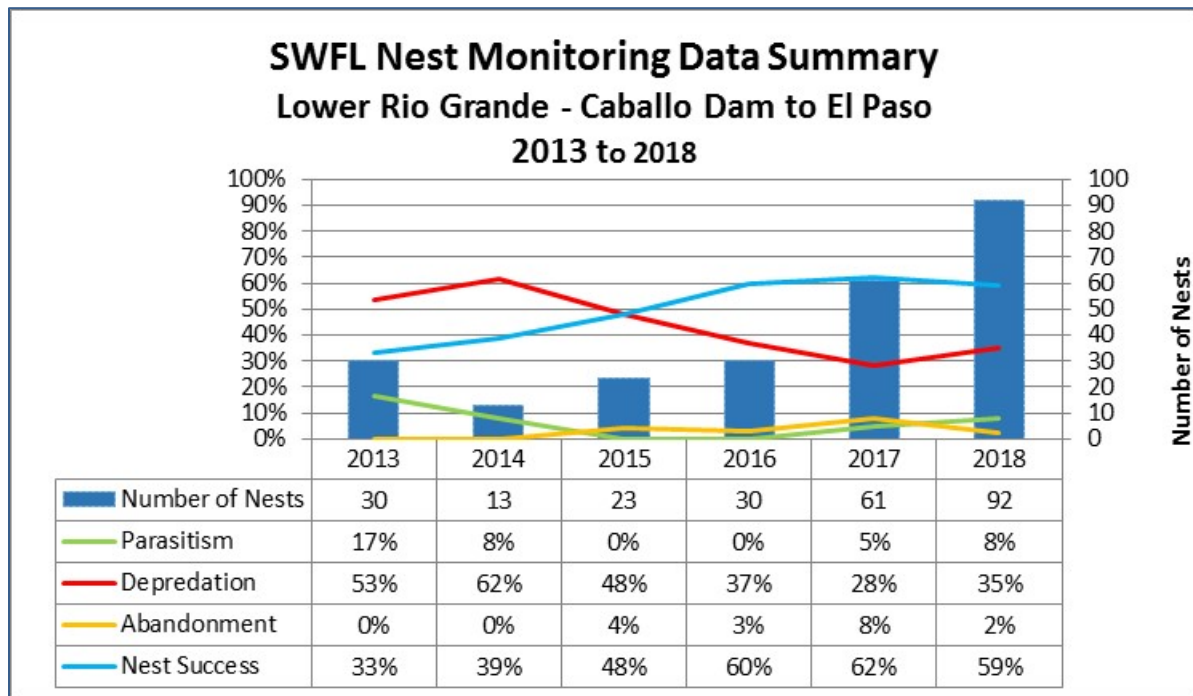
Figure 7: SWFL nest variables, Lower Rio Grande, Hatch - Leasburg Dam, 2013 – 2018

success in the Lower Rio Grande has been much higher the past three years, averaging 60 percent for territories downstream of Caballo Dam, primarily in the Hatch Reach, and 49 percent within the Caballo Reservoir Delta (Figures 7 and 8).

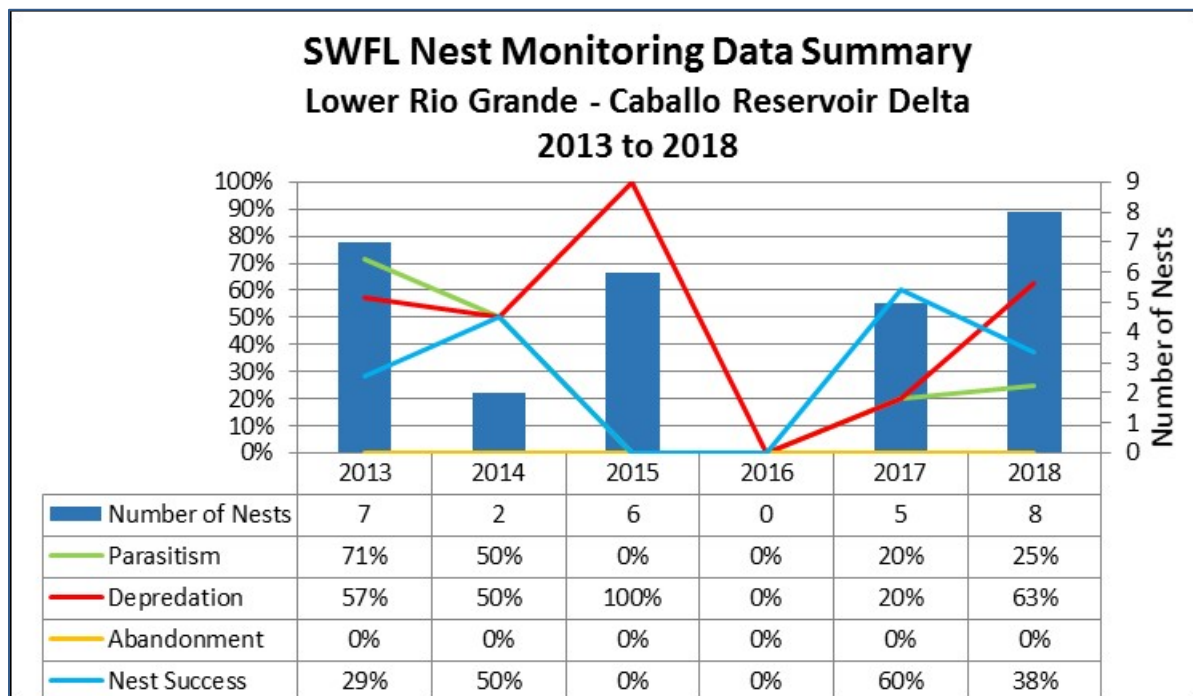
Figure 8: SWFL nest variables, Lower Rio Grande, Caballo Reservoir delta, 2013 to 2018
