Calendar Year 2019 Report to the Rio Grande Compact Commission

Interior Region 7: Upper Colorado Basin

Prepared by Bureau of Reclamation, Albuquerque Area Office, Albuquerque, New Mexico

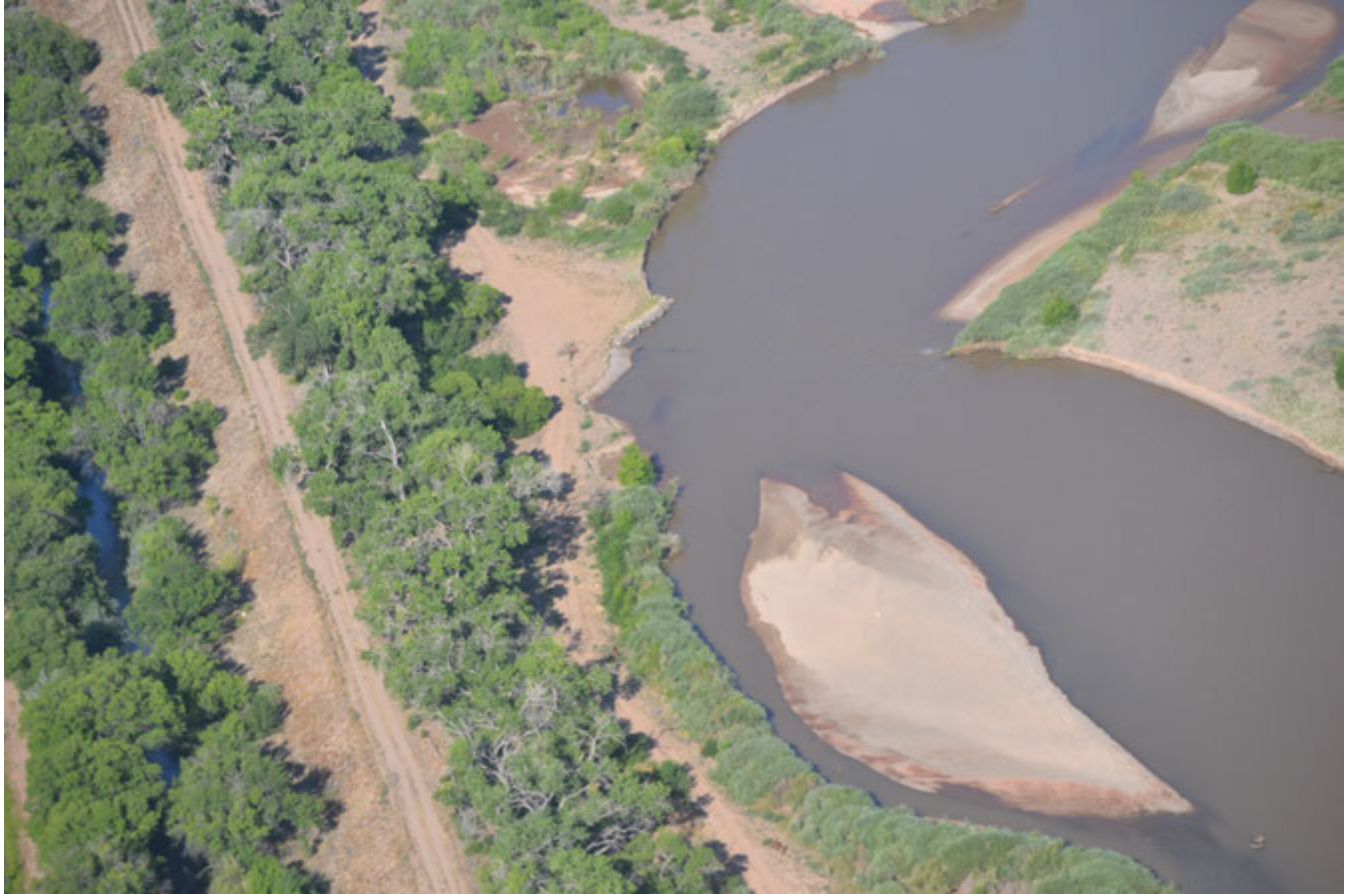
Photo 1: Aerial view of the Sandia Priority Site (flow direction from bottom to top of photo). The eroding bend apex has moved downstream roughly 400 feet in four years and point bar deposition now protects the bankline at the bendway weirs at low flows. (7/18/2019)

In 2016, there was new erosion along the east bankline at the site. With the approval of the Pueblo's tribal council, Reclamation strengthened the bankline at the bendway weirs in March and April 2017.

An investigation to evaluate the specific geomorphic and hydraulic conditions that led to the 2016 spring runoff bank erosion was completed in August 2018. As a result of this investigation, Reclamation has planned adaptive maintenance work at the site as part of a longer-term repair project. The adaptive maintenance work will include rehabilitating the side channels constructed on the western floodplain as part of the original 2008 project, and include additional features such as bank lowering immediately across from the eroding bendway weir site, a new side channel to facilitate water and sediment transport from an arroyo on the western floodplain, and two new side channels immediately downstream of the project in an area that is also eroding. Construction is anticipated to begin in early 2020.

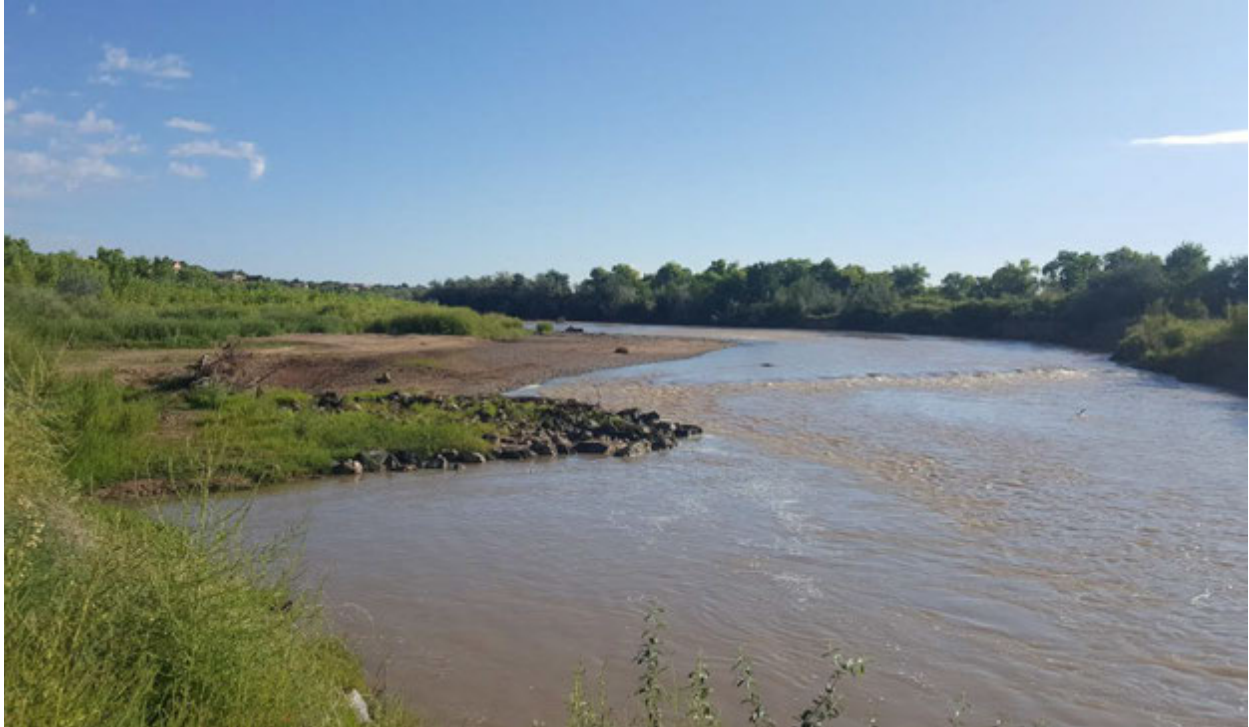
Photo 2: Looking upstream at the Corrales Siphon and the 2016 riprap protection placed downstream of the siphon. The river upstream of the riprap protection has filled in with sediment. (9/11/2019)

The Corrales Siphon, at RM 199.7, is in Corrales, New Mexico, just north of Albuquerque, and about 700 feet downstream of the Arroyo de la Barranca confluence. The siphon was constructed in the early 1930s by the MRGCD to provide irrigation water to the Corrales Main Canal. During river reconnaissance in 2012, Reclamation discovered that degradation in the area had exposed the siphon. MRGCD requested emergency technical assistance and construction support from Reclamation to temporarily protect it during the 2016 runoff.

Reclamation and MRGCD collaborated on a short-term project that placed riprap in the scour hole downstream of the exposed siphon. Approximately 1,800 cubic yards of riprap were placed upstream and downstream of the siphon along the west bankline.

The scour hole and exposed part of the siphon have moved away from the west bank toward the center of the river channel. New developments caused by geomorphic responses to the temporary repair will continue to be monitored by Reclamation. MRGCD is working on a longer-term solution, and Reclamation is awaiting further information about their proposed project.

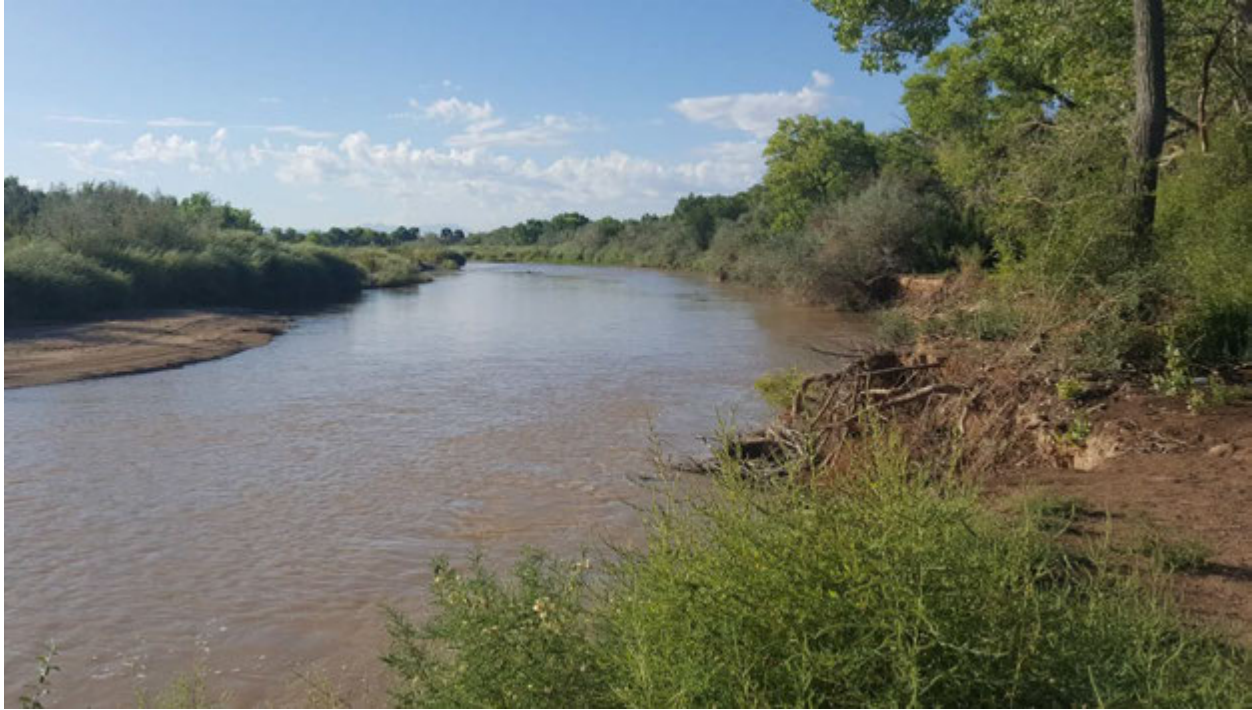
Photo 3: New erosion in the RM 199 project area. Photo is looking downstream immediately below Corrales Siphon. (9/11/2019)

In spring 2017, Reclamation identified a new erosion site near RM 199 in the Corrales area. This site is on the west side of the river, and the active bankline is approximately 120 feet from the west levee toe. The Angostura to Montaña reach plan provides a detailed geomorphic and hydraulic study of the reach and sub-reaches and has helped evaluate erosion at RM 199 in the context of the overall reach needs.

In 2019, Reclamation began alternative formulation and analysis to address bank erosion near the Corrales levee system. Project goals include dissipating energy in the surrounding two-mile reach between the Corrales Siphon and RM 198 and improving ecological function at this site. In 2020, an alternative will be selected and designed.

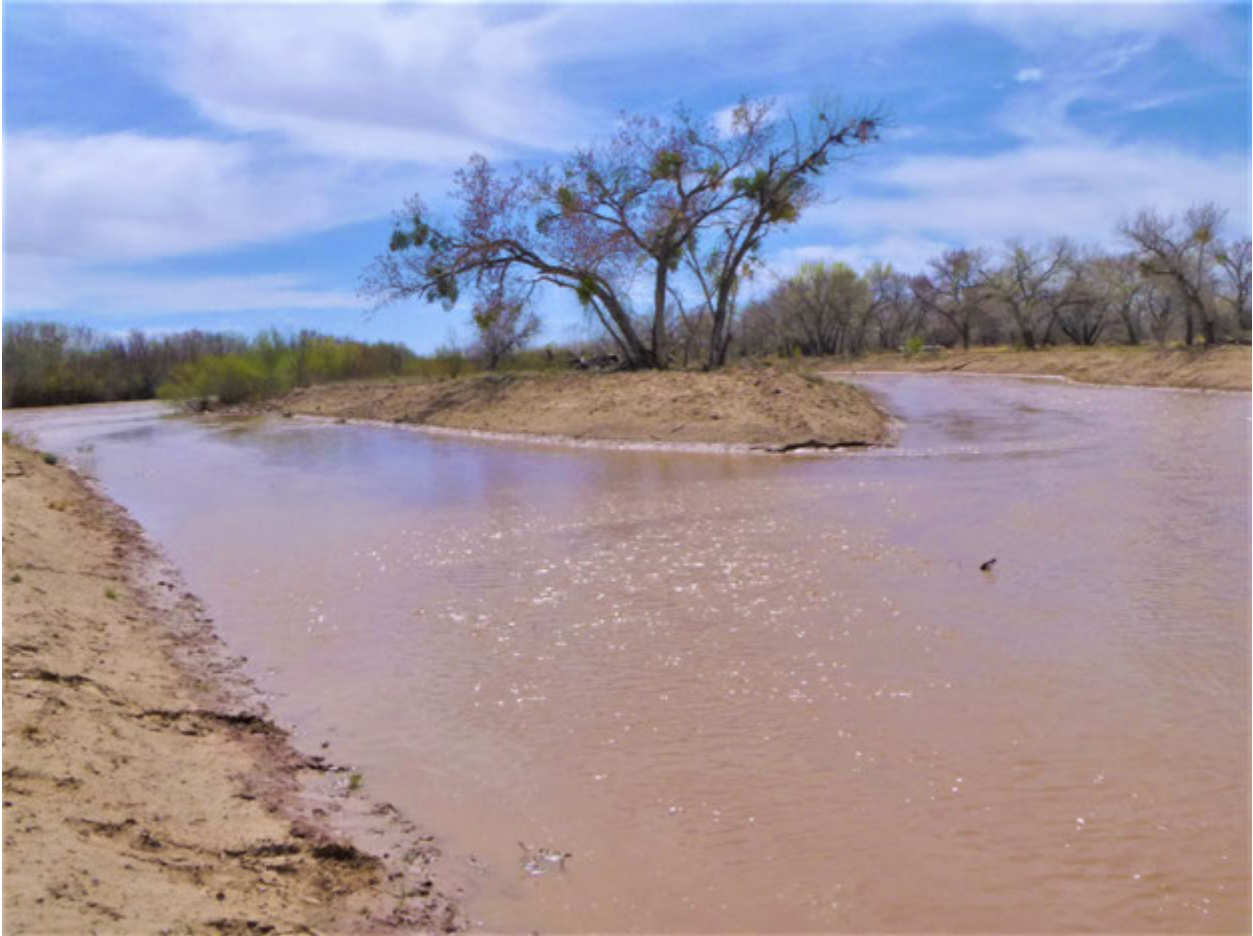
Photo 4: Escondida side channel project during 2019 spring runoff. (4/22/2019)

In June 2016, a wildfire burned approximately 524 acres in the bosque near Escondida, New Mexico. Two aquatic habitat restoration sites were designed and construction was completed in July 2018. The two sites include floodplain lowering at the Arroyo de la Parida delta and a side channel network just upstream of Nogal Arroyo. This work helps Reclamation and its partners meet 2016 BO commitments.

In 2019, six monitoring visits were made to the sites. The monitoring included surveying sedimentation changes, collecting inundation extents, flow velocity and depth, water temperature, isolated pool monitoring, and noxious weed mapping. This monitoring data will inform future adaptive management decisions.

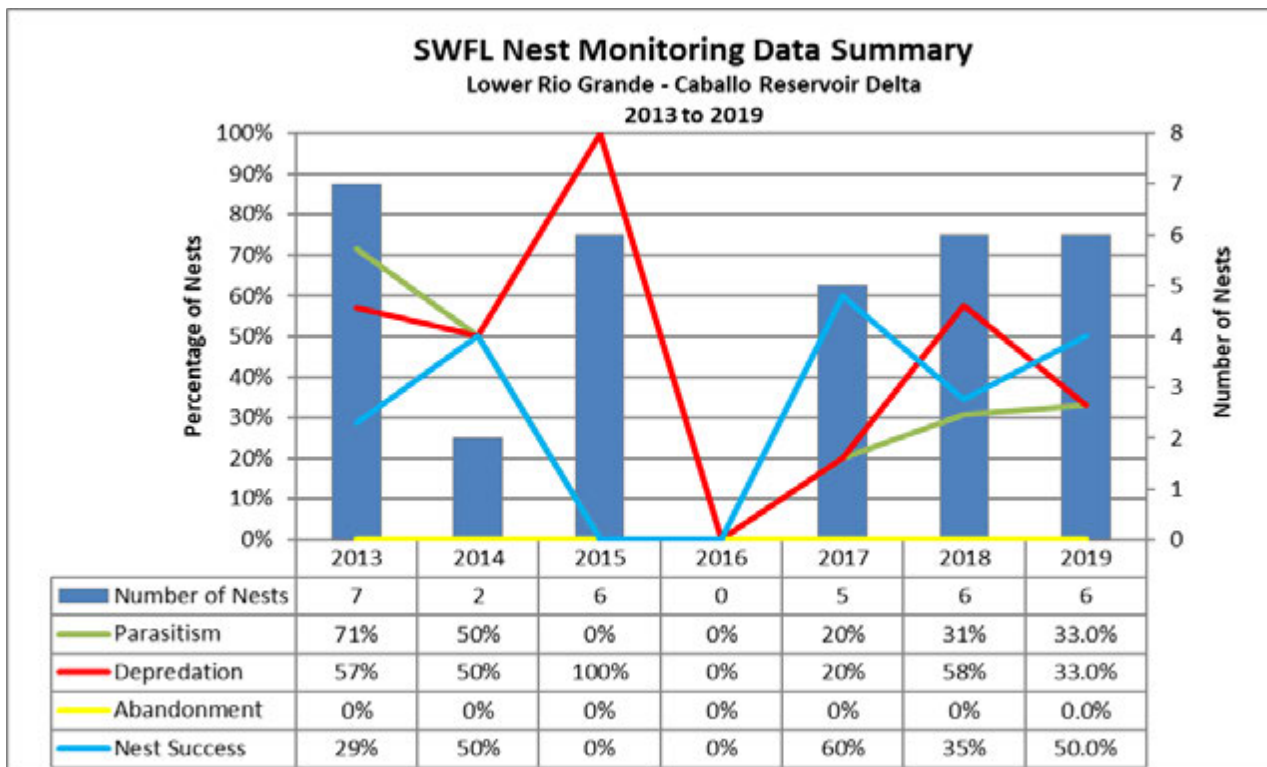
Figure 8: SWFL nest variables, Lower Rio Grande, Caballo Reservoir delta, 2013 to 2019

These changes may be a result of reduced habitat quality as a result of lower flows. Drought conditions, which typically result in reduced discharge and groundwater levels, reduce plant vigor and canopy cover. This reduces nest concealment, exposing the nest to predators and the elements. The defoliation of saltcedar by *Diorhabda* spp. has similar effects and may be of greater concern in the future. Nest success in the Lower Rio Grande has been much higher the past four years, averaging 58 percent for territories downstream of Caballo Dam, primarily in the Hatch Reach, and 48 percent within the Caballo Reservoir Delta (Figures 7 and 8).
