3.0 Affected Environment

3.2. Description of Relevant Resources (see issues from 1.6 of Chapter 1)

3.2.2. Cultural Resources (Issue #2 Historic Features of the Riverside Canal)

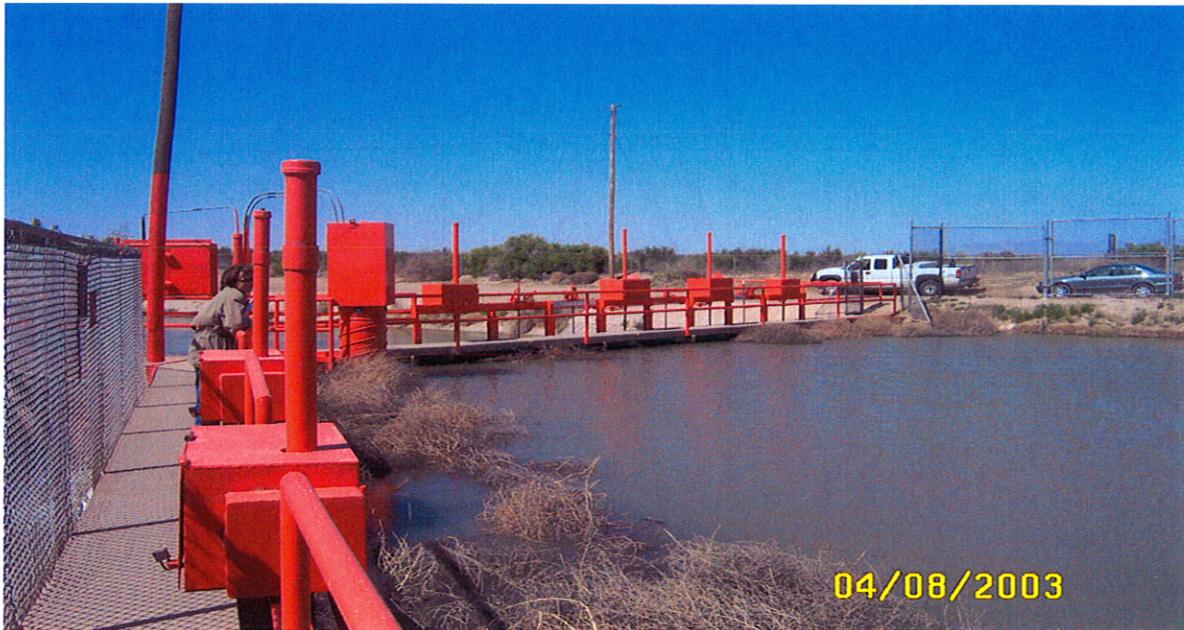
View of the upstream side of Franklin Check Structure (on the left) and the Partidor Check Structure (on the right).

The proposed Project takes place entirely within the District, which is included on the NRHP. Three hydraulic structures in excess of 50 years of age would be replaced in the Project. These structures include the Franklin, Partidor, and Wasteway One Check structures. In addition, the width of the Canal in the Project will be modified. Pages 13 and 14 show pictures of the existing structures on the NRHP.

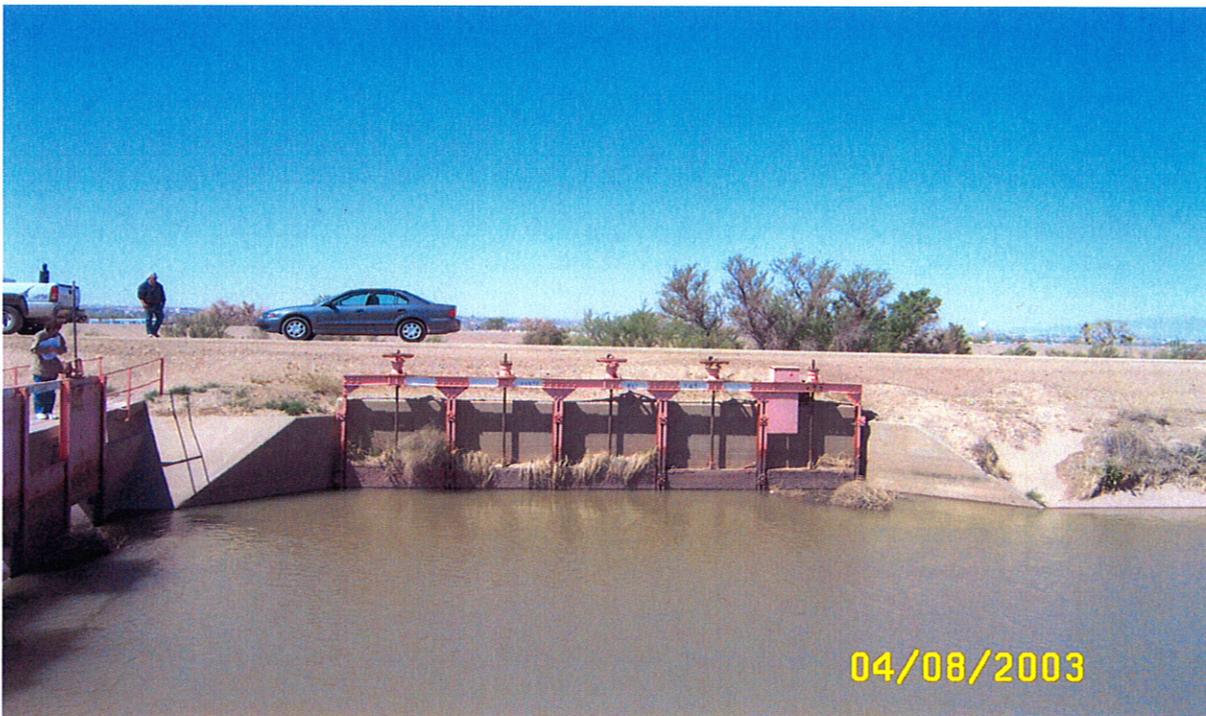
View of the existing Wasteway One and Check Structure on the left.

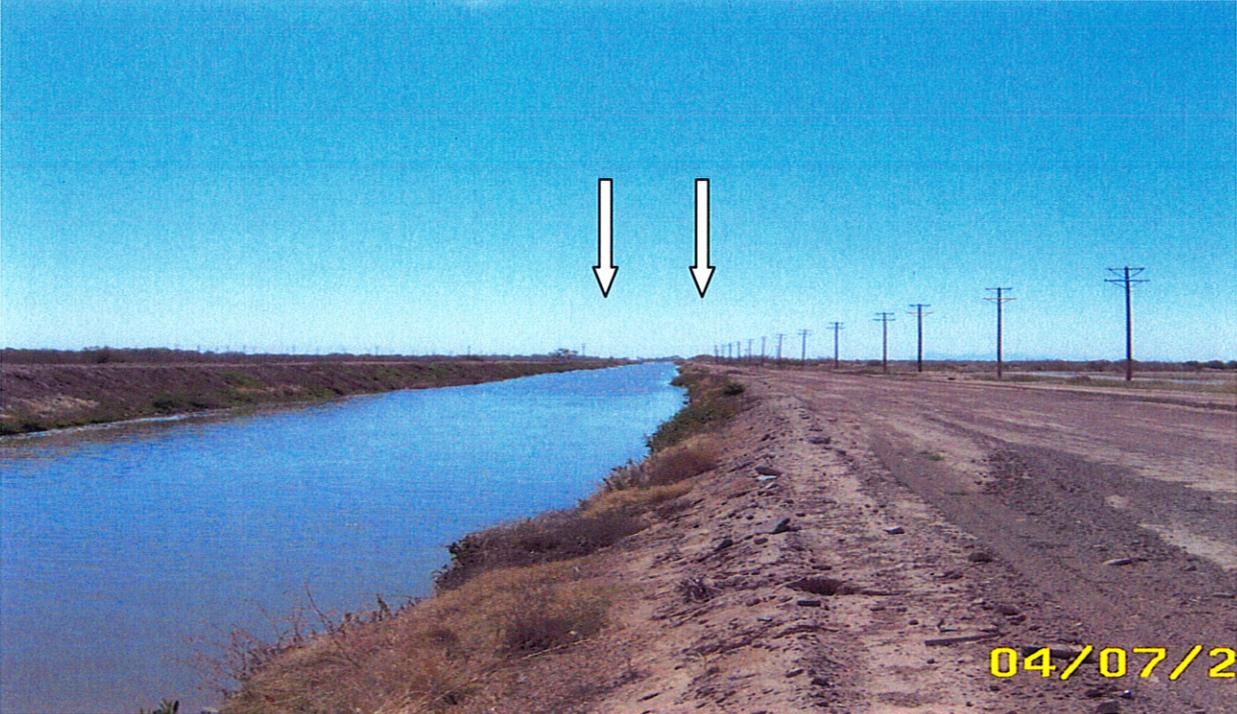
Typical view of the width of the Riverside Canal as it currently exists
