RECLAMATION

CONTRIBUTIONS TO DELISTING RIO GRANDE SILVERY MINNOW: EGG HABITAT IDENTIFICATION

PROGRESS REPORT-2005

January 2006

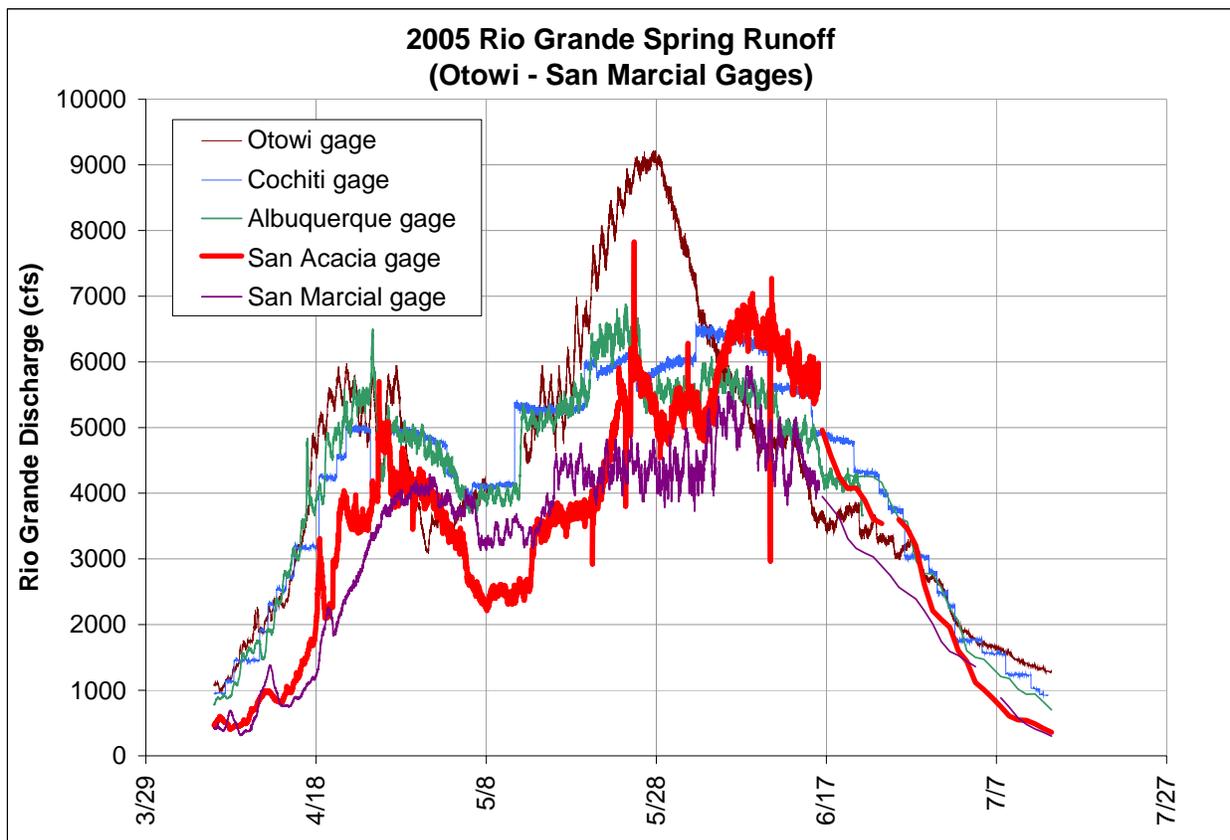
Figure 2: Hydrograph for spring runoff 2005 from the USGS Rio Grande gage at Otowi, NM (Otowi gage) upstream of Cochiti Reservoir to the USGS Rio Grande floodway gage at San Marcial, NM (San Marcial gage) at the upstream end of Elephant Butte Reservoir.

Three sets of data were collected, with runs in April, May and June. The first sample, taken on April 22-23, 2005 was during the rising hydrograph at a flow of 5,300-5,500 cfs (Figure 2). This sample was taken as spring runoff was just beginning. The May data collection run was on May 12-13, 2005 at a steady flow of 5,000 cfs. The third data collection effort occurred on June 20-21, 2005 during the rapidly descending limb of the hydrograph (3,800-4,200 cfs). From these three data collection events, 24 collection sites were designated (Figures 3 & 4).

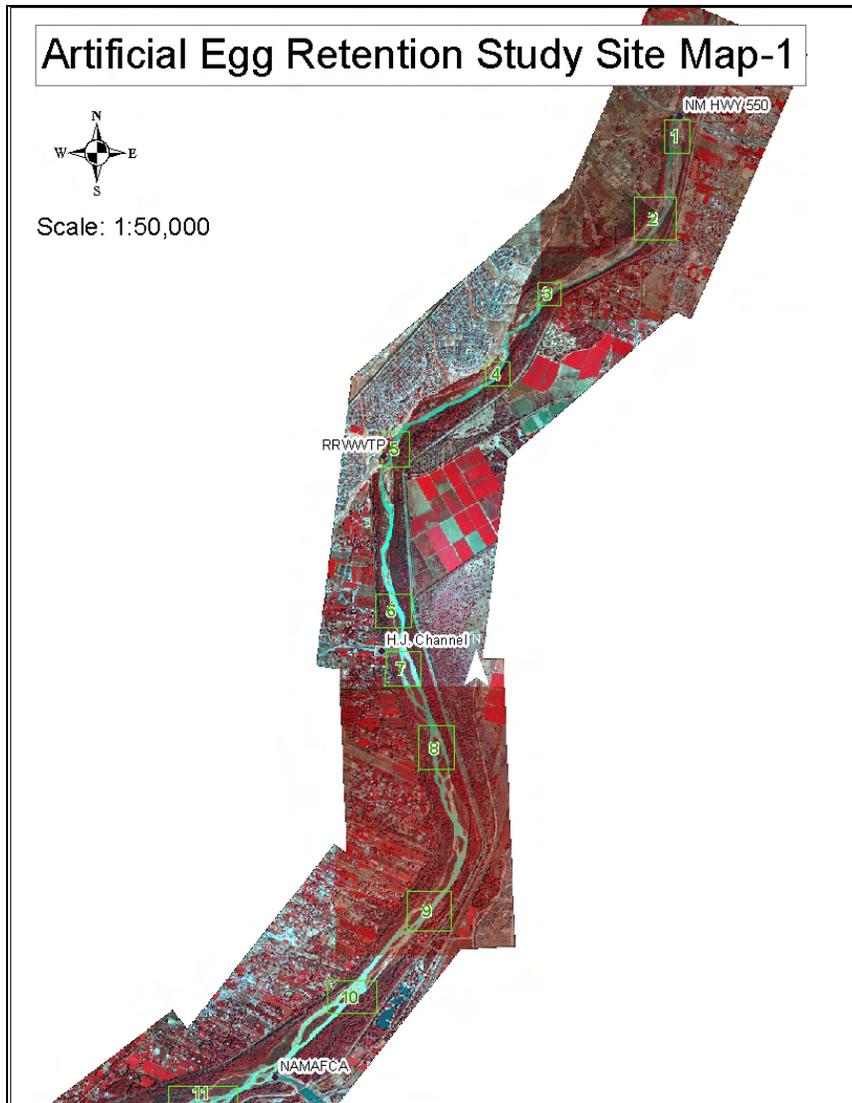
Figure 3: Northern half of the sampled area, from NM HWY 550 bridge crossing to the North Albuquerque Metropolitan Arroyo Flood Control Authority (NAMAFA), locating Sampling Sites 1-10. Background photography is from Oct. 2004, scale of 1:50,000.

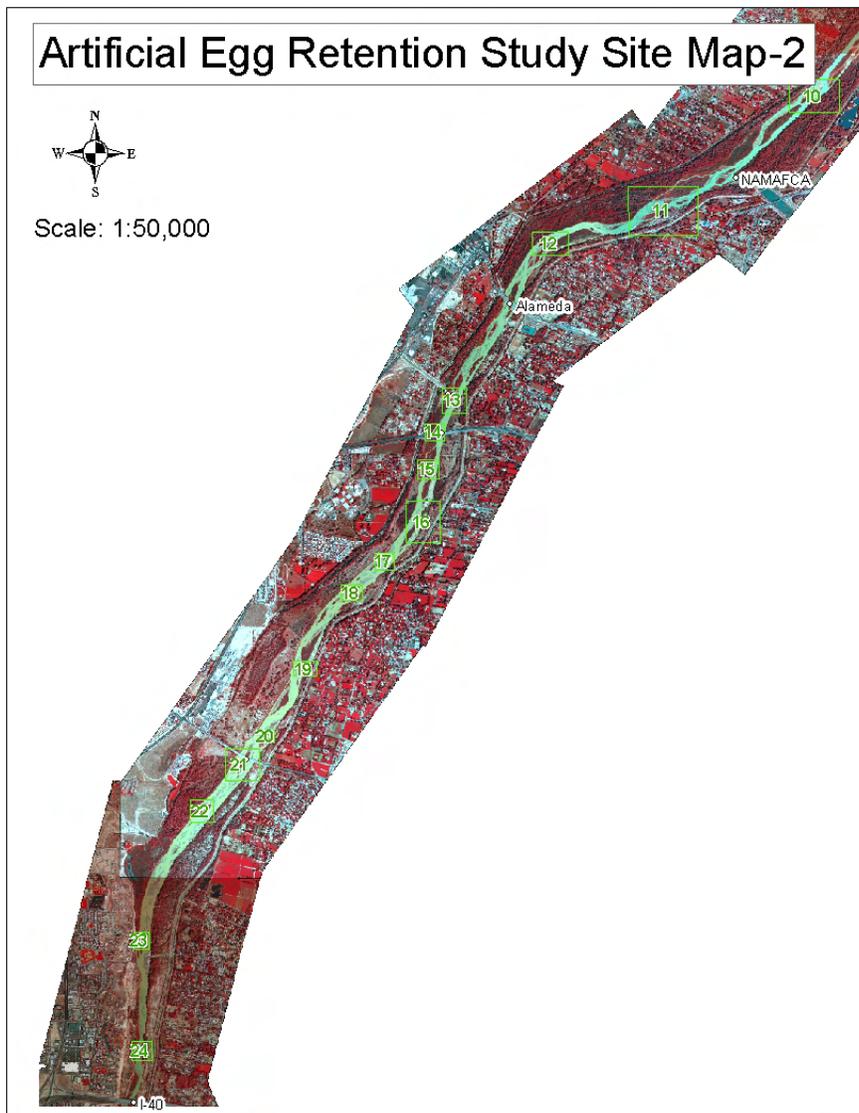
Figure 4: Southern half of the sampled area, from NAMAFCFA to the I-40 bridge crossing, locating Sampling Sites 11-24. Background photography is from Oct. 2004, scale of 1:50,000.

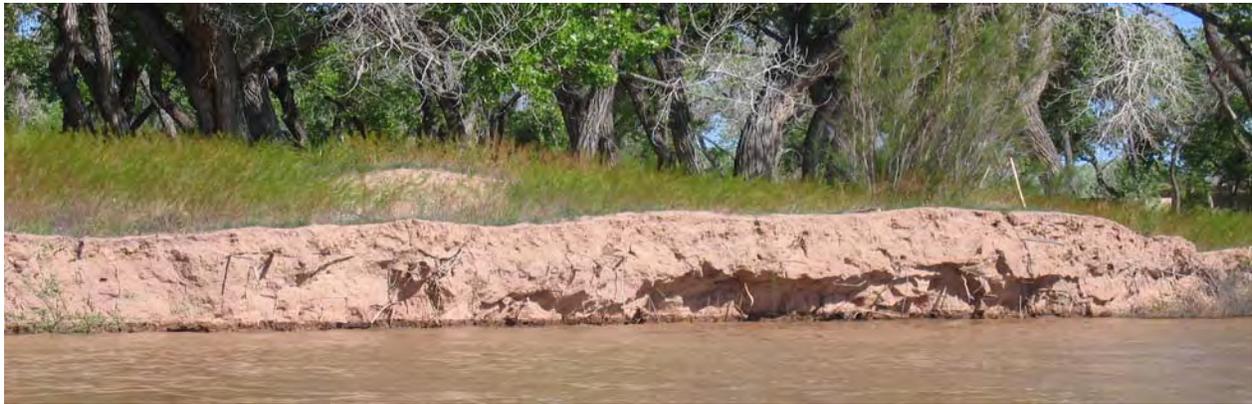
Figure 5. Bankline along a terrace.

Bankline – along the base of an elevated terrestrial surface (Figure 5).

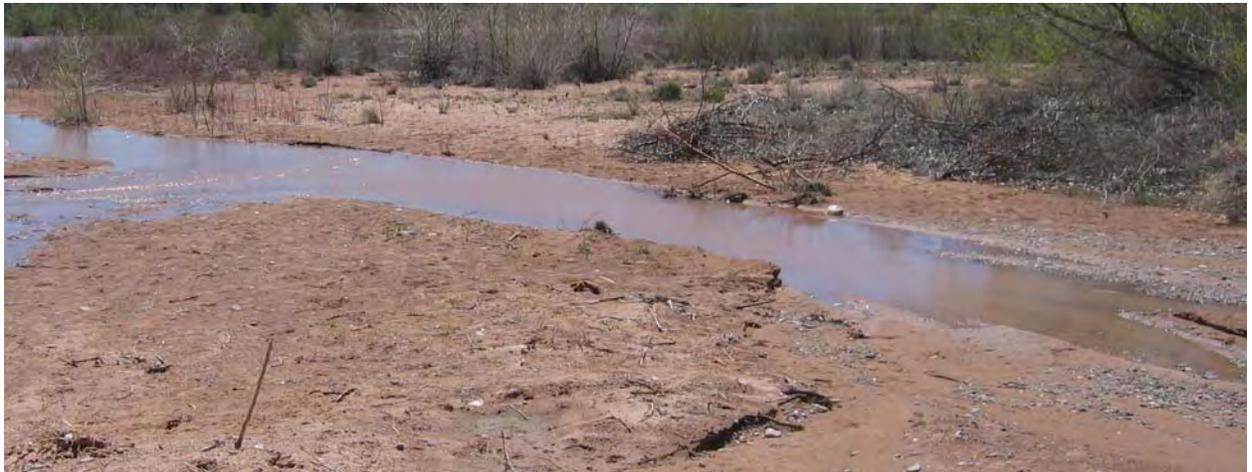
Figure 6. A small habitat inlet formed by an arroyo channel.

Inlet – water feature enclosed on three sides (Figures 6 and 7).

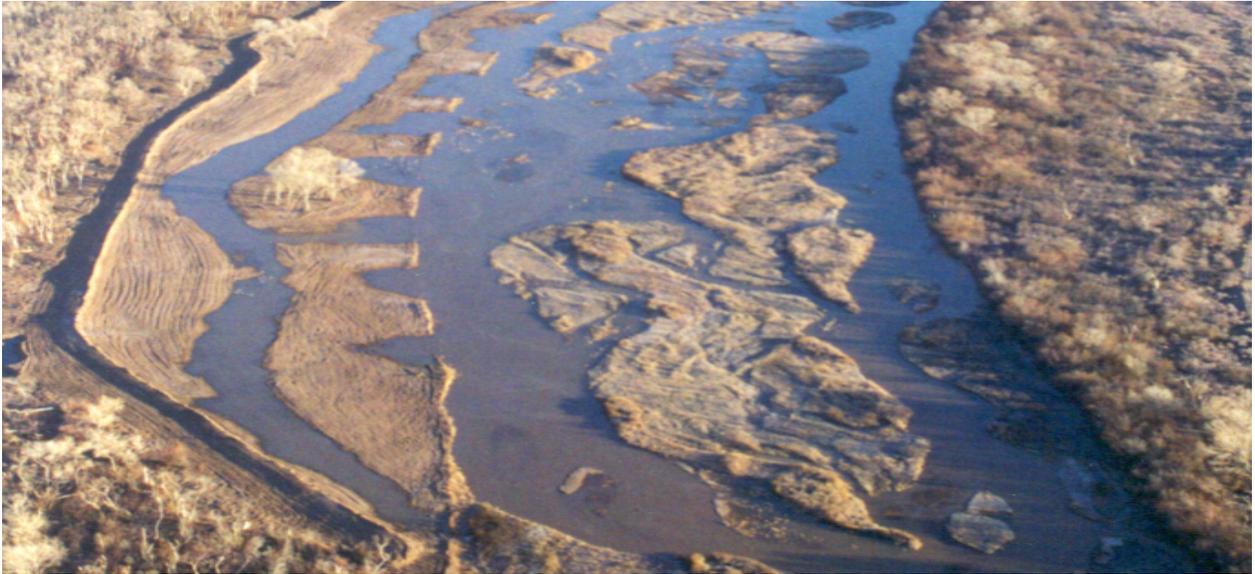
Figure 7. Habitat inlets, islands and side channel.

Island – vegetated mid-channel bar or braid bar features (Figure 7).

Side channel – a distinct flowing channel over a surface lacking vegetation (Figures 7 and 9).

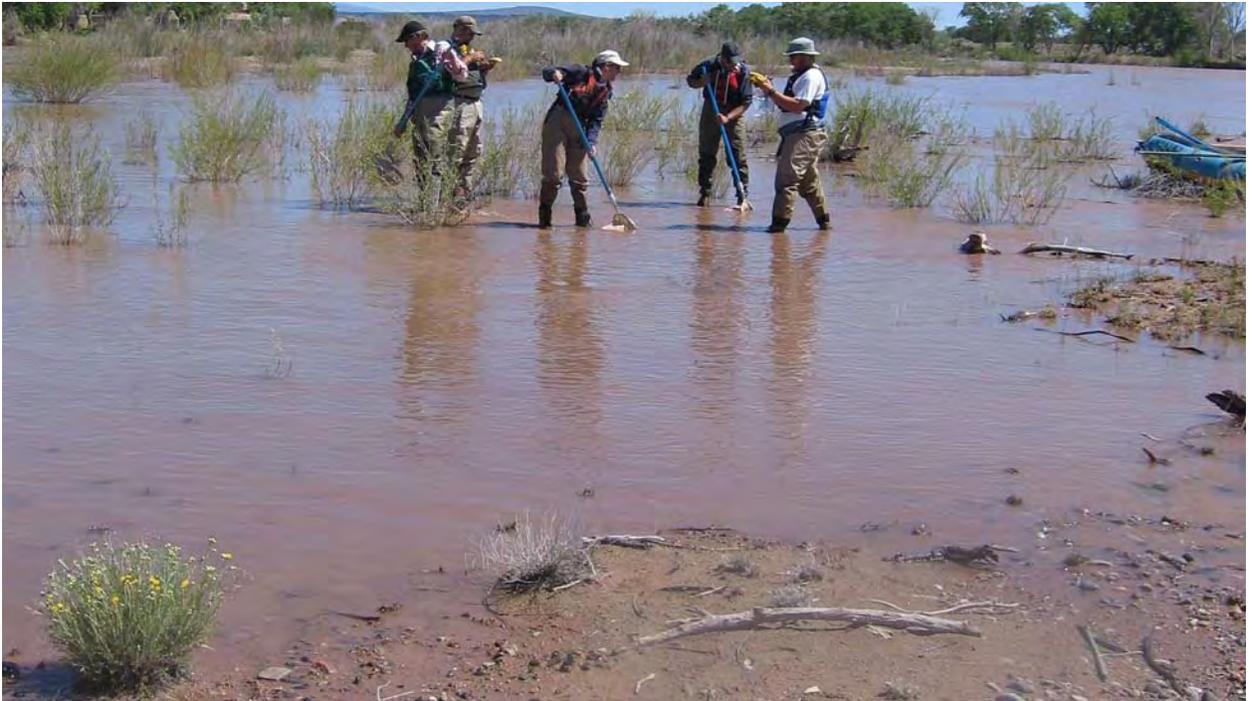
Figure 8. A shallow habitat shelf.

Shelf – a relatively flat inundated surface (may be sloped) (Figure 8).

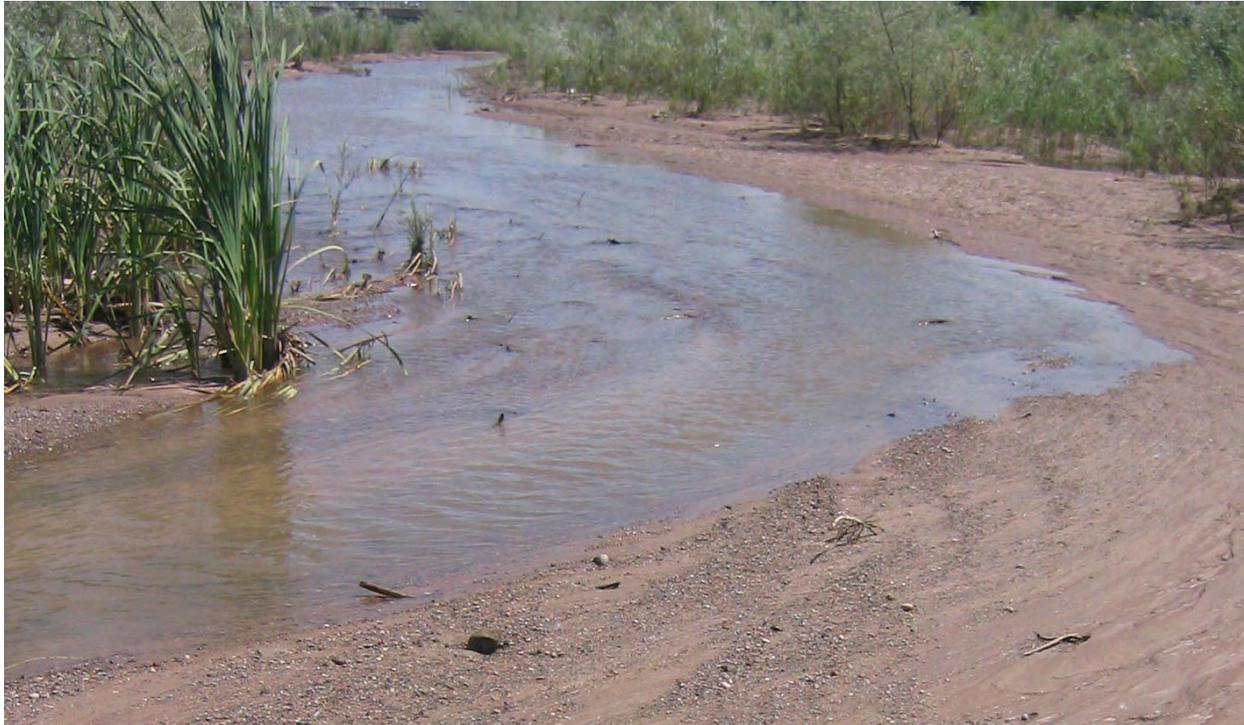
Figure 9. Flowing water in a side channel.

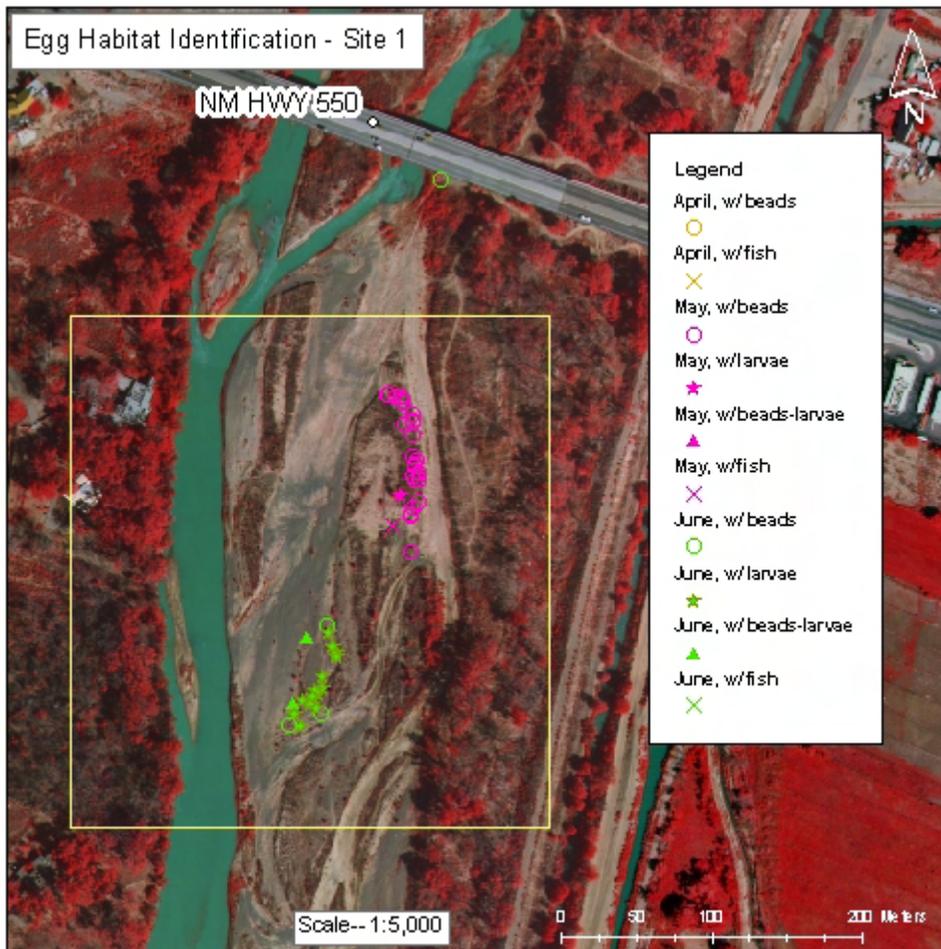
Figure 10: Sampling site #1.

Site 1 is located immediately downstream from the New Mexico State Highway 550 bridge crossing, in the east side braid-bar complex (Figure 5). This complex of islands and bars is separated by high flow channels that were flowing on all three data collection trips. Beads and larvae were collected in the May and June data collection trips (Table 6). Generally this complex of islands and side channels can be classified as a braid-bar complex with sporadic mid-channel bars. The beads and larvae collected in May were collected on a mid-channel bar, while the beads and larvae in the June trip were collected on the lower elevation Level-2 braid bar.

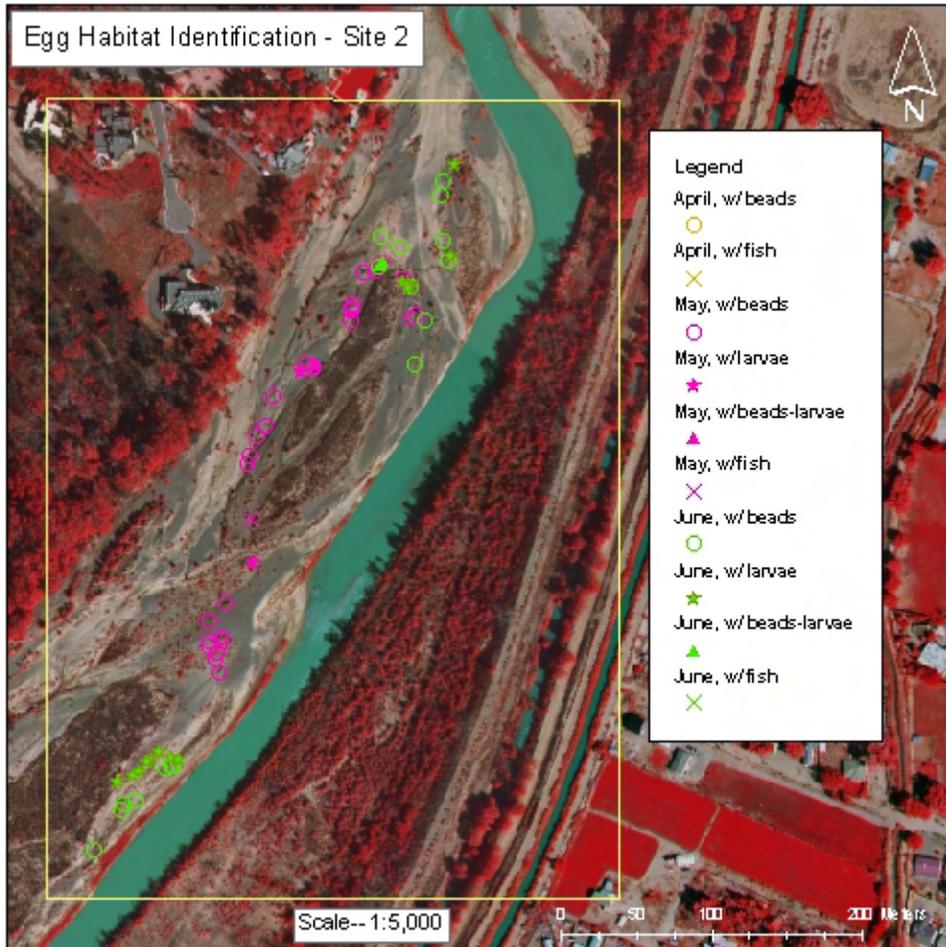
Figure 11: Sampling site #2.

Site 2 is located 1.2 kilometers downstream from the New Mexico State Highway 550 bridge crossing, in the west side braid-bar complex (Figure 6). This complex of islands and bars is separated by high flow channels that were flowing on all three data collection trips. Beads were collected at this site for both of the May and June trips (Table 7). About the same number of beads were found on both trips; however, significantly more larval fish were found in June. Generally this site is classified as a braid-bar complex with sporadic mid-channel bars, however, both the beads and larval fish were found only on the Level-2 braid bars.

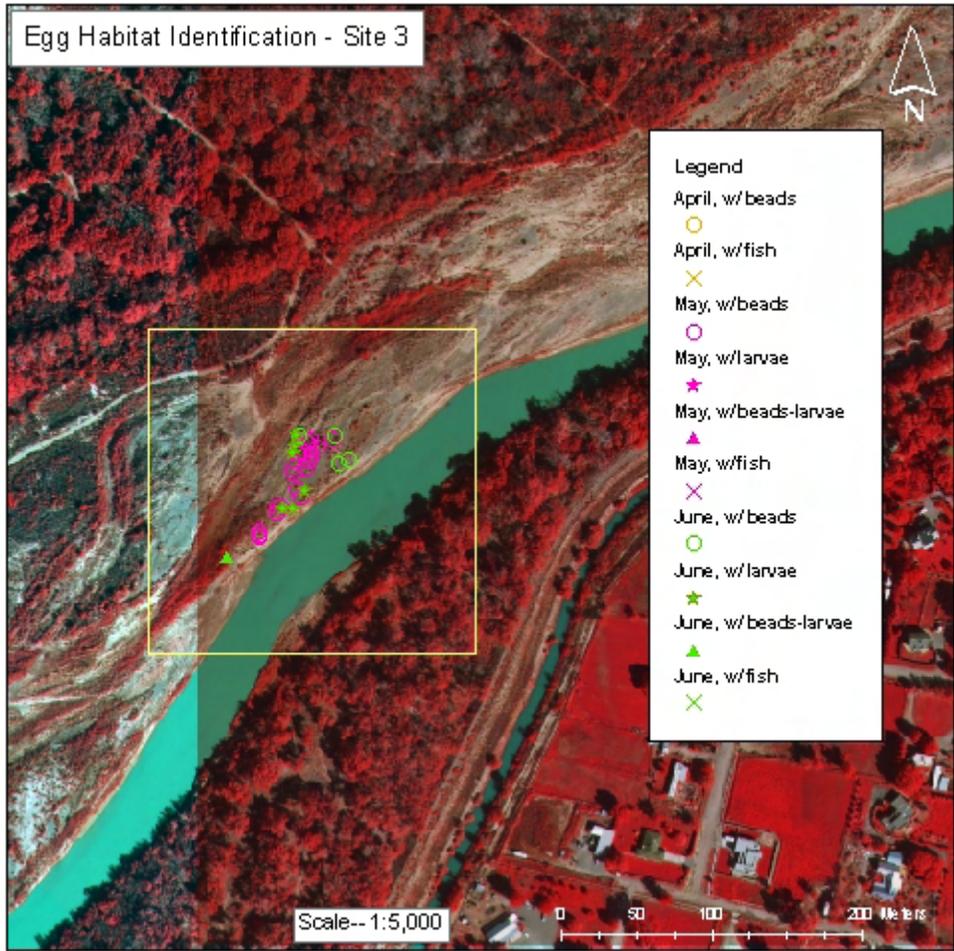
Figure 12: Sampling site #3.

Site 3 is located 3.1 kilometers downstream from the New Mexico State Highway 550 bridge crossing (Figure 7). This small complex of sparsely vegetated islands and bars is dissected by high flow channels that were flowing on all three data collection trips, however beads were only collected at this site on the May and June runs (Table 8). Generally this site is classified as a braid-bar complex with Level 1 and Level 2 braid bars and mid-channel bars. The beads collected in May were predominantly found on the small, deeper, mid-channel bar; however, no larval fish were observed at this site. Although some beads were found in the June run, almost 500 larval fish were observed. Although some beads were found in the June run, almost 500 larval fish were observed.

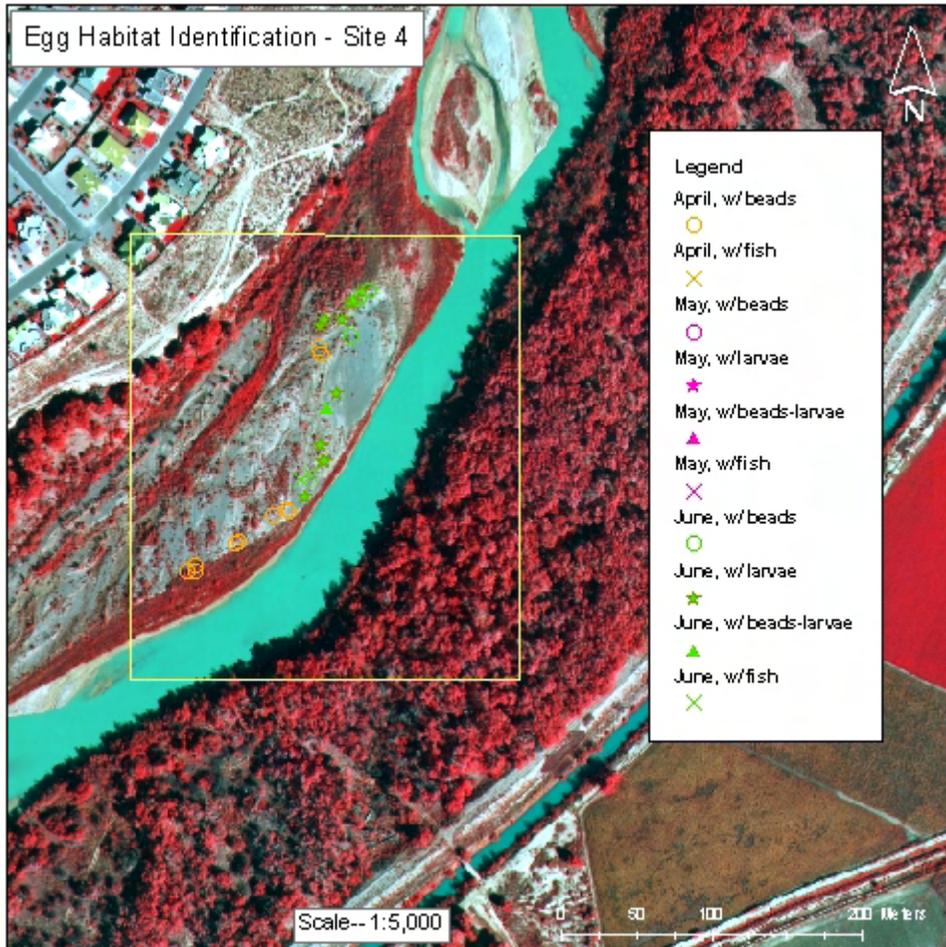
Figure 13: Sampling site #4.

Site 4 is located 4.2 kilometers downstream from the New Mexico State Highway 550 bridge crossing (Figure 8). This site is a partially dissected bank-attached bar with a variety of vegetation densities and small side channels flowing across the surface. This was the first site where beads were collected in the April run and all of them were collected within slightly vegetated areas on the bank attached bar (Table 9). The beads collected in June were also found in the sparsely vegetated regions of this bar, while the abundant larval fish were found in both the sparsely vegetated section and the section without vegetation.

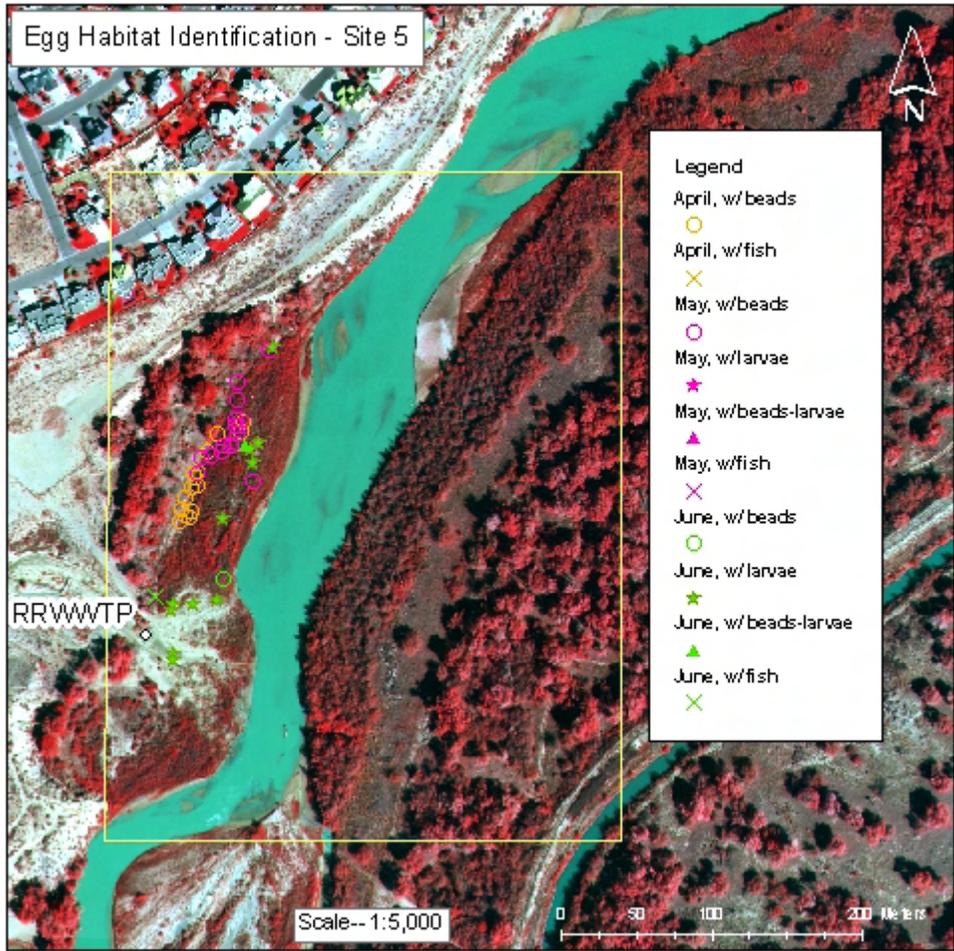
Figure 14: Sampling site #5.

Site 5 is located 6 kilometers downstream from the New Mexico State Highway 550 bridge crossing (Figure 9) at the confluence of Arroyo de la Barranca (Rio Rancho WWTP#3). This site is a bank-attached bar with dense vegetation. Beads were collected from this site in all runs, with all of the April collection occurring next to the historical floodplain (Figure 9). Beads and larval fish in May were found near the historical floodplain and near the middle of the bar, while beads and fish observed in June were almost exclusively found within the interior of the bar. The water depth data shows that the depth was greatest in April and decreased into May and subsequently into June, with June having the shallowest flooded surface (Table 10).

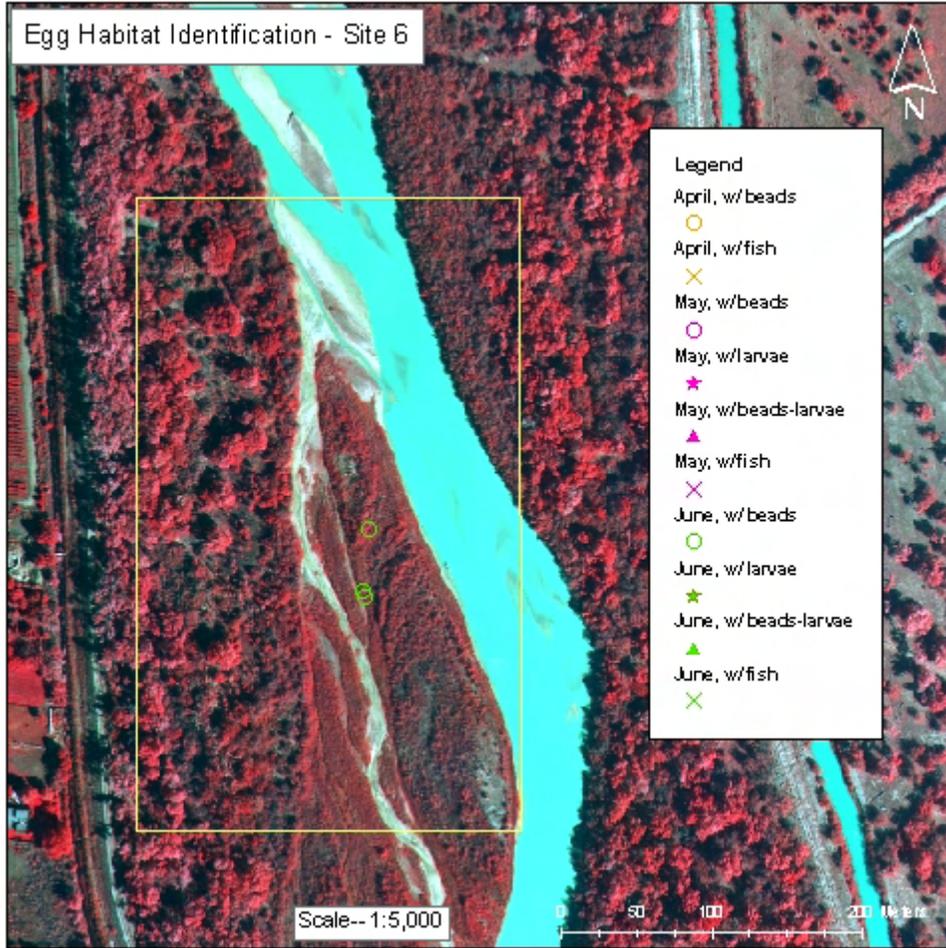
Figure 15: Sampling site #6.

Site 6 is located 8 kilometers downstream from the New Mexico State Highway 550 bridge crossing (Figure 10). This site is a mid channel bar with dense vegetation. Beads were collected from this site only in June (Table 11) along the upstream end of the bar.

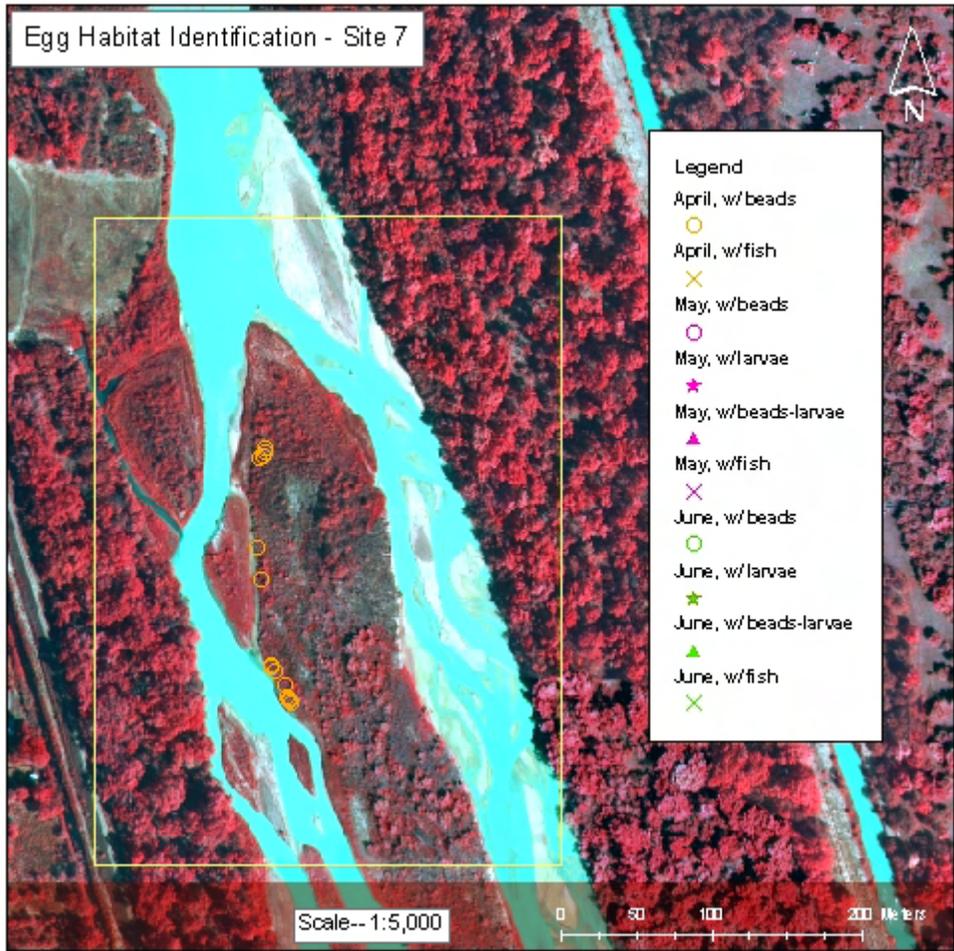
Figure 16: Sampling site #7.

Site 7 is located 9 kilometers downstream from the New Mexico State Highway 550 bridge crossing which is just downstream from the Harvey Jones Channel (Figure 11). This site is a mid channel bar with dense vegetation. Beads were collected from this site only in April (Table 12) and were collected only on the edge of the island. The Rio Rancho WWTP#2 discharges into the area within the box.

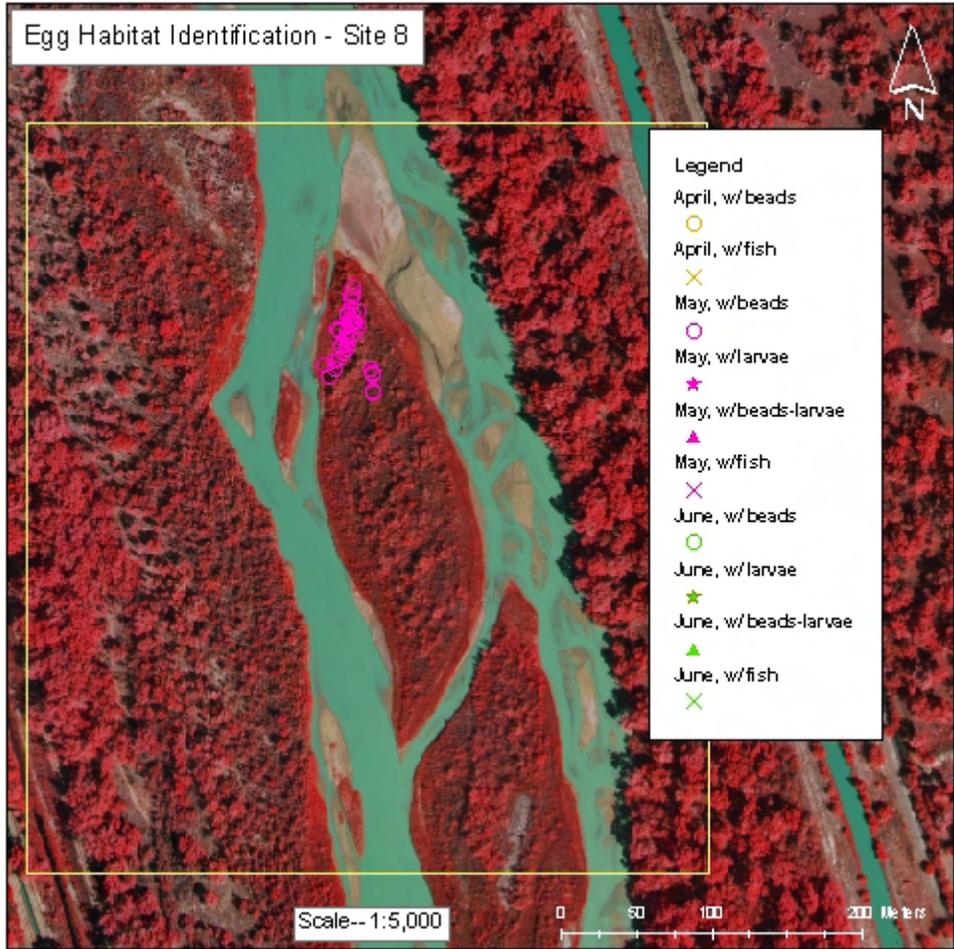
Figure 17: Sampling site #8.

Site 8 is located 10 kilometers downstream from the New Mexico State Highway 550 bridge crossing (Figure 12). This site is a densely vegetated mid channel bar. Beads were collected from this site in May and were concentrated at the head of the island. No larval fish were observed at this site (Table 13).

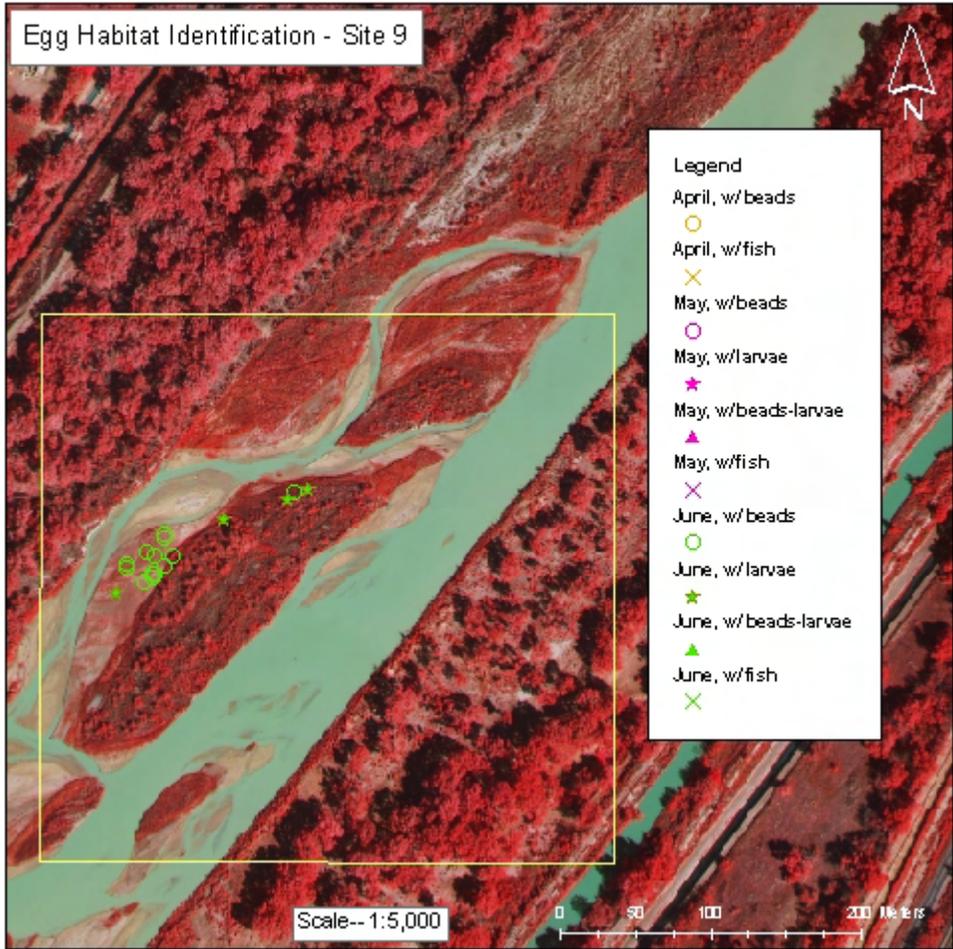
Figure 18: Sampling site #9.

Site 9 is located 12 kilometers downstream from the New Mexico State Highway 550 bridge crossing (Figure 13). This island contains both a Level 2 braid bar and a mid channel bar (densely vegetated portion). Although beads and larval fish were found on both surfaces, most of them were found on the Level 2 braid bar which was slightly deeper (Table 14).

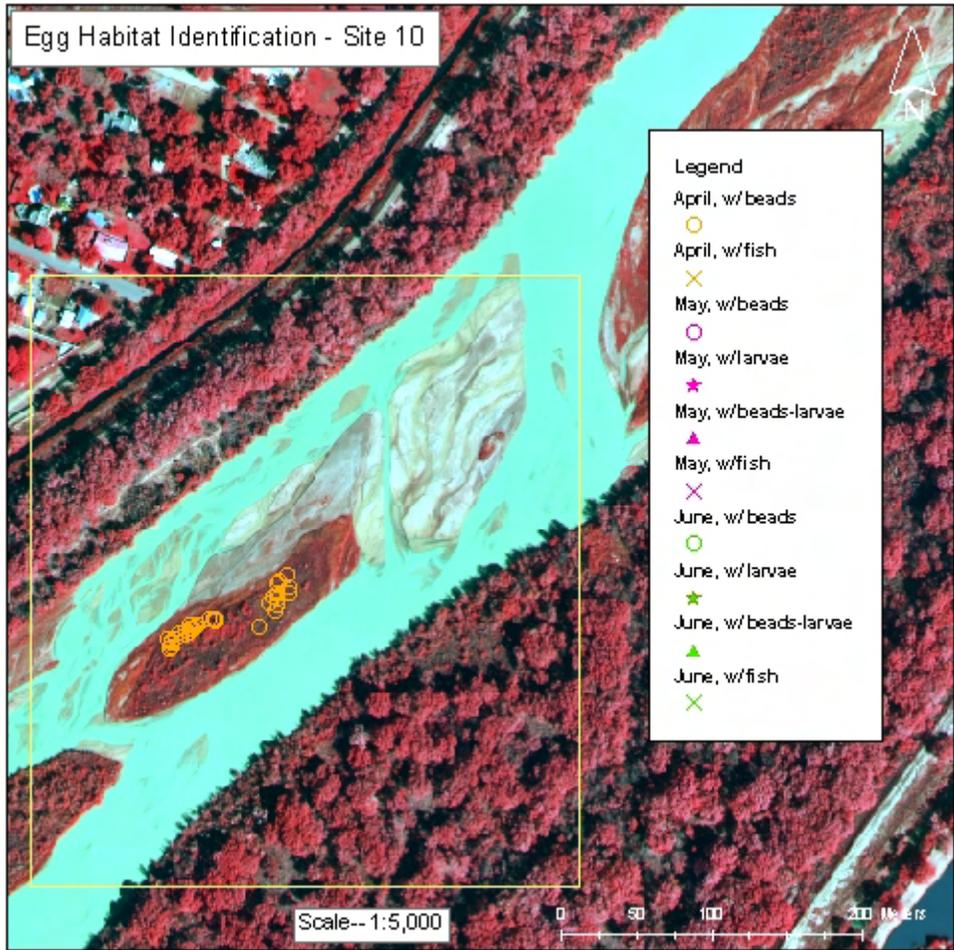
Figure 19: Sampling site #10.

Site 10 is located 13.5 kilometers downstream from the New Mexico State Highway 550 bridge crossing (Figure 14). Beads were only collected on this mid channel bar in only the April run (Table 15), and were collected throughout the island (Figure 14).

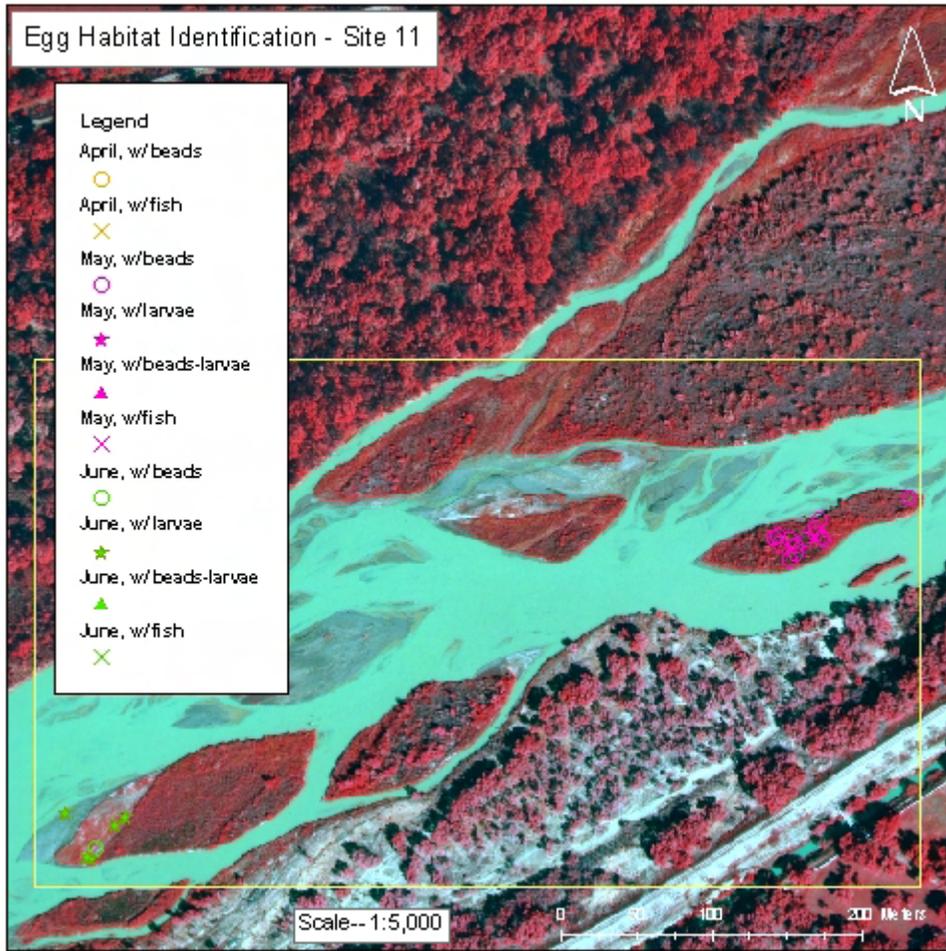
Figure 20: Sampling site #11.

Site 11 is located 15.7 kilometers downstream from the New Mexico State Highway 550 bridge crossing which is just downstream from the AMAFCA North Diversion Channel confluence (Figure 15). Data were collected during both the May run and the June run, but at separate locations. The May data collection occurred on a well vegetated mid channel bar and found only beads. In June, almost 170 larval fish were observed on a Level 2 braid bar with only one bead found (Table 16).

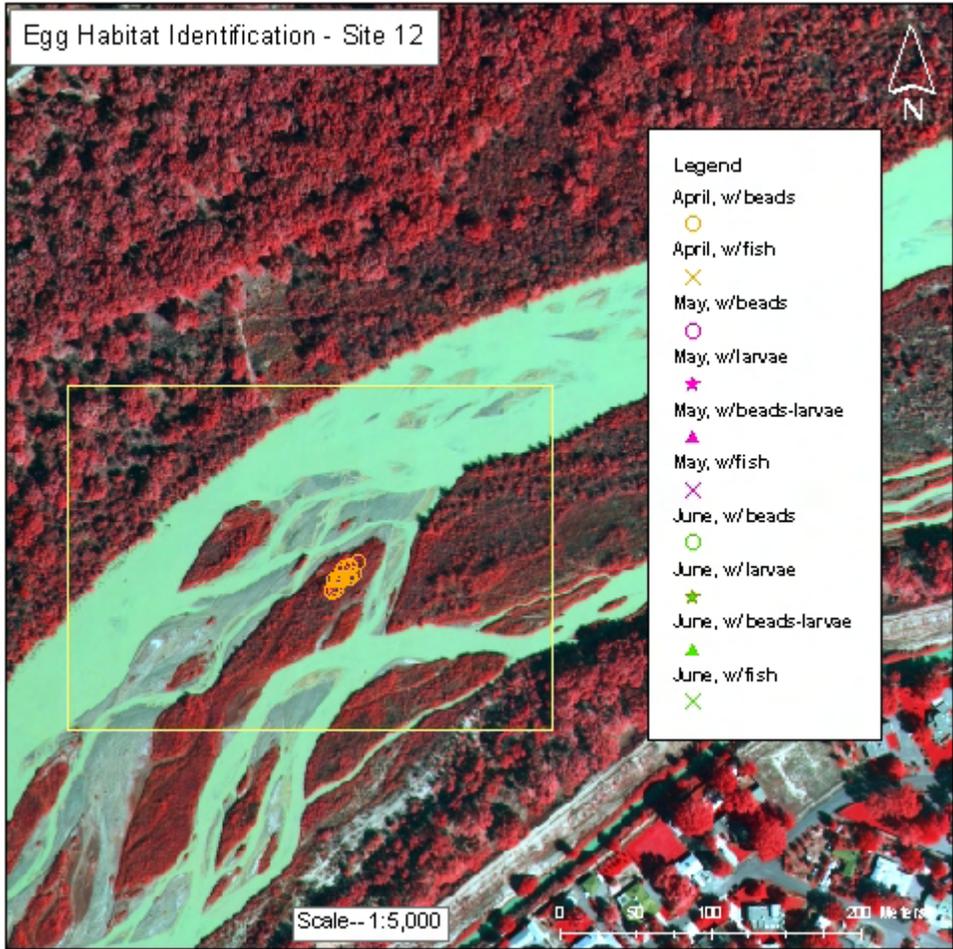
Figure 21: Sampling site #12.

Site 12 is located 17.6 kilometers downstream from the New Mexico State Highway 550 bridge crossing (Figure 16). This site contains data on the beads that were retained in the April run (Table 17). The portion of the island that retained the beads is the head of a well vegetated mid channel bar.

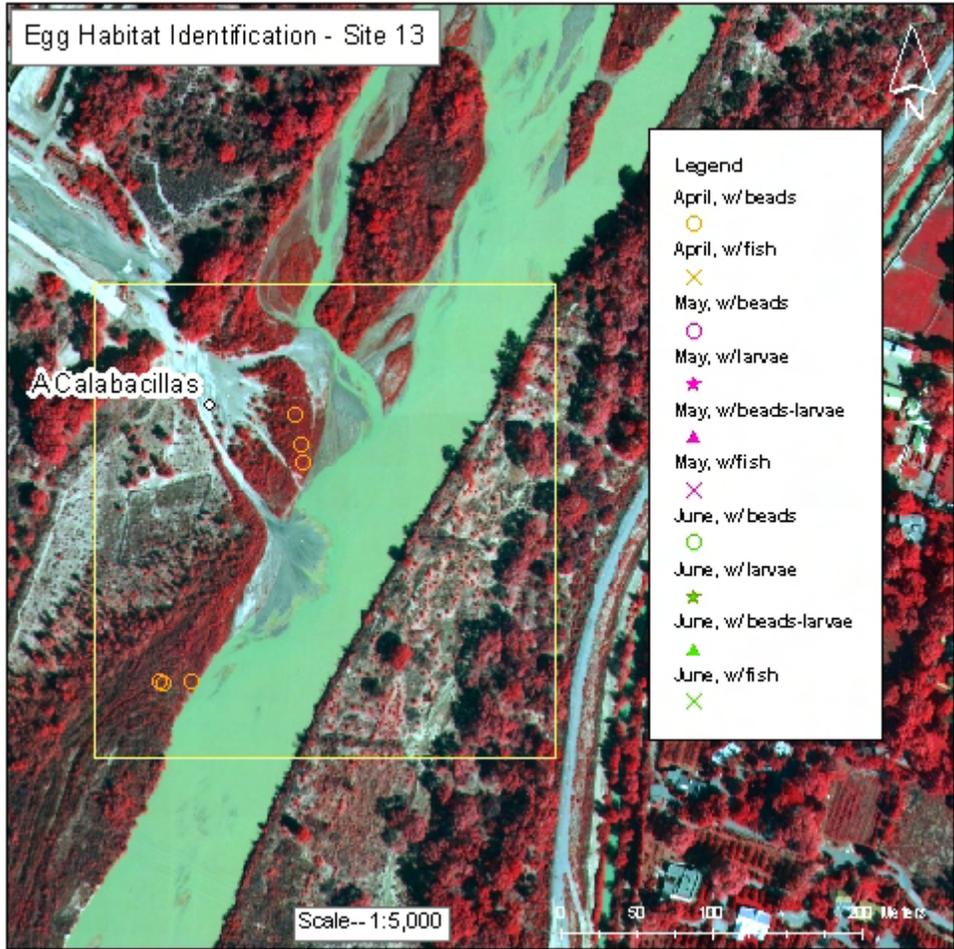
Figure 22: Sampling site #13.

Site 13 is located 19.8 kilometers downstream from the New Mexico State Highway 550 bridge crossing, located on the Arroyo Calabacillas fan (Figure 17). This site retained beads released in the April run, but did not retain any of the other released beads (Table 18). This is an arroyo fan which we categorize as a bank attached bar.

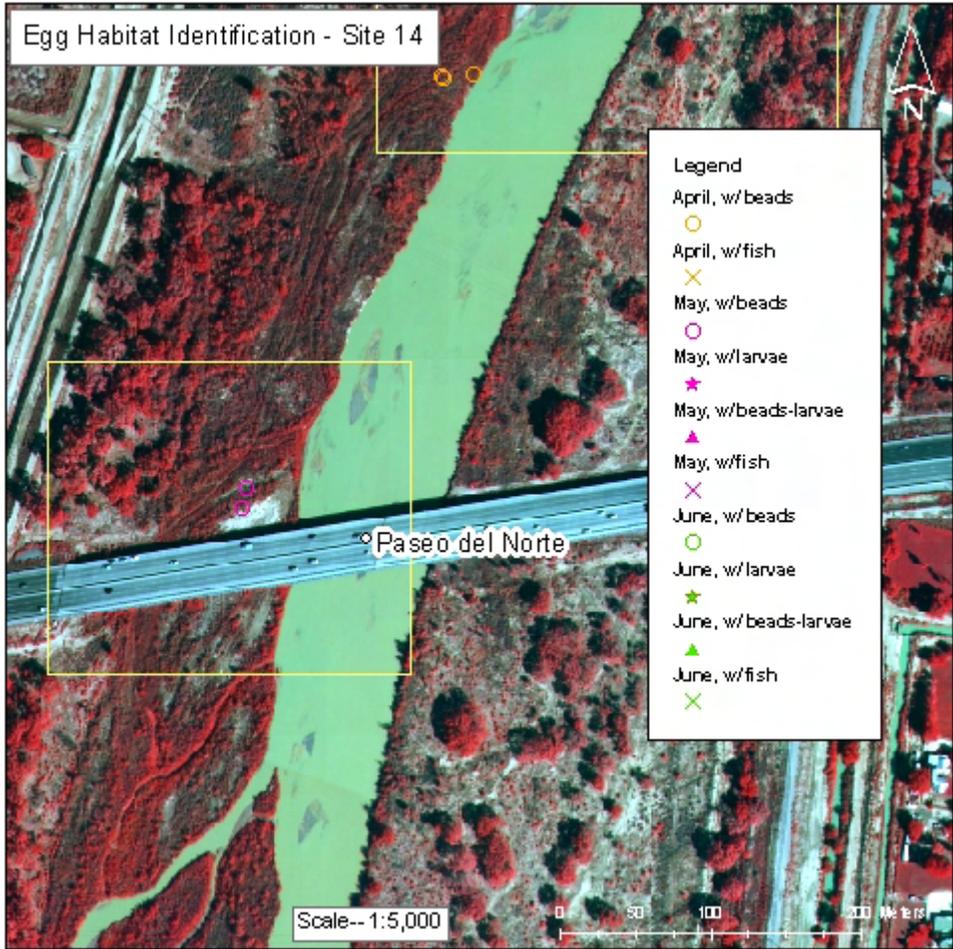
Figure 23: Sampling site #14.

Site 14 is located 19.8 kilometers downstream from the New Mexico State Highway 550 bridge crossing, located almost under the Paseo del Norte bridge (Figure 18). This site retained beads released in the May run on Arroyo Calabacillas fan which is described as a bank attached bar (Table 19).

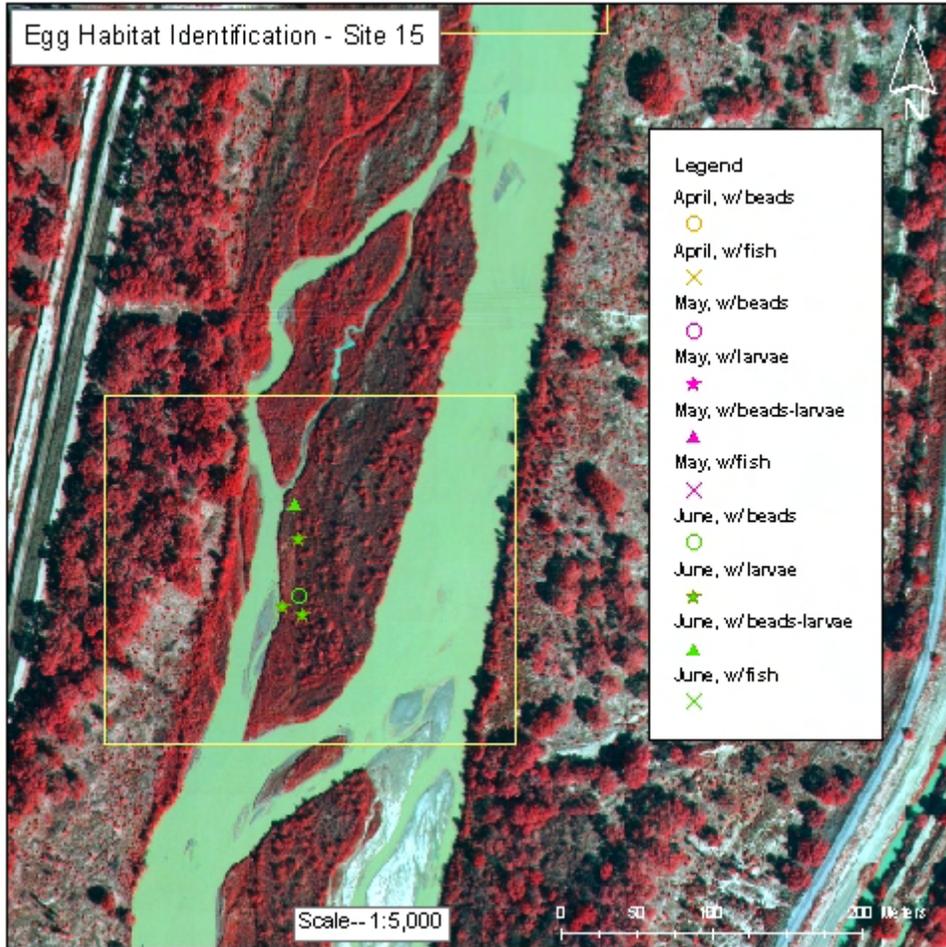
Figure 24: Sampling site #15.

Site 15 is located 20.3 kilometers downstream from the New Mexico State Highway 550 bridge crossing, located just downstream from the Paseo del Norte bridge (Figure 19). This site retained beads released in the June run on a bar best described along the edge of a densely vegetated mid channel bar (Table 20). Several larval fish were also observed on this bar.
