RECLAMATION

CONTRIBUTIONS TO DELISTING RIO GRANDE SILVERY MINNOW: EGG HABITAT IDENTIFICATION

PROGRESS REPORT-2005

January 2006

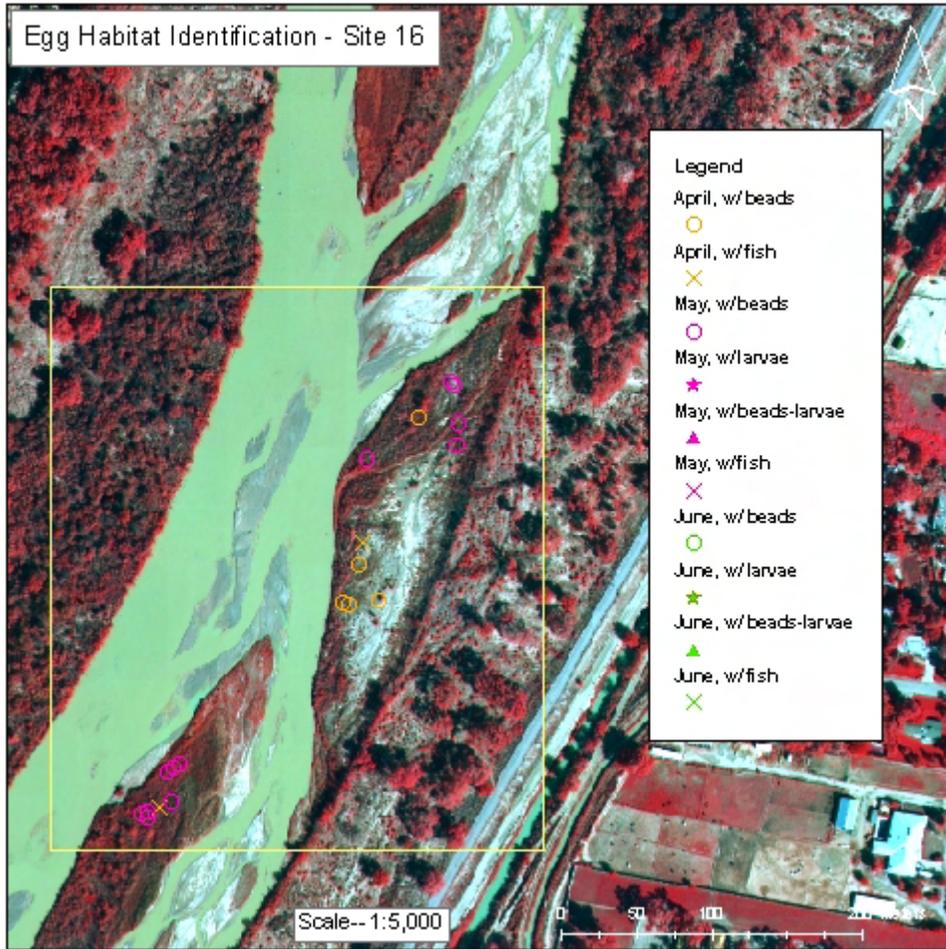
Figure 25: Sampling site #16.

Site 16 is located 21.2 kilometers downstream from the New Mexico State Highway 550 bridge crossing (Figure 20). This site has two macro features: a bank attached bar on the east side of the channel and a mid channel bar immediately downstream from the bank attached bar. Beads from both the April and May runs were retained on the bank attached bar while beads from only the May run were found on the mid-channel bar (Table 21).

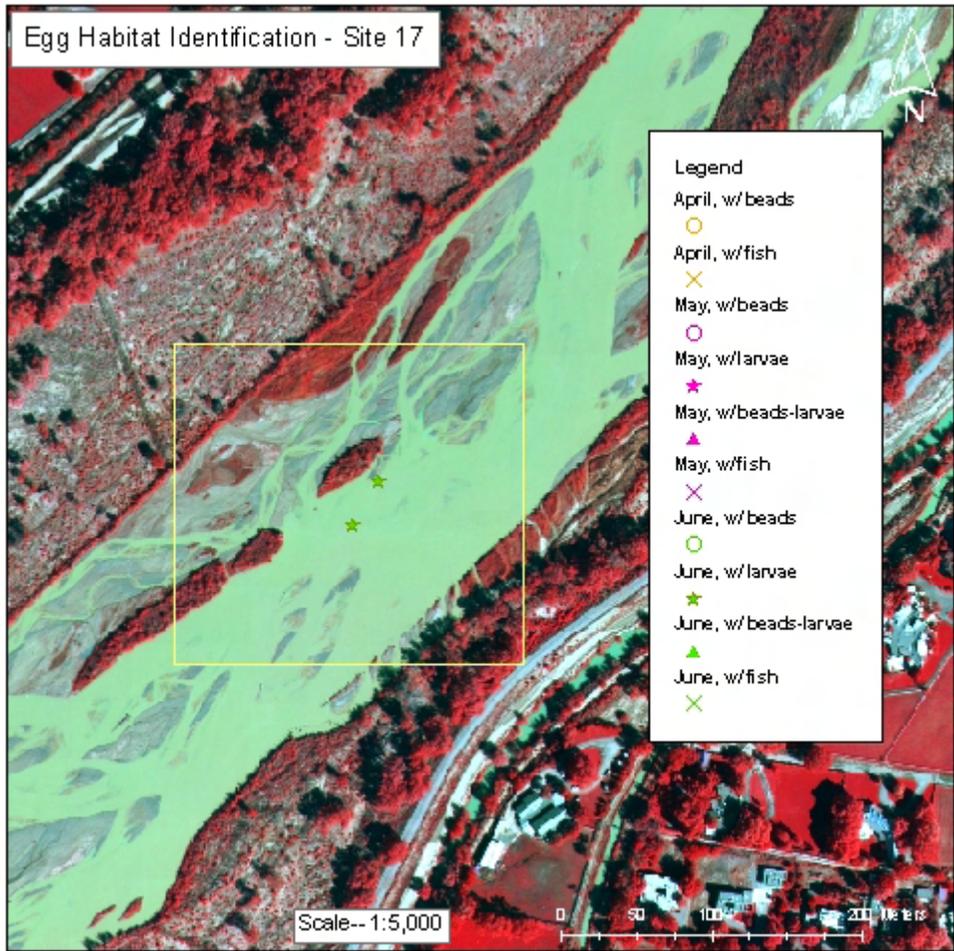
Figure 26: Sampling site #17.

Site 17 is located 22 kilometers downstream from the New Mexico State Highway 550 bridge crossing (Figure 21). Although no beads were collected at this site, numerous larval fish were observed (Table 22). The fish were found on the downstream side of an active linguoid bar.

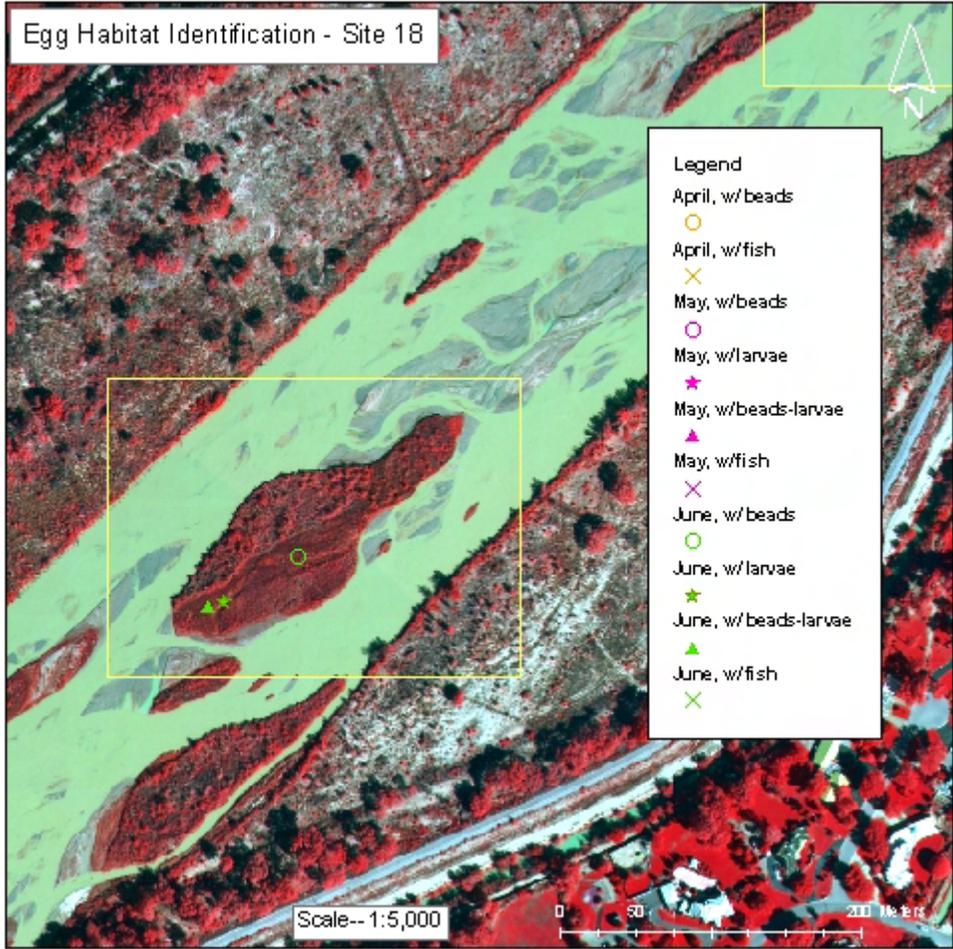
Figure 27: Sampling site #18.

Site 18 is located 22.6 kilometers downstream from the New Mexico State Highway 550 bridge crossing (Figure 22). This island is a mid channel bar with dense vegetation and a Level 2 braid bar with younger vegetation; in the June data collection run, the mid channel bar section was no longer inundated. On the Level 2 bar section, which coincides with a lower elevation, 2 beads were found with several larval fish observations (Table 23).

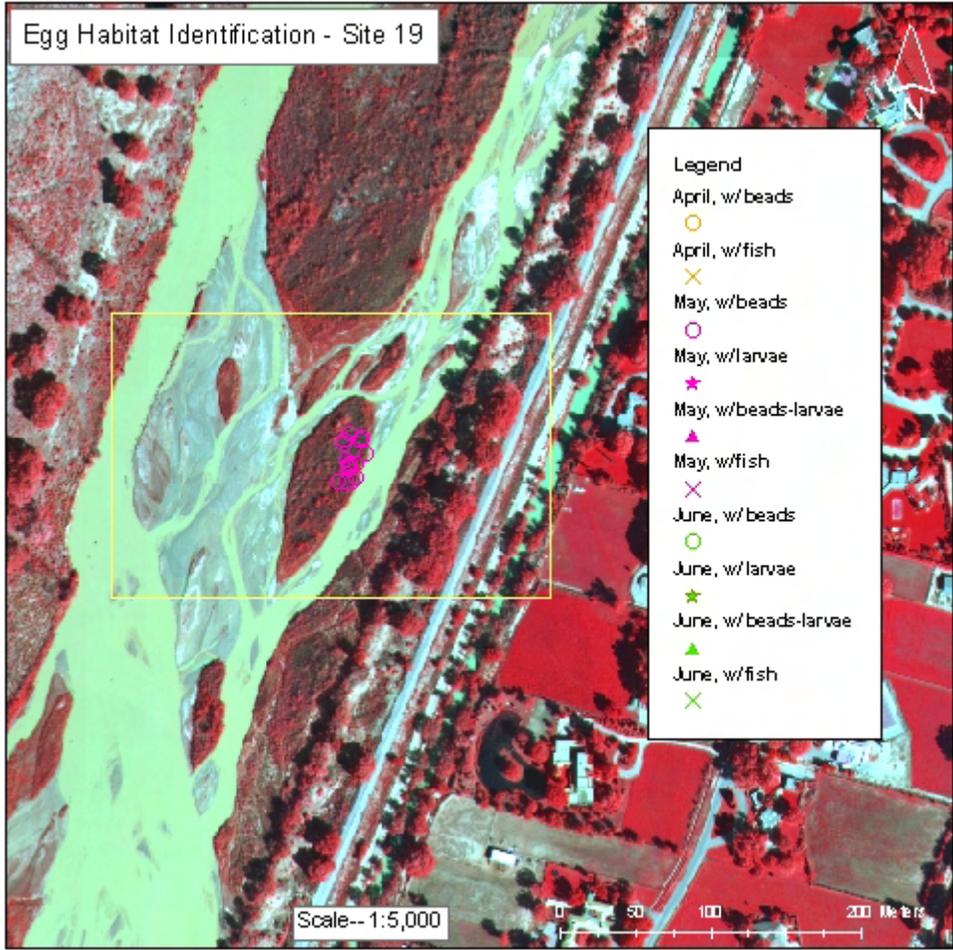
Figure 28: Sampling site #19.

Site 19 is located 23.7 kilometers downstream from the New Mexico State Highway 550 bridge crossing (Figure 23). This small island is part of a larger complex of islands which are Level 2 braid bars. Only beads from the May run were collected on this bar (Table 24).

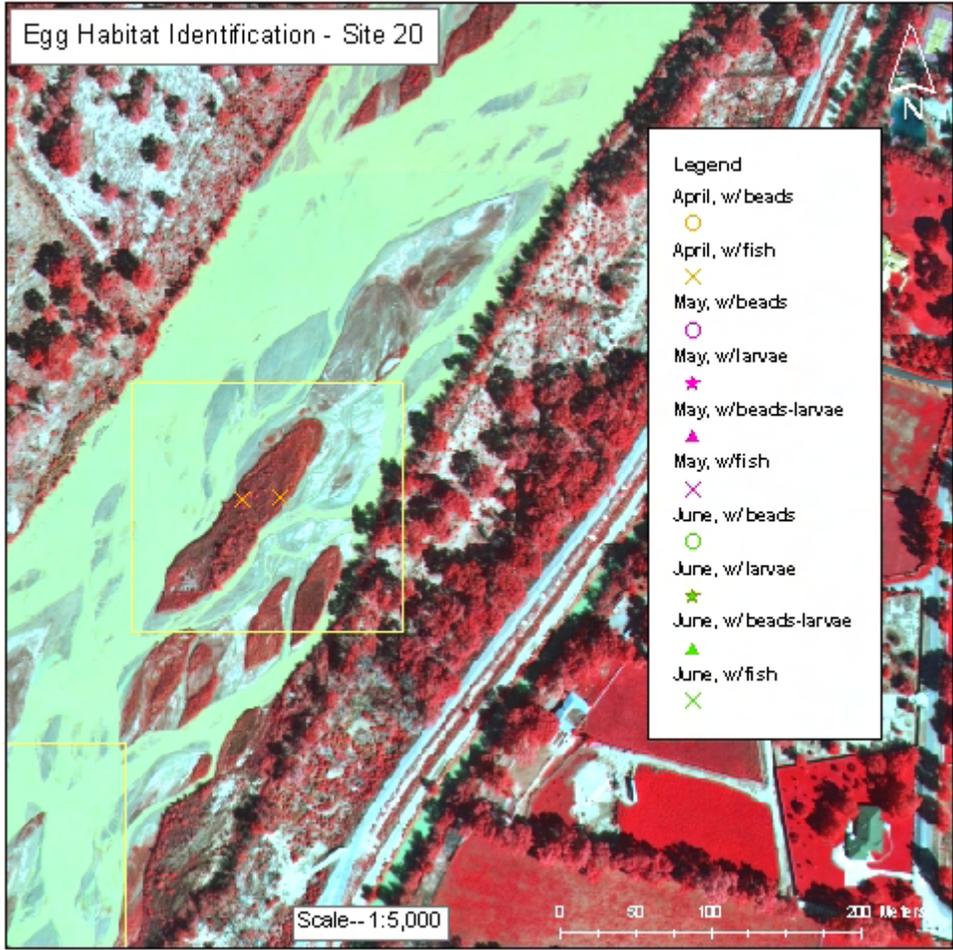
Figure 29: Sampling site #20.

Site 20 is located 24.7 kilometers downstream from the New Mexico State Highway 550 bridge crossing (Figure 24). At this location two fish were collected, but no beads. The fish were captured on the edge of the mid channel bar (Table 25).

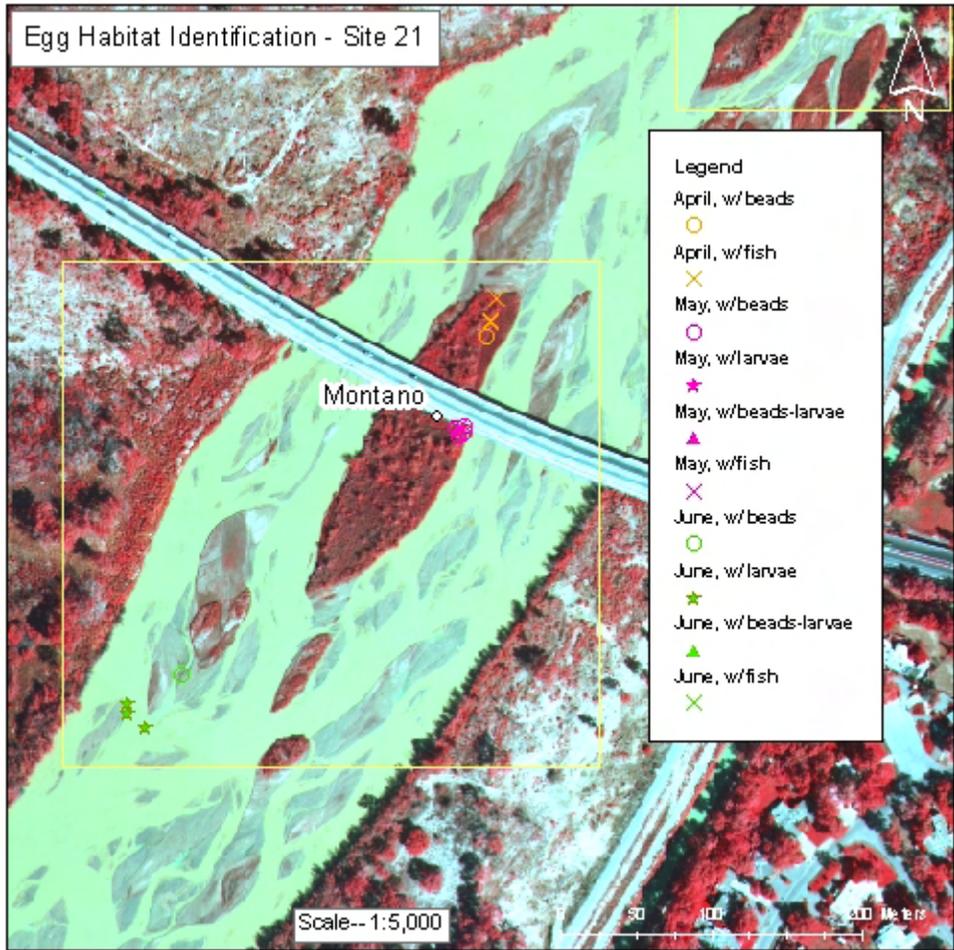
Figure 30: Sampling site #21.

Site 21 is located 25 kilometers downstream from the New Mexico State Highway 550 bridge crossing at the Montano Blvd. bridge crossing (Figure 25). Two collection locations exist at this location: a mid channel bar and a braid bar complex that contains both a linguoid bar and a Level 1 braid bar (Table 26). The relatively large mid channel bar formed under the Montano Blvd bridge retained beads during both the April and May runs; fish were also collected on this bar. The Level 1 braid bar retained a bead, while at the linguoid bar many larval fish were observed.

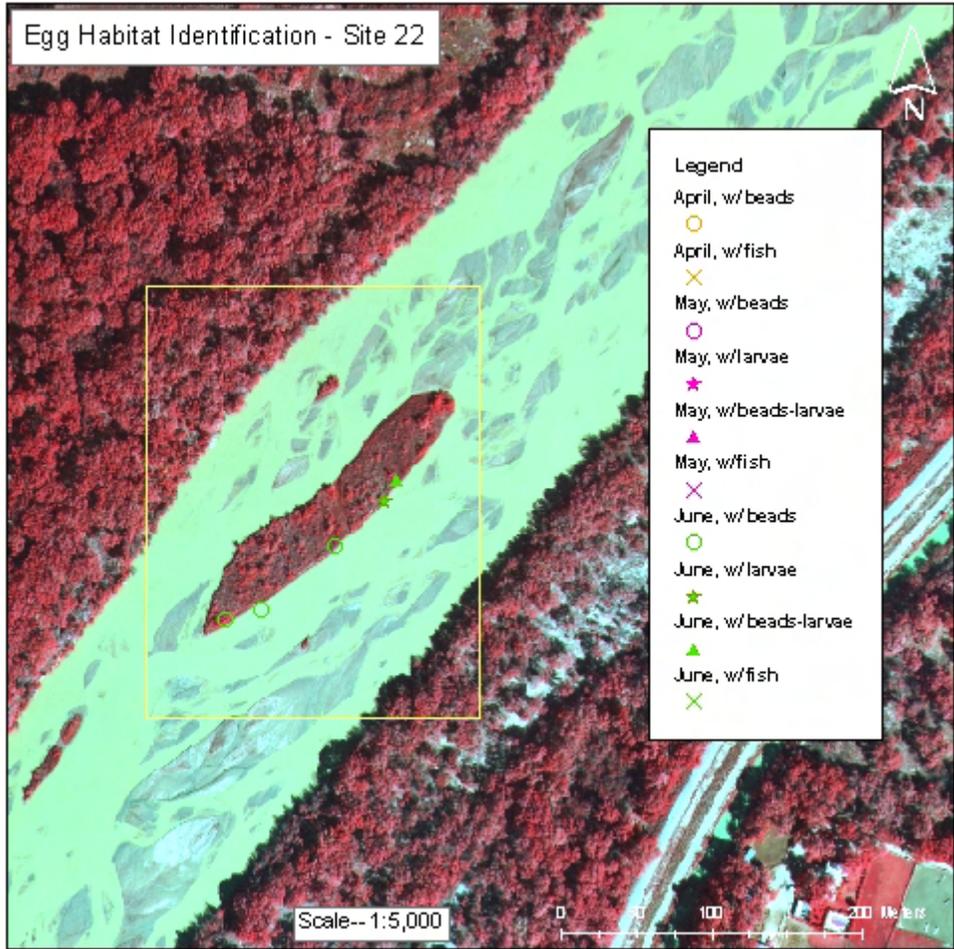
Figure 31: Sampling site #22.

Site 22 is located 25.4 kilometers downstream from the New Mexico State Highway 550 bridge crossing (Figure 26). This small island, a mid channel bar, retained beads along its edge during the June flows (the lowest flows sampled) but also appears to be providing edge habitat for larval fish (Table 27). A bead was also found just off the bankline on a linguoid bar.

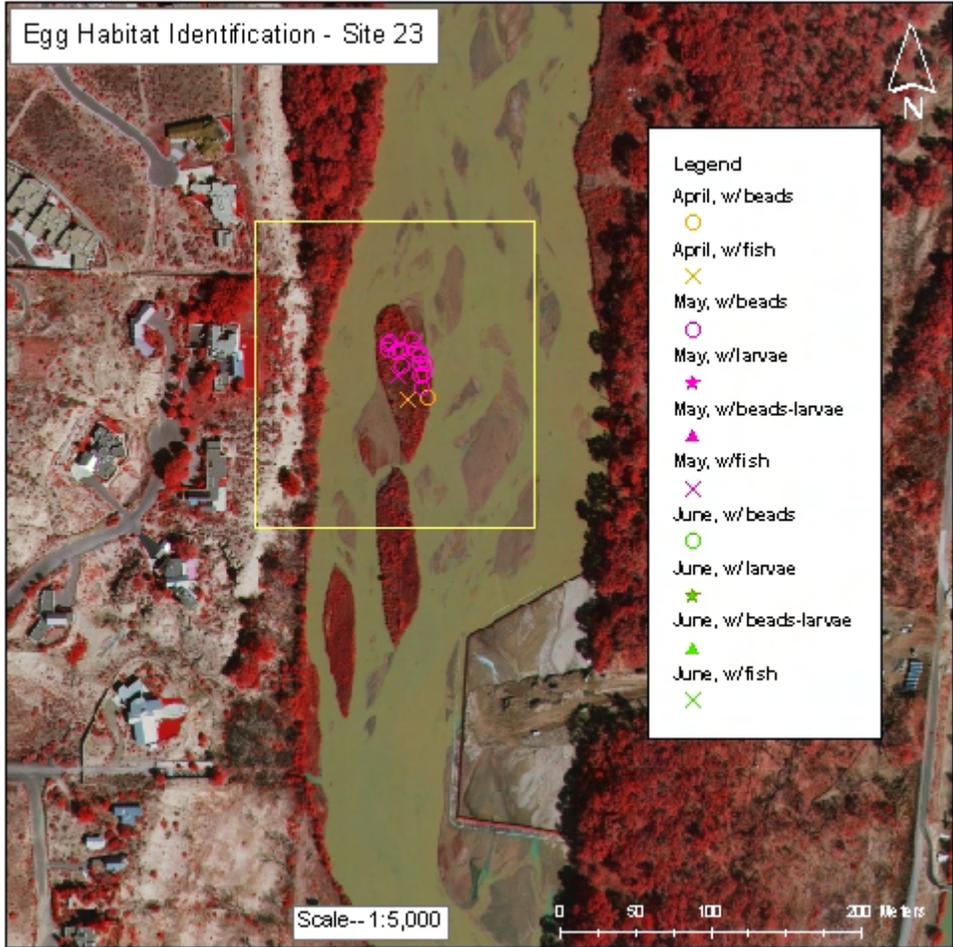
Figure 32: Sampling site #23.

Site 23 is located 26.3 kilometers downstream from the New Mexico State Highway 550 bridge crossing (Figure 23) near the City of Albuquerque’s “drinking water project”. This bar is a mid channel bar and retained beads in both the April and May runs (Table 28), but not in the June run. The retained April bead (and captured fish) were both found near the downstream end of the island, while the June beads were found in the middle of the island.

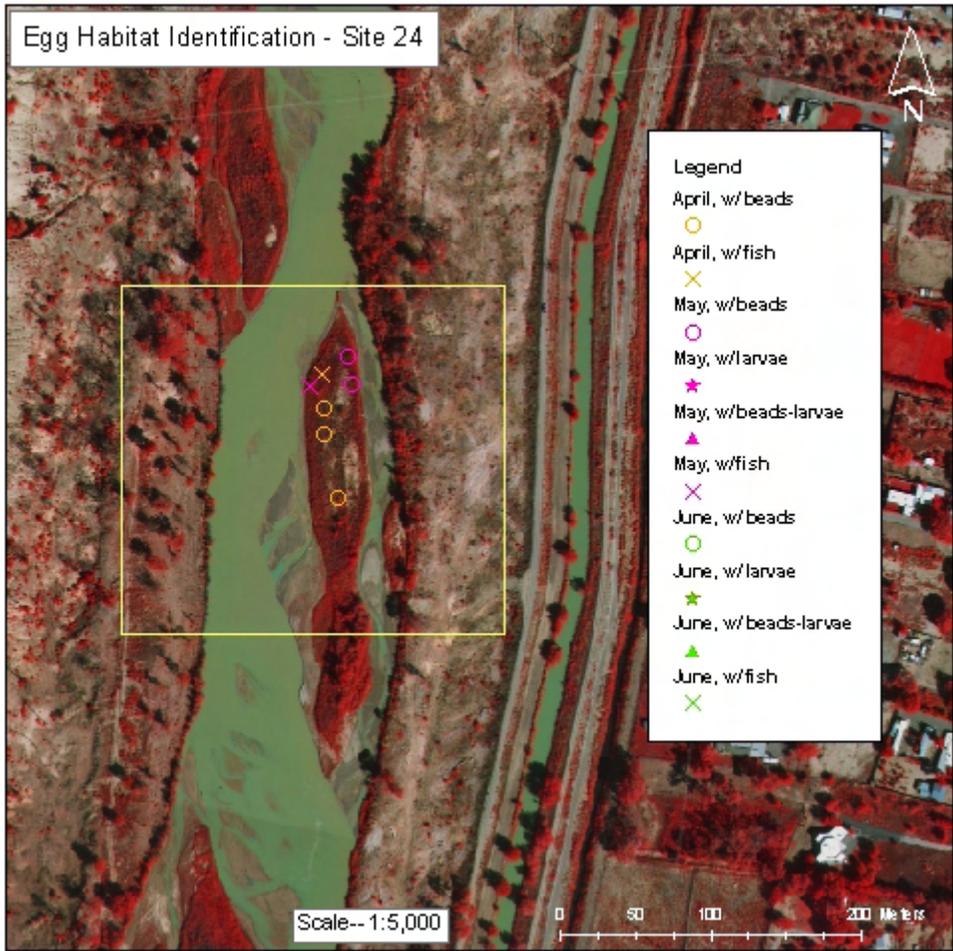
Figure 33: Sampling site #24.

Site 23 is located 27.9 kilometers downstream from the New Mexico State Highway 550 bridge crossing (Figure 28), just upstream from where I-40 crosses the river. Although this mid channel bar retained beads in both the April and May runs (Table 29), it was dry in the June run. As found at other sites, the beads collected in April were further downstream from the collection locations in May. Also noticeable at this site is that the water level was significantly higher in April than in May.

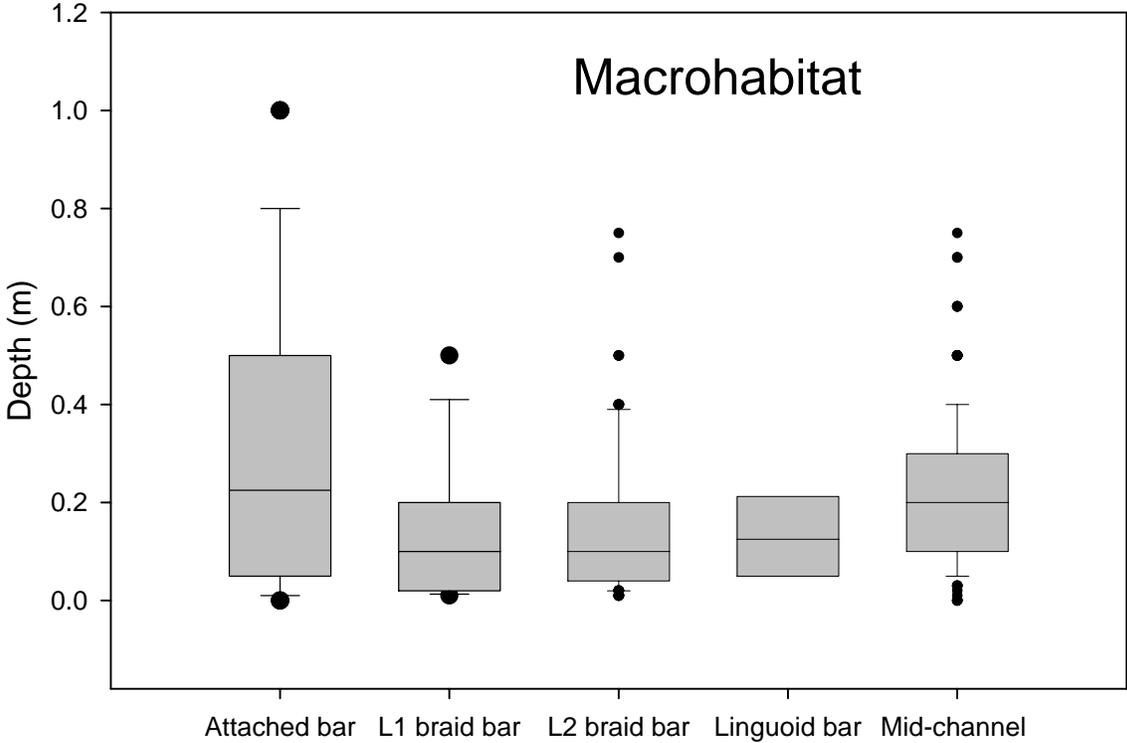
Figure 34: Depth distribution of beads recovered on macro-habitat features.

The variation in bar types capturing beads as a function of flow levels indicates a range of macro-habitat features that provide nursery habitat. Although both beads and larval fish were collected from each type of bar discussed in this report, some of the bars were more effective. Mid-channel bars and Level 2 braid bars appeared to be better at capturing the drifting gellan beads and presumably the silvery minnow eggs (Table 1); while the bank attached bars appear to be more favored by larval fish. Although the bank attached bars typically were deeper than the other bar types, the difference was not statistically significant (Figure 29). Also noticed, the bank attached bars behaved more like a floodplain, such that water flowed generally in one direction onto the surface with drainage (a slow flowing side channel) developing along the bankline/historic floodplain. Based solely on bar type and surface elevations within the active channel, nursery habitat availability could be quantified with a physical model based on cross section data and river discharge.

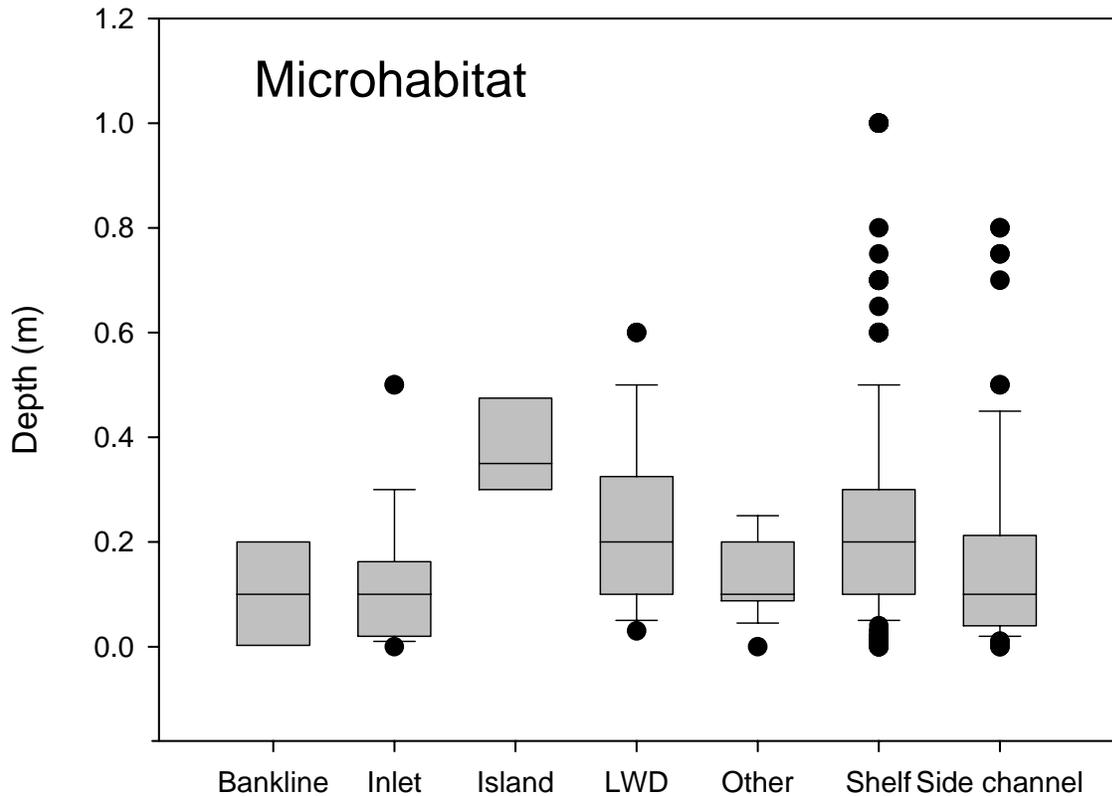
Figure 35: Depth distribution of beads recovered on micro-habitat features.

The observed micro-habitat varied significantly with surface characteristics and flow patterns on the bar surfaces. The high occurrence of beads in the shelf habitats (68% of beads) and ranges of depths for shelves suggests that these features provide some of the best conditions for capturing silvery minnow eggs out of the current and retaining them. Relatively few beads were collected in the other micro habitats identified in this study (Table 5). As all of these micro-features tend to have shallow water depths (11-25 cm depth), water depth, although commonly used, does not appear to be the defining physical feature capturing or retaining beads or eggs (Figure 30).
