## Calendar Year 2010 Report to the Rio Grande Compact Commission

U. S. Department of the Interior  
Bureau of Reclamation  
Albuquerque Area Office  
Albuquerque, New Mexico

March 2011

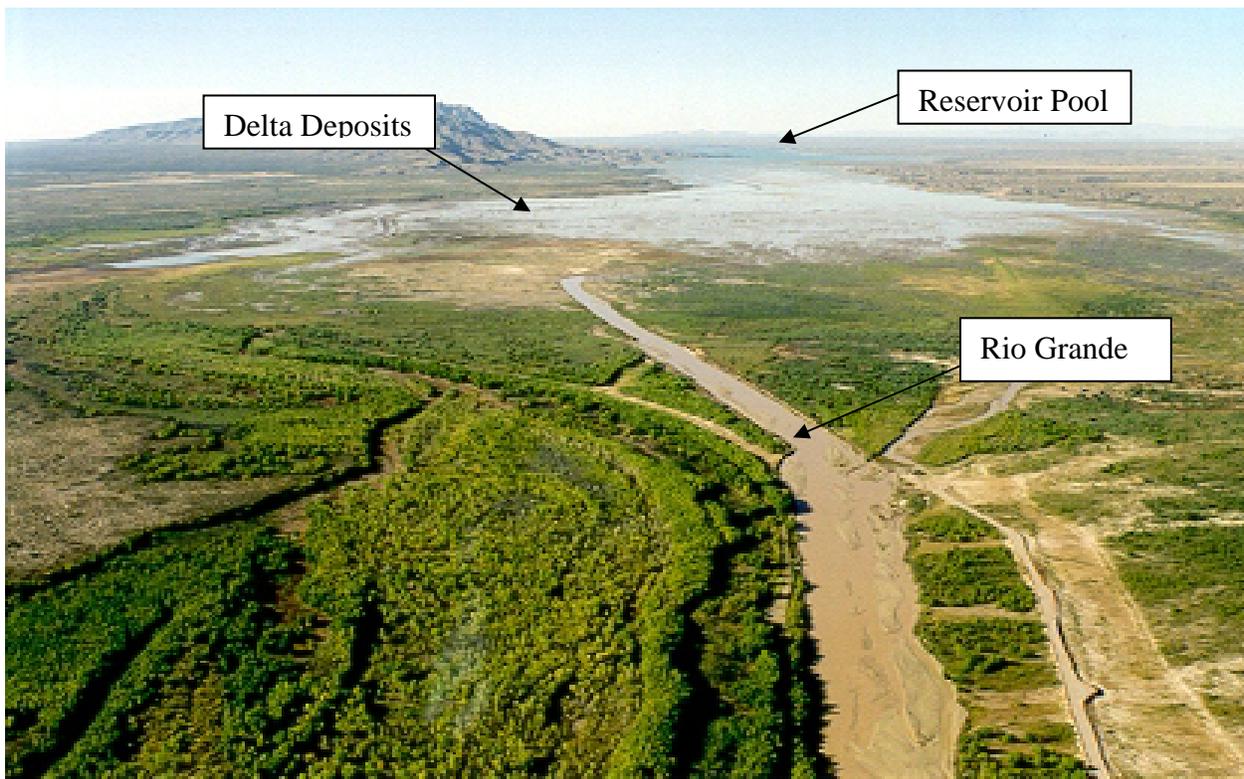
Photo 1: Headwaters of Elephant Butte Reservoir, prior to construction of the Temporary Channel (1998)

- Temporary Channel 2002: Constructed from 2003 to 2004, a length of 11 miles, it begins at Nogal Canyon (RM 51.5) and ends just downstream of the Elephant Butte Narrows (RM 41). The average width for this reach is 150 feet.
- Temporary Channel 2004: Construction began in 2004, and approximately 3 miles have been constructed to date. This channel begins at RM 41 and will be extended downstream as needed in response to future retreat of the reservoir. The average width for this reach is 75 feet.

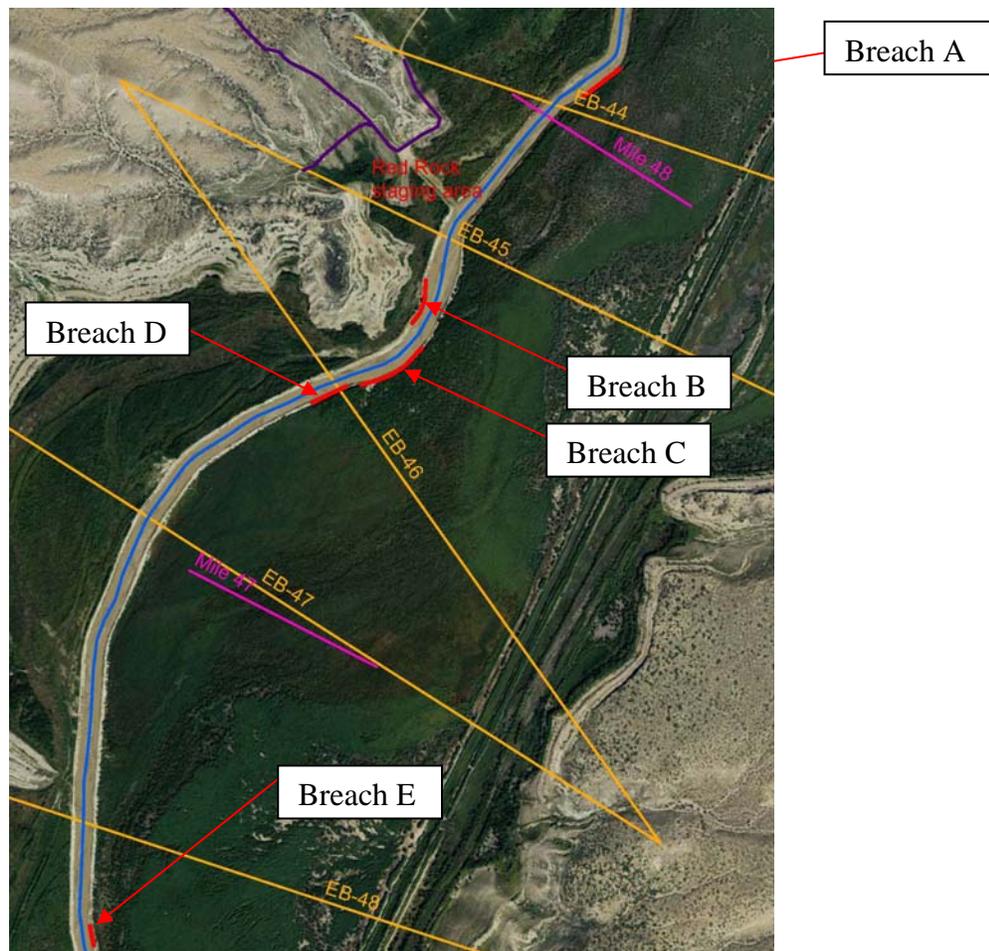
Photo 2: Aerial map showing plotted locations of 2010 breaches (November 2010, Holste)

The majority of work performed in 2010 was on the Temporary Channel 2002 reach within the vicinity of the Red Rock Staging Area. A review of the Temporary Channel was conducted by Reclamation personnel at the end of July 2010. Based on visual observations five breaches were identified as needing repair between EB-45 and EB-49 (Photo 2). Breach A is an outflow breach and is located upstream of the Red Rock Staging Area at EB-44. The breach is located along the east side of the channel and is approximately 500 feet long. Breaches B and C are both located downstream of the Red Rock Staging Area between range lines EB-45 and EB 46. Breach B is an outflow breach located on the west side of the channel and is also approximately 500 feet long. Breach C is an outflow breach located on the east side of the channel and is approximately 700 feet long. Breach D is an outflow breach located downstream of the Red Rock Staging Area starting at range line EB-46. It is located on the east side of the channel and is approximately

400 feet in length. The last breach is Breach E. It is a return flow breach located downstream of the Red Rock Staging Area between range lines EB-48 and EB-49. It is located on the east side of the channel and is approximately 200 feet in length.

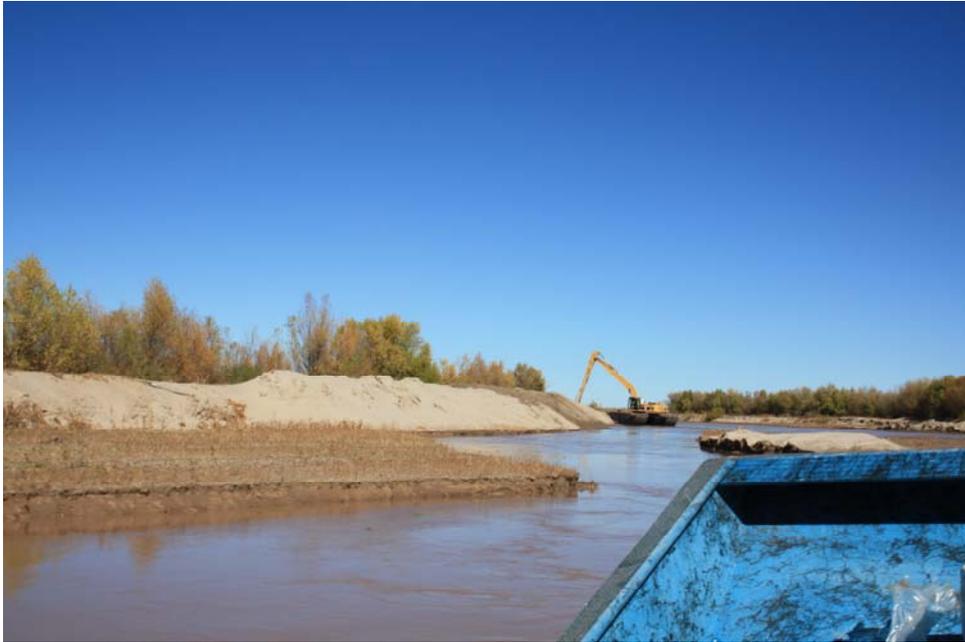
Photo 3: Amphibious excavator working on Breach B south of the Red Rock Staging Area (November 2010, Holste)

The Socorro Field Division began mobilization of equipment and access road maintenance on October 12, 2010. Dredging of the channel and berm repair began on October 25, 2010. Initial repairs of the larger outflow breaches were completed in early December 2010. However the repaired berms have not proven stable as they are composed of fine cohesionless sand. The Socorro Field Division monitors and repairs the berms, as they are continually eroding.

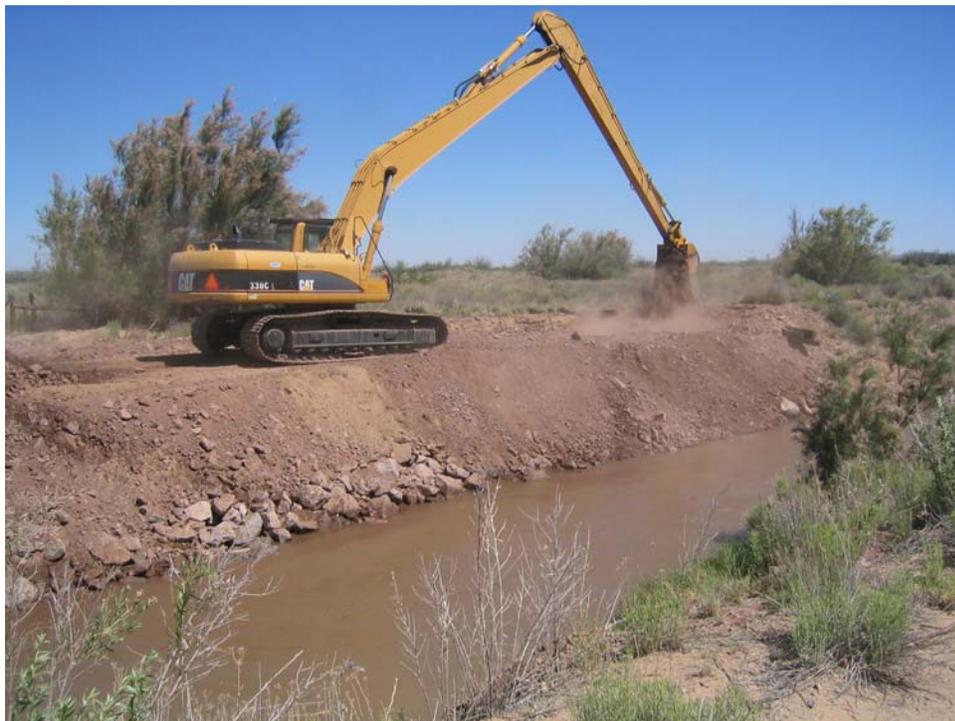
Photo 4: Reclamation construction crews repairing washout at Drain Unit 7 Extension, near the north end of the Ladd Gordon Waterfowl Complex (June 2010, Weems)

providing for the use of \$125,000 of Agreement funds for completion of critical safety rehabilitation work identified by Reclamation and NMISC. Work at Drain Unit 7 Extension began in late May 2010 and was completed in November. Repairs included fixing washouts in the access road and drain bankline, replacing the gate at the north end of the Ladd Gordon Waterfowl Complex, repair of an existing weir, and mowing and blading roads to improve accessibility. Reclamation provided inspection and administration for the work.

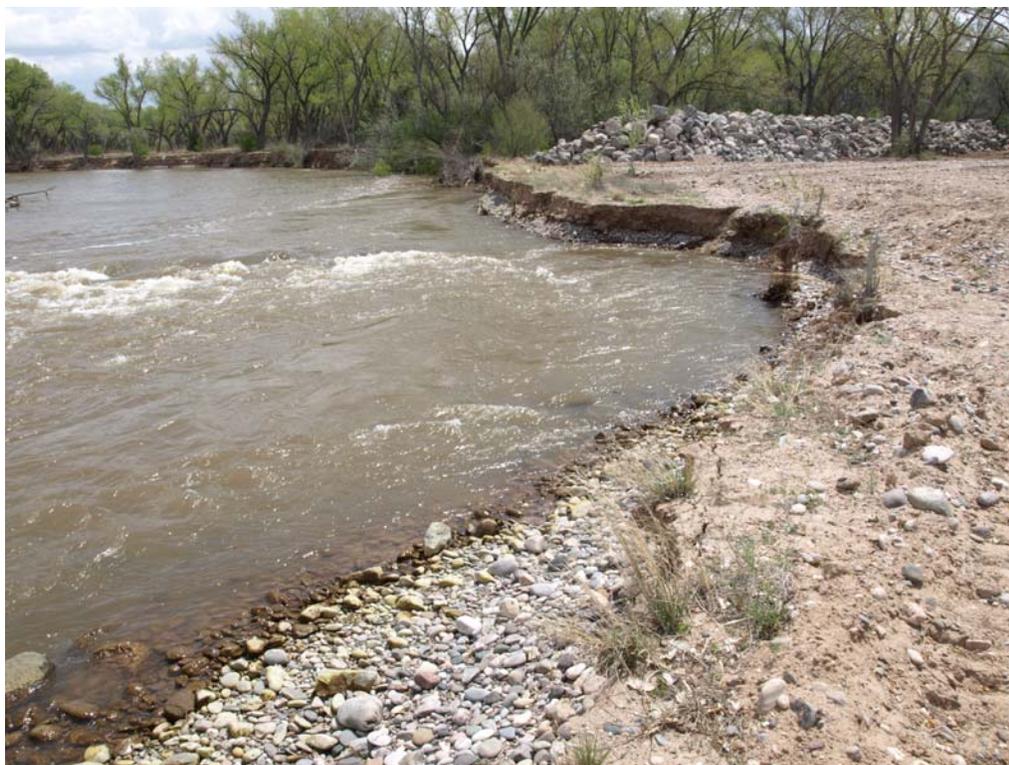
Photo 5: San Ildefonso bankline erosion and riprap windrow (May 2010, Holste)

This priority site is located at River Mile (RM) 259. In spring 2007, a river maintenance project was constructed by Reclamation's Socorro Field Division to provide protection for the San Ildefonso fishing pond. Eight buried rock vanes were placed with this project and were intended to become functional as bankline erosion progressed. To further stabilize the site, Reclamation worked with the Pueblo de San Ildefonso to plant 150 cottonwood and Gooding's willow poles throughout the project site during the winter of 2008. A line of dense vegetation north of the project site provided additional protection to the pond through recent spring runoffs (2005, 2007, and 2008), despite the active bank erosion seen on the bend immediately upstream of the pond. During the spring runoff of 2009, however, the channel eroded through this line of dense vegetation, resulting in the loss of about 80 feet of bankline in portions of the previously constructed project area.

This bank erosion exposed and threatened to flank three of the buried rock vanes. Reclamation worked with the Pueblo de San Ildefonso to construct a temporary solution prior to the 2010 spring runoff. The project consisted of two design components: a buried trench riprap revetment and a riprap windrow. The trench riprap revetment has a length of 205 feet with an alignment approximately parallel to the river. The riprap windrow ties into the upstream end of the trench riprap and extends for a distance of 180 feet with an alignment on top of the existing diagonal rock vane (Photo 5). Approximately 2,200 cubic yards of rock was installed with a nominal diameter of 24 inches. This temporary protection provides flanking protection and additional bankline stabilization for the previously placed rock vanes, allowing time for the development and permitting of a longer term solution.

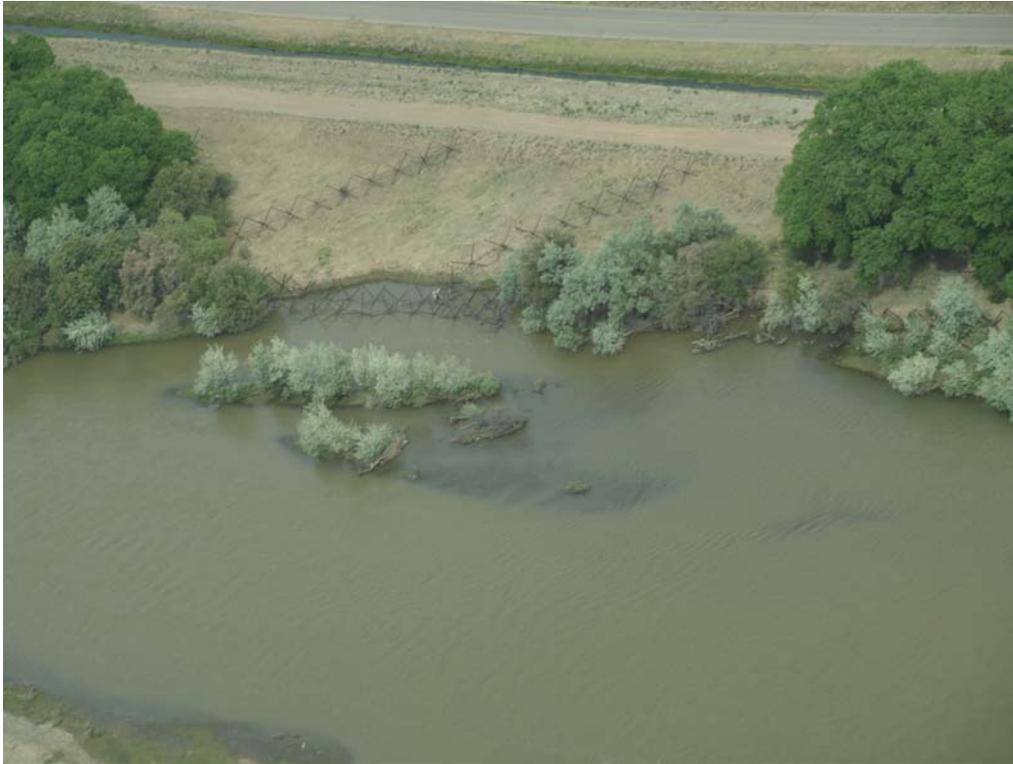
Photo 6: Kewa Pueblo RM 224.6 Priority Site (June 2010, Benoit)

There are currently three priority sites on the reach of the Rio Grande passing through Santo Domingo Tribe lands (RM 225.1, RM 224.6, and RM 223.9). At these sites, bankline erosion on the west side of the river is cause for concern because of the close proximity to the levee and riverside drain. RM 224.6, which is across from the confluence of the Rio Galisteo, is shown in Photo 6, and RM 223.9 is shown in Photo 7. A Data Collection and Confidentiality Agreement was executed between the Santo Domingo Tribe and Reclamation in August 2007 to allow collection of design data for the three priority sites. Reclamation is currently working with the Santo Domingo Tribe to reach consensus on a final design.

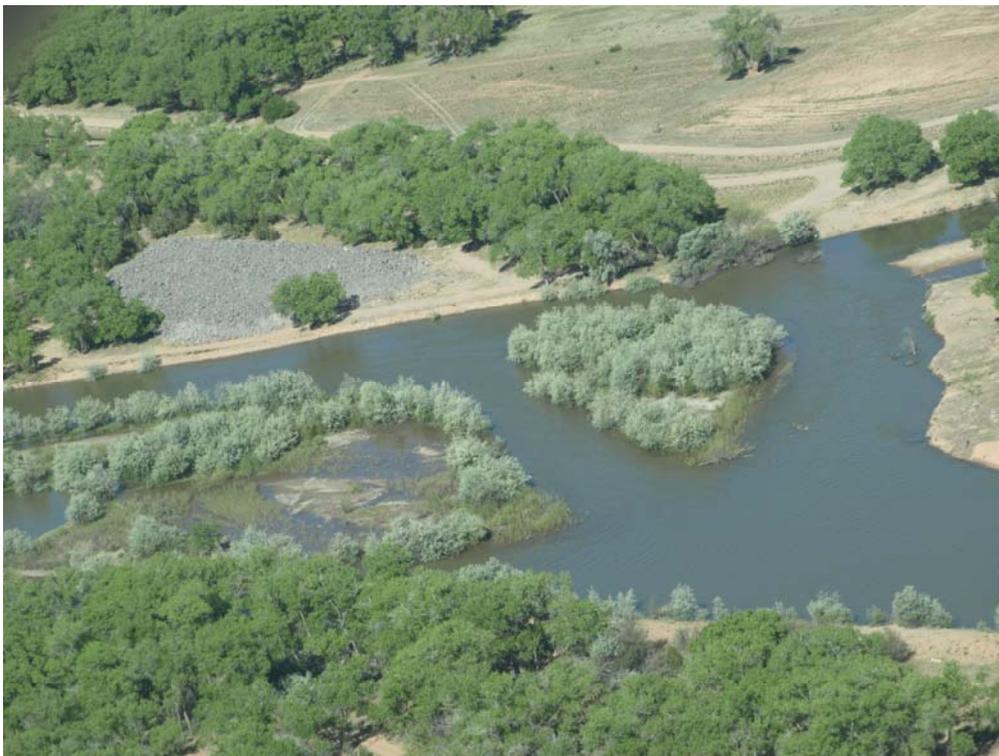
Photo 7: Kewa Pueblo RM 223.9 Priority Site, looking west (May 2010, Benoit)

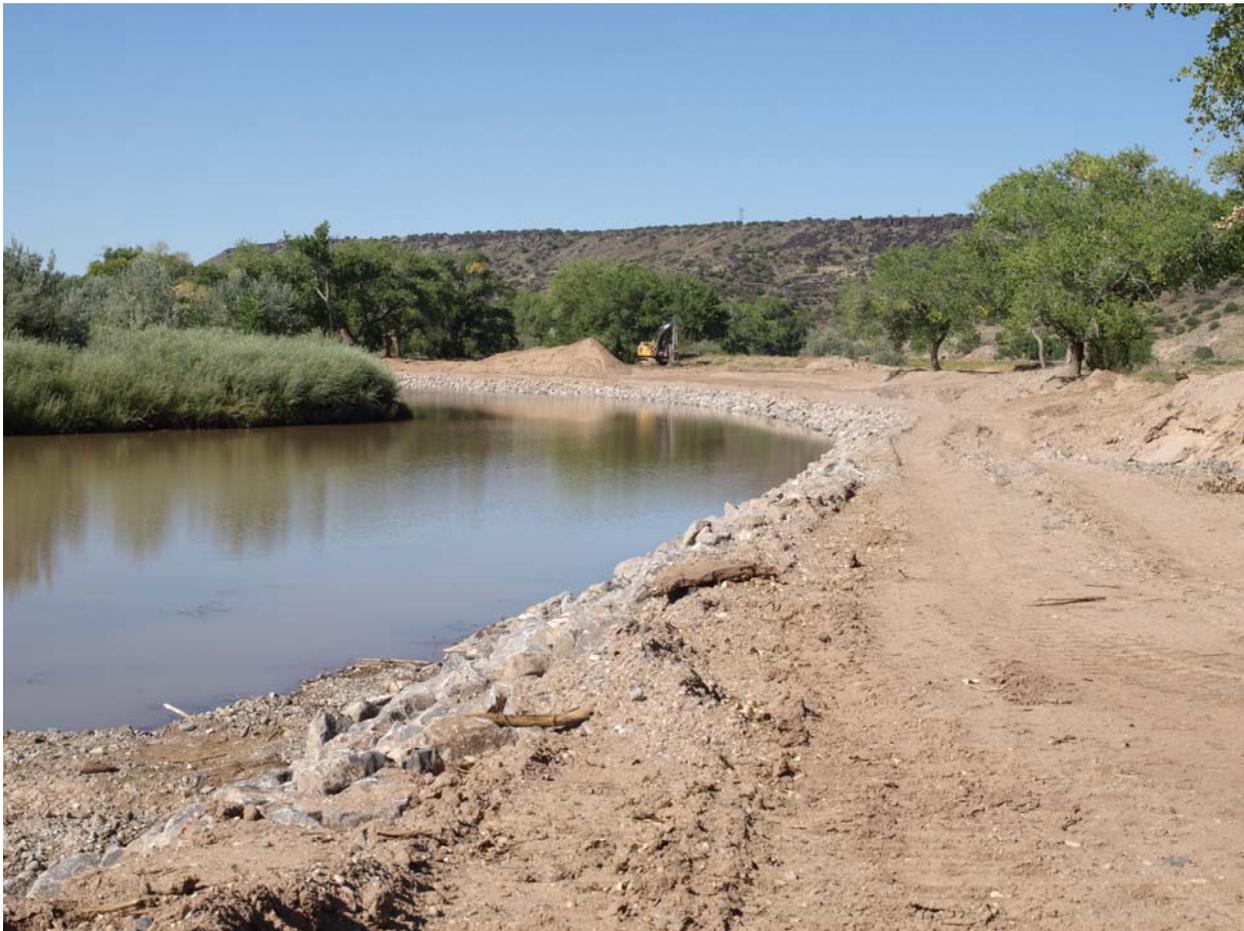
Photo 8: Rock toe placement at Priority Site 213.4, San Felipe (September 2010, AuBuchon)

There are currently nine river maintenance priority sites on the Pueblo of San Felipe. Current conditions at these sites could lead to damage of levees, irrigation infrastructure, roads, and a residential area of the Pueblo. In late 2006, Reclamation obtained permission from the Pueblo to collect cross-section and bed material data for use in designs to address these sites. Construction commenced at four of these sites in 2010, with two expected to be completed by April 2011. Photo 8 shows the site at RM 213.4.

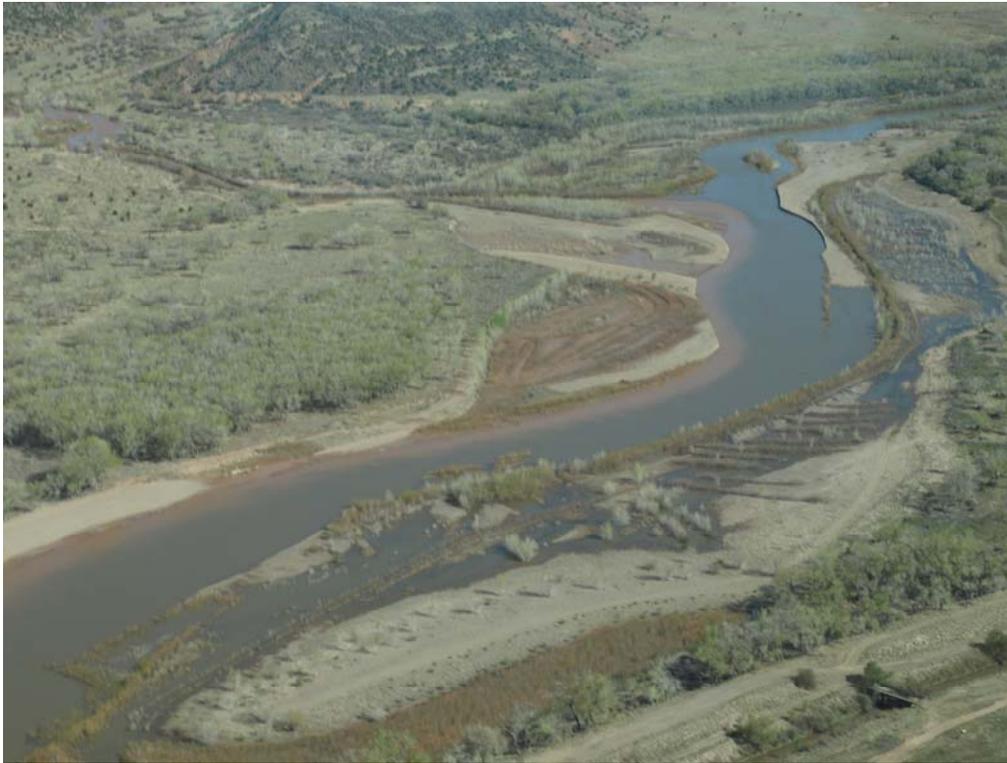
Photo 9: Looking upstream at location of sediment spoil pile on the Pueblo of Santa Ana after sediment has been removed. Flow in the Rio Grande is approximately 3000 cfs (April 2010, Holste)

The 2010 spring runoff saw increased inundation in the project area (Photo 9), and also new bank erosion on the eastern bank upstream of gradient restoration facility. A planned solution to protect the bank and prevent flanking of the gradient restoration facility is underway and is expected to be completed in 2011.

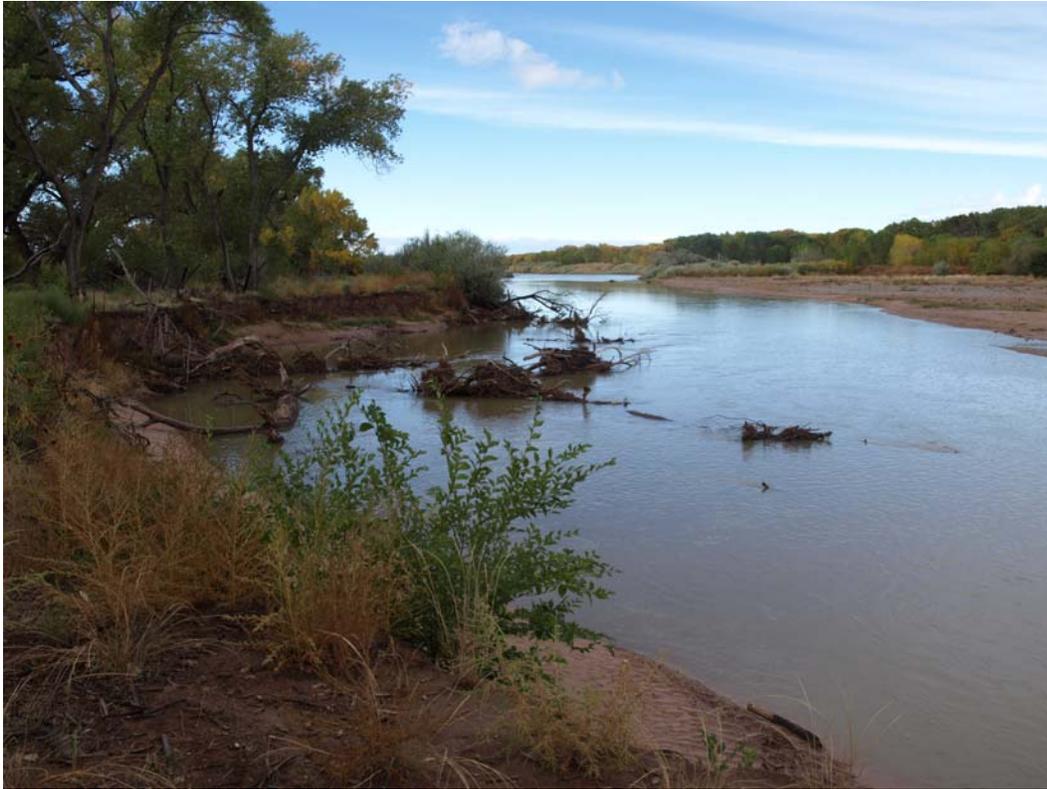
Photo 10: Looking downstream at the bend erosion at the Santa Ana RM 205.8 priority site (October 2010, AuBuchon)

An additional priority site was added within the Pueblo of Santa Ana, on the east bank of the Rio Grande across from the Tamaya Resort special events tent, following the 2008 spring runoff. For many years, the bankline had been stable and followed the jetty jack line. Prior to the 2008 runoff, the bankline migrated beyond the jetty jack line; further erosion occurred during the 2008 spring runoff.

Due to the close proximity of the spoil levee and the amount of bankline erosion observed during 2008, this site was elevated to the status of a priority site. The Corps of Engineers, through their Section 1135 project authority, undertook an island and bar lowering project on the Rio Grande through the Pueblo of Santa Ana, a portion of which was adjacent to this priority site (Photo 10). Observations from the 2009 and 2010 spring runoff indicate that this project helped reduce the active bank erosion at this site by increasing the conveyance capacity at high flows (Photo 11). Reclamation is currently working with the Pueblo of Santa Ana to implement an Information Sharing Agreement and develop a preferred protection strategy.

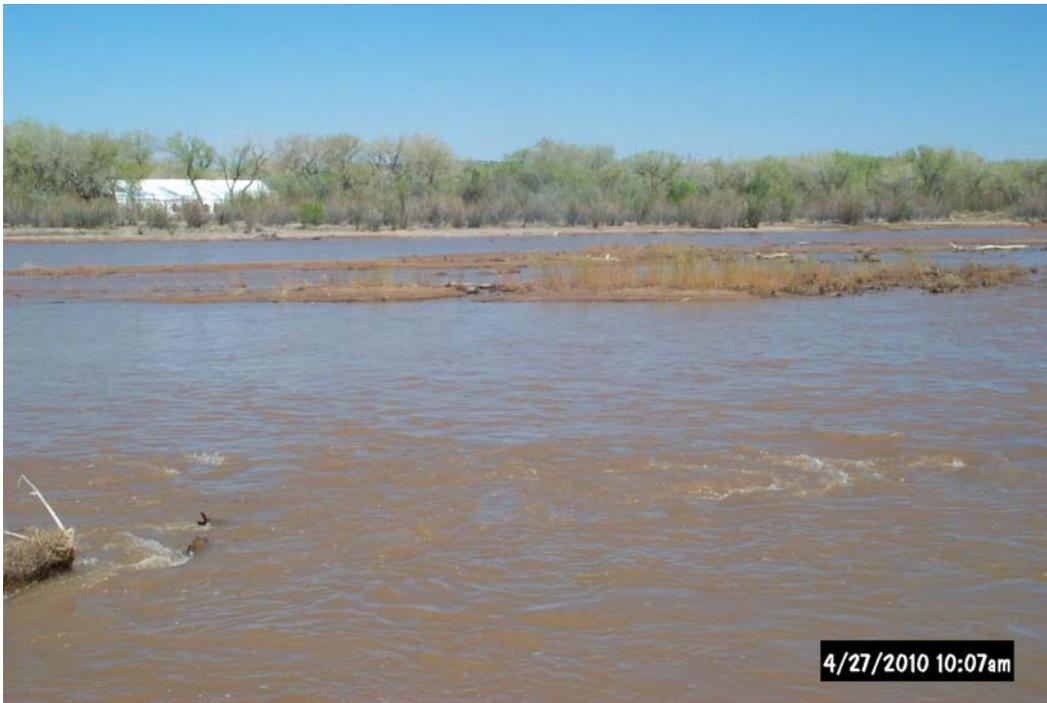
Photo 11: Increased wetted width at higher flows (approximate river flow is 2800 cfs) from the Corps of Engineers' bar lowering at the Pueblo of Santa Ana across from the Santa Ana RM 205.8 priority site (April 2010, AuBuchon)

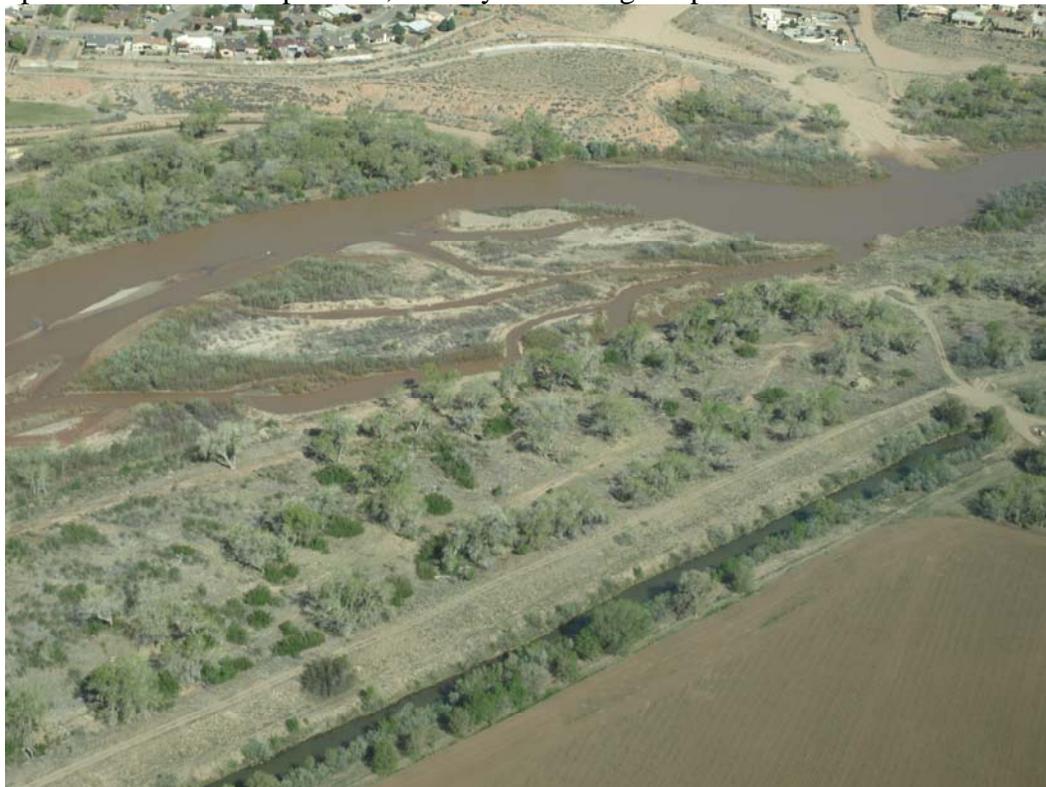
Photo 12: Looking west at Corrales Siphon river maintenance site location during spring runoff. Note high flow channels cut in bar by Pueblo of Sandia. Flow in the Rio Grande is approximately 3000 cfs. (April 2010, Holste)

However, in early 2008, Reclamation became aware that the inverted siphon consists mostly of a wood pipeline that was constructed in the 1930s. Because of concerns about the stability of the wood pipeline when subjected to the loading and vibration of construction equipment, vibration testing and video examination of the pipe were performed. While the video was inconclusive, the vibration testing indicated that equipment should stay approximately 50 feet from the pipe to avoid damaging it. In addition, conditions at the site have changed, as deposited sediment and high flow side channels cut in the bar on the opposite bank by the Pueblo of Sandia have alleviated some of the pressure at the higher discharges (Photo 12).

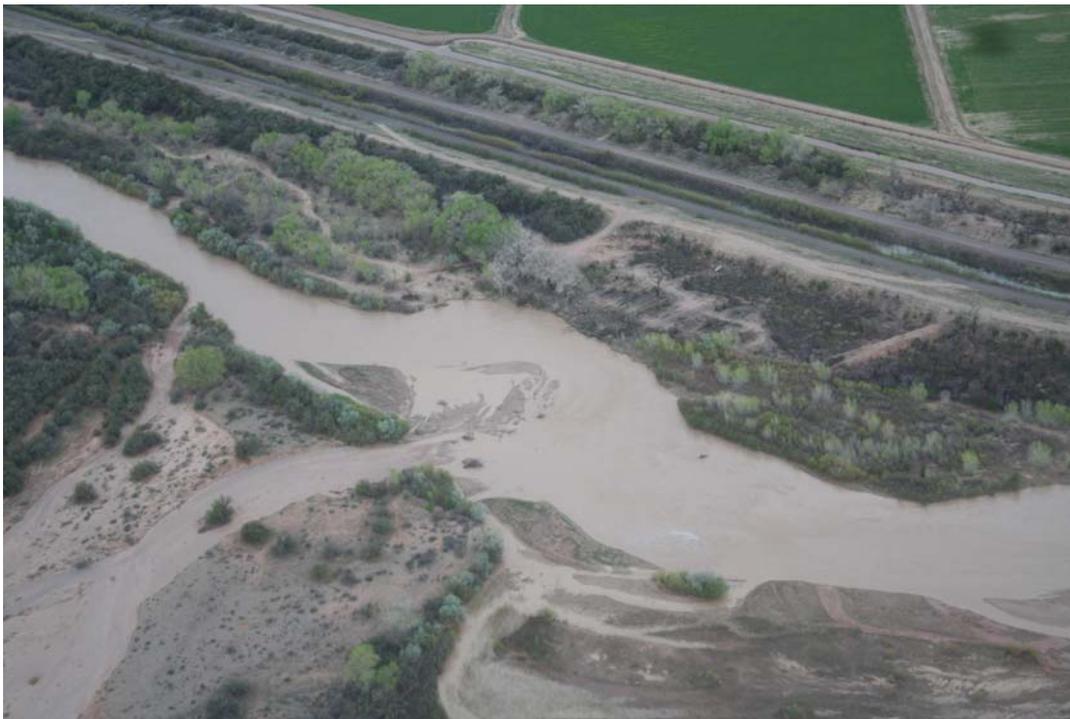
Photo 13: Aerial photograph of the Arroyo de las Cañas (April 2010, Gonzales)

This river maintenance site is located at RM 95.5 (Photo 13) on the west bank of the Rio Grande, upstream of Arroyo de las Cañas. When the site was identified in 2005, the bankline was less than 100 feet from the levee toe, and the thalweg was along the outside of the bend nearest the levee. While the bankline was eroded during the 2005 runoff, subsequent years (2006 and 2007) saw extensive deposition at this site. Spring runoff conditions in 2008 and 2009, along with a fire that burned a majority of the vegetation in the area in the early part of 2009, have again raised concerns that this site may be susceptible to erosion, although no additional erosion was observed through the 2010 spring runoff. This site has been downgraded to monitored site status. Proactive bank stabilization of depositional features is being evaluated to see if it could reduce the risk of further erosion.

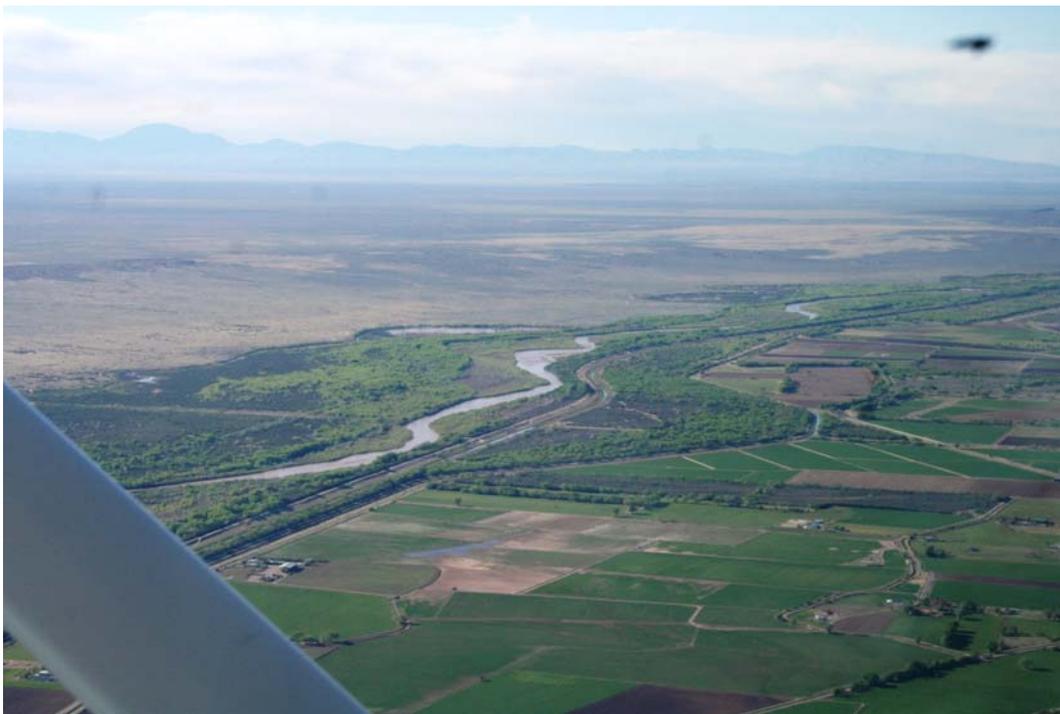
Photo 14: The reach of river currently considered most prone to sediment plug formation, taken from just north of the North Boundary BDANWR, looking south (April 2010, Gonzales)

Reclamation continues to monitor the 2008 sediment plug area, and has analyzed sediment plug potential in the general reach of river from RM 89 (2 miles upstream of the U.S. Highway 380 Bridge) to RM 80. A geomorphic assessment and hydraulic and sediment-continuity analyses report for this reach was completed in February 2010. In addition to assessing sediment plug potential, the report identified specific areas most vulnerable to plug formation and measures that may prevent future plug formation. Evaluation of alternatives for addressing sediment plugs is in progress, and Reclamation will monitor river conditions and runoff projections during 2011. The area thought to currently have the greatest potential for sediment plug formation is shown in Photo 14.

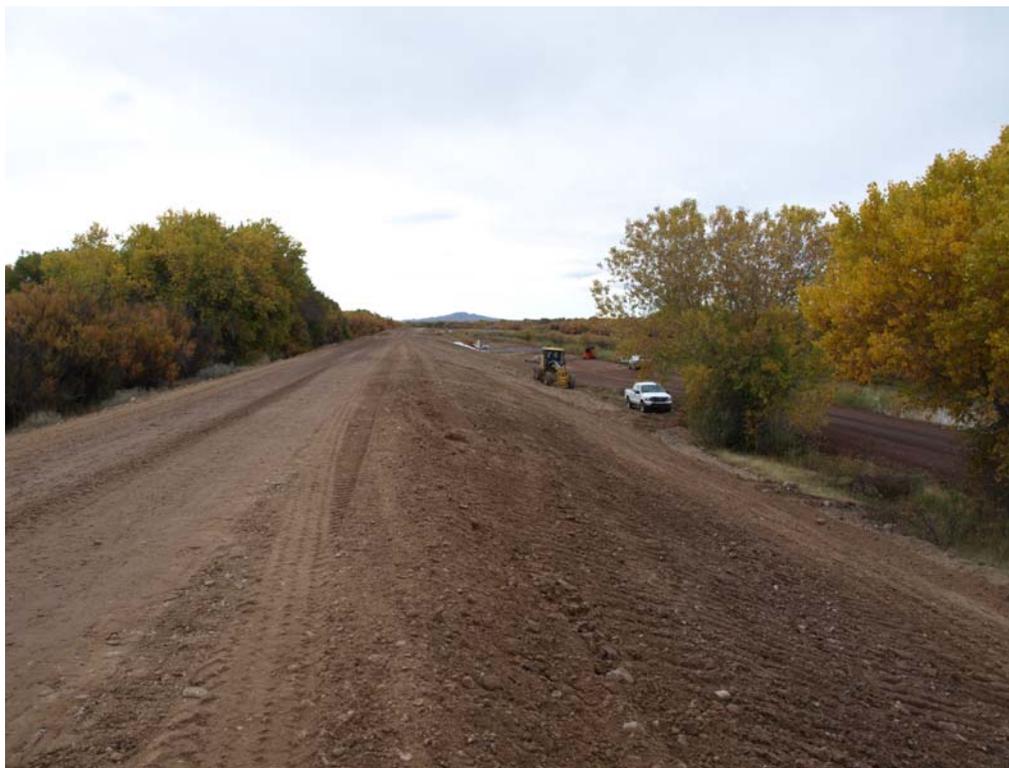
Photo 15: A completed section of the 2009 Bosque del Apache Levee ARRA improvements (October 2009, Rolland)

In 2009, Reclamation requested American Recovery and Reinvestment Act (ARRA) funds for improvements to the levee, and received \$2 million. The improvements included raising low areas and widening narrow areas within a three mile stretch of levee where conditions are of greatest concern. This work was awarded to Stoven Construction, Inc., by a task order under the 2009 Simplified Acquisition of Basic Engineering Requirements (SABER) contract. Contract work included loading and hauling Government-furnished borrow material from the Valverde borrow site to the levee. Reclamation's Socorro Field Division shaped the material on the levee after it was dumped by the contractor.

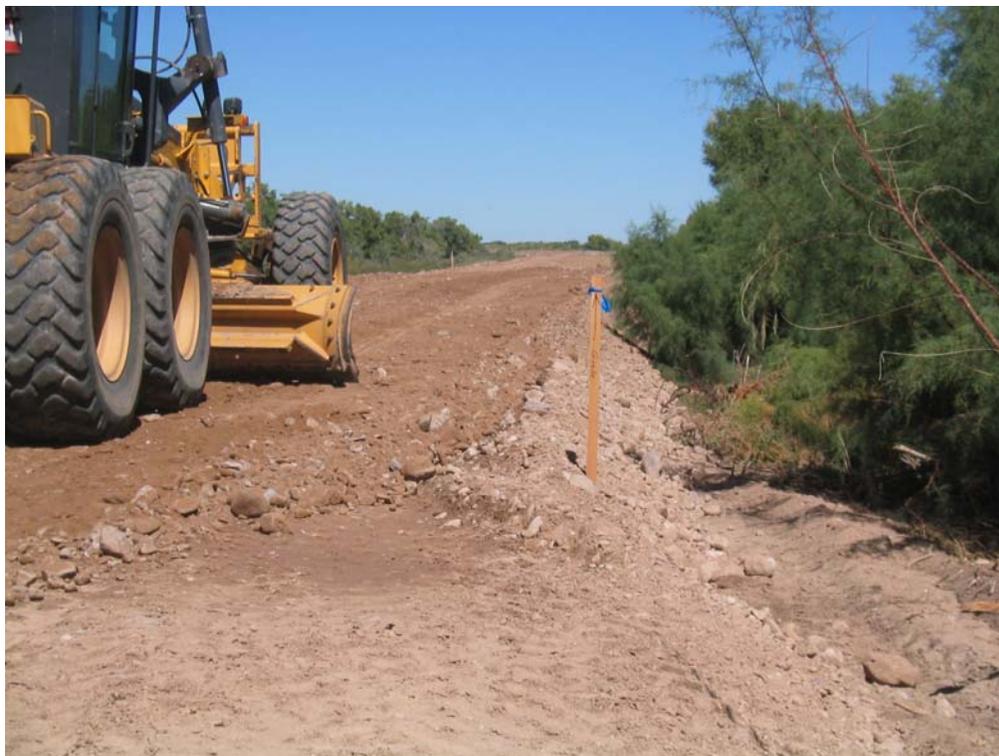
Photo 16: Levee raising north of BDANWR (September 2010, Weems)

Because of schedule limitations imposed by the BDANWR due to migratory bird season, construction for this project was divided into two periods of performance. The first period ran from October 26, 2009, to November 10, 2009, and provided approximately 52,200 tons (33,700 cubic yards) of material on the levee (Photo 15). The second period went from March 1, 2010, to March 26, 2010, and added approximately 83,300 tons (53,800 cubic yards) of material. The total quantity of material hauled and added to the levee is estimated to be 135,500 tons (87,500 cubic yards). The Reclamation crew is currently working on a 1.2 mile portion of the levee north of BDANWR (Photo 16). Initial material placement to bring the top of the levee to width and grade took place from August 16, 2010, to October 7, 2010. Work will resume in spring 2011 to widen the base of the levee.

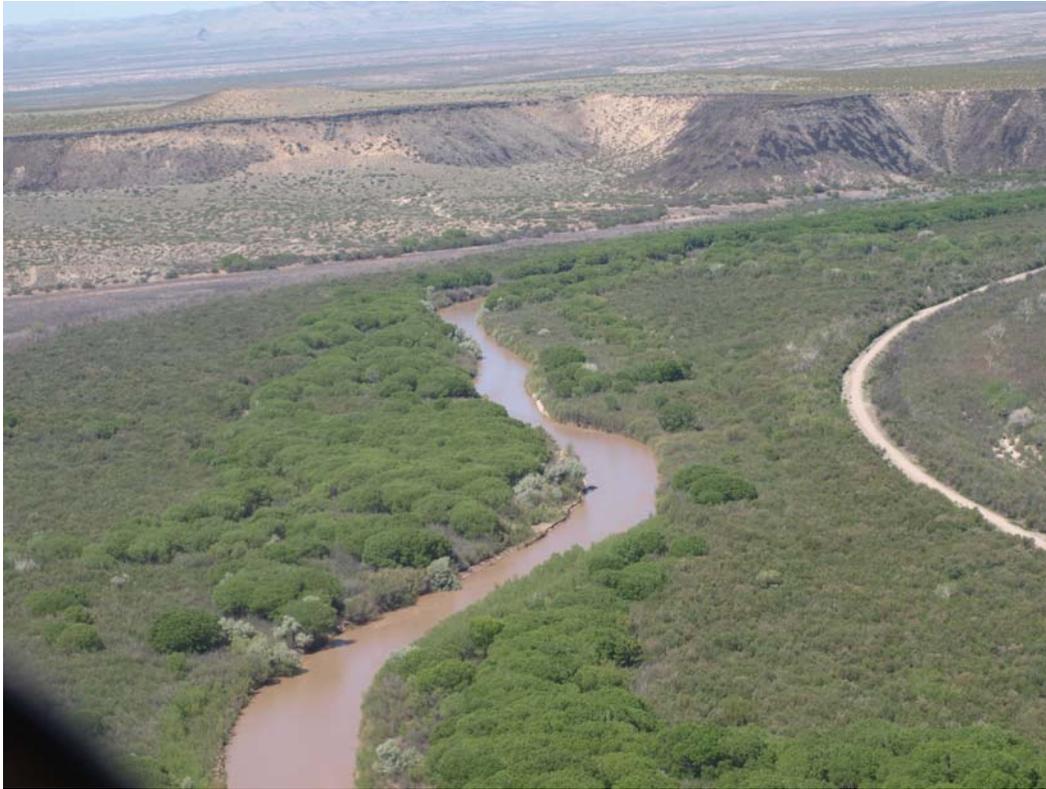
Photo 17: Vicinity of 2005 Tiffany Sediment Plug (May 2010, Padilla)

During the 2005 spring runoff, a sediment plug formed in the vicinity of RM 70 (approximately 1.5 miles upstream of the San Marcial railroad bridge), and then grew in the upstream direction to a length of over 3 miles. In a joint effort between NMISC and Reclamation, the plug was removed in 2005. Reclamation has continued to monitor this site closely, and has evaluated alternatives for solutions to the problem. However, a recent evaluation indicates that channel bed lowering in this reach of the river (Photo 17) in the last few years has increased the channel capacity and therefore lowered the risk for formation of another sediment plug at this site. Reclamation may eventually implement a project for channel work to reduce the probability of future plugs in this area, but it has become a lower priority due to the recent bed lowering.

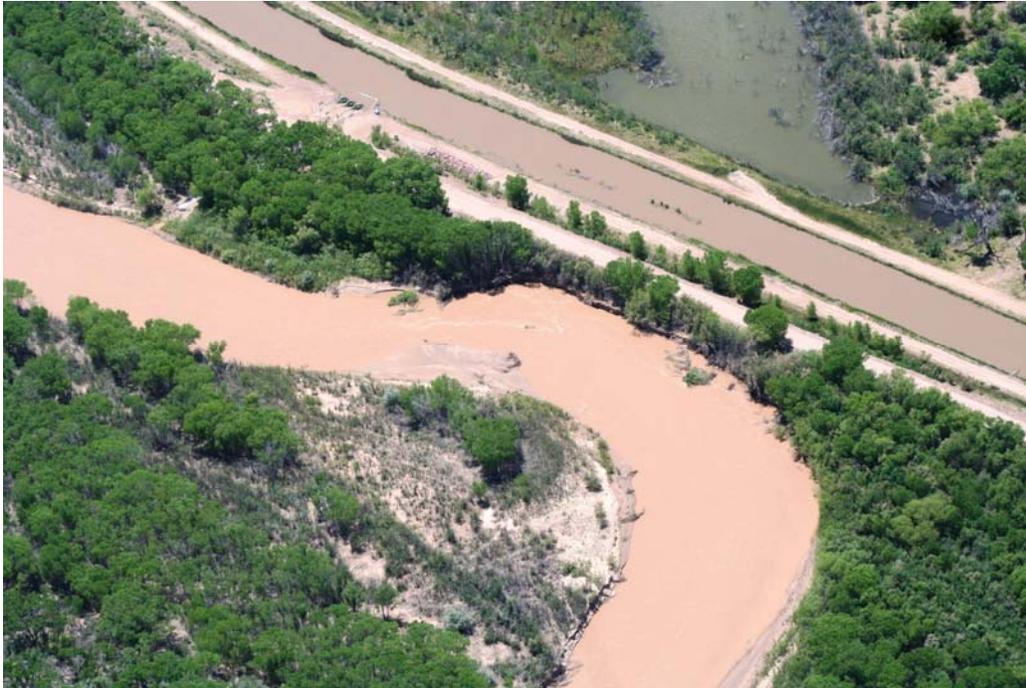
Photo 18: Fort Craig Bend priority site, looking southwest (May 2010, Gonzales)

The river bend at this site has been fairly stable in past years, but became active during the 2008 runoff, with even more erosion activity during the 2009 runoff. The upper portion of the bend was stable during the 2010 runoff, but the erosion continued to progress downstream, with almost 50 feet of bankline lost at one location. A riprap windrow has been designed to provide short term protection and is anticipated to be placed between the top of bank and the levee toe during spring 2011.

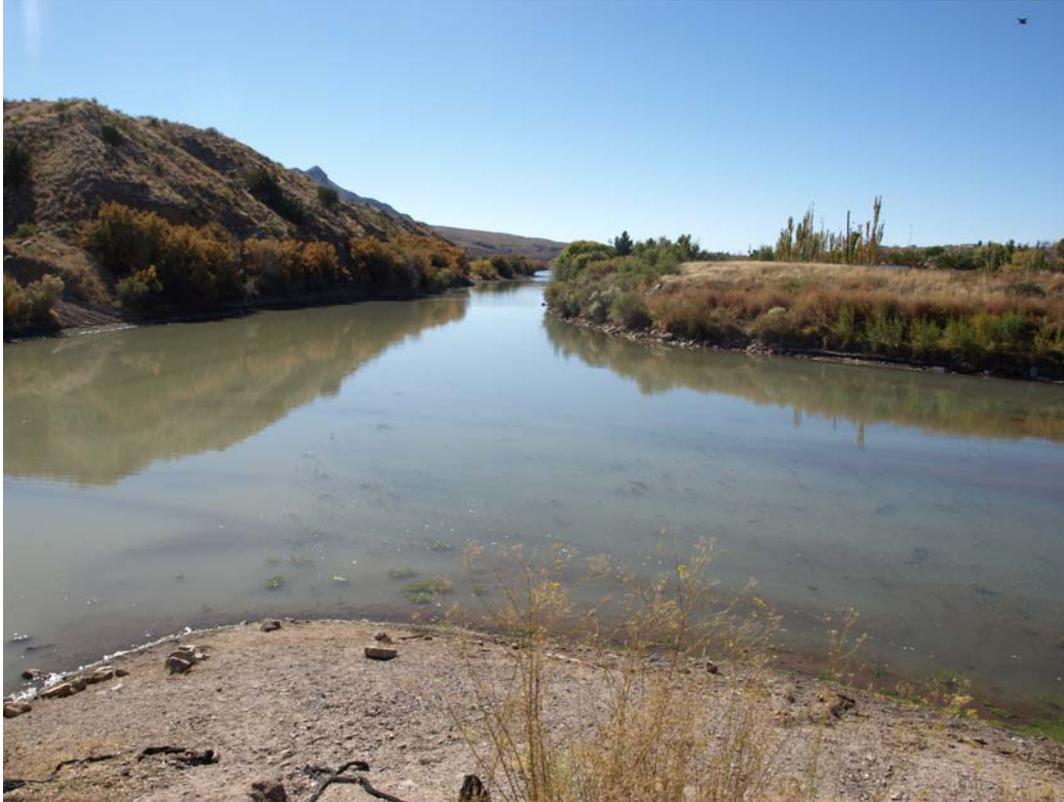
Photo 19: Rio Grande and Cuchilla Negro Creek confluence after sediment excavation (November 2010, AuBuchon)

Sediment excavation was performed in 2010 at arroyo mouths (Photo 19) and various reaches of the river channel, with a total volume of 9,900 cubic yards removed.

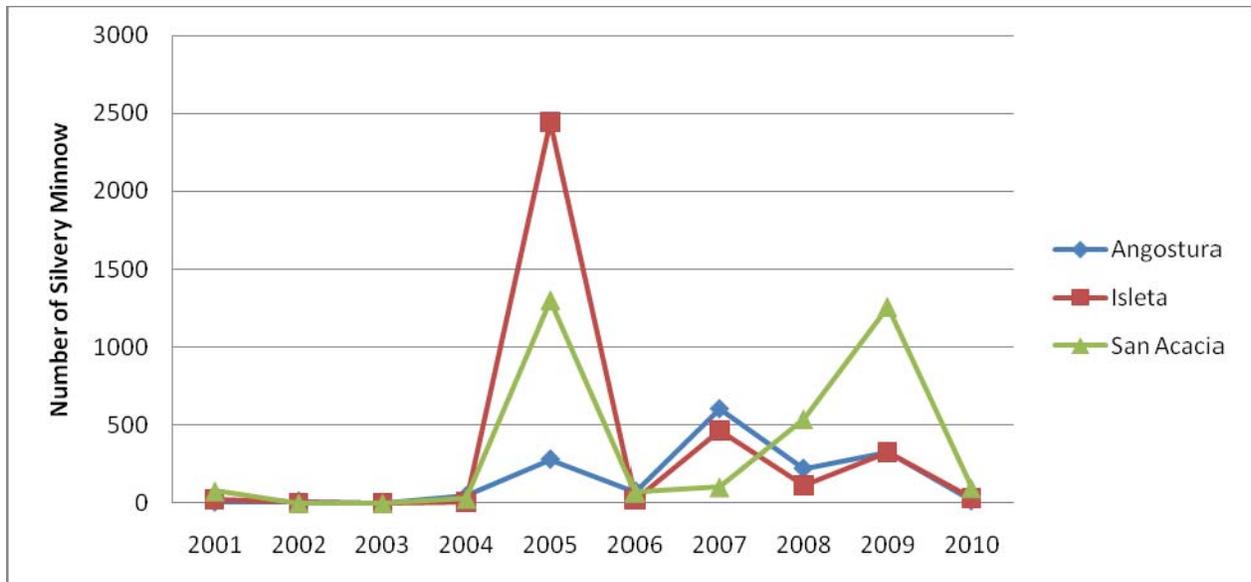
Figure 5: Total Number of Rio Grande Silvery Minnow Captured in October Population Monitoring Surveys

Figure 5 shows silvery minnow population monitoring trends from 2001 through 2010, based on annual October population monitoring contracted through the Program. This monitoring is conducted using seining by habitat and has been the consistent method used for over ten years. The silvery minnow population has fluctuated since 2003. Despite spring runoff being enhanced by a planned Cochiti overbanking deviation and effective post-runoff water management, population appears to have experienced reduced recruitment success in 2010 in all reaches. This apparent decline may be due to a combination of habitat loss and crowding within existing habitats during periods of low flow accompanied by drying, however, further studies may be necessary to determine the actual cause. Table 10 shows the total numbers of silvery minnow captured and the number of sample sites (in parentheses), by reach, during October surveys between 2001 and 2010.
