# **Animas-La Plata Project Mitigation Opportunities Report for the La Plata River Corridor**

**Huntington Ranch, Southern Ute Indian Tribe, Taylor, and Boyle Properties**

**DRAFT REPORT**

August 1997

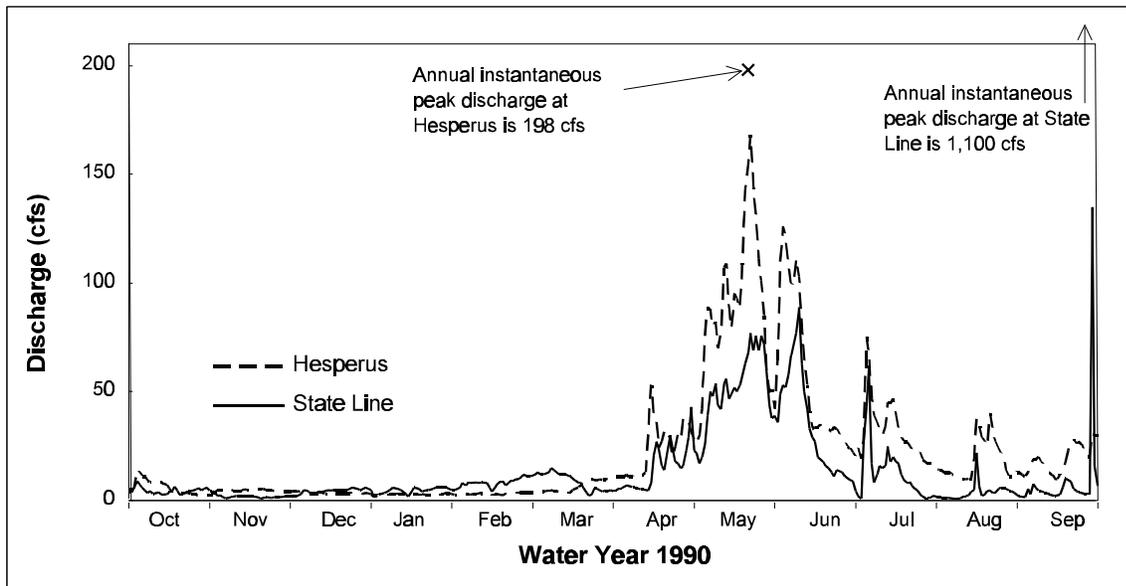
**Figure 2-1. —La Plata River hydrographs as recorded at the Hesperus, Colorado, and Colorado-New Mexico State line gages for water year 1990, a fairly typical year. Also shown are the annual instantaneous peak discharges that occurred at these locations.**

springtime melting of the mountain area snowpack (Figure 2-1). Streamflow is generally low that originate as overland runoff in the watershed's lowlands may occur from July through October. These flood events have high peak-discharge flows but are short-lived, with the entire flood event usually lasting less than one or two days, and sometimes just a few hours. Late-summer floods typically have higher instantaneous peak flows compared to spring snowmelt floods, with this trend becoming more apparent downstream from Hesperus. La Plata River high flow conditions produce large suspended sediment loads and turbid water, a condition that increases downstream due to an increasing number of arroyo tributaries. Average annual streamflow of the La Plata River in the study area is about 26,000 acre-feet. Mean annual discharge is about 36 cfs.

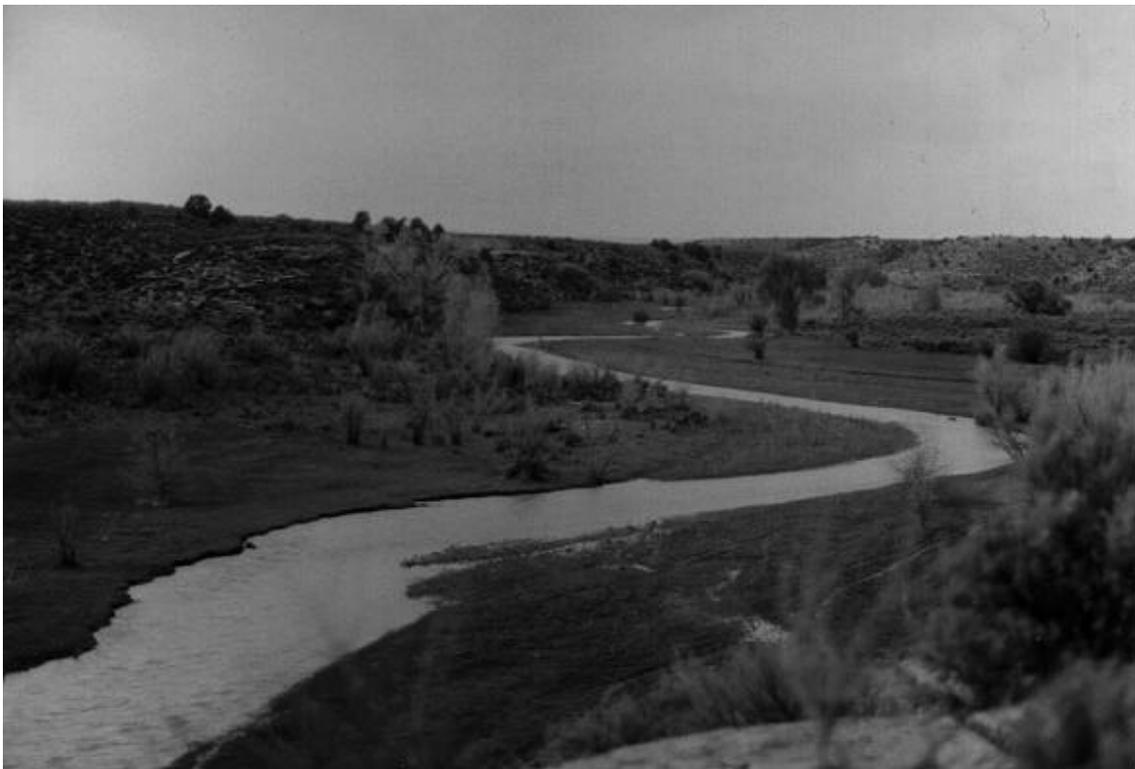
**Figure 2-4. —Typical setting of the La Plata River valley within the study area.**

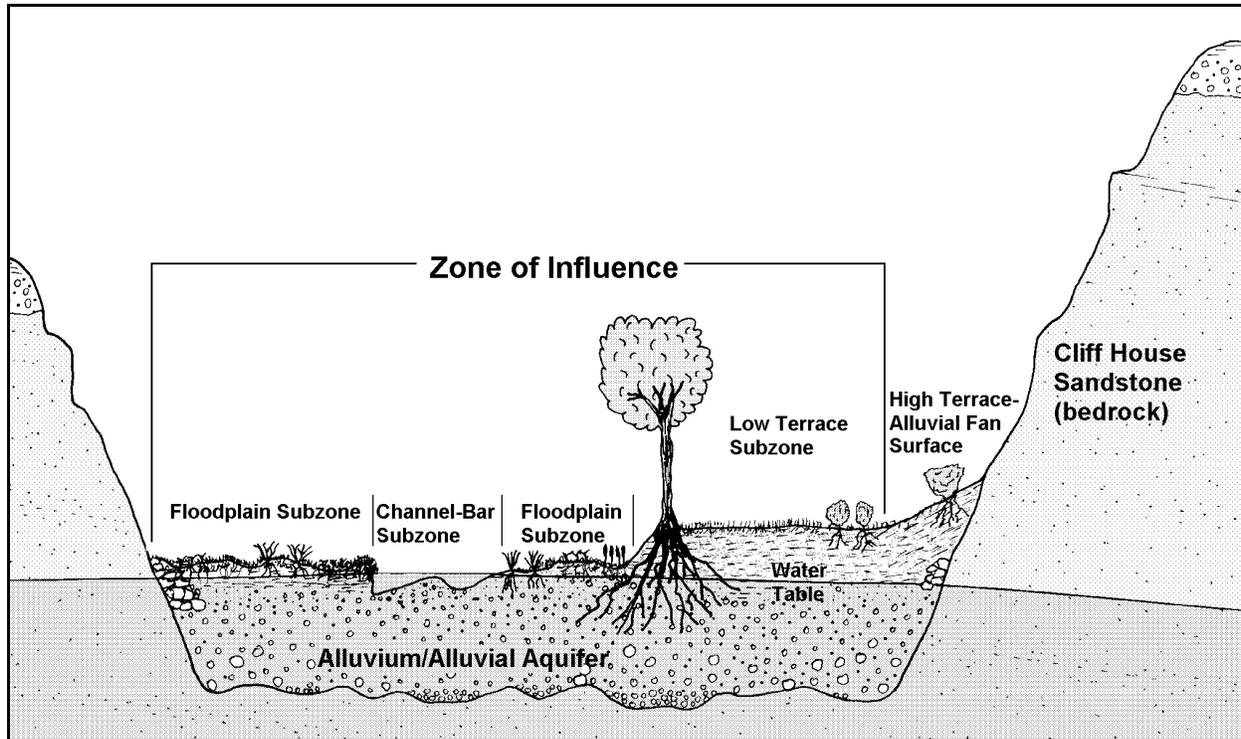
**Figure 3-1. —Cross-section of La Plata River valley bottom.**

on the hydrology and geomorphic processes of the river. Within the study area, three surfaces were identified within the river's zone of influence: (1) the channel-bar subzone, (2) the floodplain subzone, and (3) the low terrace subzone. One surface, the high terrace-alluvial fan, was designated outside the zone of influence (Figure 3-1).

The area of most active fluvial processes is herein termed the *channel-bar subzone* (Figure 3-1). This subzone incorporates the river channel and generally encompasses a band of recently deposited sediment on either one or both riverbanks. This subzone is subject to frequent flooding and is prone to rapid erosion and/or deposition. Its surface is located within one to two feet of normal flow level and depth-to-ground water is typically shallow. Plant communities in the channel subzone are those that are water tolerant and whose recruitment requires a bare-sediment nursery condition. Dominant plant species include narrowleaf cottonwood (*Populus angustifolia*), sandbar willow (*Salix exigua*), and tamarisk (*Tamarix ramosissima*). Seedling recruitment of these species appears to occur on an annual basis, but mortality is high due to scouring flood flows and/or livestock depredation. Nevertheless, multiple classes of seedling-sized cottonwoods, willows, and tamarisk (1-6 years) were observed within this subzone throughout the study area. Although livestock grazing suppresses these communities from reaching their full potential (Figure 3-2), the degree of suppression can vary greatly among the

Located about 2-feet above the channel is the *floodplain subzone* (Figure 3-1). This is a predominantly depositional environment, with clays, silts, and sands accreted from suspension during flooding. A lesser flood frequency on a surface with a relatively shallow ground-water table allows for the establishment of herbaceous vegetation. Plant communities of the floodplain subzone include wet meadows of riparian sedges (*Carex spp.*), arctic rush (*Juncus arcticus*), grasses (*Agrostis spp.*, *Hordeum jubatum*, and *Poa spp.*) and various forbs. Marshes of bulrush (*Scirpus spp.*), spike rush (*Eleocharis spp.*) and cattail (*Typha latifolia*) occur in oxbow meander scars and chute channels where the ground-water table intersects the floodplain. Cottonwood, willow, and tamarisk communities are also present; although, their recruitment is probably limited, occurring mainly on sandy sediment deposited near riverbanks or in chute channels after moderately large floods.

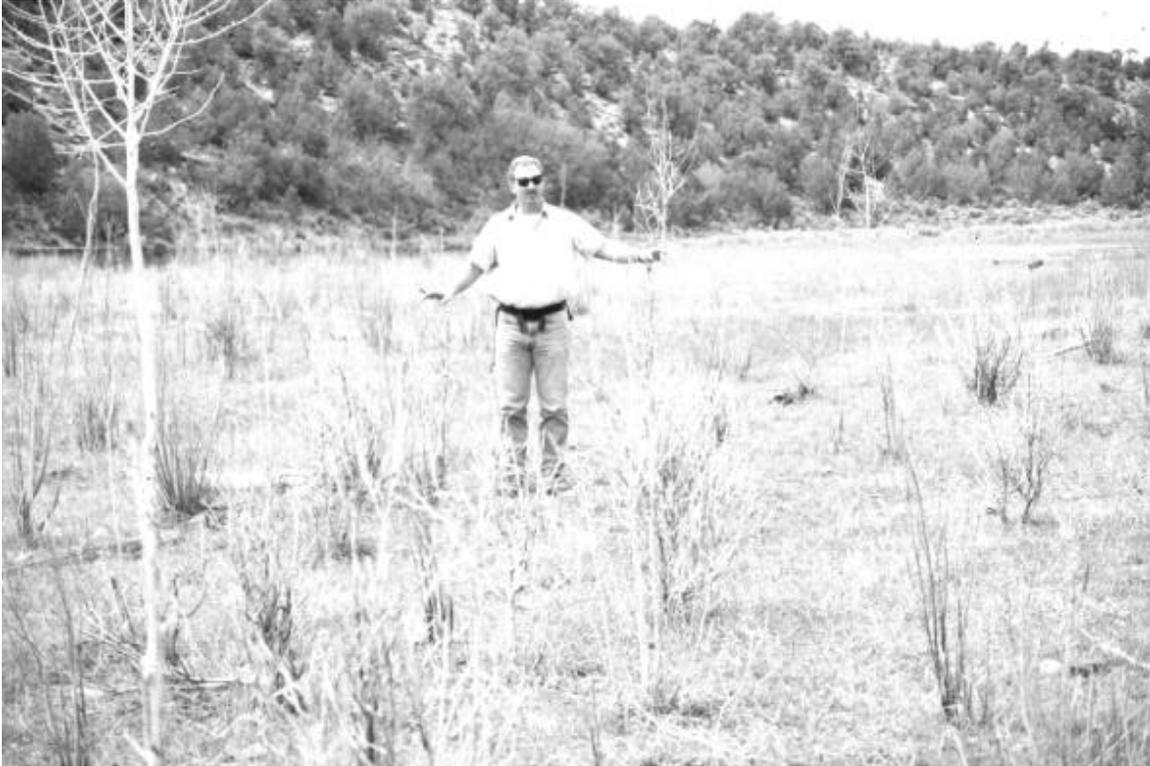
**Figure 3-2. —Example of grazing restricting the height of young cottonwoods. Note height of less-grazed tree of same size class in foreground.**

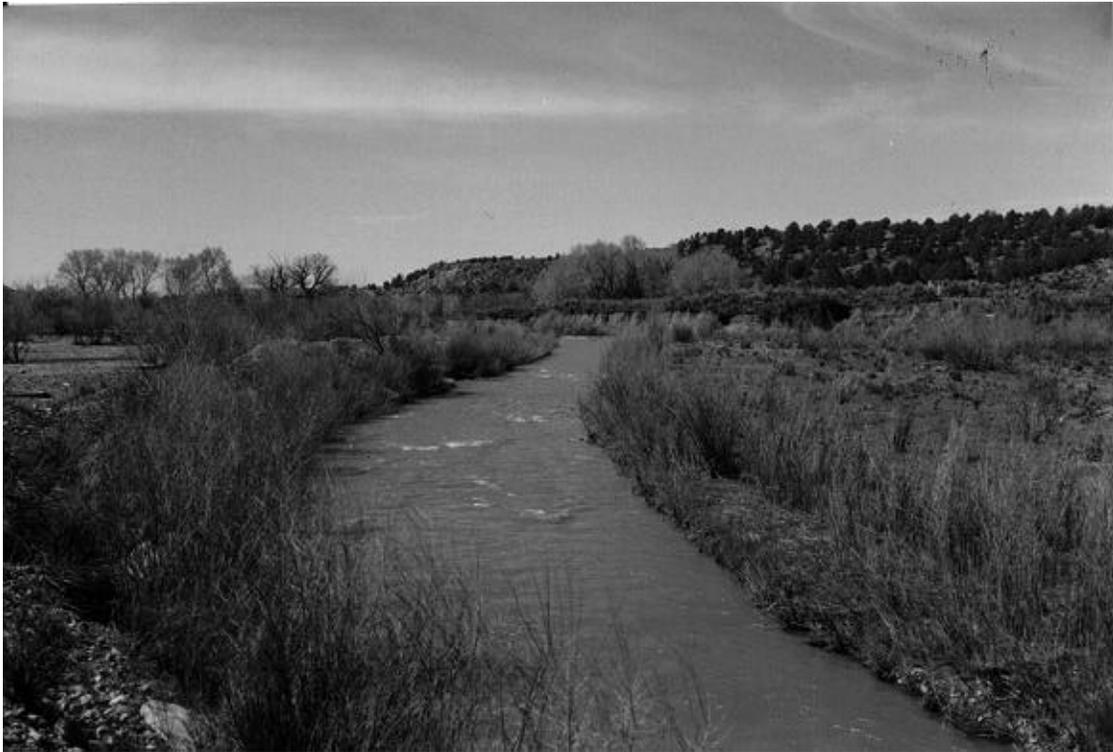
**Figure 3-4. — Reach of straightened and leveed channel in Segment III, Reach 10. Note that woody vegetation has established on the banks since completion of relocation activities.**

its confluence with Long Hollow (Figure 3-4). In addition, river water is diverted into a small irrigation canal located on the western riverbank near the Long Hollow confluence. Leakage from the canal probably affects ground-water conditions and vegetation growth below it on the west side of the valley for most of the length of Segment III.

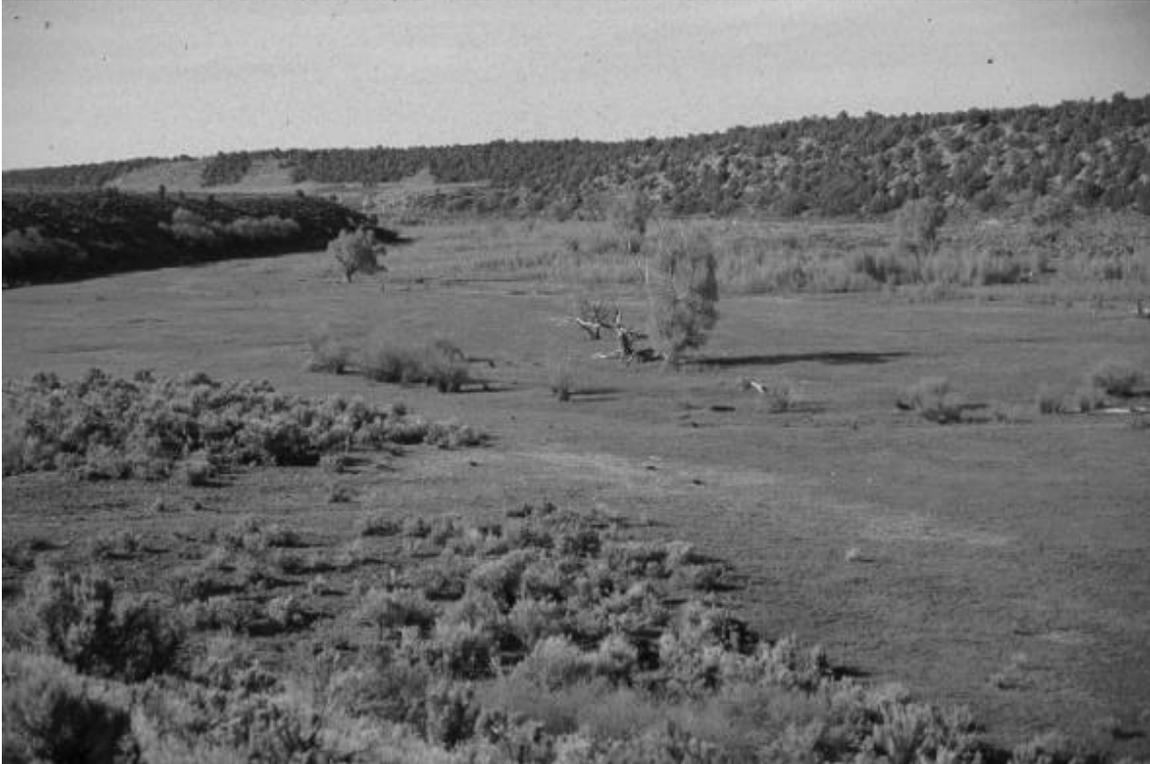
**Figure 3-5. —Example of isolated mature cottonwood tree on low terrace subzone. Note extent of pasture conversion within the river corridor.**

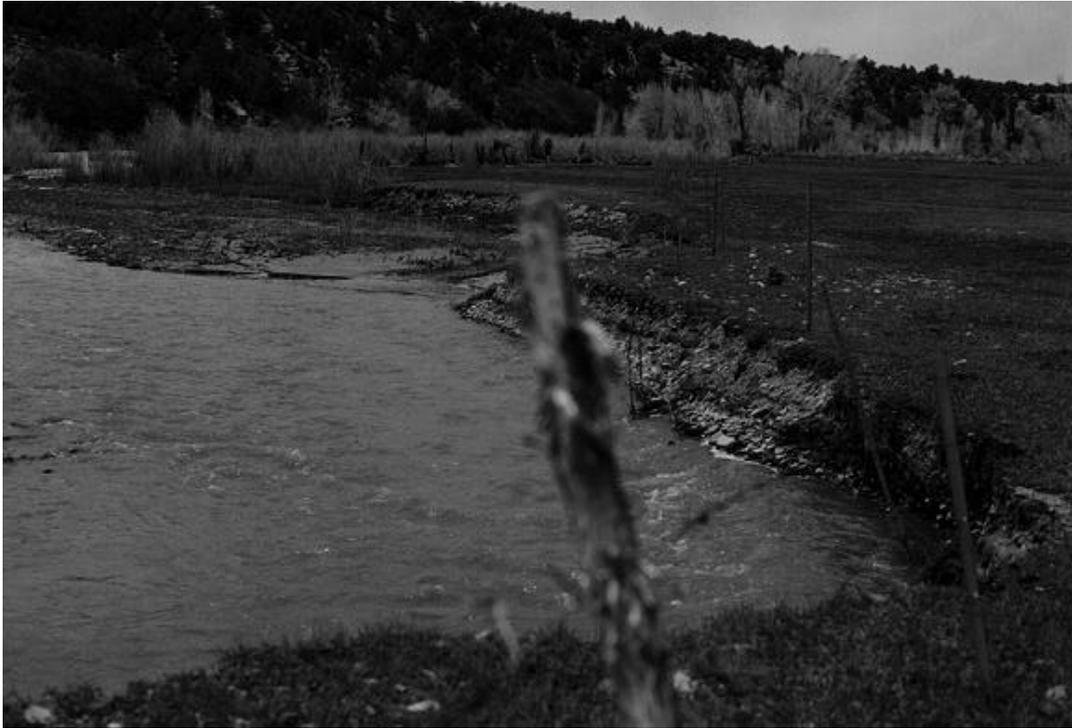
**Figure 3-6. —Channel widening and bank erosion in Reach 2. Floodplain and terraces on the right have had vegetation converted to pastureland. To the left background, willows are being recruited on the channel-bar level.**

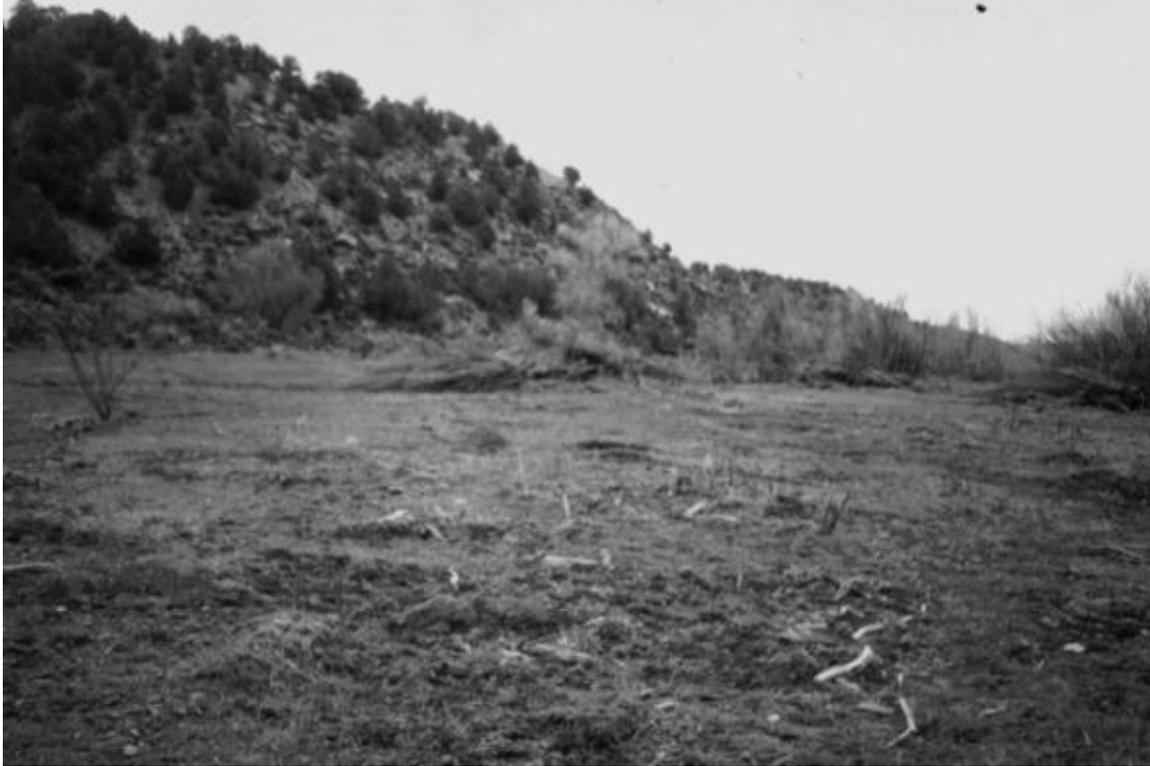
**Figure 3-7. —Example of removal of woody riparian-wetland vegetation to increase livestock pasture.**

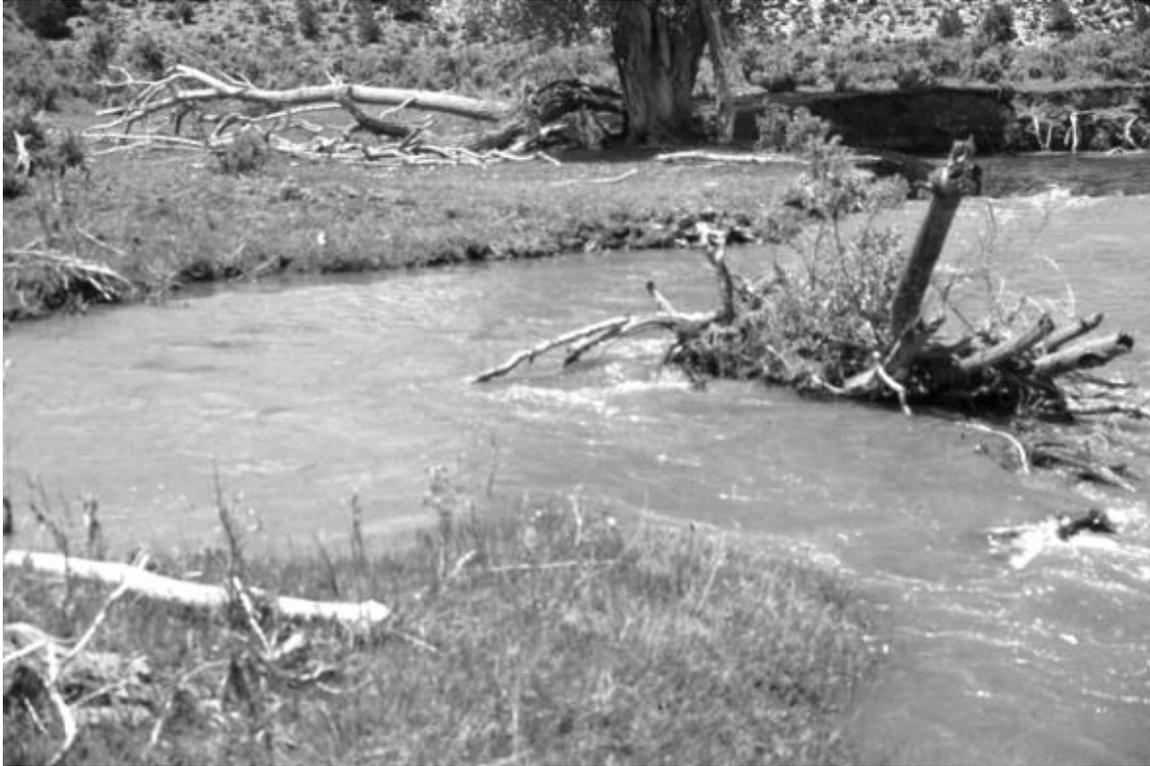
Figure 3-8. —Example of a single fish habitat unit created by a fallen birch tree in reach 5.

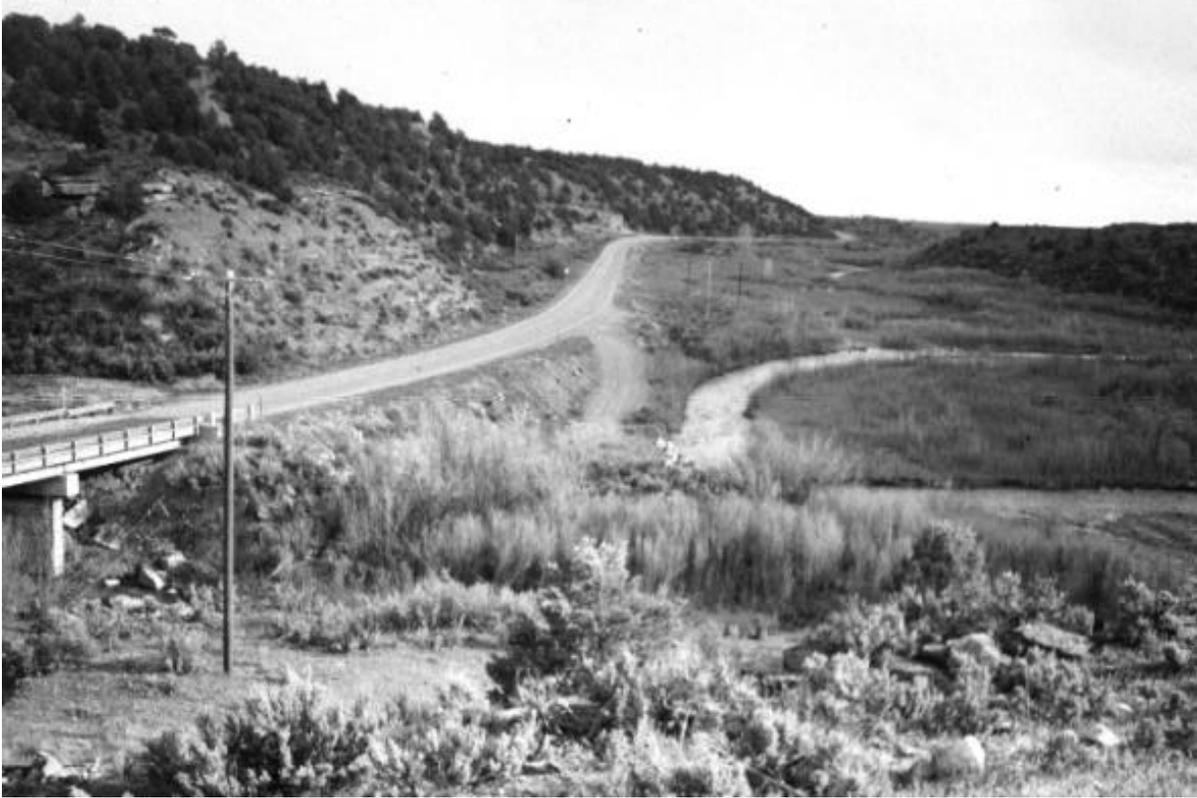
**Figure 3-9.** —Looking down the La Plata River valley in Segment III, reach 9. Highway bridge at left crosses Long Hollow flowing from the east.

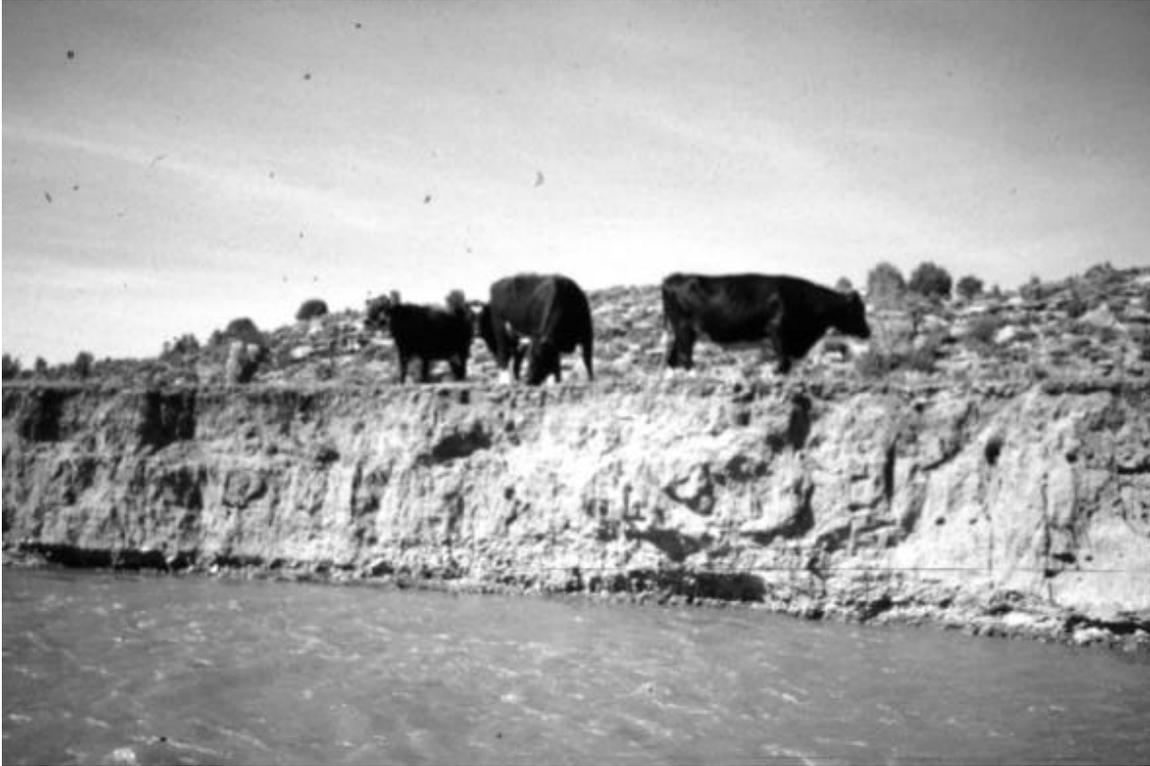
**Figure 4-1. —Cattle present on overgrazed pasture located on the low-terrace subzone. Note the lack of roots in the eroded riverbank.**

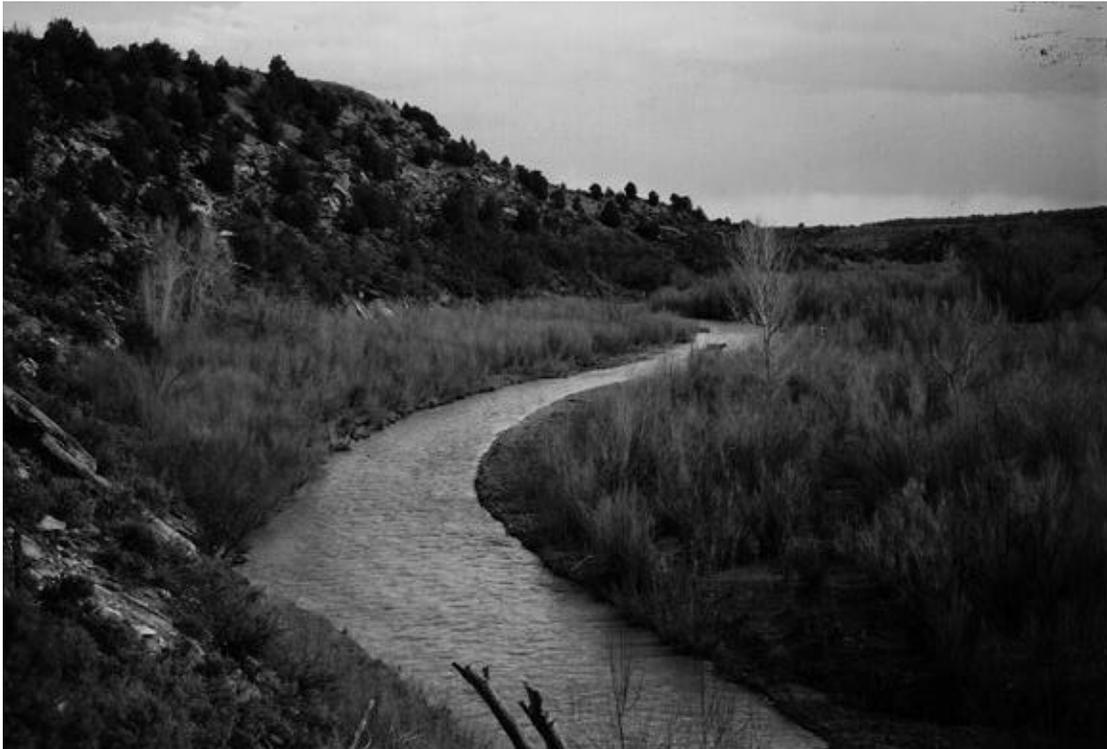
**Figure 4-2. —Potential area for the establishment of a roundtail chub population above the Long Hollow confluence in Segment II, reach 8.**

An approximately 1-mile long stretch of river in Segment II, including all of reach 7 and the upper quarter of reach 8, has excellent potential for habitat improvement to establish a second roundtail chub population (Figure 4-2). Property control along this stretch of river is primarily Taylor and SUIT, with Huntington controlling a short section at the upper end. Suitable habitat for roundtail chub already occurs in two short segments at the upstream and downstream ends of

this section of river. In these locations, the river erodes into low terrace, high terrace-alluvial fan, or the valley wall and exposes large sandstone boulders that provided lateral and overhead cover that create several contiguous pool/eddy complexes. The intervening stretch of river has swift runs and riffles, with few pools and little overhanging bank cover, but offers good recovery potential.
