Angostura Dam to Montaña Bridge: Geomorphic and Hydraulic Analysis

**Upper Colorado Region
Albuquerque Area Office
Technical Services Division
Middle Rio Grande Project, NM**

Middle Rio Grande Project, NM
Technical Services Division
Albuquerque Area Office
Upper Colorado Region

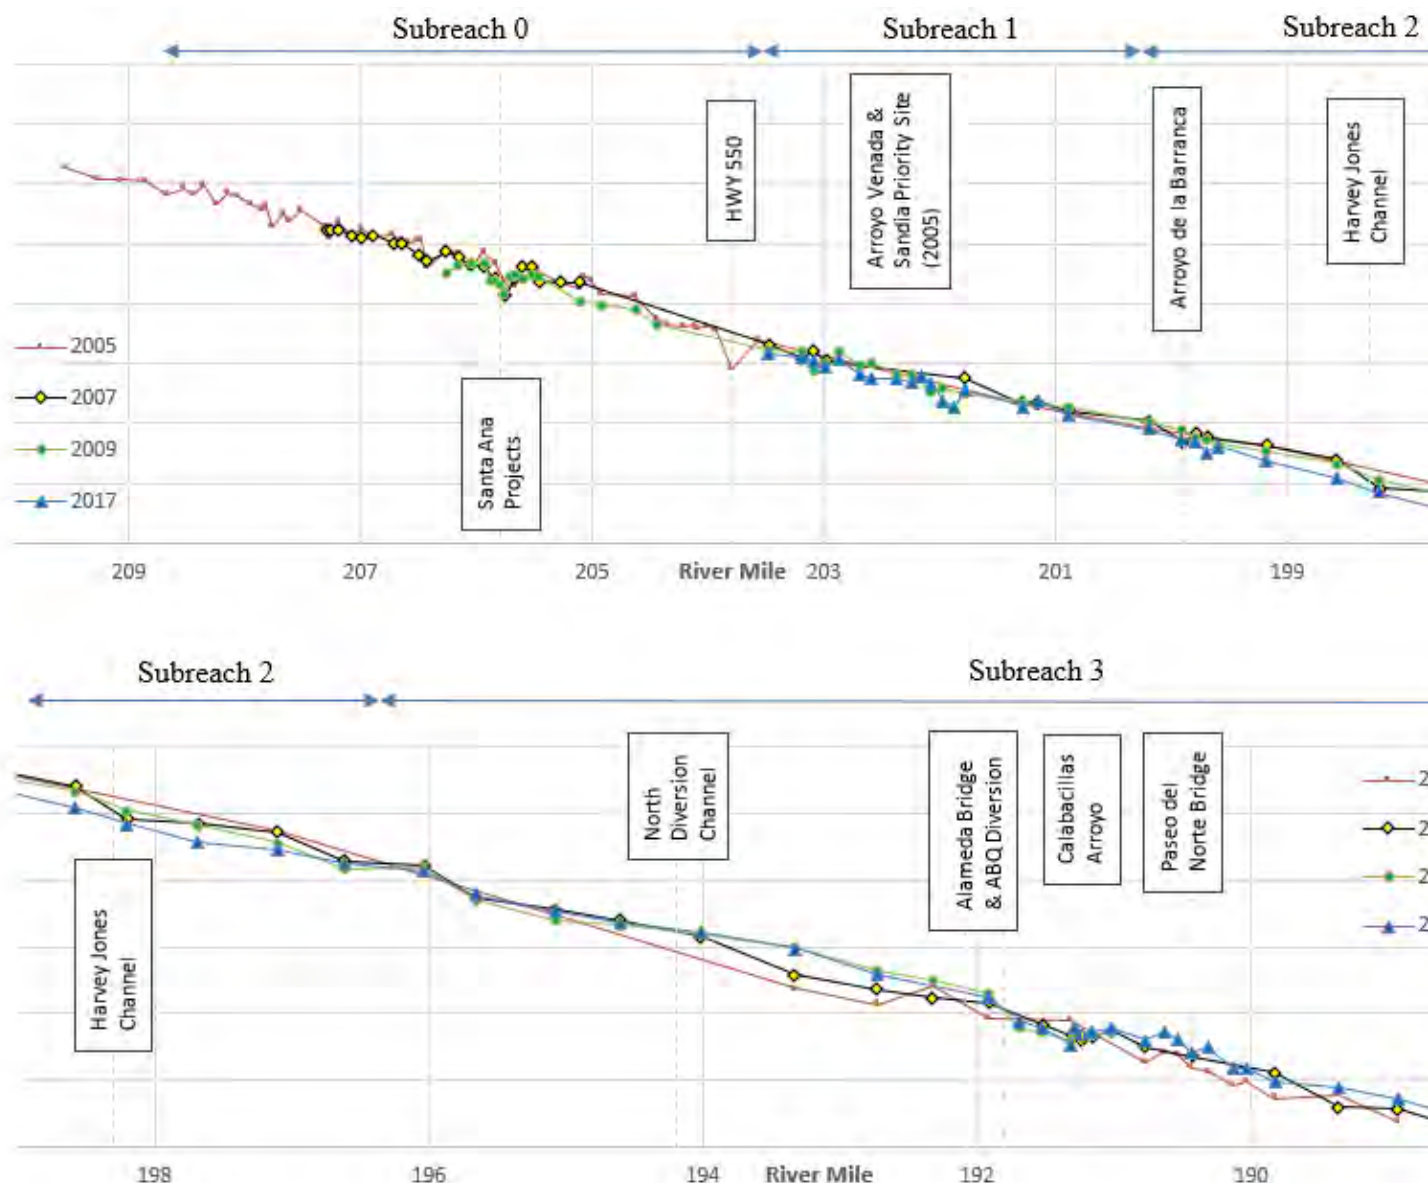
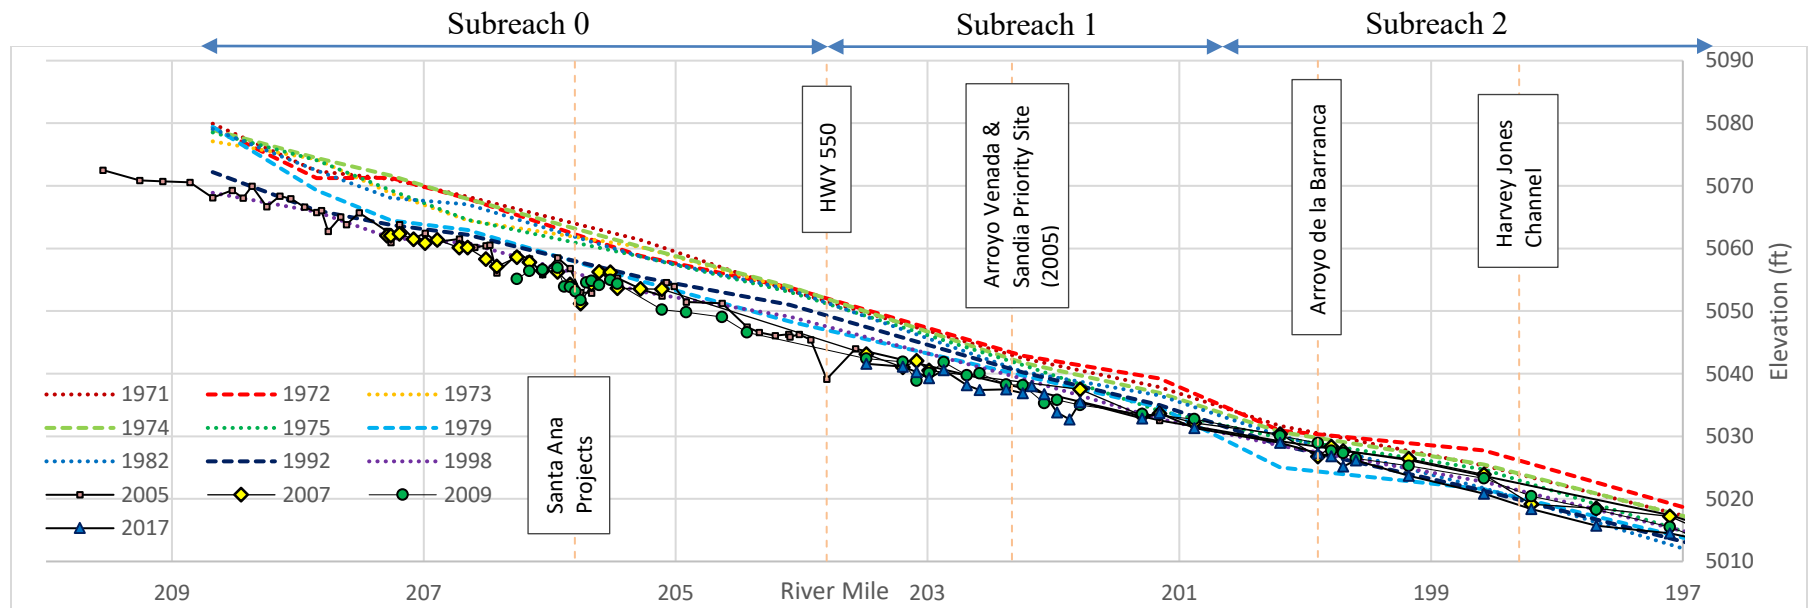
Figure 3 Longitudinal profile of the Rio Grande within the reach.

Cochiti rangeline (CO-lines) data was compiled for years following the closure of Cochiti Dam, from 1973 to 1998. In Figure 3, these data are shown as a dashed line. The most current data captures particular rangelines throughout the reach, represented with solid black lines, to easily discern the most recent data to the more generalized historical data. It should be noted that the data for Subreach 0 was collected at a different time than for Subreaches 1 to 3. The rangelines of Subreach 0 are located on the Pueblo of Santa Ana, and the Pueblo conducted its own hydrographic data collection that was independent from data collected by Reclamation's contractors. For Figure 3, Subreach 0 data for 2007 was actually collected in 2008; data for 2009 was collected in 2010 (Santa Ana Pueblo data). These data were consolidated with Subreaches 1-3 for these respective years.

As visible from the Angostura Diversion Dam to approximately the AMAFCA North Diversion Channel, the reach has been degrading over time. Ephemeral tributaries such as the Arroyo de la Barranca, the Arroyo Venada (across from the Sandia Pueblo Priority Site), and the Calabacillas Arroyo have effects on the channel thalweg, as indicated by depressions in the thalweg corresponding with degradation occurring downstream of arroyos. Depending on the arroyo's sediment characteristics and hydrologic transport efficiency and the magnitude of events that occur in its watershed, arroyos affect the Rio Grande as a local grade control. The signal of an arroyo input is indicated in a longitudinal profile with areas that have a flat slope upstream and a steeper slope downstream.

Structures such as the AMAFCA North Diversion Channel and the Alameda Bridge act as local vertical and lateral controls, respectively. Throughout the past decade the thalweg profile has been stable in the vicinity of these structures. In the period between 1971 and 1998 generally the entire reach was degradational; this trend continued up to 2017 below the Harvey Jones Channel to the end of sub-reach 2 near River Mile 197. Downstream of the AMAFCA North Diversion Channel the current thalweg elevations are comparable to 1973 elevations. Effects to the river bed in Sub-reach 3 from immediately upstream of San Juan Chama Surface Diversion Dam to the North Diversion Channel are evident in the profile with rise in the bed and a flattening of the slope. This channel spanning diversion facility was installed in 2008.

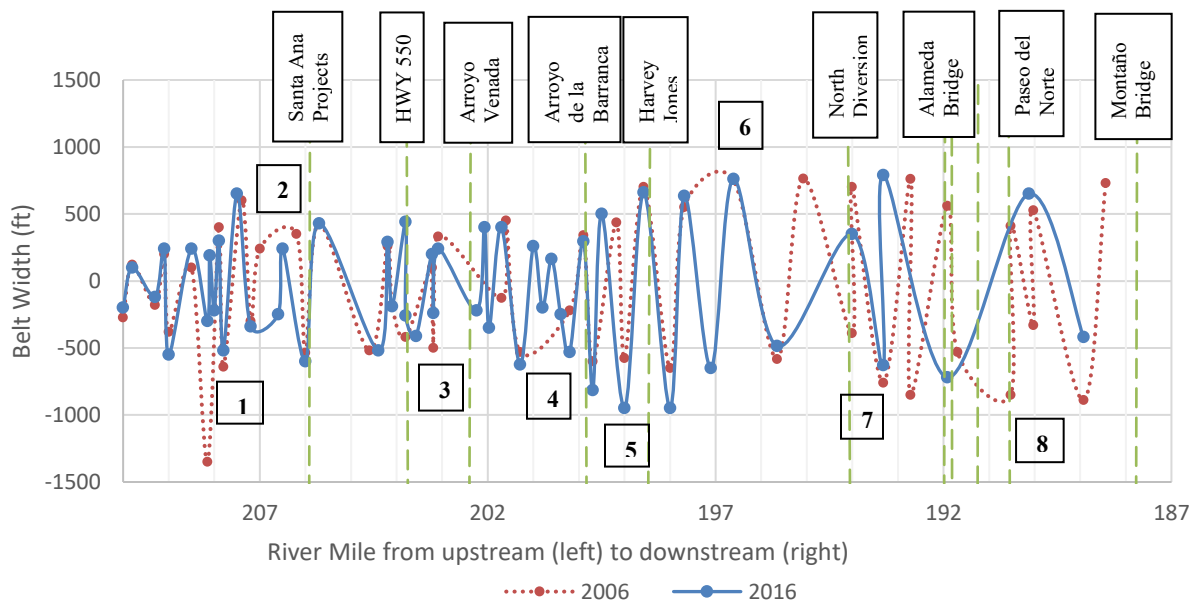
Figure 11 Meander belt widths based on location in the reach; negative values indicate bends on river left. Areas of divergence (1-8) are discussed in following figures.

Once the meander geometry, wavelength and belt width were identified and measured from historical aerial photography in 2006 and 2016, the belt width was plotted and compared (Figure 11). To facilitate in comparison, bends to the east or river left had their width demonstrated with negative (-) values. Areas of divergence between 2006 and 2016 are indicated as number 1-8 in Figure 11, and will be further discussed. General observations from Figure 11 indicate that in the upstream portion of the reach, from Angostura Dam to around RM 200/Arroyo de la Barranca, the belt width is generally uniform, with a width of less than 500 feet and the meander wavelengths are consistent. Downstream from near Corrales Siphon (RM 200) towards Montañño Bridge, the belt widths increase, and the meander wavelengths also increase. Also, the locations of bends change dramatically between 2006 and 2016 relative to upstream geometry measurements. Description of mechanisms for these changes are described in the following figures.

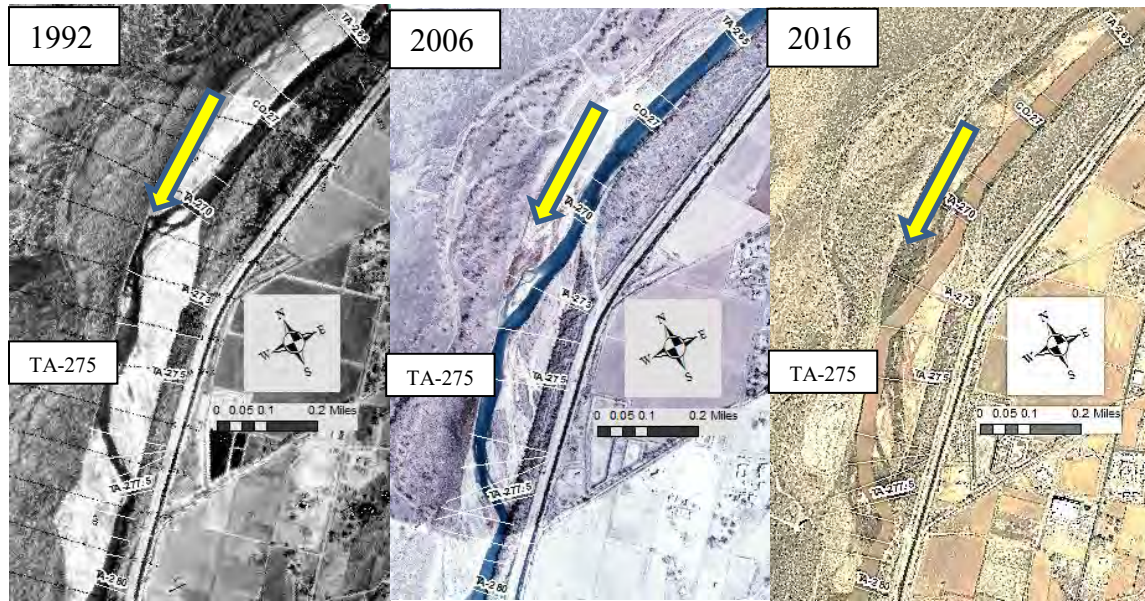
Figure 13 Near TA-275. Bend migrating downstream, resulting in a tighter meander, as the river's left bend at TA-277.5 is fixed, this location coincides with Santa Ana Projects. Yellow arrow is approximately at the same position in all images. (2)

Divergence 4 at CO-32, near RM 200 indicates a similar trend to Divergence 2 (Figure 13), where the bend is migrating downstream. The migration at Divergence 4 occurs both above and below Arroyo de la Barranca at BB-338, where the bend below has migrated since 1992. Both of these divergences (2 and 4) show that the river runs straight along the river right edge of the active channel planform as if the Rio Grande would have a smooth bend with a wider belt width if it had not reached some rigid bankline control.

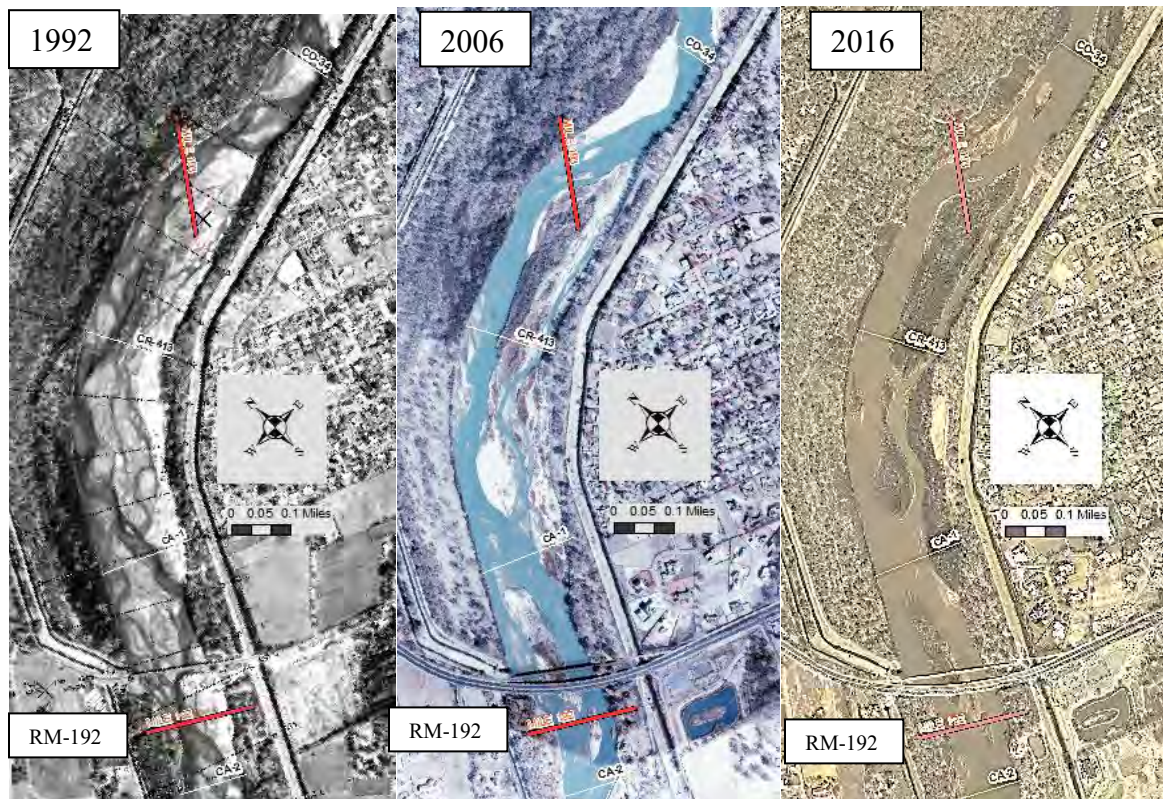
Figure 16 Changes in the planform above Alameda Bridge, where the braided planform has become established by vegetation, and connected side channels in 2016 imagery. (8).

The changes at CR-400 near the AMAFCA channel, above Paseo del Norte Bridge at the CA-rangelines near RM 191 (7), below Paseo del Norte Bridge to CR-441 (8) are of a similar progression as that identified near CR-372 (Figure 15). The encroachment of vegetation in the form of bank attached bars and islands is evident in these portions of the reach, and the braided channel planform with non-vegetated sand bars has progressed to a single channel. From 2006 to 2016 imagery, the area above Paseo del Norte Bridge shows disconnection of the Calabacillas Arroyo and vegetation stabilizing in the area.

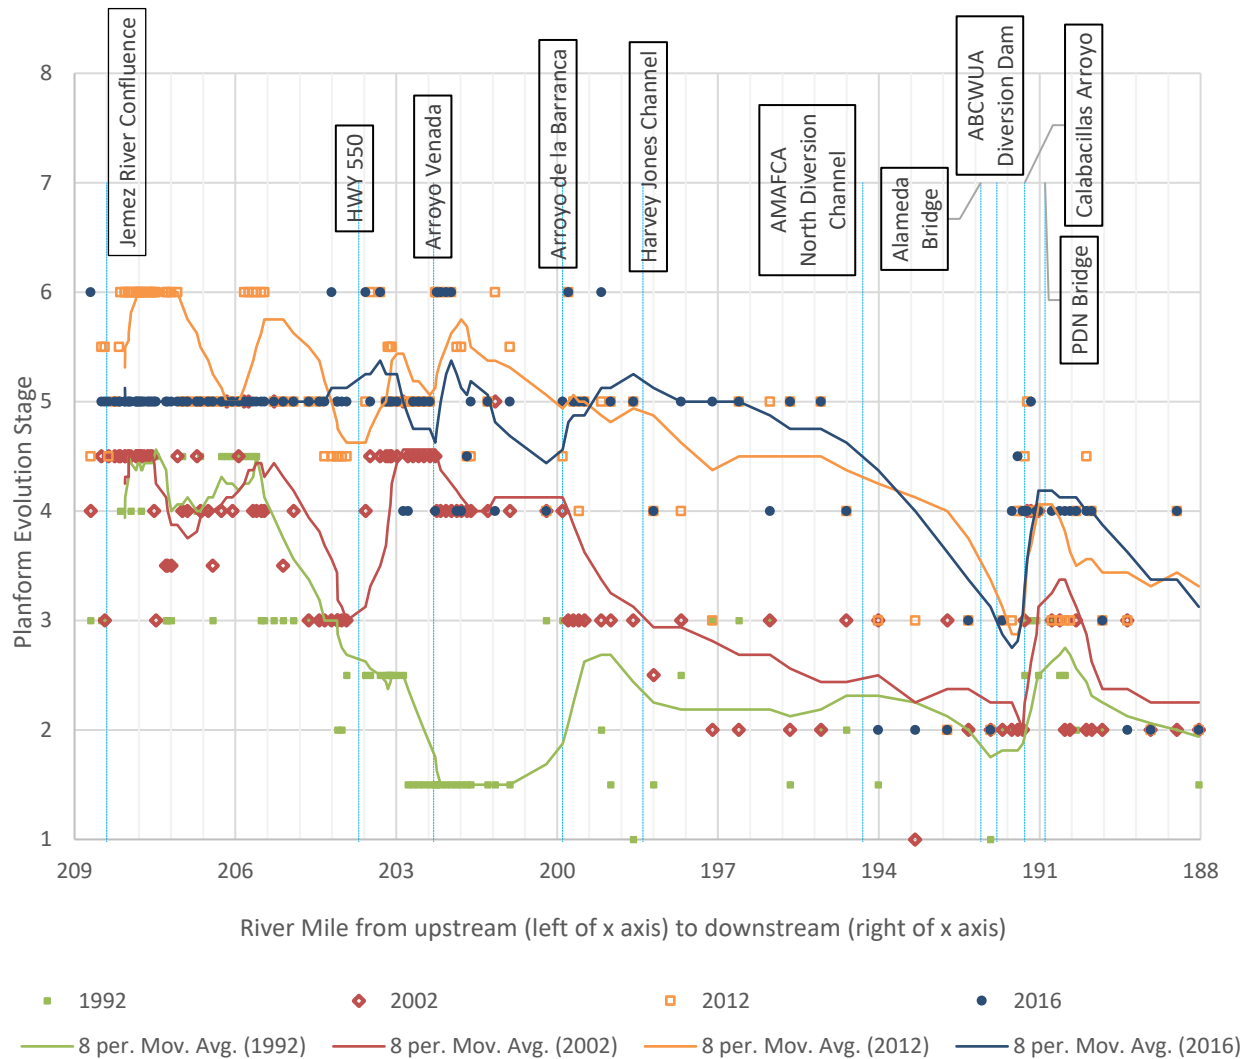
Figure 20 River planform analysis for the Angostura Dam to Montañito Reach, 1992 to 2016.

Figure 20 shows the planform classification for years 1992, 2002, 2012, and 2016. An 8-period moving average was used to demonstrate overall trends in each year. The changes in planform from cross section to cross section would not be expected to have an algebraic relationship, but the moving average shows areas where generally the planform stage is similar or changing relative to surrounding cross sections.

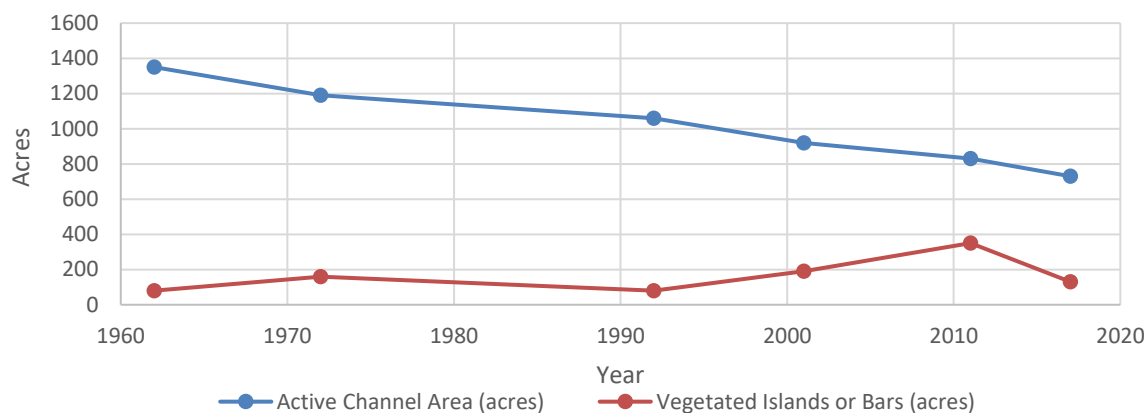
Figure 22 Active channel area in comparison to vegetated islands and bars, modified from Tetra Tech (2013).

Trends are shown in Table 10 and Figure 22, where the active channel area has decreased persistently from 1962 to 2017. The area of vegetated islands and bars have varied, as the islands and bars have likely attached and vegetated to the point of being inaccessible by normal channel discharges. In 2017, it was evident that most islands persisted in the lower part of the reach, Subreaches 2 and 3.

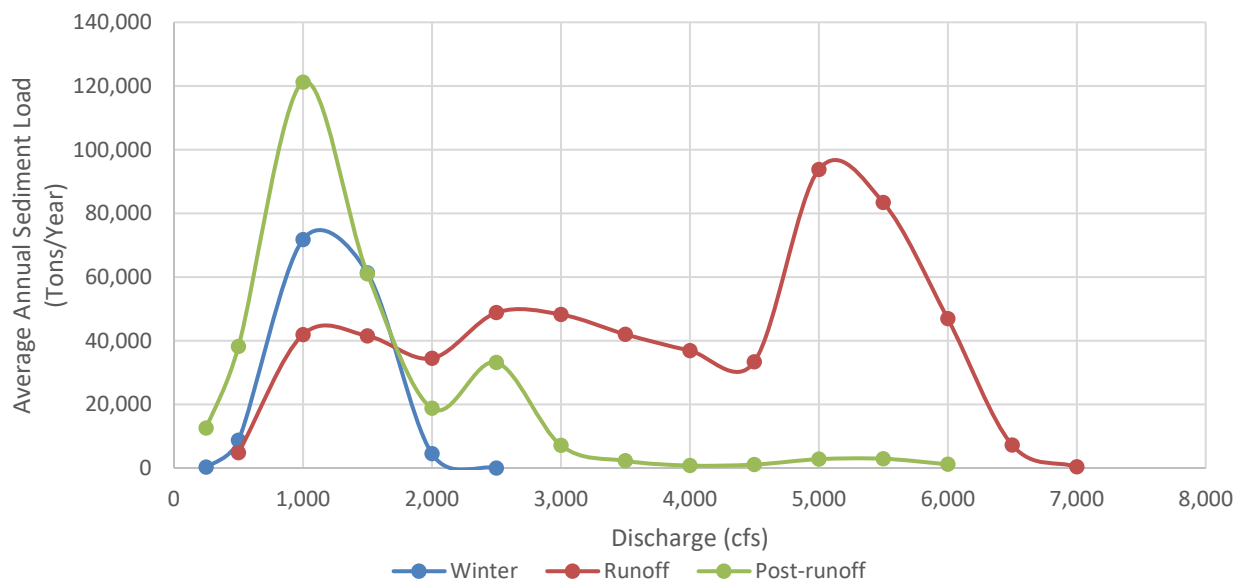
Figure 27 Effective discharge calculations demonstrating the hydrologic seasons and the sediment transported per unit discharge.

The results (Figure 27) indicate that for the post-runoff or monsoon season 1,000 cfs is the most effective at transporting sediment in this reach. For the winter season approximately 1,100 cfs is the most effective in transporting sediment, and for the spring runoff season about 5,100 cfs is the most effective for transporting sediment. The fact that the post-runoff season has the highest sediment load in tons indicates the influence of upstream tributaries to the reach such as Jemez or other tributaries conveying sediment, some unchecked by upstream dams. The winter season is the least effective at transporting sediment.
