# **Aggradation and Degradation of the Palisades Gully Network, 1996 to 2005, with Emphasis on the November 2004 High-Flow Experiment, Grand Canyon National Park, Arizona**

Open-File Report 2008–1264

By Joseph E. Hazel, Jr., Matt Kaplinski, Roderic A. Parnell, and Helen C. Fairley

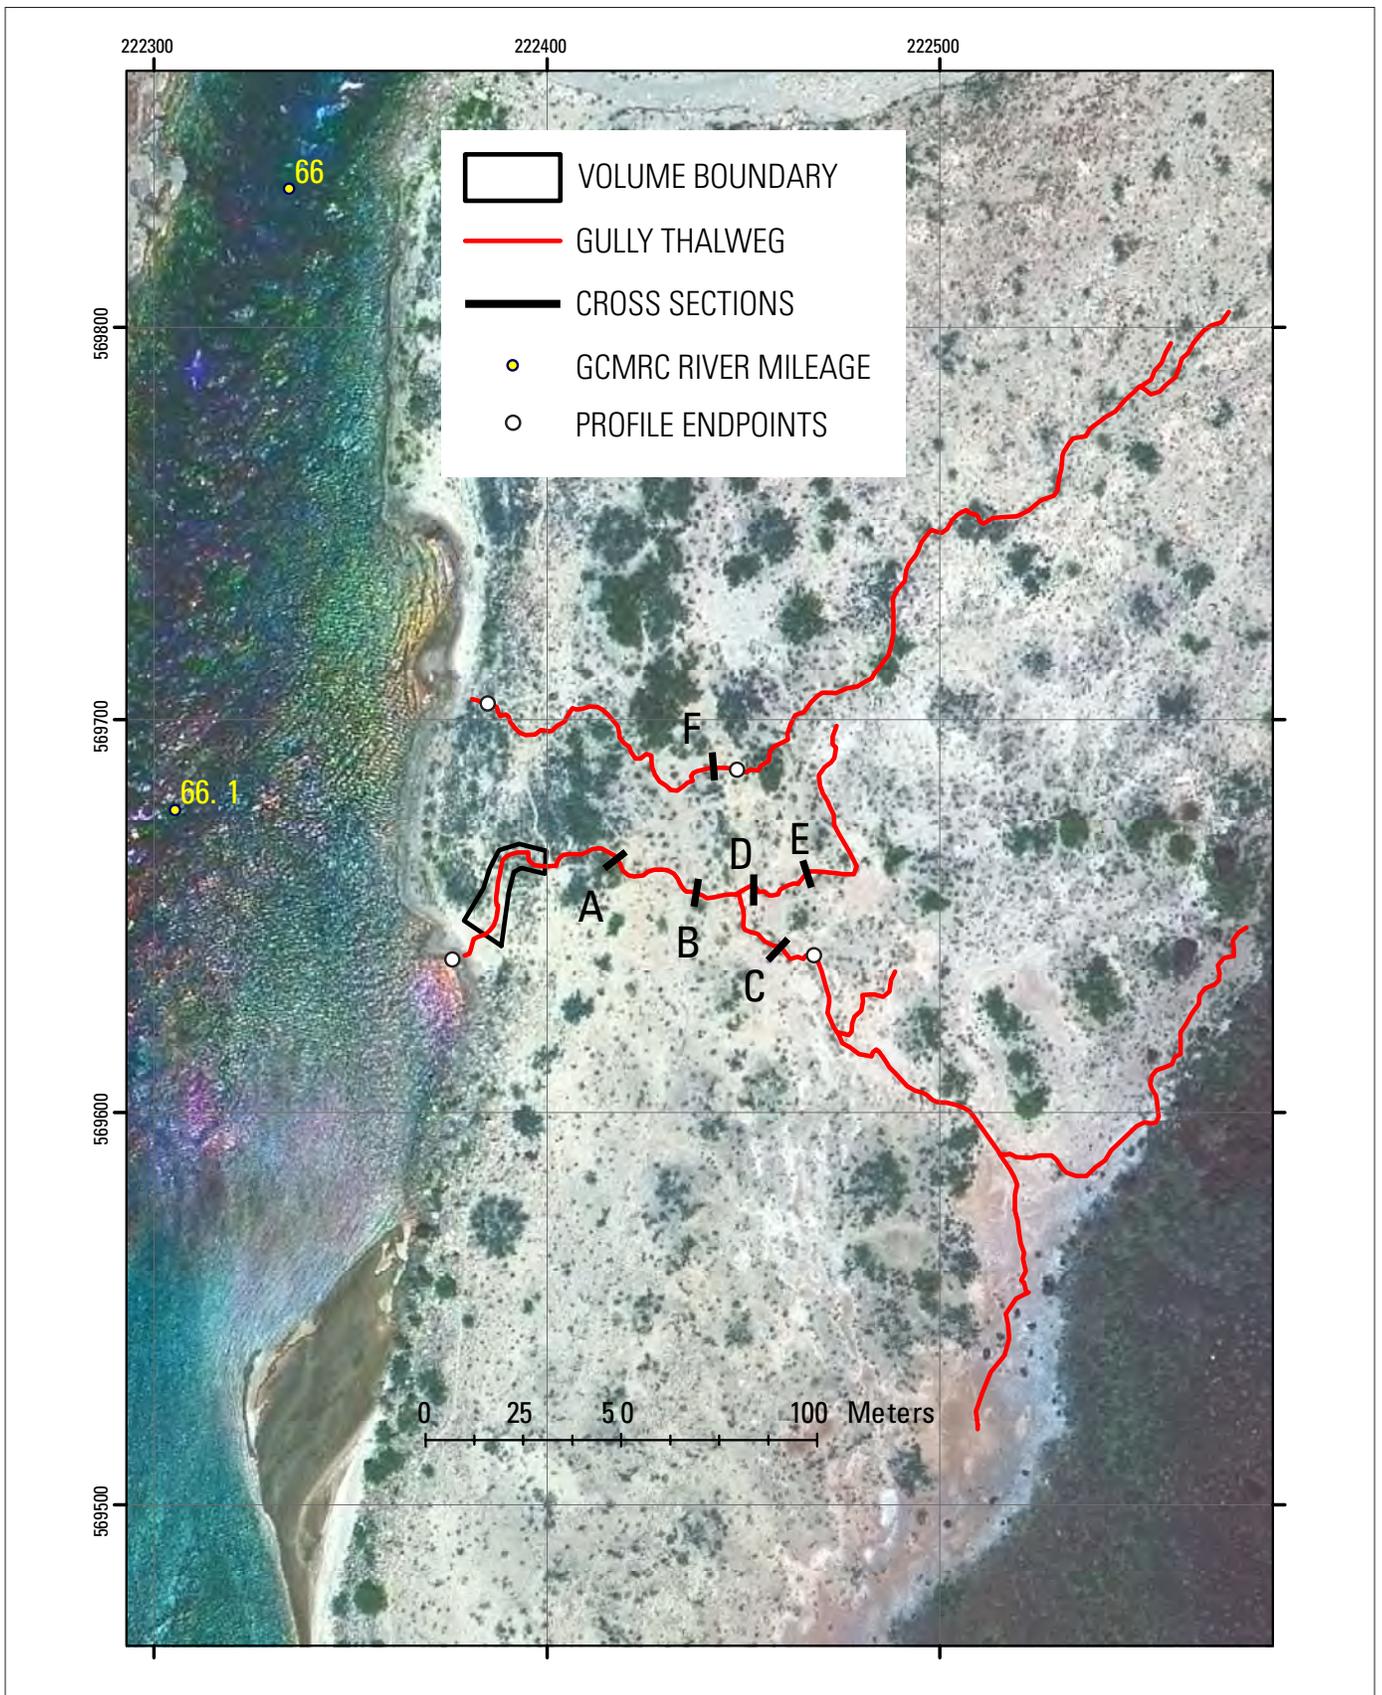
**Figure 2.** Aerial photograph taken in May 2002 showing the Palisades gully network. Colorado River discharge is approximately 226  $\text{m}^3/\text{s}$  and flow is from top to bottom of the photograph. Location is shown on figure 1.

The drainage network consists of two adjacent gullies, with numerous subsidiary channels (fig. 2). The local catchment is large (about 2 ha) and drains from the playa-dune complex on top of the highest terrace and from the southern margin of the Palisades debris fan (Hereford, 1996; Pederson and others, 2003). Terrace incision appears to have begun sometime after 1890; erosion increased dramatically between 1973 and 1984 (Hereford and others, 1993). By 1980, the drainage network extended across the dunes to the Colorado River (Thompson and Potochnik, 2000).

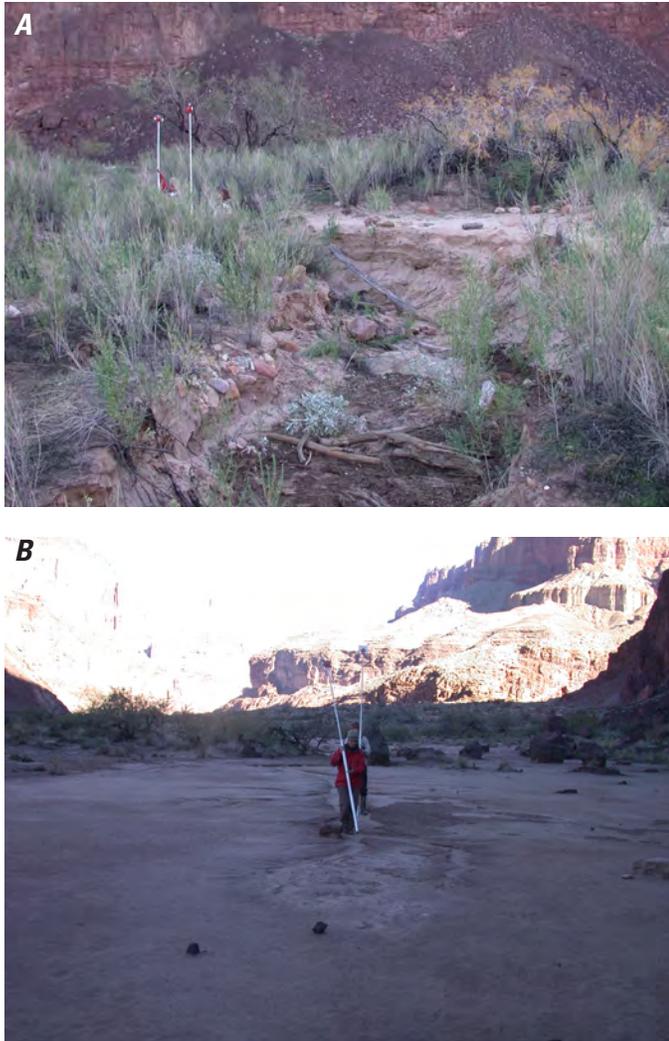
**Figure 3.** Photographs of the Palisades gully network taken on November 17, 2004. *A*, The south gully as viewed toward the playa catchment area. The Cardenas Basalt and a talus slope in background form the distal margin of the catchment area. *B*, The unvegetated playa catchment at the eastern margin of the Palisades area as viewed to the north. Photographs by David Topping, U.S. Geological Survey.

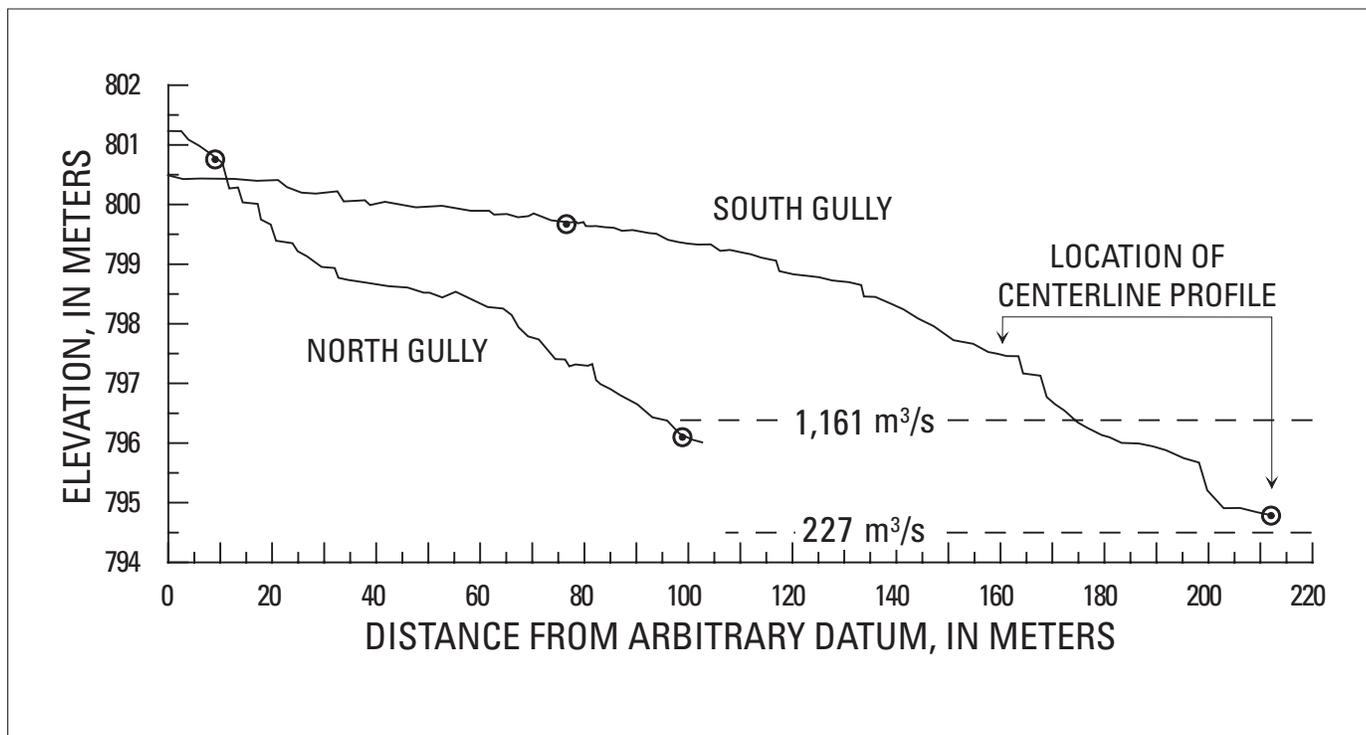
**Figure 4.** Longitudinal gully profiles showing the stage elevations reached by flows of  $227 \text{ m}^3/\text{s}$  and  $1,161 \text{ m}^3/\text{s}$  and the mouth area discussed in the text; the symbols indicate normalized profile endpoint locations. Note that the  $1,161 \text{ m}^3/\text{s}$  discharge of the 2004 high-flow experiment was insufficient to inundate the north gully mouth.

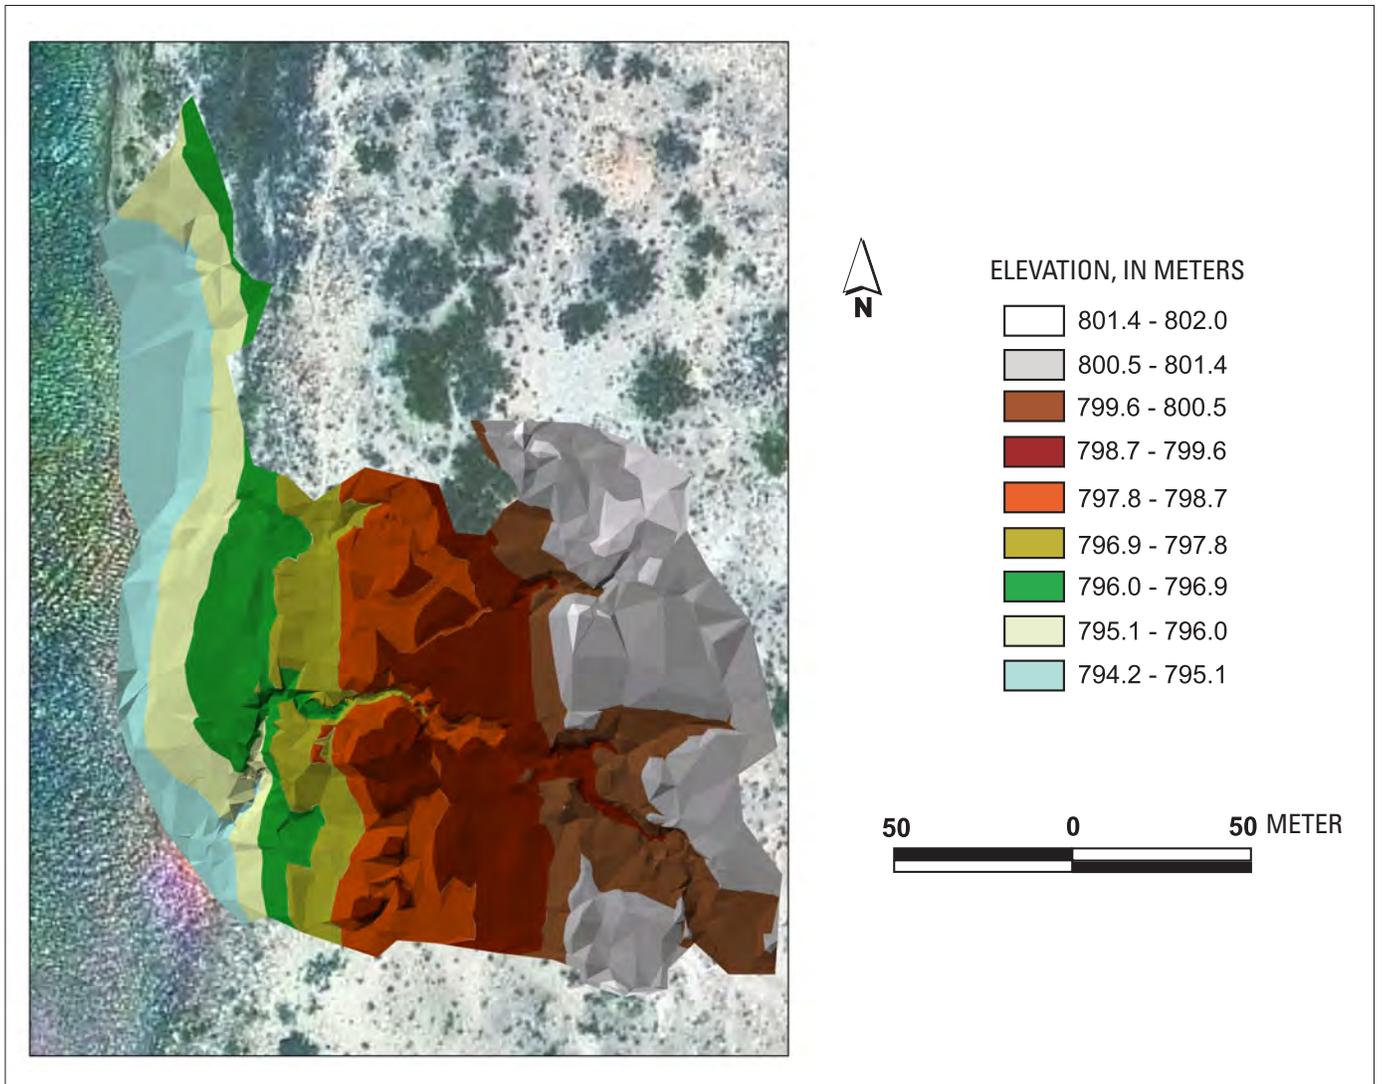
**Figure 5.** Palisades drainage network topography constructed from the point data collected on November 20, 2004.

Digital elevation models (DEMs) were created from surveys where survey extent allowed using surface modeling software (fig. 5). The DEMs were used to calculate volume changes and to delineate a channel centerline along equally spaced 0.2-m distances in the south gully mouth between the 566 and  $1,274 \text{ m}^3/\text{s}$  stage elevations. However, it is difficult to account for channel sinuosity with this method, and elevation errors are introduced with increasing gully length and convexity. Pederson and others (2003) developed a technique, which was adopted by this study, to compare longitudinal gully profiles by normalizing points collected along the gully thalweg between two fixed endpoints. The endpoint locations are shown in figures 2 and 4. Neither centerline method nor the normalized alternative method is “noise free,” and considerable variation is introduced to the profile depending on how the check dams and thalweg were defined and surveyed by different researchers. The centerline method is less subjective than the normalized alternative, which

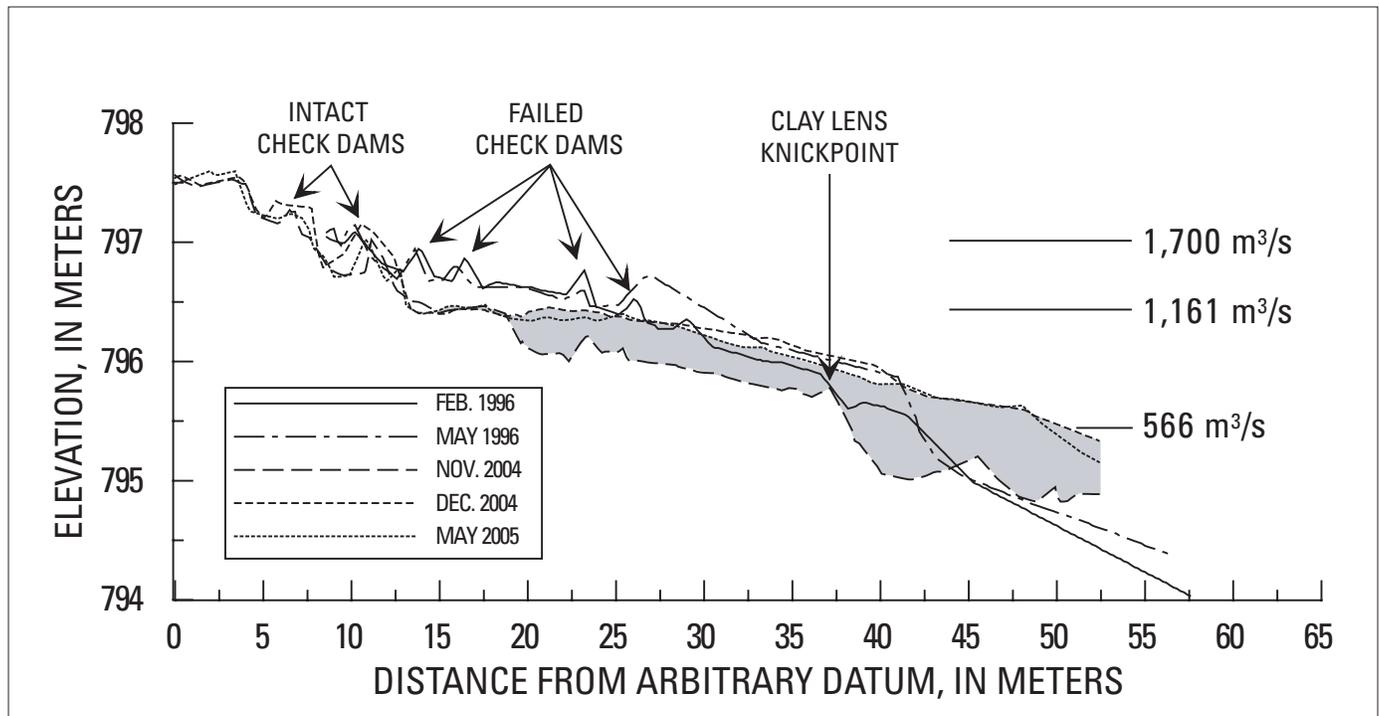
**Figure 6.** Pre- and post-flood centerline longitudinal profiles of the south gully mouth. The gray shaded area represents infilling of the gully mouth by the 2004 high-flow experiment (HFE). Variation in the longitudinal profile at elevations higher than those reached by the experimental flows is possibly the result of remediation efforts between 1997 and 2004 but also may represent inaccuracies in centerline positioning.

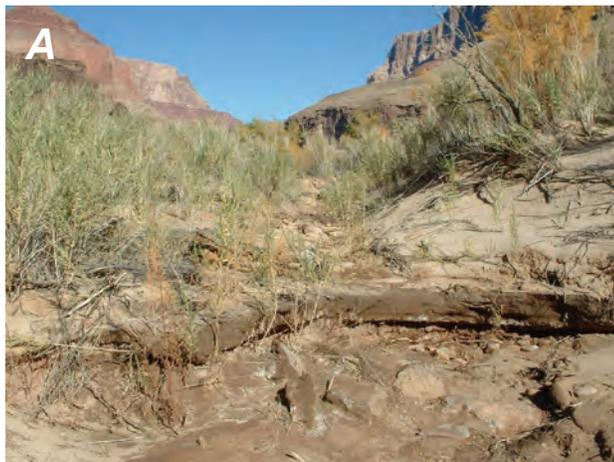
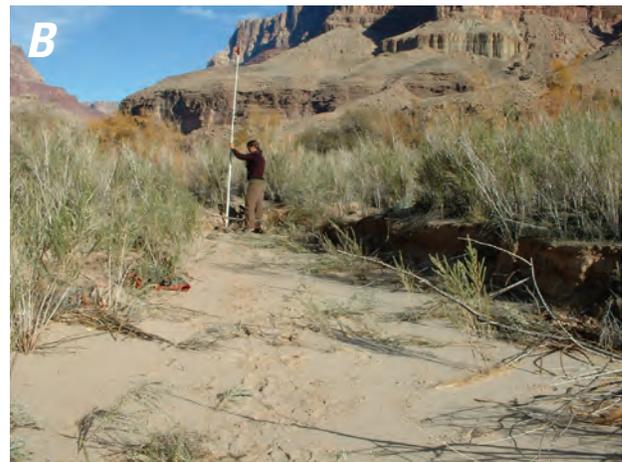
**Figure 7.** The south gully mouth viewed from the terminus at the Colorado River. *A*, The clay lens knickpoint as it appeared on November 20, 2004. *B*, Deposition in the gully bottom and erosion of the southern margin of the gully wall. Photographs by Amy Draut, U.S. Geological Survey.

capped by a 0.2-m-thick layer of silt and clay, was buried by nearly 1 m of new sediment (fig. 7A). Erosion and bank retreat at the southeast margin of the gully wall, near the edge of the lowermost terrace, resulted in widening of the gully mouth (fig. 7B). About 12.0 m<sup>3</sup> of material was eroded from these areas, but the net change was positive (table 2). Infilling of the south gully was substantially greater in 2004 than infilling observed in 1996 because the gully mouth was considerably larger in 2004 (Increased accommodation space is discussed in a following section.).

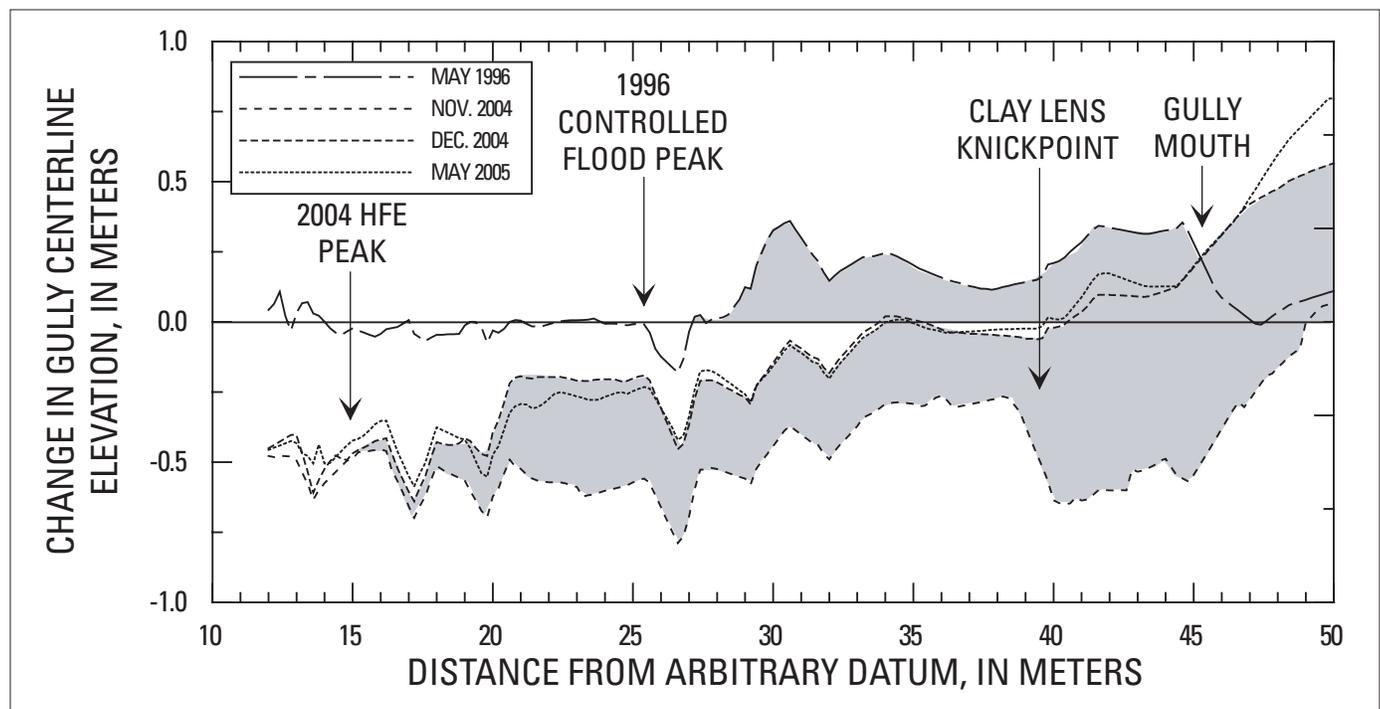
**Figure 8.** Pre- and post-flood changes along the centerline longitudinal profile of the south gully. Changes in gully elevation are with reference to a common datum (the solid horizontal line) defined by the pre-1996 flood condition. The gray shaded area represents infilling of the gully mouth by the 1996 controlled flood and 2004 high-flow experiment (HFE). Note that the 2004 HFE extended into the gully mouth about 10 m farther from the Colorado River than did the higher magnitude 1996 controlled flood.

tion increase along the channel centerline following the 1996 controlled flood was 0.16 m compared to 0.34 m following the 2004 HFE (fig. 8). The sediment deposited in the south gully mouth by the 1996 controlled flood was still largely present in May 1999, after which the gully was incised 0.5 m in the 4-yr period before the 2004 HFE (fig. 9). About 66.5 m<sup>3</sup> of material was scoured from the 30 m length of the south gully mouth area (table 2), and four check dams present in the 1990s were entirely removed (fig. 6). As a result of renewed gullying between 1999 and 2004, the 2004 HFE flood peak extended about 10 m farther into the gully (fig. 8). Thus, the marked difference in depositional volume in the south gully mouth is likely the result of greater accommodation space available for deposition in 2004, rather than the result of differences in sediment supply or flood duration between the two flood experiments.

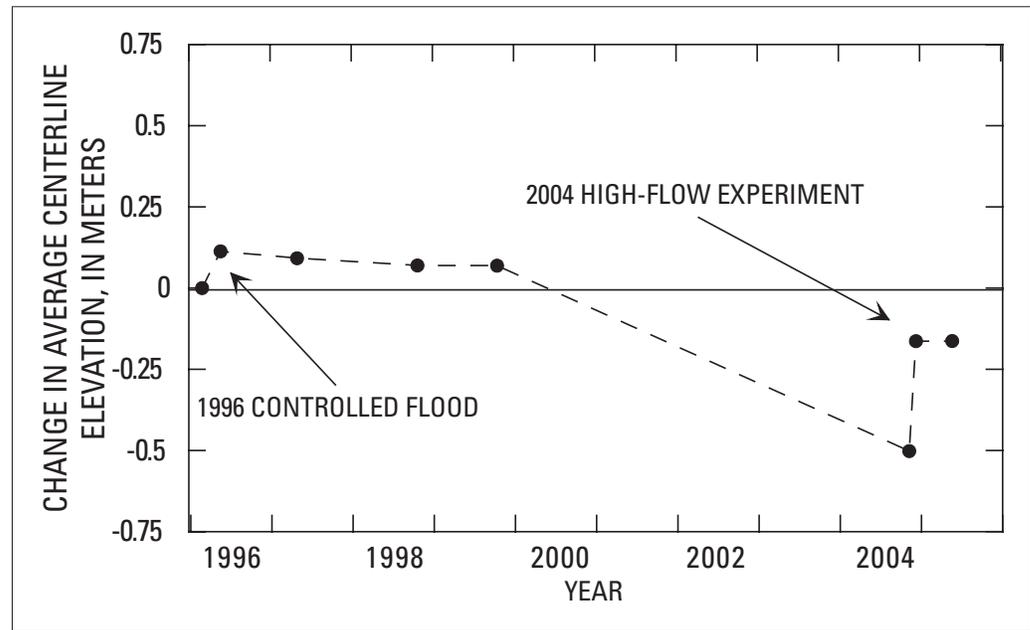
**Figure 9.** South gully mouth time series constructed from the average centerline elevation data in figure 8. The February 1996 elevation equals 0. Note that even though the deposition was two times greater in 2004 compared to 1996, the base level of the gully mouth was not restored to the 1996 pre-flood condition.

The channel centerline method was used to compare the effects of the 1996 controlled flood with those of the 2004 HFE, because detailed thalweg profiles were not measured in 1996 (table 1). In order to directly compare a longitudinal profile in the south gully mouth, the centerline values interpolated from the DEMs were subtracted from the pre-1996 flood values, which was arbitrarily defined as the baseline condition (fig. 8). The points were then averaged to produce a time series of base-level change within the gully mouth (fig. 9).

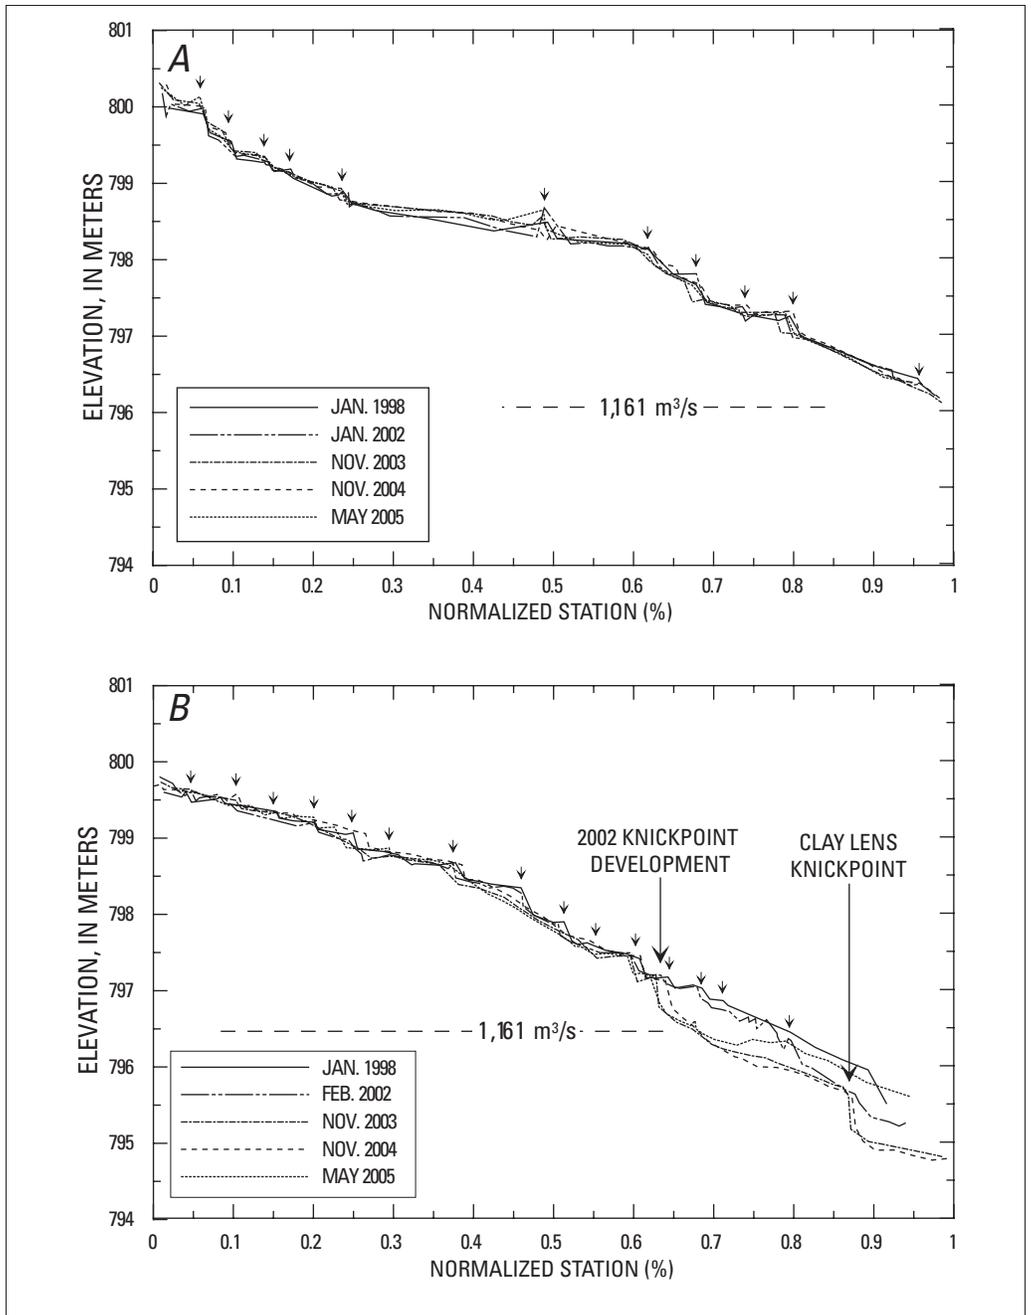
**Figure 10.** Normalized longitudinal profiles. *A*, The 3.9-m drop of the north gully over a length of 85 m. *B*, The 4-m drop of the south gully over a length of 122 m. Data from October 2002, May 2004, and December 2004 are not shown for brevity. Small arrows indicate check dam locations surveyed by the National Park Service in 1998. The profile endpoints are shown in figure 2.

Erosional patterns and knickpoint retreat for a 7-yr period are shown in figure 10. The downstream endpoints are located in each gully mouth and the upstream endpoints are located at the eastern edge of the playa-like catchment area (fig. 2). Interpreting the results is complicated by profile point spacing (table 1) and the removal or maintenance of erosion-control structures between topographic surveys (Dierker and Leap,

The gradient in both gullies steepened between February 1998 and February 2002 (table 3). In the subsequent 8 mo, between February and October 2002, there was a substantial erosional event documented by Pederson and others (2003). A new knickpoint with a clay lens cap developed in the south gully near the mouth, and a previously existing knickpoint advanced up the gully about 27 m (figs. 7A and 10B). The gradient of the south gully increased from 0.037 m in January 2002 to 0.41 m in late September 2002. In the higher gradient north gully, the development of two small knickpoints resulted in a slight steepening of the gradient (fig. 10A).

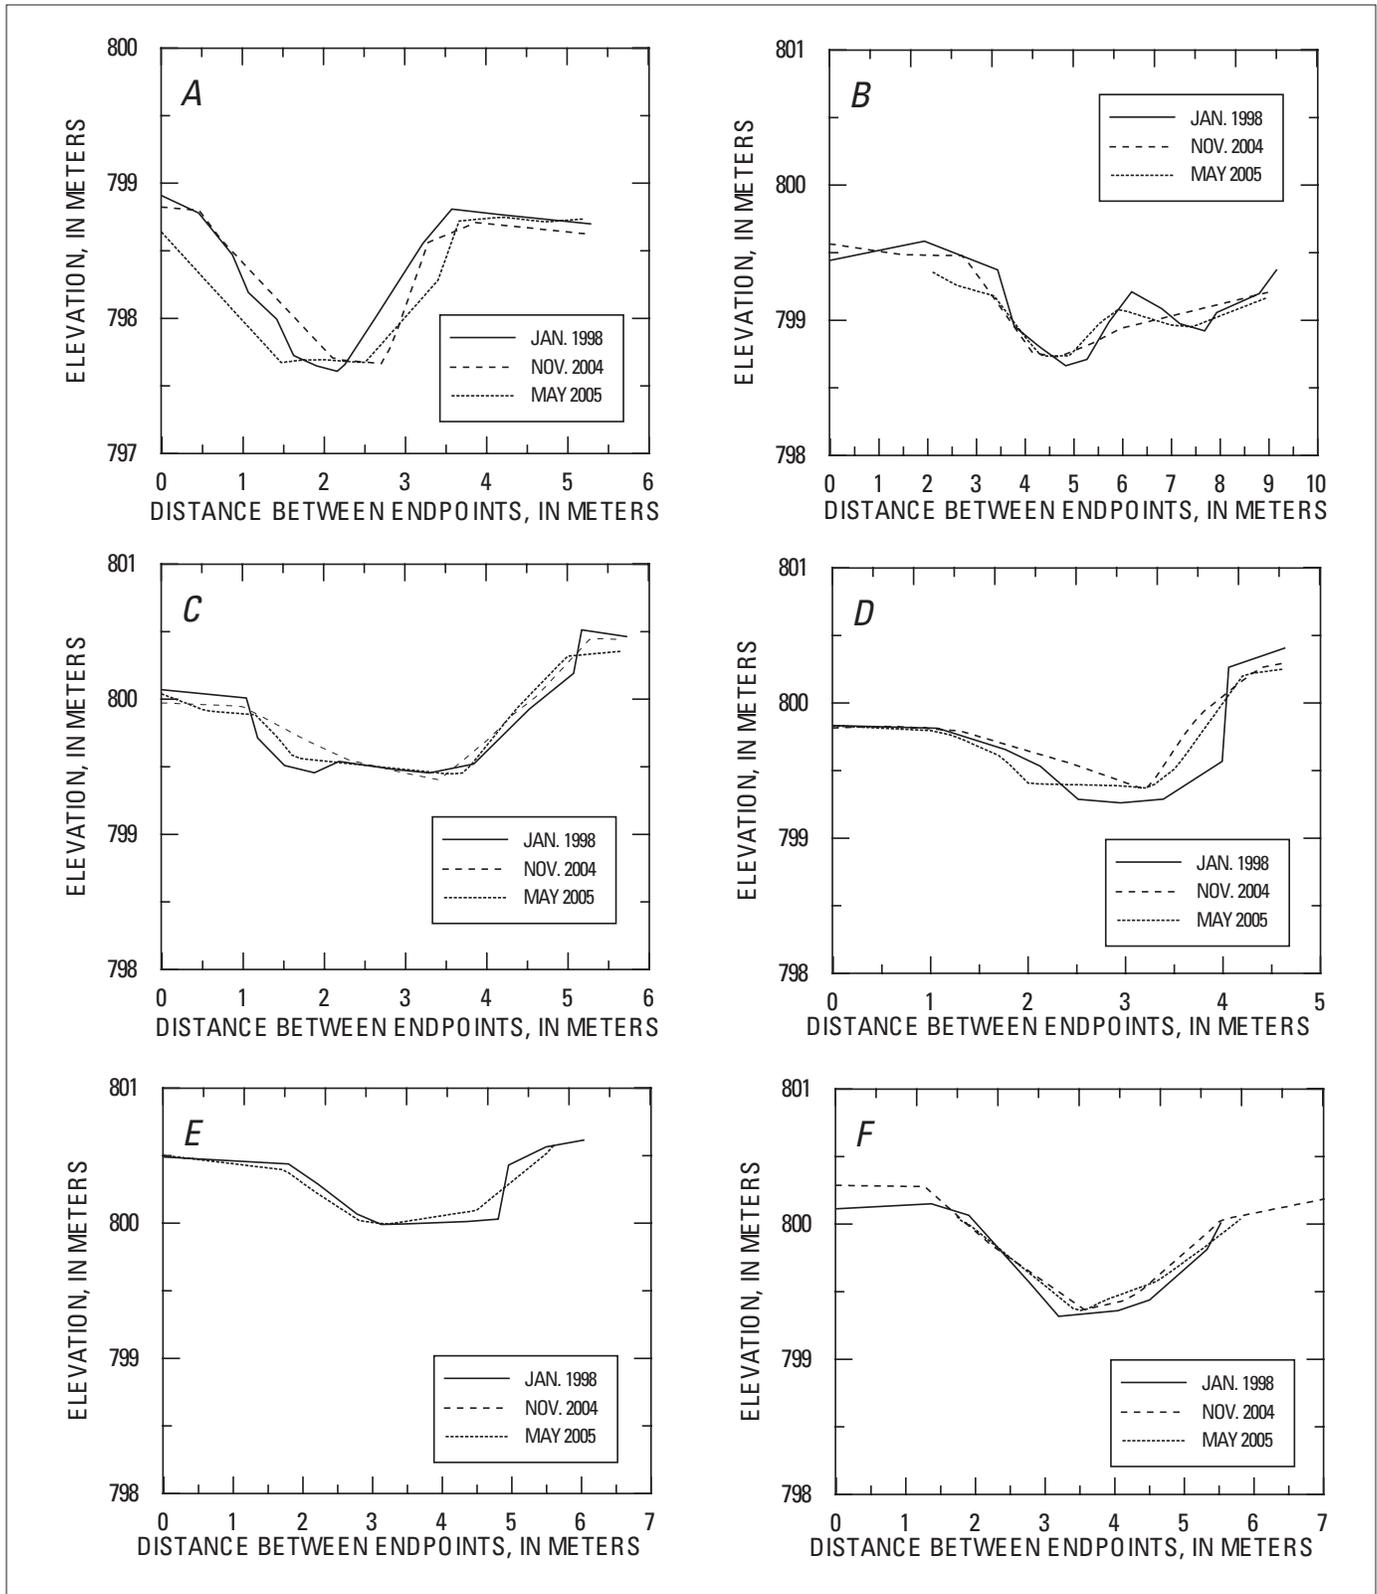
**Figure 11.** Cross sections established by the National Park Service in January 1998. *A*, The lower south gully. *B*, The middle of the south gully. *C*, The upper south gully above the confluence with the first major tributary. *D*, The lower south tributary. *E*, The upper south tributary. *F*, The middle of the north gully. Data from December 2004 are not shown. There was no change in the upper part of the gullies in the 19 days between surveys. Note that all cross sections are above the elevation reached by the 2004 high-flow experiment. Cross sections are viewed in a down-gully direction. Locations are shown in figure 2.
