Dragon Bravo Post-Fire Updates

Dragon Bravo Fire: July 4 – Sept 28, 2025

Grand Canyon National Park (GRCA): 2026 Operations

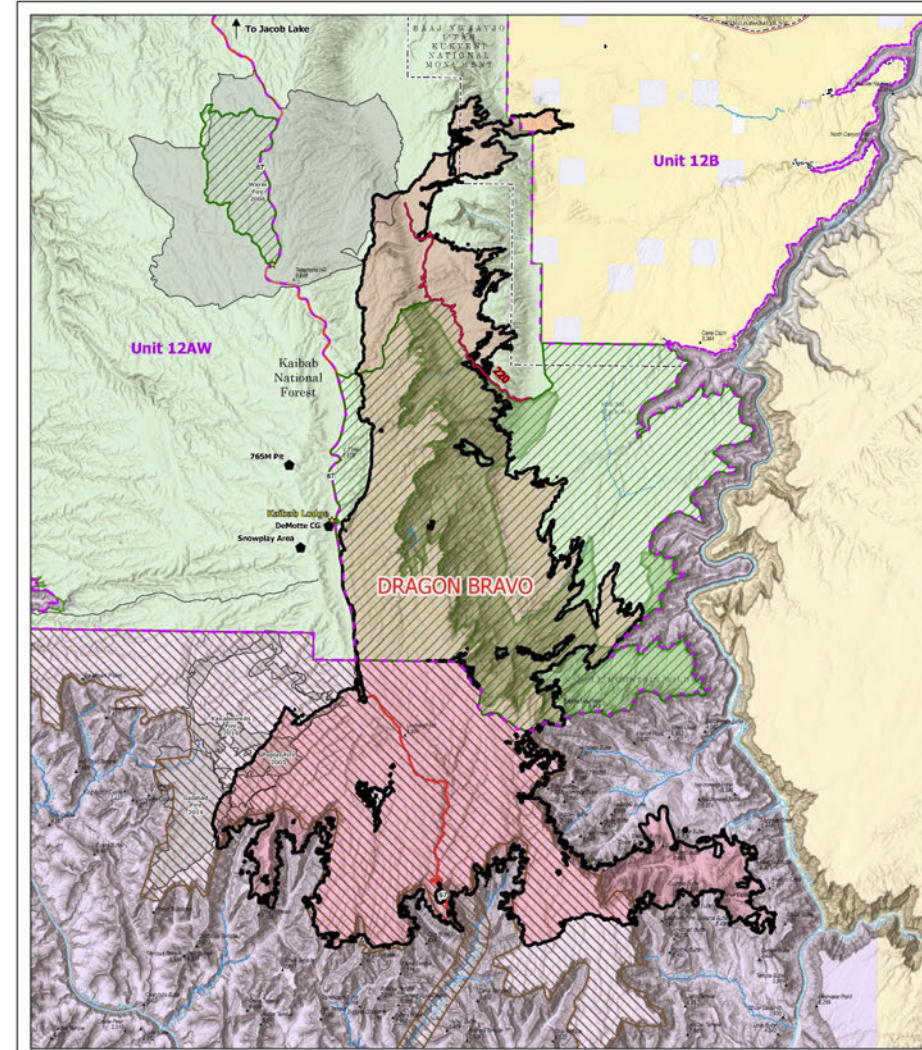
Dragon Bravo
AZ-GCP-000597
9/29/2025

145,504 acres at 8/20/2025 0120

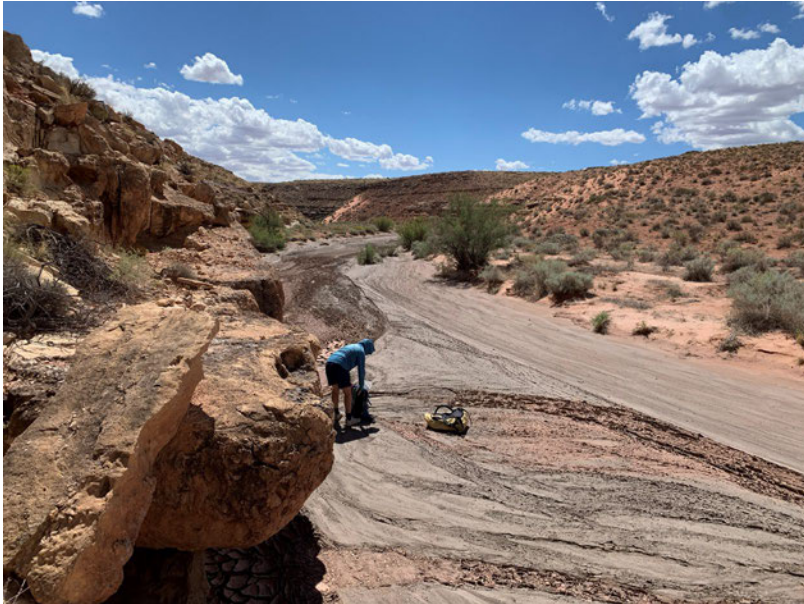
House Rock, 9/9/2025

Tributary Monitoring

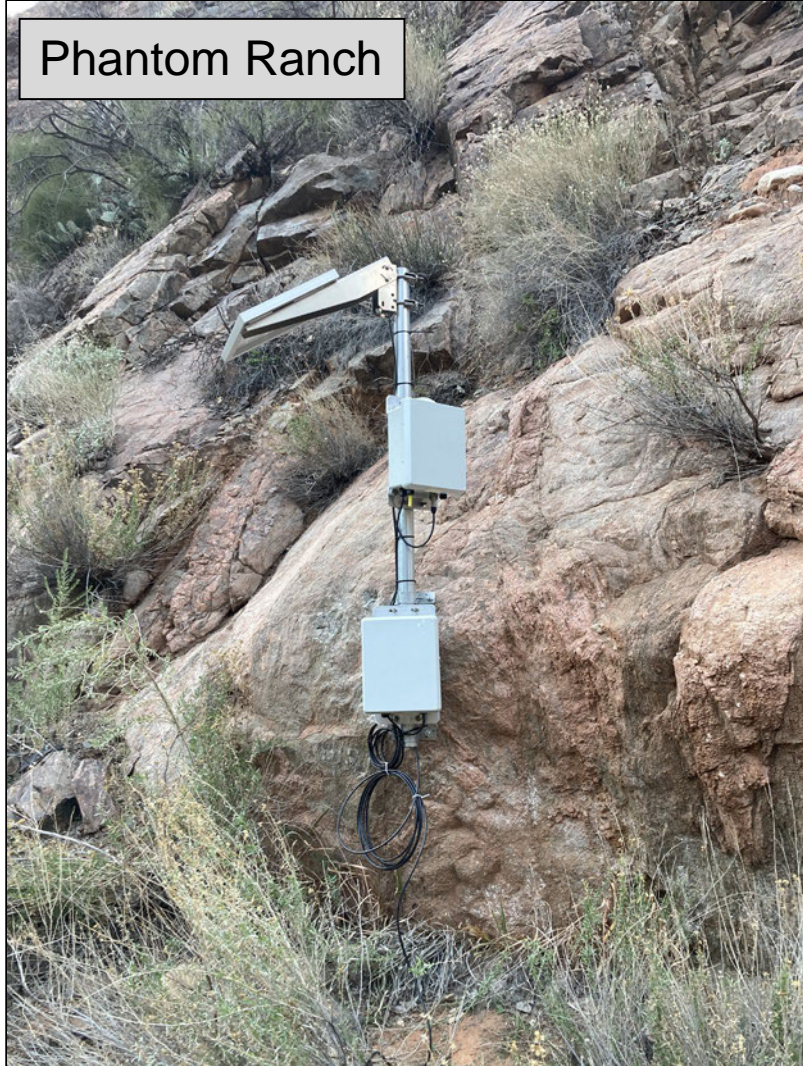
Phantom Ranch

Water Quality Monitoring

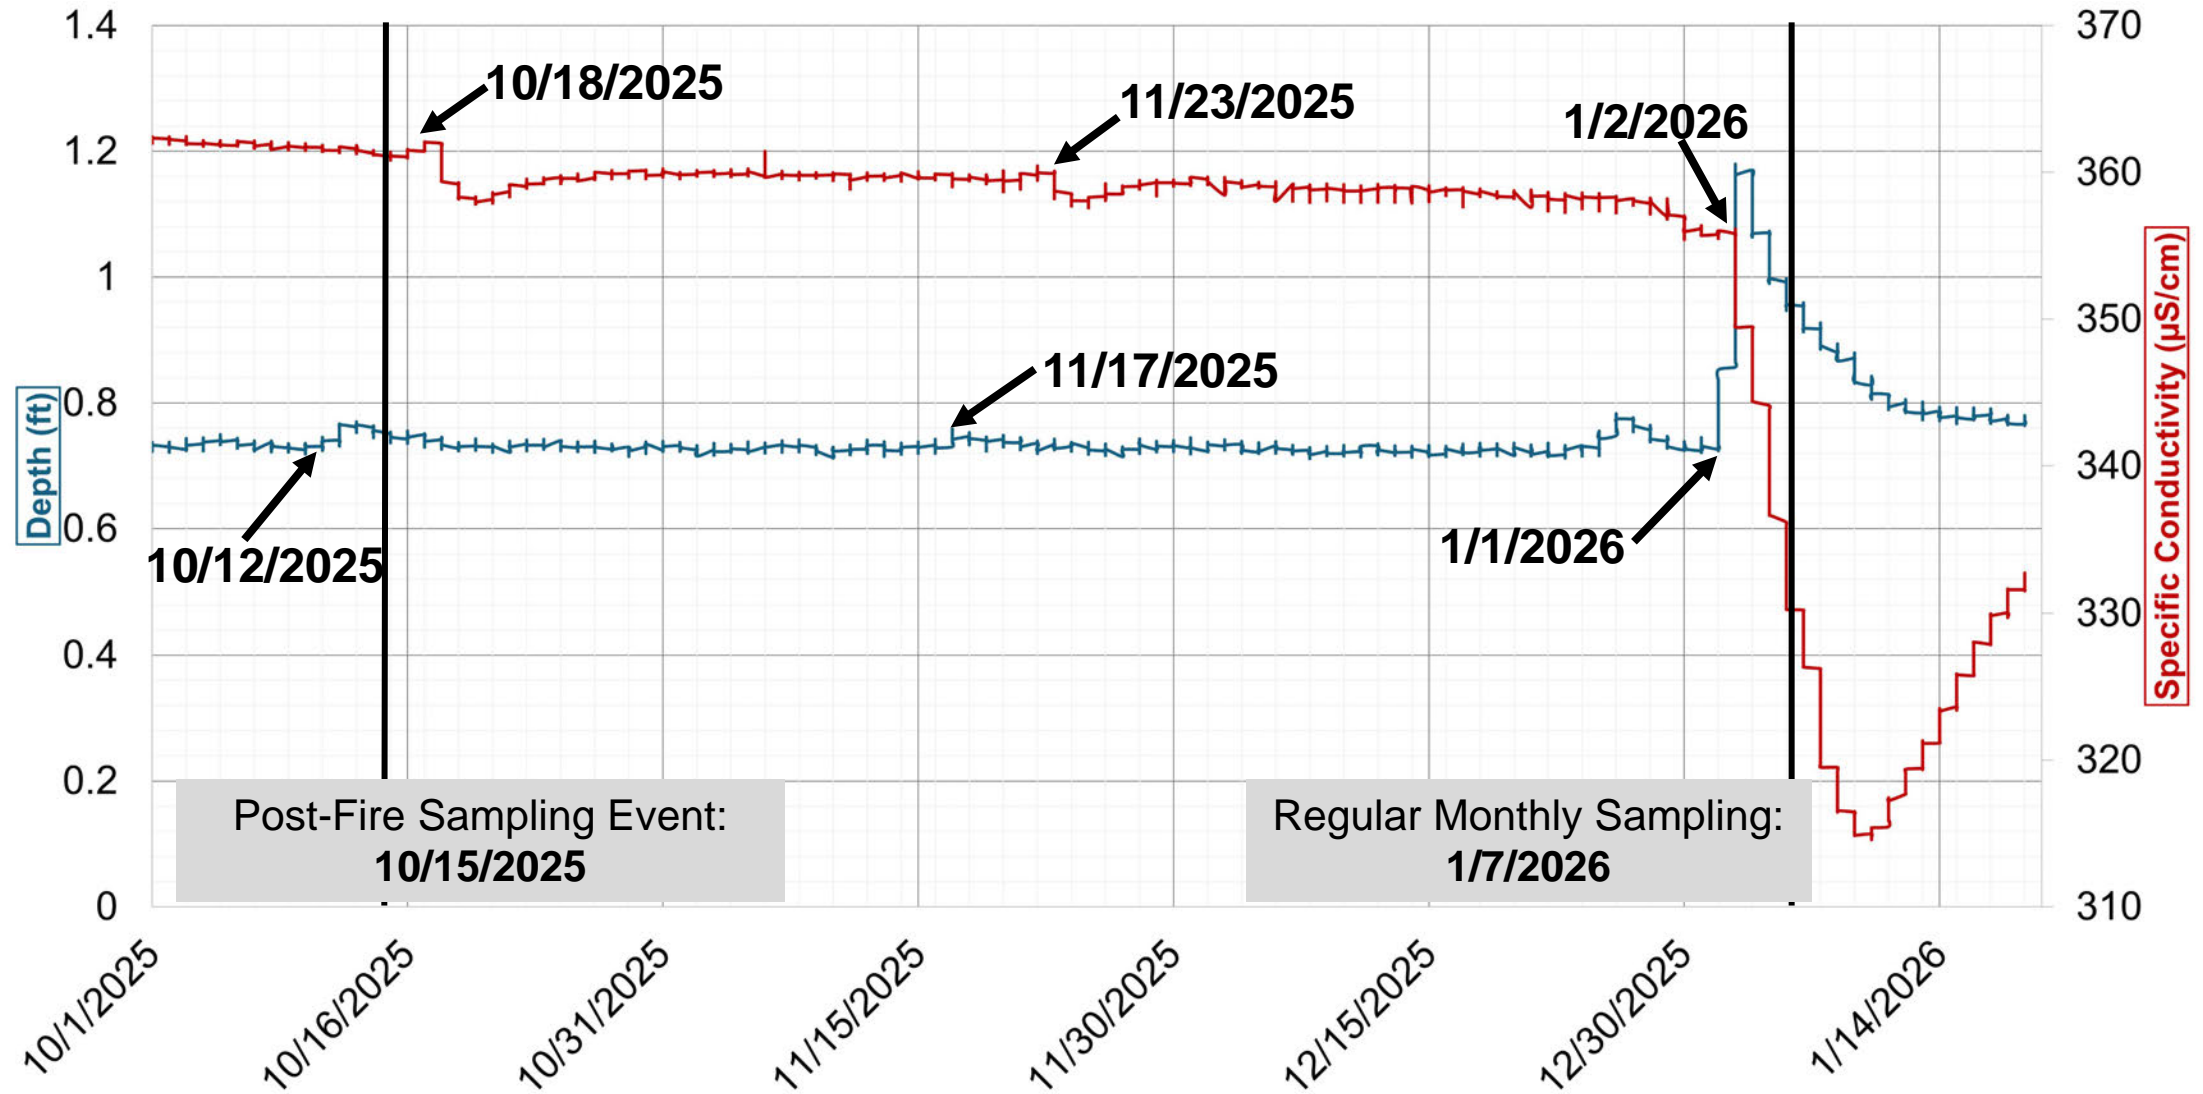
Water Quality Monitoring

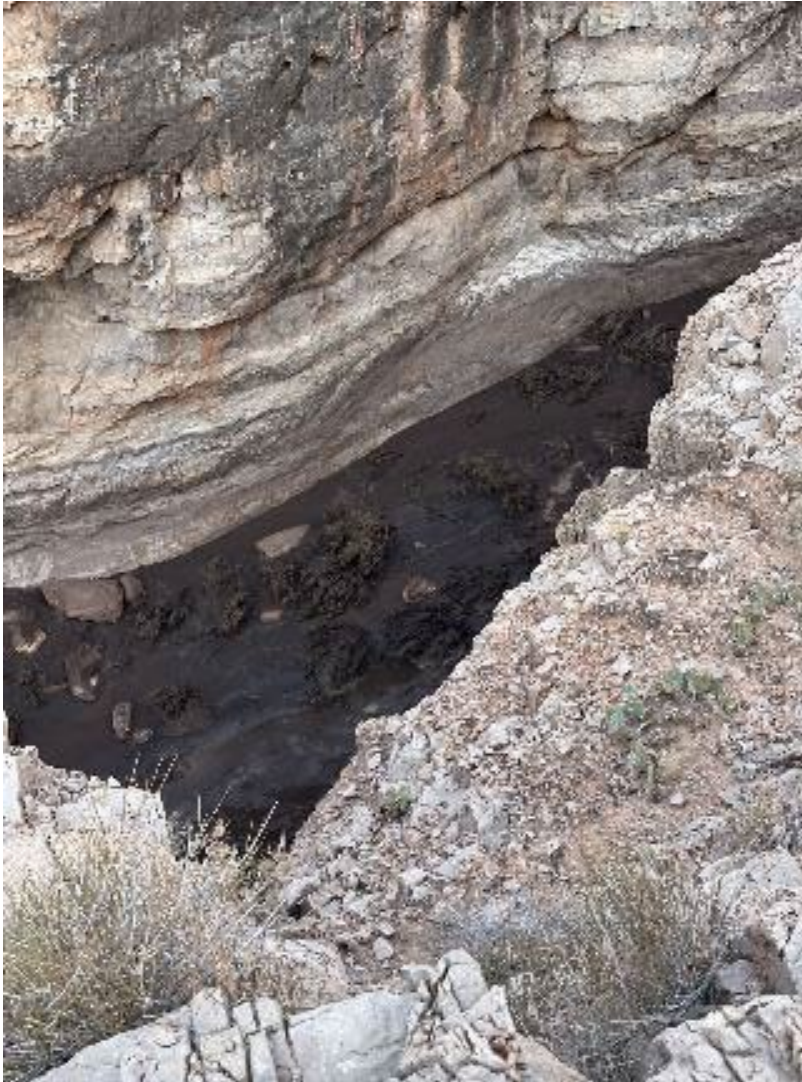
Many reports from river users of flash flooding, blackened water in tributaries and the Colorado River, ash deposition, and water smelling of smoke as far downstream as RM 207.

GCMRC/ FWS- deployed dissolved oxygen sensors:

- above Little Nankoweap Creek (52.02R),
- above Lava Canyon (Chuar) Rapid (65.60 R),
- below Upset Rapid (151.15R), and
- across from Stairway Canyon Camp (171.65L)
