# GULLY EROSION OF CULTURAL SITES

Joel Pederson,  
Paul Petersen, Wally McFarlane  
and Scott Cragun

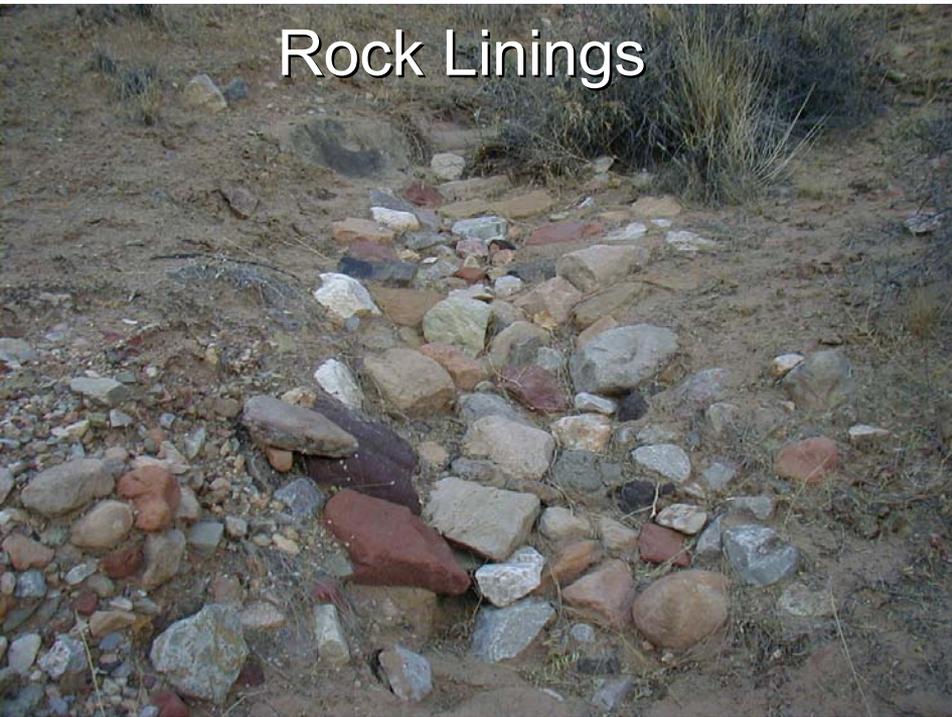
Rock Linings

- Increase roughness, slow flow velocity
- Trap sediment, reduce upchannel gradient

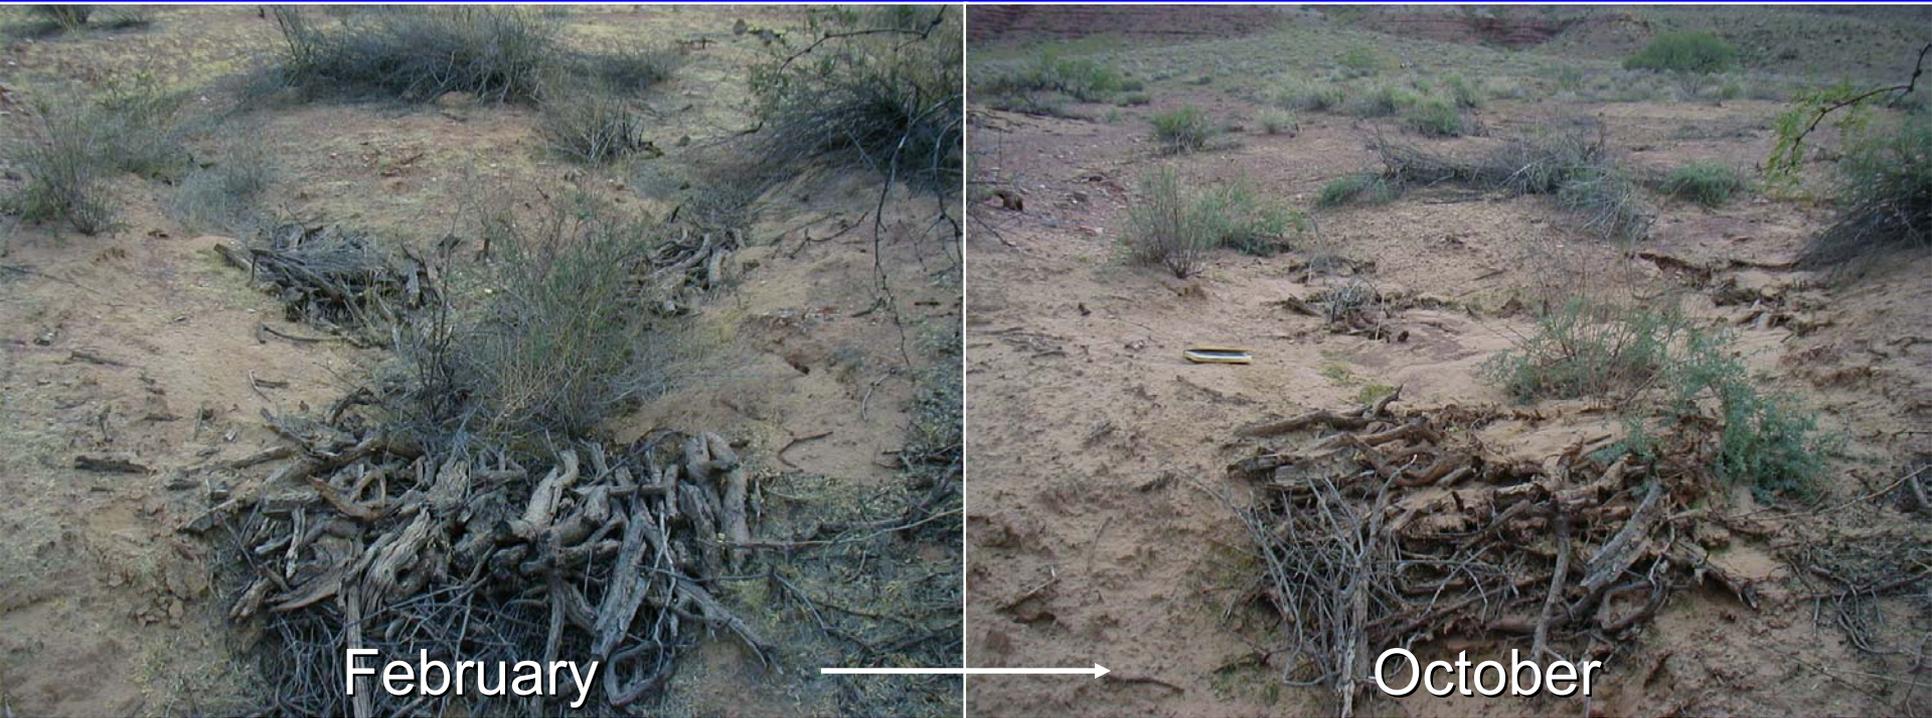
# brush checkdams superior to rock linings

- may stay intact better
- retain sediment
- encourage less scour (permeable)

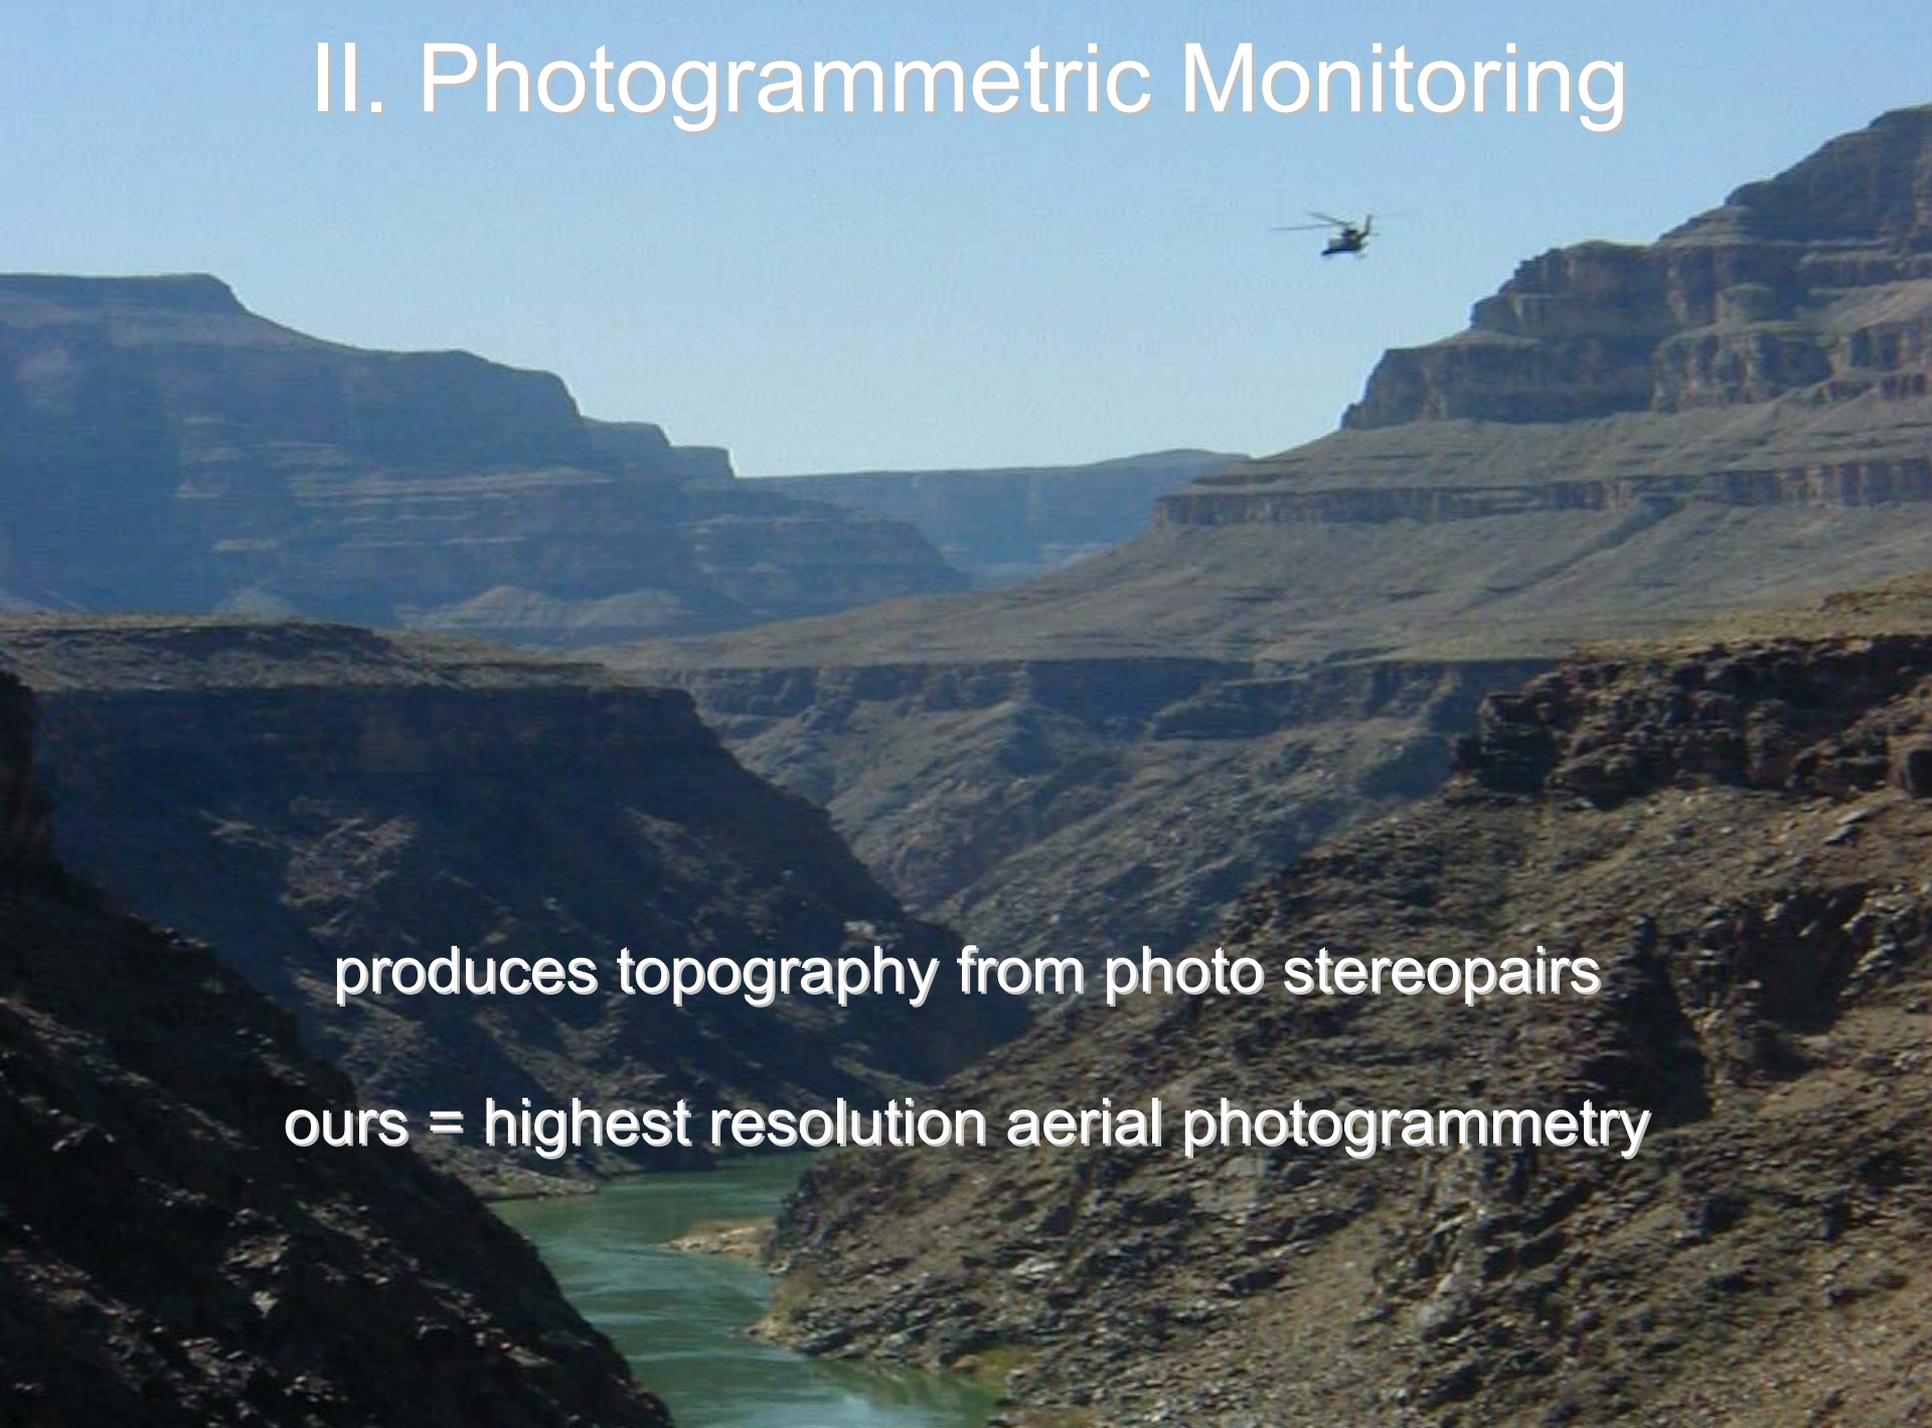
produces topography from photo stereopairs  
ours = highest resolution aerial photogrammetry

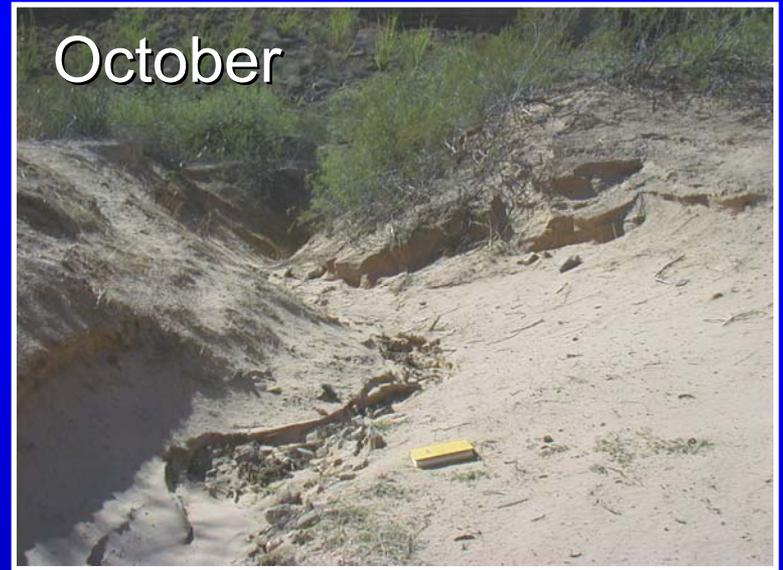
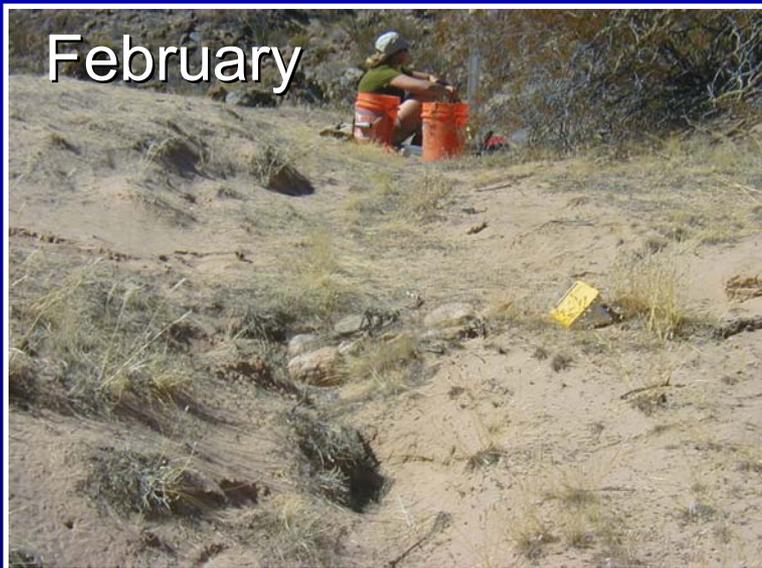
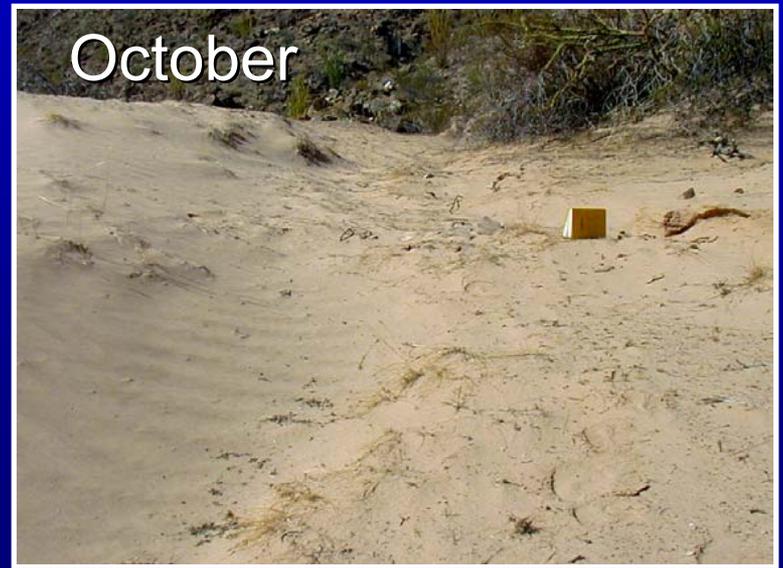
10-20 cm of observed change during study period
