Sandbar Monitoring for November 2012 Controlled Flood

Paul Grams, Bob Tusso, & Joe Hazel

USGS Grand Canyon Monitoring and Research Center with
cooperation from Northern Arizona University, Grand Canyon
National Park, and Grand Canyon River Guides

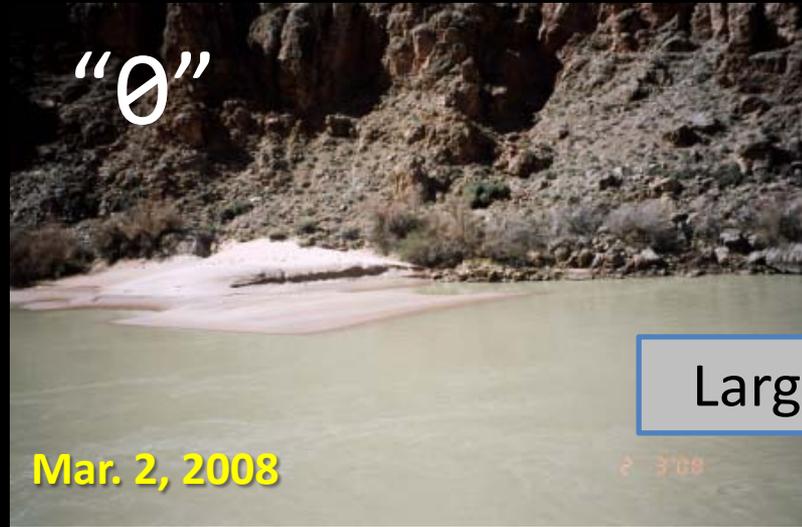
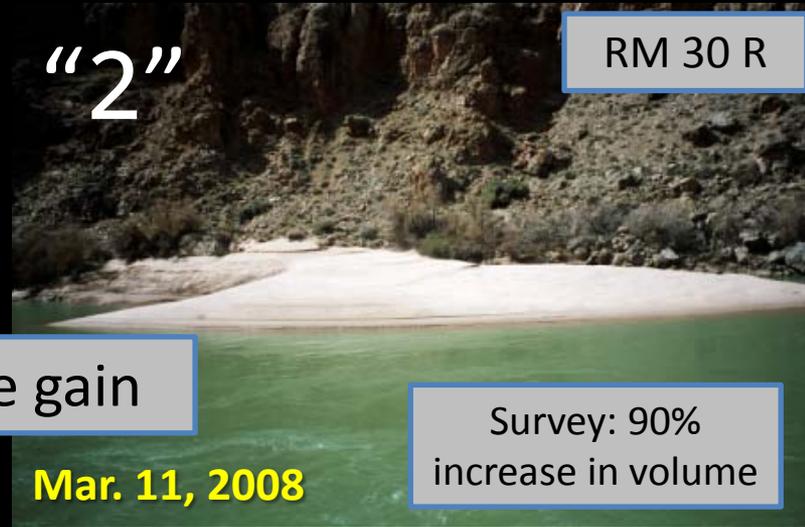
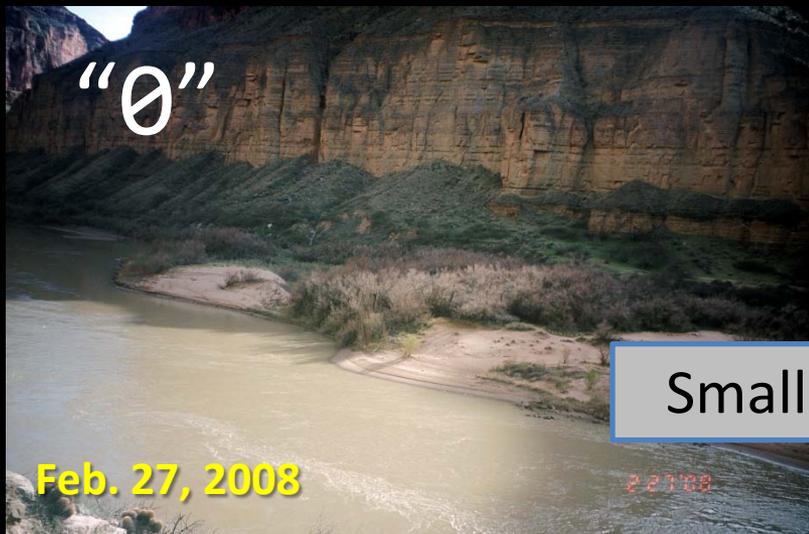
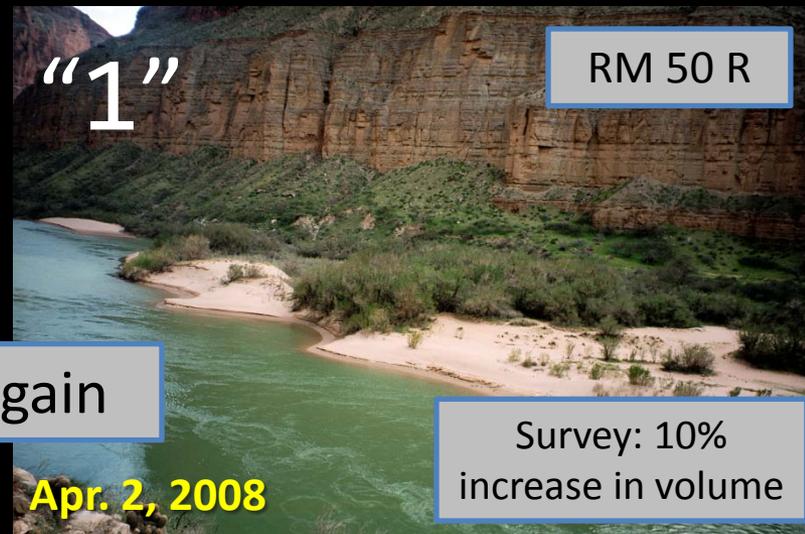
Classified Change in Sandbar Size

Large gain

Small gain

Rating	Apparent change in photos	Measured Change by survey
• 2	Large Increase	> 10 % increase
• 1	Small Increase	3 – 10% increase
• 0	Negligible Change	-3 – +3% change
• -1	Small Decrease	3 – 10% decrease
• -2	Large Decrease	> 10% decrease

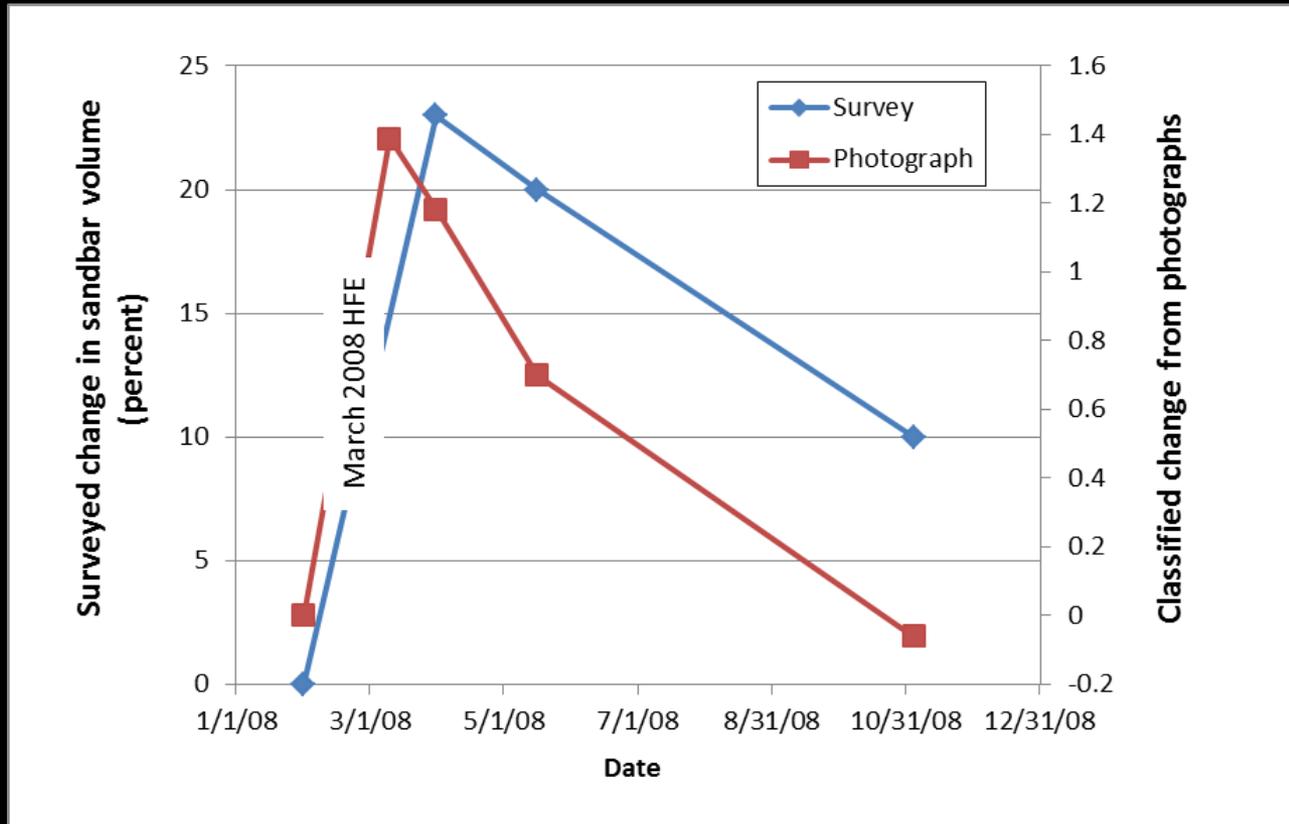
Comparison of Sandbar Response based on Topographic Surveys and Analysis of Images

Average response estimated from photographs is consistent with average response based on topographic surveys

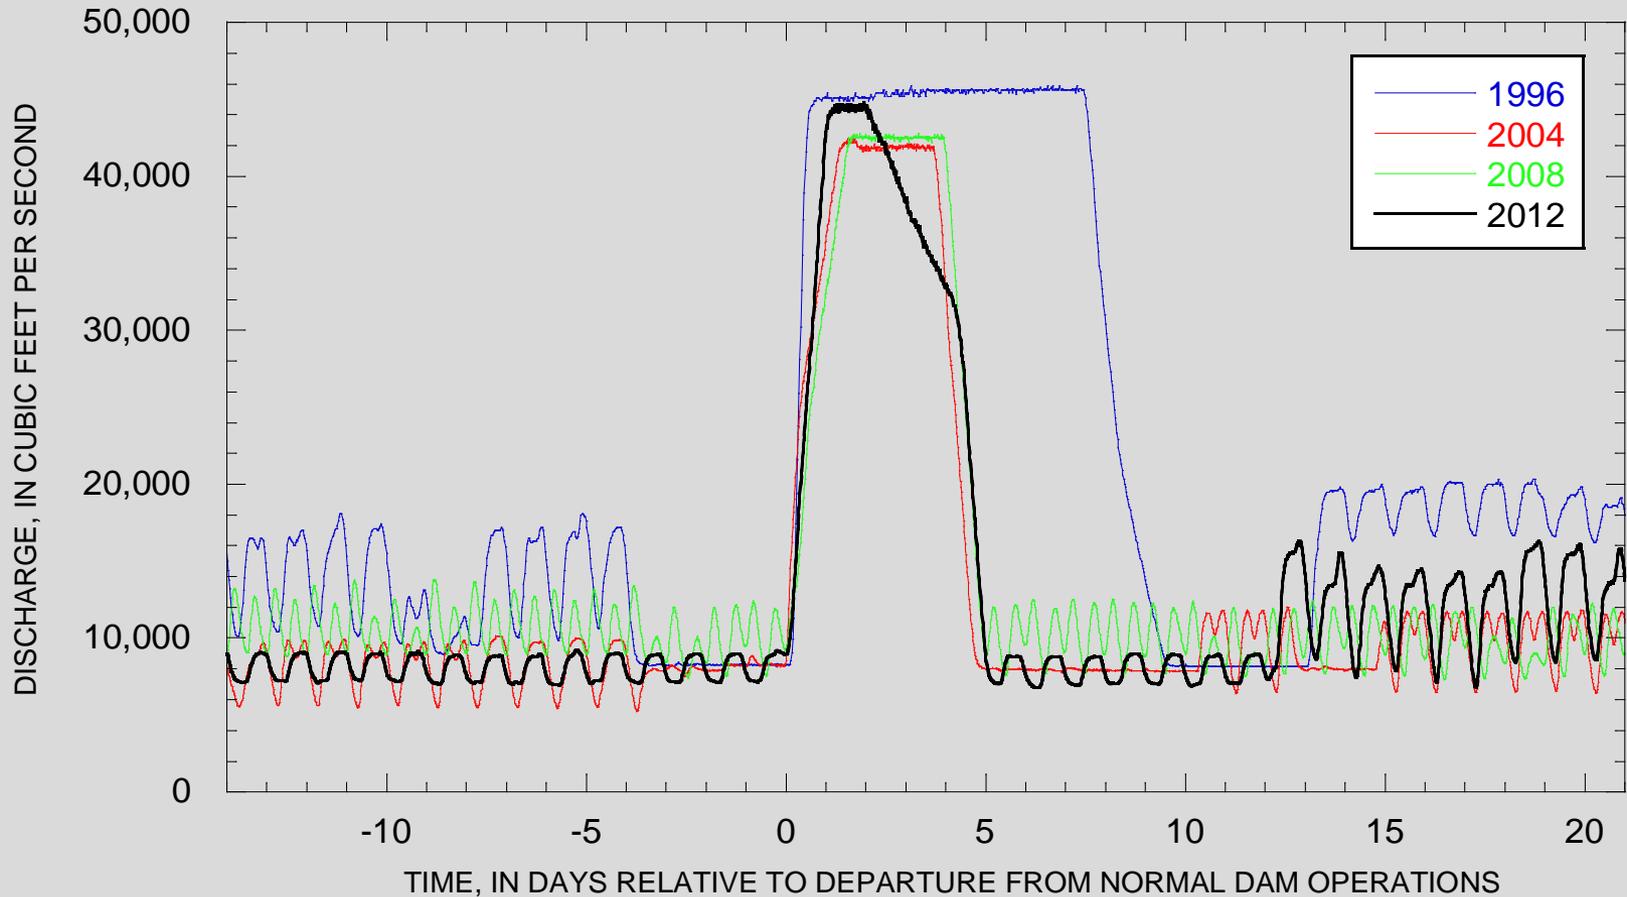
2012 Controlled Flood

- 24 hr. upramp from 7,000 to 43,400 ft³/s
- 24 hr. peak at 43,400 ft³/s

- 53 hr. downramp from 43,400 to 31,200 ft³/s
- 24 hr. downramp from 31,200 to 7,000 ft³/s

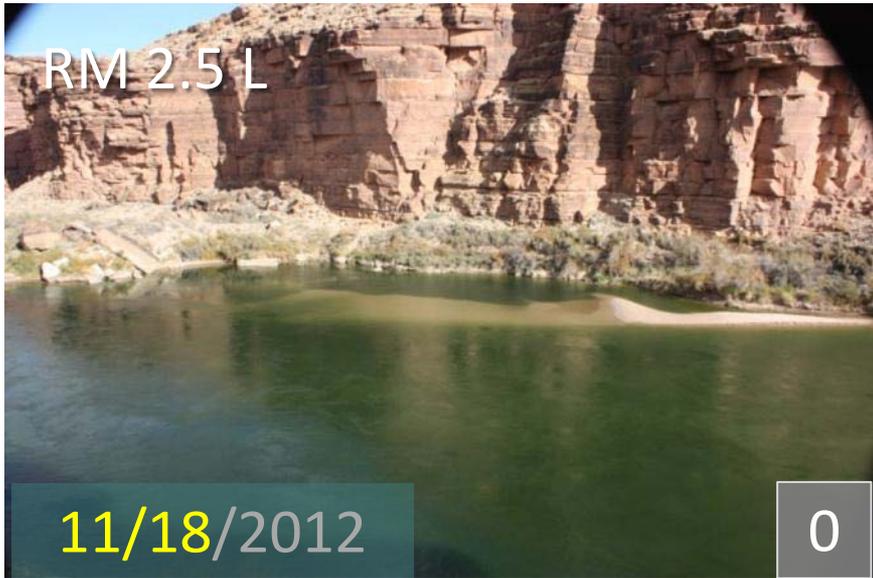
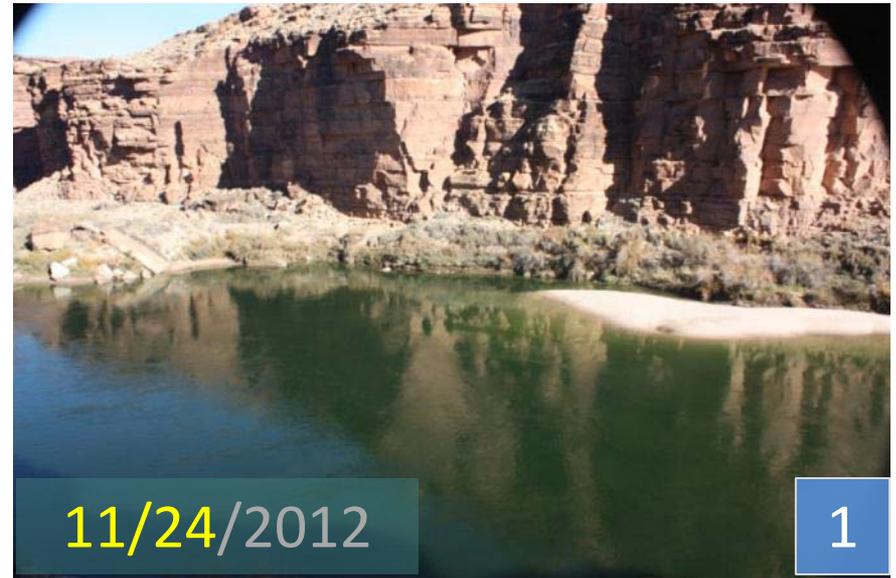
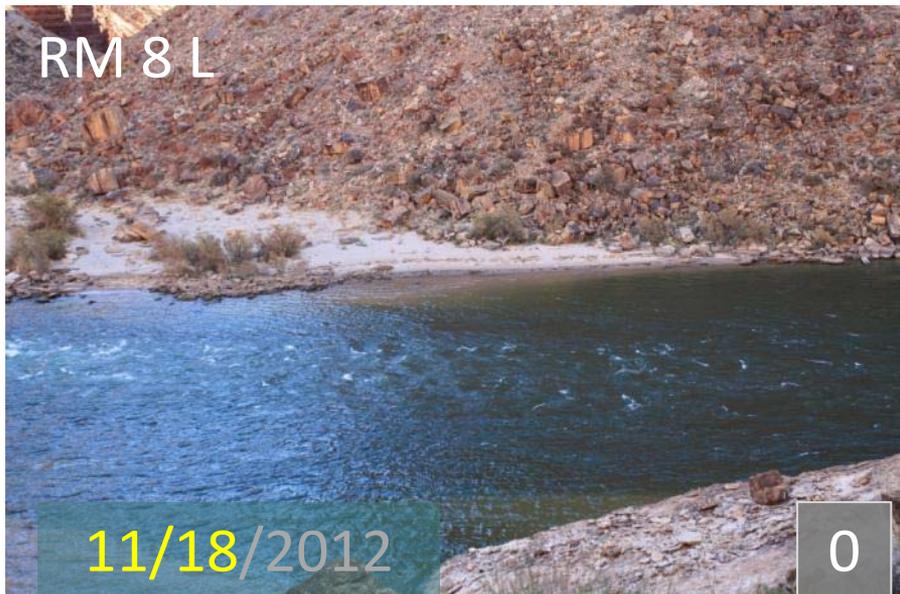
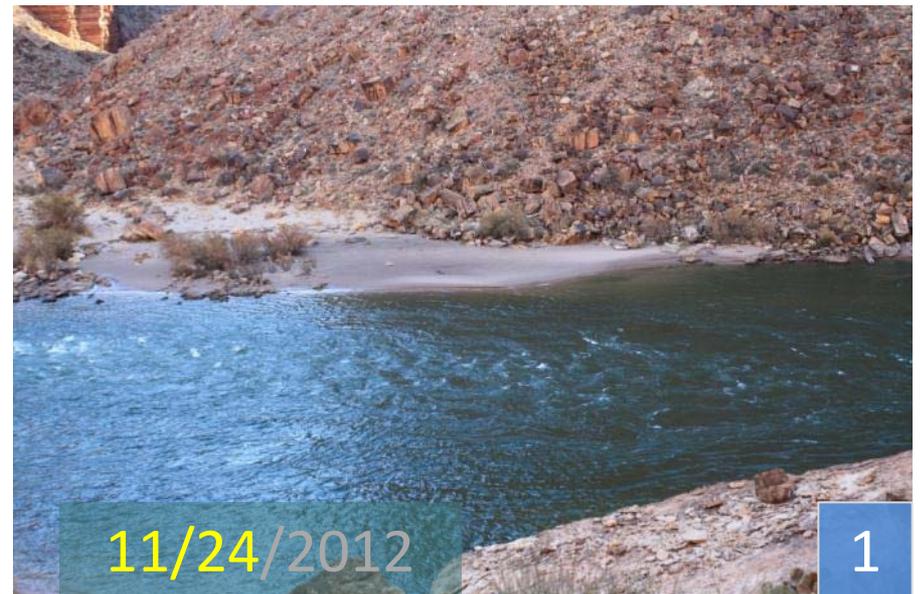
Substantial Gain (18 sites)

RM 9 L

RM 16 L

- **Summary of evaluations at 33 sites for 2012 HFE response**
 - Substantial Gain (deposition): 18 sandbars (55% of sites)
 - No substantial change: 12 sandbars (36% of sites)
 - Substantial Loss (erosion): 3 sandbars (9% of sites)
- **Downstream trends**
 - All sites between RM 0 and RM 32 increased
 - Downstream from RM 32, split between sites of noticeable gain and no change, with a few showing noticeable loss

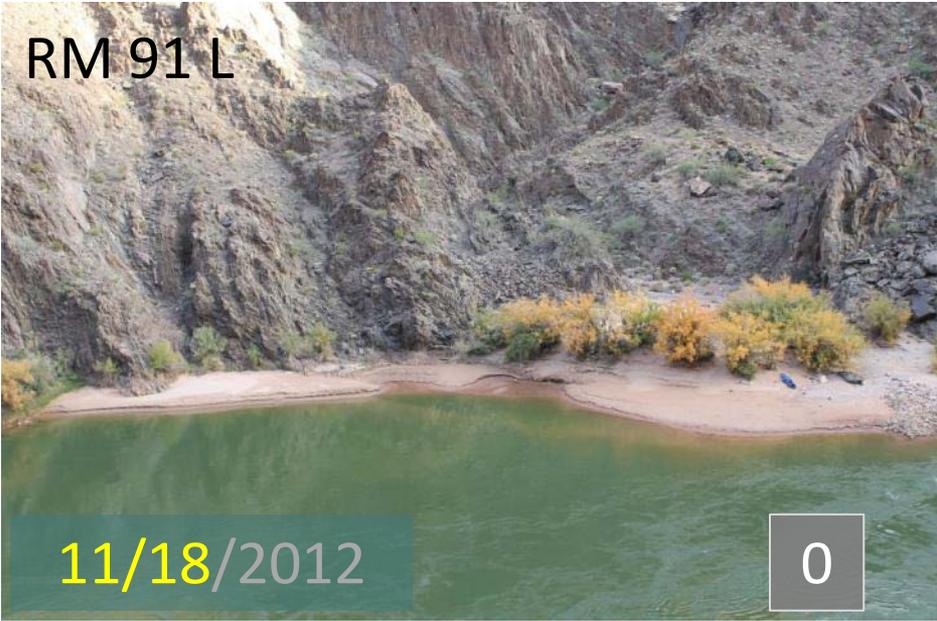
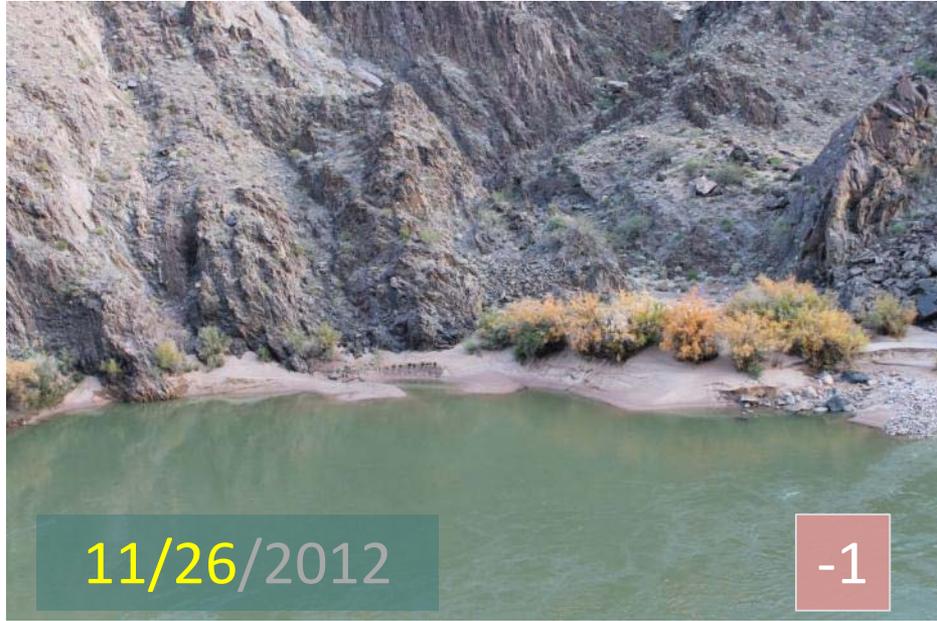
RM 91 L

-1

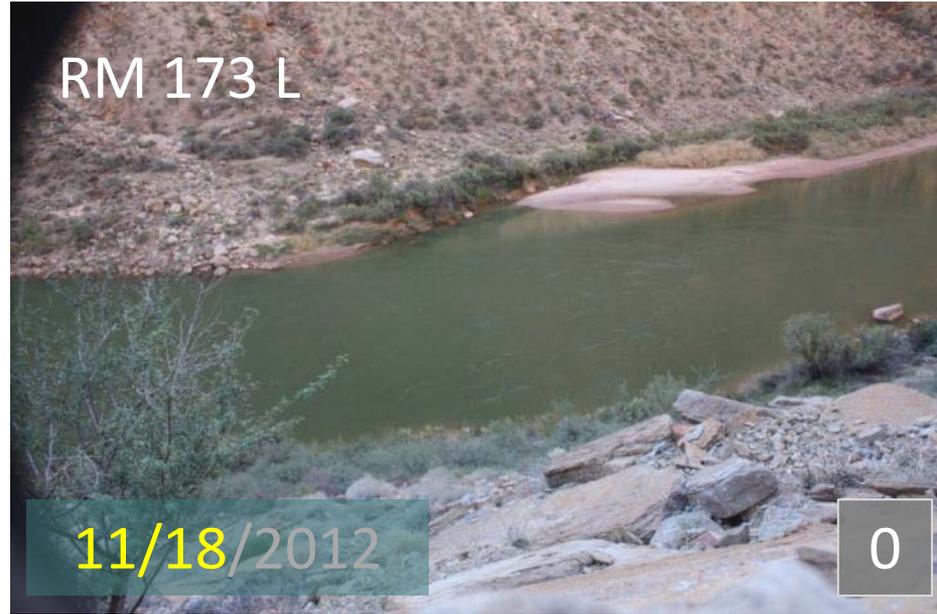
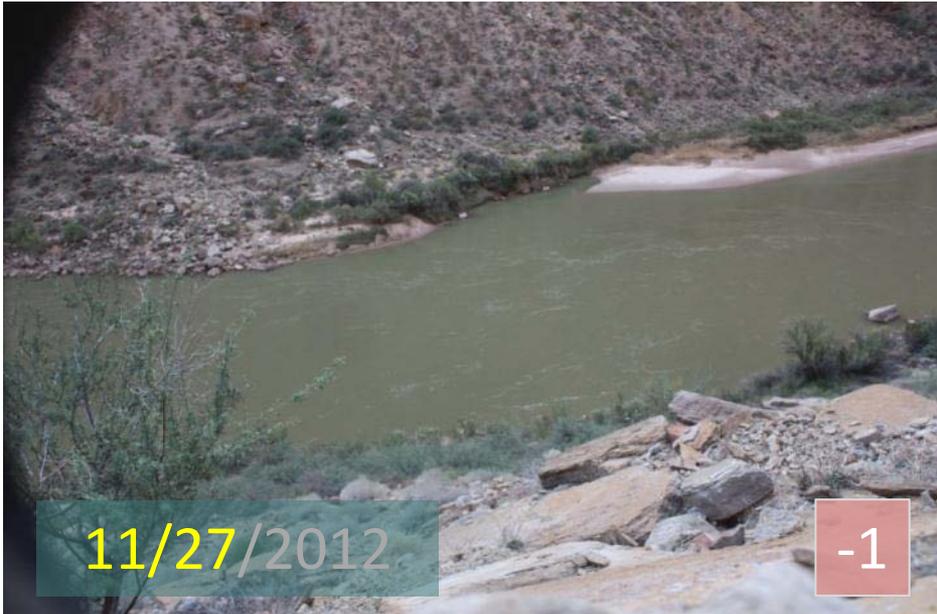
RM 173 L

-1

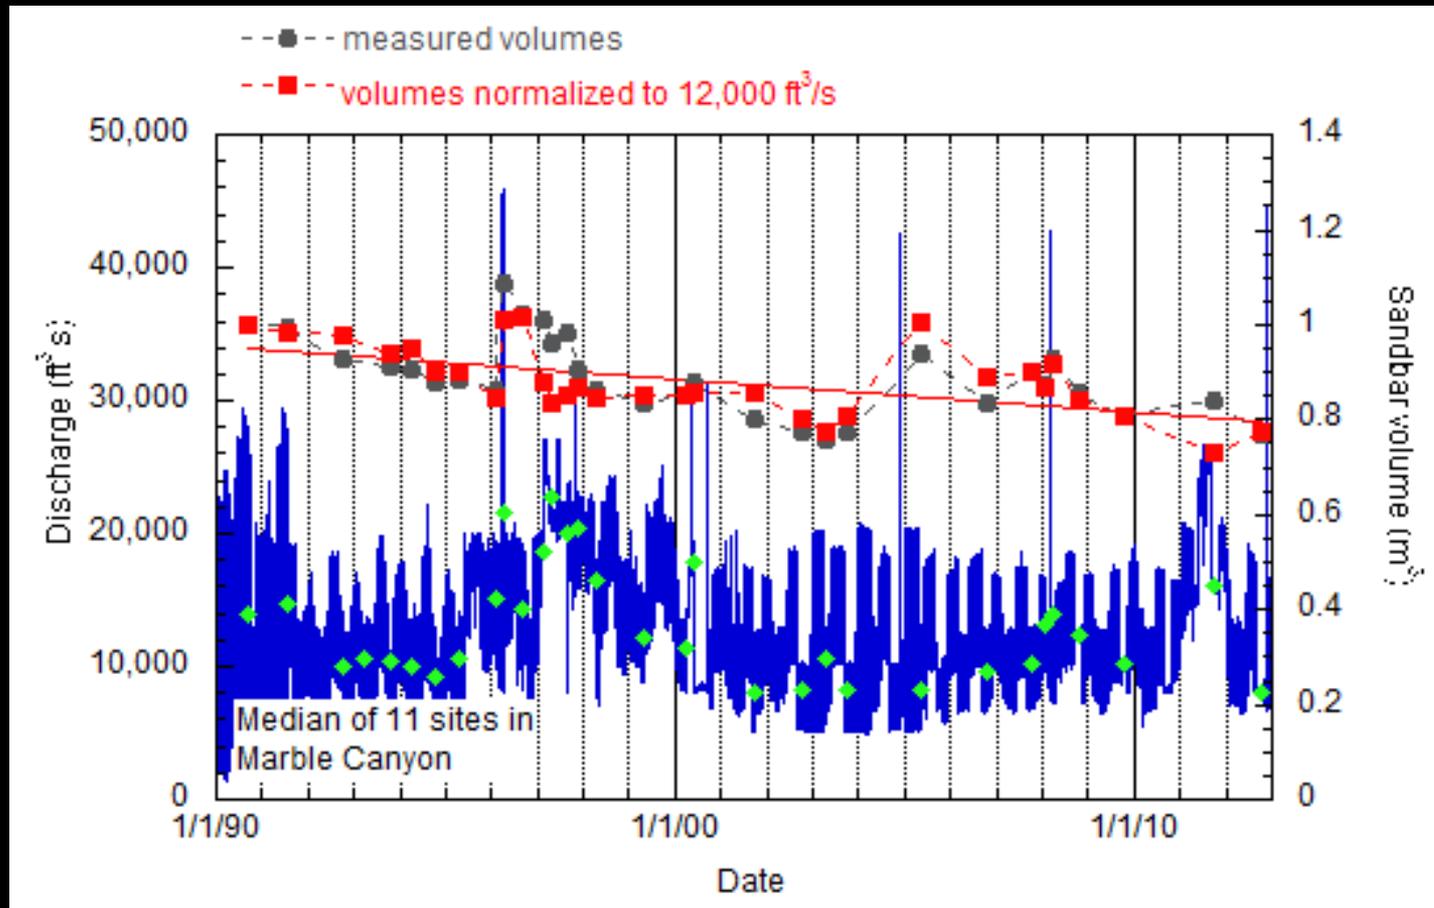
Sandbars in Marble Canyon before 2012 Controlled Flood

- *Some increase between October 2011 and October 2012*
- *Both 2011 and 2012 are low relative to early 1990's and post-flood surveys*

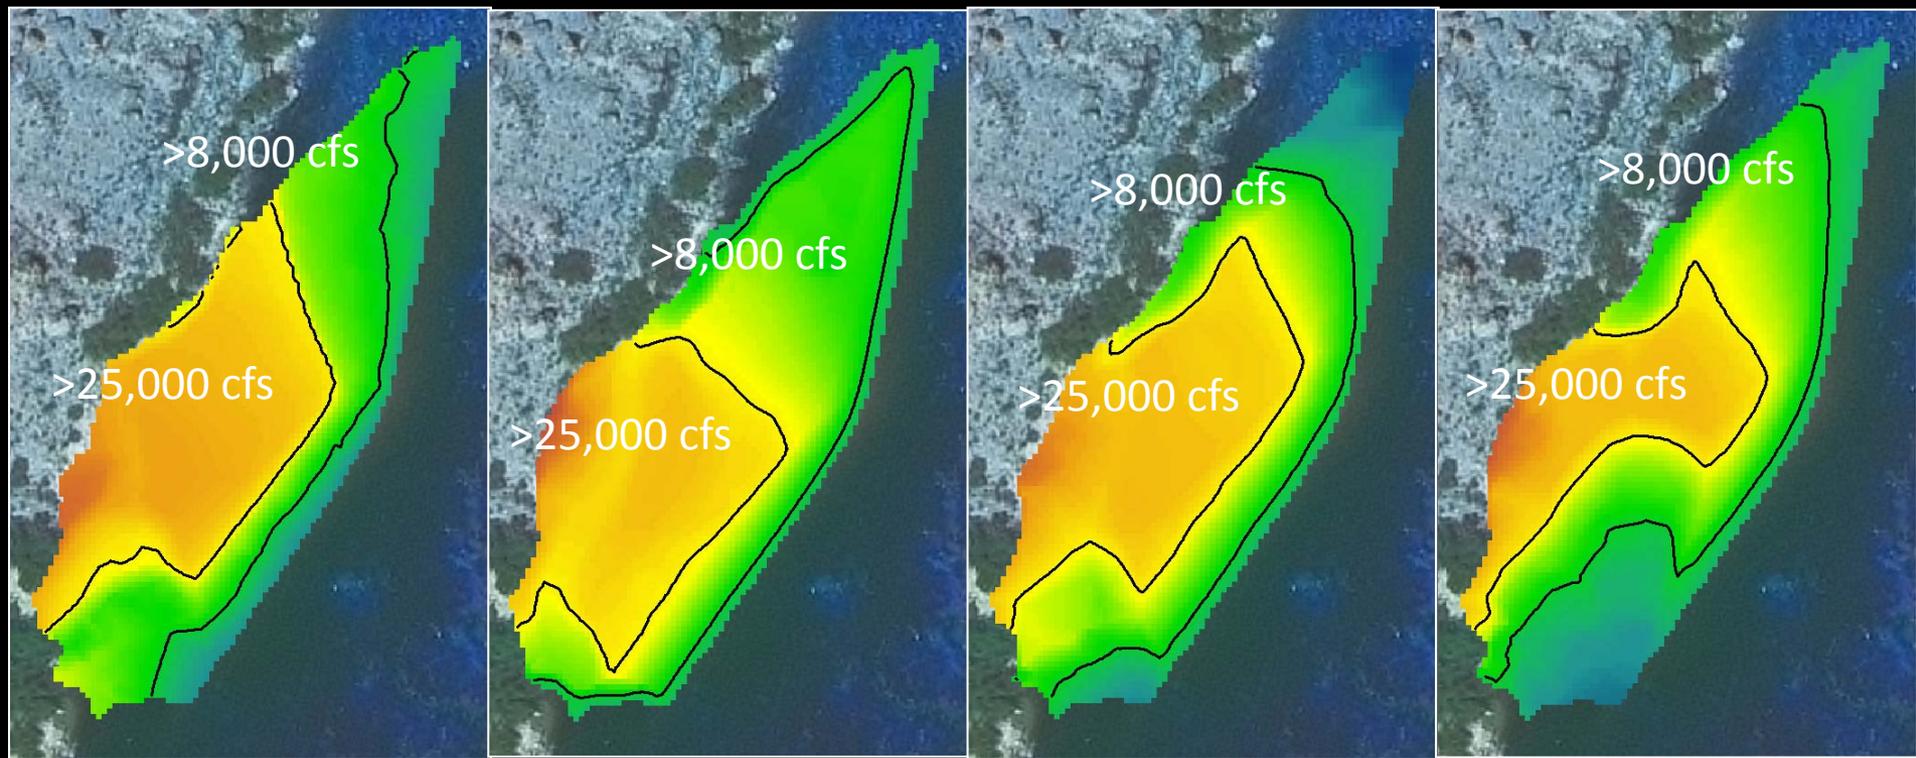
Sandbar Shape – RM 30

1996 post-HFE

2012 post-HFE

2004 post-HFE

2008 post-HFE

- *Bar volume largest in 1996, area above 8,000 cfs stage largest in 2012*

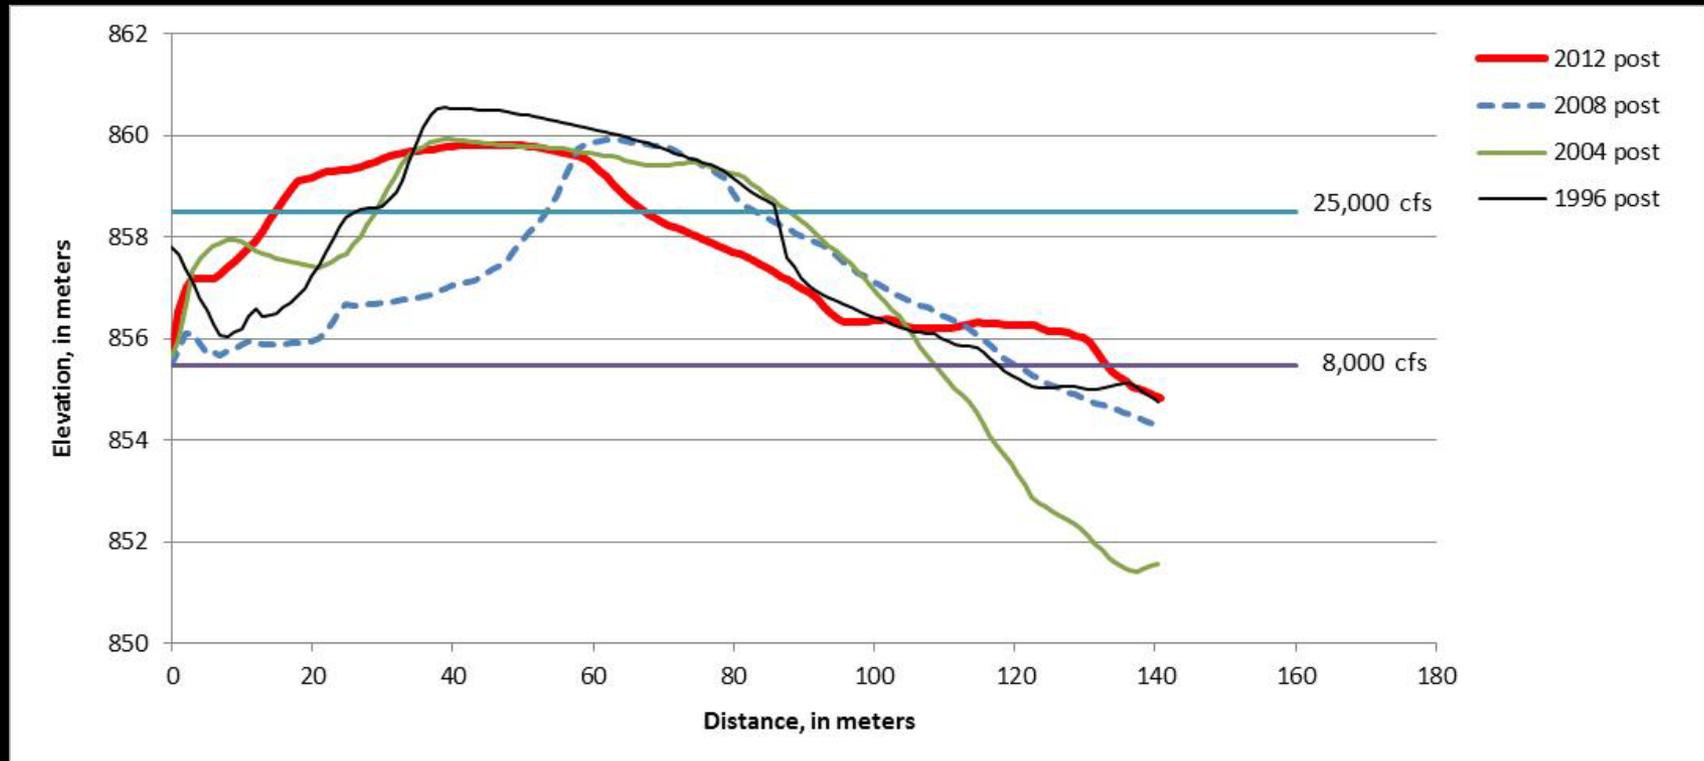
Sandbar Shape – RM 30

- Slope from bar crest to 8,000 cfs level less steep than other floods
- For 3 sites with post-flood surveys and large reattachment bars, the area of newly deposited bar above the 8,000 cfs stage with slope less than 8 deg. was larger in 2012 than previous floods
