# Summary of 2012 Accomplishments for Cultural Monitoring R&D Project, New Knowledge Gained, and Future Research Directions for FY2013-2014

Helen Fairley , Brian Collins, and Amy Draut (USGS)

Annual Reporting Meeting, Phoenix, AZ  
January 23, 2012

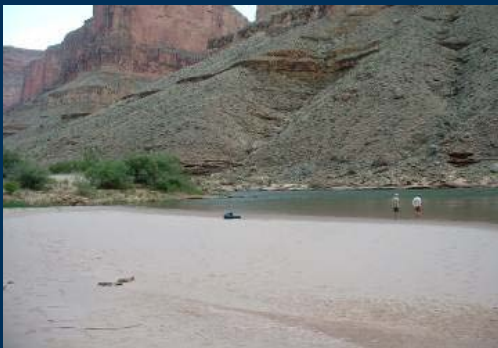
River-level sandbar

Erosion of cultural features tied to reduced sediment supply, lack of floods, increased vegetation → no flood deposits; fewer open, dry sand bars → less eolian sand to cover sites & backfill gullies → progressive deflation by wind, continuous down-cutting in gullies

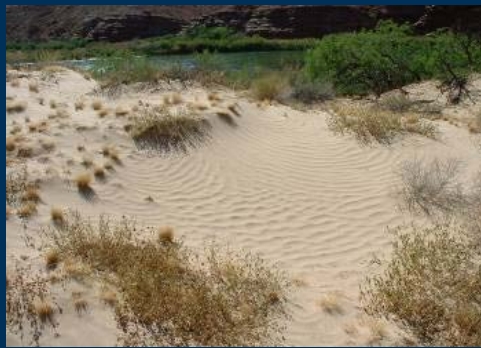
Sand dunes  
above river

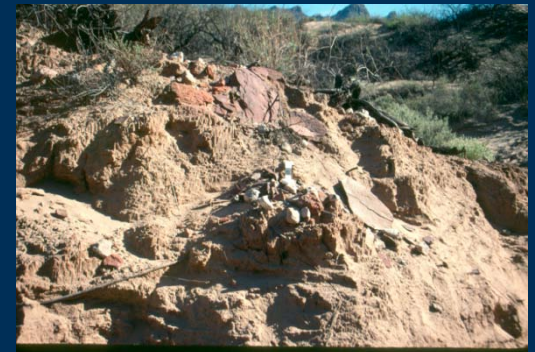
Deflating  
Arch. site

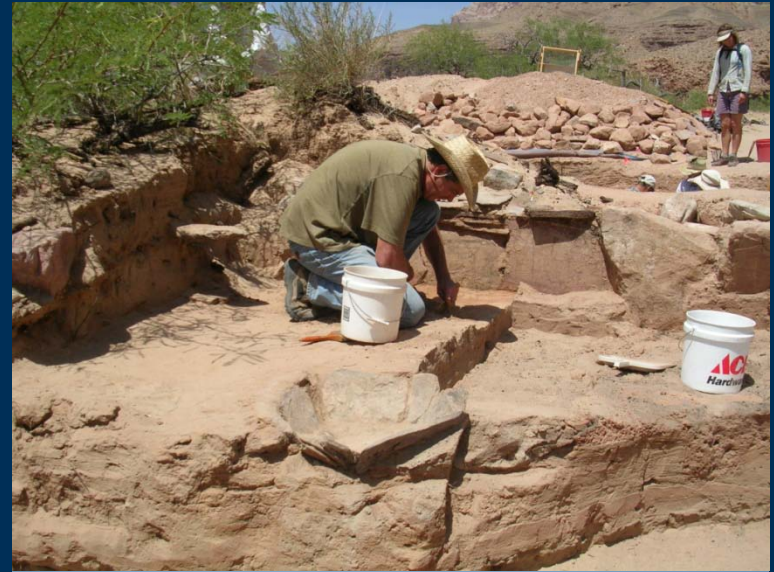
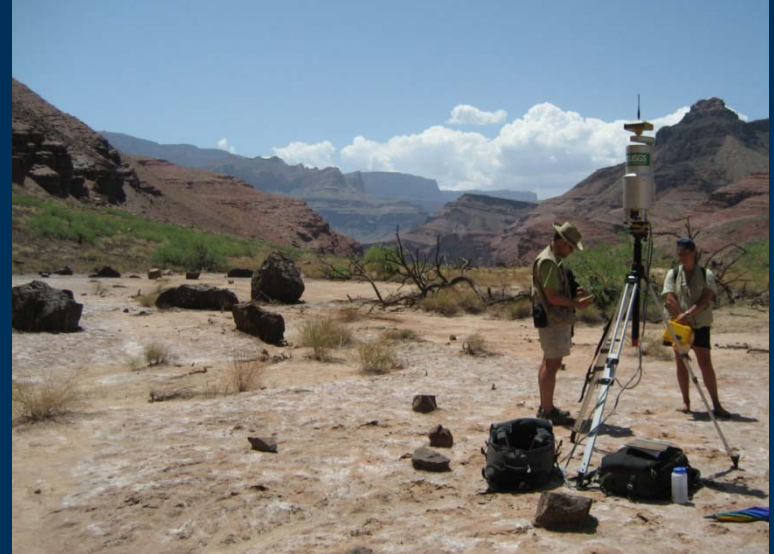
- Archaeology relies on 3-D mapping extensively
  - Context matters!
- Archaeologists quick to adopt lidar technology for:
  - Documentation (artifacts, architecture)
  - Mapping landscapes
  - Preservation tool
- Lidar efficient at collecting 3-D data w/ minimal impact

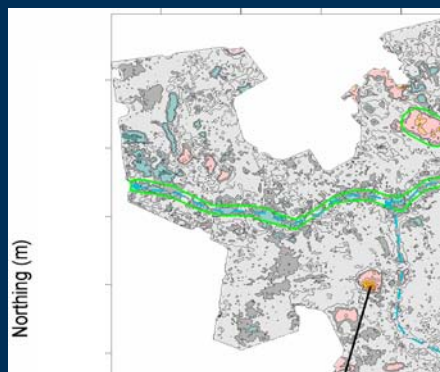
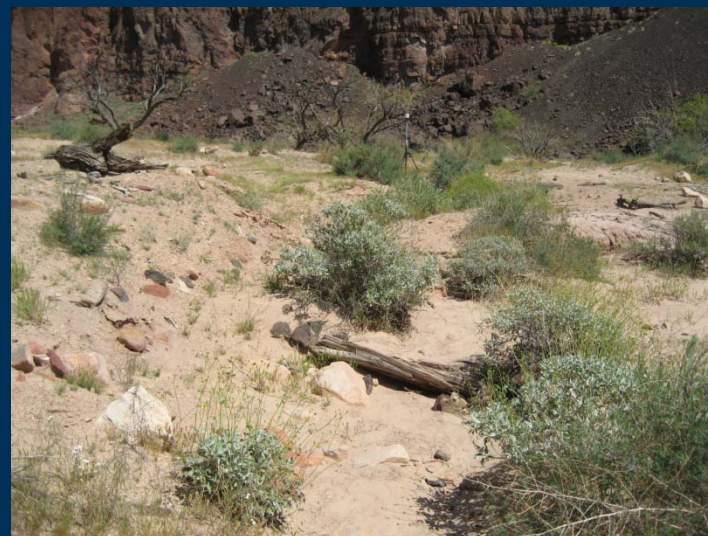
# AZ C:13:0099 – Palisades Area

- Alluvial terrace overlain by dune sands and cut by several gullies.
- Gully sidewall and sand dune erosion, and gully bottom infilling during 2006-2007.

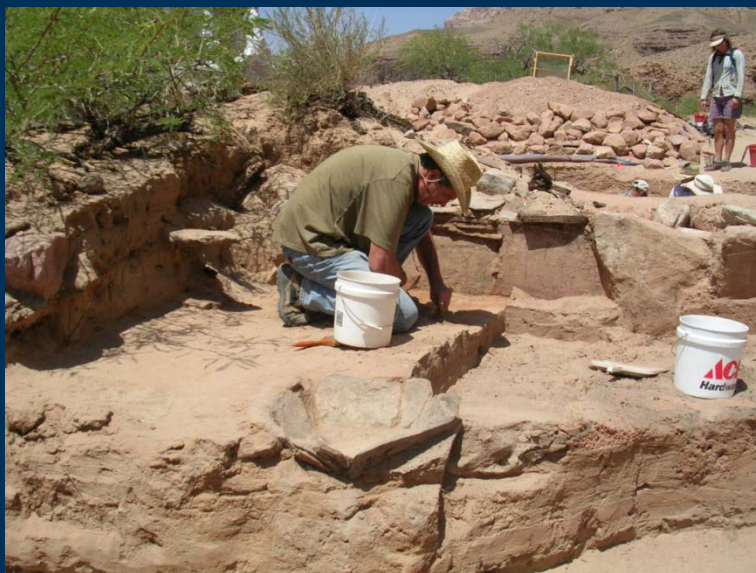
# AZ C:13:0099 – Palisades Area

Major erosion/ deposition  
during 2007-2010

2008 excavations primary  
source of change

Additional gully widening  
between 2007-2010

| Site number<br>(Sept. 2007- 2010<br>monitoring period) | Area w/<br>measured<br>erosion<br>(m <sup>2</sup> ) | Area w/<br>measured<br>deposition<br>(m <sup>2</sup> ) | Total area<br>modeled<br>w/<br>change<br>(percent) | Average<br>(max.)<br>height of<br>erosion<br>(cm) | Average<br>(max.)<br>height of<br>deposition<br>(cm) | Approx.<br>volume<br>of<br>erosion<br>(-) (m <sup>3</sup> ) | Approx.<br>volume of<br>deposition (+)<br>(m <sup>3</sup> ) |
|---|---|---|---|---|---|---|---|
| AZ:C:13:0099 | 103.0 | 22.5 | 19.6 | 12 (63) | 12 (59) | -17.3 | +2.8 |

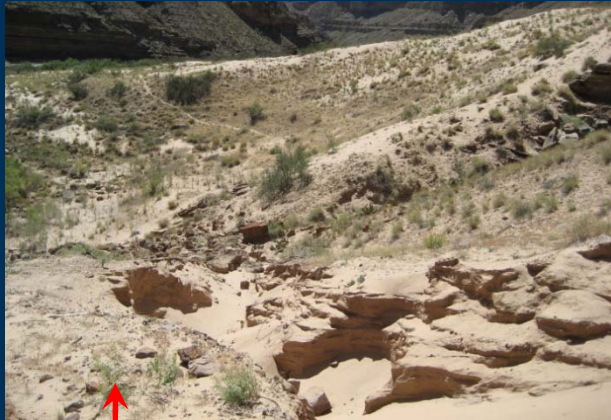
Sept. 2007

- Massive gully erosion in 2007-2010 (120 m<sup>3</sup> sediment removed, averaging 52 cm deep)
- Additional aeolian infilling following this period (11 m<sup>3</sup>)
- Potential for overall site lowering?
- Potential for additional aeolian infilling?

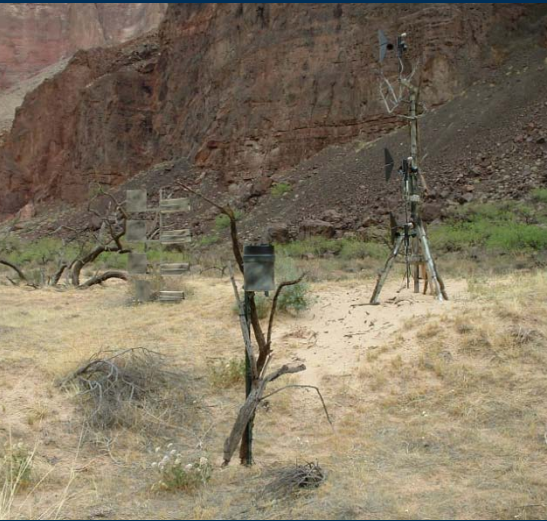
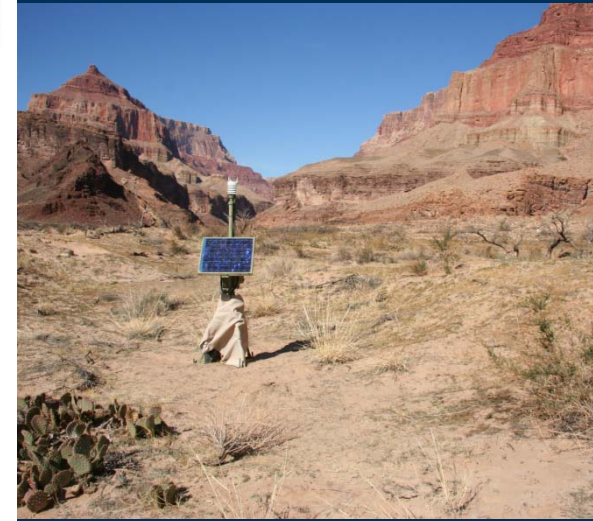
# Phase I included R&D re: Weather (Tools & Methods; local variability)

2007-2008:  
Resolved technical  
issues  
2008-2010:  
Annual Data Reports  
2011-2012:  
Additional analysis

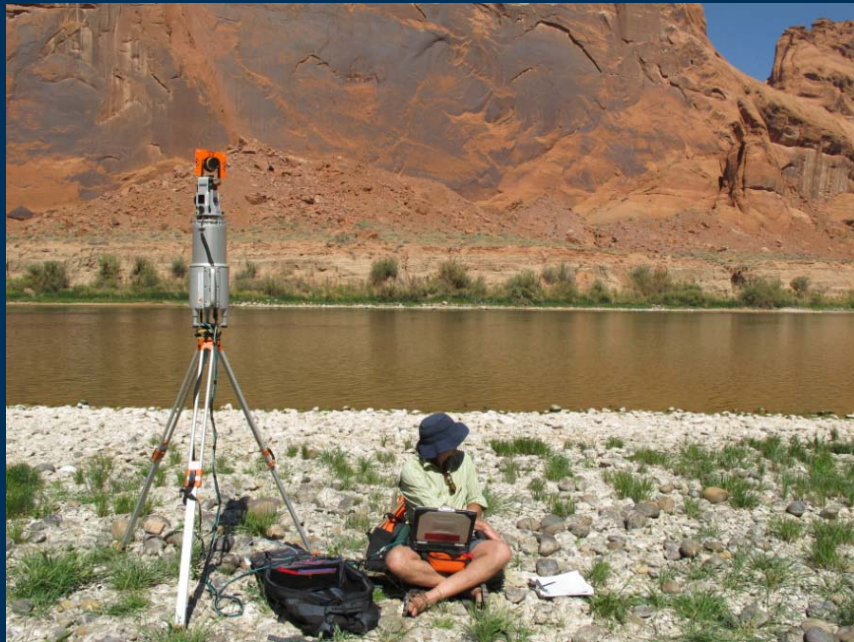
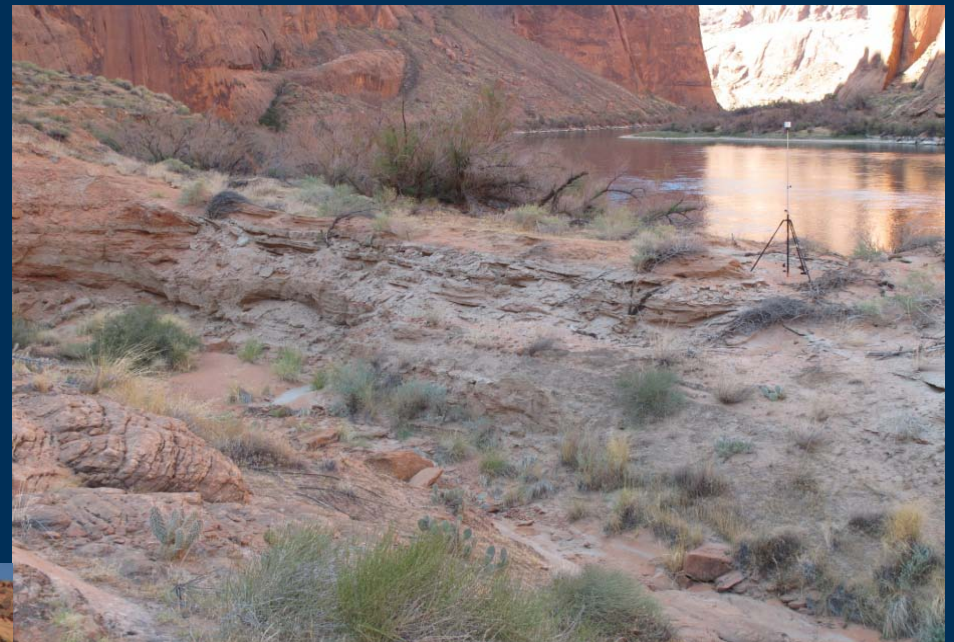
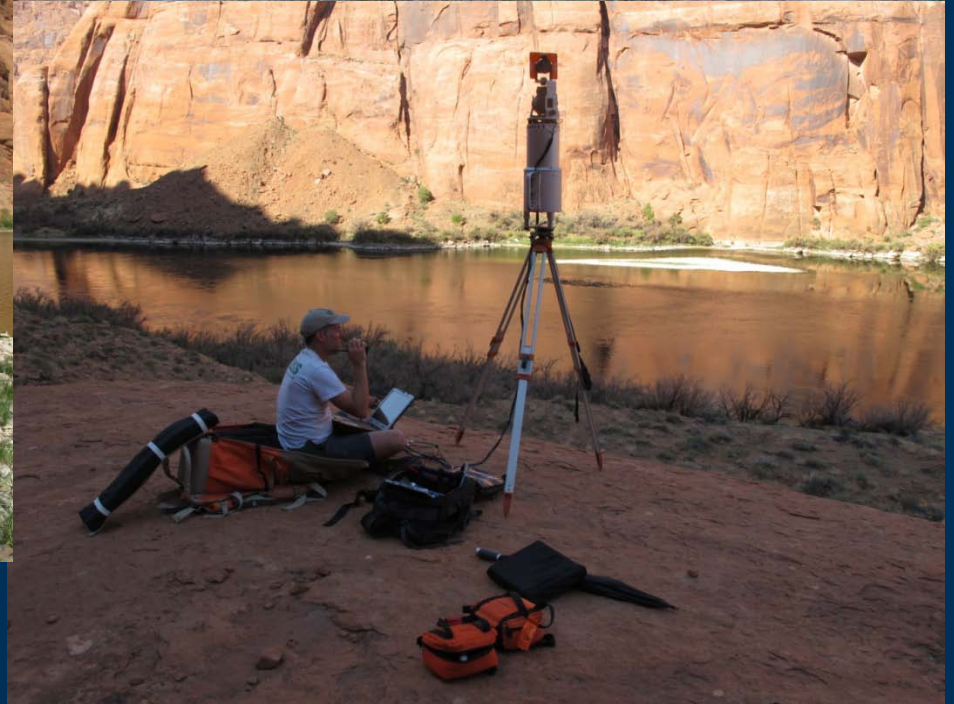
# Sept 17-21, 2012

## Baseline Topographic Data Collected for 4 Glen Canyon Sites & Surrounding Area

- **September 17-22, 2012**
  - Collected topographic surveys from 4 sites, plus surrounding terrain
  - Initiated mapping of geomorphic setting
- **November 2012**
  - Stationary cameras collected repeat photographs of -9 Mile cut bank during HFE
  - Documented 42,300 cfs shoreline (photos, survey)

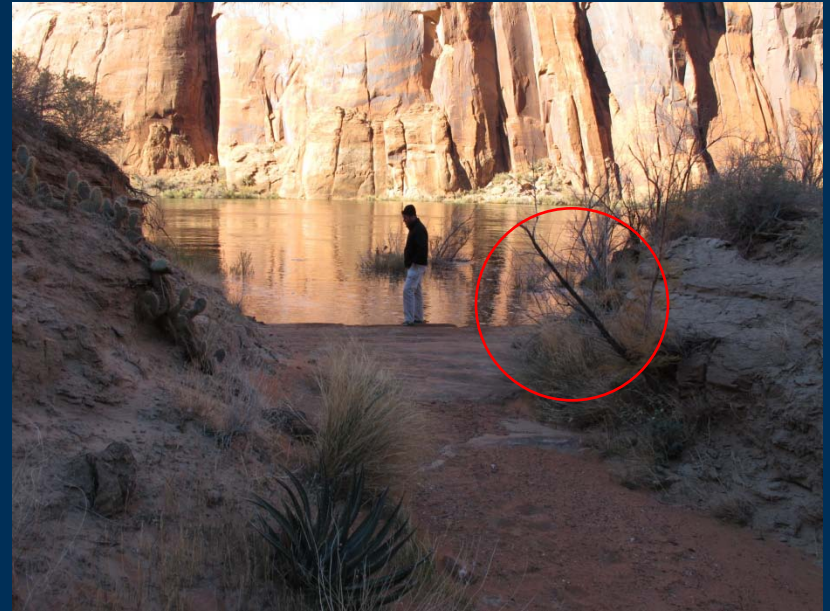
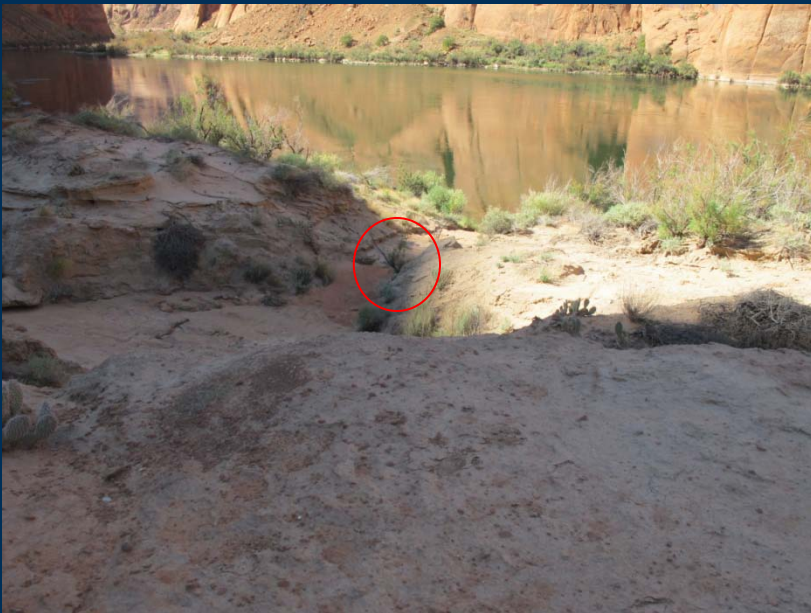
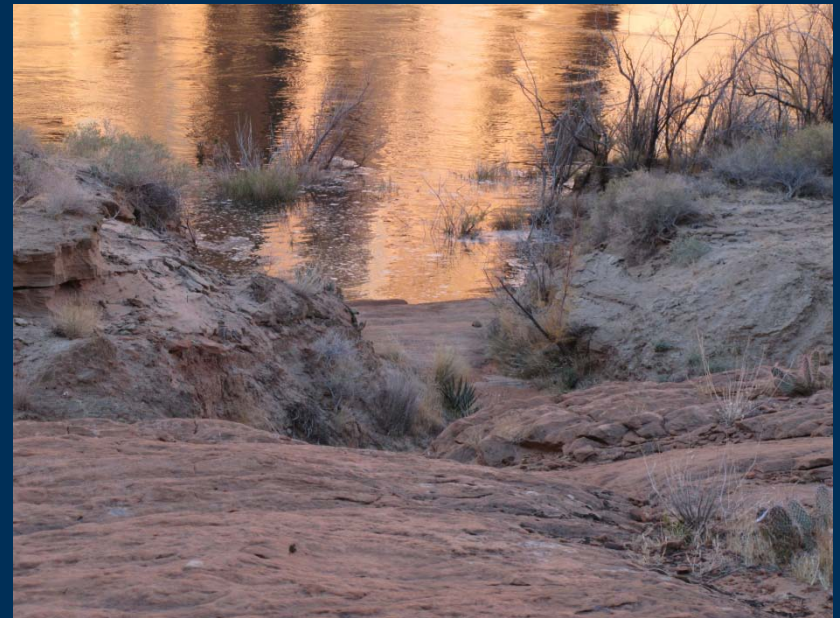
# AZ C:2:75

## Level of inundation by 2012 HFE

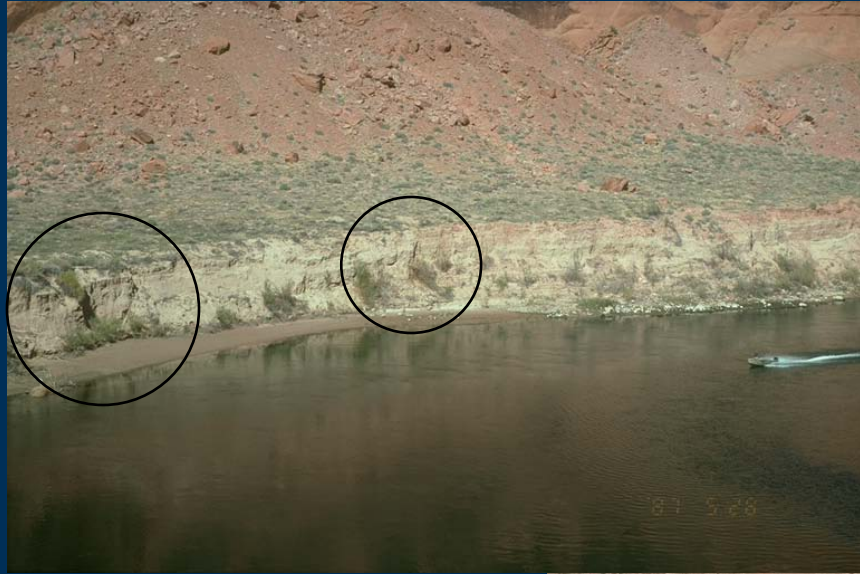
Before

# Stationary Cameras (1996 HFE)
