**Installation of Nets to Contain Green Sunfish in Minus-12-Mile Slough
Glen Canyon National Recreation Area
October 6-7, 2015**

TRIP REPORT

**Prepared by:
Brian Healy and Emily Omana Smith
Grand Canyon National Park
October 15, 2015**

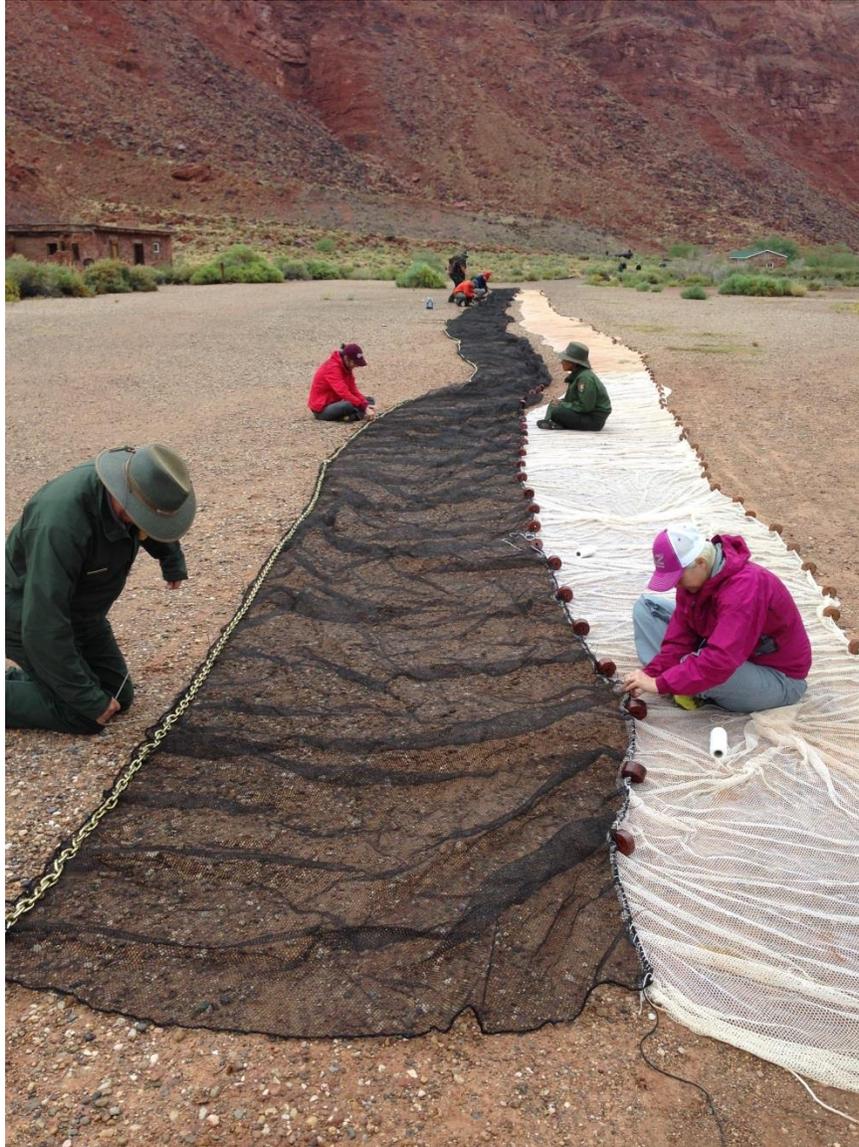
Photo: NPS and AZGFD staff assembling the block net at Lees Ferry. NPS photo by Brian Healy.

On October 6, two NPS-Grand Canyon National Park (GCNP) fisheries biologists met eight GCNRA staff at Lees Ferry to begin assembling the block nets into a single net. Nets were sewn together (see photo above) using twine, parachute chord, and zip ties, and all holes in nets were repaired. A chain was sewn into the bottom of the net to keep it in place under fluctuating flows and maintain a tight seal with the substrate in the slough. Chain was also necessary because other options to secure the bottom of the net, such as placing rocks taken from the bottom of the slough, would require CWA permitting. The sewing process took approximately 5 hours.

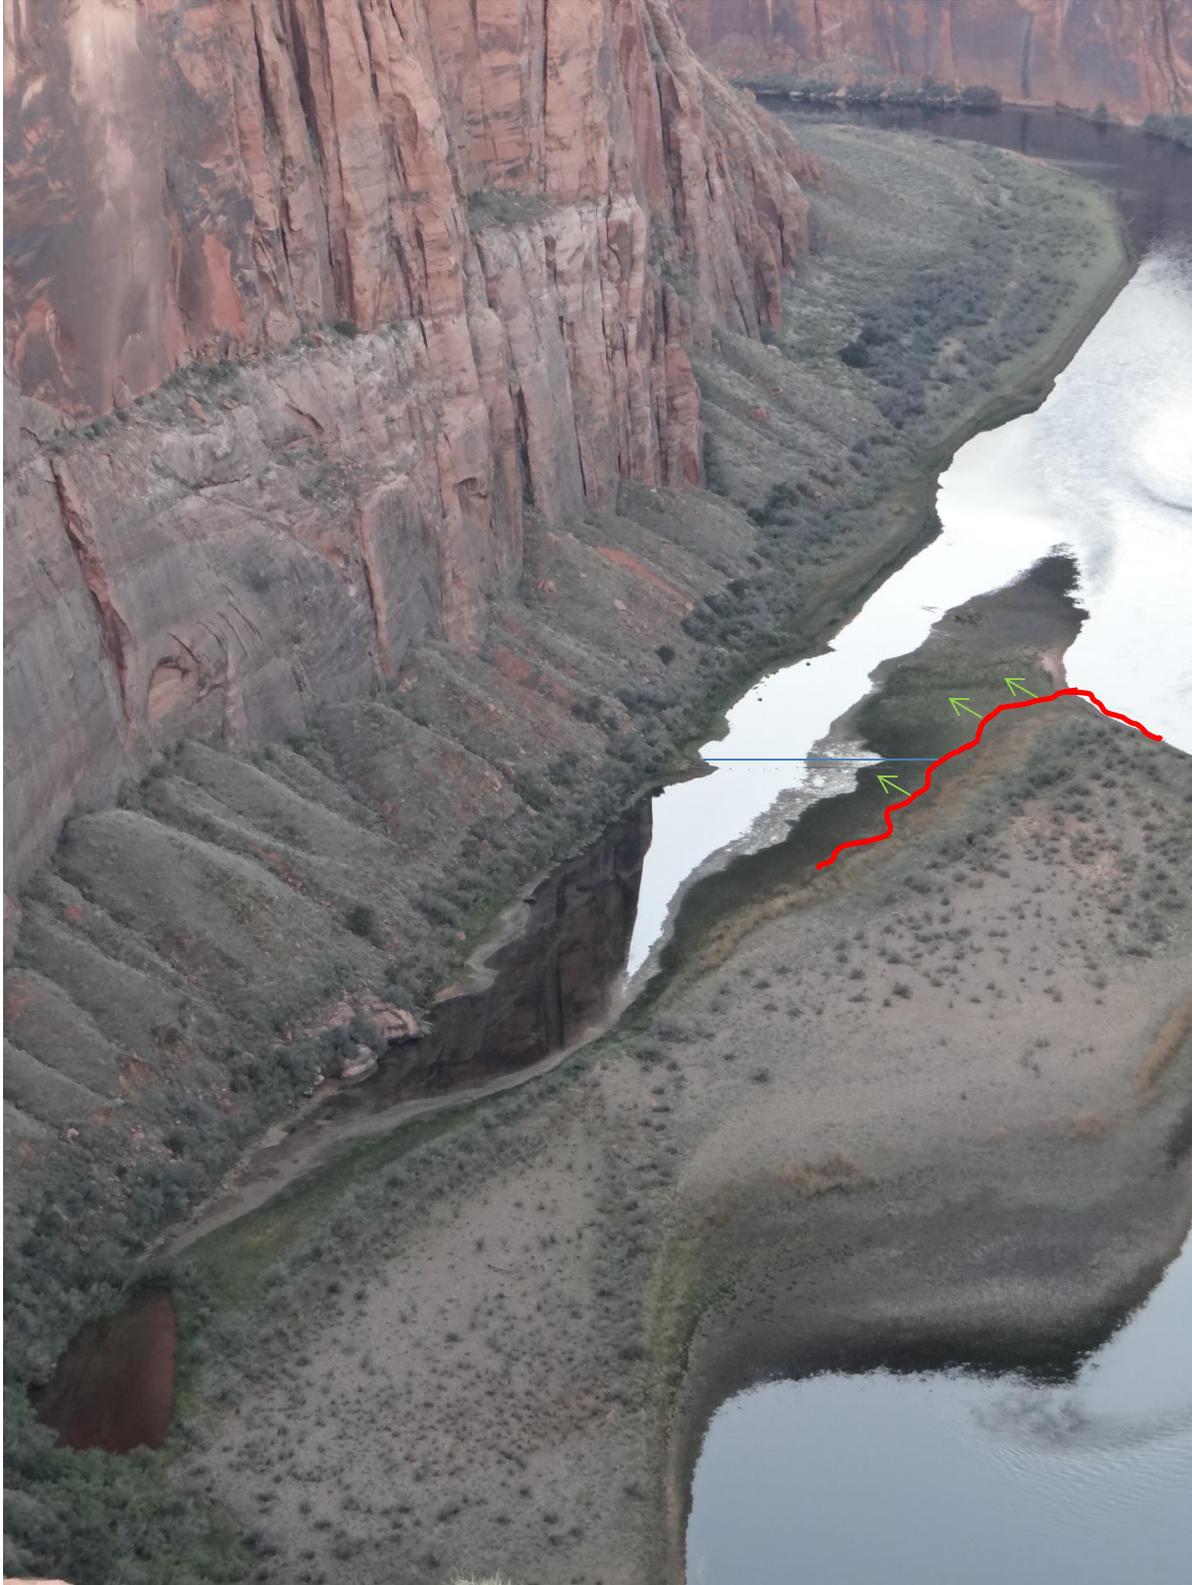
Figure 1. Location of block net placed in the slough. Area to the left of the red line, indicated by green arrows, is inundated at daily peak flows. The blue line indicates the location of the block net, which is the

shortest distance that could be effectively blocked with the length of net available (160'). NPS Photo by Mark Anderson).

Upon arrival at the slough on the morning of the 7th, it was apparent that the entire area of the slough would be difficult to block completely with the length of net that was available. While dam discharge was relatively low in the morning when the net was placed, it would be expected to peak later in the day and inundate a very large area of the lower section of the bar that separates the slough from the mainstem of the Colorado River (Figure 1). At higher daily peaks, water would flow around the block net, and it would not be effective. To compensate, after discussion among NPS and AZGFD biologists, the net location was moved upstream, inside the slough, at a location that could be more effectively blocked with the width of net that was on hand.

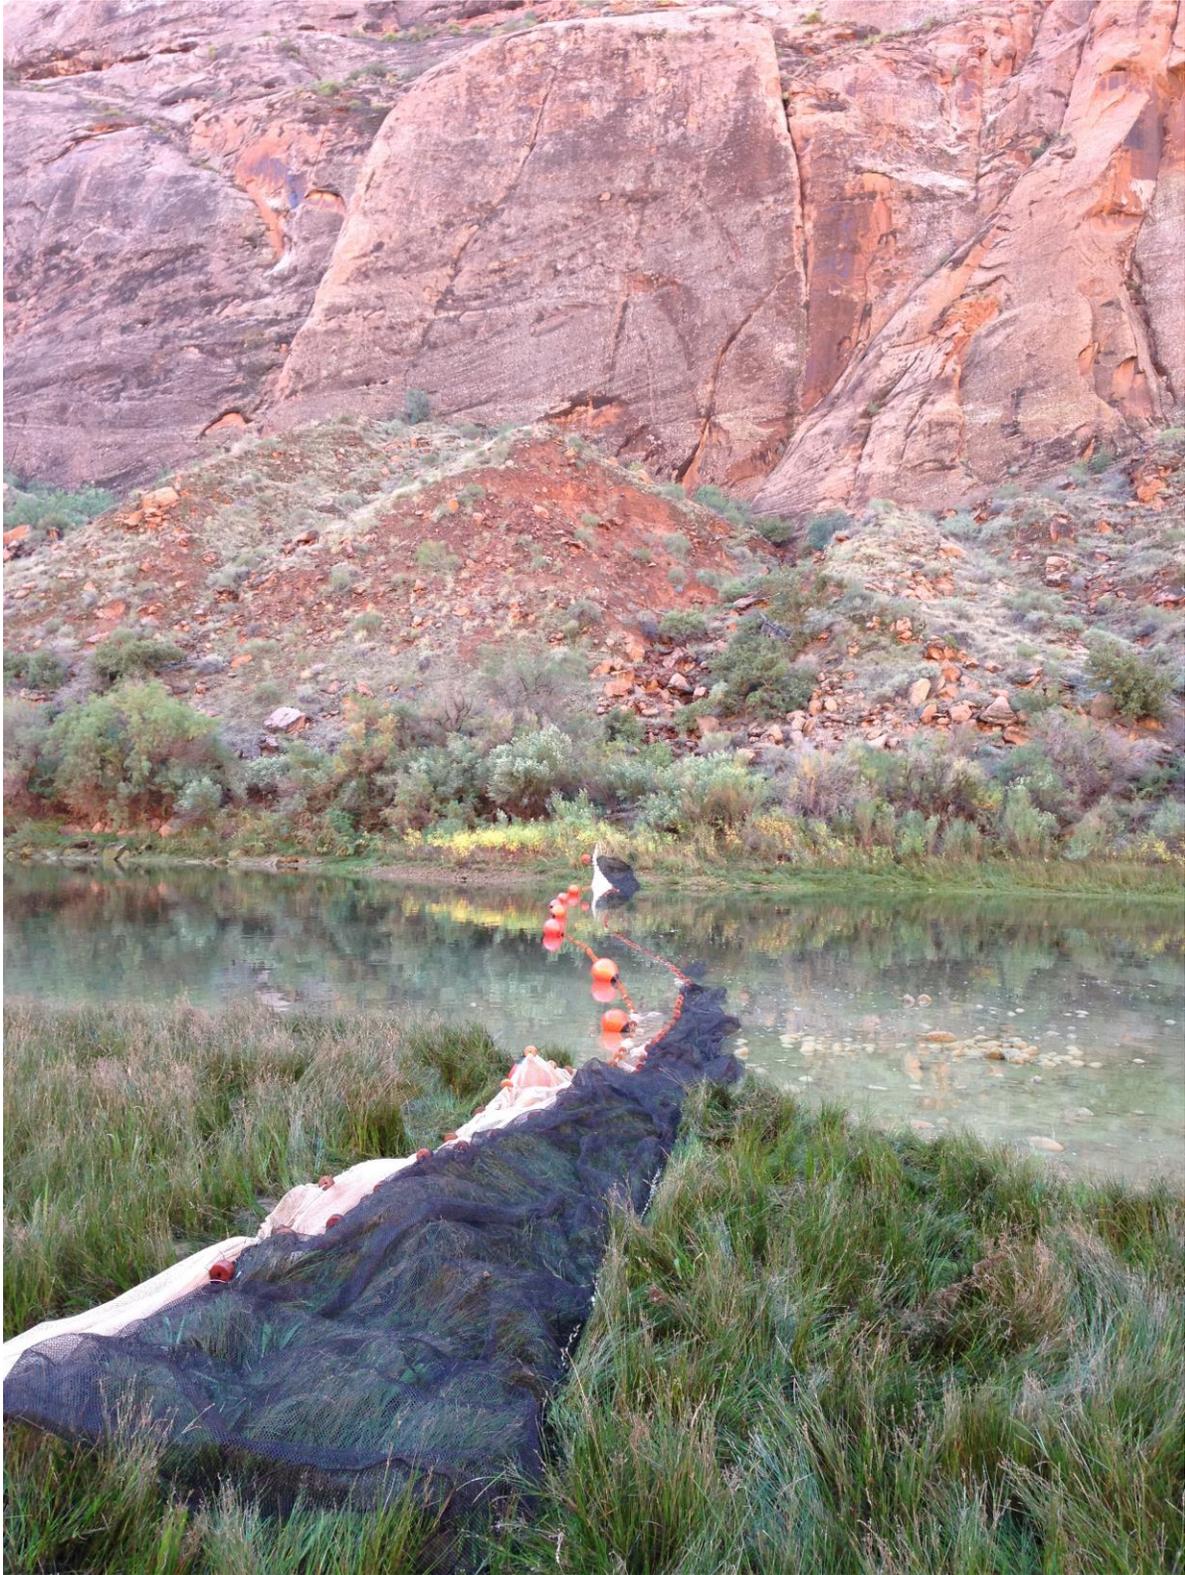
Figure 2. Block net deployed with buoys attached. NPS Photo by Brian Healy.

The block net was in place by 11:00 AM. One GLCA staff member, wearing a dry suit, waded across the slough and secured the net and buoys, after the net was deployed by staff wearing waders and by inflatable kayak. Buoys were placed approximately every 3-5 meters all the way across the net, to minimize the risk of watercraft contact with the net. In addition, GLCA staff placed closure signs at the net (Figure 2).
