Using Repeat Photography to Document Dam Operation Effects on Sand Supply, Aeolian Landscapes, and Terrestrial Ecology in the Colorado River Ecosystem

GCDAMP Annual Reporting Meeting
January 21, 2021

Helen C. Fairley

USGS Grand Canyon Monitoring and Research Center

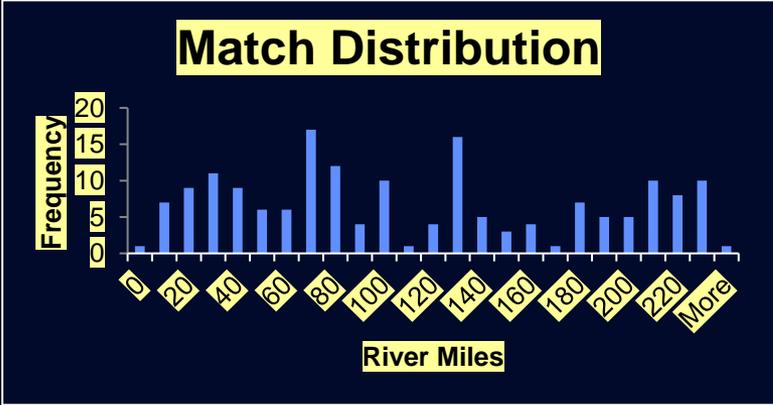
- ~200 matches so far
 - Focus on matching photos from 1923 USGS trip
 - Matches not evenly distributed
-

- Each panorama match requires 7 digital images
 - 1-3 hours required to complete each match
 - For each match, we also collect detailed info on plants in photo view (previous vs. present) plus any other visible changes

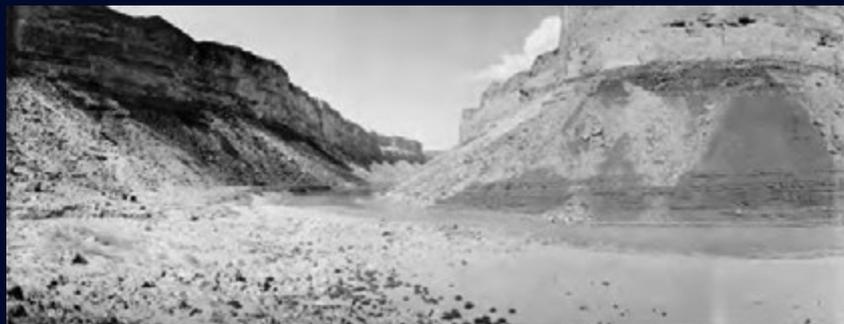
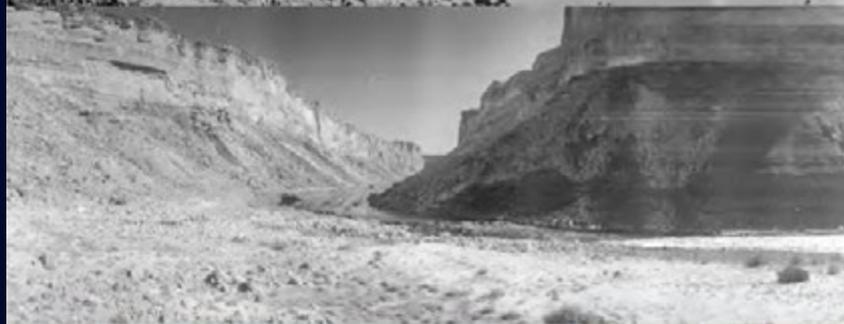
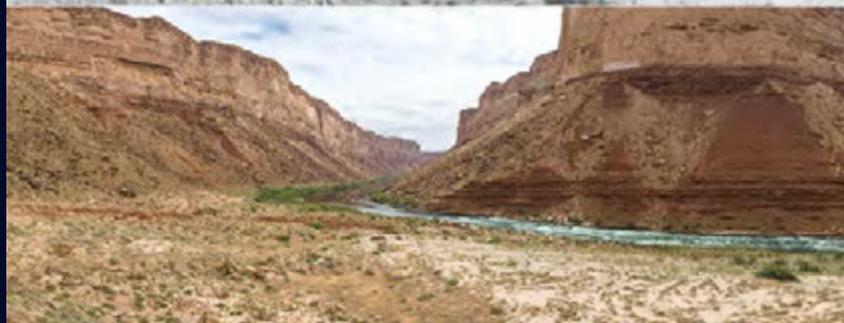
Stake 1091, RM 11.5 R, Soap Creek

Some 1923 photos were matched in 1990s, allowing study of MLLF effects*

E. C. La Rue
08/02/1923

E. Hymans
Ca. 1991

A. H. Fairley
05/06/2017

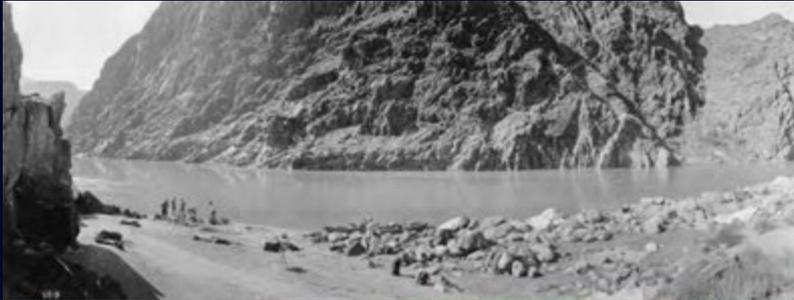
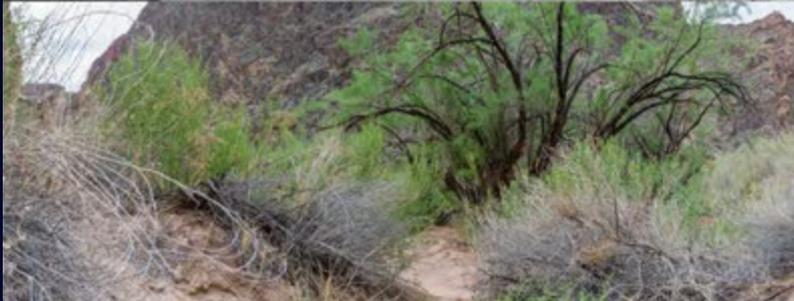
Stake 2056, true match

Exact matches vs. “pseudo-matches”

E. C. La Rue
08/30/1923

A.H. Fairley
05/06/2018

RM 98.7 L, Crystal Camp

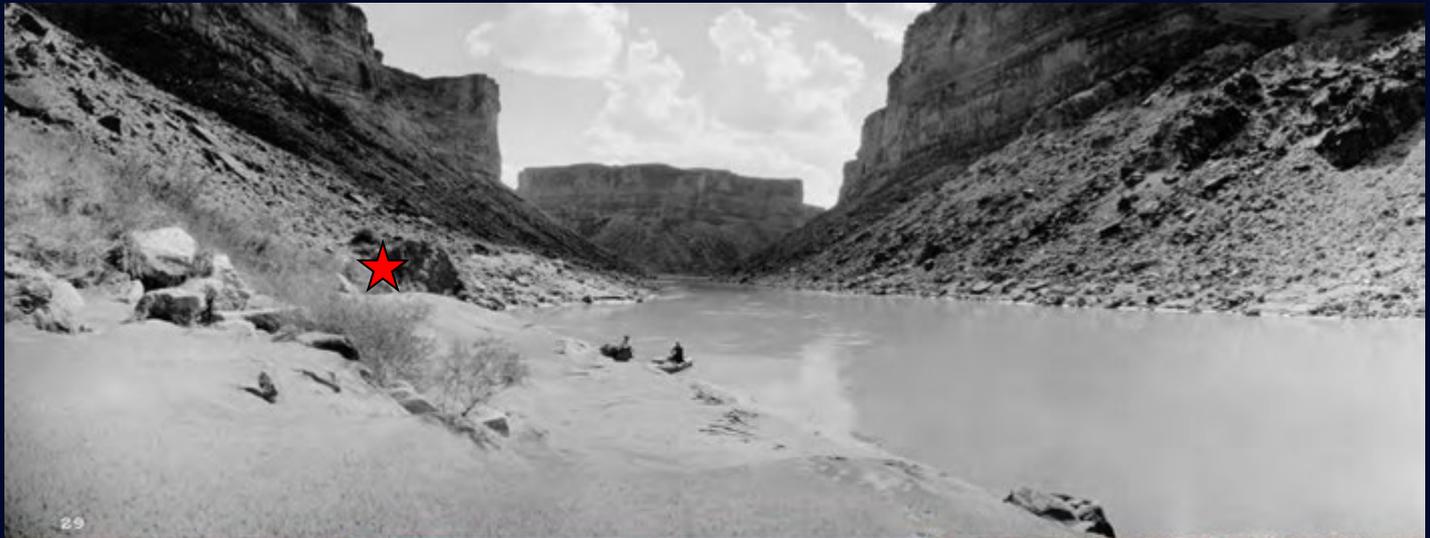
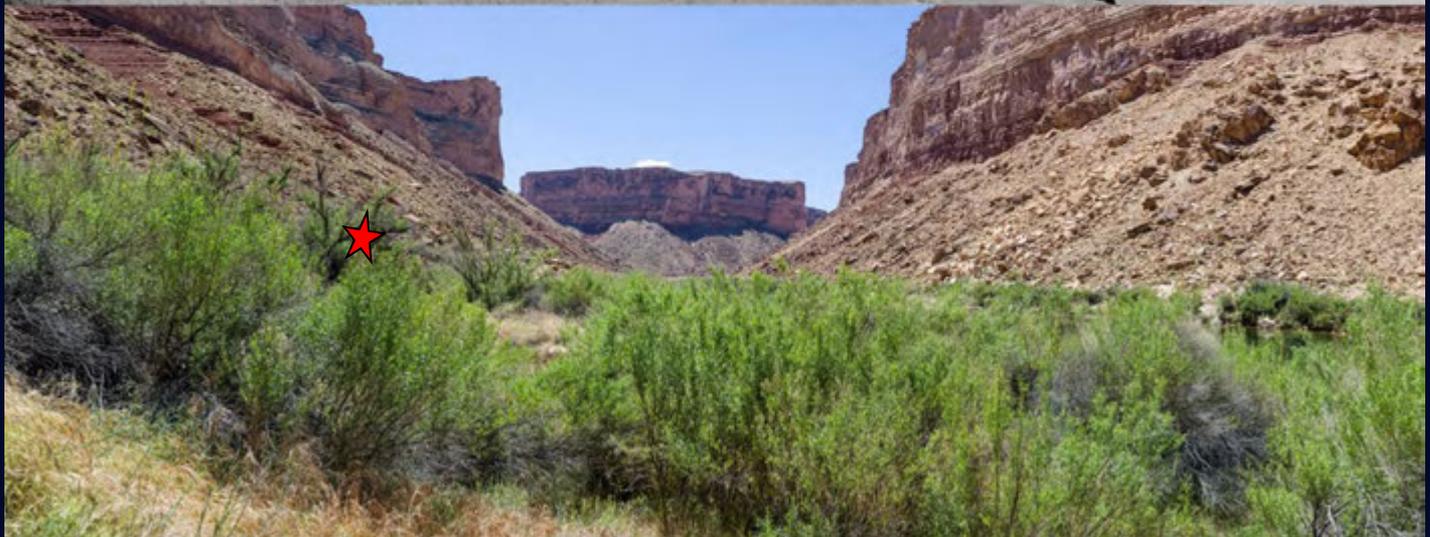
Stake 672
RM 10.6 L

Every match shows vegetation increase!

E. C. La Rue
08/02/1923

A. H. Fairley
05/05/2017

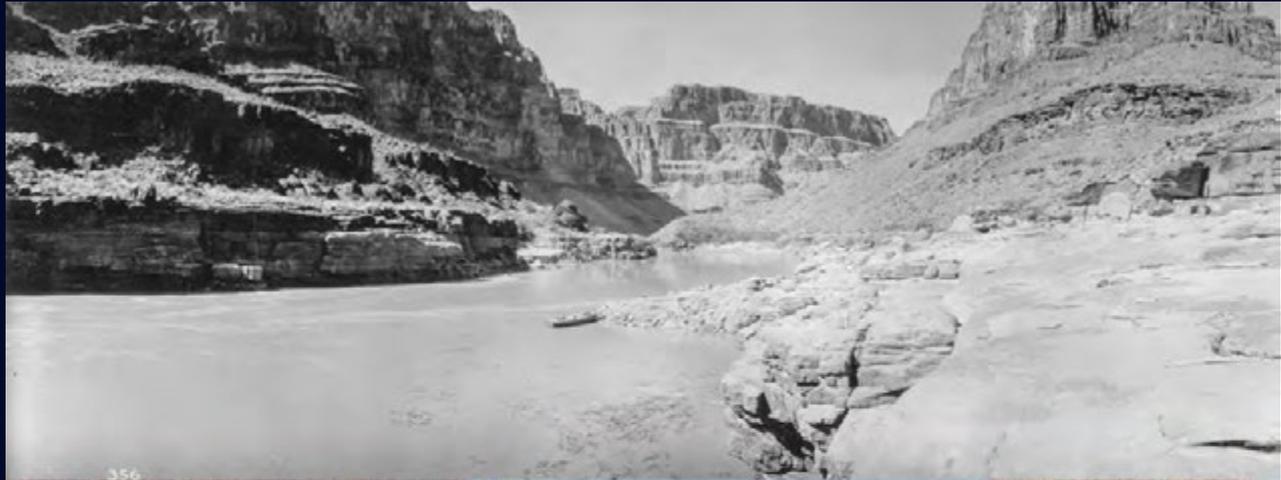
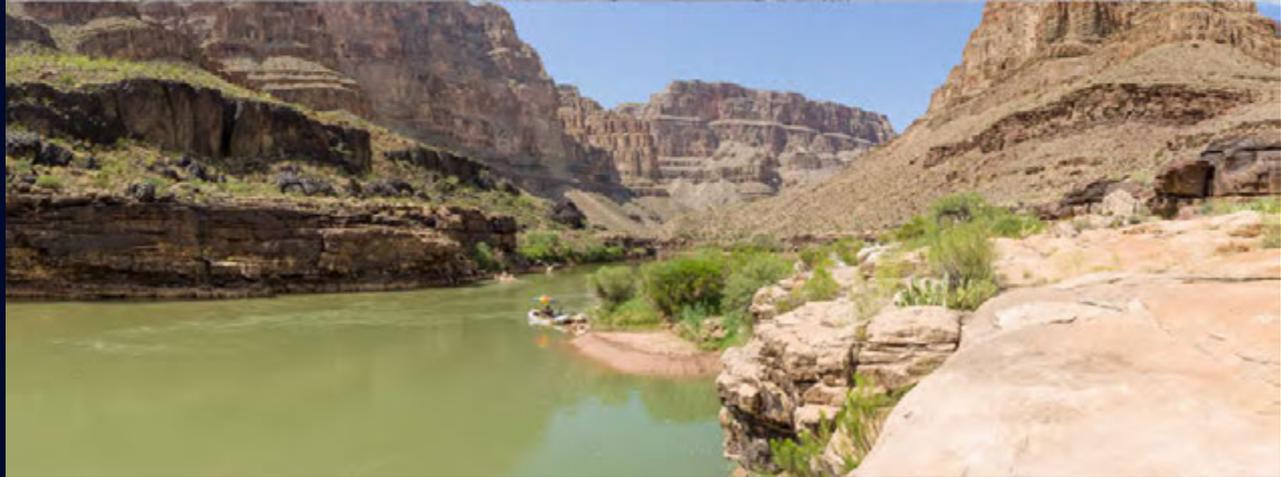
Stake 5315
RM 214.1 L

Even bedrock shorelines have increased vegetation

E. C. La Rue
09/29/1923

A. H. Fairley
09/05/2017

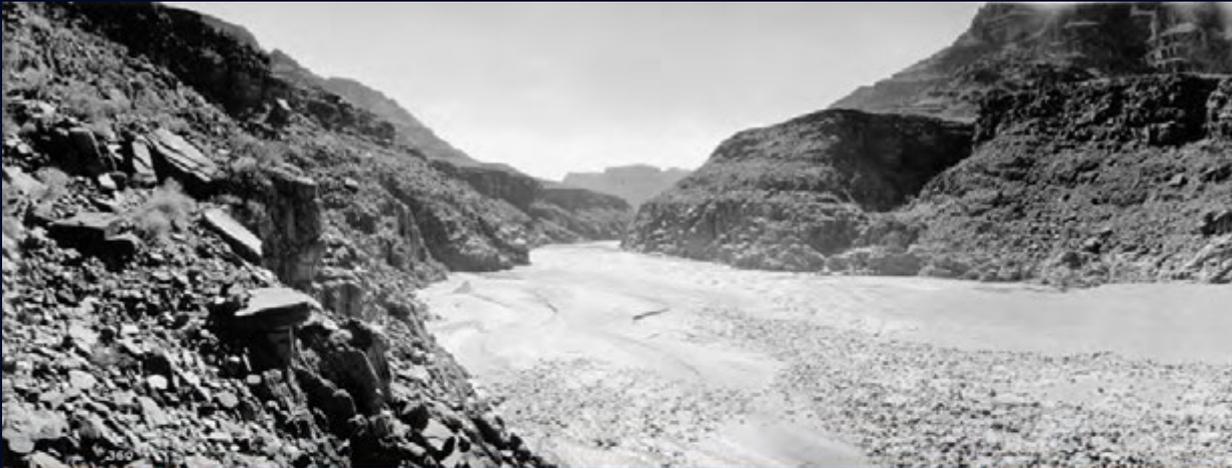
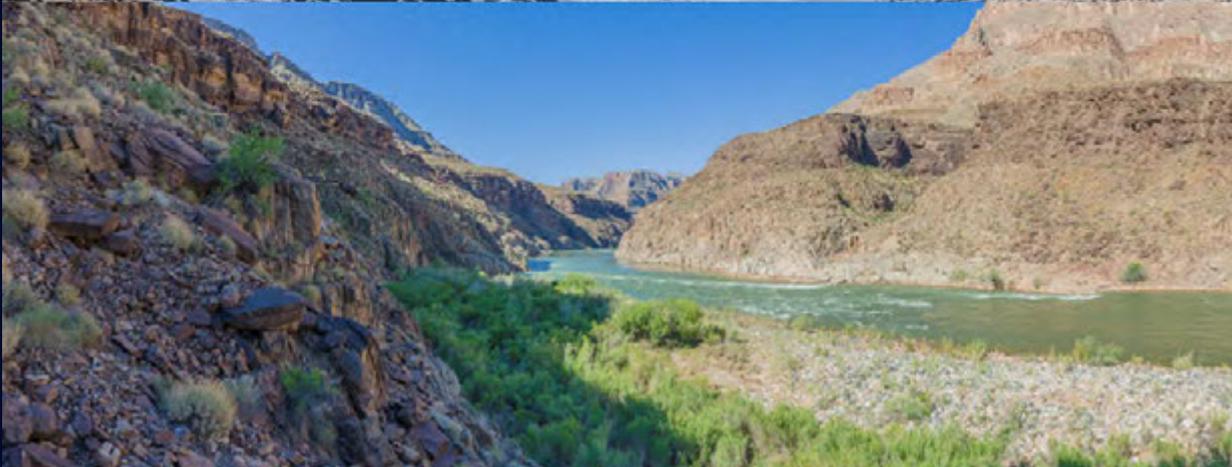
RM 217.9 L
Stake 703

Vegetation increase is densest on bare sand

E. C. La Rue
09/30/1923

A.H. Fairley
05/18/2017

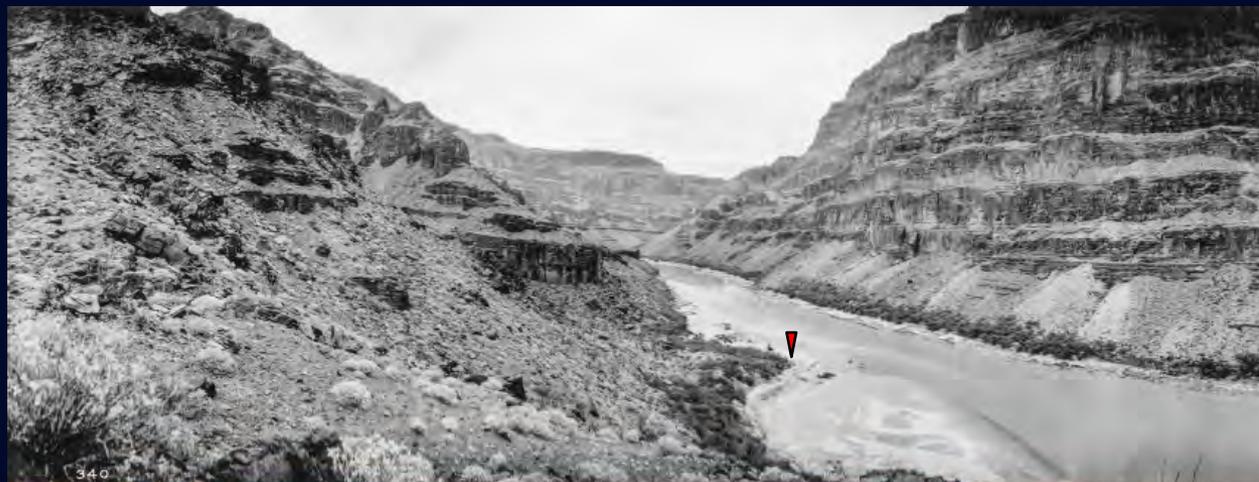
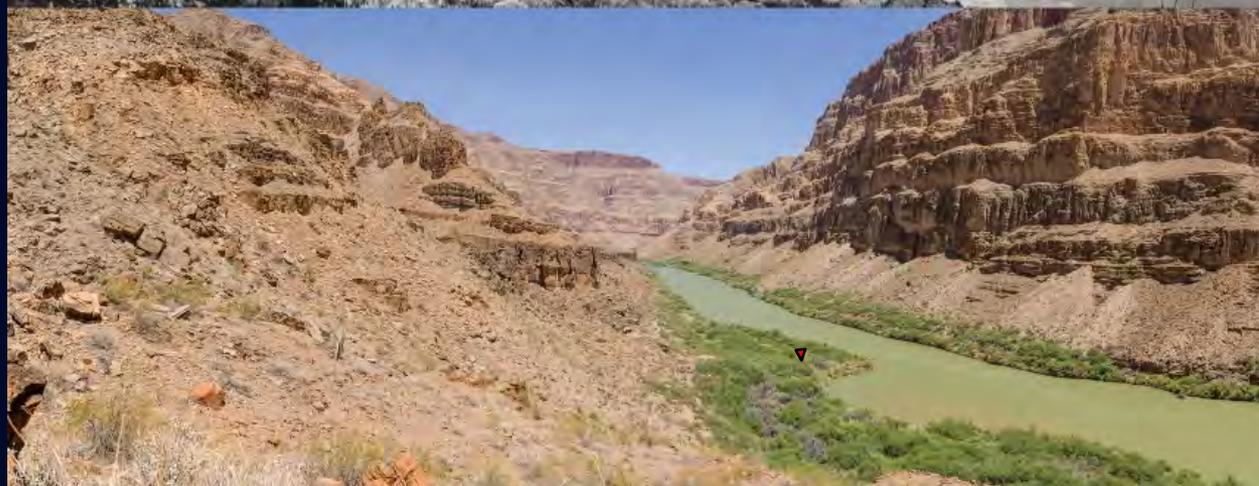
Stake 1802
RM 204.5 R

In addition to covering bare sand, vegetation encroachment is leading to channel narrowing in some areas

E. C. La Rue
09/27/1923

A. H. Fairley
05/11/2018

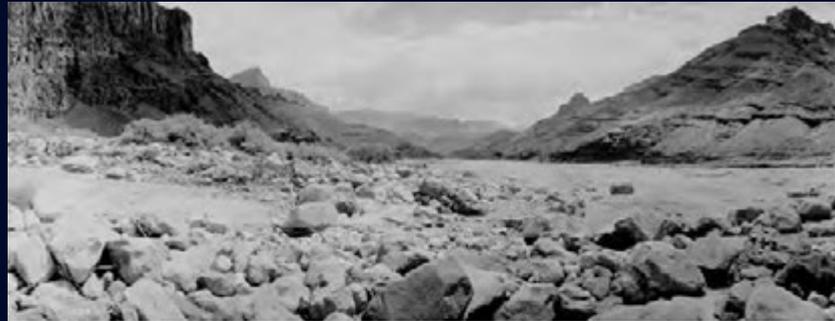
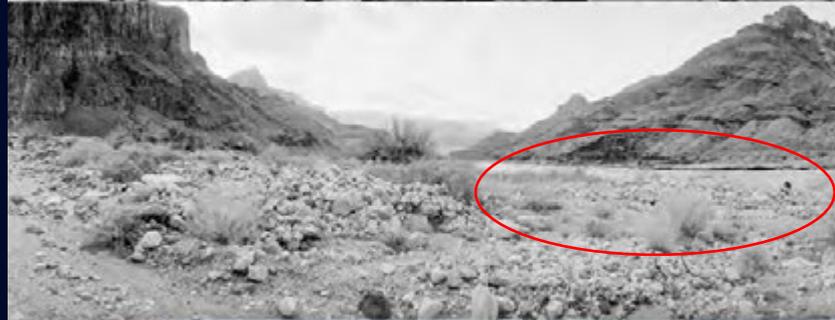
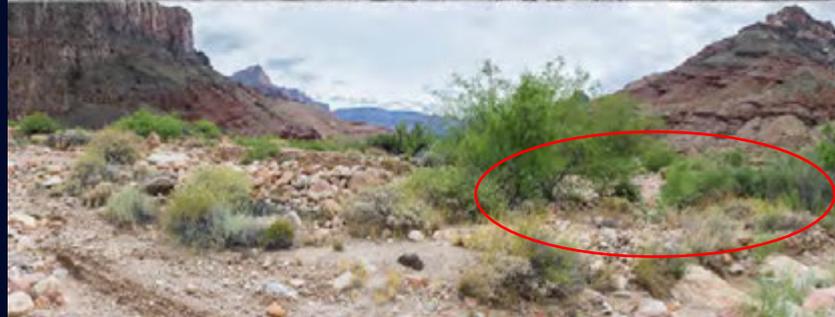
Stake 1707a, RM 66.0 L

Matches from early 1990s show less shoreline vegetation than today

E. C. La Rue
08/14/1923

E. Hymans
02/24/1993

A. H. Fairley
05/10/2017

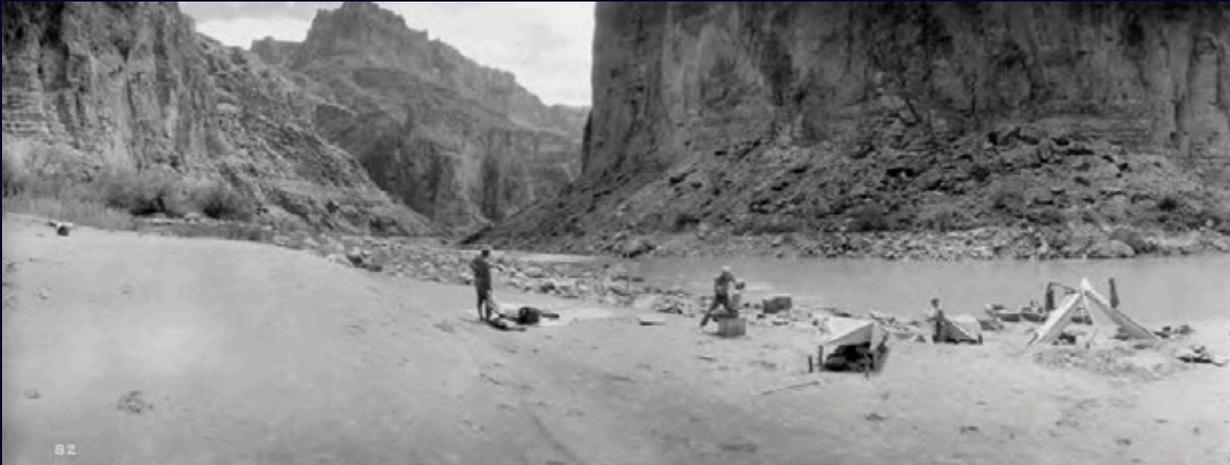
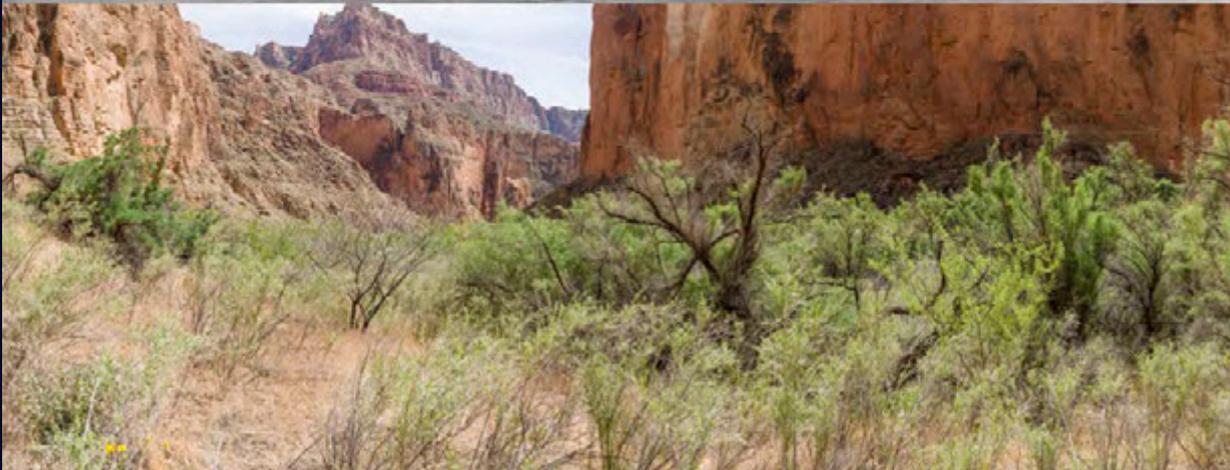
Stake 678
RM 43.9 L

Many 1923 sand bar camps (aeolian sand sources) are unavailable today due to vegetation encroachment

E. C. La Rue
08/10/1923

A.H. Fairley
05/06/2019

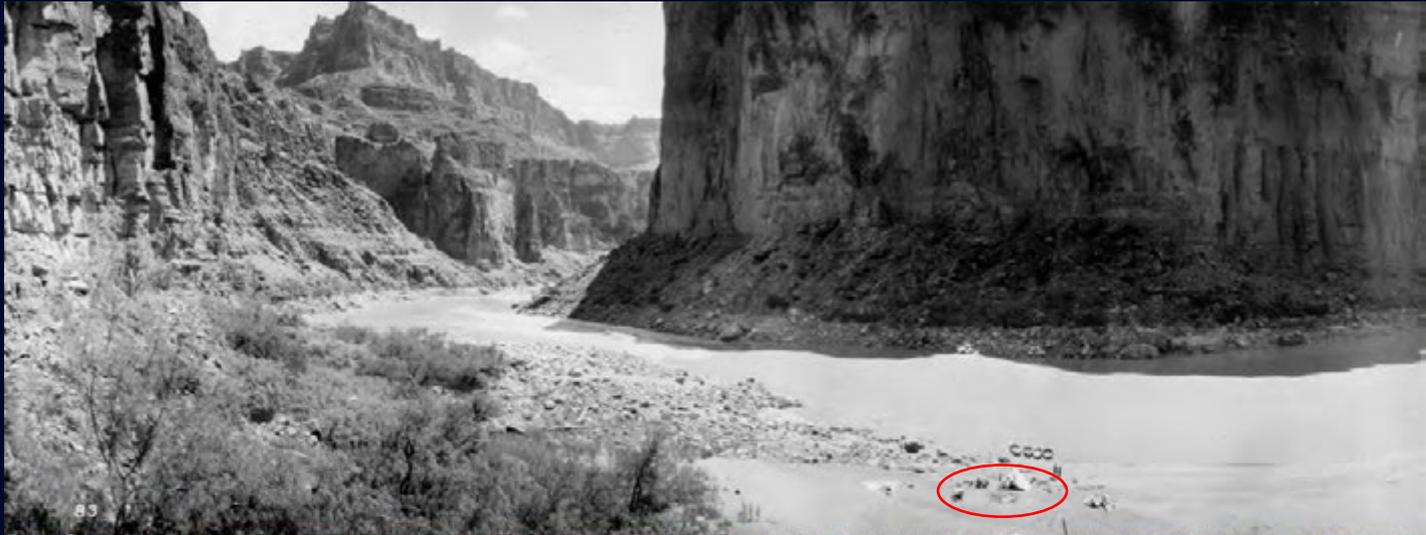
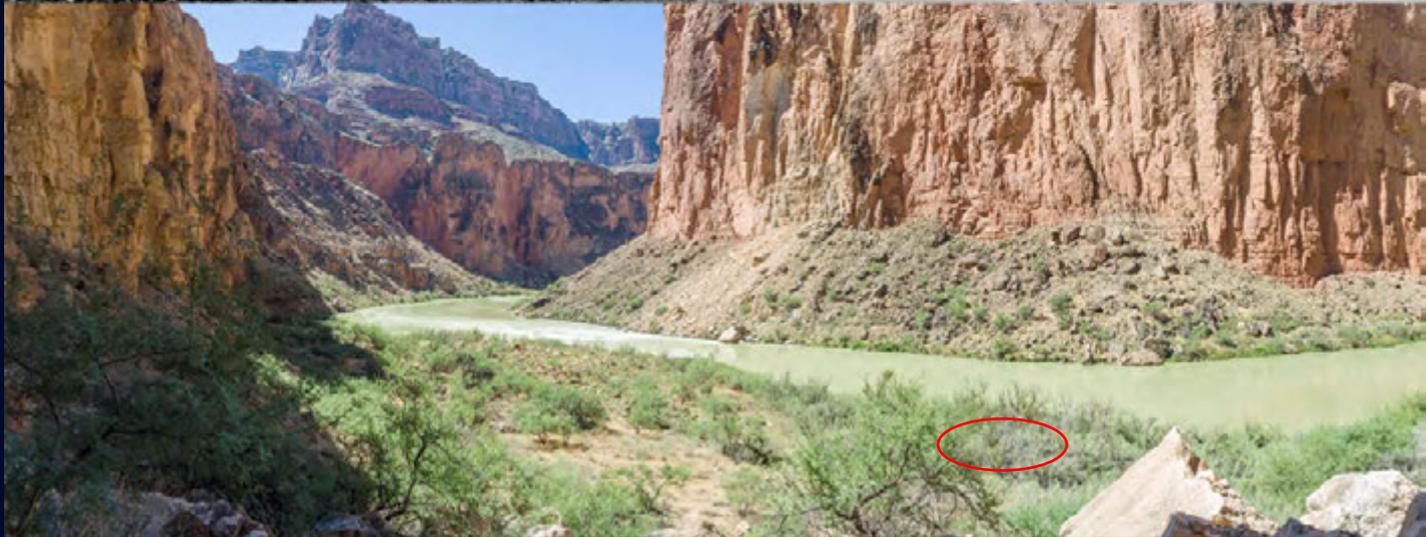
Stake 677
RM 43.9 L

Repeat photographs of RM 43.9 L, stake 677

E. C. La Rue
08/10/1923

A. H. Fairley
08/26/2017

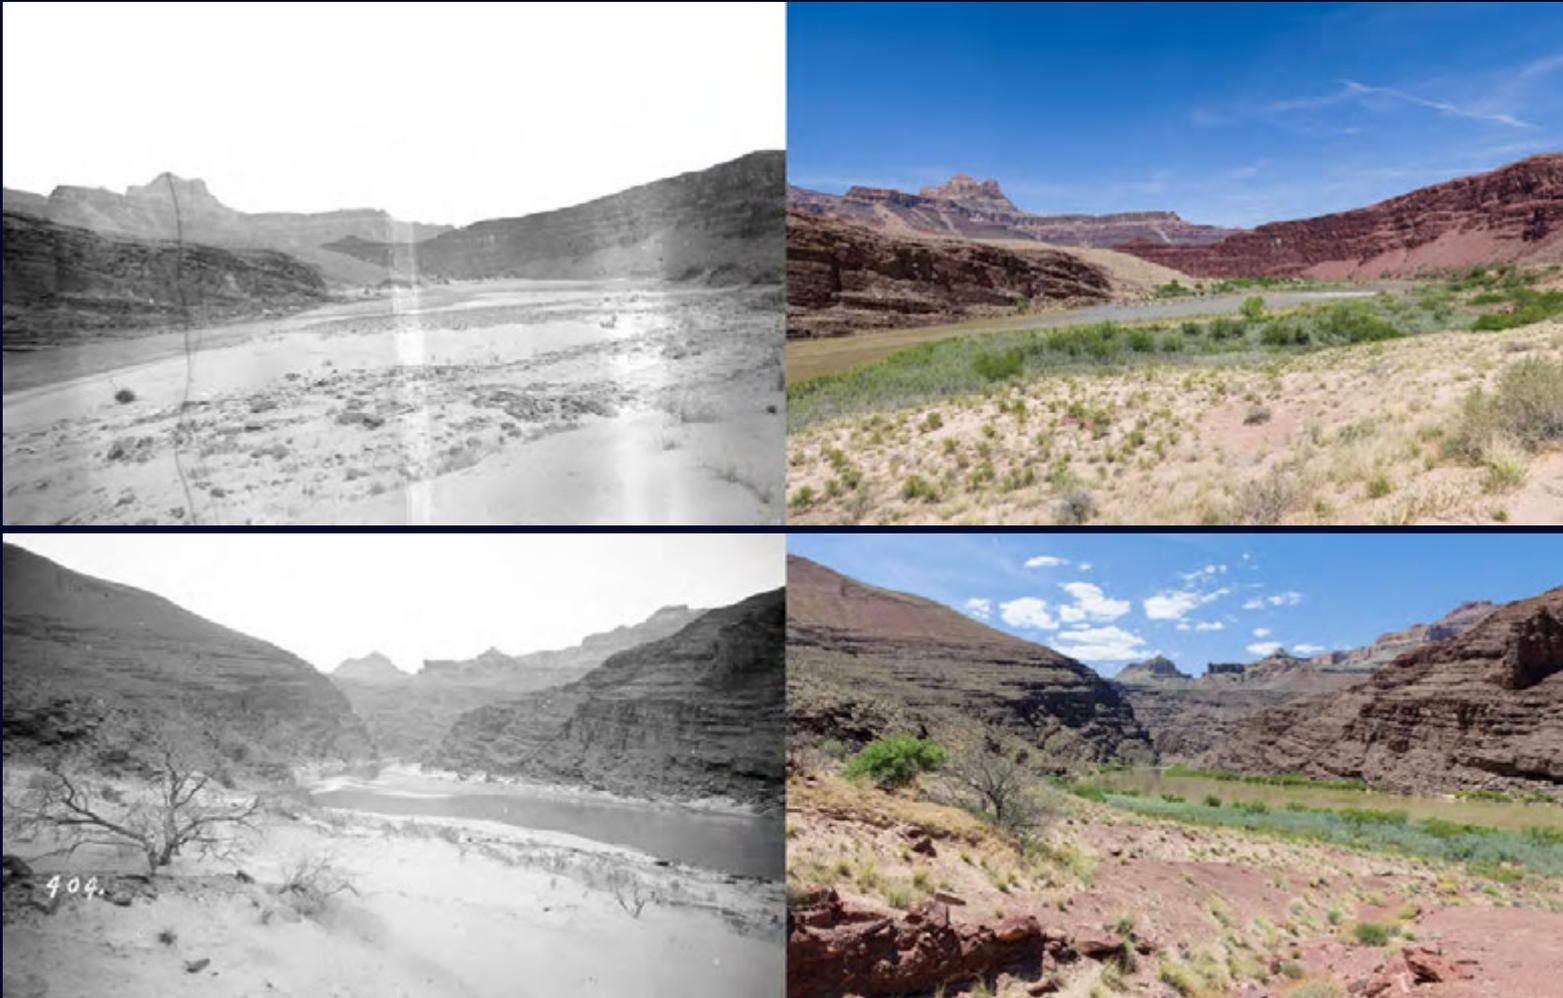
Loss of aeolian sand has affected large portions of the bio-cultural landscape of the Colorado River ecosystem

Lower Unkar, RM 73.9 L. Top, S1575, looking upstream; Below, S1574, DS view. Left: R. B. Stanton, 01/24/1890; Right: A. H. Fairley, 08/23/2017

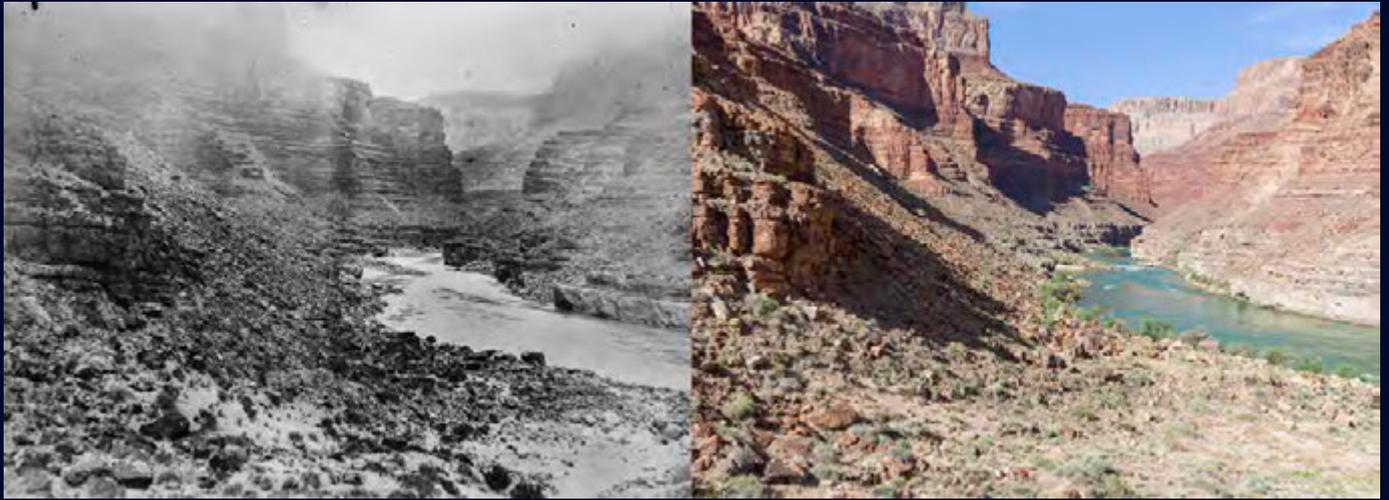
With loss of sand supply, dunes have become less active, more vegetated*

River Mile 24.7 L
Left: R.B. Stanton
07/14/1889,
Right: A.H.Fairley,
05/07/2017

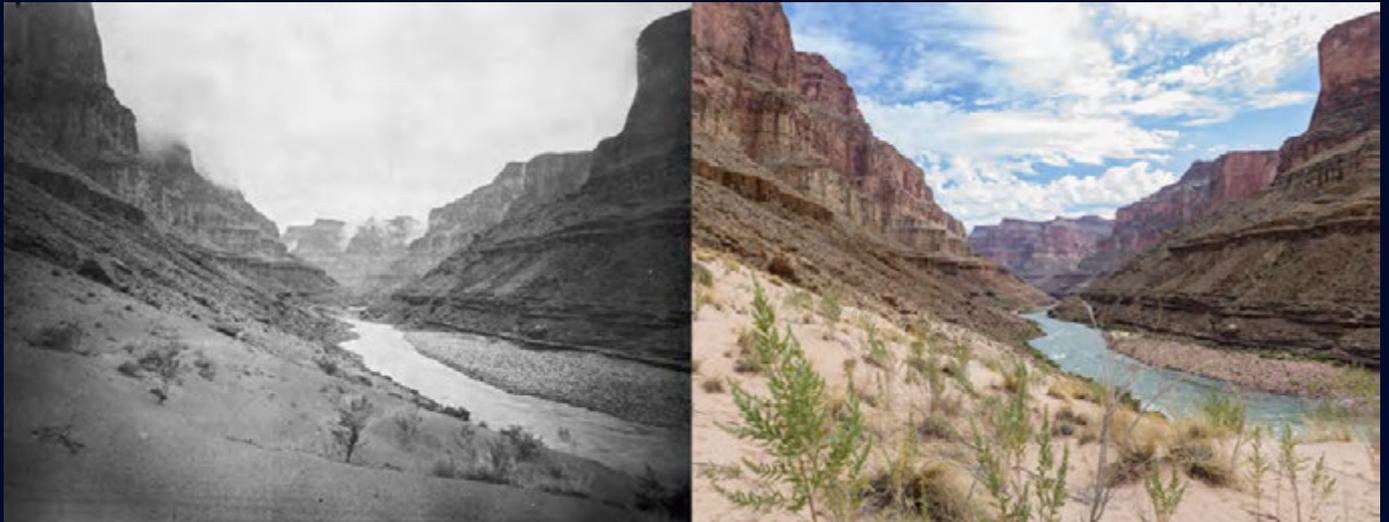
River Mile 125.6 L
Left: R.B. Stanton
02/21/1890,
Right: A.H. Fairley,
08/31/2017

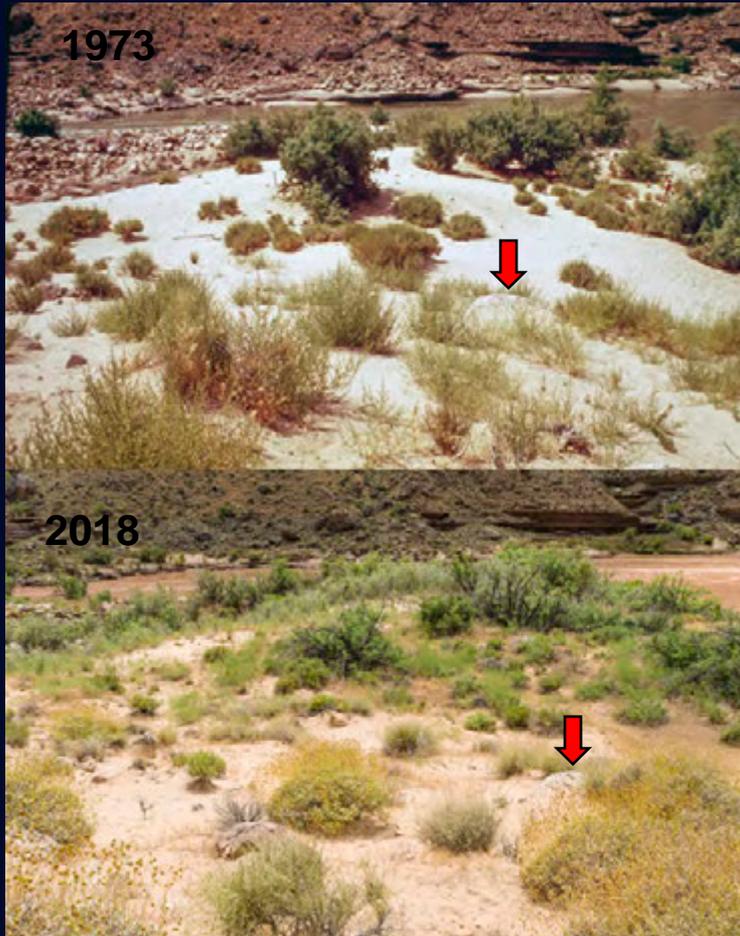
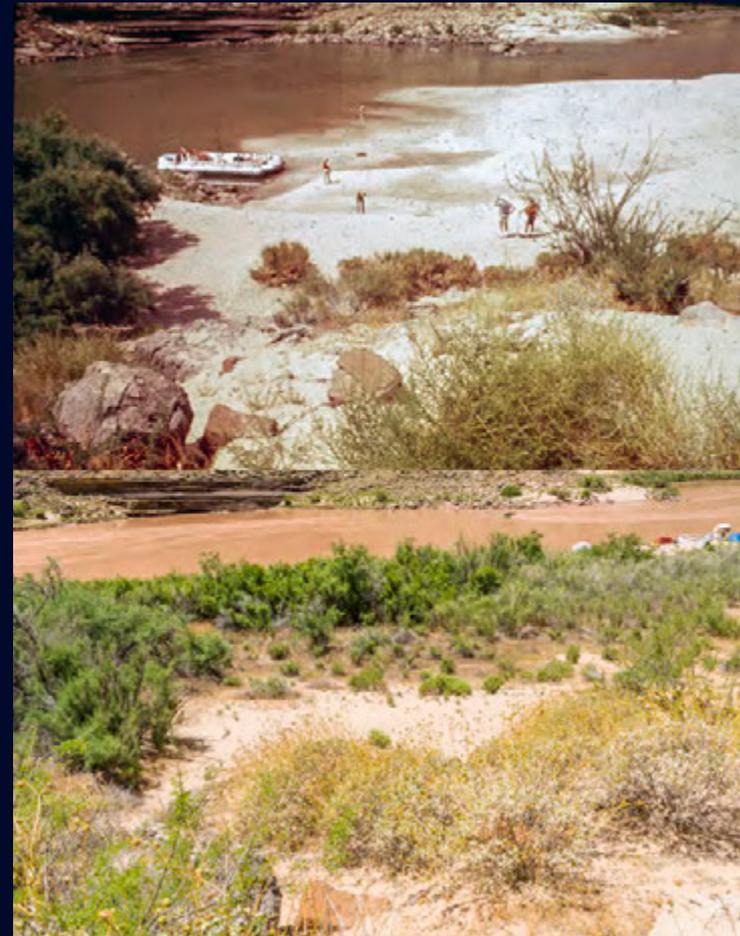
Loss of fluvial-aeolian connectivity impacts area and quality of campsites as well as archaeological site integrity*

122 Mile Camp (Project D Study Site)
Top: Borden-Weeden photos, July 1973
Bottom: A. H. Fairley, May 12, 2019

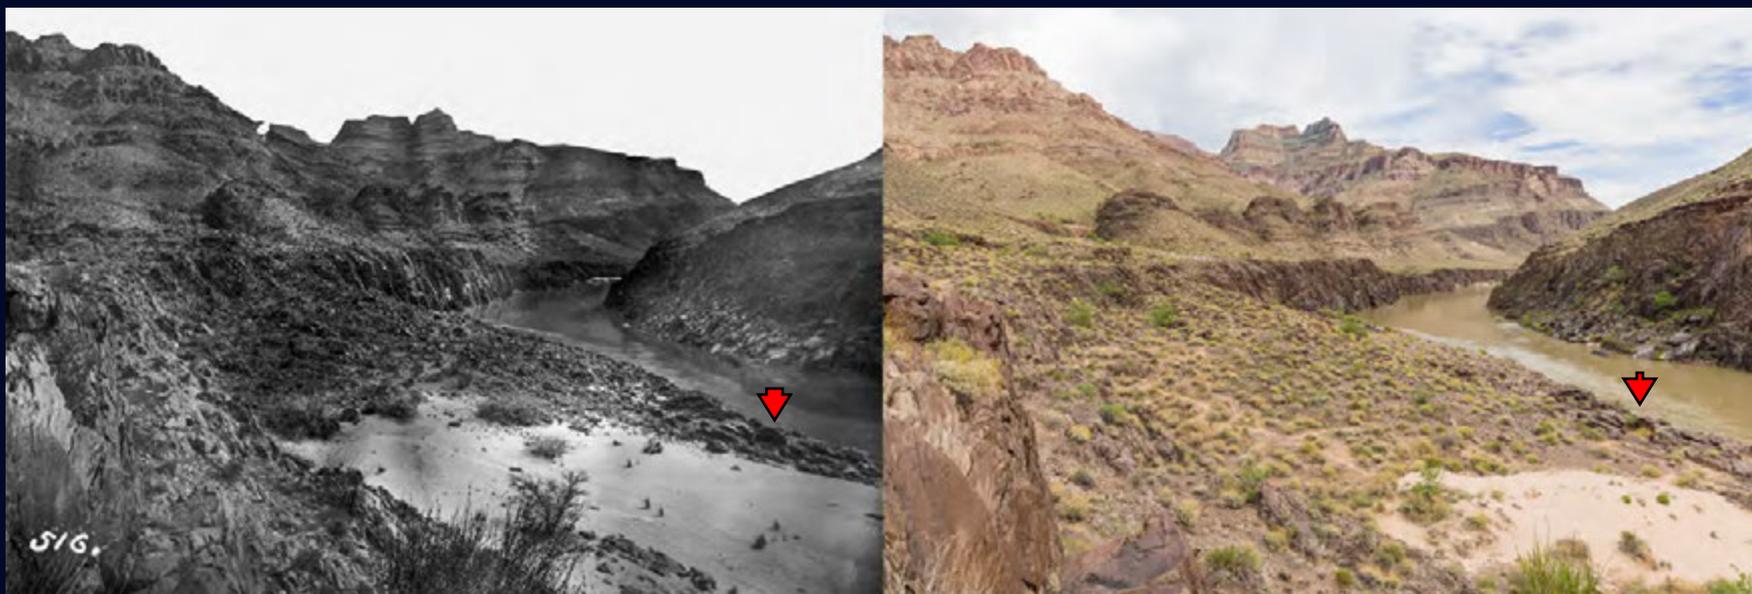
RM 109 R, Bass Camp, upper half (Stake 1580)

Bass Camp: an example of how aeolian sand contributes to camp site area . . .

R. B. Stanton, 02/17/1890

A.H. Fairley, 05/11/2019

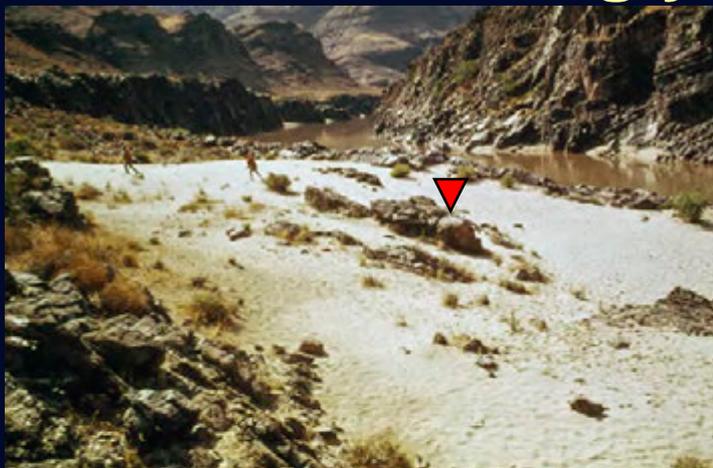
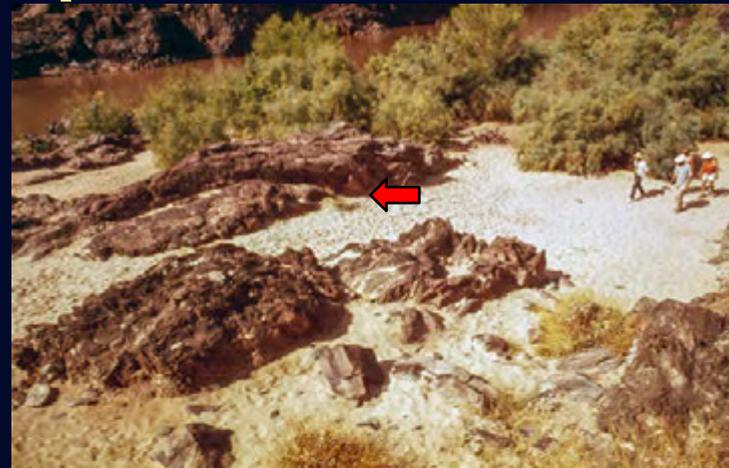
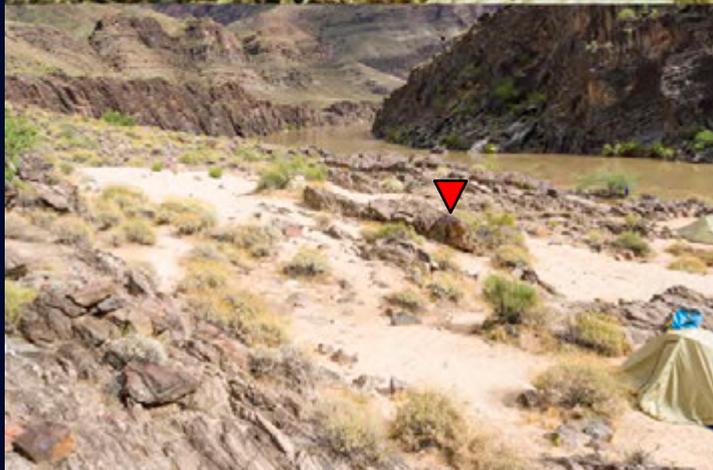
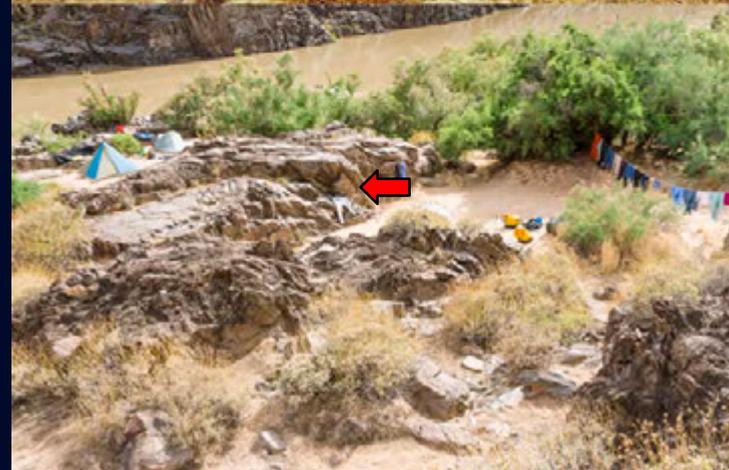
Bass Camp, River Mile 108.9

... and quality! As aeolian sand deflates and is not replenished, rocky substrate becomes increasingly exposed

July 1973

May 2019

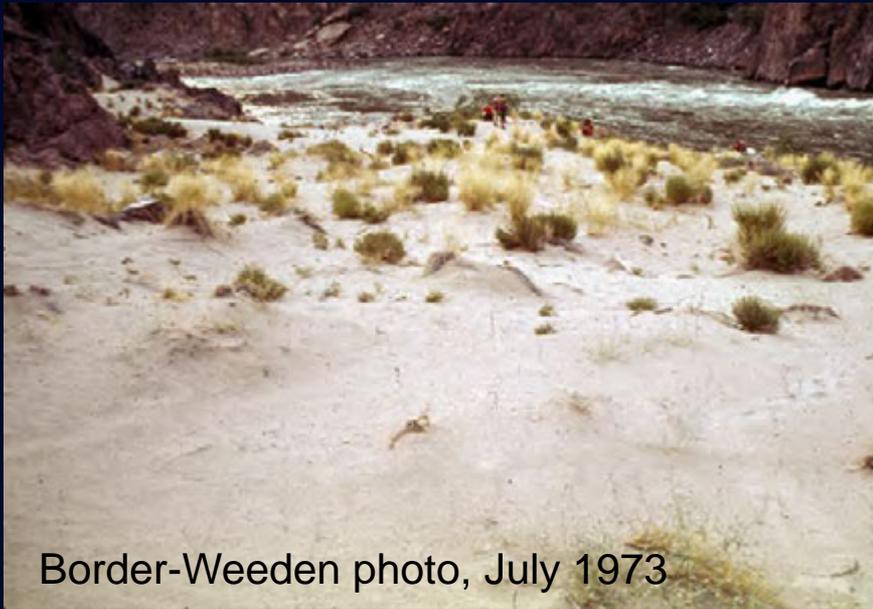
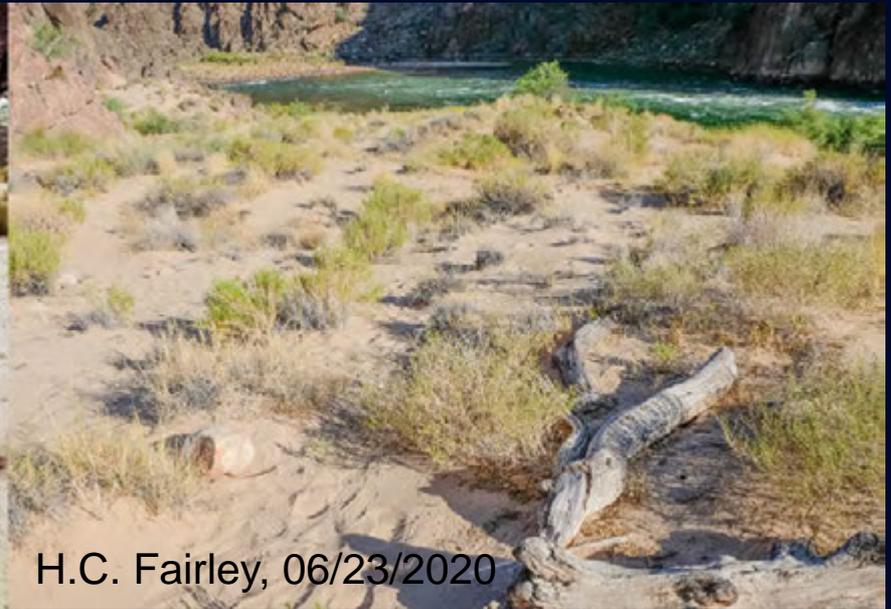
Lower Granite Camp, River mile 93.9 L

Loss of aeolian sand has implications for the plants and animals that need or prefer aeolian sand habitats*

This photo match shows how perennial shrubs (mostly *Isocoma acradenia*) have largely replaced the bunch grasses (mostly *Achnatherum hymenoides*, a.k.a. Indian Rice Grass) which formerly grew abundantly on the dunes at lower Granite Rapids
