Project L: Remote Sensing Overflight in Support of Long- Term Monitoring and LTEMP

Annual Reporting Meeting – January 12, 2022

Joel B. Sankey, USGS, Southwest Biological Science Center, Grand
Canyon Monitoring and Research Center

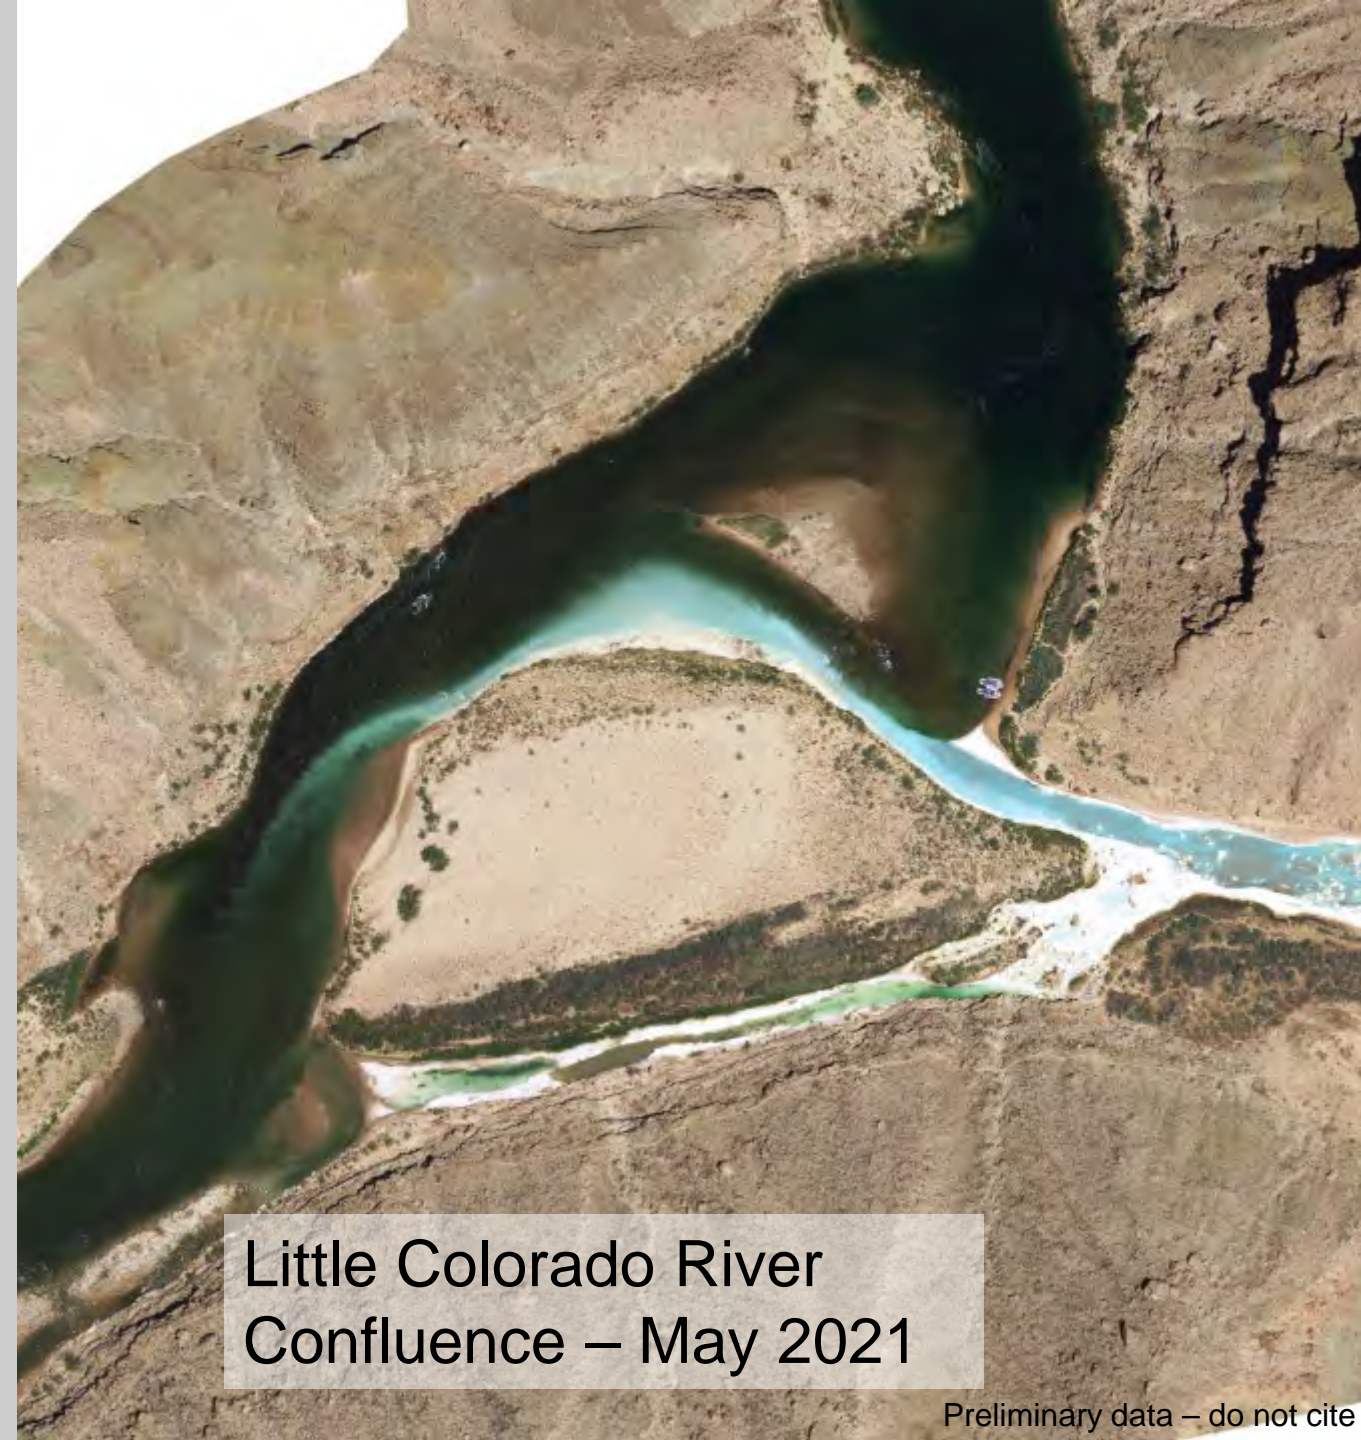
Little Colorado River
Confluence – May 2021

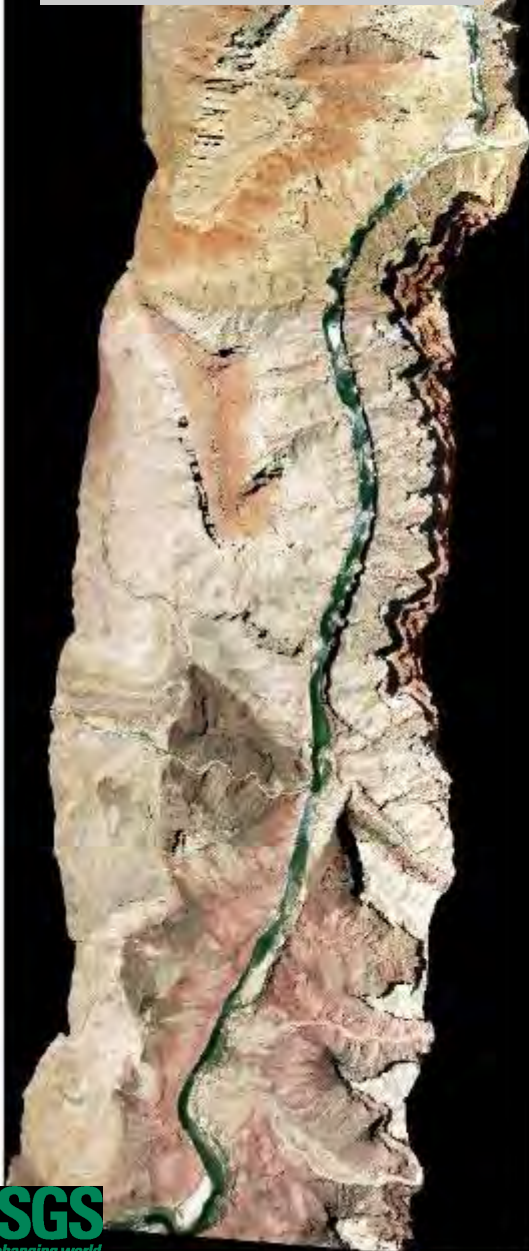
Imagery:
All raw flightlines

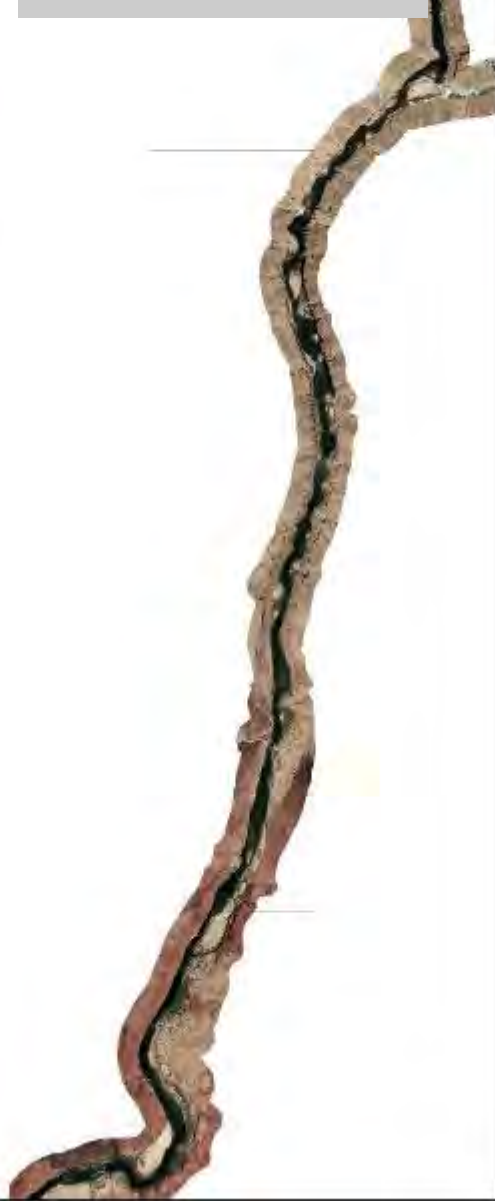
Imagery:
4 band
Orthomosaic

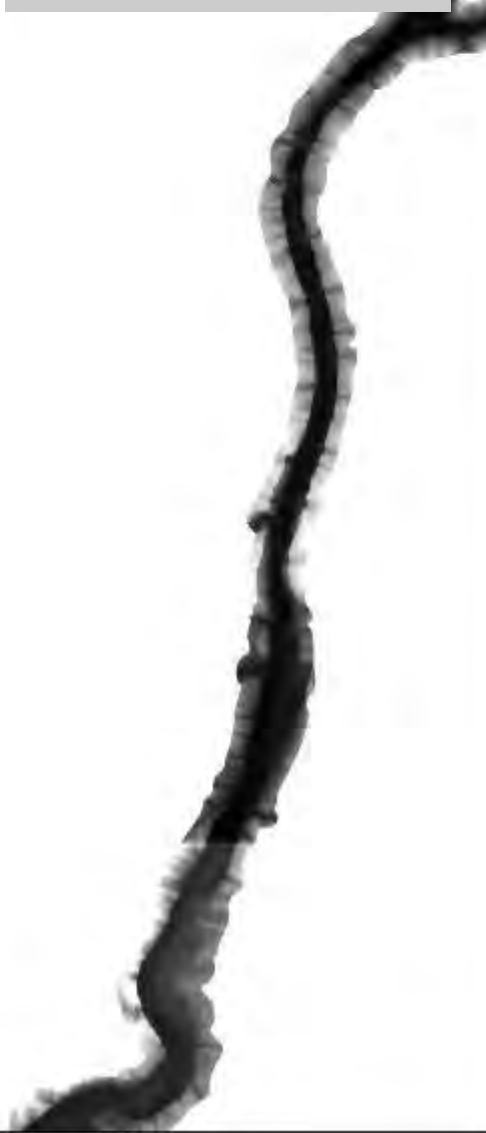
Topography:
Digital Surface
Model & Digital
Elevation Model

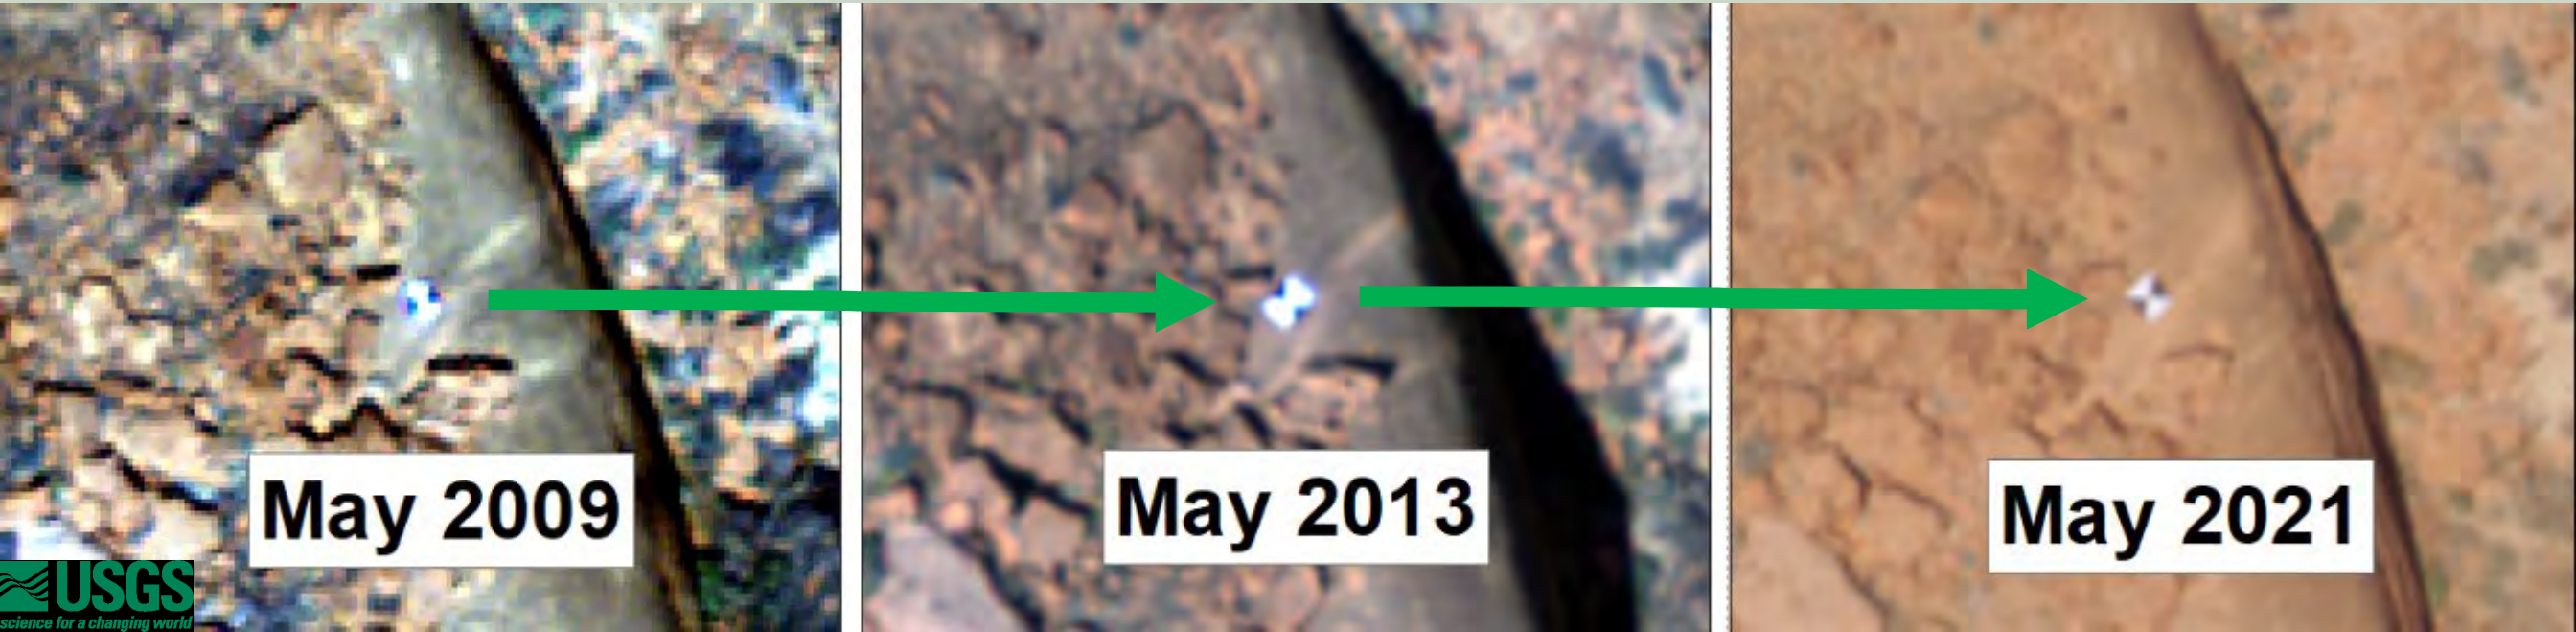
May 2021 Overflight Imagery Positional (Horizontal) Accuracy

- ❑ 156 black and white ground truth panels were placed between Glen Canyon Dam and Pearce Ferry to assess positional accuracy on the Earth surface.
- ❑ Many of the same ground truth locations were also occupied in previous overflights allowing GCMRC to accurately assess positional accuracy between overflights.

2021 accuracy to Survey Control (meters)			
	Total	Northing (y)	Easting (x)
RMSE	0.521	0.436	0.284
95% Confidence	1.274	0.855	0.557

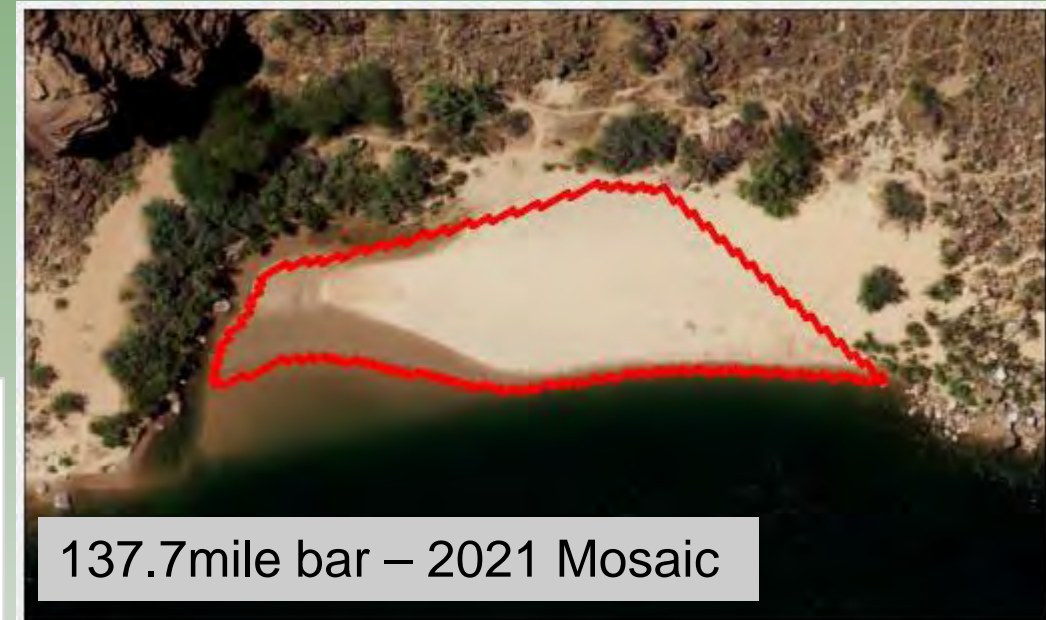
137.7mile bar – 2021 Mosaic

May 2021 Overflight Topography Positional (Vertical) Accuracy

- ❑ 23 sandbars were topographically surveyed during the overflight steady low flows.
- ❑ We used the interpolated survey surfaces for these bars to evaluate the accuracy of the DEM & DSM datasets.

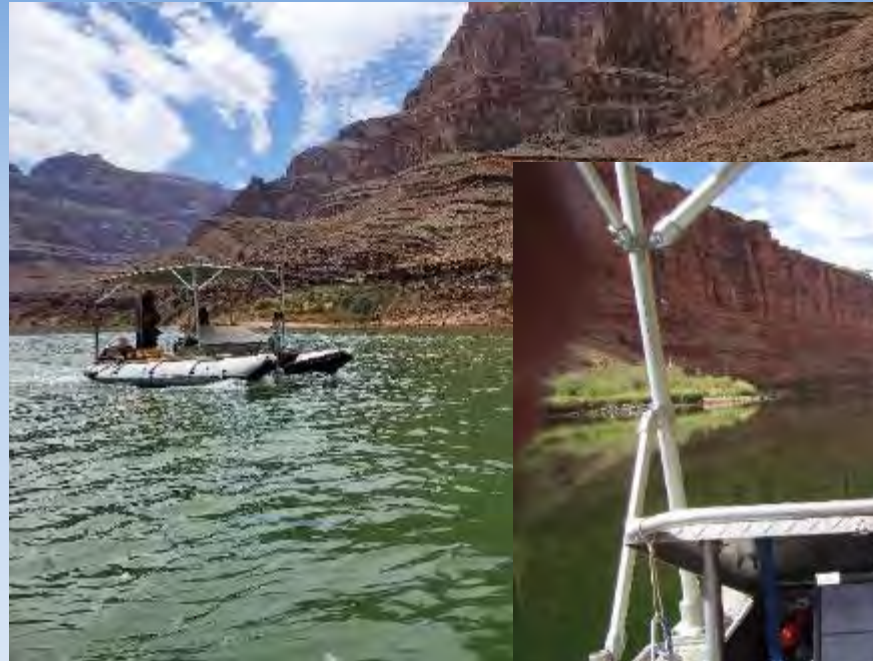
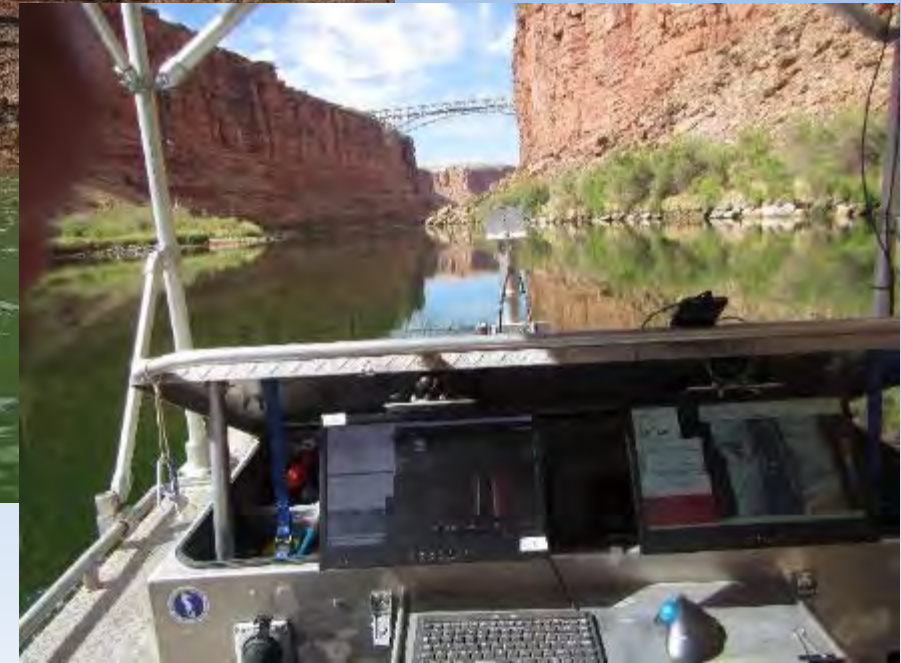
Measurement of water-surface profile during 2021 overflight

- Continuous profile collected by boat from Lees Ferry to Pearce Ferry
- 187 surveyed water surface elevations at (1 every ~1.2 miles)
- 23 topographic surveys for validating the overflight digital elevation model
- All water-surface and topographic surveys have been processed
- Preliminary comparison between 10 surveyed water-surface elevations and boat-based measurements indicate improved accuracy (maximum difference of 0.11 m with mean difference of 0.02 m)

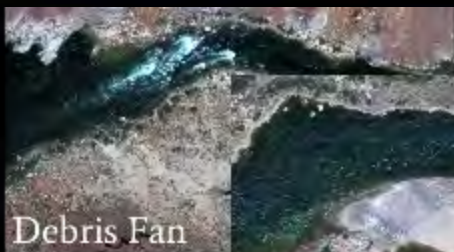
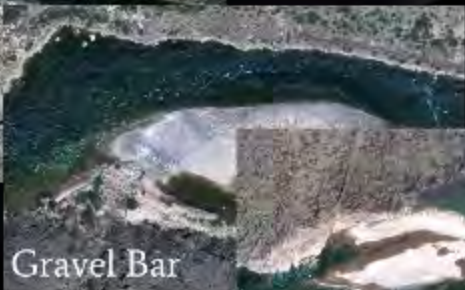
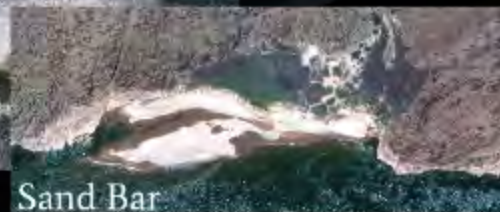
Durning et al, 2021

- Hydrologic zone 1 Debris fan
- Hydrologic zone 1 Gravel bar
- Hydrologic zone 1 Sandbar
- Hydrologic zone 2 Debris fan
- Hydrologic zone 2 Gravel bar
- Hydrologic zone 2 Sandbar

Summary (Durning et al. 2021)

- Riparian vegetation expanded from 2002 to 2013.
 - Three quarters of the expansion occurred between 2002 & 2009.
- Seep willow, tamarisk and arrowweed were the primary encroaching woody species.
- Common reed and horsetail were the primary encroaching herbaceous species.
- Encroachment composition from 2002 to 2009 was similar to the entire riparian landscape, whereas encroachment from 2009 to 2013 primarily consisted of seep willow and early colonizing herbaceous species.
- Emergence of seep willow and arrowweed after burial by sand deposited by controlled floods indicated that those species were resilient to this form of disturbance.
- Describing patterns of species encroachment is an important step towards designing flow regimes that favor riparian species and ecosystem functions valued by stakeholders

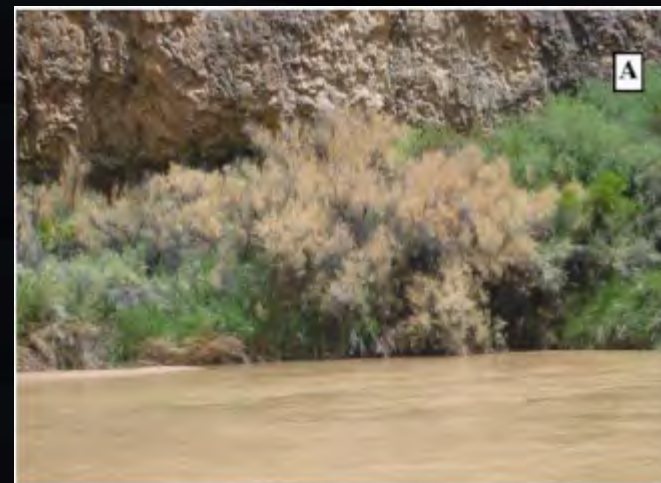
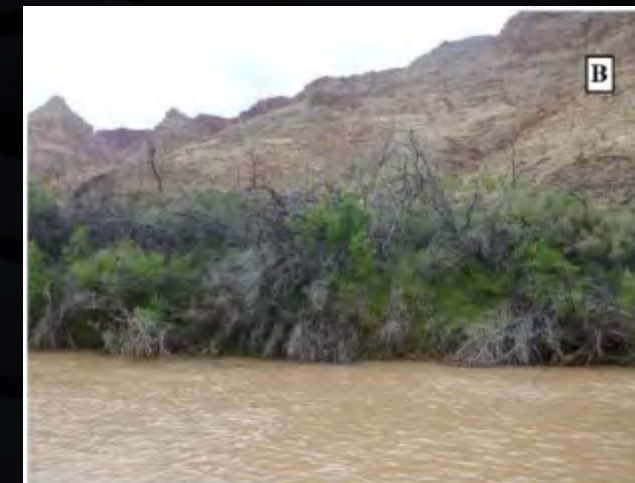
Summary (Bransky et al. 2021)

- We used highly accurate classifications derived from overflights and satellites to map changes in tamarisk cover
- During the growing season of 2019 we documented a 47.5% decline in tamarisk
- At the decadal scale, we observed a 29.5% decline in healthy tamarisk canopy between 2009 and 2019
- (note 2021 overflight imagery will provide system-wide update on beetle impacts to tamarisk)
- These maps provide detailed information that can allow managers to target mechanical and other invasive species management efforts
