Objective: Understand and quantify relation between changes in bed configuration in Western Grand Canyon and dam releases.

Do certain dam operations reduce, exacerbate or mitigate sediment accumulation in this reach?

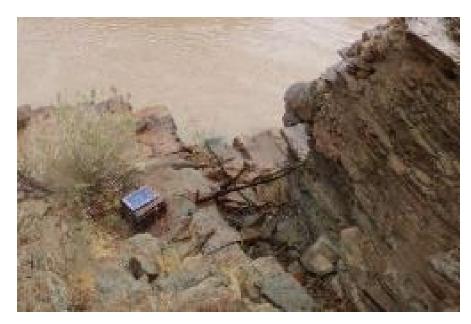
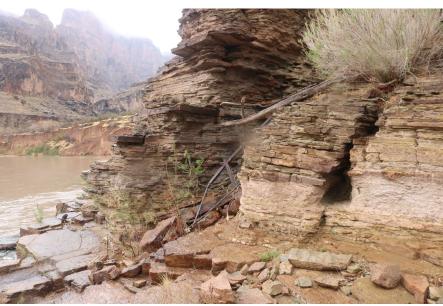
Temporary Gage at RM 275

- This gage measures water surface elevation
- It is used to calculate travel time between the Colorado River gage at Diamond Creek (RM 226) and the study reach

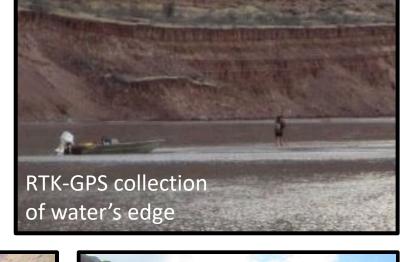
- GPS observations of benchmarks
- Multibeam sonar survey of riverbed
- Boat-based lidar survey of banks
- Ground-based RTK-GPS survey of water's edge, topography, and check points
- Time-lapse cameras to show bars during low-flow and bank erosion

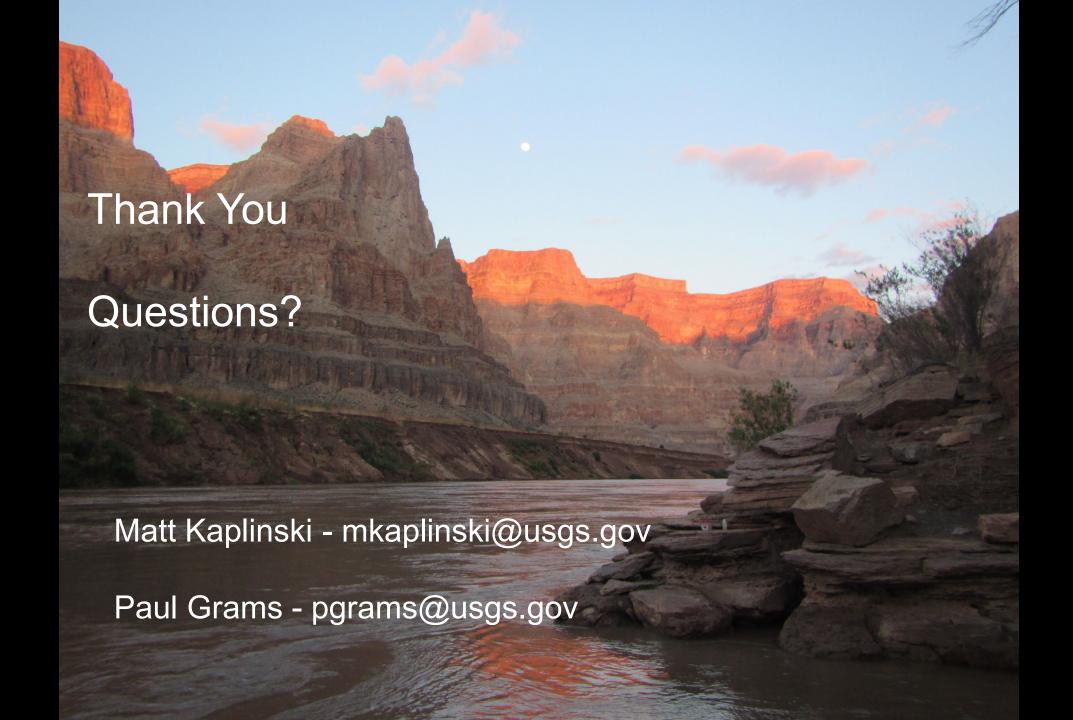
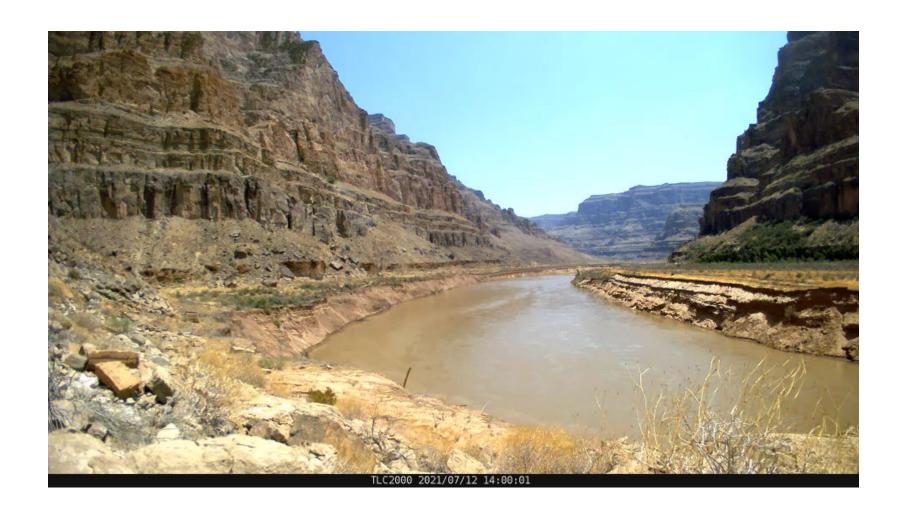
Columbine Reach Bank erosion

- Time-lapse cameras capture bank erosion
- This bank eroded on July 14 and 15, 2021
