## VEGETATION AND WILDLIFE MITIGATION FINAL REPORT

Animas-La Plata Project, Colorado and New Mexico  
Upper Colorado Region

April 2008

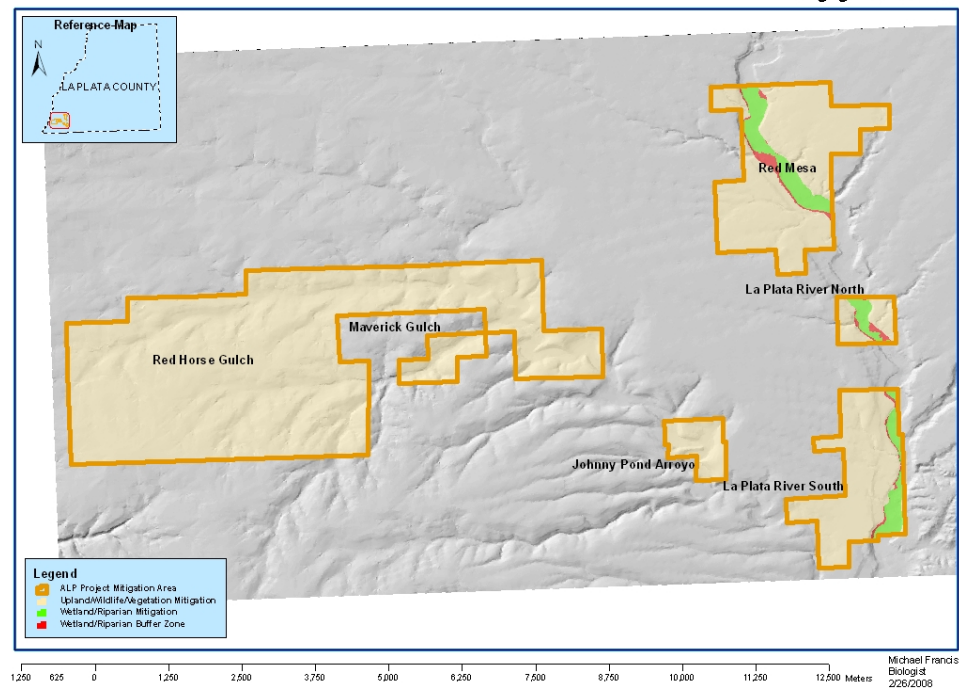
**Figure 3. ALP Project Mitigation Area Zones.**

In the 2000 FSEIS Reclamation committed to purchasing the Mitigation Area (MA) for wetland/riparian vegetation purposes prior to initiation of construction of the ALP Project. In 2002 Reclamation completed the purchase of the MA which consists of three separate purchased parcels (tracts) in 6 non-contiguous blocks, totaling nearly 6,000 acres (Table 1, Figure 2, below, and Appendix A). The MA also serves as the location for wildlife habitat mitigation and upland vegetation mitigation needs also identified in the FSEIS. A significant portion of the MA contains segments of the La Plata River and its floodplain. There are approximately 232 acres of wetland/riparian vegetation within the MA in tracts II and III, along with associated buffer zones (Figure 3, below).

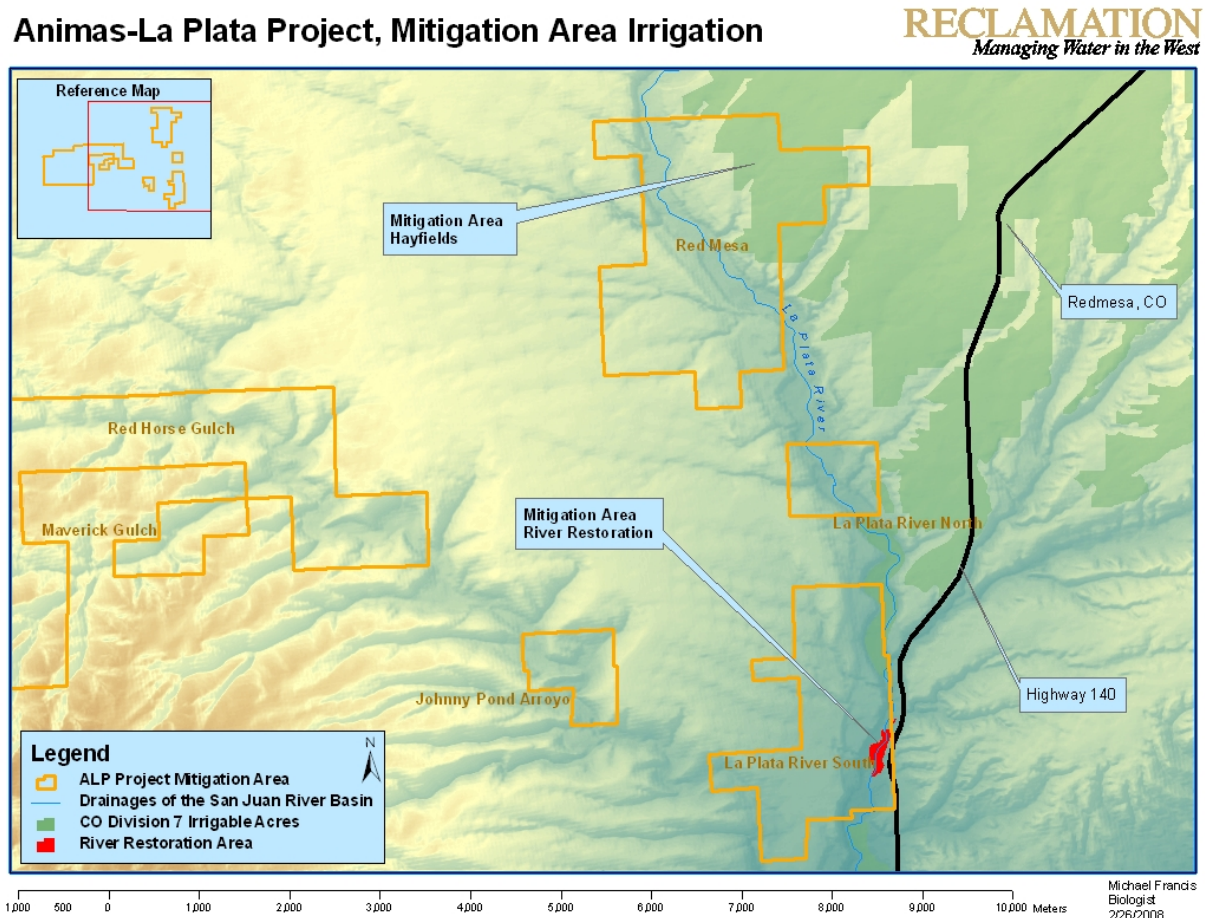
**Figure 4. 2007 Mitigation Area Irrigation.**

approved by the Colorado Division of Water Resources. Reclamation utilized a small portion of Reclamation's acquired water from storage in Redmesa-Ward Reservoir further downstream in the La Plata River restoration area (Figure 4) as a measure to ensure mitigation vegetation establishment (Figure 5). Reclamation will not seek to renew the SWSP in 2008 as vegetative standards are being attained in the river restoration area.

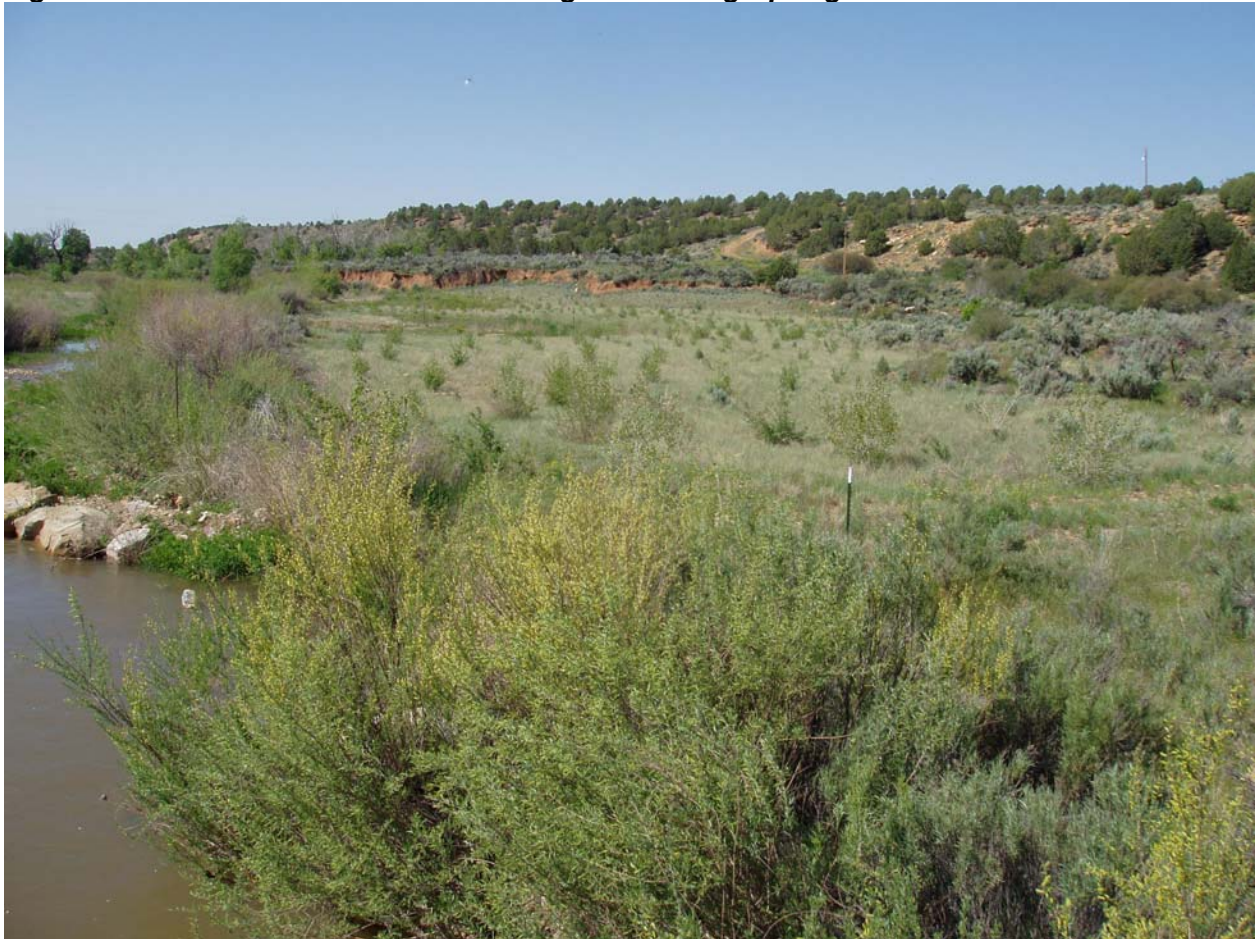
**Figure 5. River Restoration Area Irrigated During Spring of 2007.**

Reclamation has completed this requirement through the annual application of its acquired water rights in the irrigation of hayfields and the river restoration area of the MA.

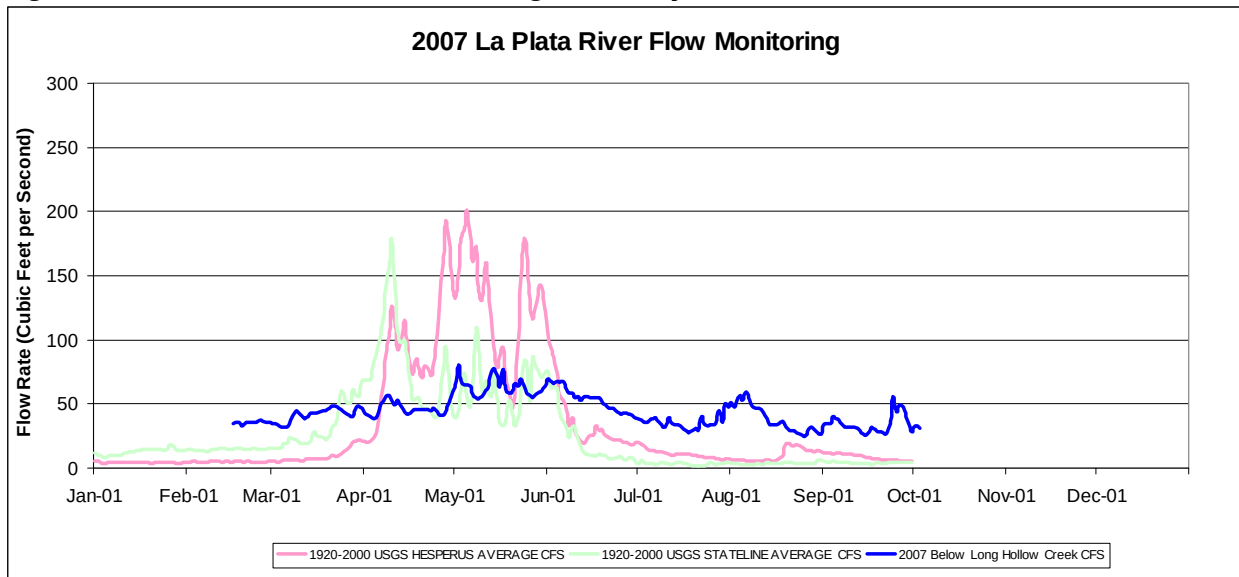
**Figure 6. La Plata River Monitoring Summary Results for 2007.**

Figures 6-11 below display the annual results of Reclamation's La Plata River flow monitoring for 2002 through 2007. Years of particular note are 2002 (a very low water year, Figure 11) and 2005 (a very high water year, Figure 8).

Reclamation has completed this requirement by annual monitoring of the La Plata River flow rates on the river below the confluence with Long Hollow Creek.

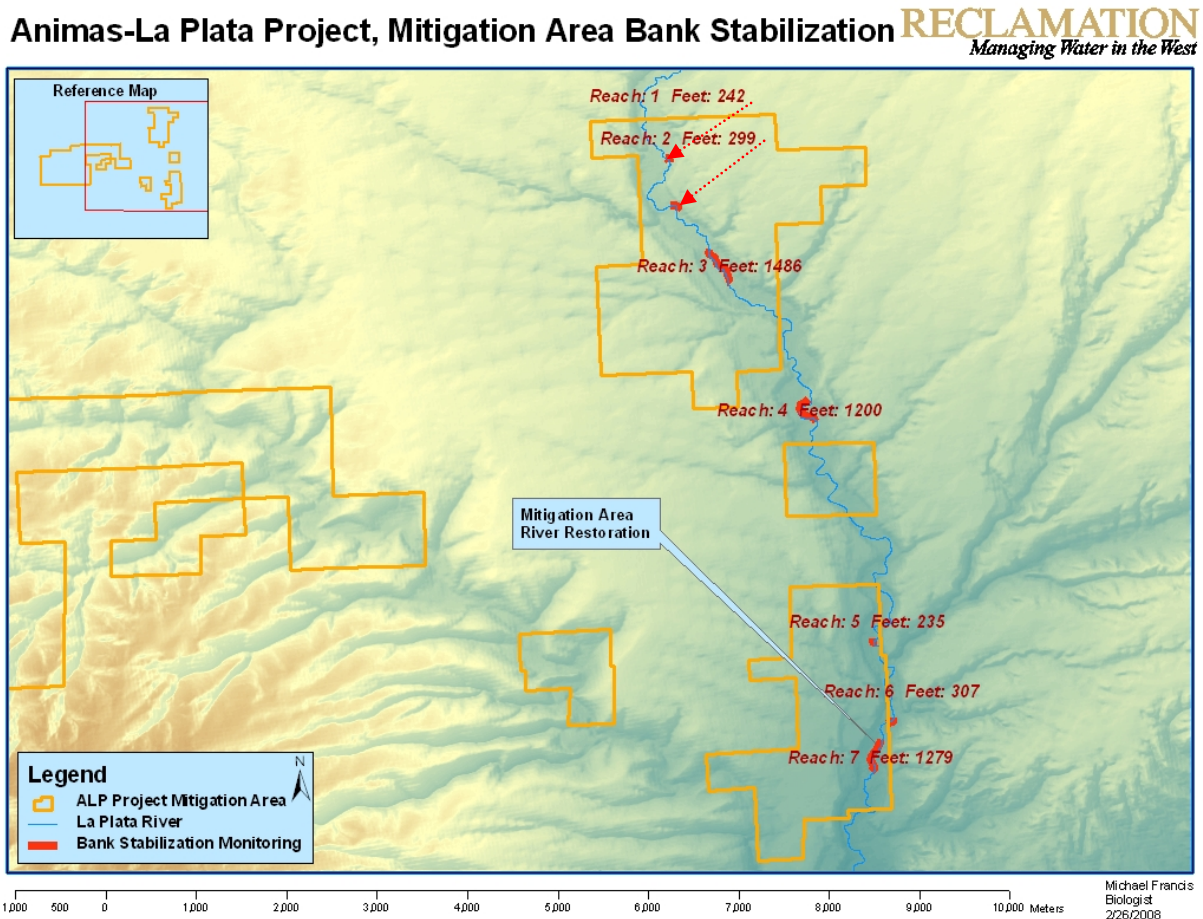
**Figure 12. La Plata River Bank Stabilization Monitoring Locations.**

Based on studies completed in 2001, a total of seven different locations (approximately 1,500 total linear feet) of La Plata River stream bank were found to be experiencing accelerated erosion and were possibly in need of stabilization (Figure 12, below). From 2003 through 2007, Reclamation monitored these locations to determine if natural vegetation recovery following the removal of cattle and horse grazing would suffice to protect denuded/damaged stream banks.

Of most concern to date are the river restoration reaches (reaches 6 and 7, Figure 12) and reach 3 which changed channel location and had significant sediment deposition resulting from flooding in 2005. Reclamation has not continued monitoring reach 4, as it is not located on Reclamation property.

Observations made through 2007 indicate that morphologic changes occurred at all of these reaches due to periodic spring and late summer flood flows following 2003. However, the removal of uncontrolled livestock grazing followed by selective seeding has resulted in the expansion of each reach's desirable vegetative community and has subsequently provided for stabilization. Segments 6 and 7 were stabilized through both reconstruction and revegetation.

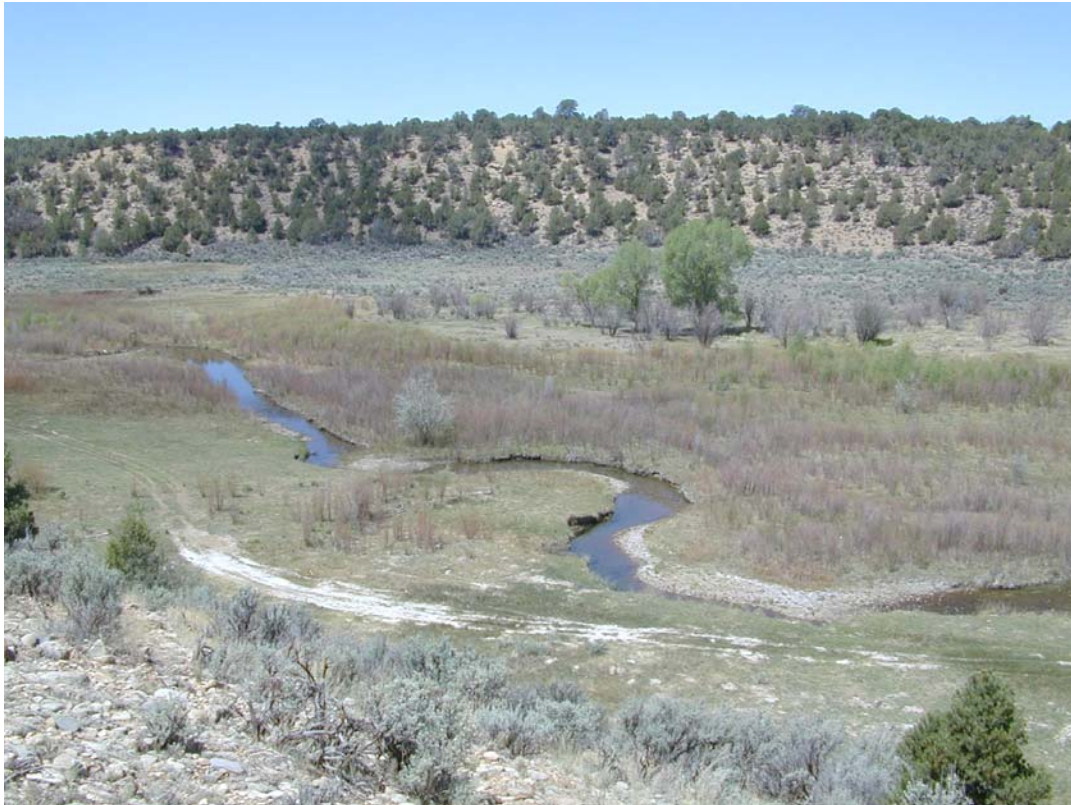
**Figure 13. Reach 1 in 2002.**

Note that reach 4 is not on Reclamation land and has been removed from this evaluation. Photos of some recovering reaches and graphic representations are provided in Figures 13 to 28 below. Photos of reach 5 were not available for this report.

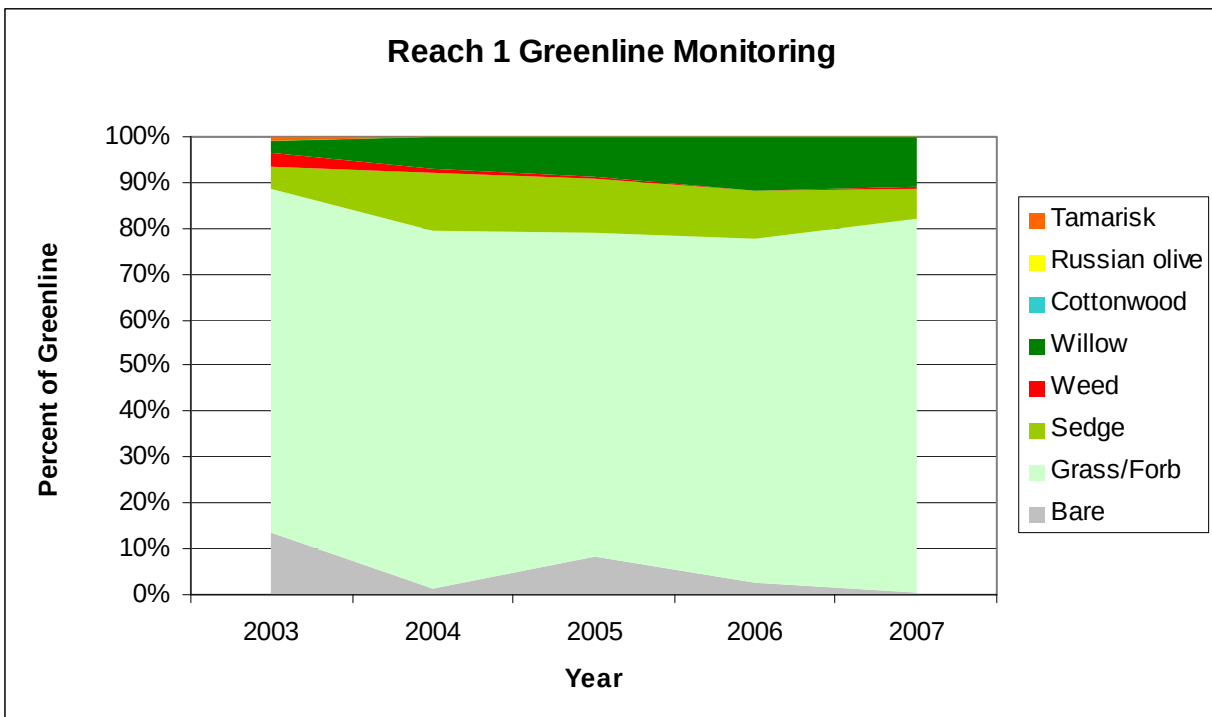
**Figure 15. Greenline Monitoring Results for Reach 1, 2003-2007.**

<sup>2</sup> The ‘Greenline Riparian-Wetland Monitoring’ method is described in USDOI Technical Reference 1737-8 (1993) as developed by the US Bureau of Land Management. This method is useful as an evaluation tool for determining if site-specific vegetation objectives of coverage and composition are being met. In this context, Reclamation desired to determine whether native vegetation along destabilized river banks was naturally recovering or not. The greenline method describes existing conditions, has measurable objectives and is useful as a descriptor of change over time.

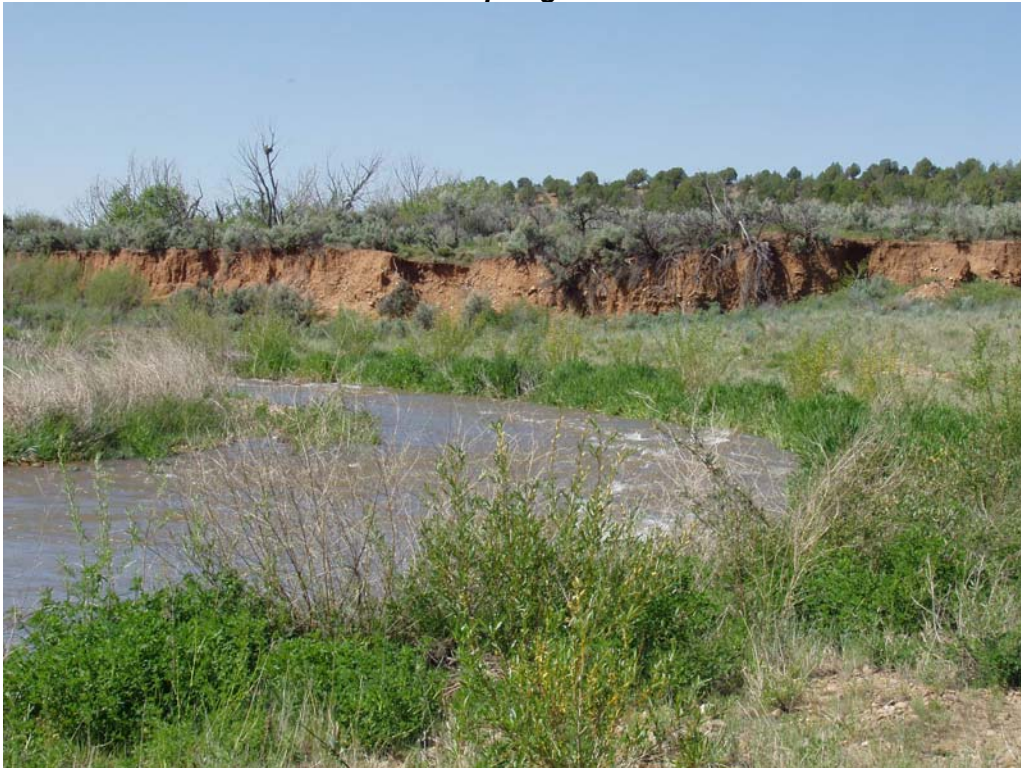
**Figure 27. A Portion of Reach 7 in the Spring of 2007.**

Reach 7 is contained fully within the river restoration area where complete bank and floodplain reconstruction and revegetation occurred.

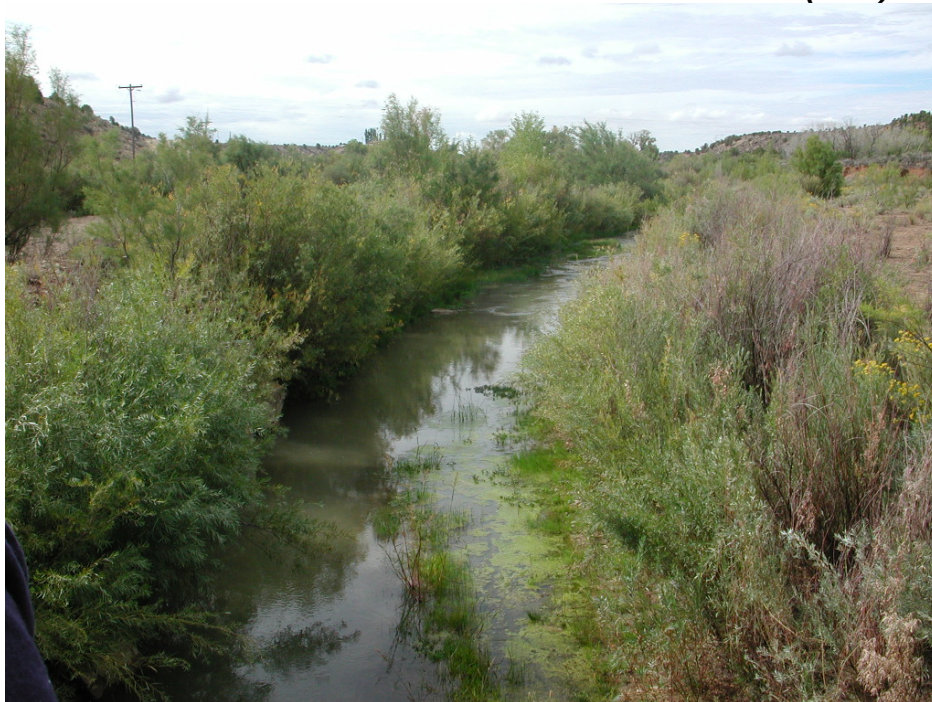
**Figure 29. Restoration Area Prior to Restoration or Weed Control (2002).**

A significant part of Reclamation's wetland/riparian vegetation mitigation commitment is to create and restore habitats along the La Plata River (along with protection and enhancement of these same habitats). Reclamation's restoration of 1700 linear feet of channel with its associated 13 acres of floodplain on the La Plata River entailed eliminating the unnatural levees, re-establishing a sinuous river channel and re-establishing river/floodplain interactions to restore the river's zone-of-influence. The result of these measures has served both to restore and create new functional wetland/riparian habitats. The primary channel and floodplain restoration construction was completed in December of 2004 with minor remediation in 2005 following severe spring flooding. Figures 29 – 38 below, shows changes in the river restoration area over time.

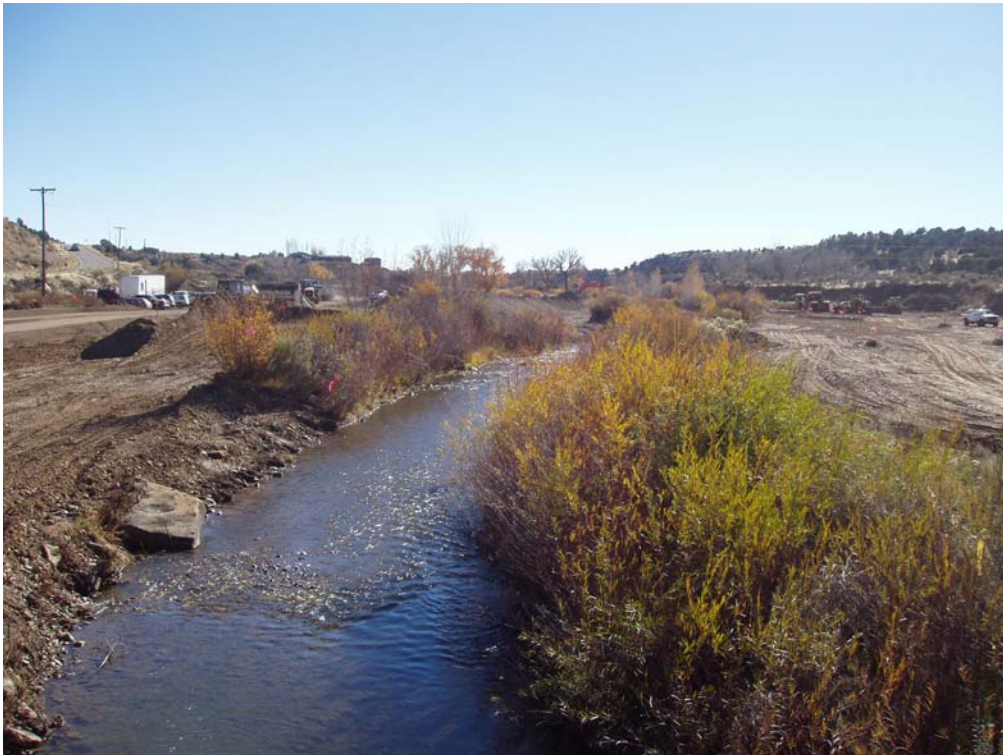
**Figure 31. River Restoration under Construction in 2004.**

Reclamation contracted with a private company for the development of a river restoration design which was reviewed and completed in August of 2003. Construction of the restored La Plata River channel and floodplain were completed in December of 2004. Re-planting a small segment of trees and shrubs was completed in early spring of 2005. Discussion regarding revegetation efforts is included under section 2.3.2, below.

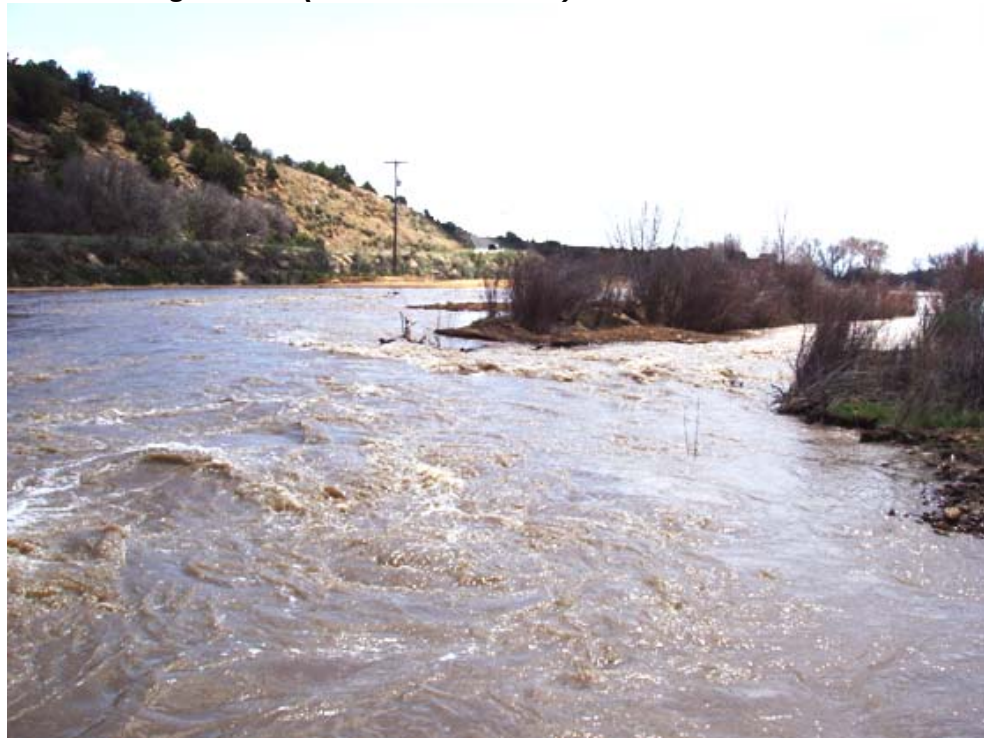
**Figure 33. Flooding in 2005 (Not at Peak Flows).**

Severe flooding in the mid-spring (end of May through the first part of June) of 2005 caused considerable damage to the river restoration work before vegetation could be established (Figures 33, 34, and Figure 8. (See the ALP Project Wetland/Riparian Mitigation 2005 Annual Report for added detail). In 2005 Reclamation completed the remediation and correction of the flood damage with minor modifications to aid in sediment transport (Figure 35). The 2006 and 2007 growing seasons saw the vegetation density and composition significantly improve and the remediated channel functioning well (Figures 36 and 38). The river channel has been designed to allow for natural meandering over time.

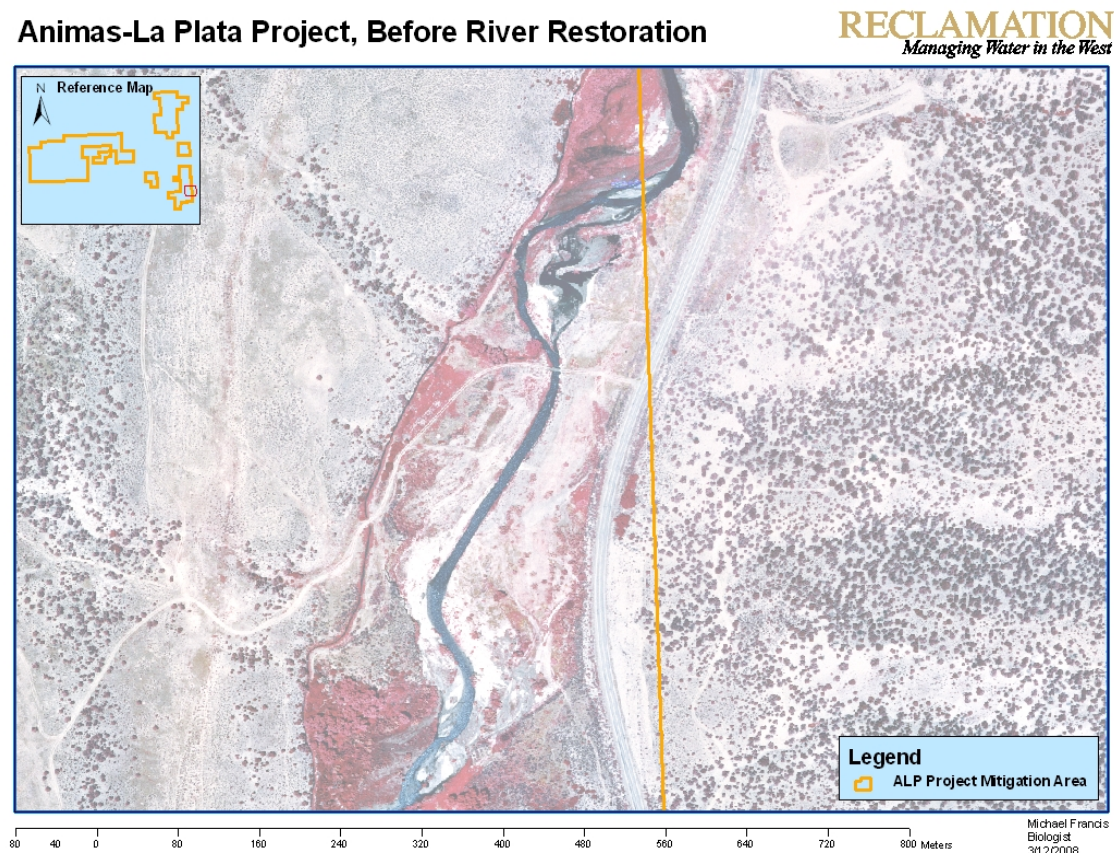
**Figure 37. Channel Restoration Area Before Restoration, 1997.**

Reclamation reached full completion of this requirement as described above under 2.2.3.1.1. Aerial/satellite images of before and after river restoration are below in figures 37 and 38.

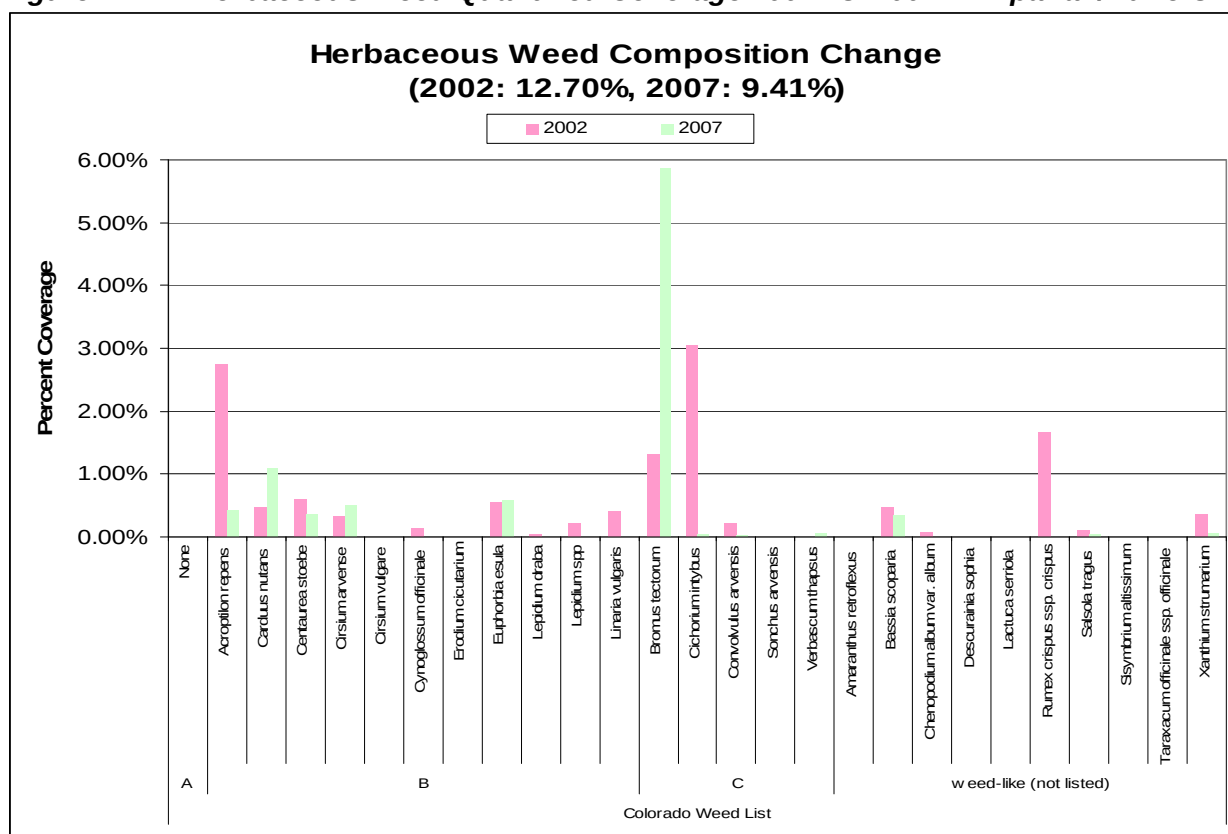
**Figure 42. Herbaceous Weed Quantified Coverage 2002 vs. 2007 in Riparian/Buffers.**

Herbaceous treatment in the riparian and riparian buffer zones, particularly against annual weed species, was the most problematic issue in the weed control effort (Figure 42). (See Appendix B for a list of common and scientific names of the plants listed in the following figures.)

There are several factors acting in synergy that made annual weed control challenging within the MA during the mitigation development period. First, as perennial noxious weeds were being controlled with aggressive herbicide application and grazing, a void was left for annual weeds to re-colonize from the existing weed-laden seedbed. Second, the compounding effect of drought conditions at the beginning of the weed management work likely stressed many desirable plants on the fringes of the riparian zone and in the buffers, enabled some weeds to spread readily where competition was reduced. Third, with the removal of intensive year-round cattle grazing, there was a loss of heavy grazing controls on some annual (and perennial) weeds, particularly

Reclamation has reduced weed infestations to less than 10% areal coverage through the implementation of an IVMP Plan. This has included the tamarisk and Russian olive removal noted above as well as herbaceous weed control. Figures 42 and 43 above, regarding riparian weed control include data collected in the riparian buffers as the targets for both were the same.

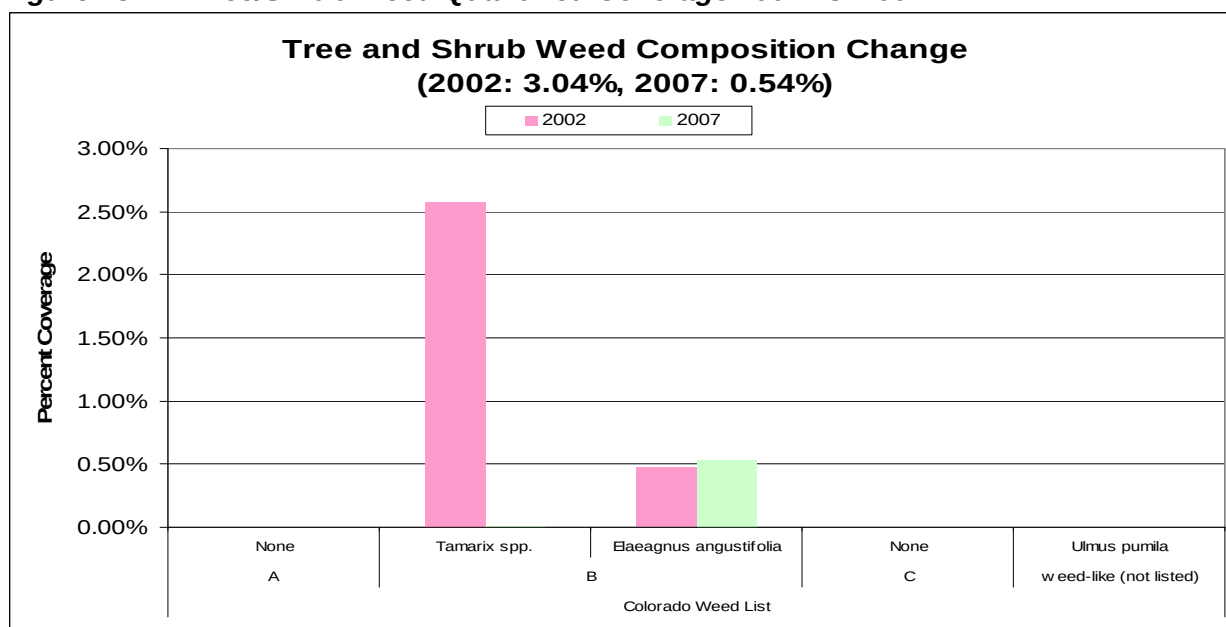
**Figure 43. Tree/Shrub Weed Quantified Coverage 2002 vs. 2007.**

It is also important to note that while the figures in this section reflect weed coverage in the MA in 2002 and 2007, these years do not represent the maximum weed coverage experienced in 2003 and 2004, following the removal of cattle grazing. There was a significant rise in weed coverage that had to be addressed before any net decline could be achieved. A recommendation for other similar programs would be consideration of replacement or changes in grazing regimes, not exclusion.

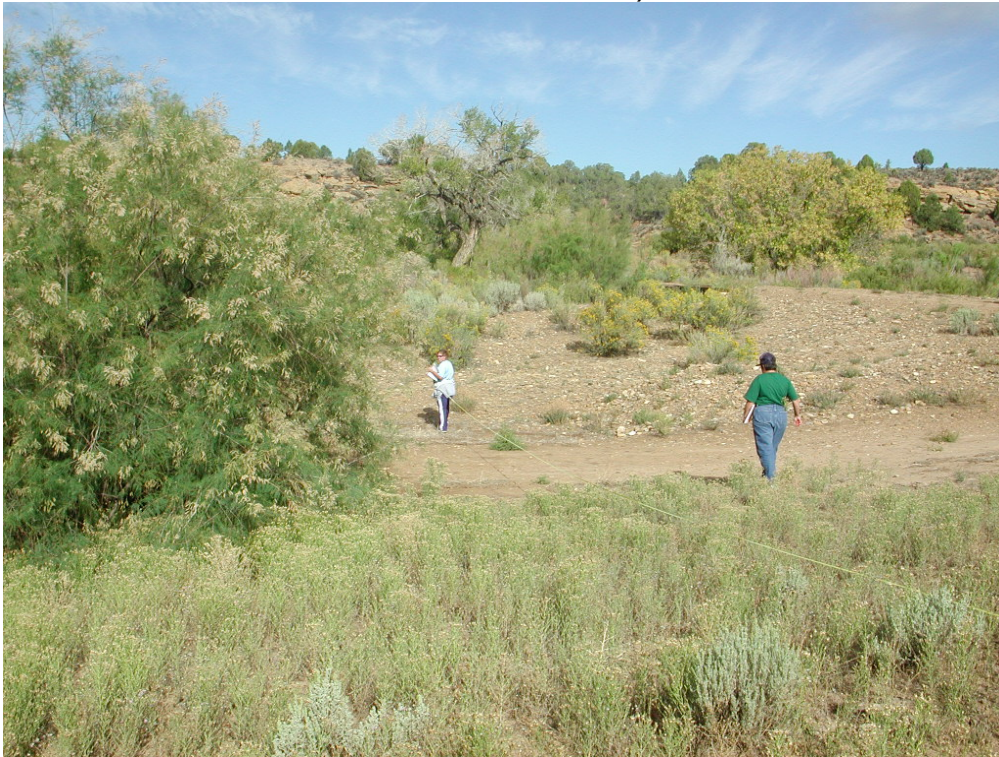
**Figure 44.     *Conditions in the River Restoration Area, 2002.***

Figures 44-48, below, illustrate some of the weed control conditions and efforts over the mitigation development period. Various methods were employed throughout the weed management effort based upon site-specific access limitations, weed types, river proximity, soil moisture and recent precipitation.

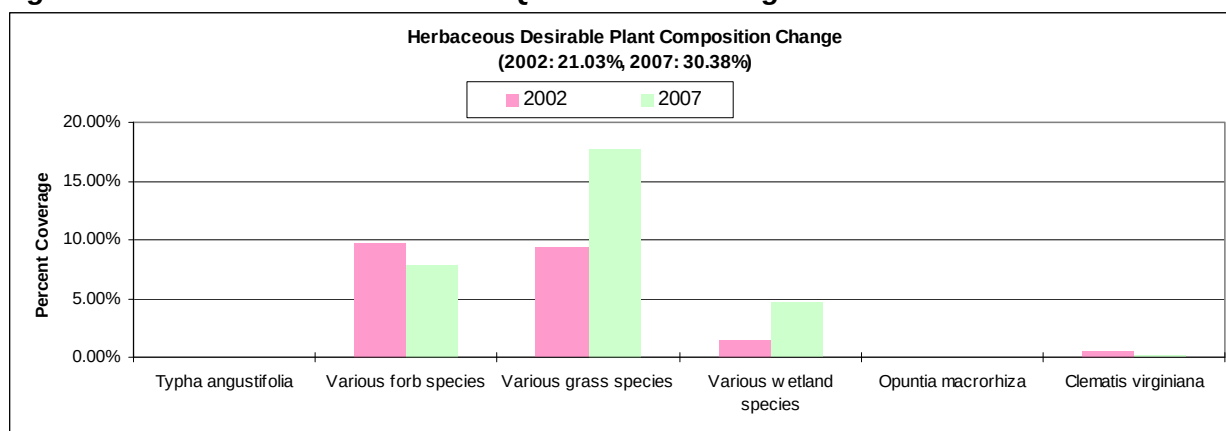
**Figure 49. Desirable Herbaceous Quantified Coverage 2002 versus 2007.**

Reclamation also committed to improving the desirable herbaceous ground coverage percentage through the riparian and buffer zones. Figures 49 – 51 below, illustrate the overall changes in desirable species by canopy type in the riparian and riparian buffer zones combined. Common names of species identified in the flowing graphs are provided in Appendix B.

Desirable forb, grass and wetland indicator plants were gathered into a single category each for the purposes of this evaluation and report.

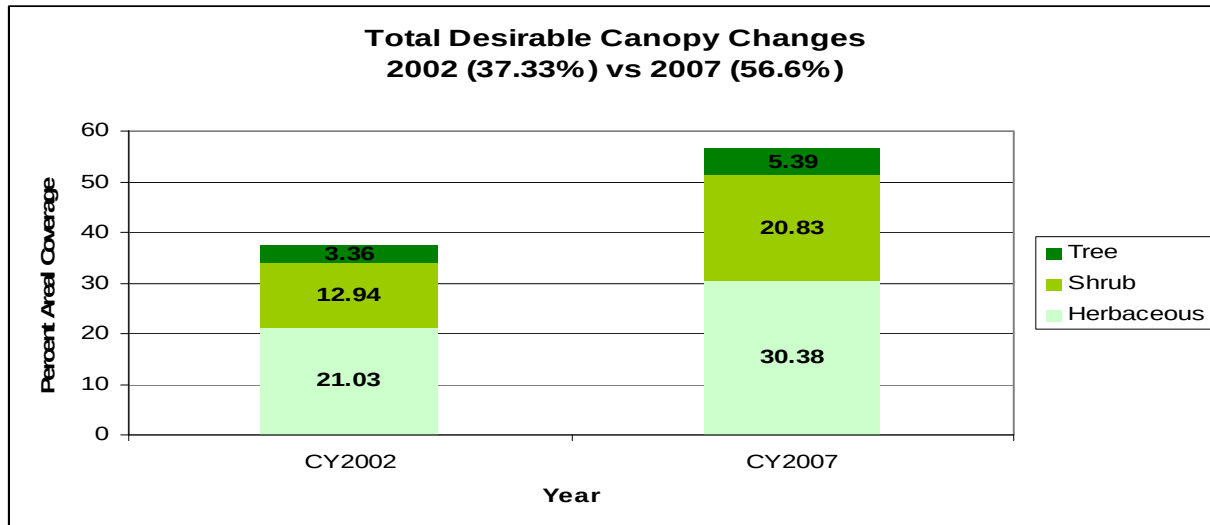
**Figure 52. Total Desirable Quantified Canopy Coverage 2002 versus 2007.**

Figure 52, below, summarizes the improvements in riparian and riparian buffer desirable canopy coverage achieved by Reclamation from the base of 2002 to completion in 2007.

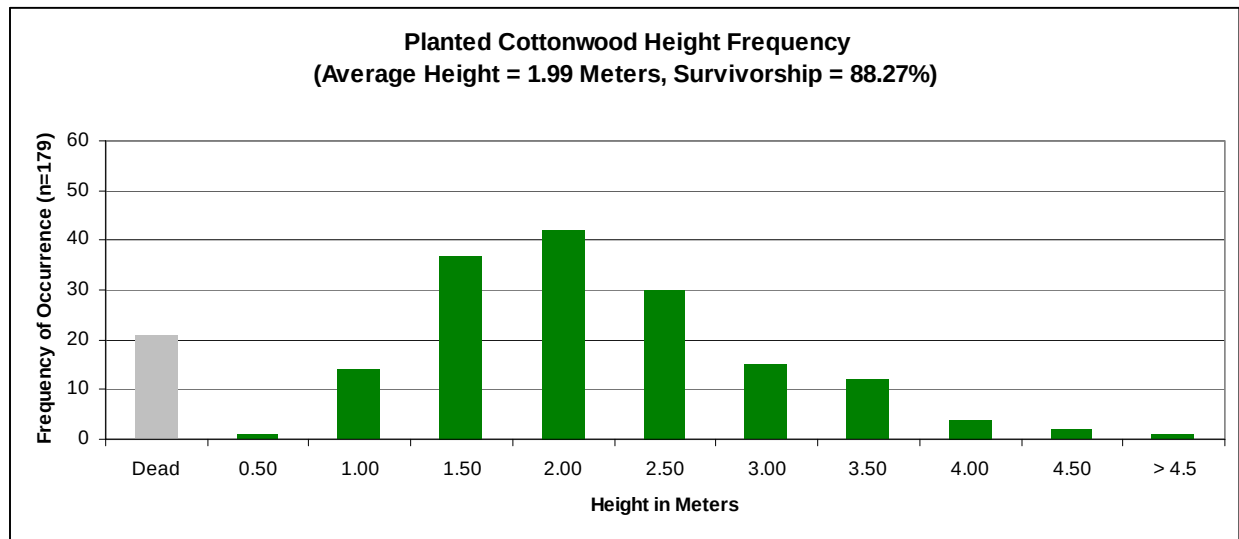
**Figure 53. Planted Cottonwood Growth and Survivorship.**

Reclamation committed to having a minimum of 80% survival rate and an average height of 2 meters for planted cottonwood trees at time of “mitigation success” with the resulting vegetation canopy densities maintained for the life of the project. Live cottonwood trees planted in the MA are an average of 1.99 meters in height and more than 88% have survived to date. See Figure 53, below. Thus Reclamation has essentially met the growth target and exceeded the survivorship standards for all cottonwoods planted.

Table 4, below, describes the statistical analysis of surviving planted cottonwood tree growth in the MA.

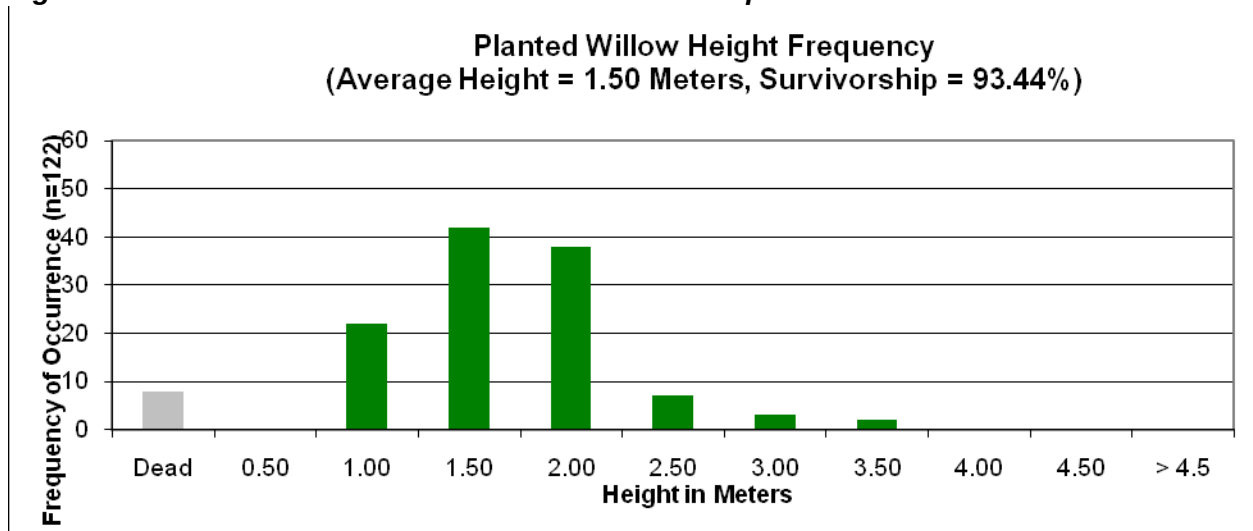
**Figure 54. Planted Willow Growth and Survivorship.**

About 2,200 total coyote willow (*Salix exigua*) and peachleaf willow (*S. amygdaloides*) were planted on the active floodplain of the river restoration area. Reclamation's target was to assure an 80% survival rate with an average height of 1.5 meters at time of reservoir filling. Plantings occurred on 10 foot (3 meter) centers (or denser). Figure 54, below, shows how the live planted willows have reached an average of 1.5 meters in height and how more than 93% of the planted willows have survived to date. Willow establishment has achieved both growth and survivorship goals.

Table 5, below, describes the statistical analysis of surviving planted willow shrub growth in the MA.

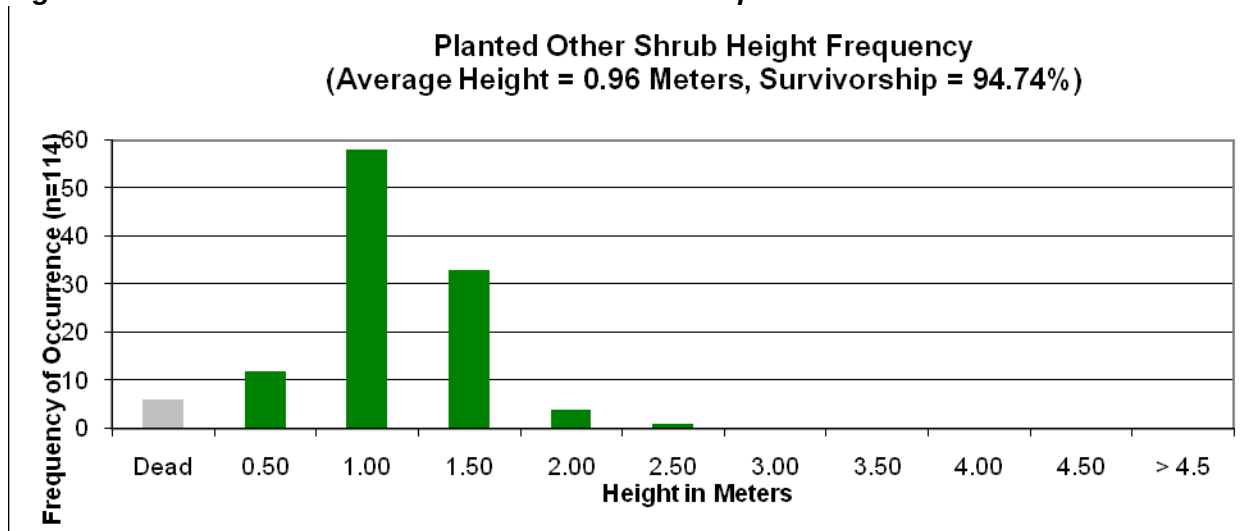
**Figure 55. Planted Shrub Growth and Survivorship.**

Approximately 800 total mixed desirable woody shrub species were also planted in the river restoration area: chokecherry (*Prunus virginiana* spp. *melanocarpa*), three-leaf sumac, New Mexican privet and silver buffaloberry. Reclamation committed to assuring a minimum of 80% survival rate with a mean height of 1 meter at time of reservoir filling with the resulting vegetation densities maintained for the life of the project. Native rabbitbrush (*Ericameria nauseosa* spp. *consimilis*) and big sagebrush (*Artemisia tridentata* spp. *Wyomingensis*) were also established from seed in the river restoration area. Figure 55, below, illustrates the average growth of live shrubs and the overall shrub survivorship in the river restoration area. Reclamation has essentially met the growth target with the average height of 0.96 meters and has well exceeded the target survivorship at nearly 95%.

Table 6, below, describes the statistical analysis of surviving planted other shrub growth in the MA.

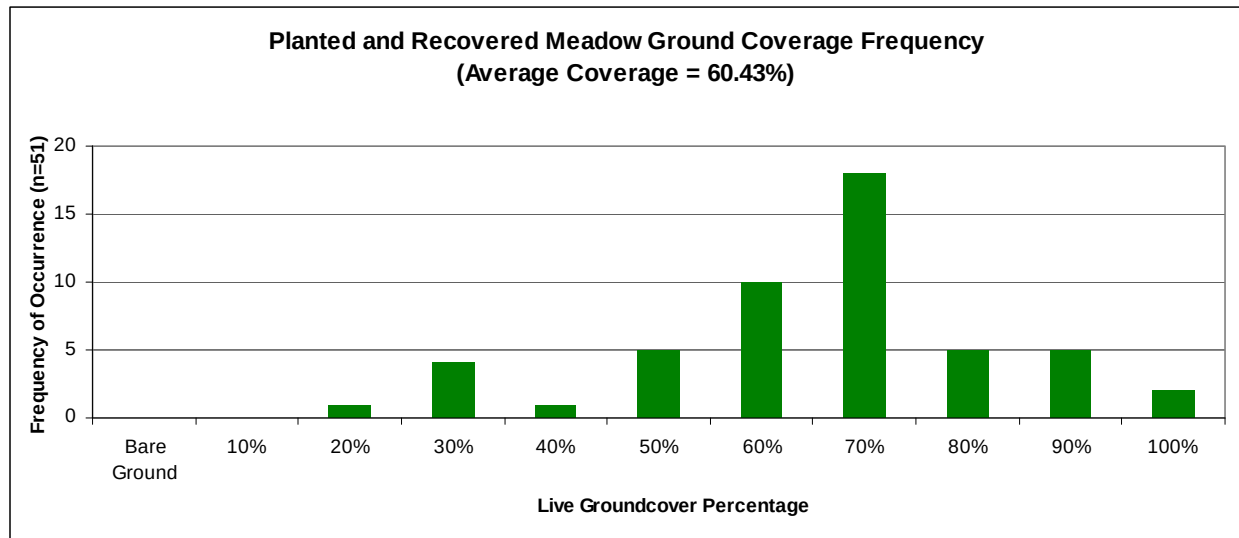
**Figure 56. Groundcover for Riparian Meadows.**

In late 2004 Reclamation planted 20 acres of riparian restoration area with a mixture of western wheatgrass (*Pascopyrum smithii*) and streambank wheatgrass (*Elymus lanceolatus* ssp. *lanceolatus*). Reclamation performed augmentation seeding in 2006 on approximately 50 total acres of riparian and riparian buffer areas. Figure 56, below, illustrates the average quantified live plant ground cover in the MA along the La Plata River through the MA where riparian

meadows experienced supplemental seeding. Reclamation has exceeded the target of an average of 50% groundcover. Measurements were not necessary to confirm that the average desirable plant height well exceeded 20 cm.

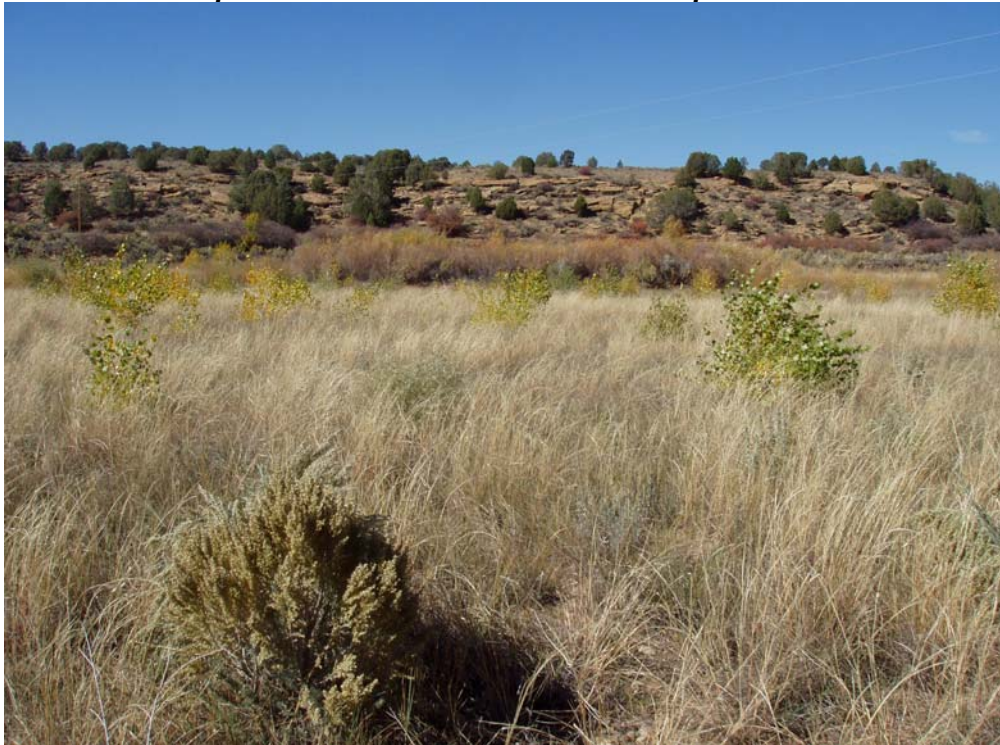
**Figure 57.     *Planted Riparian Groundcover Growth Example.***

Figures 57 and 58, below, are examples of groundcover height from seeding and natural recovery, respectively with grazing excluded.

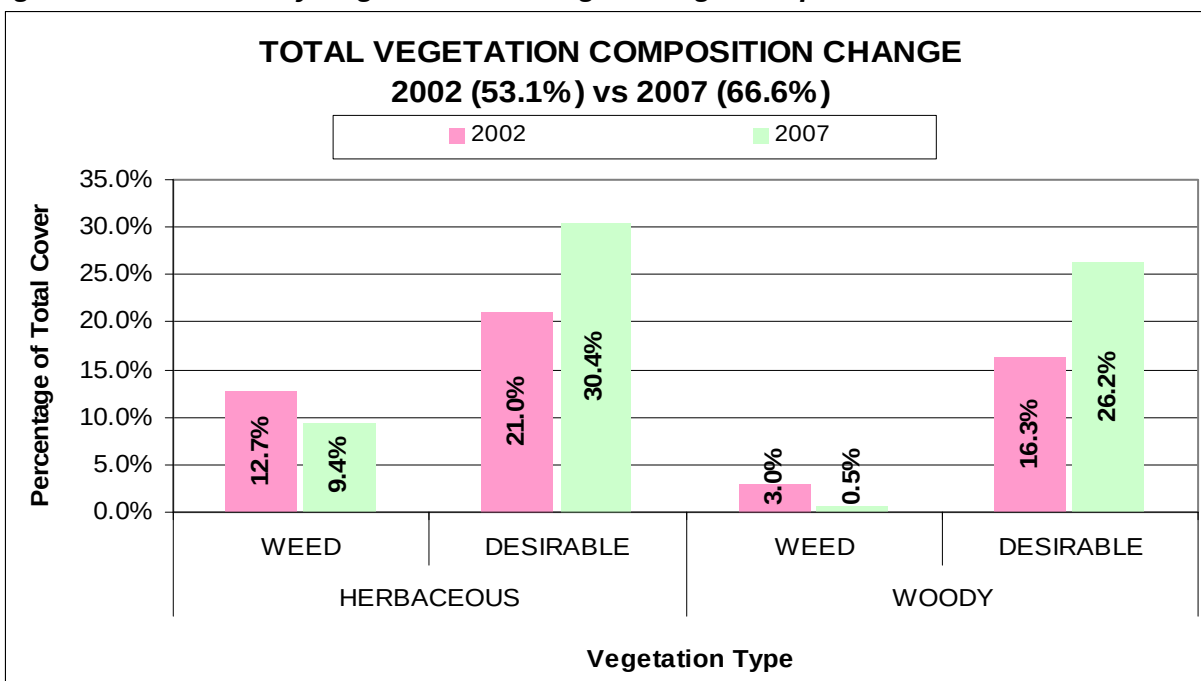
**Figure 59. Summary Vegetation Coverage Change in Riparian and Buffer Areas.**

Figure 59, below, summarizes the overall change in the composition of the combined riparian and riparian buffer vegetative communities in the MA from 2002 to 2007 for both desirable and weed species in both the herbaceous and three/shrub canopies.

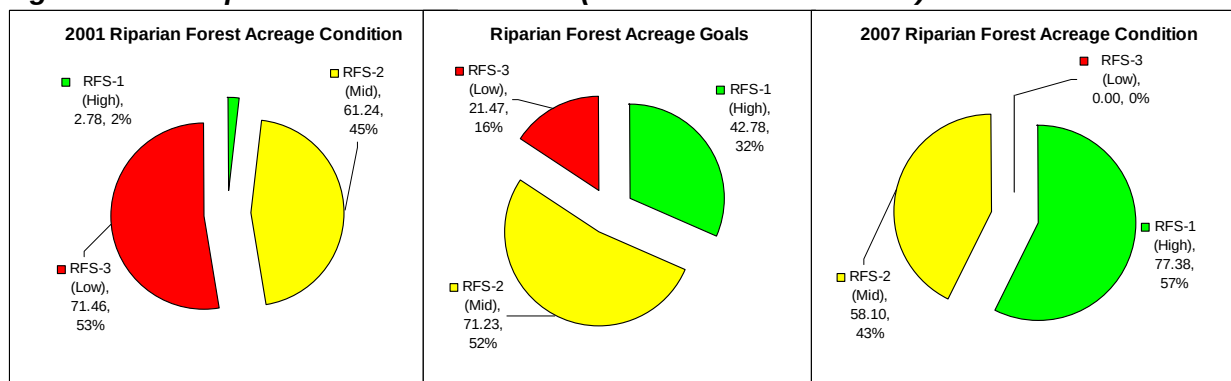
**Figure 60. Riparian Forest Conditions (2001 vs. Goals vs. 2007).**

The following figures (Figures 60 and 61) illustrate the pre-condition found in 2001, the expected final condition as estimated in the 2005 IVMP and the actual changes achieved as found in the in the 2007 monitoring. The acreages in the figures do not include the following wetland/riparian habitats also found in the MA: riverine habitat, emergent wetland habitat, cottonwood-oak habitat or cottonwood-sagebrush habitat.

Through weed treatment, both herbaceous and tree/shrub species, the exclusion of grazing and active revegetation efforts, Reclamation has improved the functional quality of riparian habitats in the MA.
