## VEGETATION AND WILDLIFE MITIGATION FINAL REPORT

Animas-La Plata Project, Colorado and New Mexico  
Upper Colorado Region

April 2008

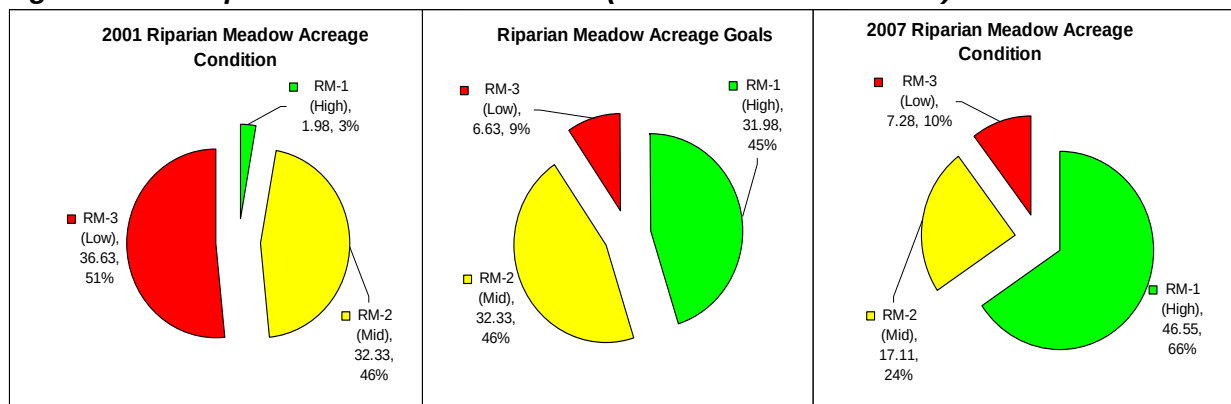
**Figure 61. Riparian Meadow Conditions (2001 vs. Goals vs. 2007).**

The following figures (Figures 60 and 61) illustrate the pre-condition found in 2001, the expected final condition as estimated in the 2005 IVMP and the actual changes achieved as found in the in the 2007 monitoring. The acreages in the figures do not include the following wetland/riparian habitats also found in the MA: riverine habitat, emergent wetland habitat, cottonwood-oak habitat or cottonwood-sagebrush habitat.

Through weed treatment, both herbaceous and tree/shrub species, the exclusion of grazing and active revegetation efforts, Reclamation has improved the functional quality of riparian habitats in the MA.

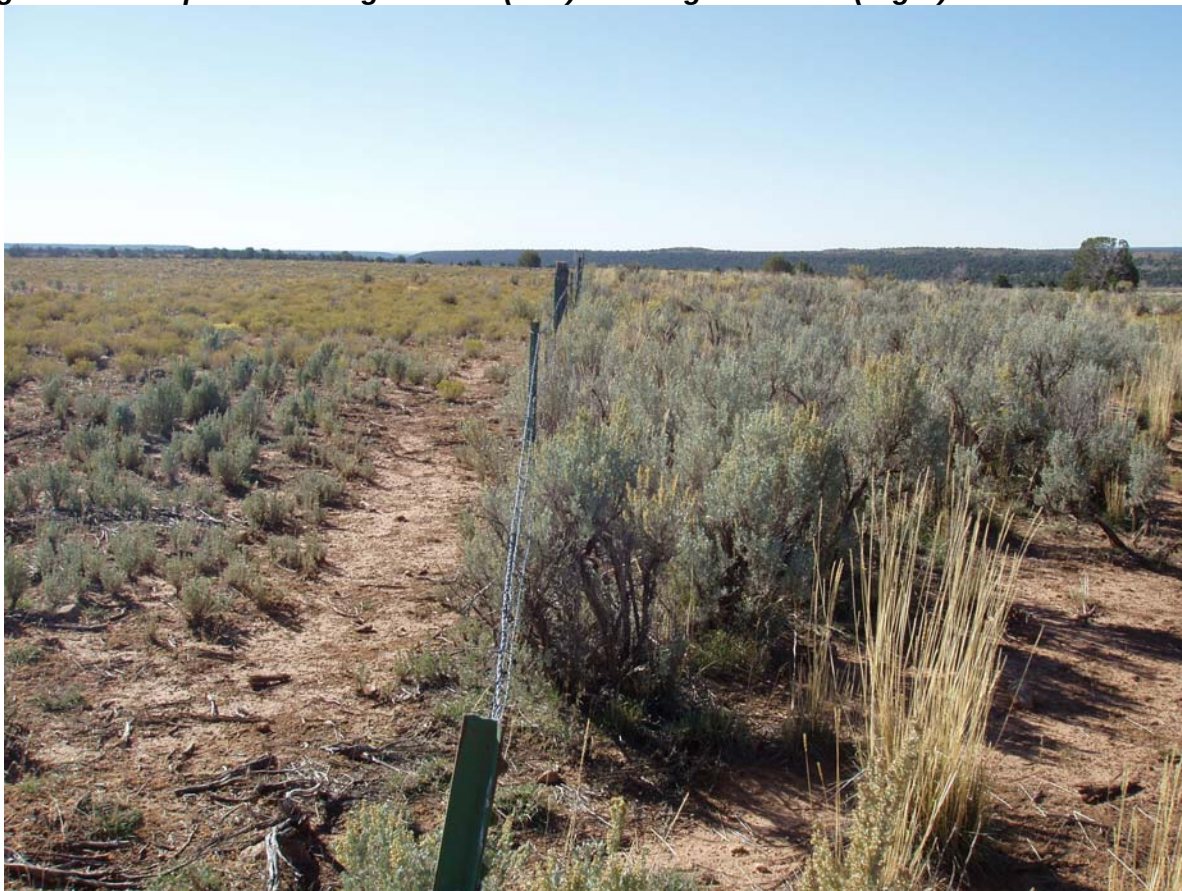
**Figure 62. Upland Grazing Pasture (Left) vs. Mitigation Area (Right) in 2007.**

The riparian tracts already fenced include a significant amount of upland vegetation/wildlife habitat. Reclamation has further committed to expanding its fencing effort along private land boundaries in tract I, where trespass livestock grazing has occurred in recent years, which will result in approximately 27,000 linear feet of new wildlife-friendly fencing. This work, while not a specific enhancement commitment, will serve to further enhance the upland habitat by reducing the impacts of uncontrolled trespass grazing.
