Grand Canyon Wildlands Council & Glen Canyon National Recreation Area

Lees Ferry 10 Acre Riparian Revegetation Project

Lees Ferry Revegetation Overview

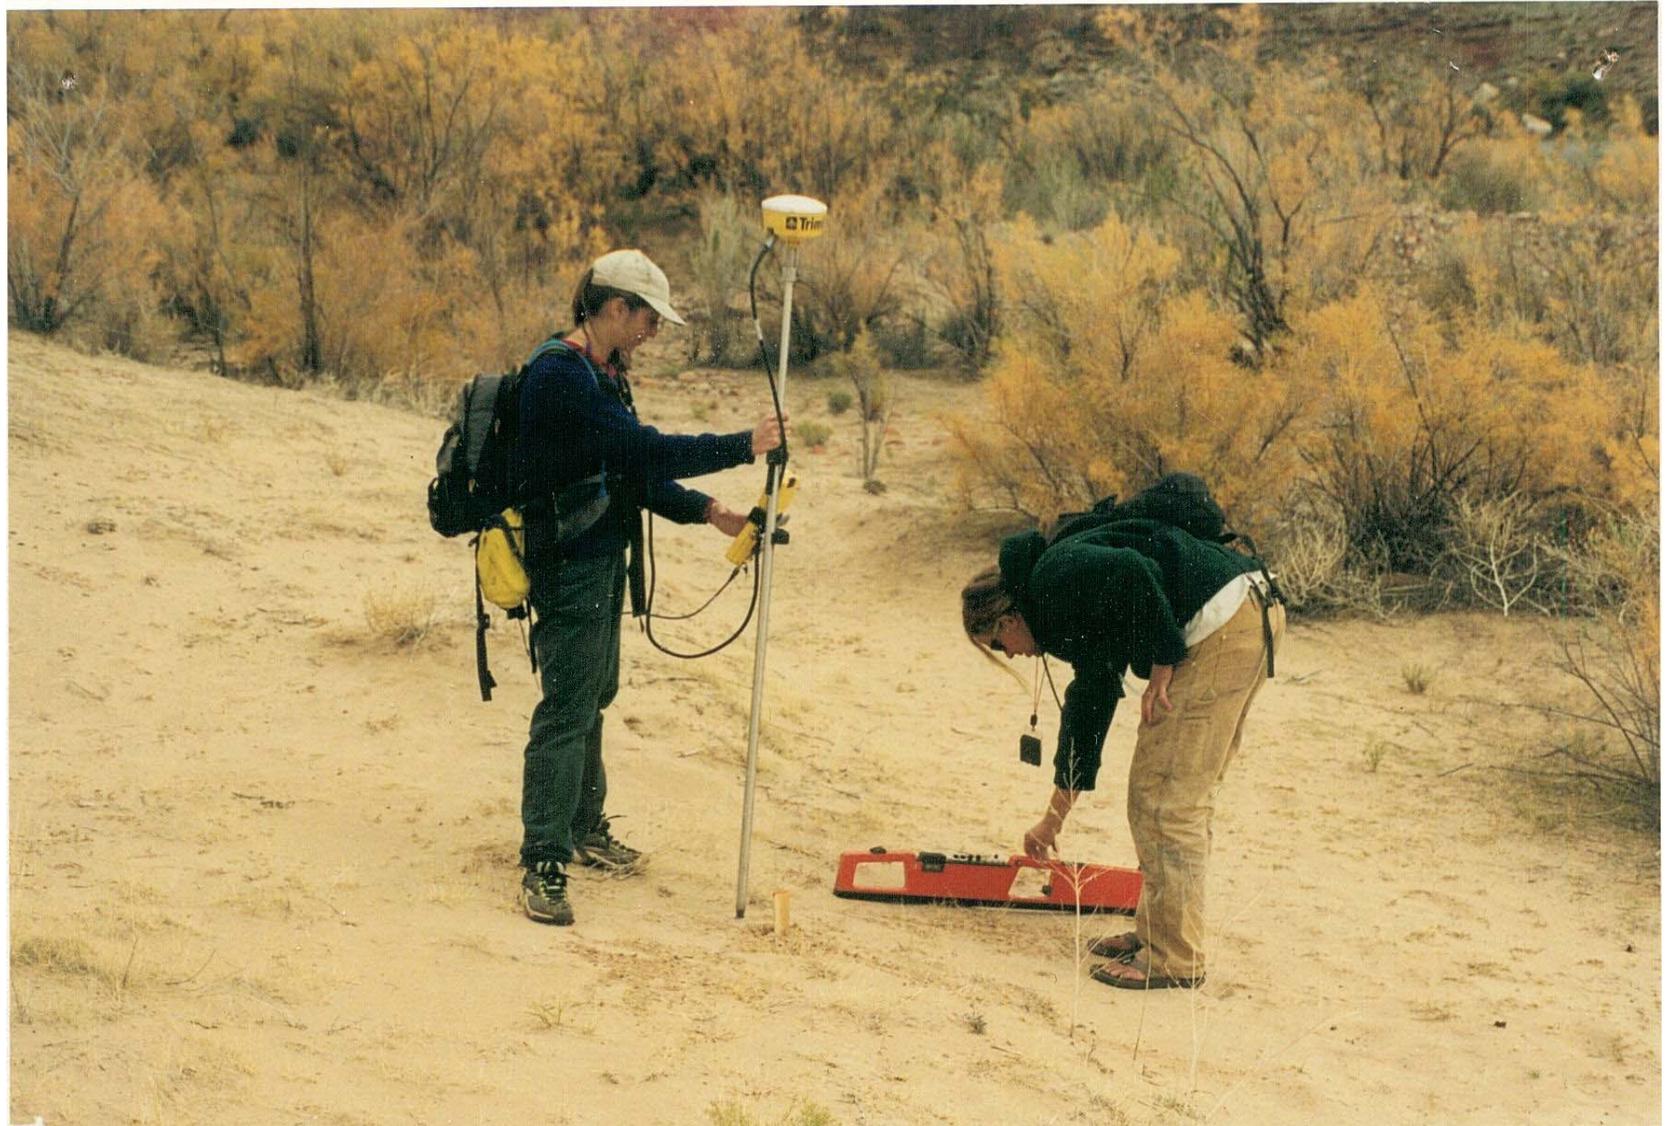
- Preliminary soil analysis of 14 evenly spaced points throughout the site
 - Soil samples at 6", 3', 6', 9'
 - Salinity, soil type, vegetation and depth to water table
- Intensive analysis using EM 38 electro conductivity meter and Trimble XTS Pro
 - 100'x25' grid across entire site
 - 235 sampling points with salinity measurements at 2' and 5'
 - Elevation and location with survey unit
 - Mapping of data

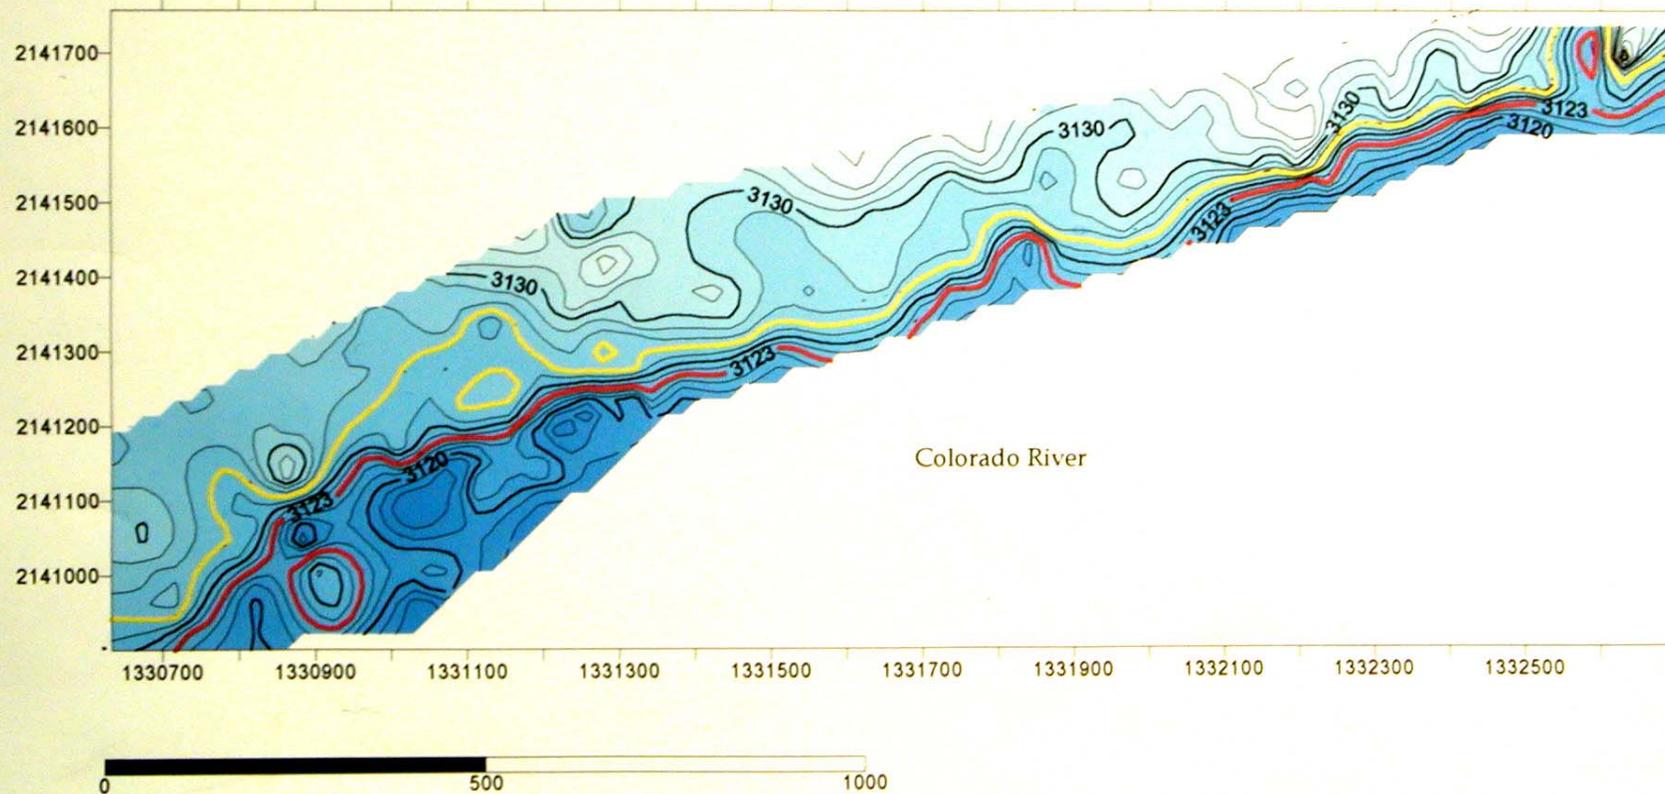
Depth To Water Table (13,000 CFS)

Red Line- 0-6'
Yellow Line - 0-10'
Above Yellow Line - 10'+

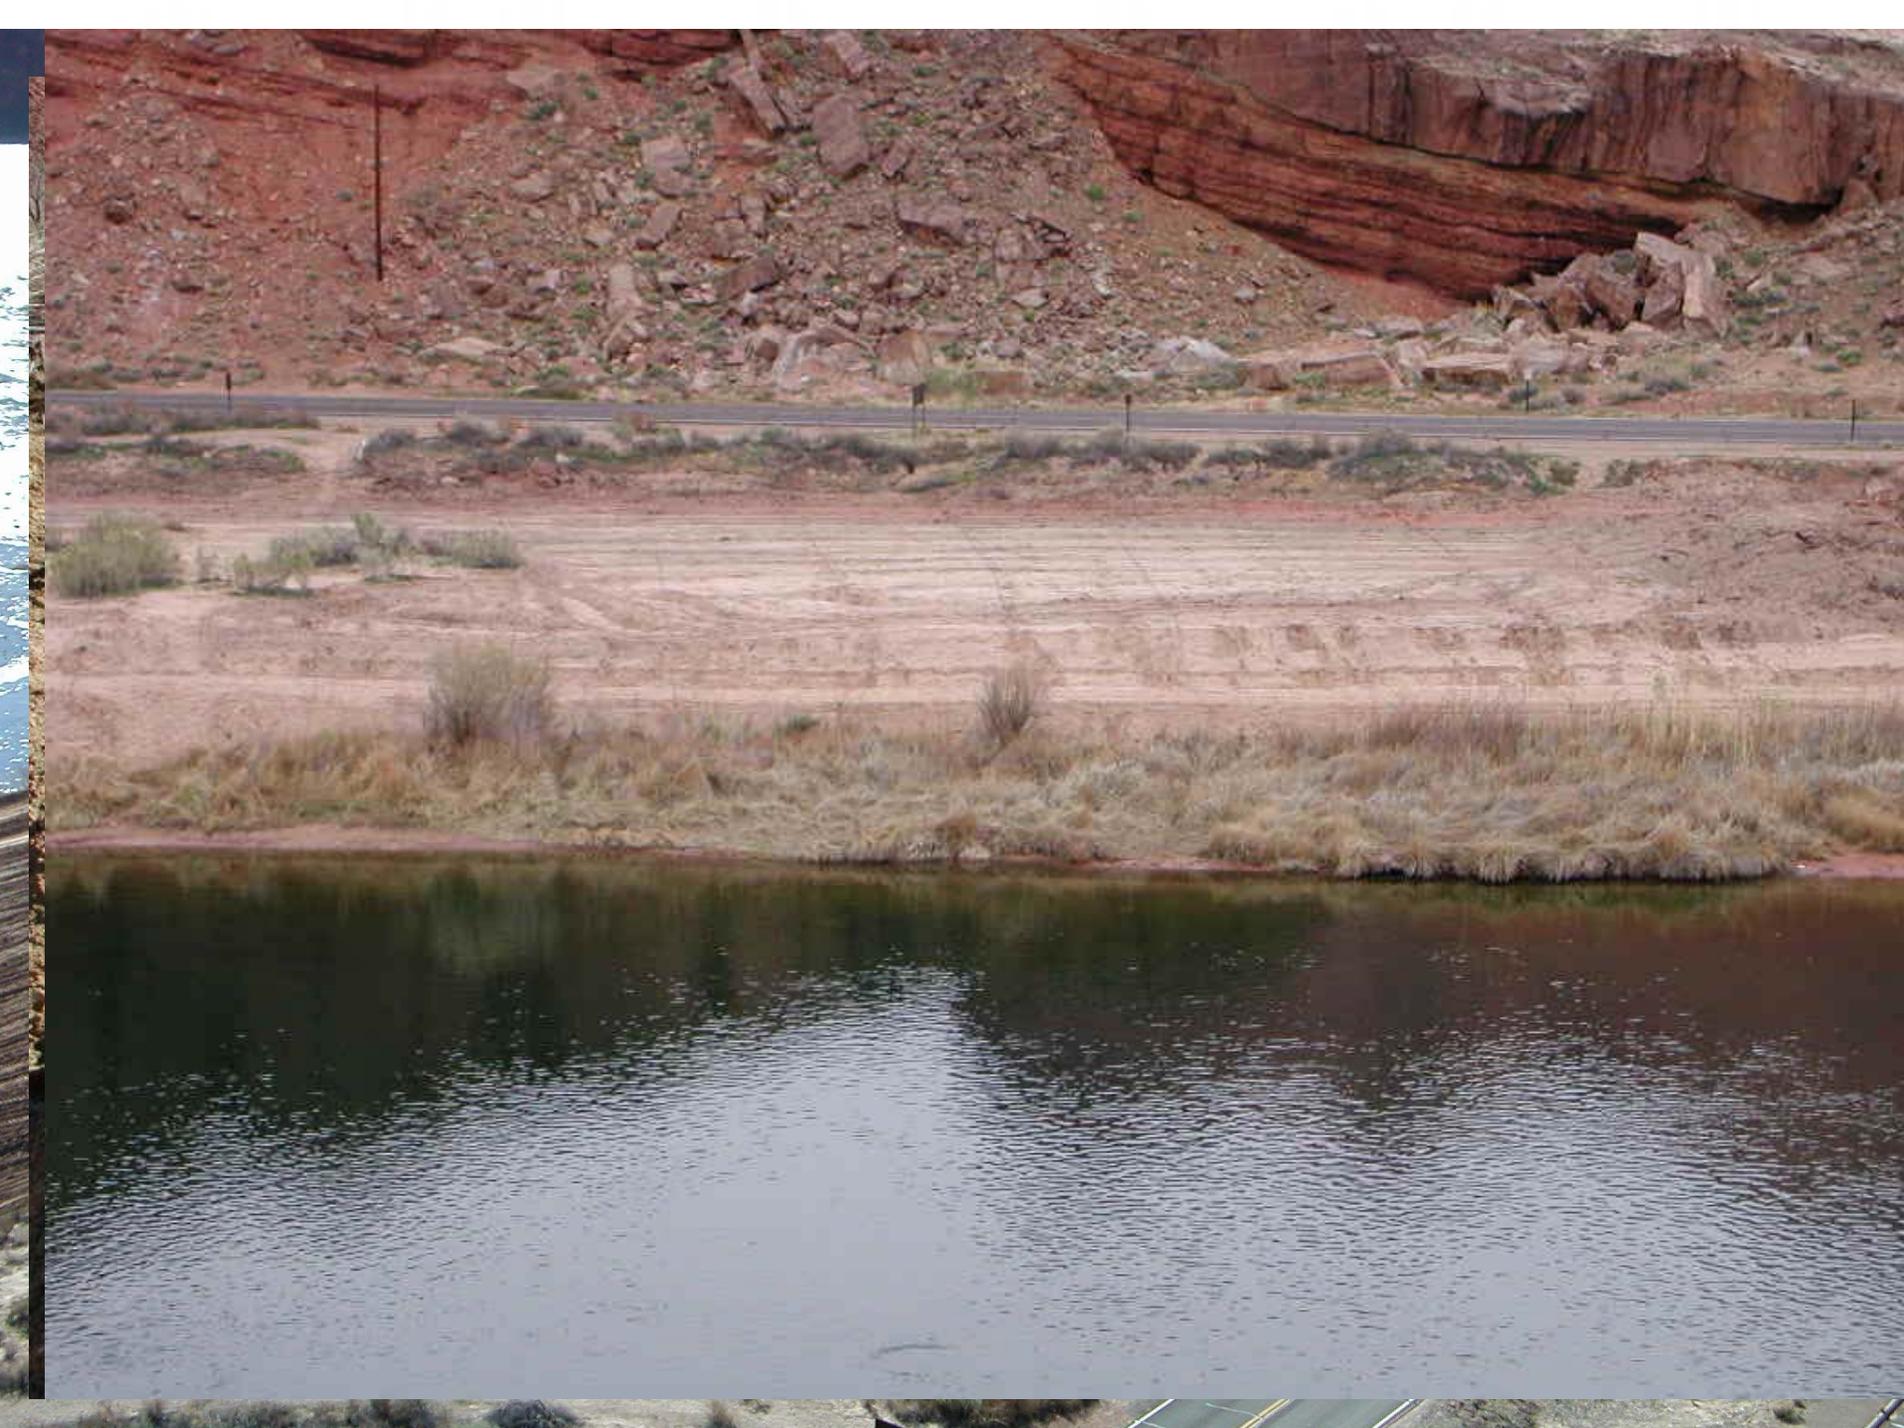
Site Clearing and Irrigation Construction

- D-7 bulldozer, chainsaws and tractor
- All exotic material cleared and piled in windrows
- Boater camp saved
- Tamarisk stand at boat launch saved
- Driftwood piles saved
- Valuable habitat along riverbank preserved
- Hand broadcast of Fourwing saltbush seed
- Berms graded along road to protect site

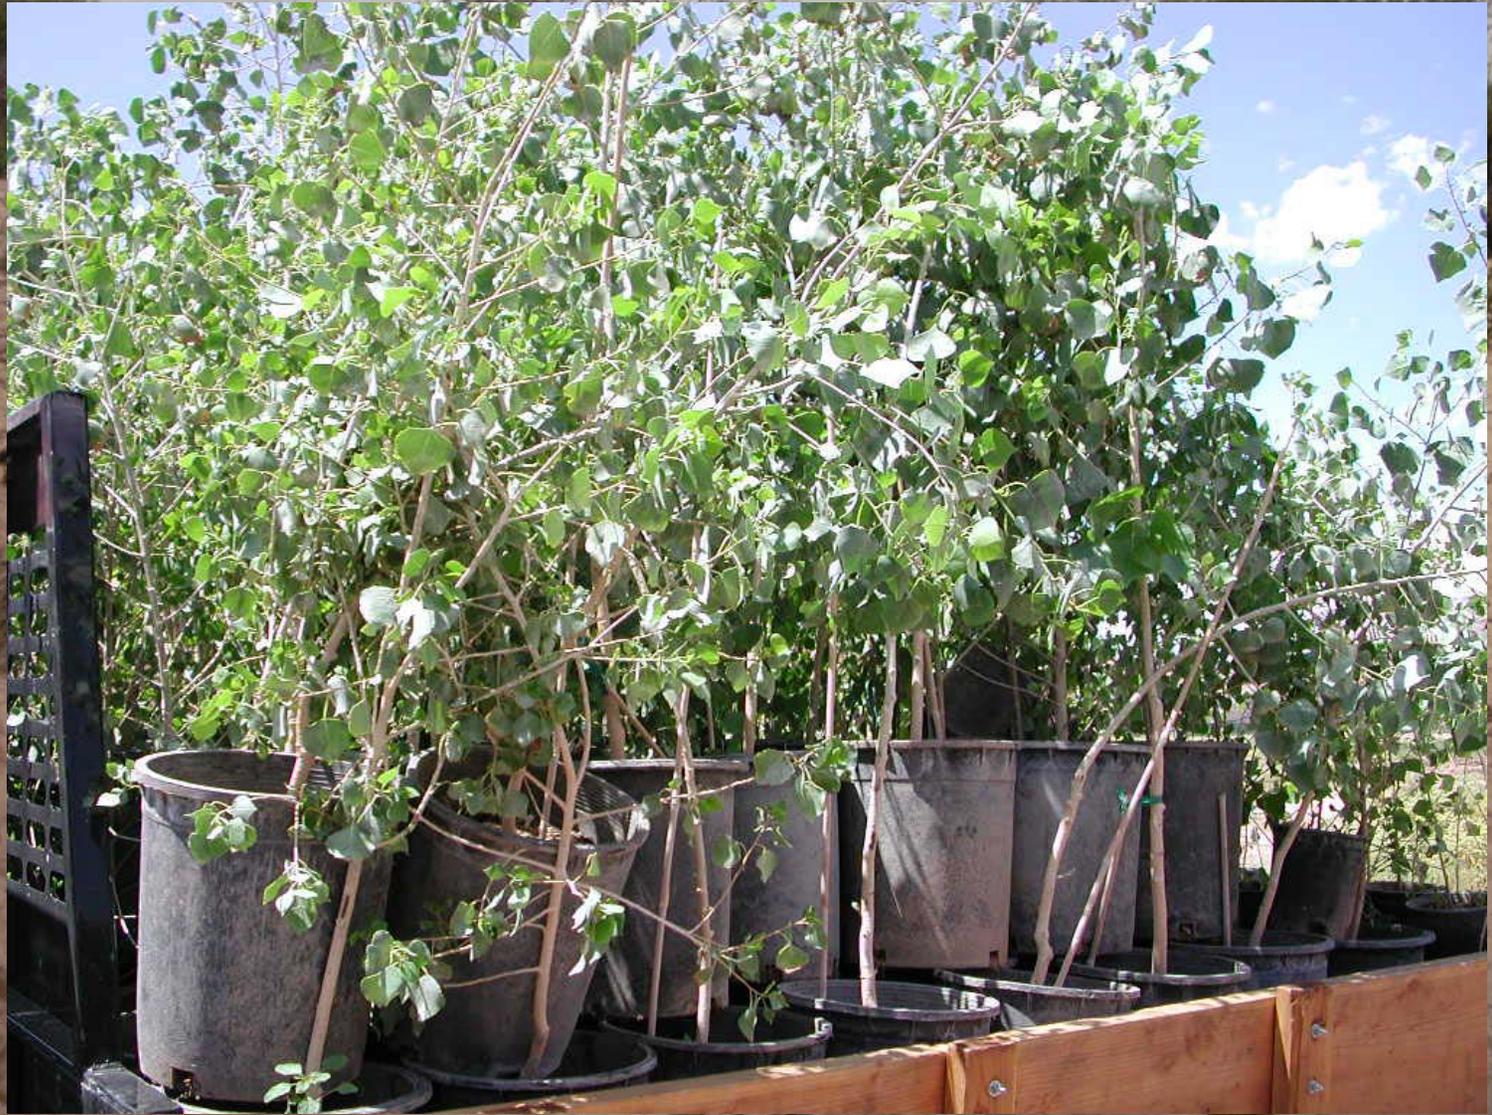
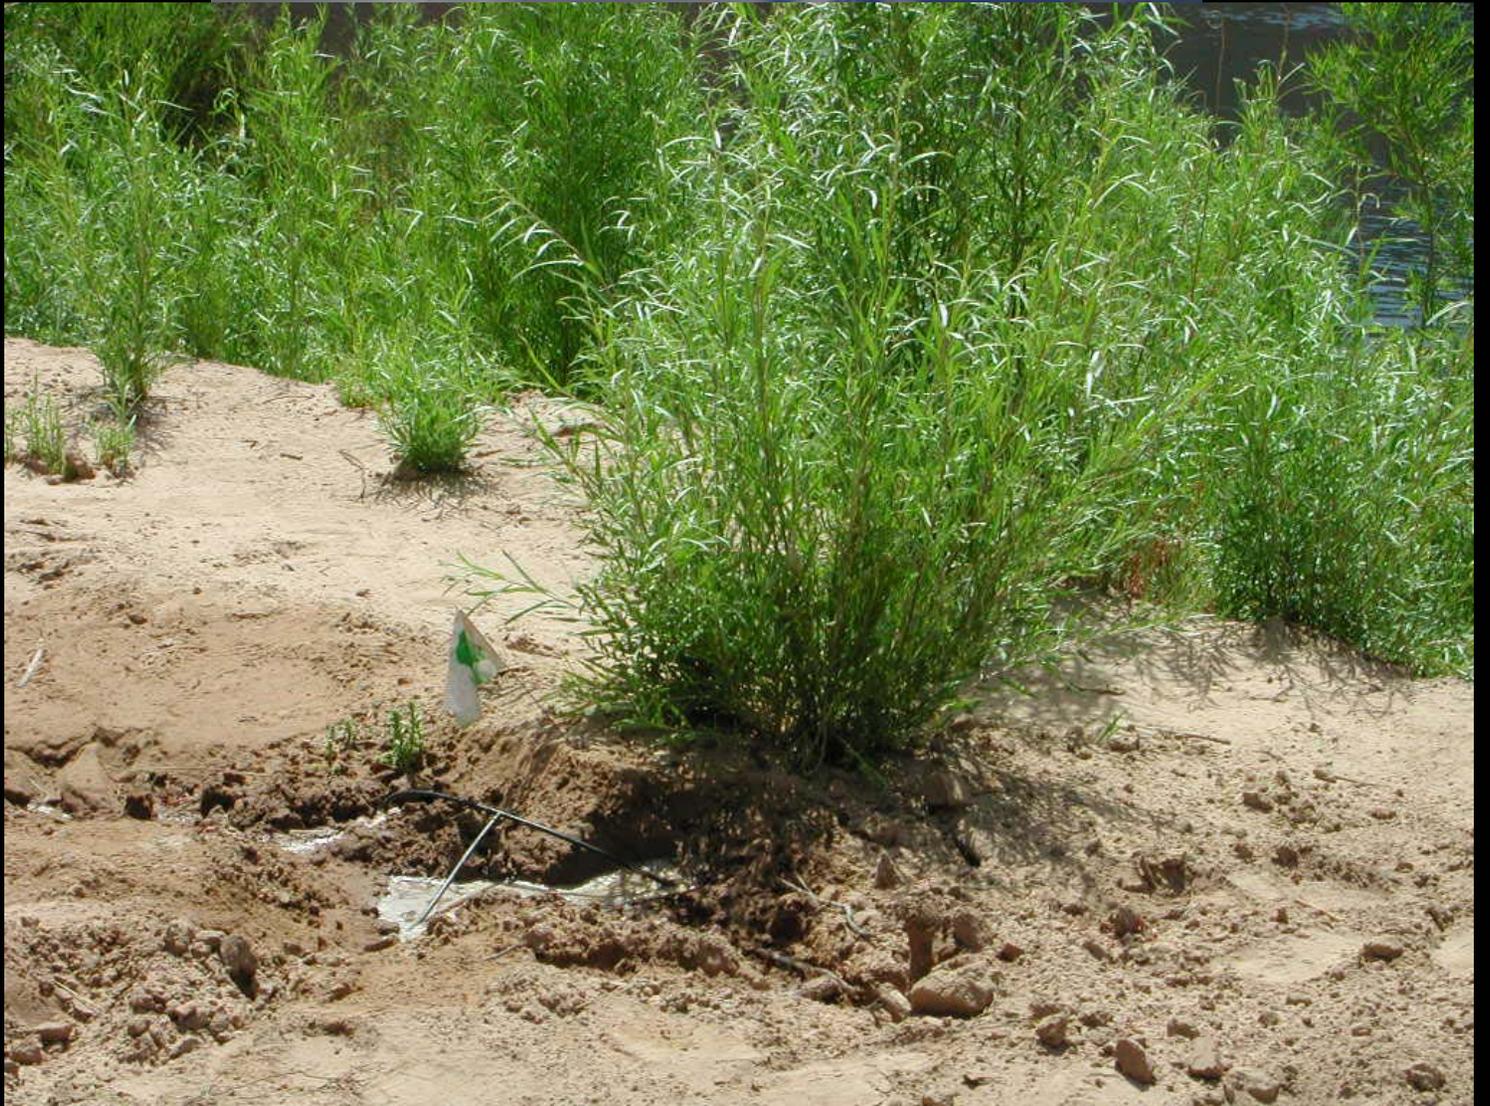
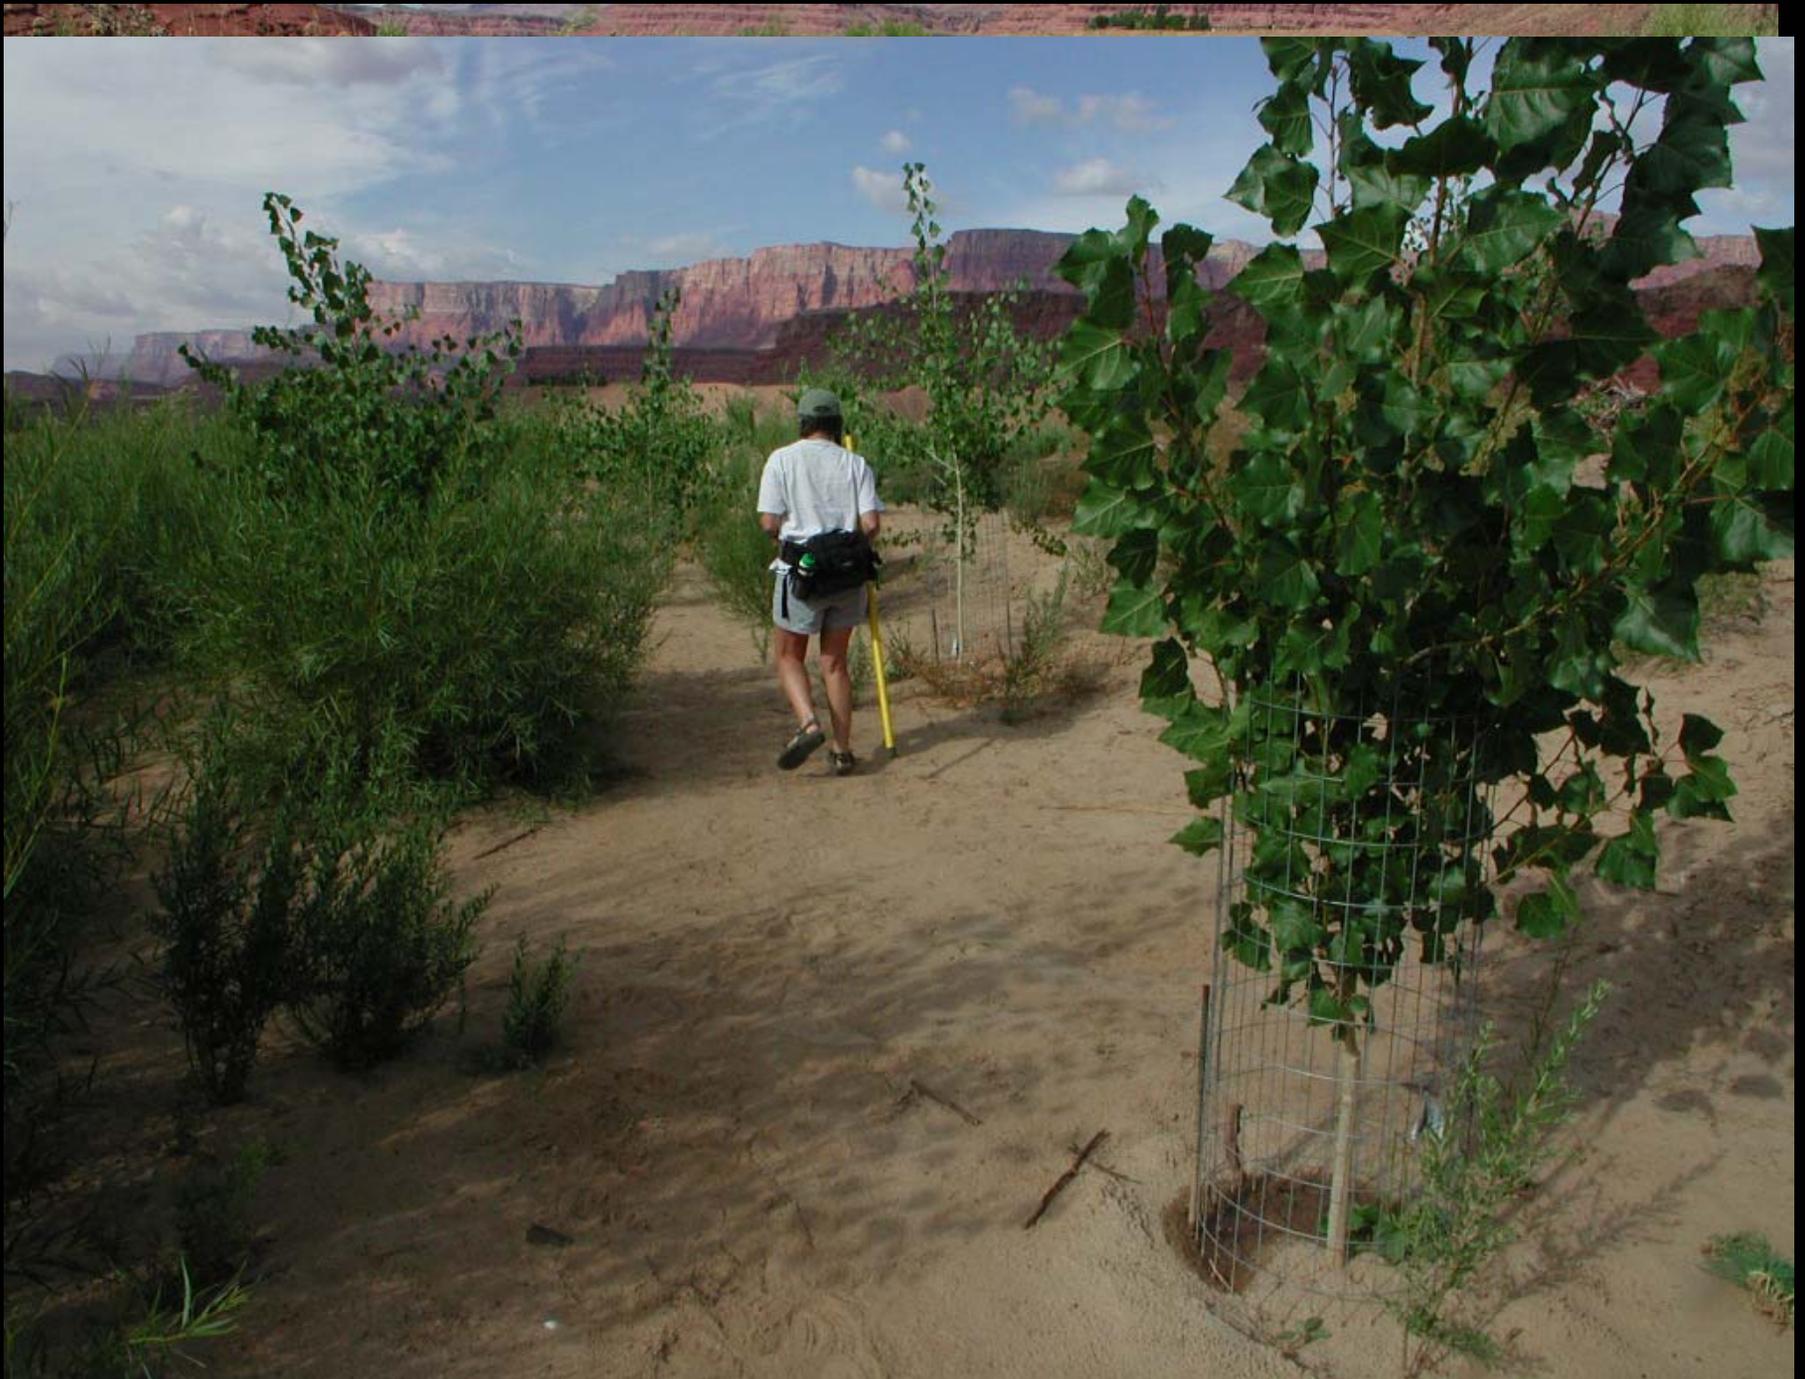
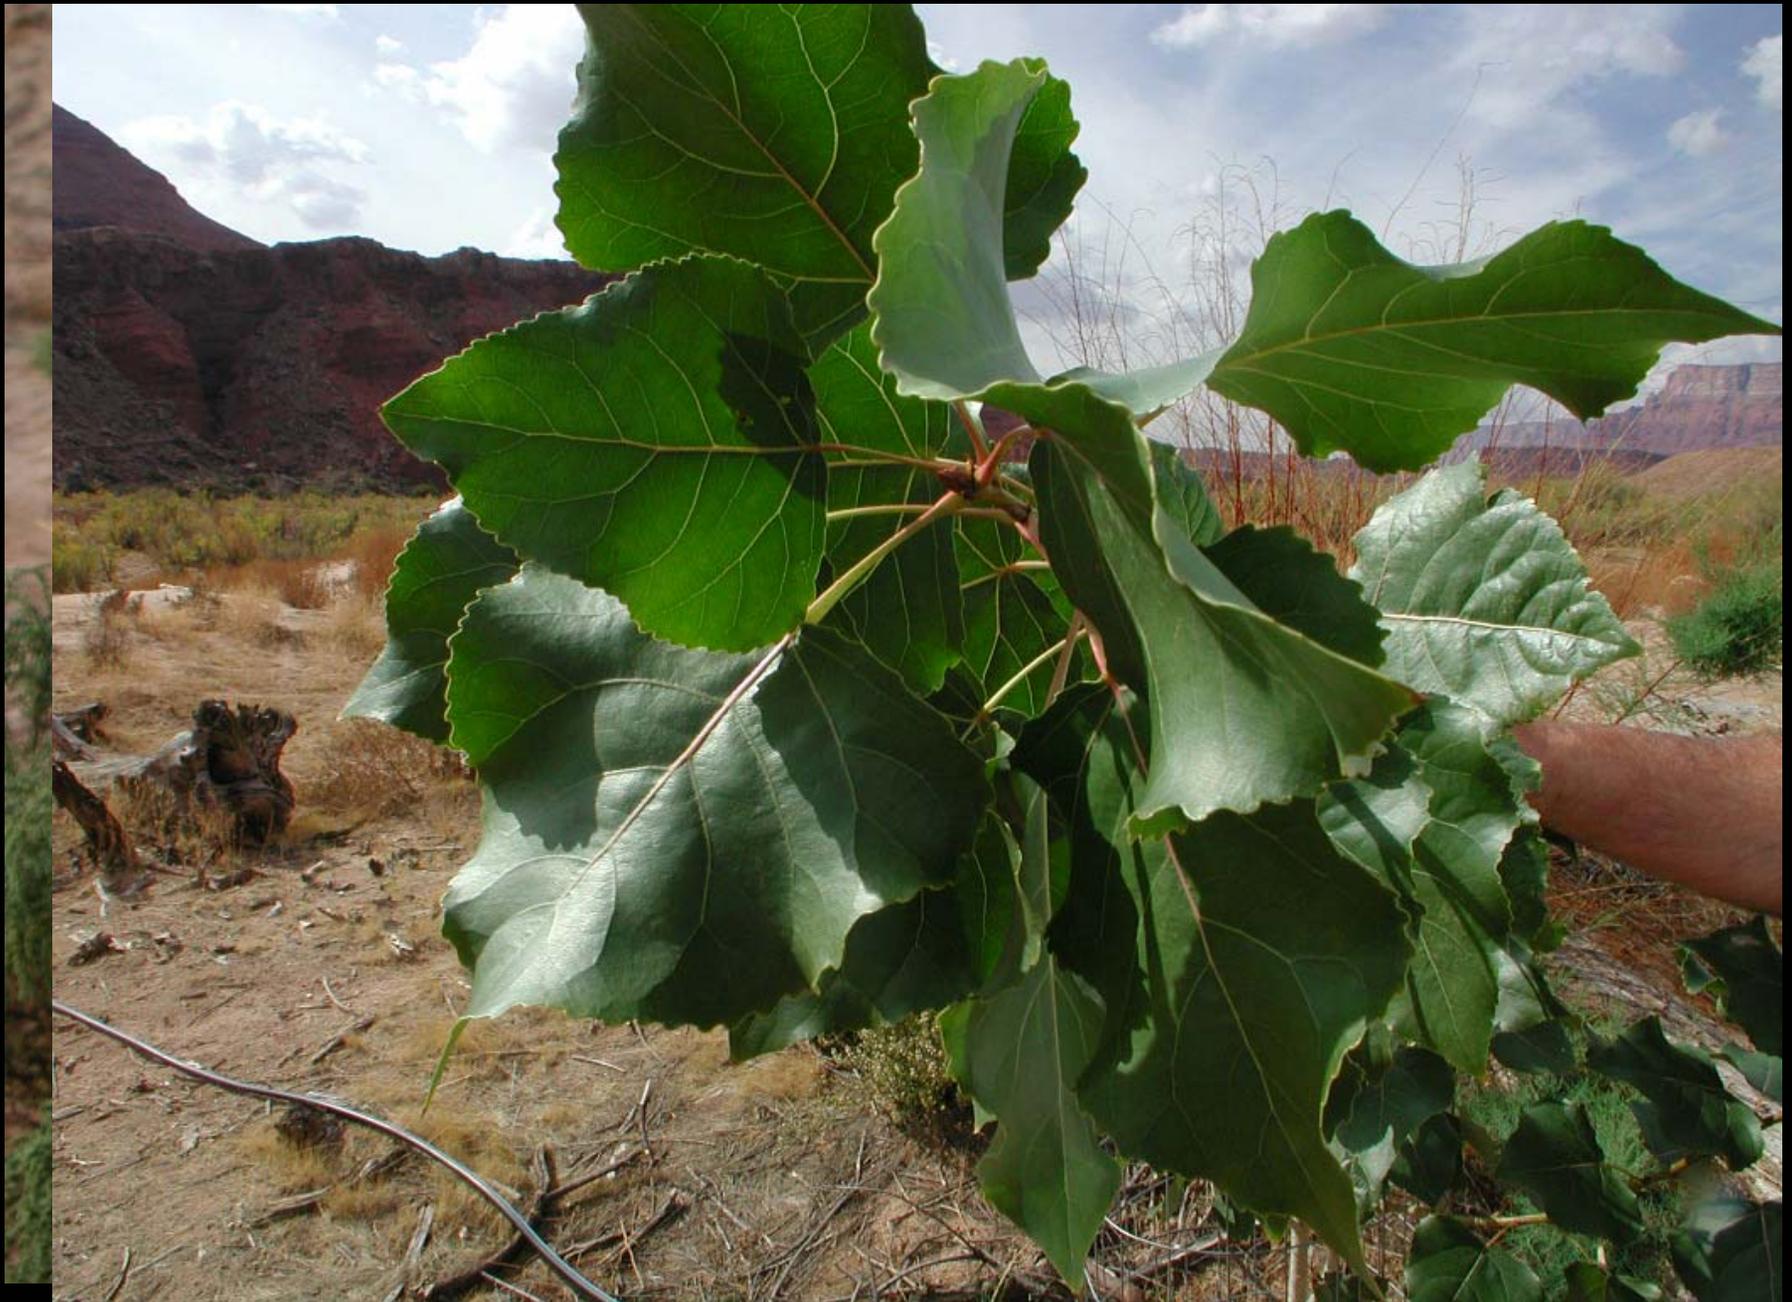
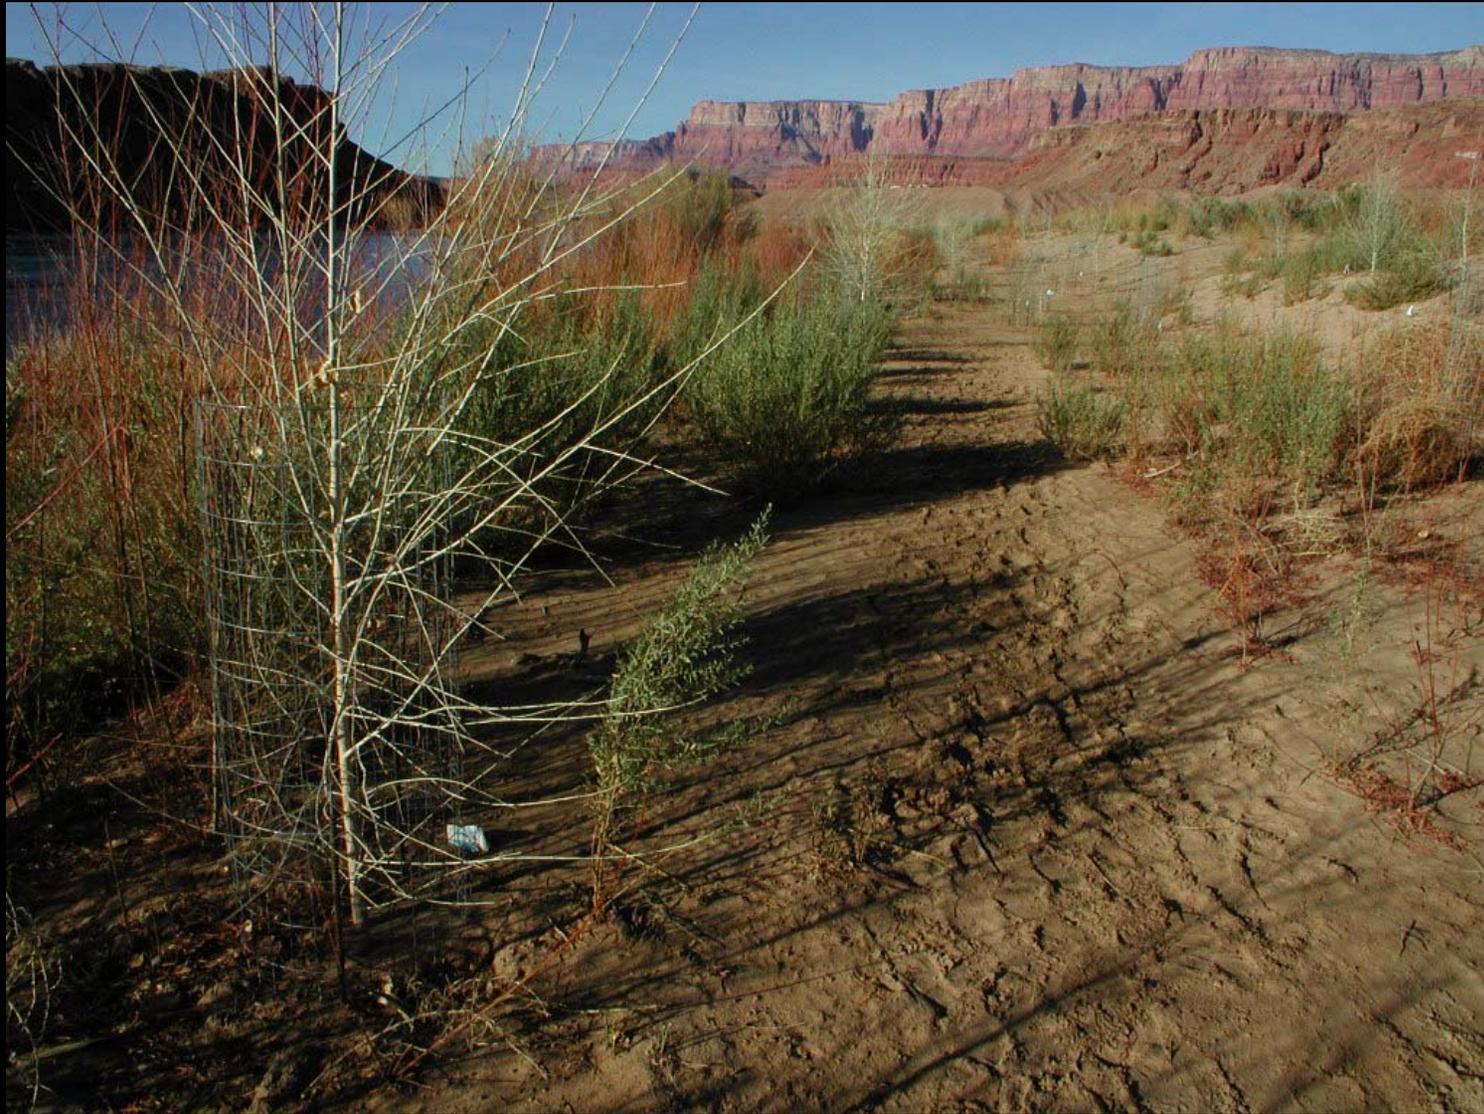
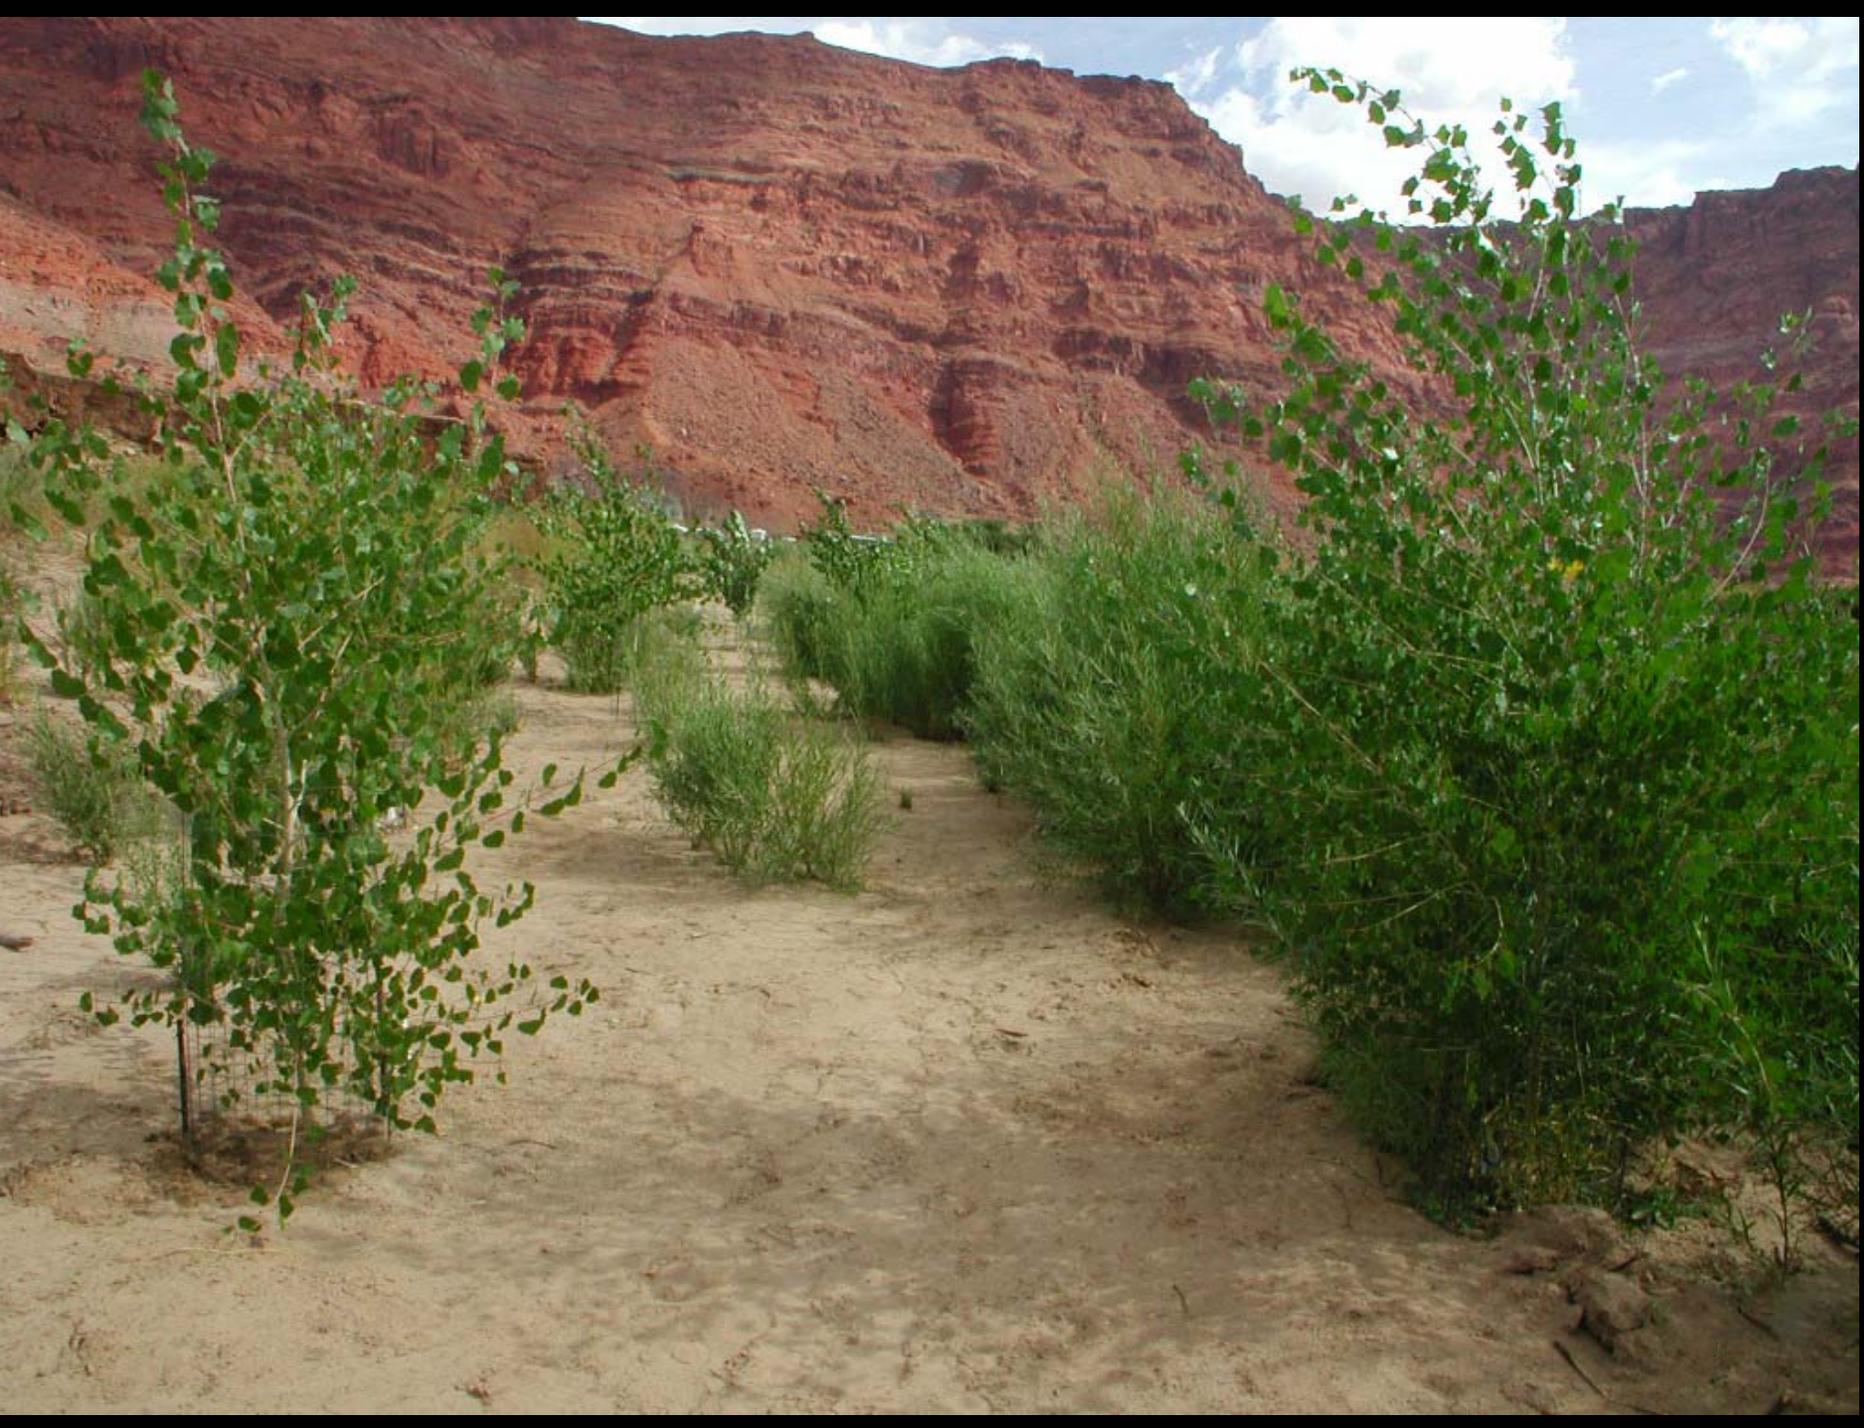
Propagules, Planting and Irrigation

- Propagules prepared from cuttings and seed from local genetic stock (1 gallon pots)
- Planting holes augered 18” diameter and 8’ deep or to water table
- Drip irrigation system construction
- Beaver Fencing around each individual tree
- Planting (volunteers?)
- Irrigated with 8 gallons a day for entire first growing season
- Periodic weeding and replanting of dead trees
