Glen Canyon Dam Adaptive Management Work Group
Agenda Item Information
February 19-20, 2014

Quagga Mussels – Impacts and Solutions for Hydropower Facilities

Taking No Prisoners Beating Back Invasive Species

**Leonard Willett
Lower Colorado Region**

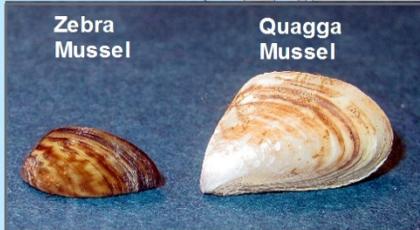
Zebra and Quagga Mussel Sightings Distribution *Dreissena polymorpha* and *D. rostriformis bugensis*

- Zebra mussel occurrences
- Quagga mussel occurrences
- Both species occurrences
- Zebra mussels eradicated

Map produced by the U.S. Geological Survey, Nonindigenous Aquatic Species Database, December 10, 2012.

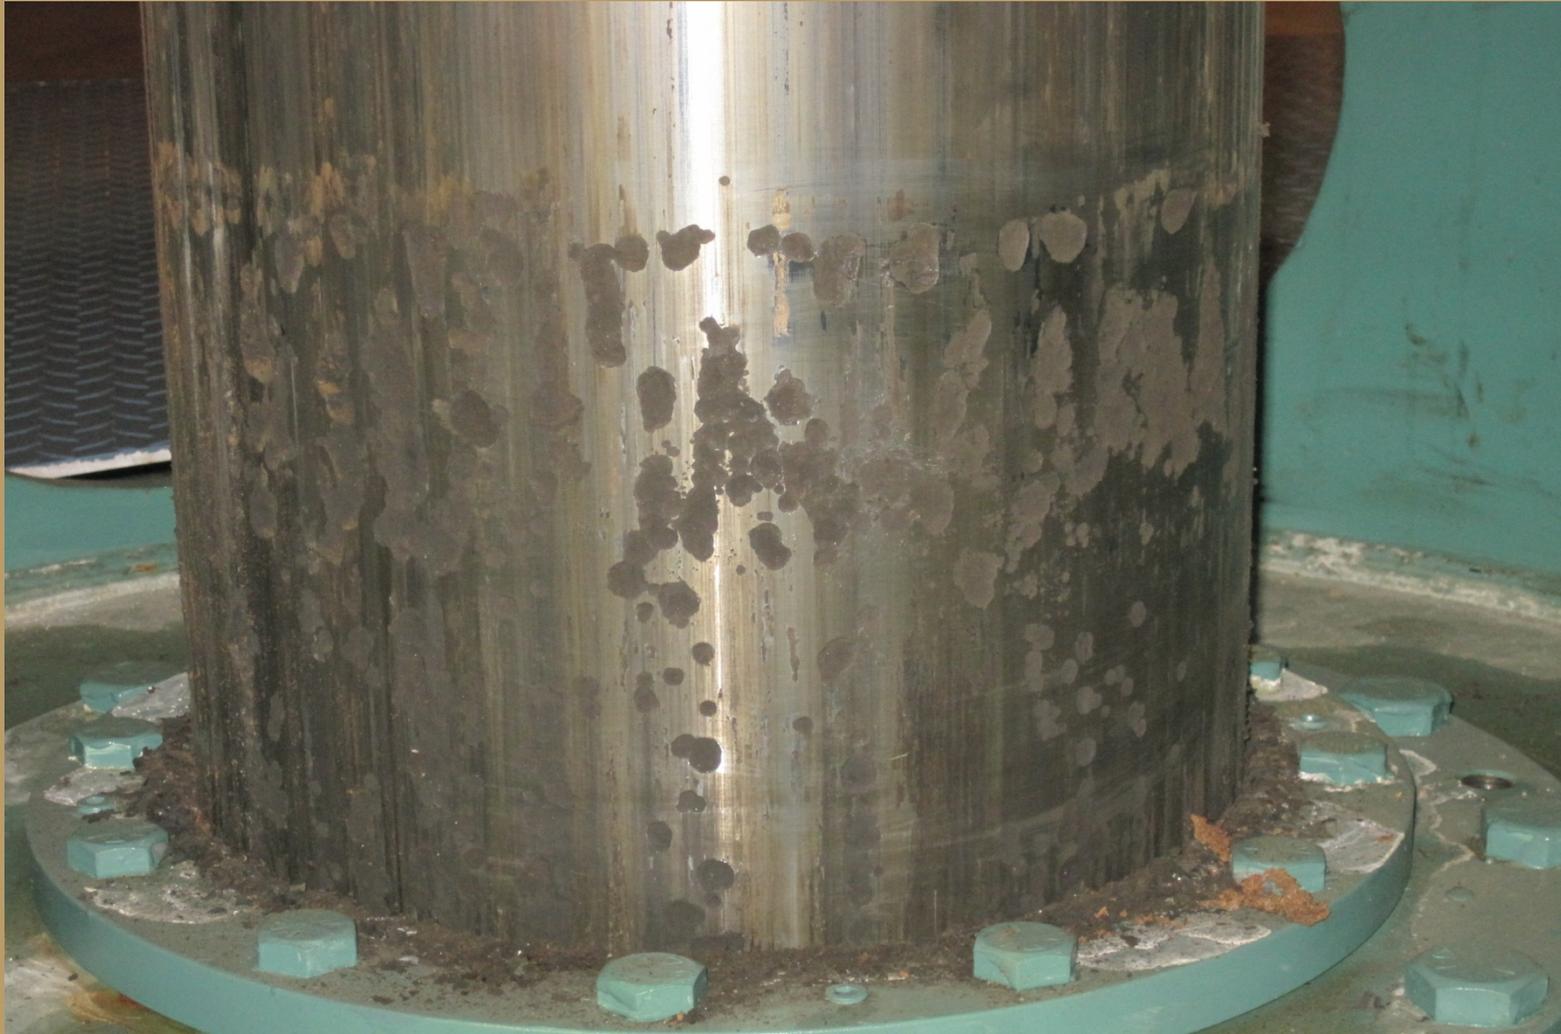
Hoover Dam Pressure Relief Valve Shaft Corrosion – April 2013

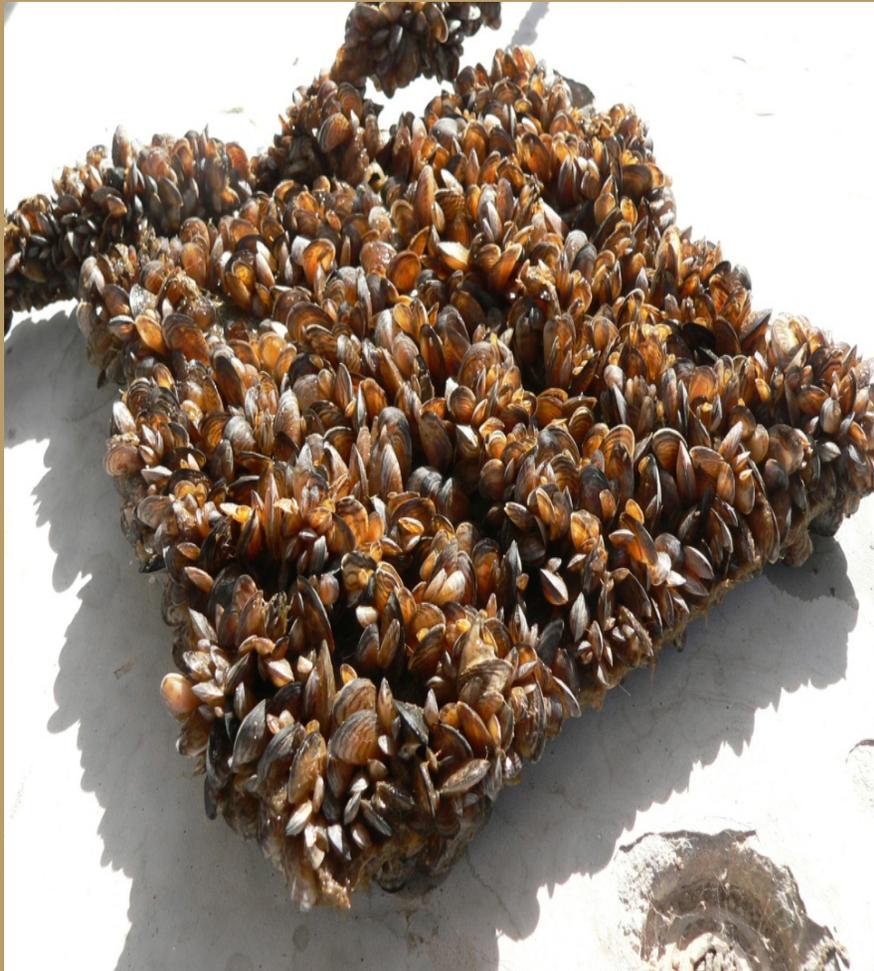
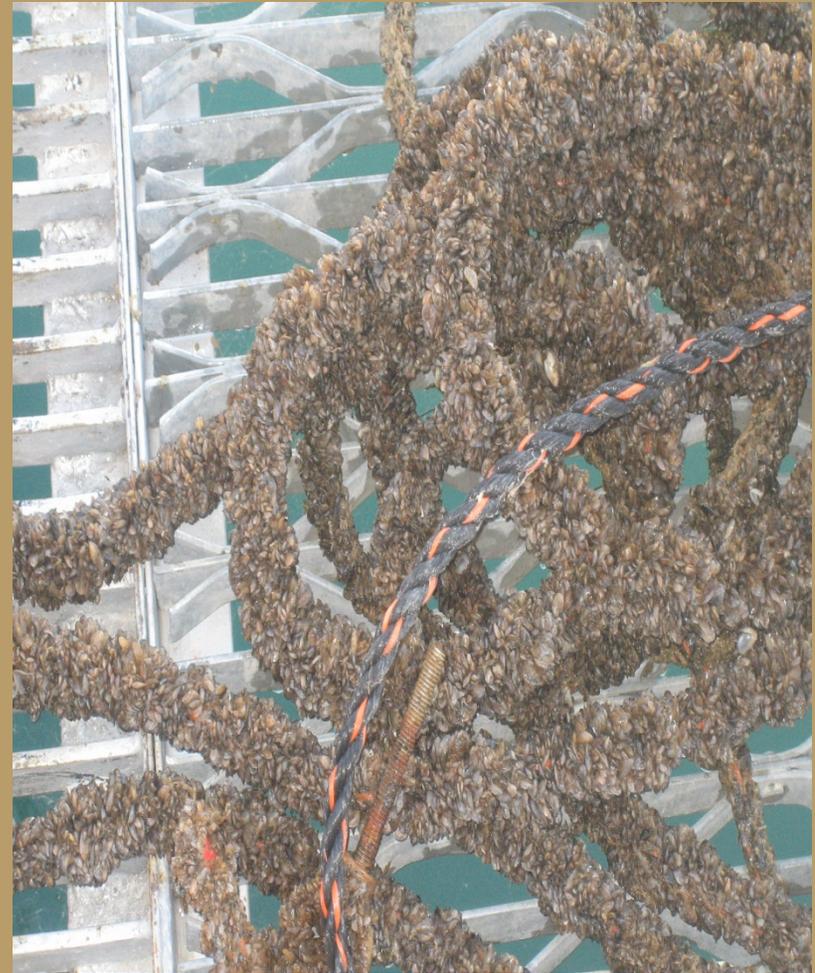
Sampling Plates at Parker Dam November 11/07 – 6 Weeks of Settlement

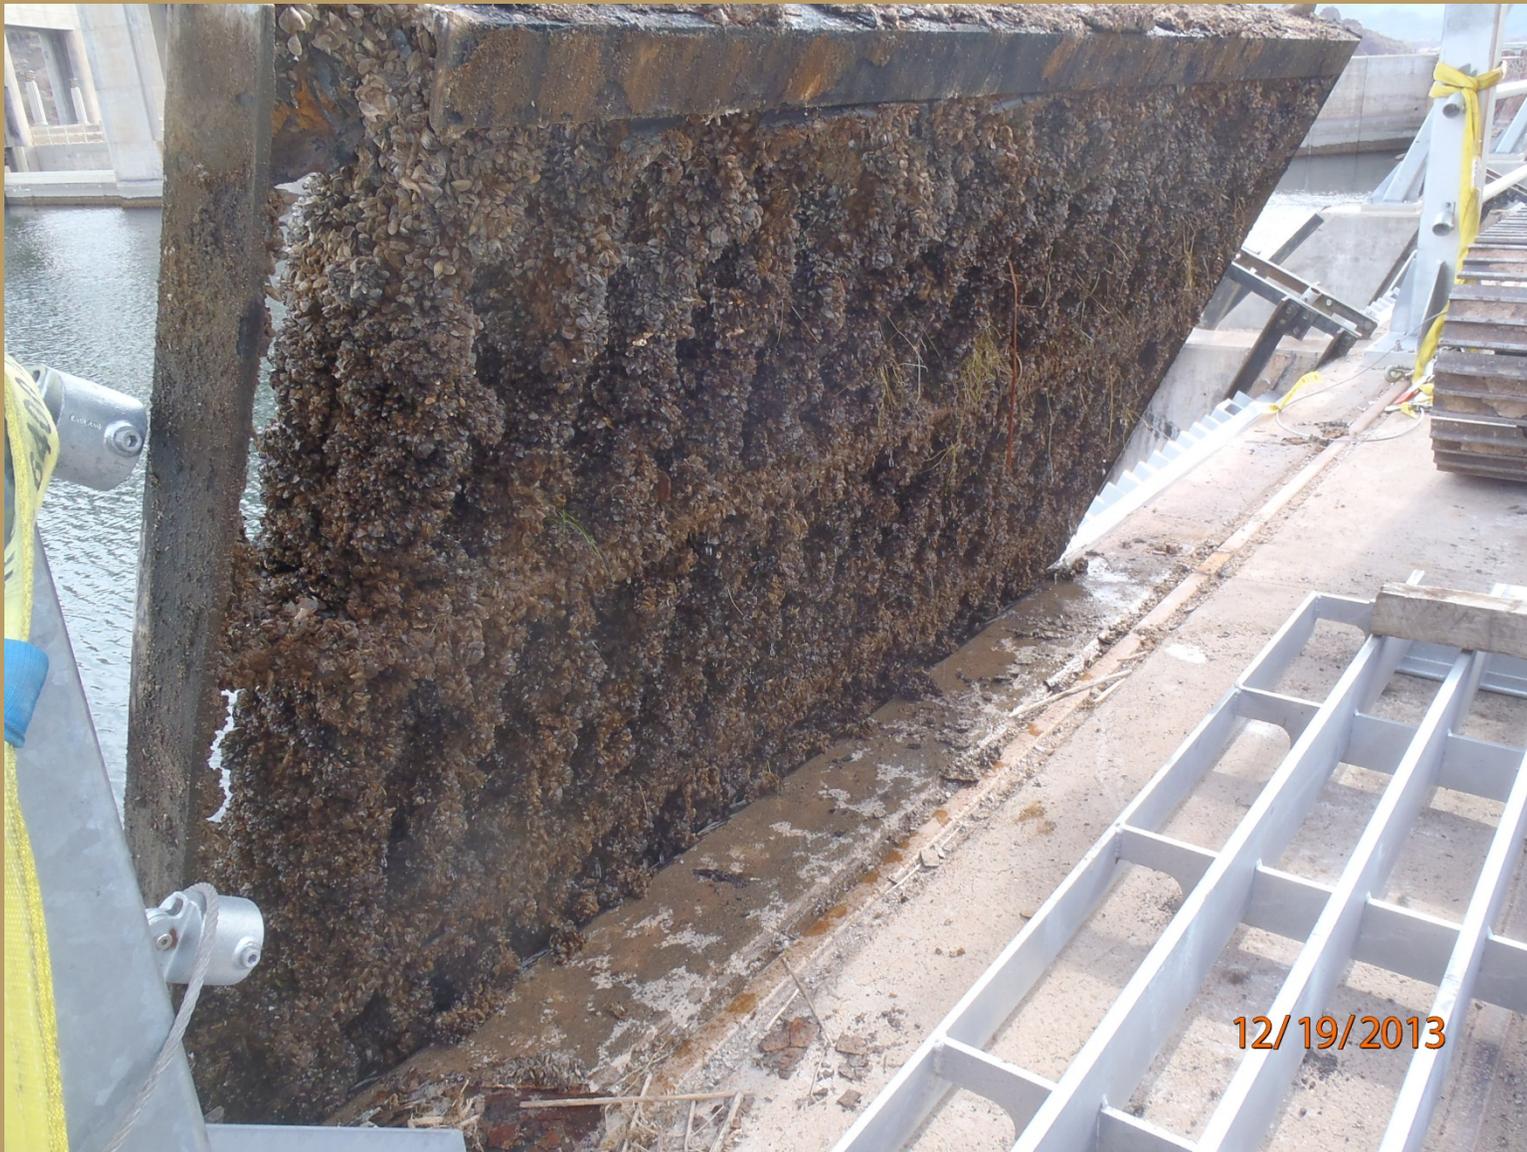
Trash Rack- Parker Dam - Jan 2013

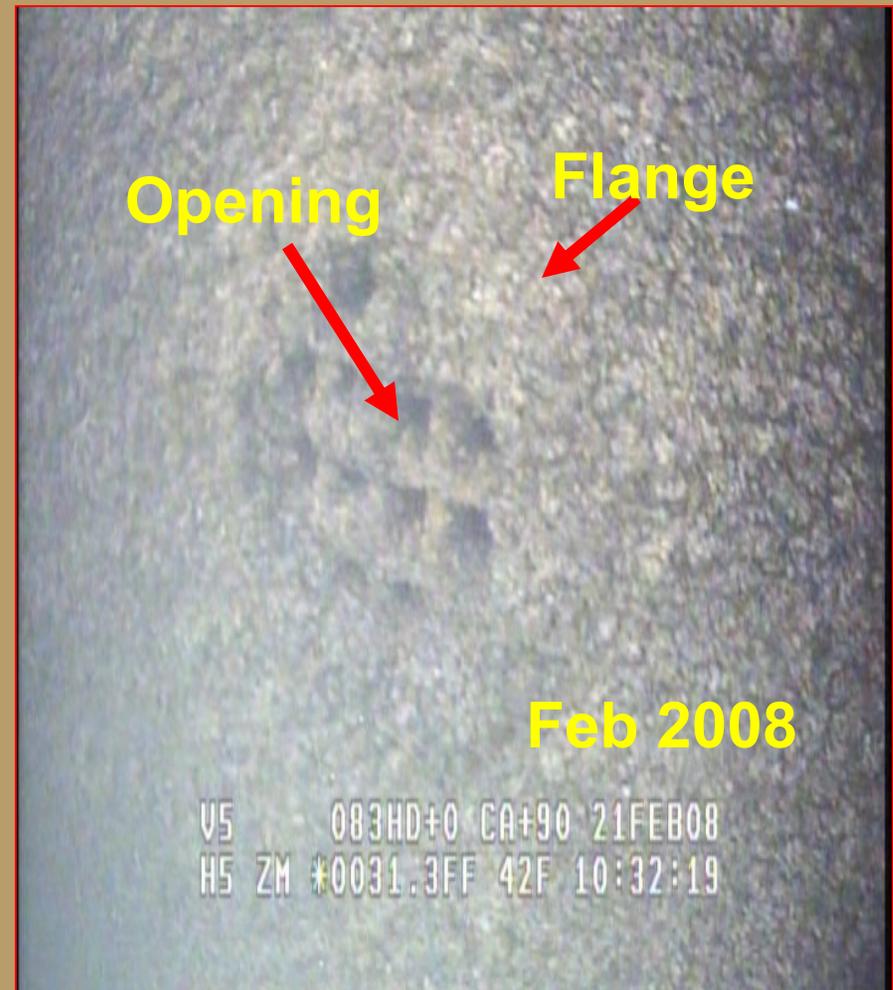
Domestic Water Intake Parker Dam

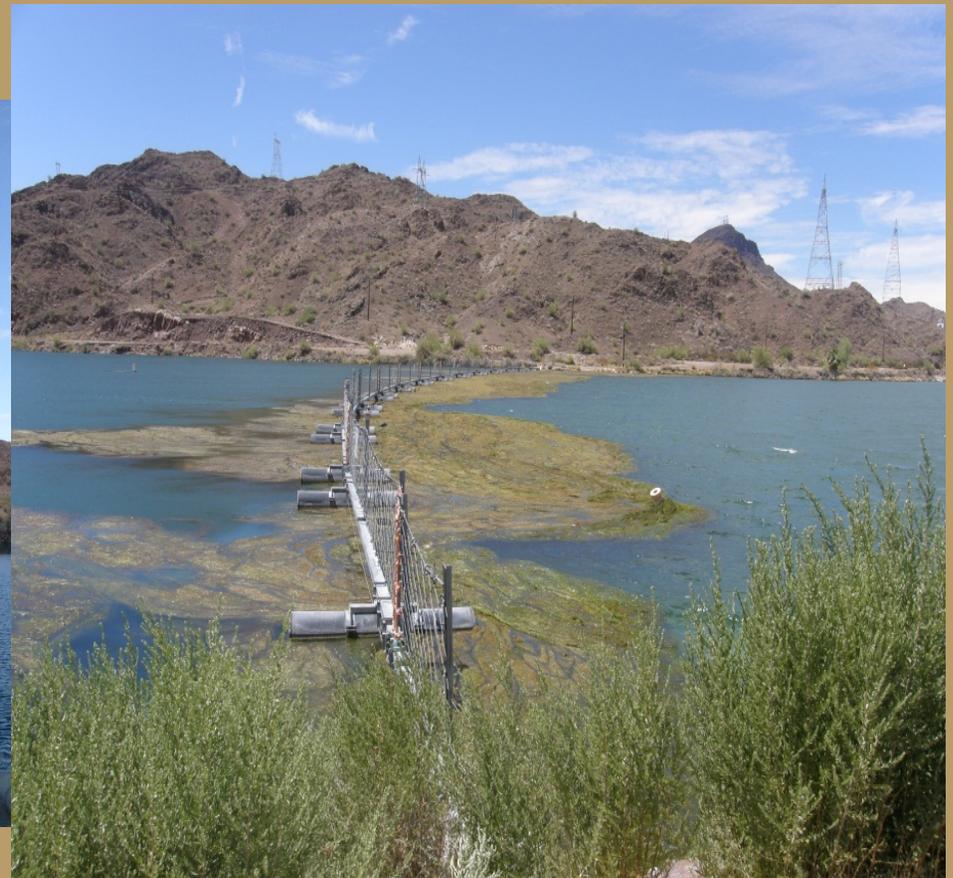
Parker Dam Trash Rake – Sept 2013

- Evaluate weeds and intake design. Retrofit of trash bar screens with racking systems (Parker Dam)
- Evaluate impacts of mussels on reservoir water quality and environmental impacts.

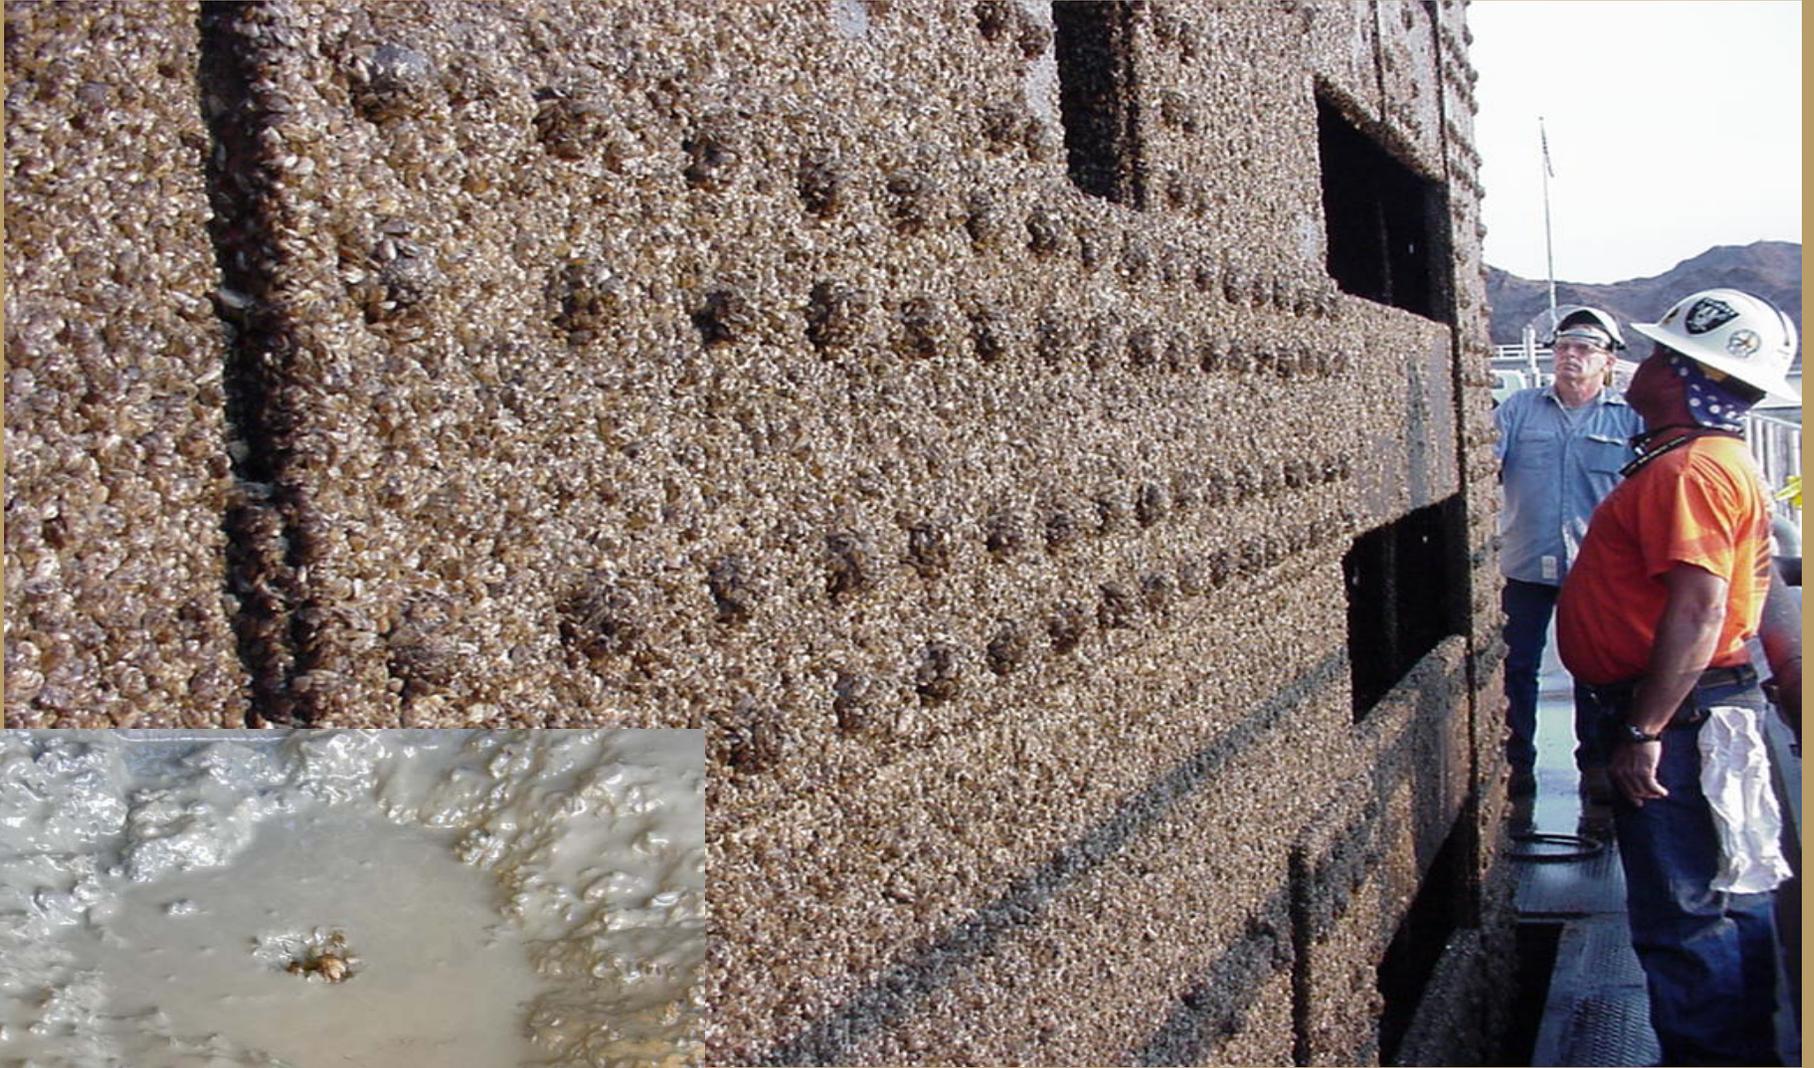
Davis Dam Fixed Wheel Gate - Oct 07

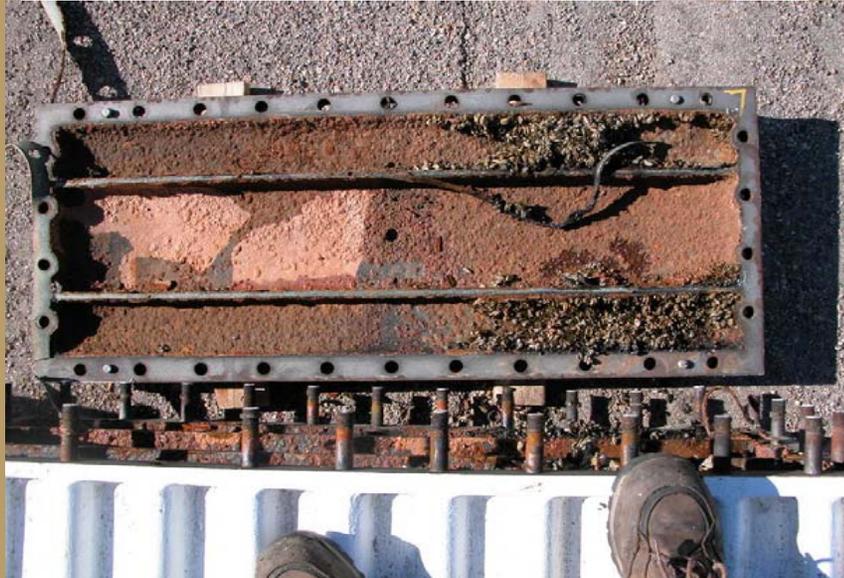
Generator Cooling Water Heat Exchanger Davis Dam - Dec 2009

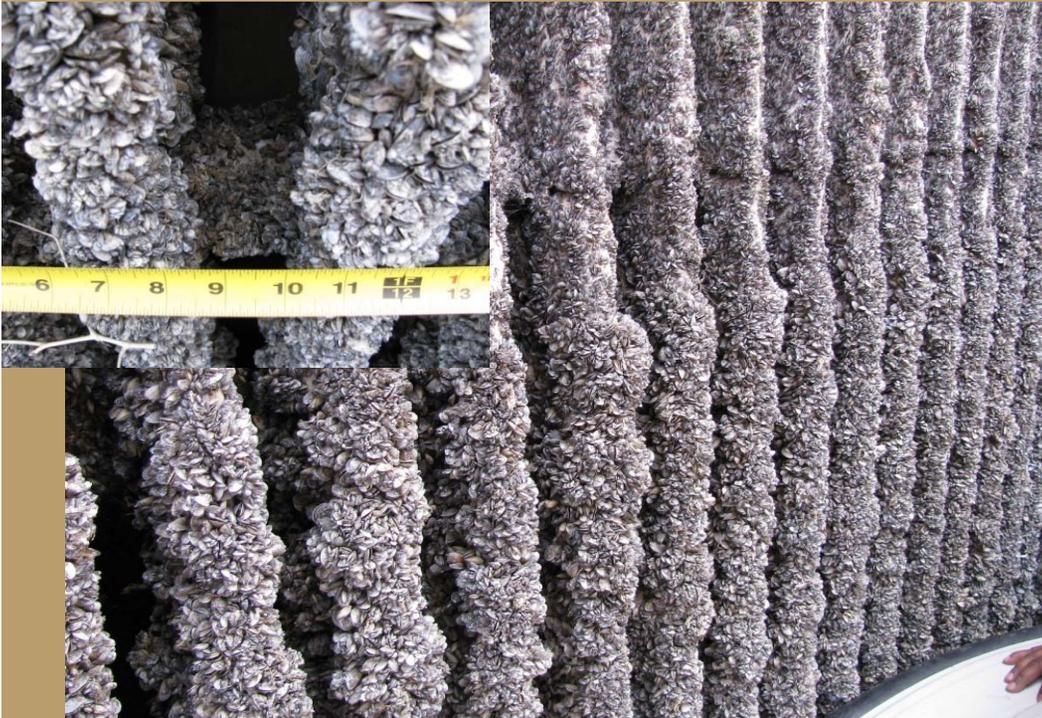
Elev 1111
Dec 2007 Lake
Mead Level

Elev 1045
66'

Elev 970
141'

Elev 894
217'

Intake Towers - April 2009

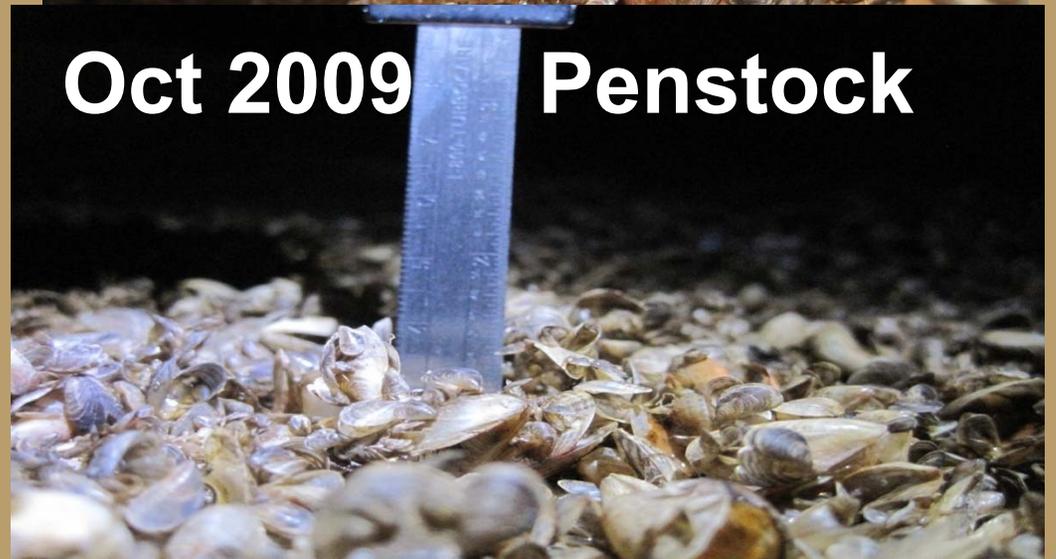
Oct 2009 Penstock

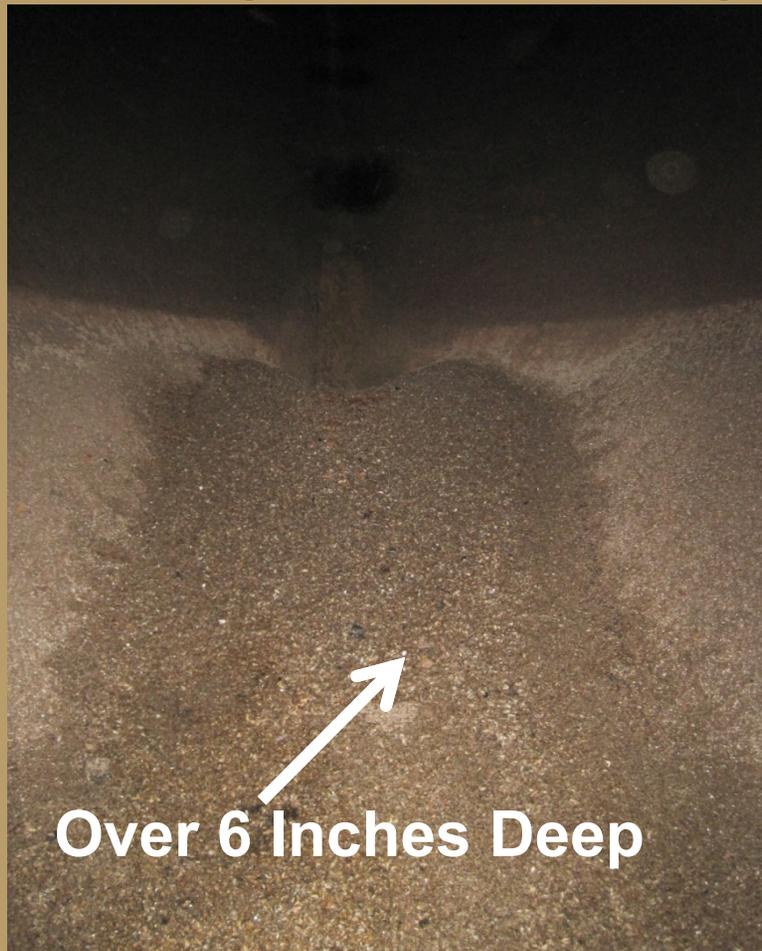
External surfaces Inspection – Oct 2008

**Penstock Lateral Shell
Debris (13ft diameter)**

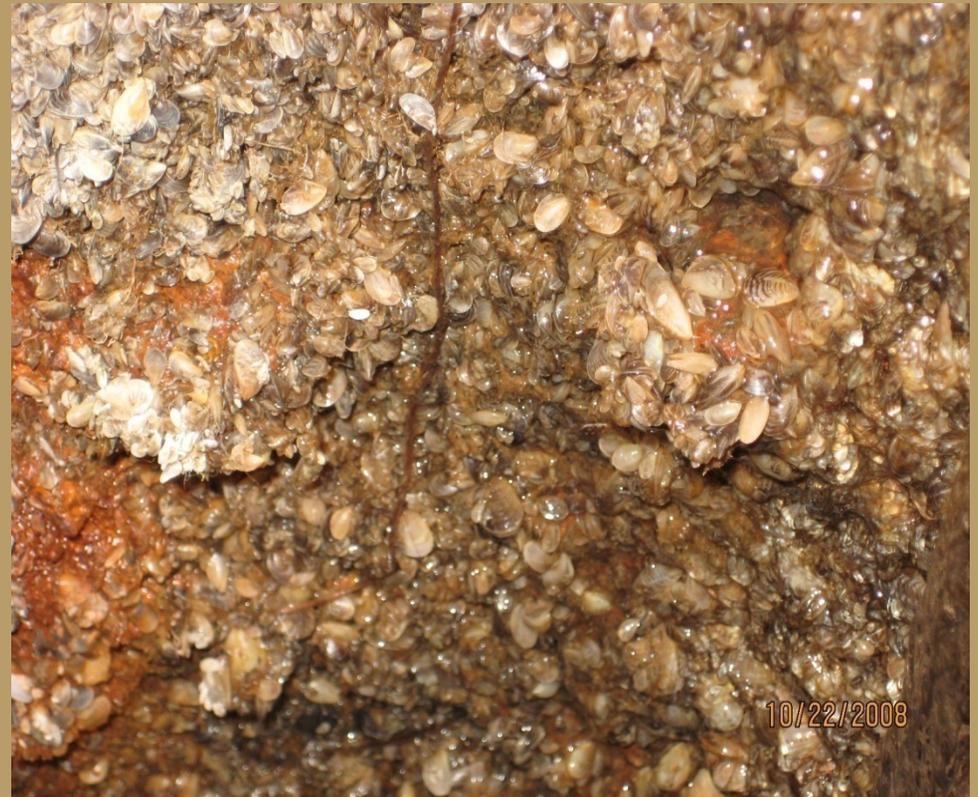
**Penstock Drain –
Heavy Settling**

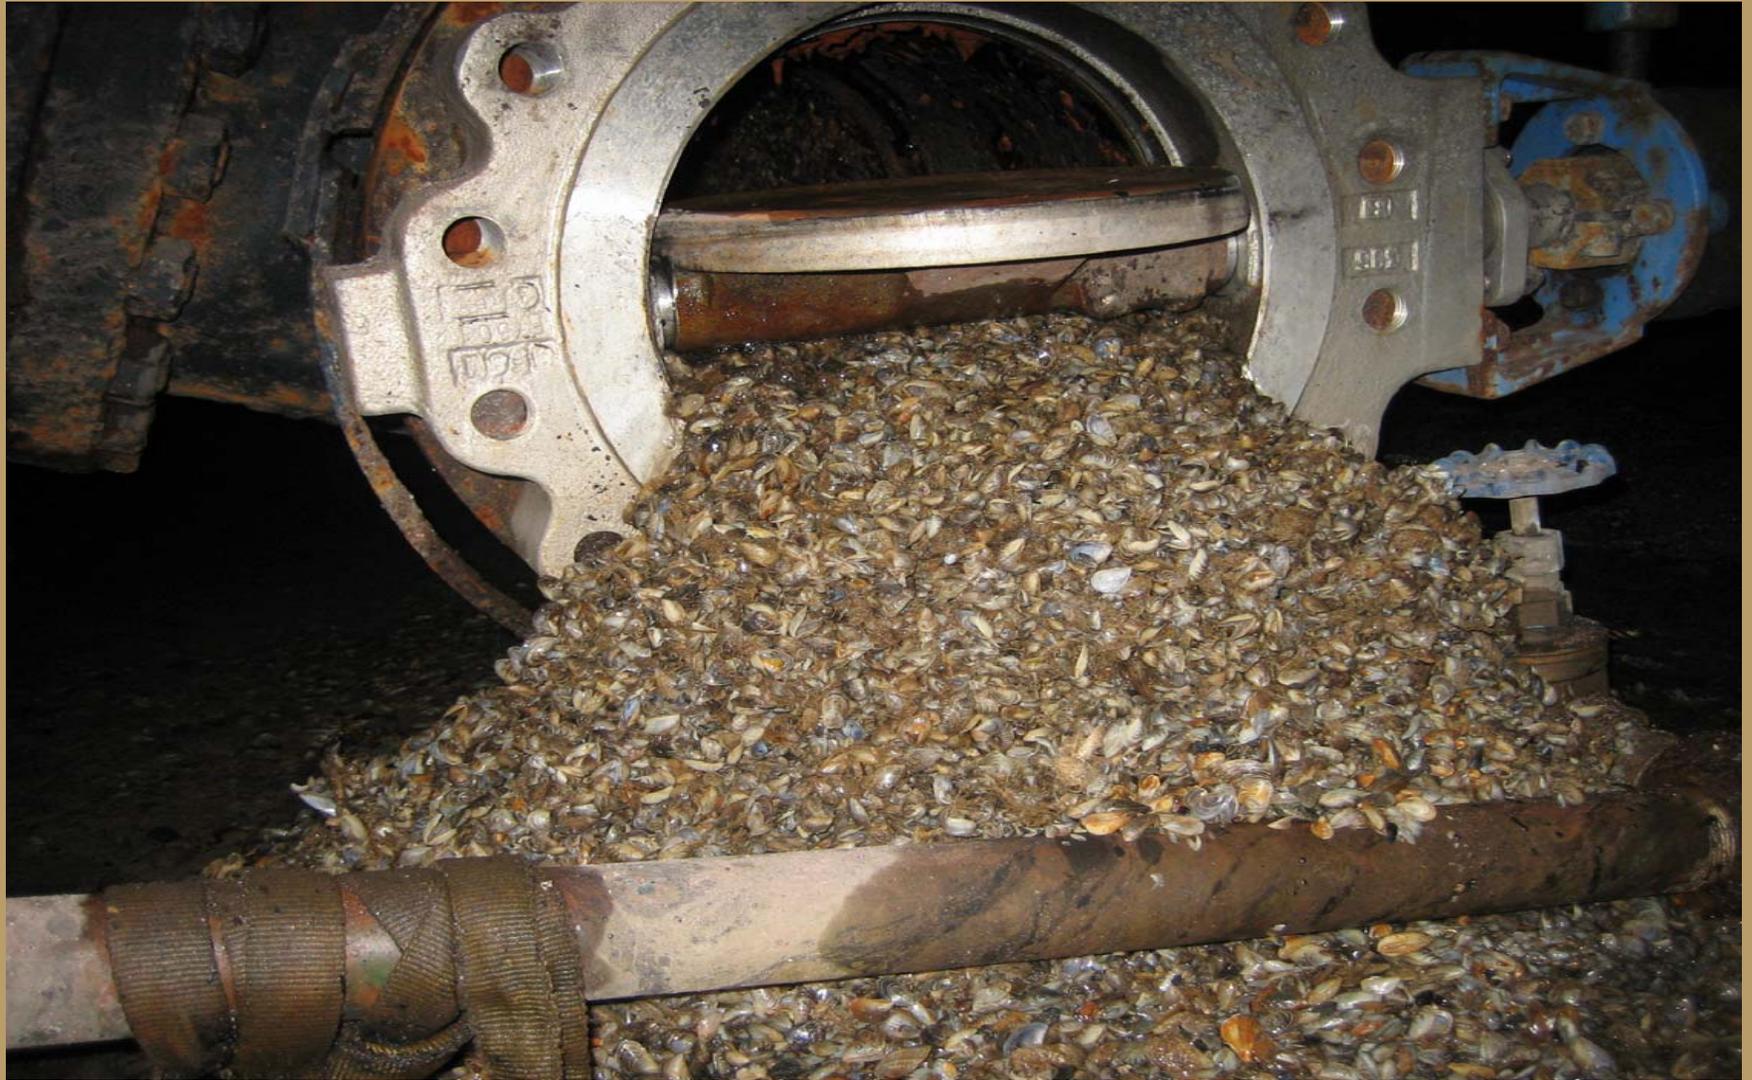
Penstock belly drain – Oct 2010

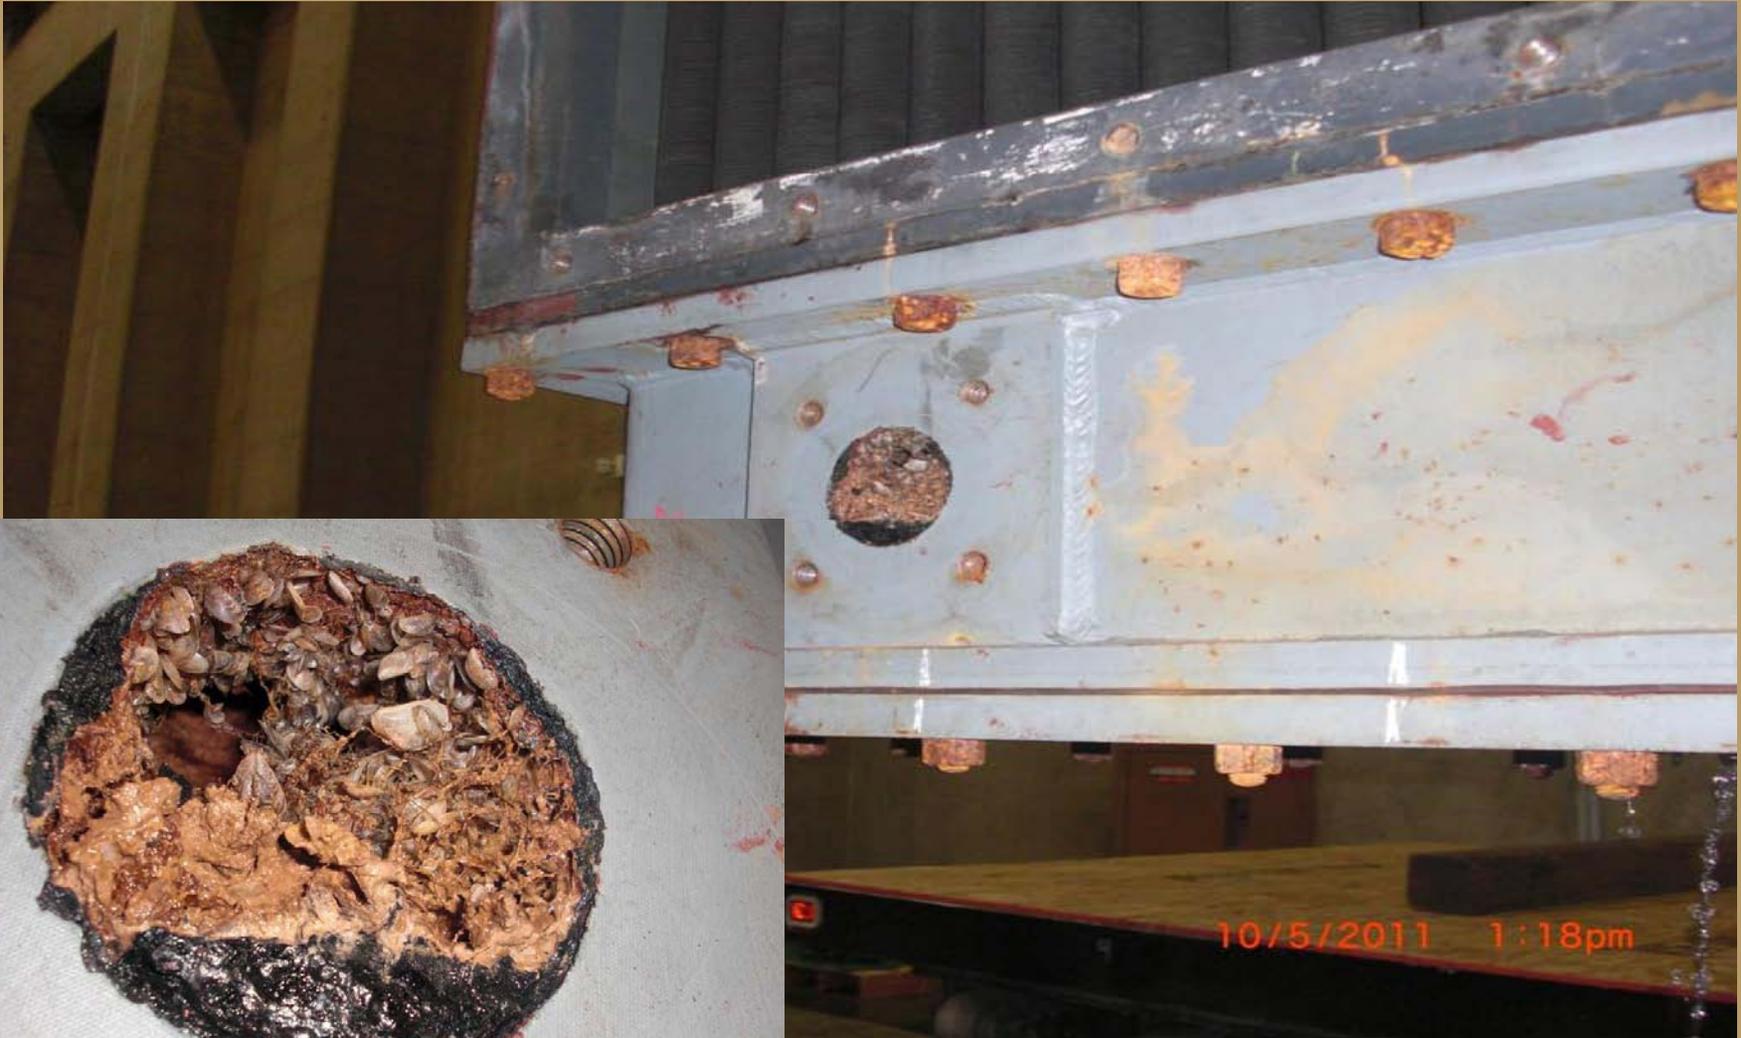
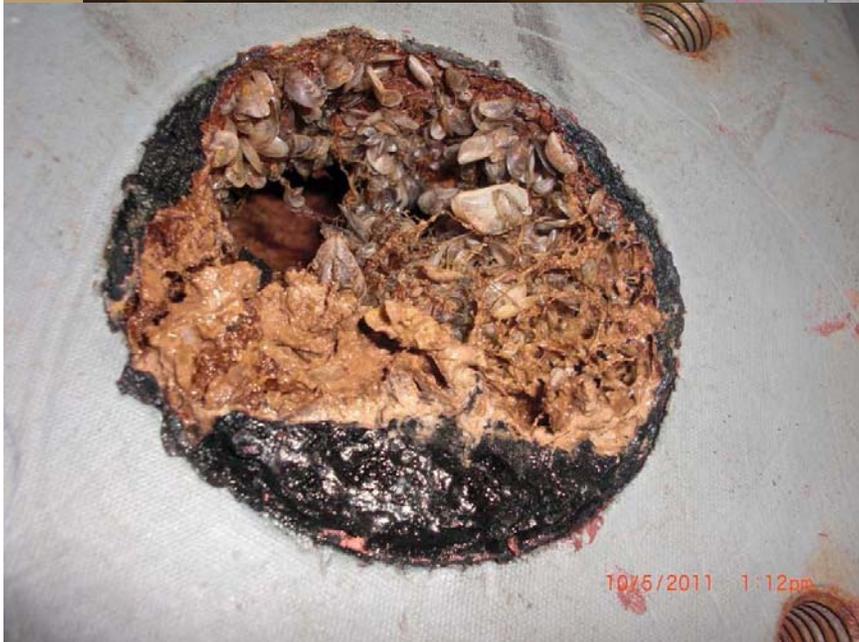
Hoover Dam A2 Air Cooler 10/05/11

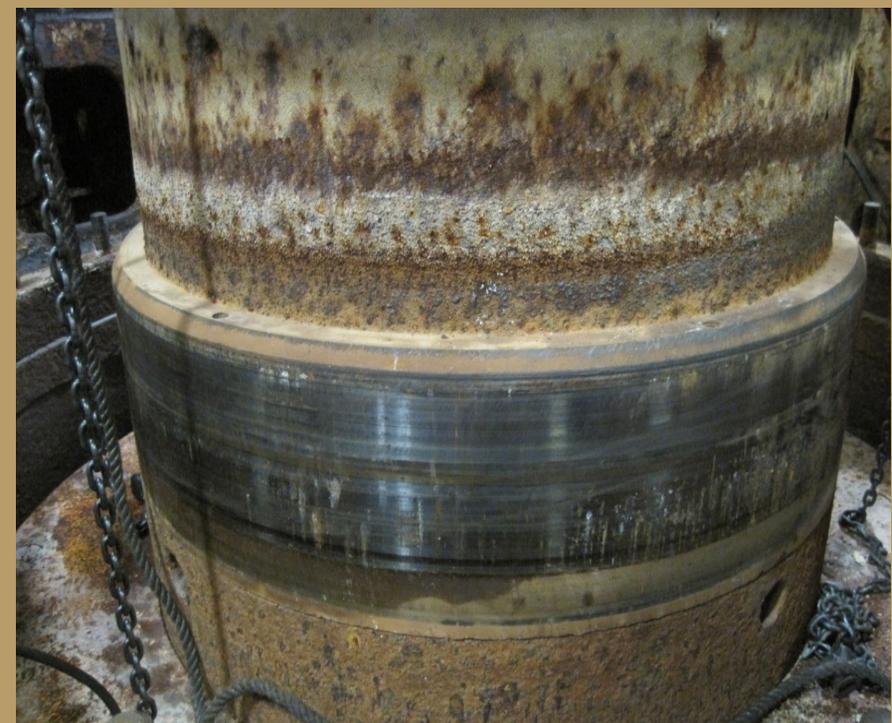
Hoover Dam Generator Packing Area Problematic Mussel Fouling

Small water opening to supply packing stuffing box

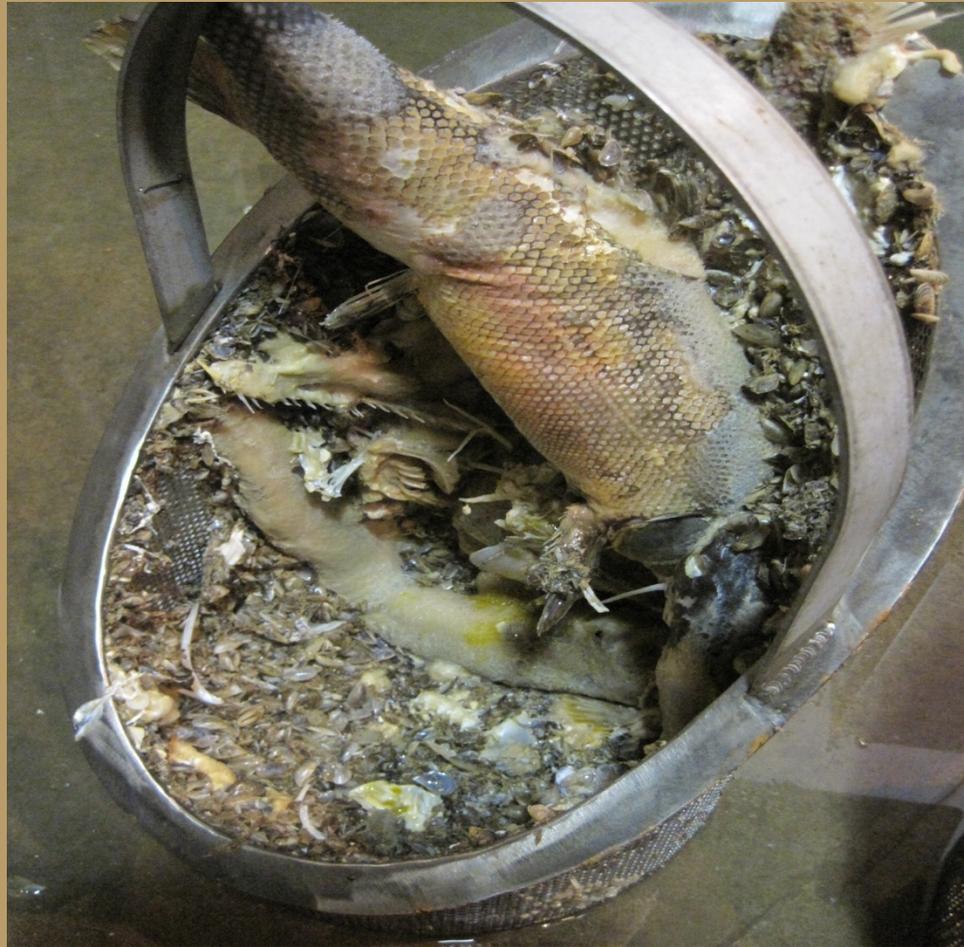
Hoover Dam 1/8" Strainer prior to UV Unit – Sept 2010

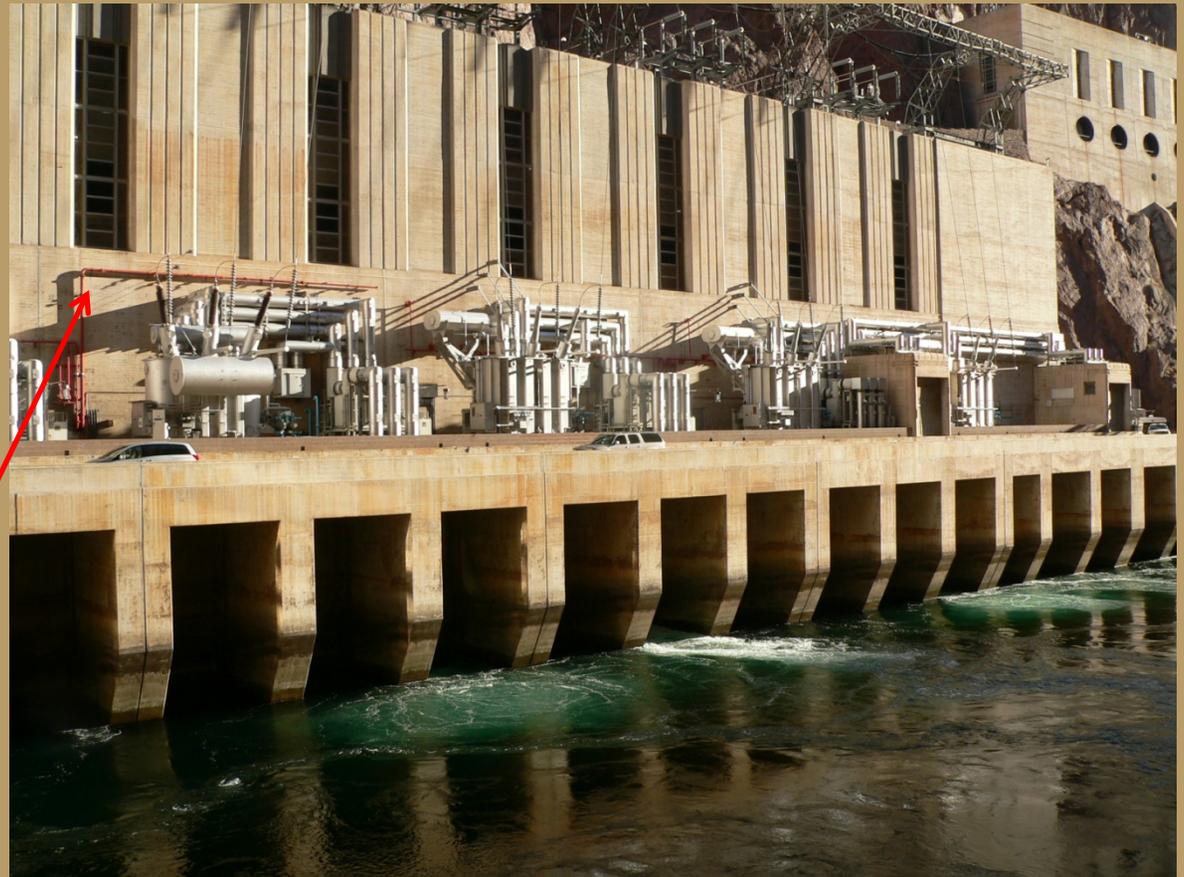
Fire protection and other cooling water systems need protection

**Transformer
cooling water**

Fire nozzles

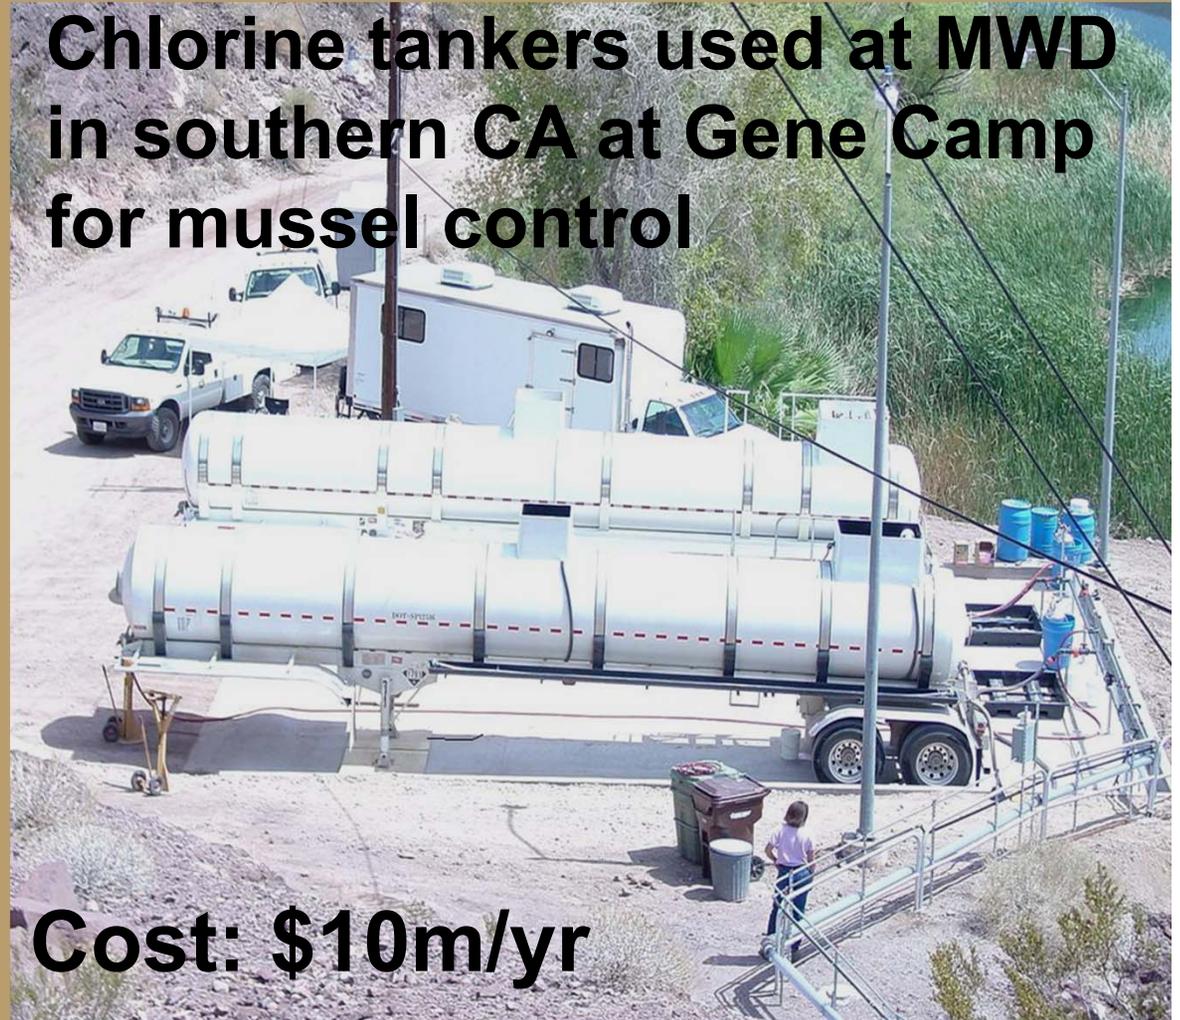
Chlorine tankers used at MWD in southern CA at Gene Camp for mussel control

Cost: \$10m/yr

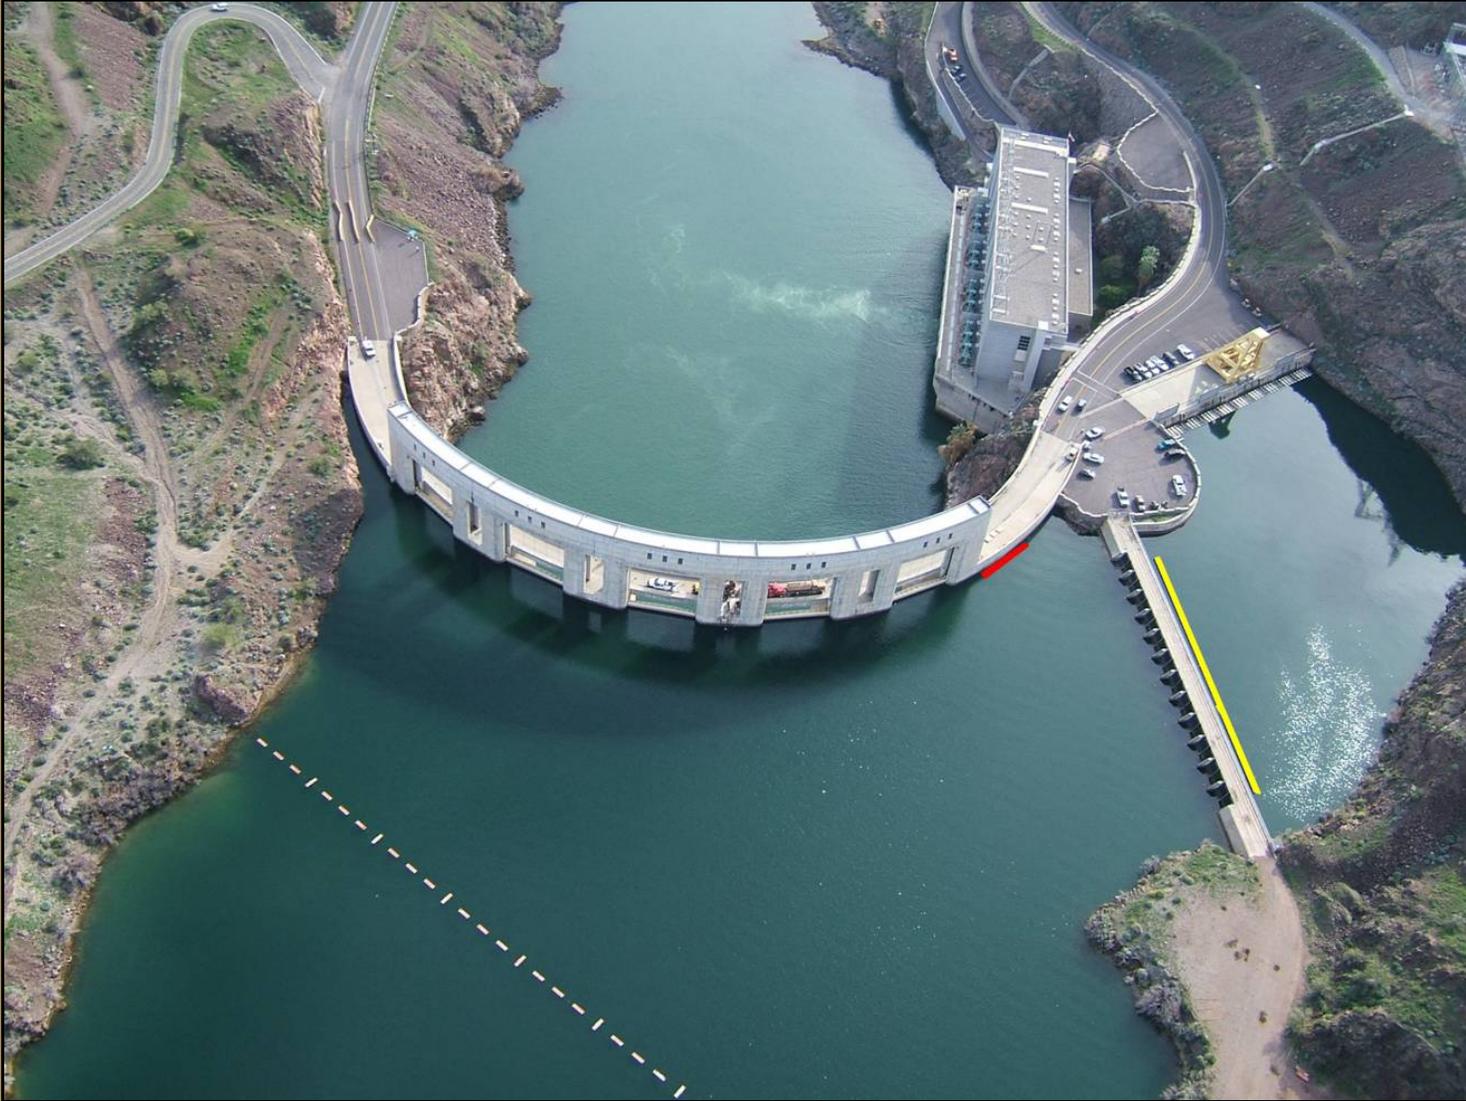
Coatings Panels Locations

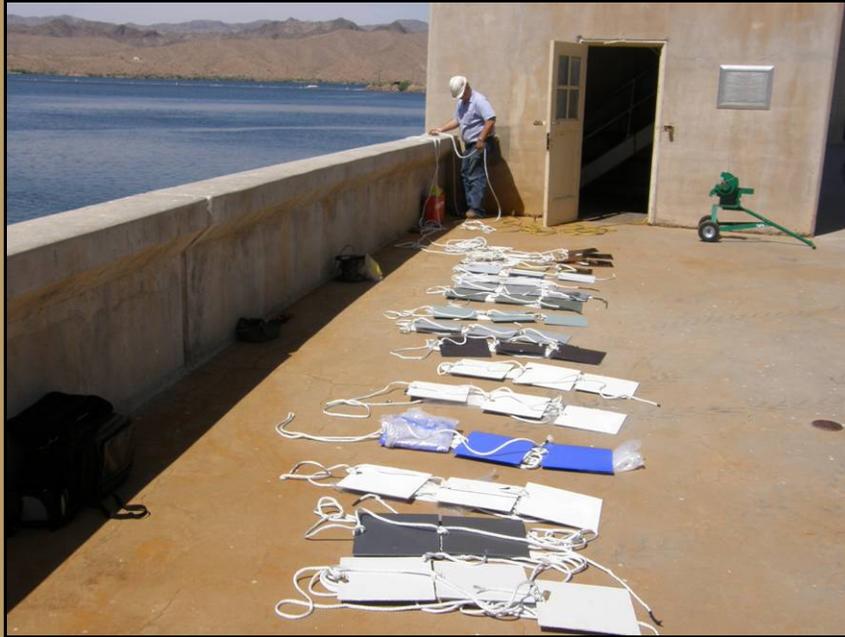
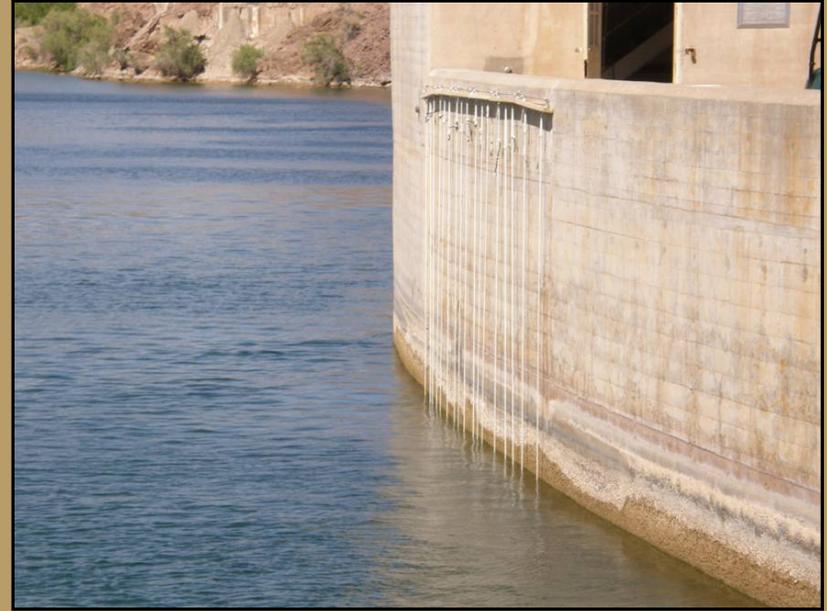
Coatings Panels

→
**3-month
fouling
rate**
