Glen Canyon Dam Adaptive Management Work Group
Agenda Item Information
February 19-20, 2014

Quagga Mussels – Impacts and Solutions for Hydropower Facilities

Taking No Prisoners Beating Back Invasive Species

**Leonard Willett
Lower Colorado Region**

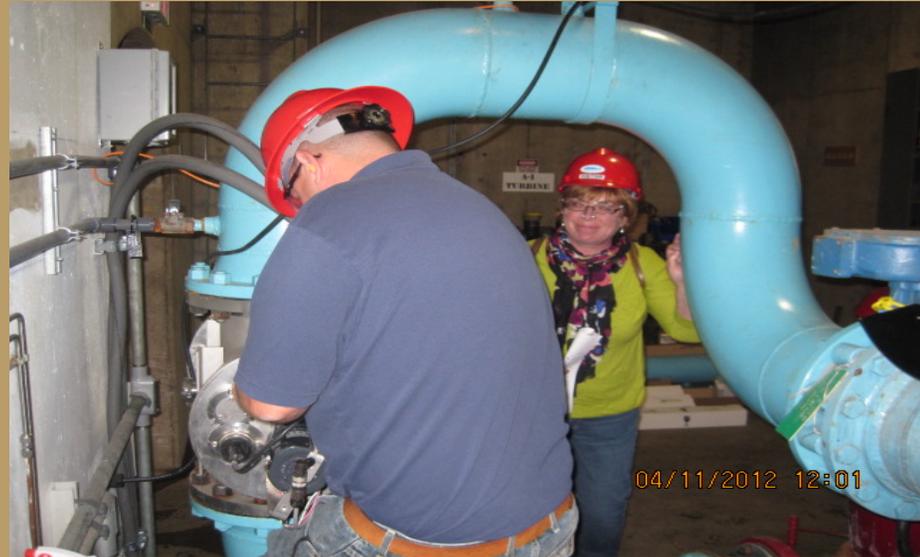
Hoover Dam Cooling Water Mussel Control UV System (research)

Started August 2010
2 lamps

Upgrade to 4 lamps to increase
dosage April 2011

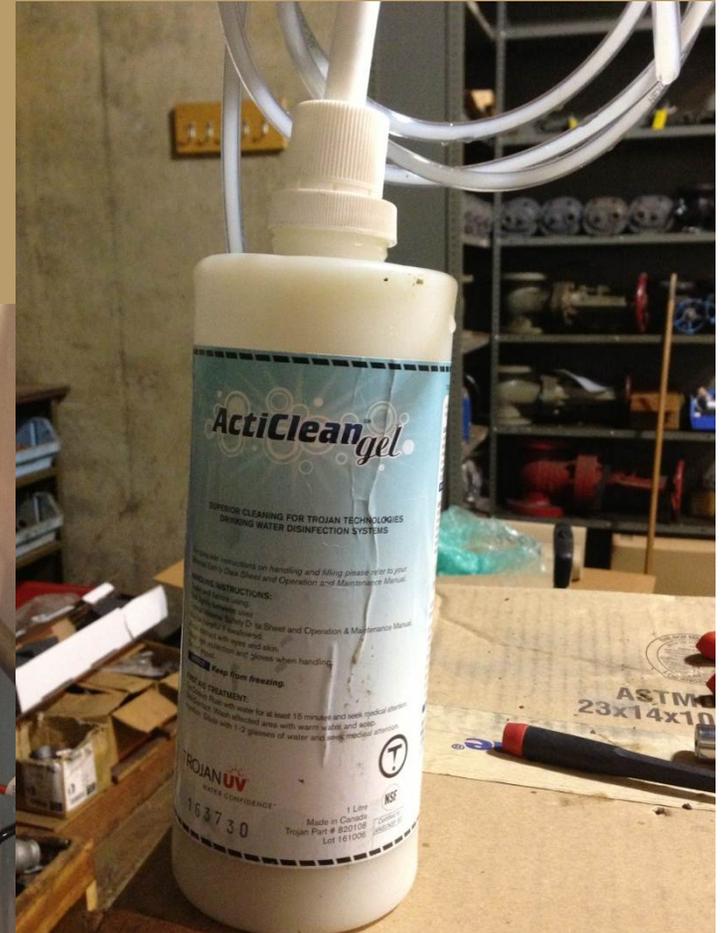
4 Lamps

Cleaning Gel storage for wiper system

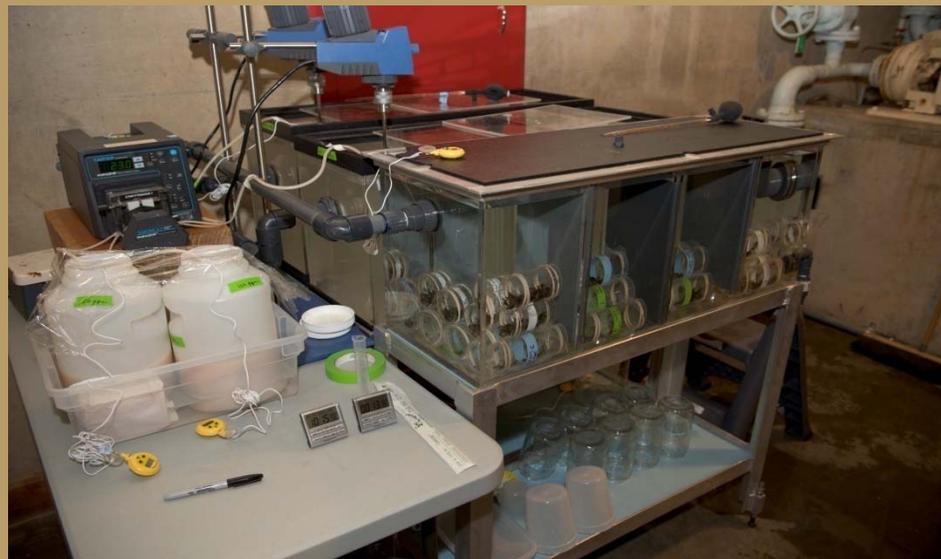
Zequanox Trials Davis Dam – Mar 2009

Zequanox Results for Adult Treatment Bio-Box Trials Davis Dam - Mar 2009

Trial Week and Water Temperature (degree C)	Dose (mg/L)	Percent Mortality (%)	Std. dev. (+/- %)	Mortality Check (day)
March 23, 2009 14 deg. C	100	87	3	34
	50	84	2	33
	75	82	5	32
	25	75	6	32

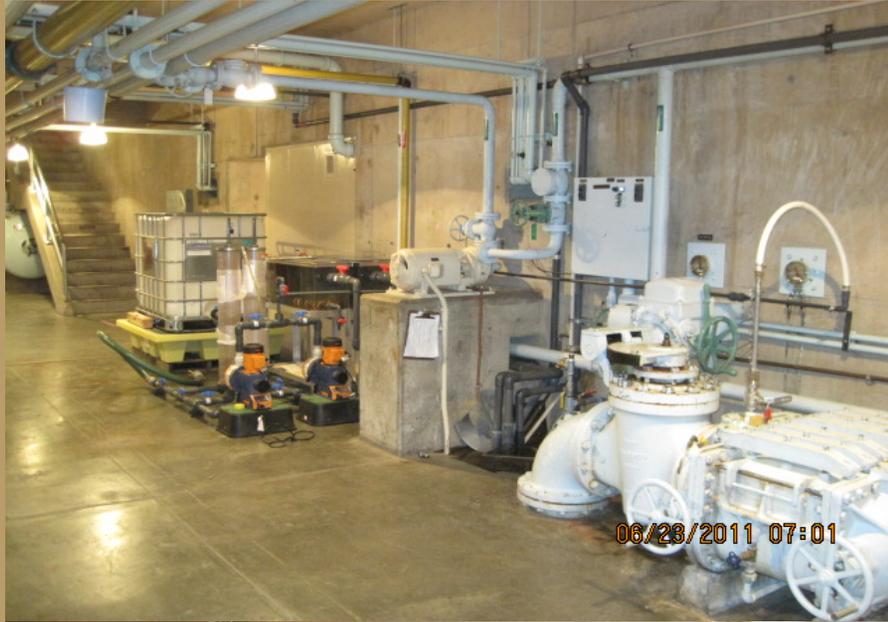
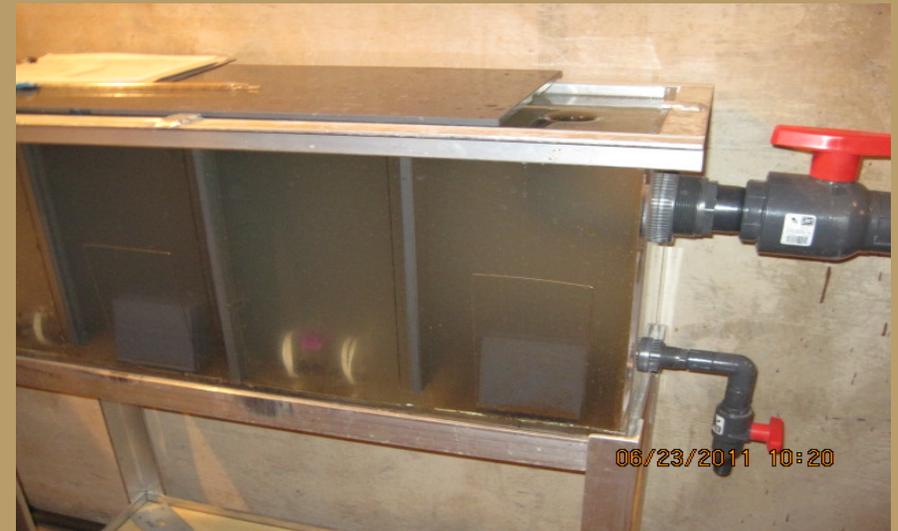
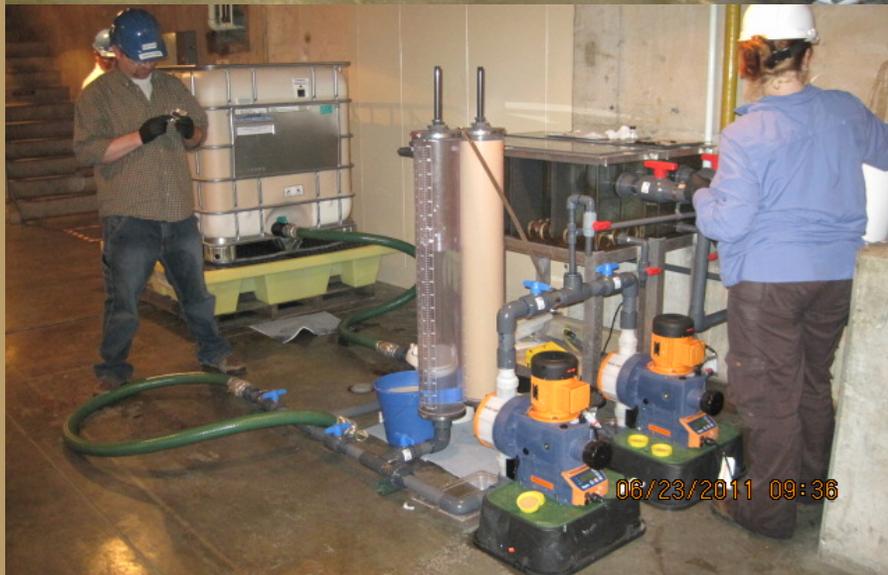
Zequanox Davis Dam June 2011

Cooling Water System

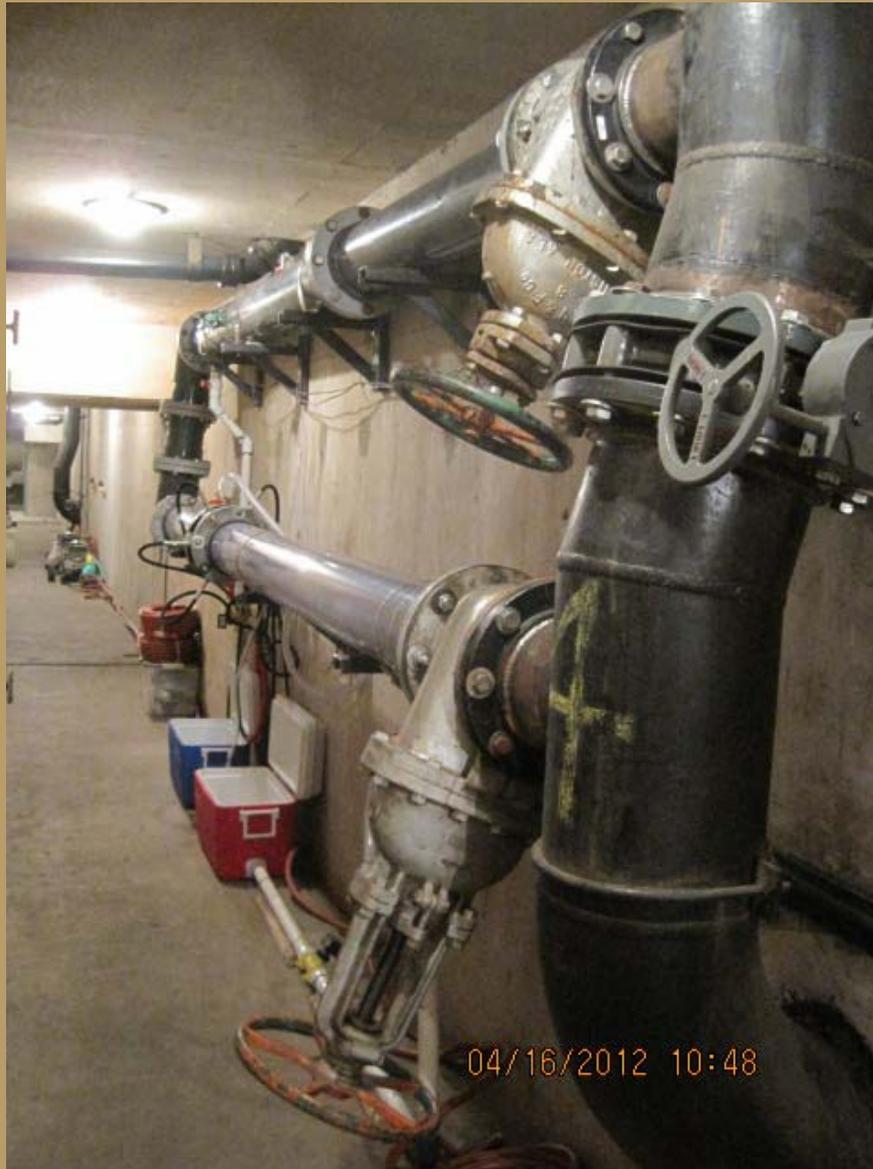
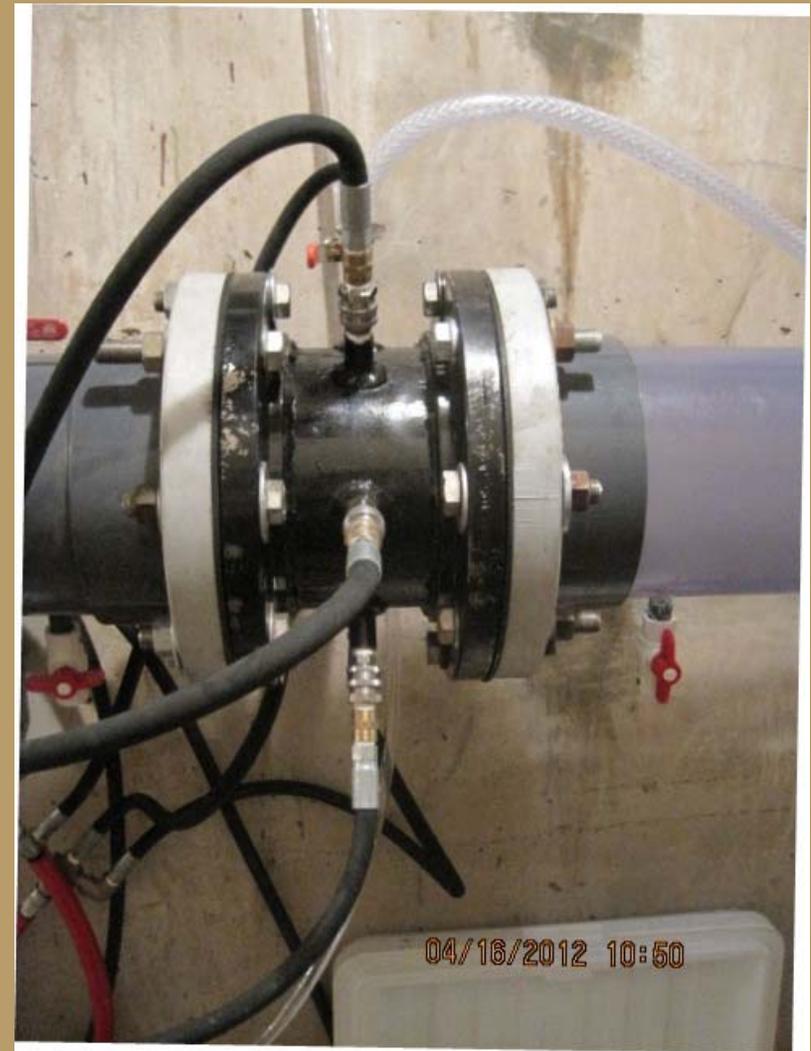
Turbulence Study – April 2013

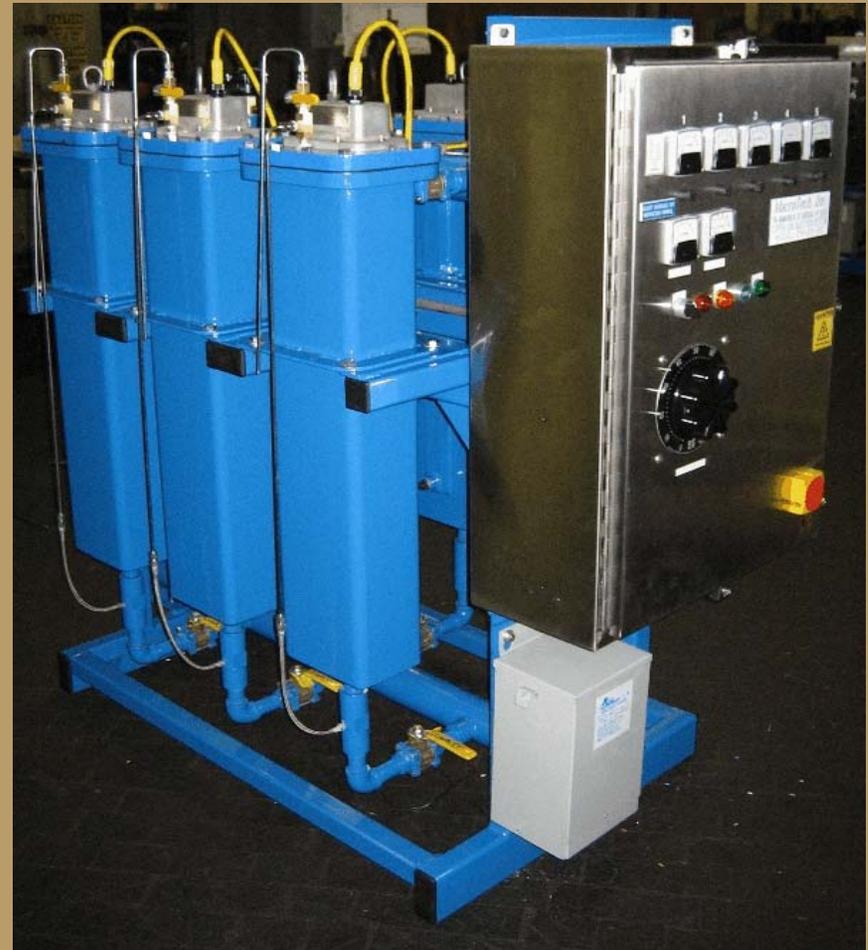
Proposed Copper Ion Generator Unit

Anodes are installed in cells (fresh water units). A side-stream of water is passed thru the unit and a copper-rich concentrate is formed. The treated solution is then distributed to one or more intakes to treat all the users.

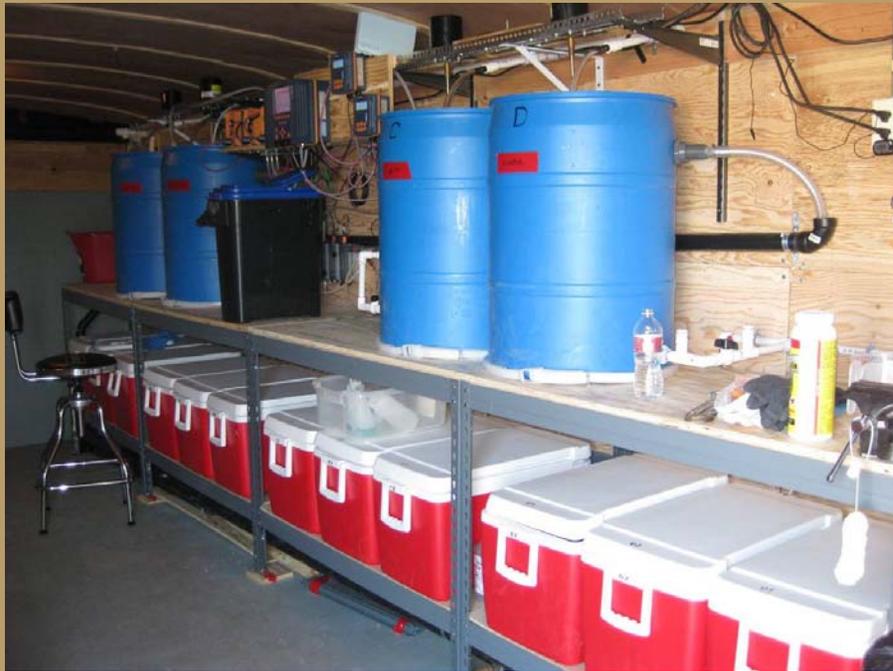
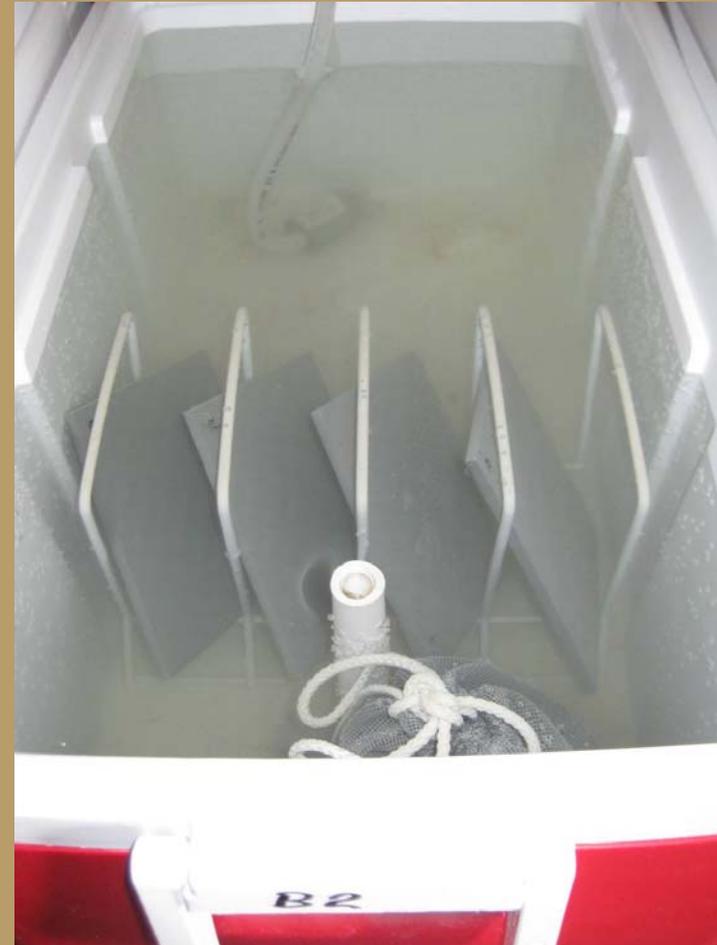
pH up evaluation

RNT Consulting pH evaluation for Reclamation

Precipitate observed after 24 hours at pH 9.3

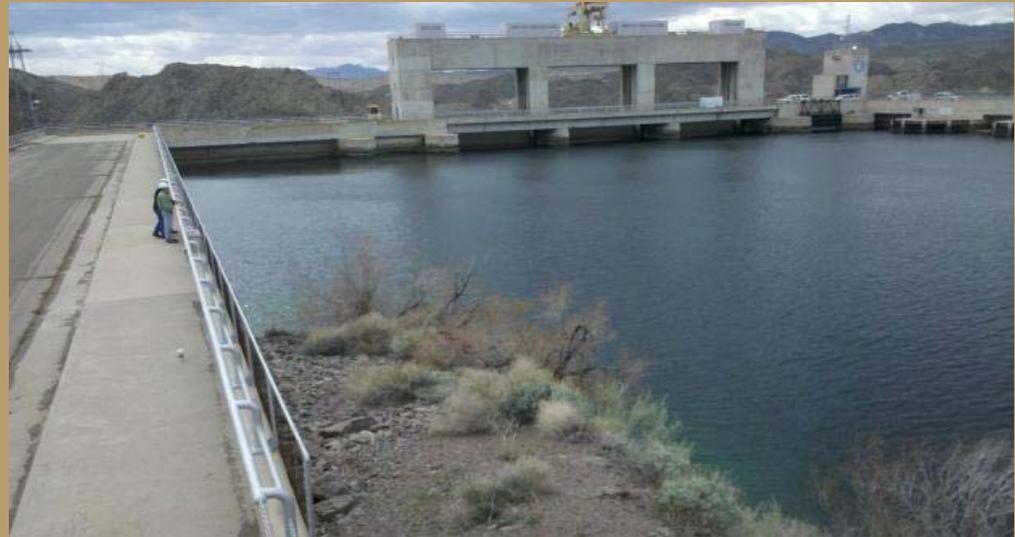
A. WATER GUN OPERATION

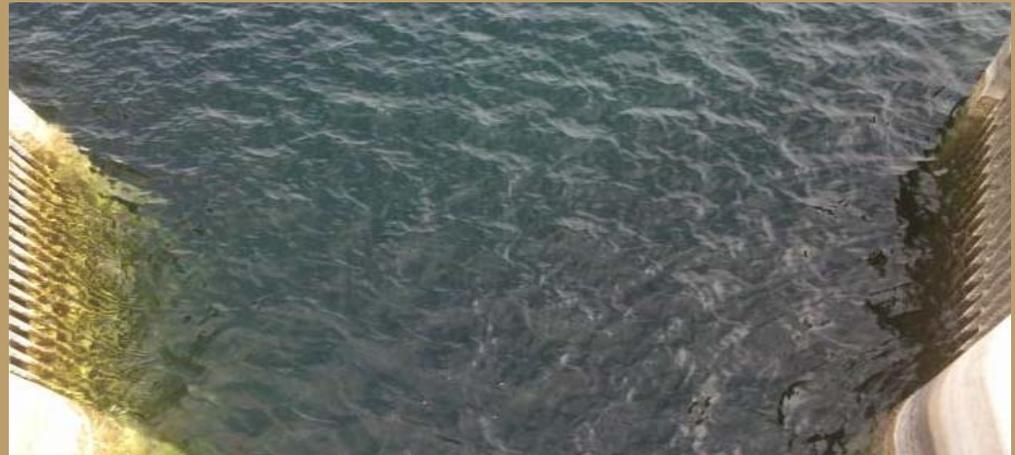
B. AIR GUN OPERATION
