McKay Creek Restoration and Prioritization Plan

Prineville, Oregon

for
Crooked River Watershed Council

July 16, 2014

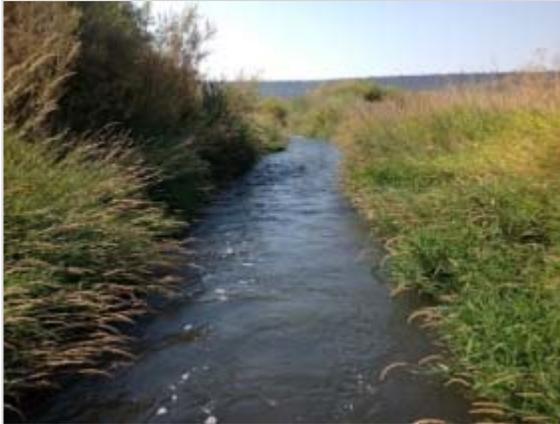
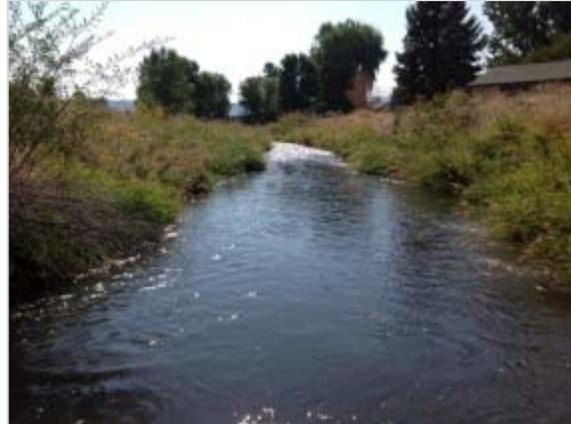
Photos show typical channel and riparian conditions within Reach 1. The riparian channel conditions include occasional trees and shrub cover but dominated by grasses, and the channel conditions are overall straightened and simplified. Project locations within this reach can be found in Appendix A, Figure 2.

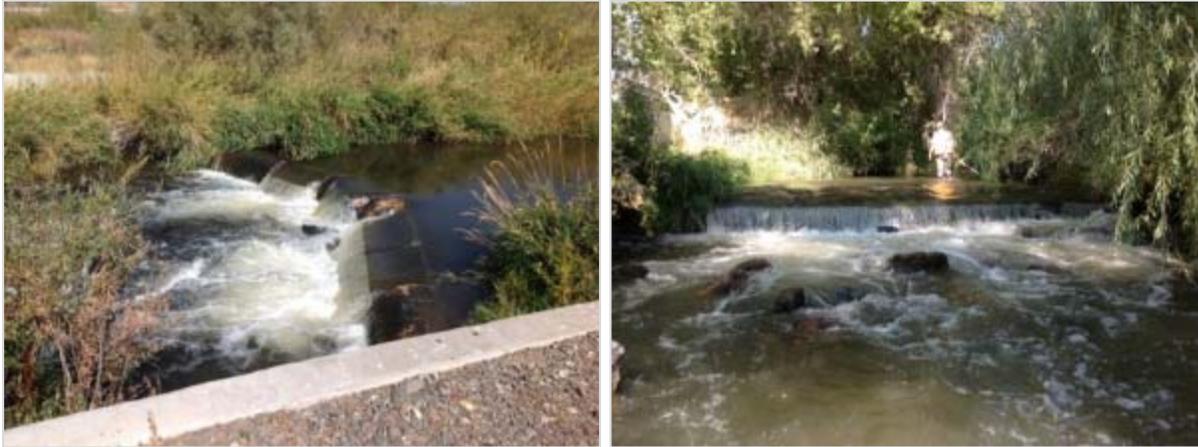
Channel-spanning drops in association with irrigation withdrawals comprised the screening barriers in Reach 1.

Two passage barriers were assessed in this reach. The lower barrier occurs at a siphon withdrawal just above RM 0.6. A 2-foot channel spanning drop occurs at a concrete V-weir and another, smaller drop spans the channel about 90 feet downstream. The upper barrier occurs at an irrigation canal crossing just above RM 1.0. At this location, the channel substrate has been modified with concrete grade control, ending with a 1.5-foot drop. The channel through this area is quite straight and fairly shallow, and the shallow plunge pool likely creates a barrier to upstream migration.

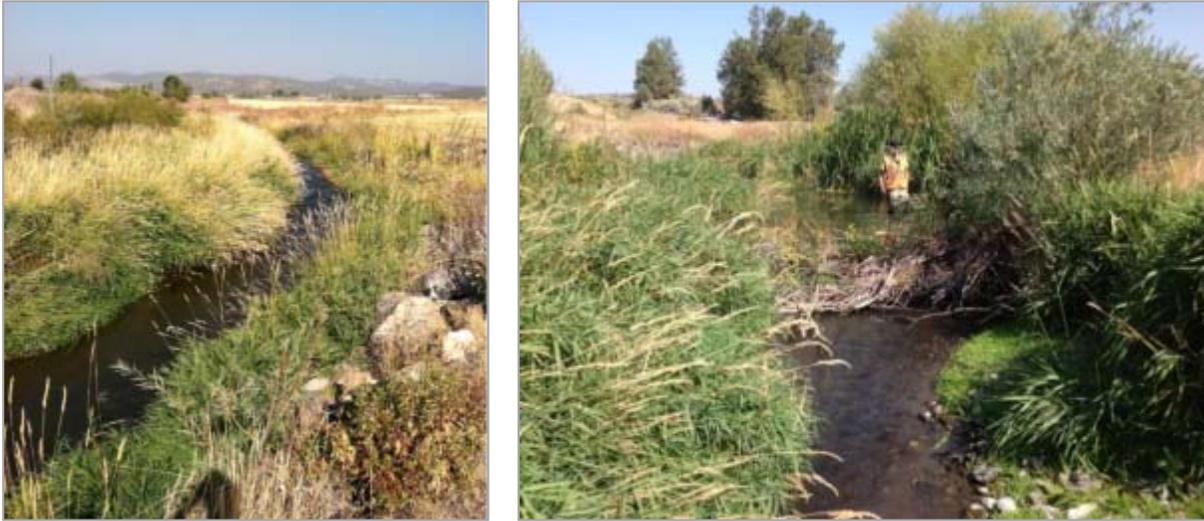
Typical conditions observed in Reach 2. Habitat quality variability is high, with some areas of grass and riprap dominance and others with thick shrub cover and heavy beaver activity. Reach 2 project locations can be found in Appendix A, Figure 3.

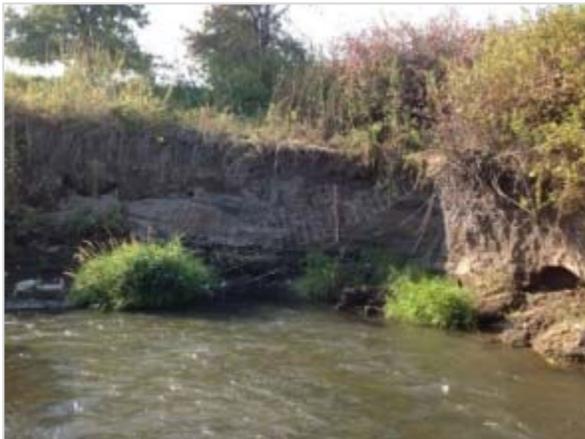
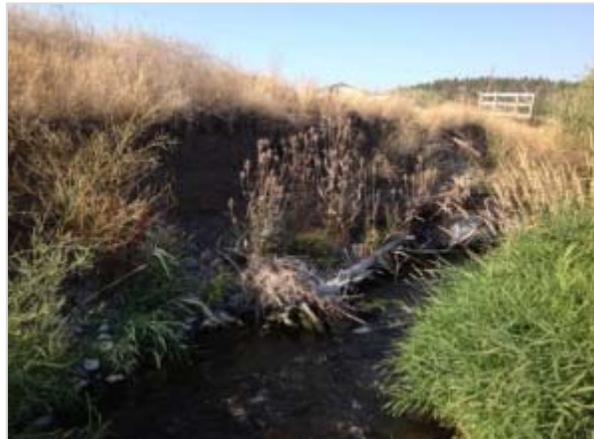
Several tall cut banks were observed within Reach 2.

Bank erosion and armoring occurs throughout this area, and in some areas there is as much as 20 feet of vertical erosion. Most often these sites are noted where riparian vegetation is lacking and banks are exposed with no root mass. A full list of locations and types can be found in Table 2.3 below.

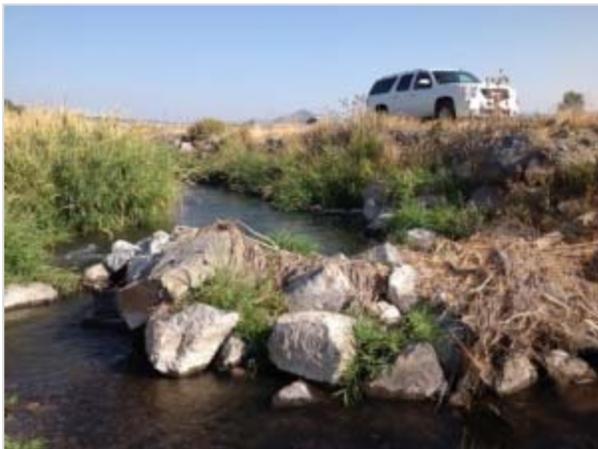
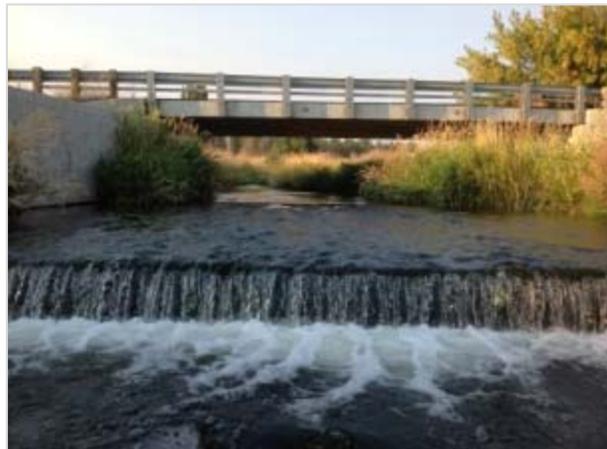
Two passage barriers were located within Reach 2, both associated with irrigation withdrawals.

Two passage barriers were surveyed through this area. At approximately RM 2.55, a boulder “J-hook” has been constructed off the left bank. Localized armoring surrounds this structure, which could present a passage barrier at some flow levels.

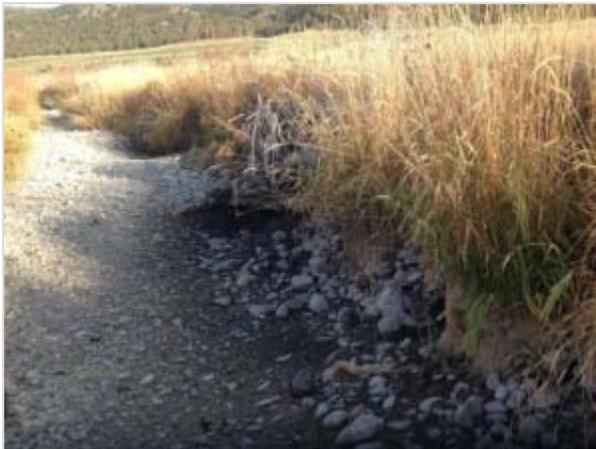
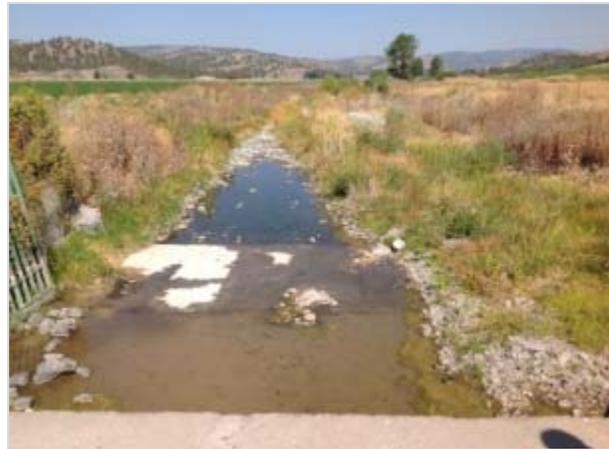
Land use pressures were high in Reach 3. Channel enhancement activities were occasionally noted, riparian vegetation quality was generally thin and low quality, with irrigated and fallow upland encroaching upon the channel. Reach 3 project locations can be found in Appendix A, Figures 4 and 5.

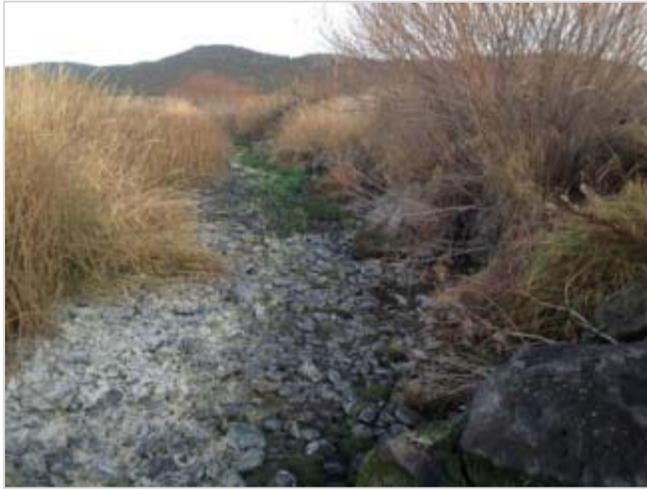
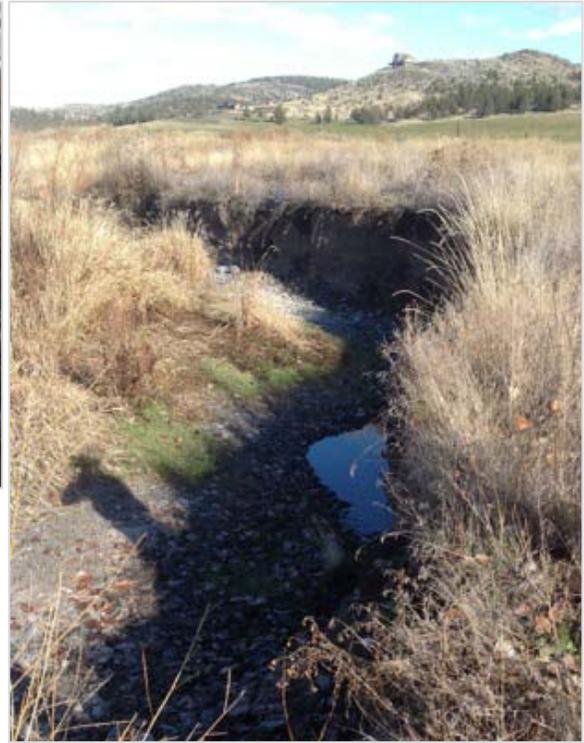
Common bank armoring and failure within Reach 3.

This reach featured the most frequent bank failures and subsequent stabilization measures of all the reaches surveyed. In most locations, the creek directly abuts an irrigated field on one or both sides; preserving this land by preventing further erosion is of primary concern through this area. In several locations, bank LWD has been installed previously; however, there are many areas where erosional impacts need to be addressed. A full list of location and size for these features is found in Table 2.5 below.

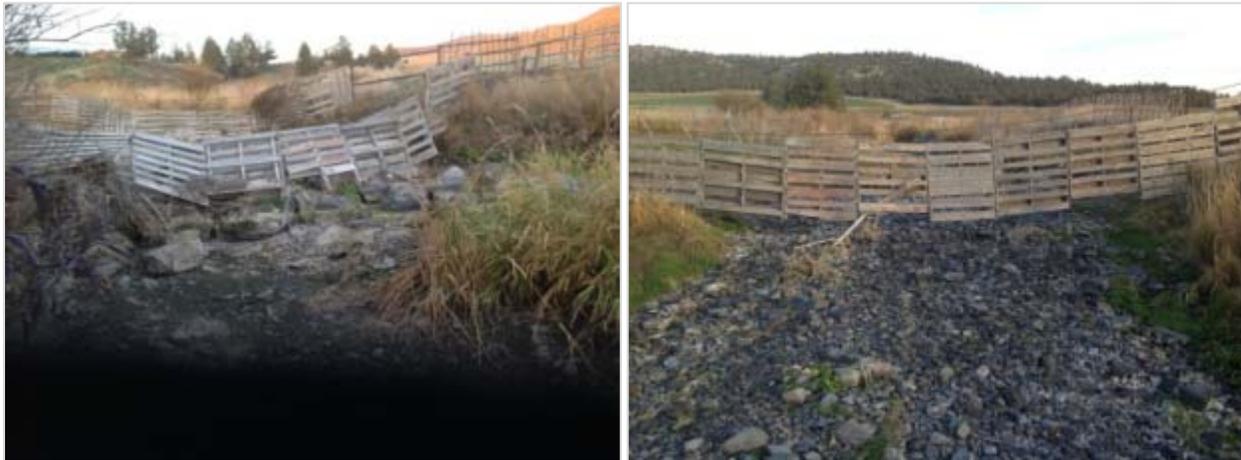
Fenced low-water crossing areas can become passage barriers with disrepair.

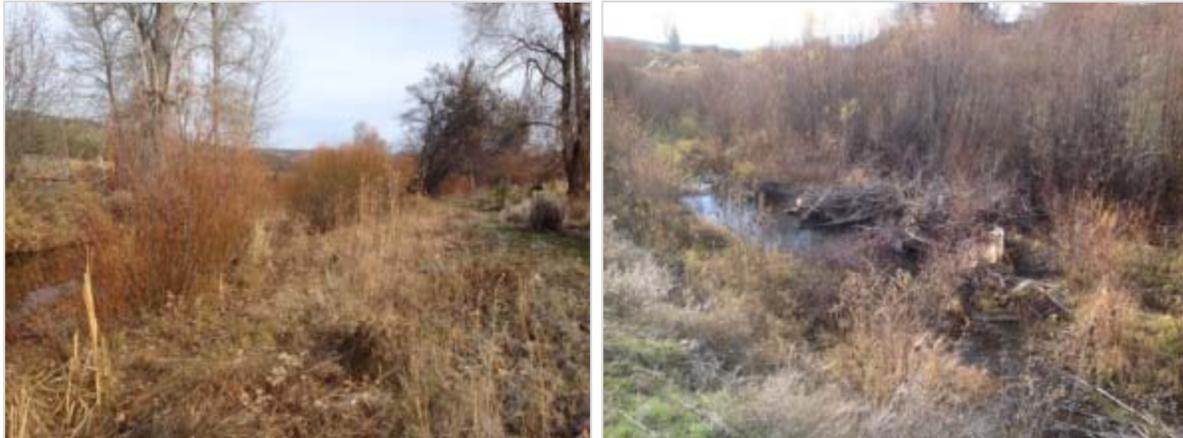
Mature cottonwood and riparian shrub vegetation becomes more common by Reach 4. Project locations within this reach are shown in Appendix A, Figure 6.

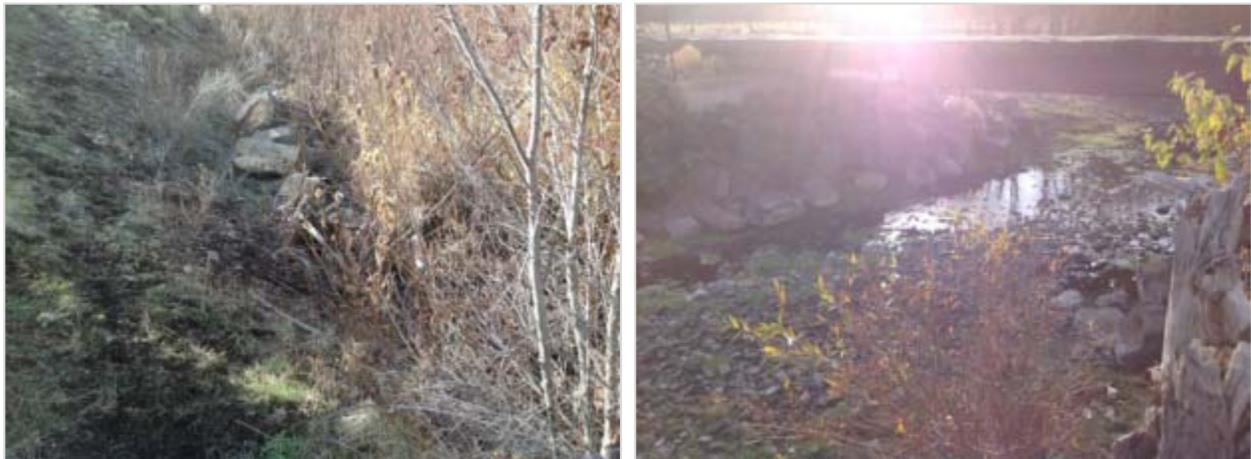
Coinciding with improved riparian conditions, bank erosion was much less common in Reach 4.

While less numerous than Reach 3, unstable banks and occasional armoring or woody stabilization structures were still infrequently found through this reach. A full list of these features can be found below in Table 2.7. Overall, it appears the increasing frequency of mature trees and the wider riparian corridor has reduced the forces exerted on bank areas prone to erosion.

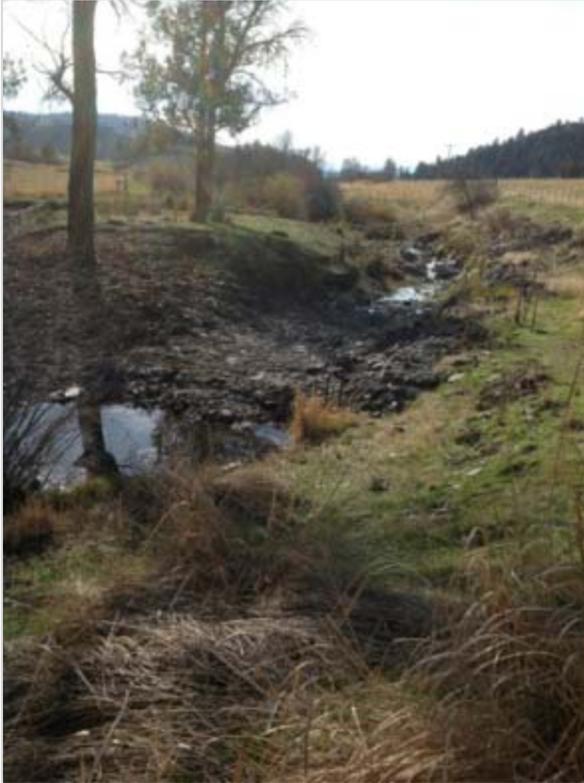
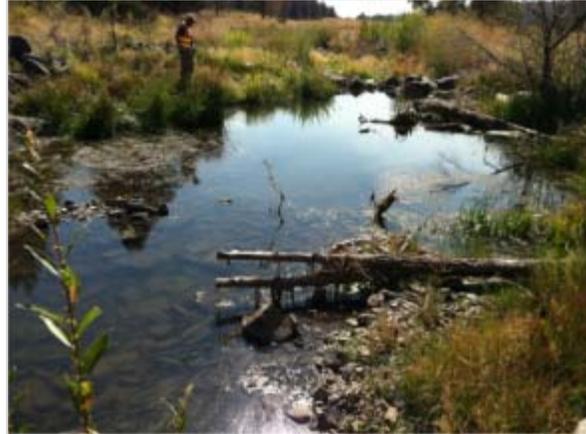
Previous restoration work included high-flow channels, irrigation withdrawal improvements, bank LWD, and rock v-weirs. Project locations within this reach can be found in Appendix A, Figure 6.

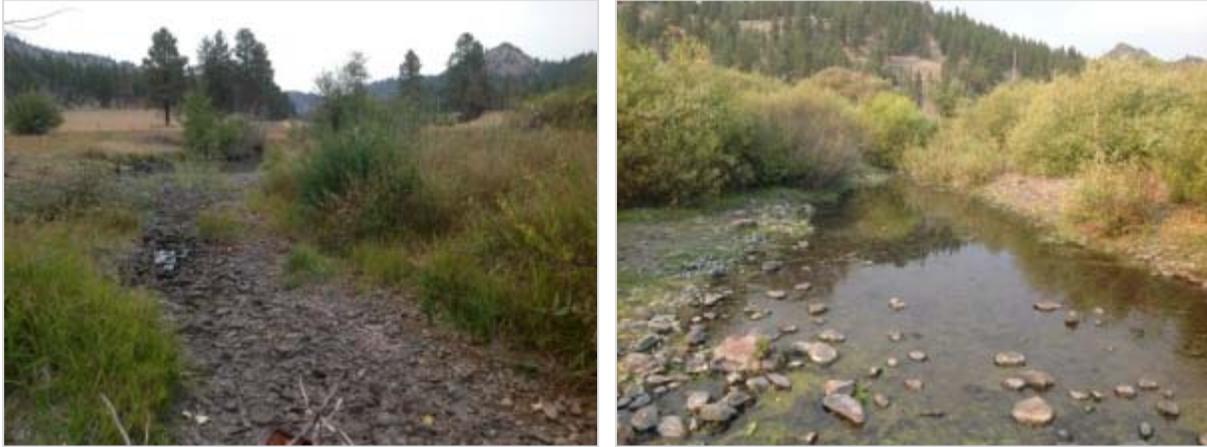
Typical conditions within Reach 6 – dense shrub cover in places, occasional juniper and pine in nearby upland. Project locations within Reach 6 can be found in Appendix A, Figure 7.

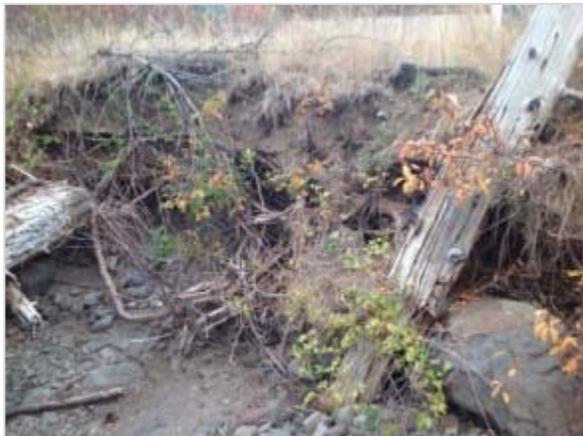
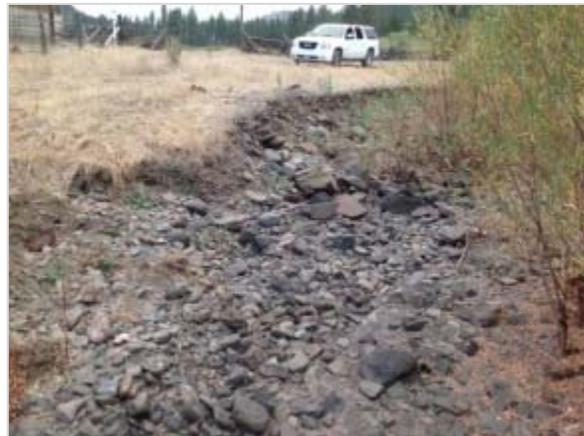
Cut banks frequently found around RM 12, generally small in height.

Most of the streambank degradation was centered around a driveway culvert crossing just below RM 12.2. Heavy vegetation has developed in many of these areas, likely limiting the overall extent of erosion at this location.

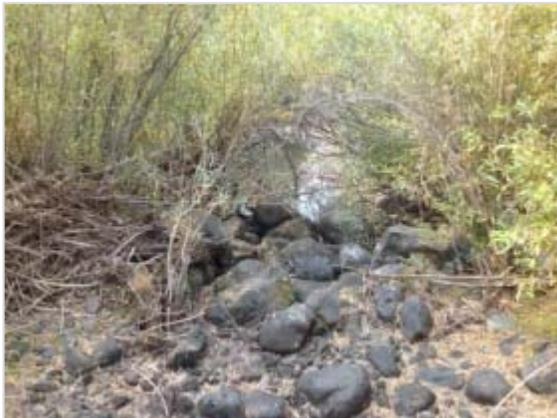
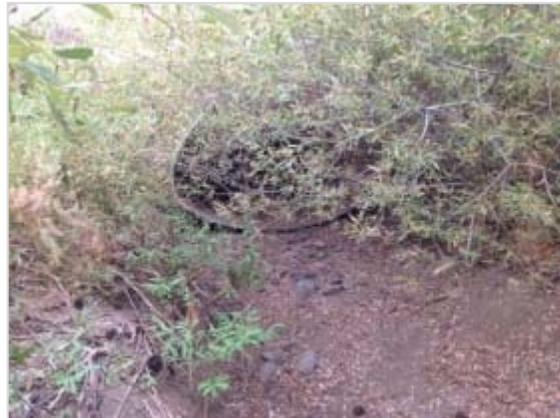
Irrigation withdrawals and a culvert crossing create fish passage barriers in Reach 6.

Multiple passage barriers were found in this reach. In the lower section just above RM 12, a channel diversion head-gate was found with a simple flashboard control lacking any screening. Further upstream just below RM 12.2, the creek passes under the landowner’s driveway through two culverts. The outfall drop was minimal, however the lack of substrate and probable high flow velocities likely create a passage barrier. Another unscreened diversion was found at RM 12.75, where a 3-foot corrugated metal pipe fed an irrigation ditch running roughly along the forested boundary.

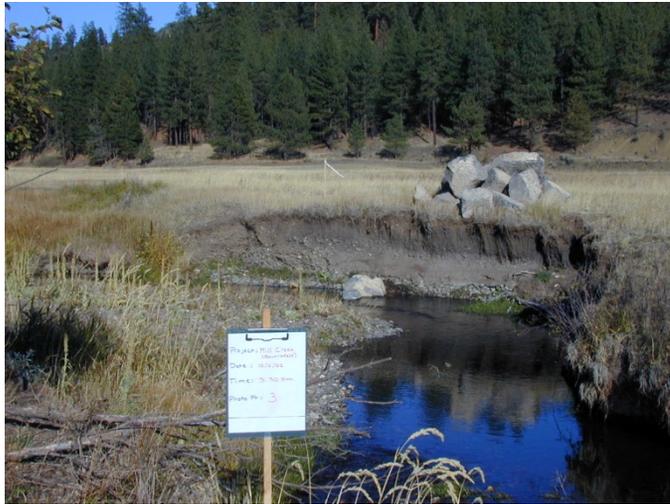
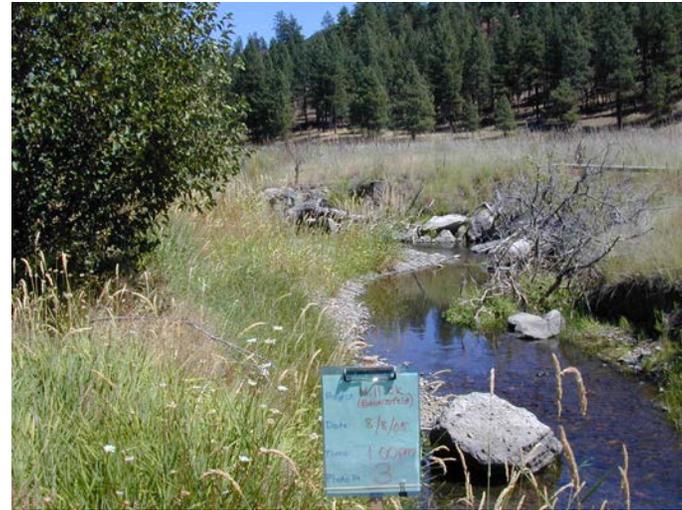
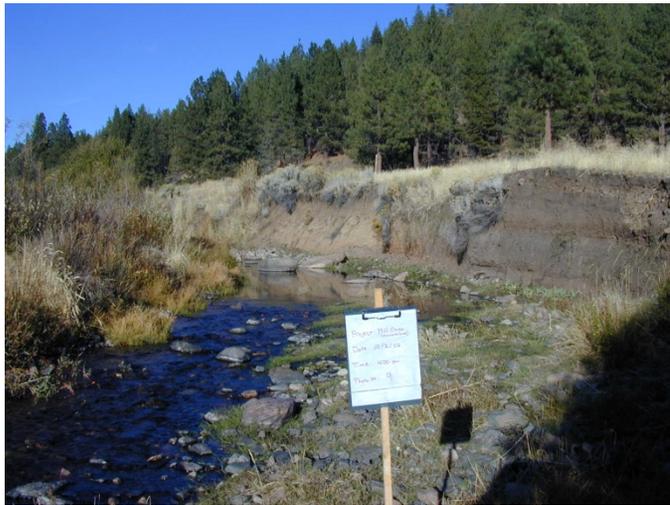
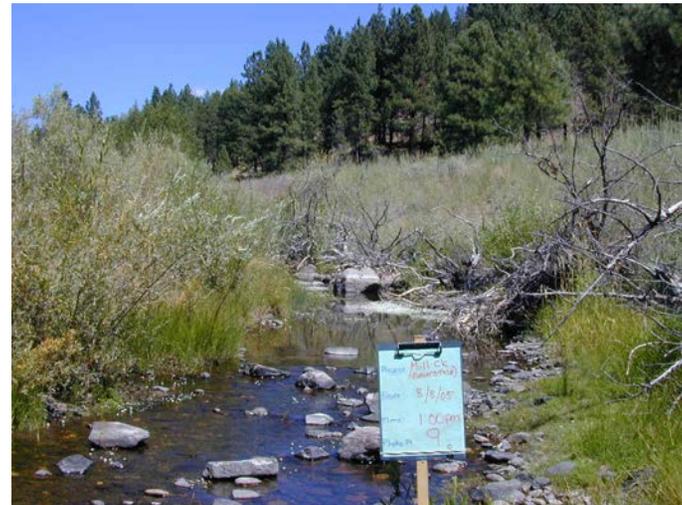
Figure 1. Before and after photos of two restoration sites on Mill Creek implemented by the CRWC.

of pools and the capture of spawning gravel. In addition, where practical, remnant berms from past channelization activities were leveled to allow the stream access to its natural floodplain. These projects have improved channel conditions, riparian vegetation and instream habitat on the majority of Mill Creek. For before and after photos of one site, please see Figure 1, on next page.

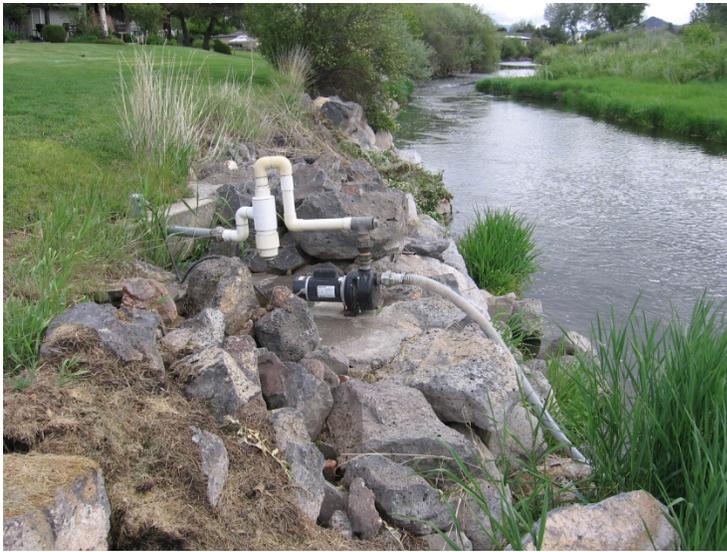
Small-sized diversion pump on Ochoco Creek

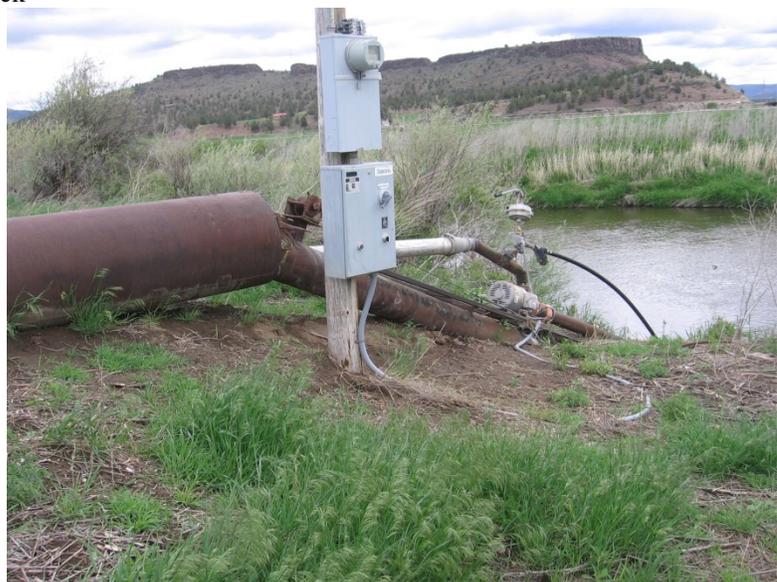
Diversion pipes with electrical supply on the Crooked River

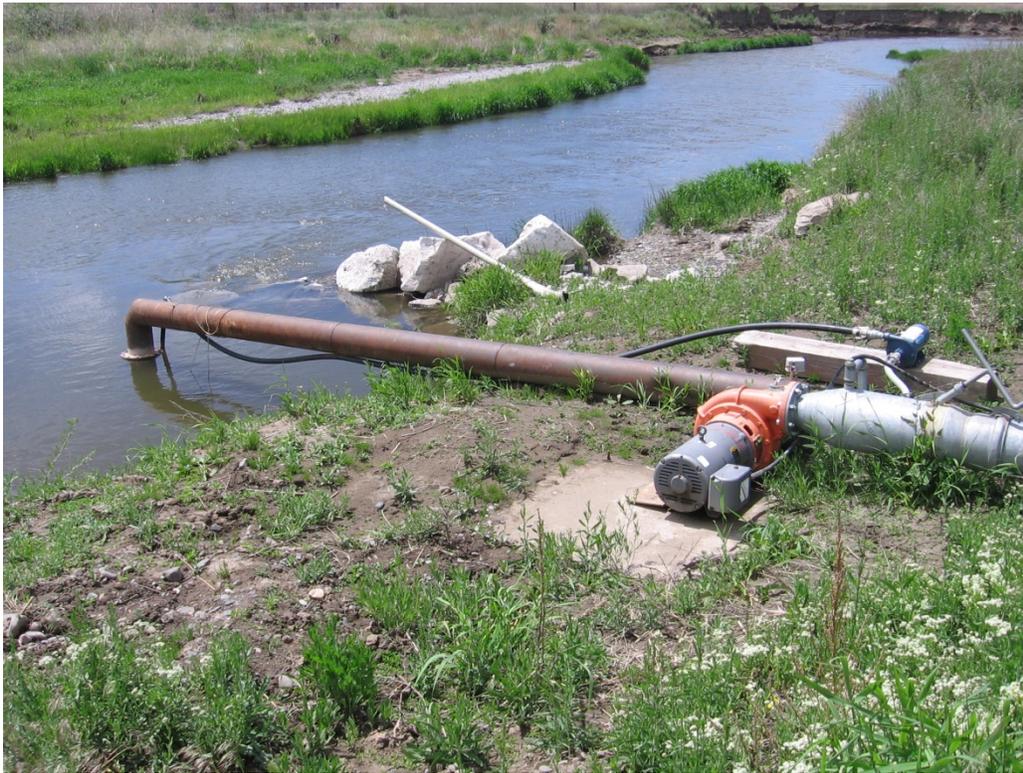
Diversion set-up on the Crooked River and a subject of the Fin Safe Program to screen diversions

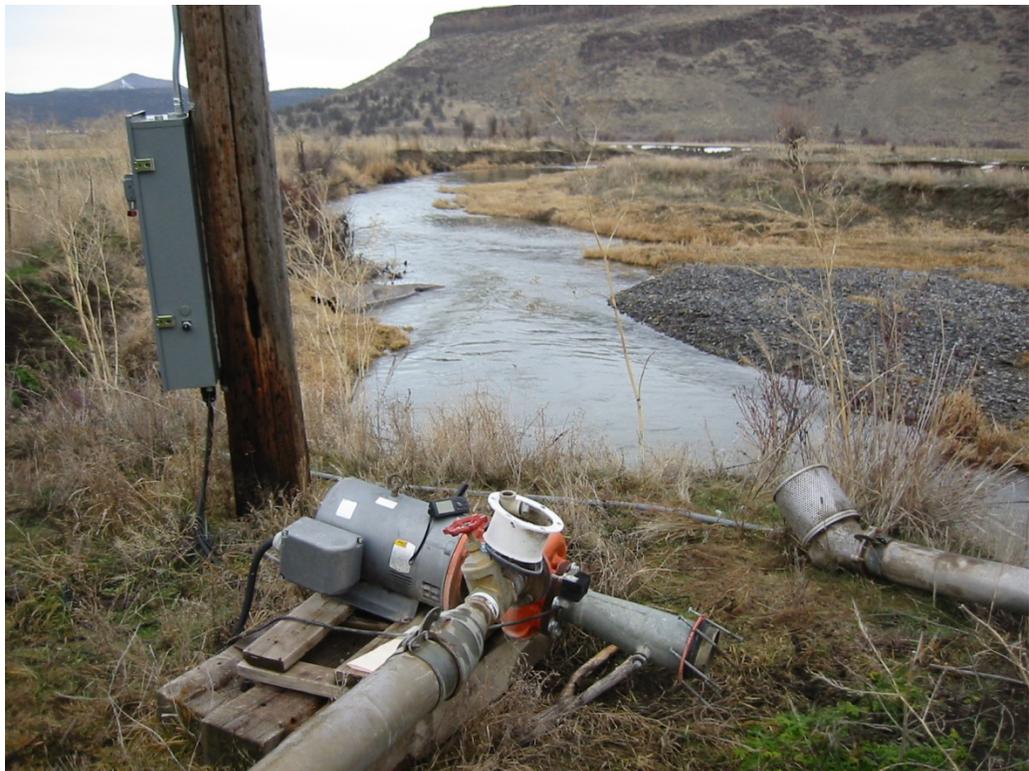
Diversion pump on Lower Crooked River (note the current “screen” at the right)

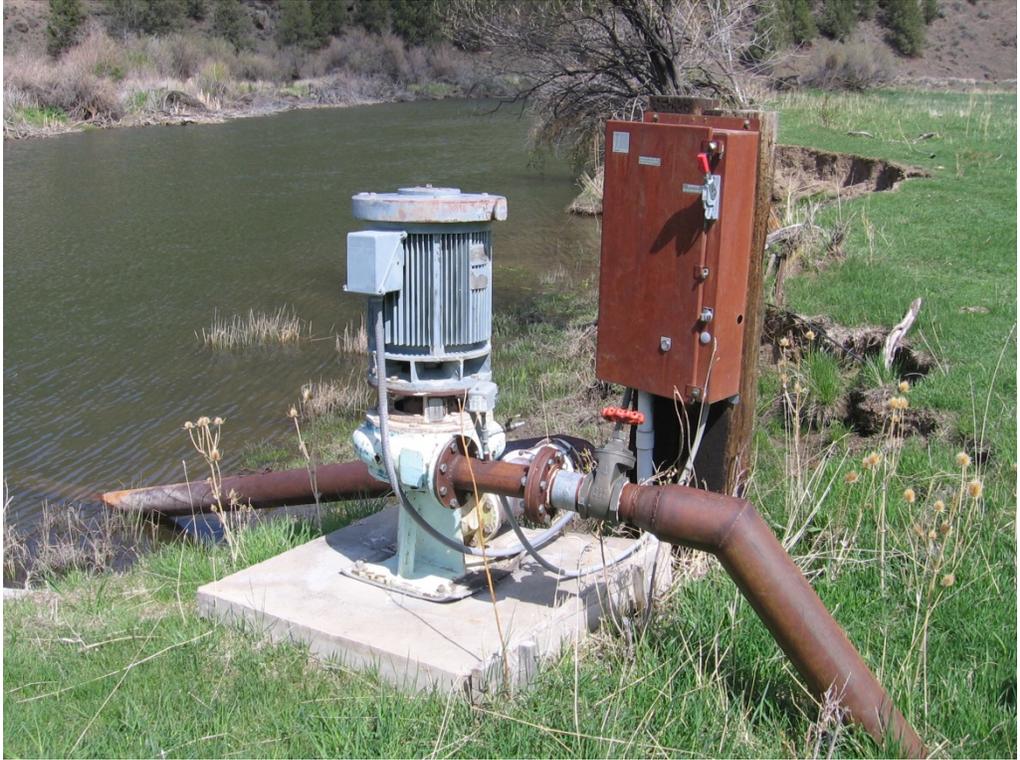
Diversion site pump, electrical supply, and intake pipe in the Lower Crooked River.

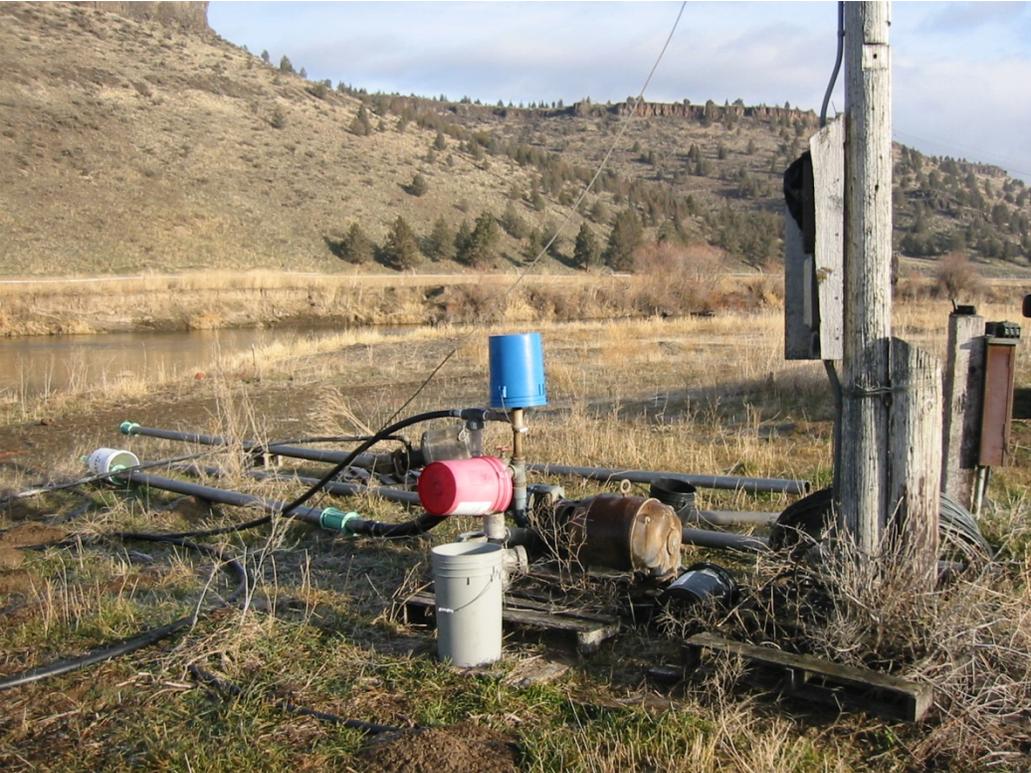
Pump and pipe parts stored for off-season period (note “screen” in middle of photo)
