HYDRAULIC LABORATORY REPORT NO. 119

FIELD ACCEPTANCE TESTS
PUMPING PLANT "D", MODOC UNIT
TULE LAKE DIVISION - KLAMATH PROJECT

Subject: Field acceptance tests, on three pumping units furnished by the Morris Machine Works under specifications No. 1492-D, Pumping Plant "D" - Modoc Unit - Tule Lake Division, Klamath Project.

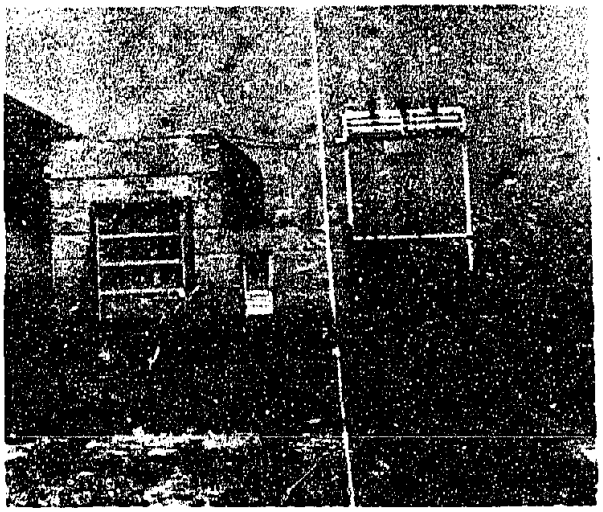
A - Pump house looking north.

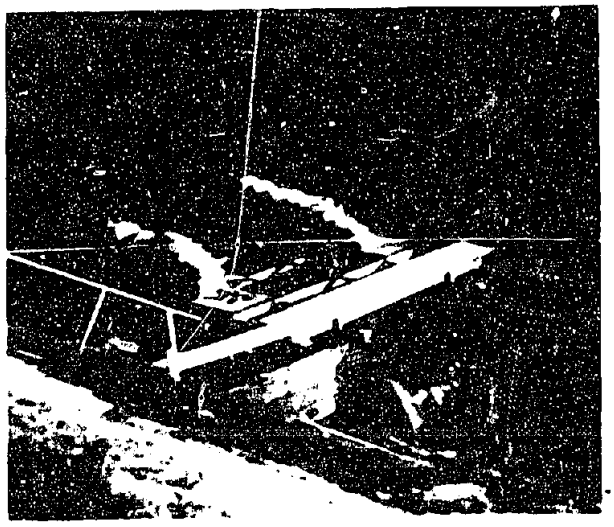
The discharge was measured over an 8-foot rectangular suppressed weir specially constructed for these tests and designed to strict accordance with the Standards of Hydraulic Institute code. This weir was located in the trapezoidal canal approximately 400 feet downstream from the outlet of the horseshoe tunnel a mile and a half from the plant as the crow flies, or 13 miles by road (figure 2). It was estimated that 25 minutes were required for a given volume of water passing through the pumps to reach the weir. Therefore, head measurements at the weir were commenced 25 minutes after corresponding observations were made at the pumps. The head on the weir was measured by some twelve observations, over a period of 30 minutes, by a hook gage reading to thousandths of a foot (figure 3C). The gage zero was determined immediately before and after the tests and was found to have changed but slightly during the period. Leakage past the weir together with canal seepage upstream was insignificant. Photographs of the weir are shown as figures 1C and 1D, and a discharge curve for this weir, computed according to the Hamilton Smith formula, is shown on figure 4. Nine runs were made on unit 3, seven on unit 2, and eight on unit 1. The head on the weir, discharge, and condition under which each run was made are shown in columns 3, 4, and 59, respectively, of table 4.

D - Eight-foot measuring weir.

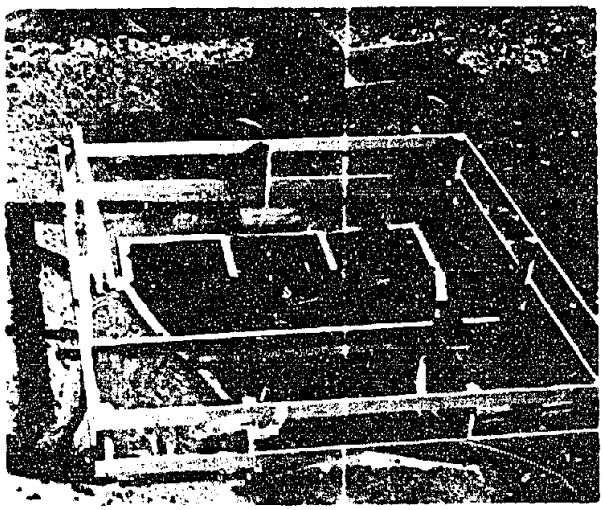
Two methods were used to measure the check gate losses, both of which showed comparable results. In the first case, the loss was considered as the difference in static head between gages 6 and 5 for runs in which the check gate swung free and a reading was visible on gage 6. In the second case, the tail-bay water surface at gage 5 was held as nearly constant as possible while the pressure at gage 3 was observed first for the check gate swinging free and then for it suspended above the water surface. The difference in pressure observed at gage 3 for the two conditions was considered as the check gate loss. The second method is not as reliable as the first. The check gate losses, in feet of water, are shown in column 38 (table 4) and these are expressed in velocity head in column 39, where V represents the velocity in the 36-inch conduit. The flap gate losses average 0.46 $\frac{V^2}{2g}$ for the outside gates and 0.64 $\frac{V^2}{2g}$ for the center gate. It so happens that the arms on the center gate were broken when the plant was first put in operation. The gate was repaired by welding and this may account for the difference in loss between this gate and the outer two.

E - Open transition and 36-inch check gates.

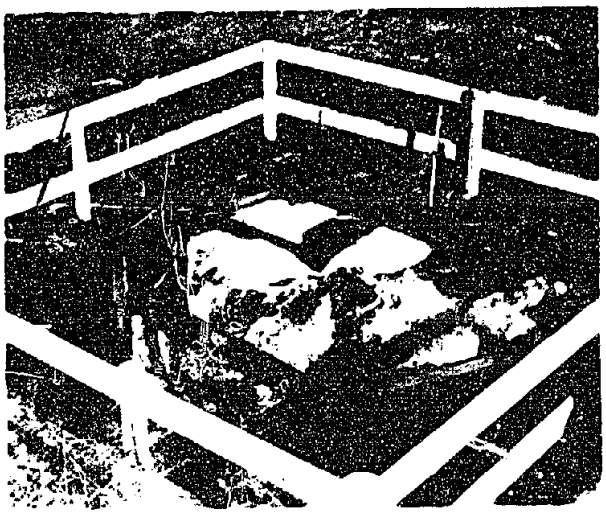
Using gage 6, which consisted of a water tube connected to the air valves immediately upstream from the check gates (figures 1F and 3B), the total loss between this point and gage 3 was determined for the runs on units 1 and 2. The total energy at the U.S.B.R. taps was in this case computed using a velocity head correction factor $\alpha = 1.20$, which was based on experiments on single suction pumps. The corrected velocity heads are shown in column 25 (table 4) and the true total energy heads, expressed in elevation, are listed in column 27.

F - Open transition showing gages and temporary needle dam. Unit No. 1 in operation.

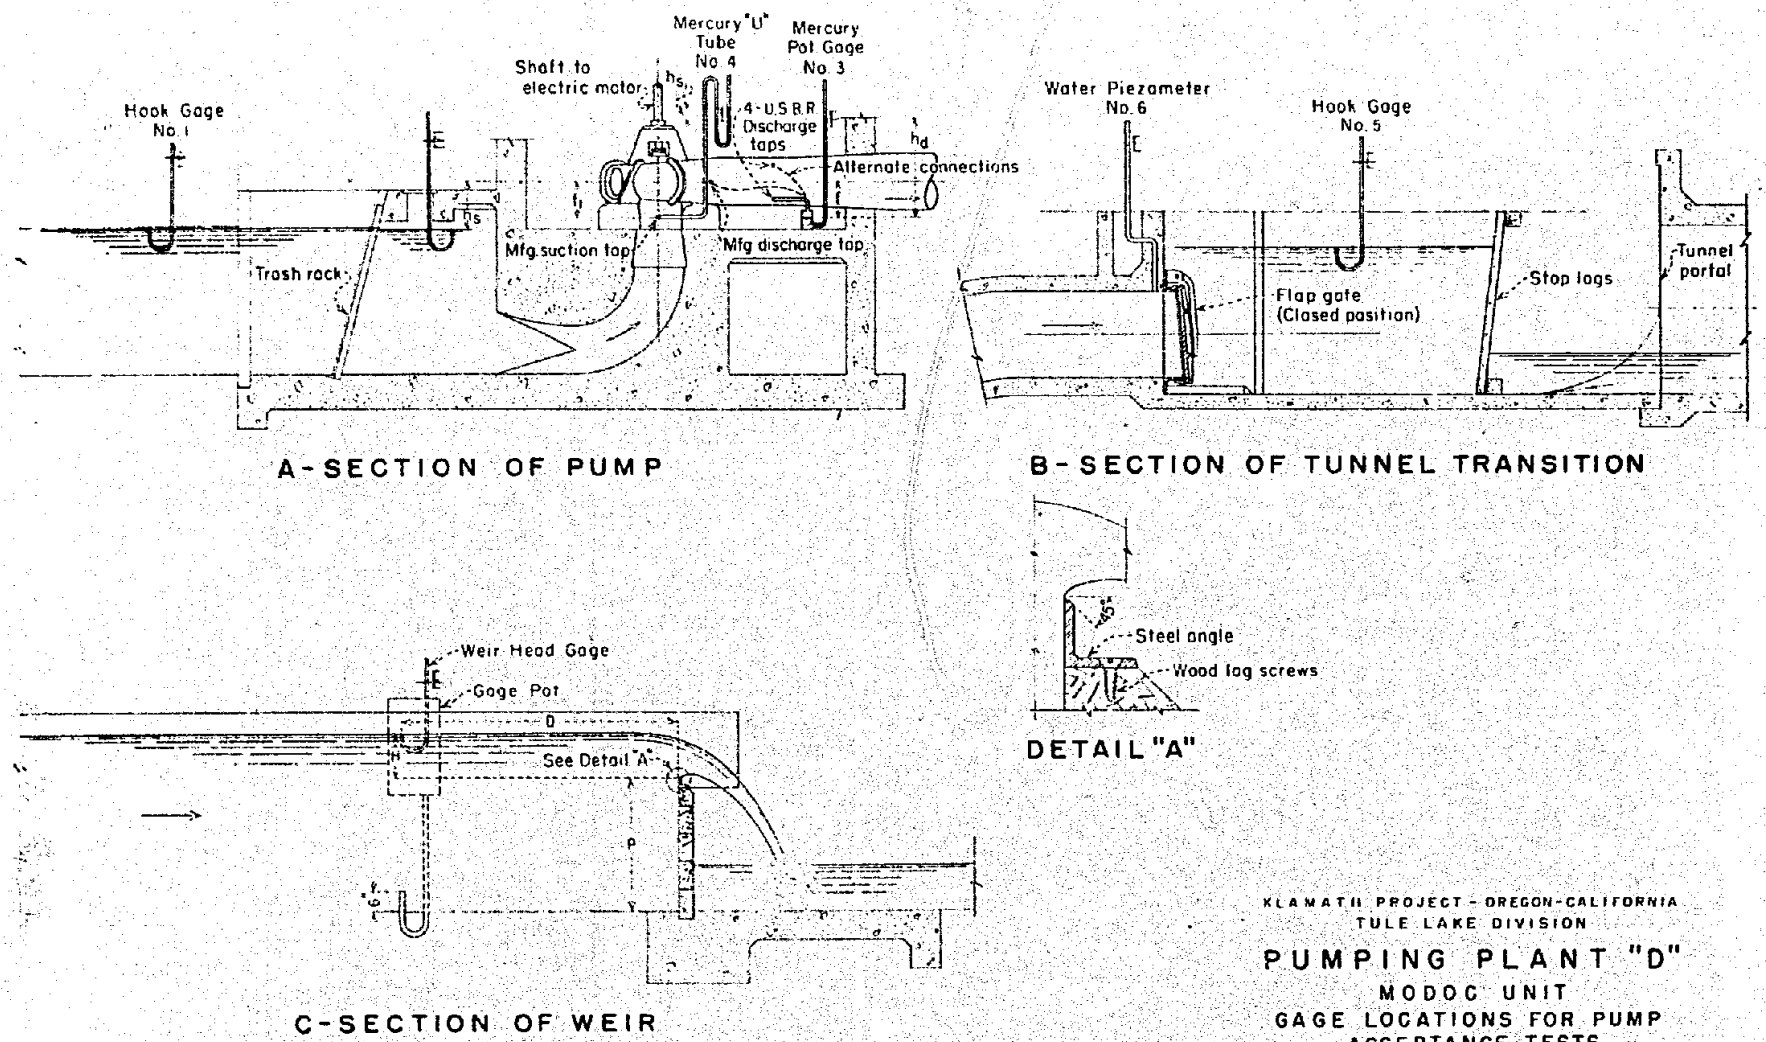
FIGURE 3

The discharge head was observed from a mercury pot gage, connected in succession to four special taps, denoted as U.S.B.R. taps, located in the 30-inch pipe directly downstream from the pump (figure 3A). The suction head was taken as the difference between the center line of the pump and the energy of the water in the intake canal measured at gage 2 inside the trashracks (figure 3A). The total pumping head, H, was therefore determined as follows:

The losses through the single trashrack structures were obtained from the difference in energy measured at gages 1 and 2 (figure 3A). These are quite small, amounting to an average of 0.012 foot of water or 1.6 $\frac{V^2}{2g}$, where V equals average velocity computed across the section at gage 2. The losses as measured for each run are tabulated in column 10 of table 4.

The gate has one drawback, however, that was discovered while priming the pumps. After two days shut-down not one of the pumps could be primed until the gates were pushed against the rubber seals. In other words, these gates do not necessarily seal when hanging in their natural closed positions. The lower lips of the gates appeared to hang from 1/2 to 1/4 inch from the seats. It is therefore recommended that this type of gate, in future installations, be either counterbalanced to a greater extent or that the end of the pipe line and rubber seal be set at a flatter angle than shown in figure 3B. It is also suggested that the present gates

be weighted so that sealing in their natural closed positions will be assured.

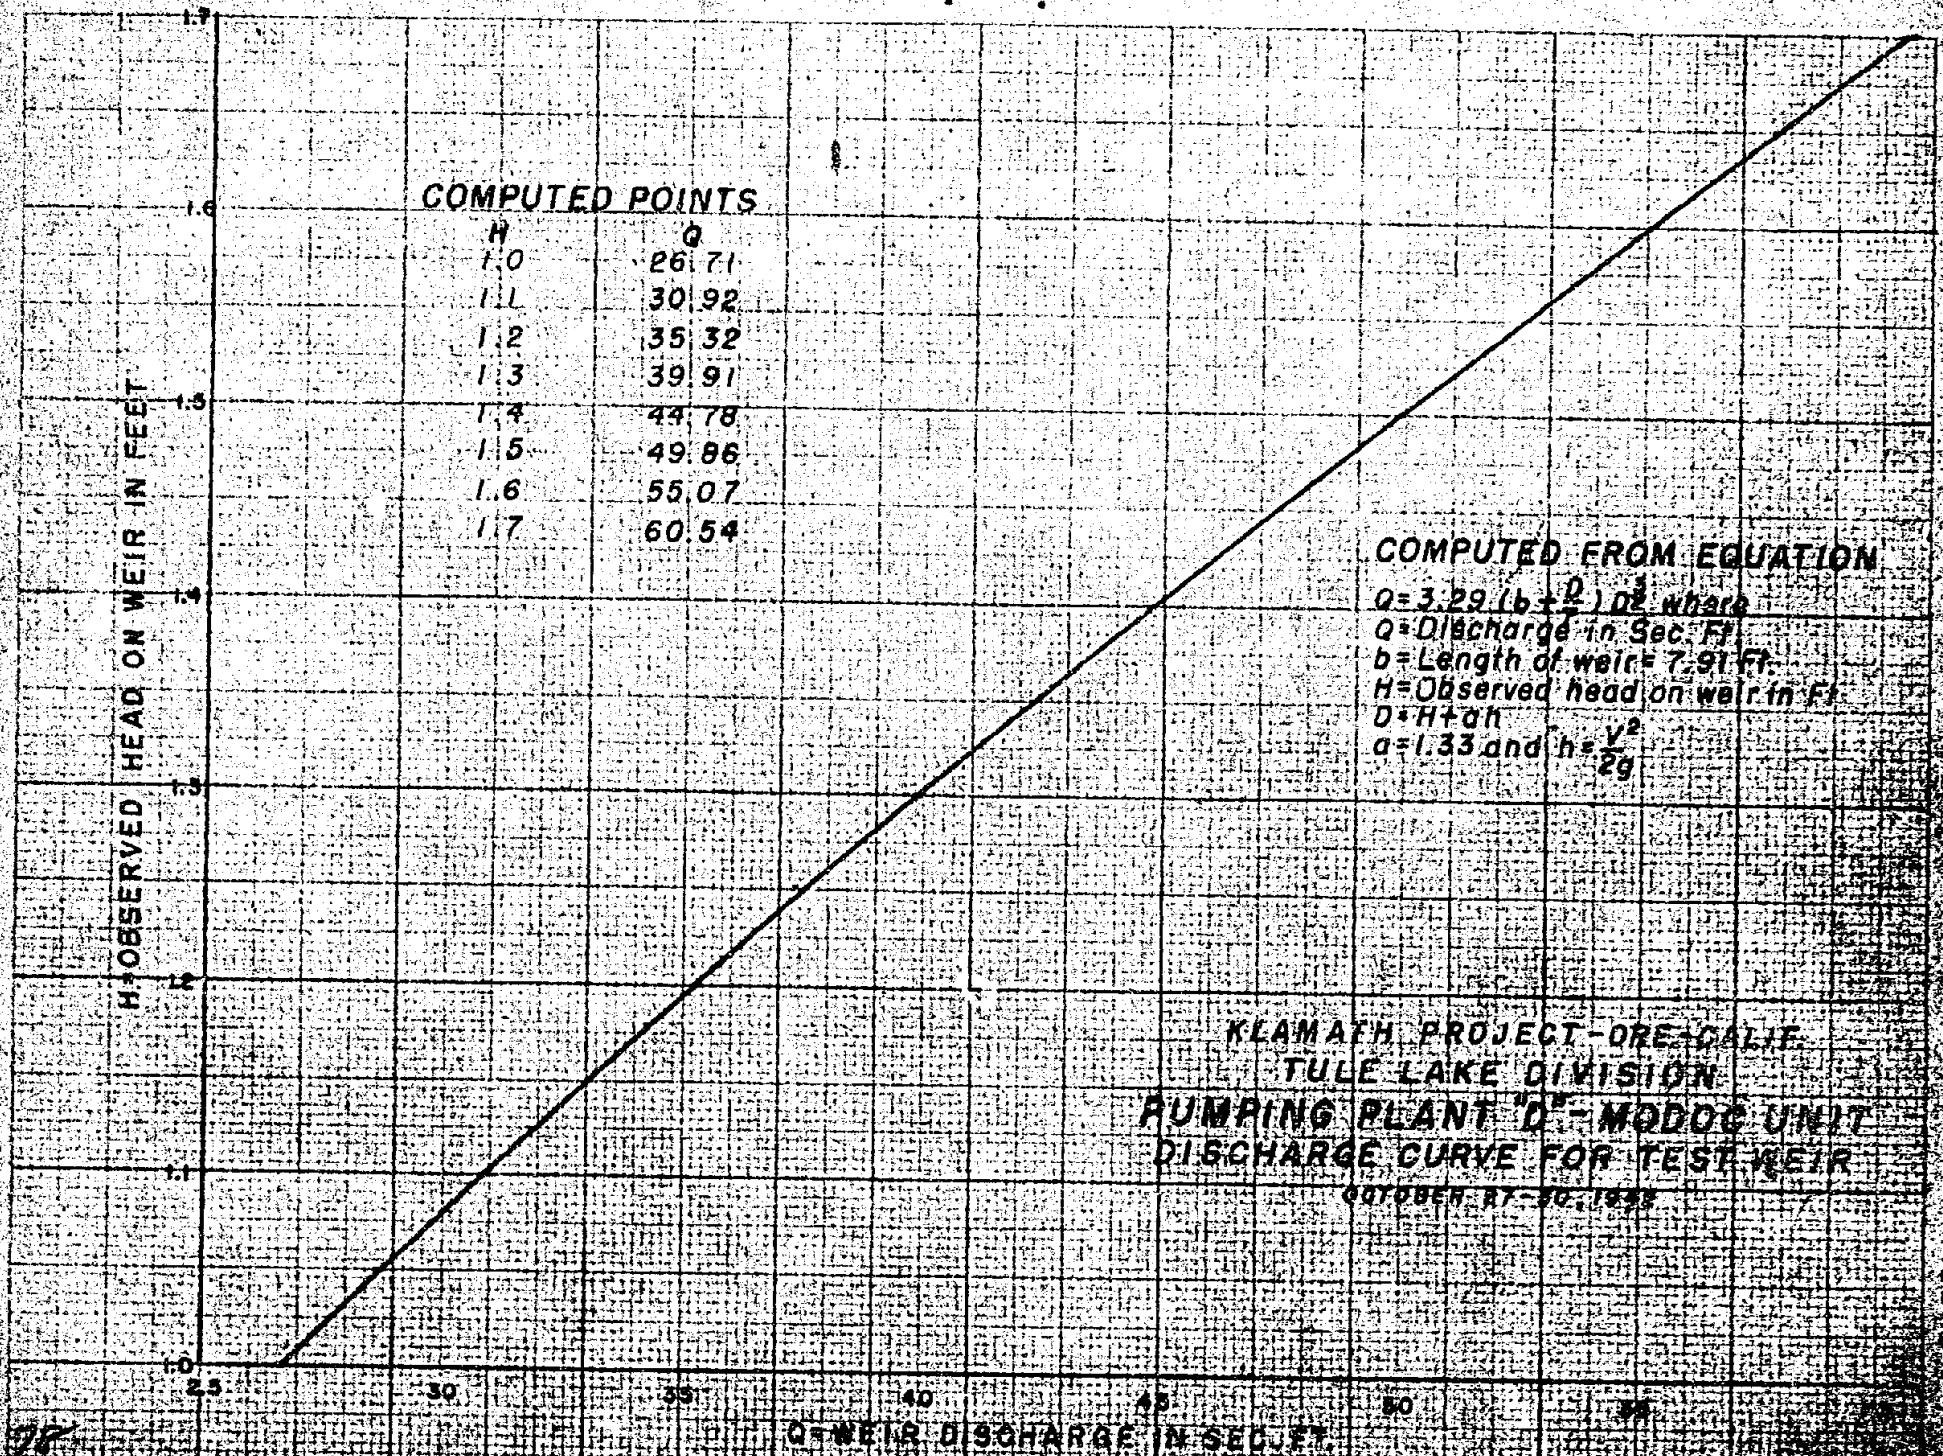
FIGURE 4

KLAMATH PROJECT-ORE.-CALIF.
TULE LAKE DIVISION
PUMPING PLANT "D"-MODOC UNIT
DISCHARGE CURVE FOR TEST WEIR
OCTOBER 27-30, 1933

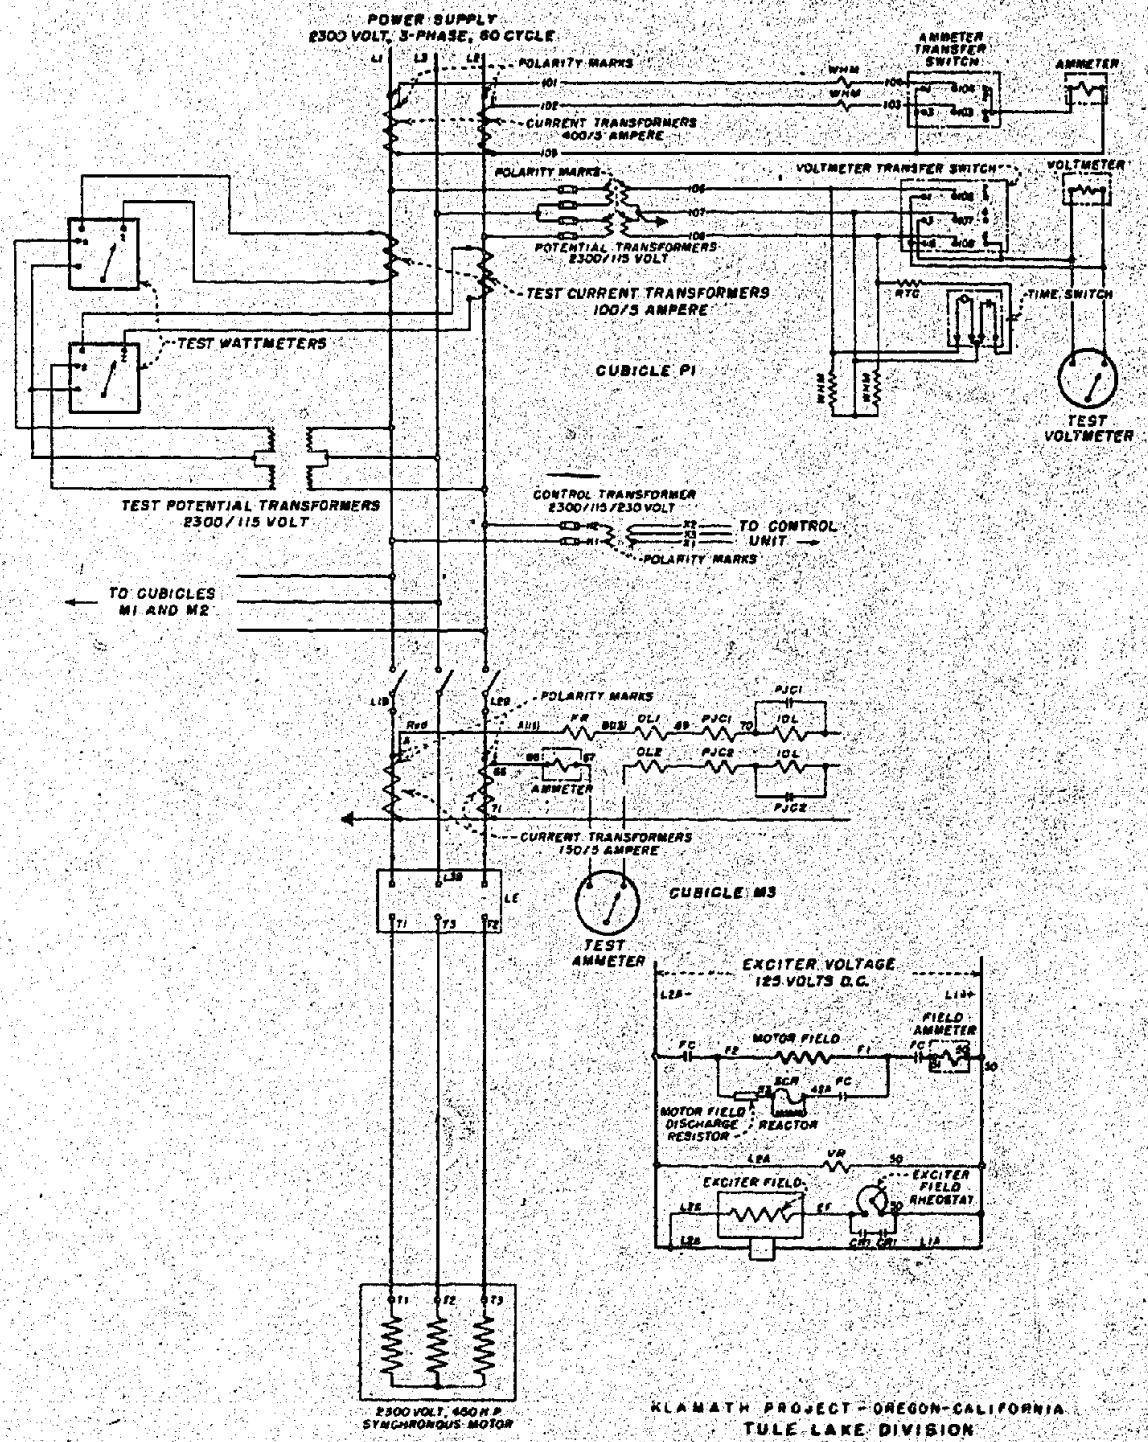
FIGURE 5

The power input to the motor was observed from two accurate test wattmeters which were calibrated before and after the test. These were connected in the main lines leading to the plant as shown on

As the panel instruments could not be read accurately, a sensitive voltmeter and ammeter were connected into the circuit as shown in figure 5. These were read several times during each run and the average readings are listed in columns 50 and 51. Normally the line voltage ranged from 2,400 to 2,500 at this plant. By shifting taps on the transformers in the switchyard, it was possible to reduce the voltage during the tests to the values shown in column 50 which were considered satisfactory. The voltage remained quite steady during the day, except for the noon hour, at which time it showed an increase of as much as 50 volts. The power in kilowatts as computed from the test voltmeter and ammeter is shown in column 52. In addition, readings of the panel voltmeters and ammeters are recorded in columns 53, 54, and 55. These can be recalibrated over the normal operating range by comparing the readings with the test instruments. Also, these readings may assist the operator in his attempt to operate the units at unity power factor.

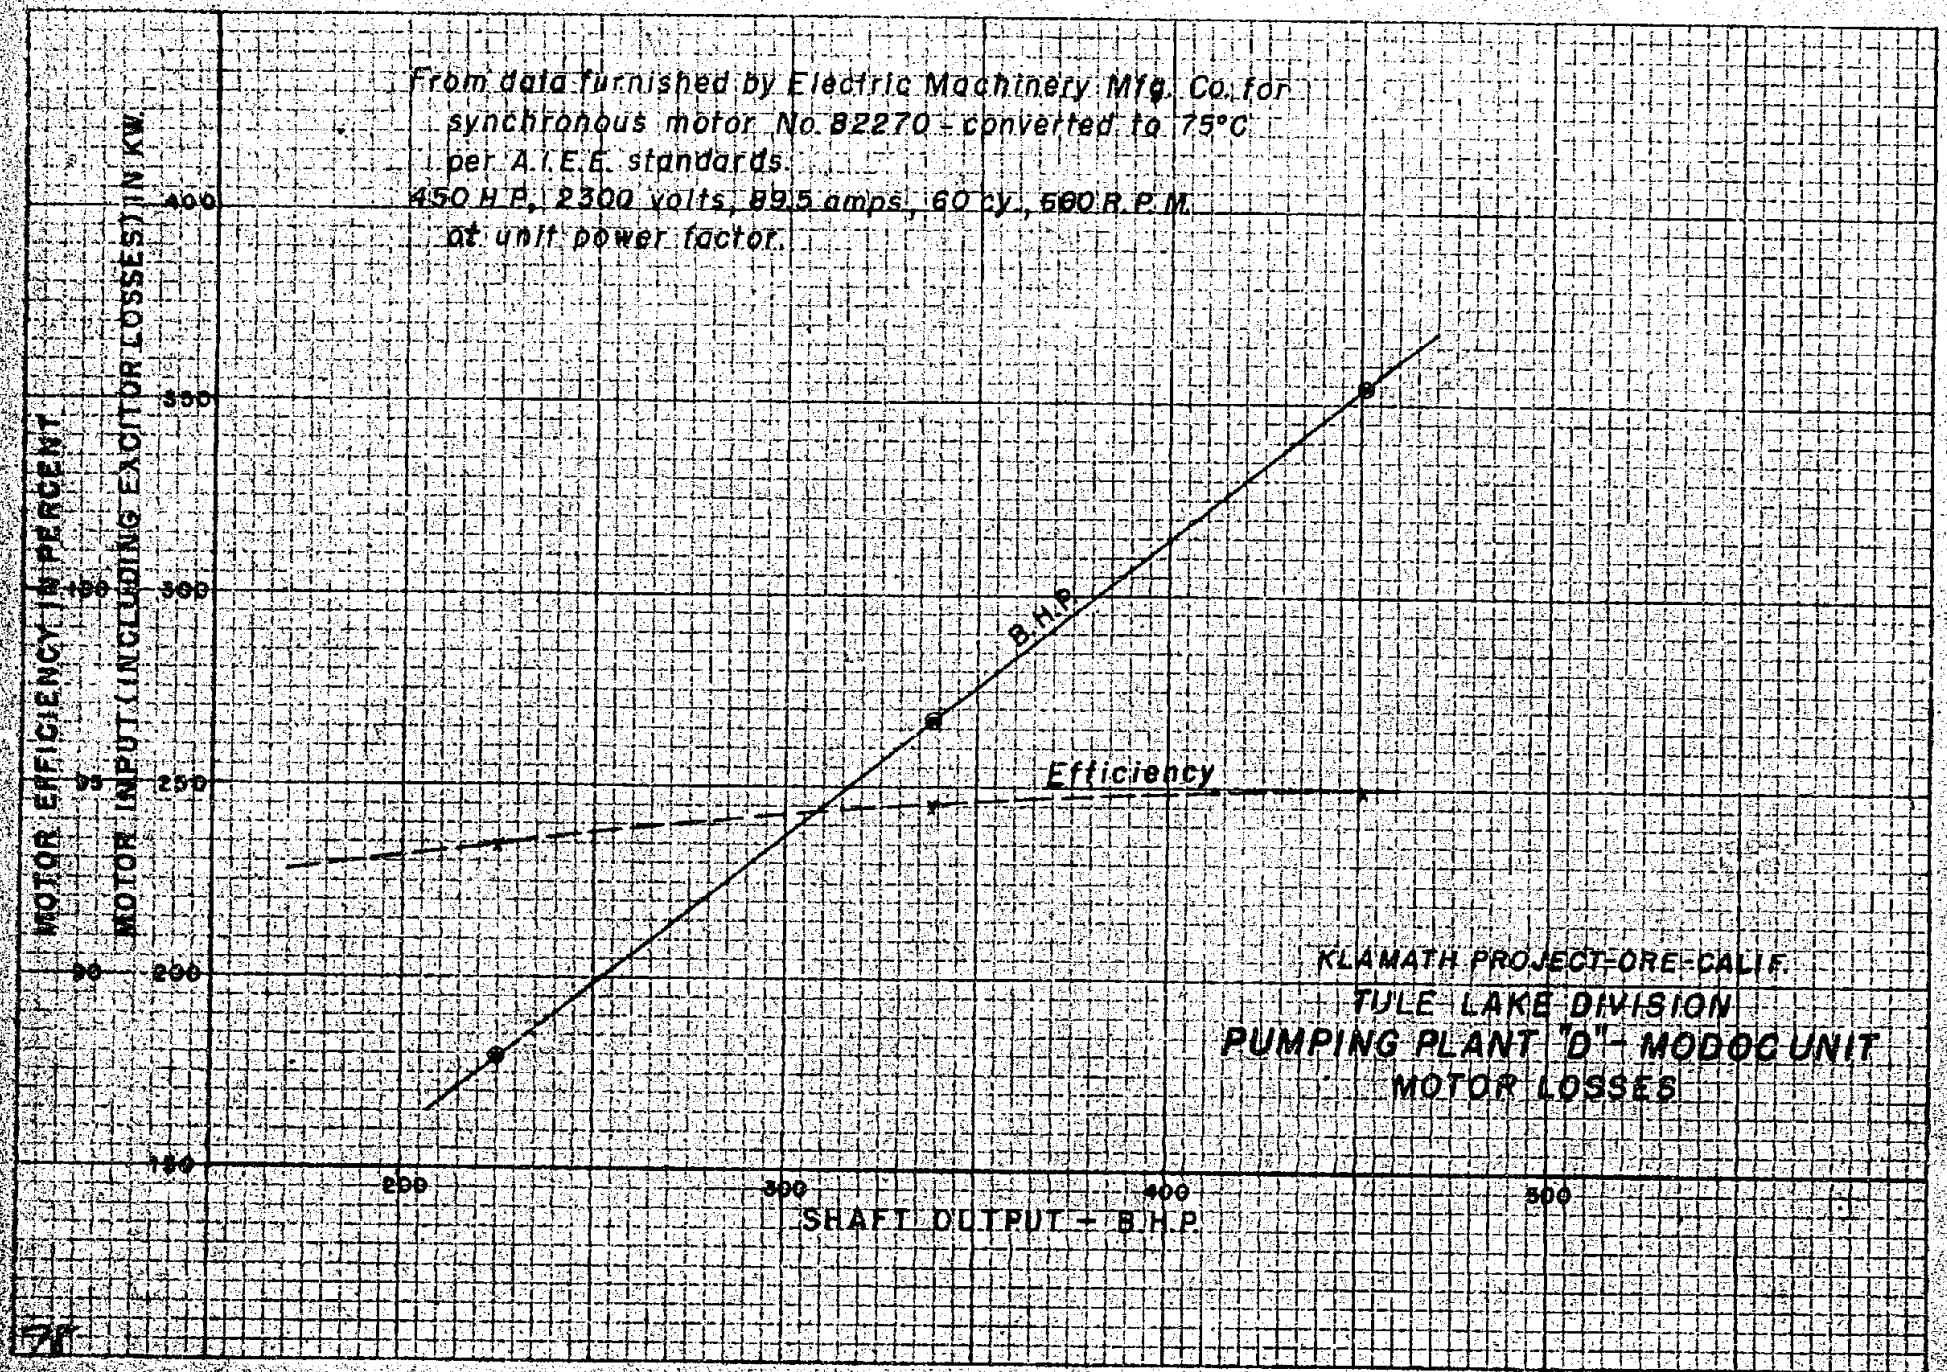
FIGURE 6

From the motor manufacturer's test curve (figure 6) the actual horsepower delivered to the pump shaft, designated as B.H.P., was obtained and this is shown tabulated in column 46. The actual pump efficiencies are listed in column 24. The extent of the pump characteristics obtained from these tests is shown plotted, by full lines, for units 1, 2, and 3 on figures 7, 8, and 9, respectively. The dotted curves were taken from Morris Machine Works print No. 32254 which was submitted by the manufacturer prior to delivery of the pumps. Unit 1 is one percent less than the over-all guaranteed

efficiency, unit 2 exceeds the requirement by 1.3 percent, and unit 3 exactly meets the requirement for the rated head of 64 feet.
