HYDRAULIC LABORATORY REPORT NO. 135

HYDRAULIC MODEL STUDIES FOR THE REDESIGN OF THE 58-INCH BALANCED OUTLET VALVES, SHOSHONE DAM, SHOSHONE PROJECT - WYOMING

J. W. BALL

Denver, Colorado
Oct. 12, 1943

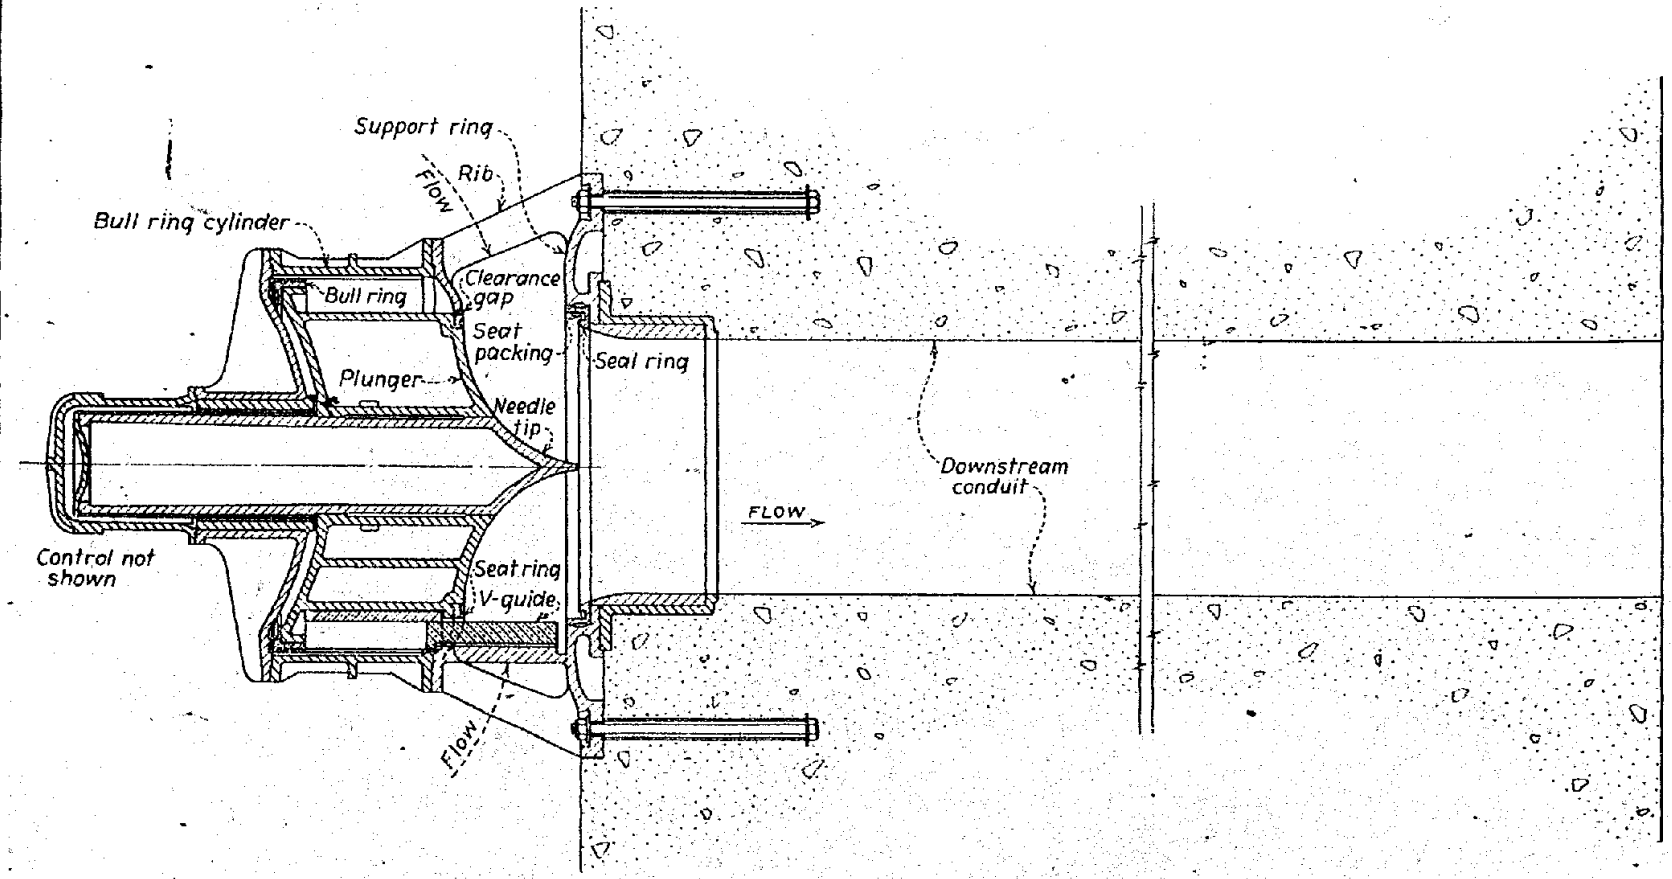
FIGURE 1

TYPICAL BALANCED VALVE INSTALLATION

"... Most of the difficulties with the outlets built by the Bureau of Reclamation can be attributed to the effect of vacuum in the conduits below the regulating devices. Generally the damage to the conduits has been more serious than to the valves, although under extreme conditions the valves have also been seriously damaged.

"In valves and conduits carrying water at high velocities an irregular pitting or cavitation of the lining is often observed. This appears first as a slight blemish on the surface, but if allowed to continue, the material becomes honeycombed to a considerable depth and is ultimately destroyed. The surface is not worn away by attrition or sandblast action, but is roughened as though attacked by chemical action."

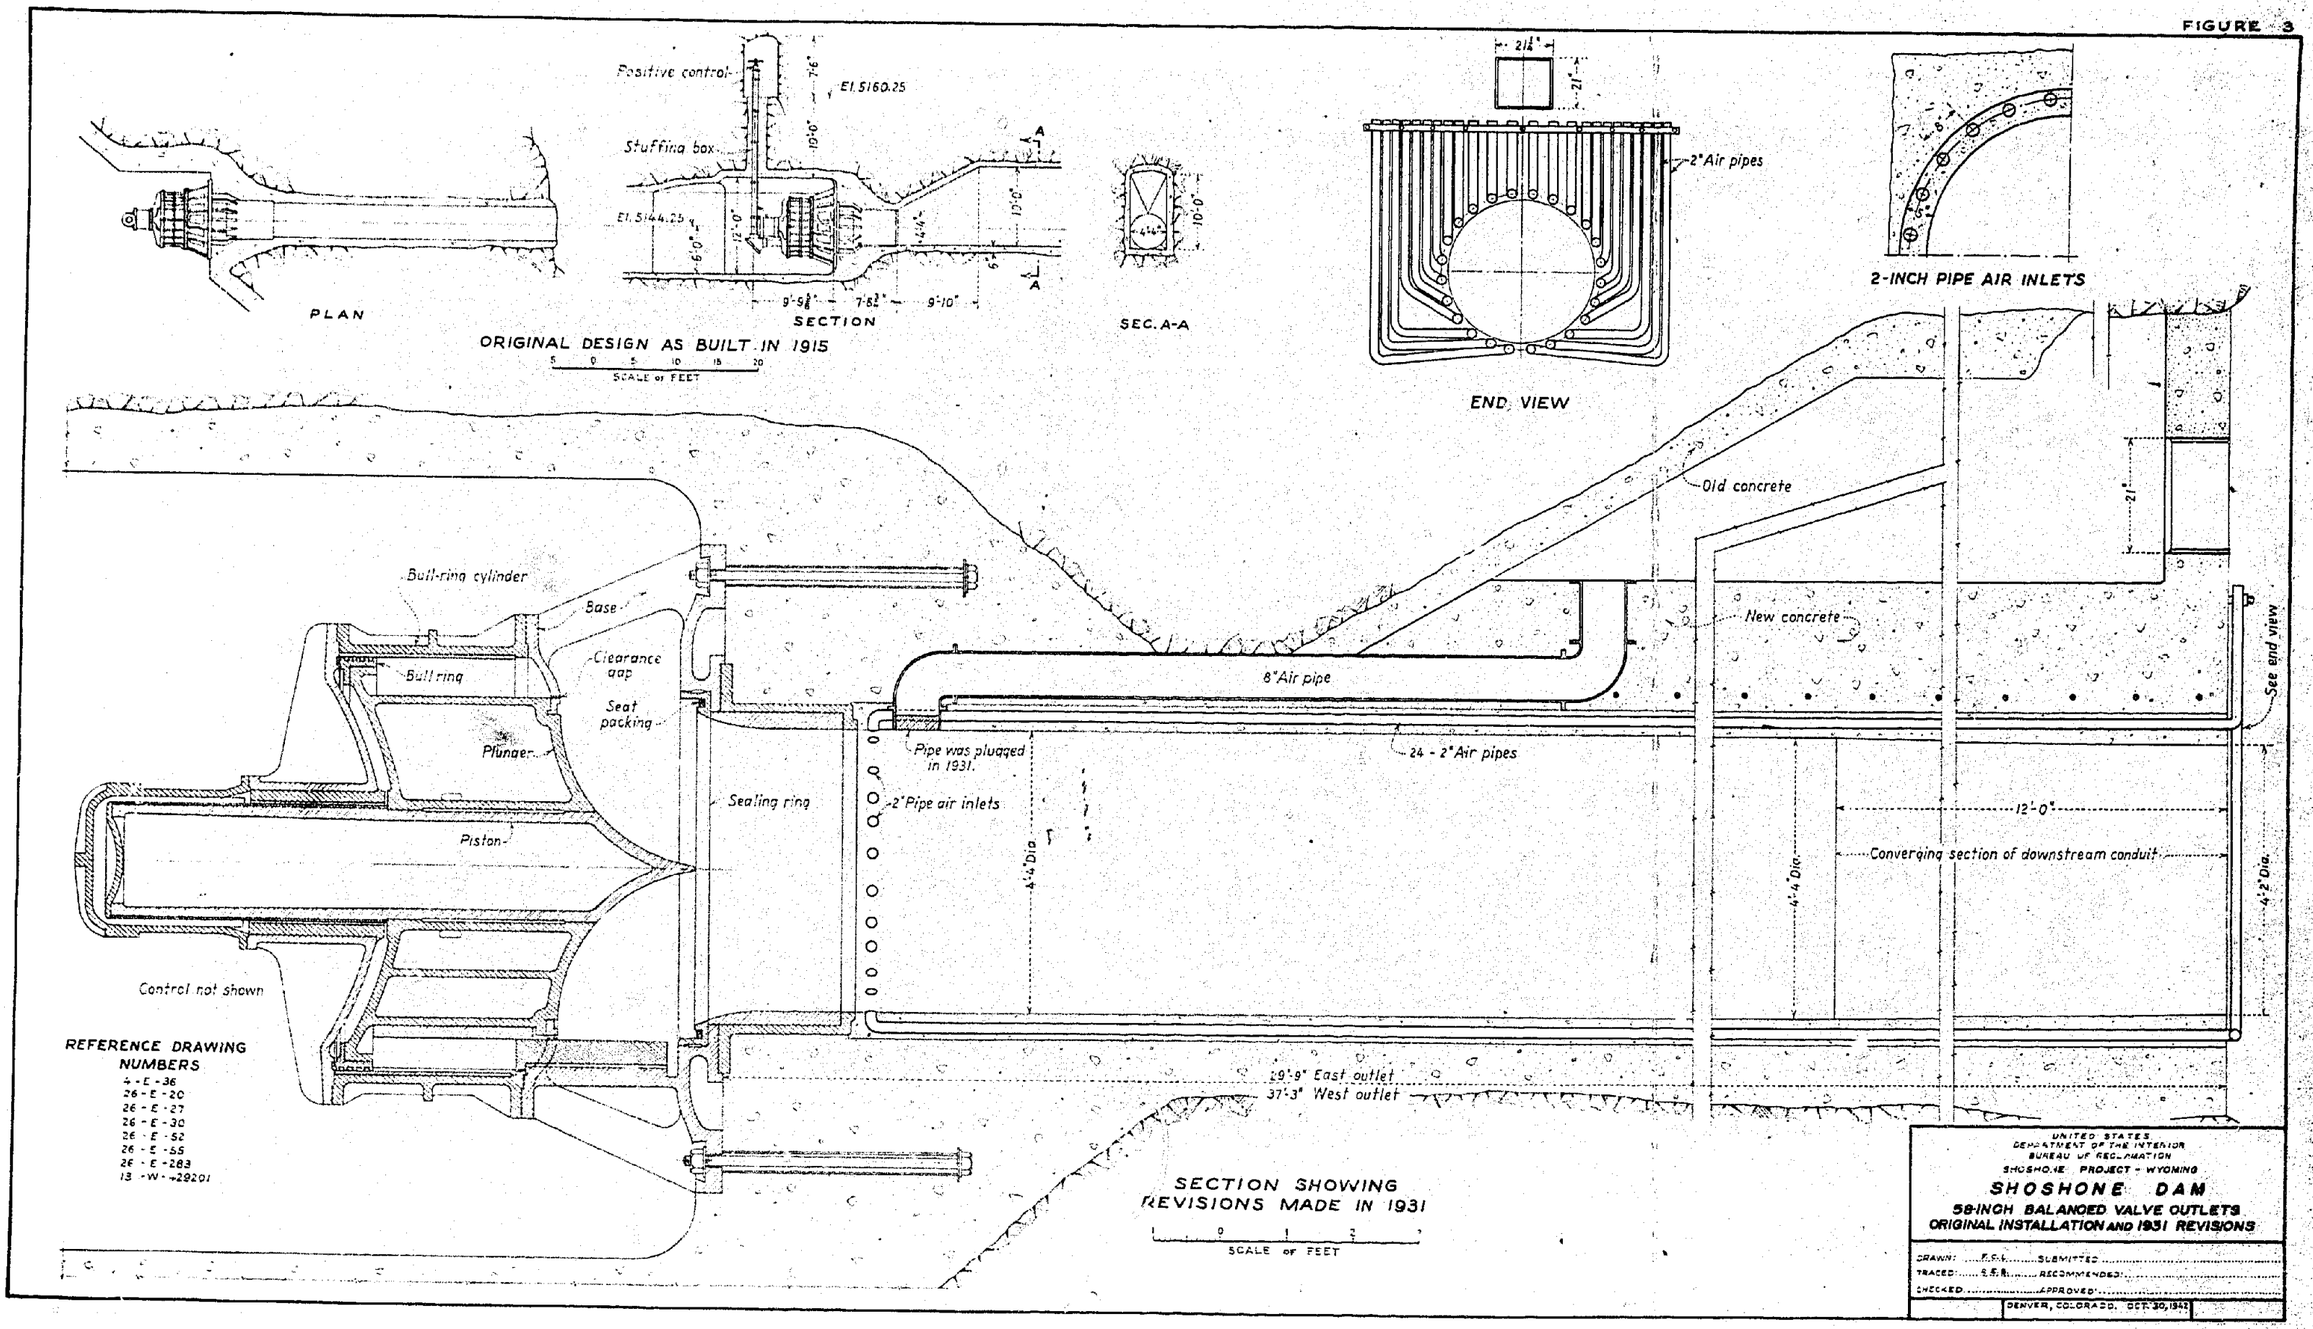
FIGURE 3

An attempt was made in the winter of 1930-31 to relieve the condition at Shoshone Dam by admitting air through a system of vents to the conduits below the valves. The conduits were repaired by patching, then lengthened and provided with twenty-four 2-inch pipes and an 8-inch duct below each valve (figure 3). Each was constricted two inches in diameter at the downstream end. A marked increase in the intensity of the noise accompanying the discharging water resulted, and the experiment was considered unsuccessful. The 8-inch vents were closed with wooden plugs when investigations disclosed them to be the main source of the increased noise. Because of the apparent failure of the vent system, resort was made to the original method of maintenance and the valves used as little as possible, being closed whenever sufficient water to meet downstream requirements passed through a notch in the spillway crest. It was realized that the pitting was serious and that repairs by the usual method were inadequate; however, a more practical method of repair was not apparent at the time.

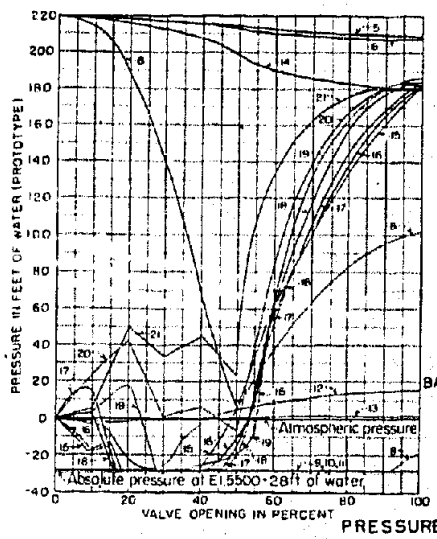
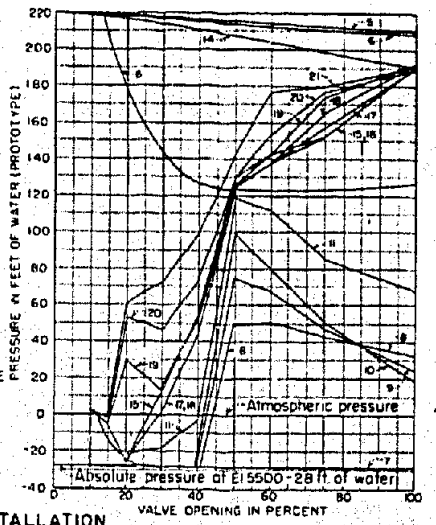
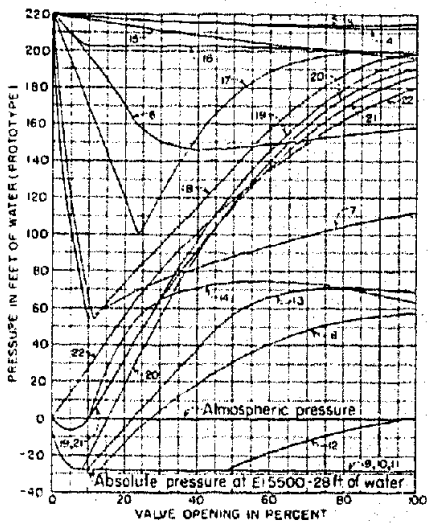
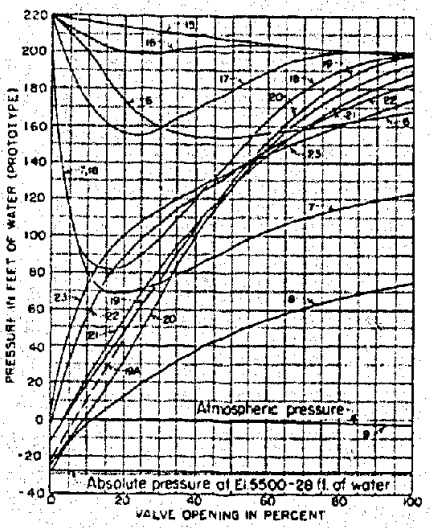
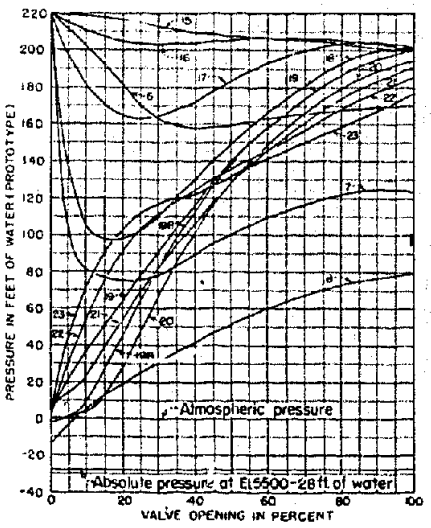
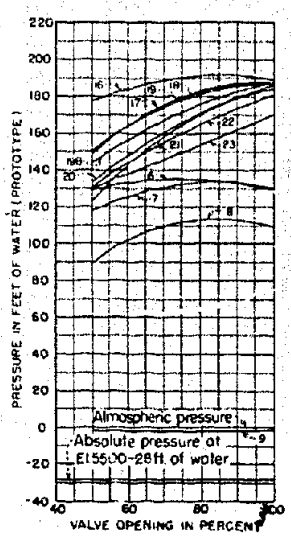
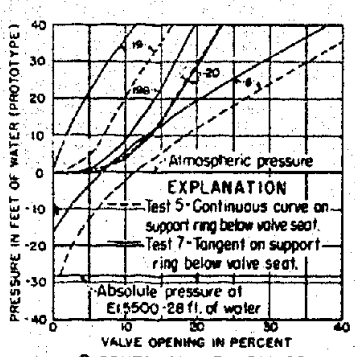
FIGURE 11

When the proposed redesign (figure 10C) was tested without aeration and the data transferred to prototype by using pressure factors based on the static head on the valve (above atmosphere) and expressed as being above or below atmosphere, the pressures near the seat on the support ring and in the discharge conduit were severely subatmospheric (as much as 42 percent of the static head on the valve), indicating that cavitation would result to the redesign if the outlets were improperly aerated (figure 11A).

The clearance-ring pressure (piezometer 16, figure 11D) was equal to or greater than any on the needle, thus indicating no trouble in closing the valve from the wide-open position as had been the case with the present field installation.

Pressure measurements for the complete range of valve opening indicated satisfactory conditions at all points in the valve except on the needle and the support-ring surfaces (piezometer 8, figure 11D) immediately below the seat where a divergent passage formed as the valve neared the closed position. To alleviate this condition, the continuous curve below the valve seat on the support ring was replaced by a short tangent, diverging one-half of one degree from the needle angle (figure 10C). Complete pressure measurements, including those downstream from the V-guides, were again taken (figures 11E and F). Though the pressures remained subatmospheric for openings of less than six percent, they were not of a magnitude indicating cavitation (figure 11G), and the design was considered satisfactory insofar as the aerodynamic investigation was concerned. Construction drawings for the changes were prepared on the basis of these findings (appendix I), but it was believed advisable to corroborate the results by hydraulic tests on the 1-to 8-2/3-scale model before the plans were

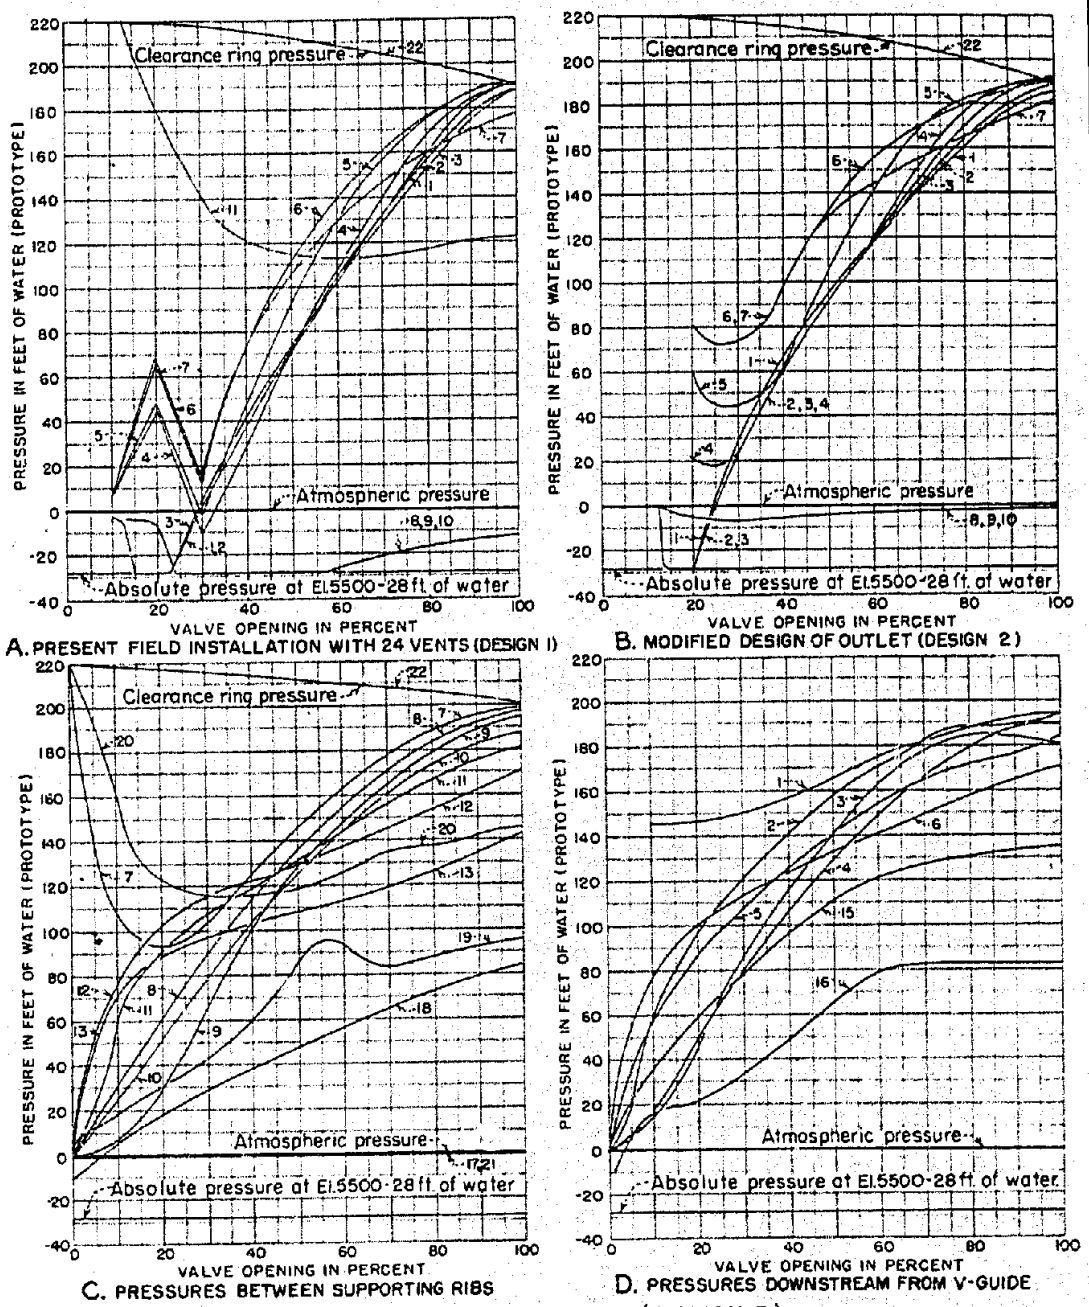
FIGURE 14

The severe subatmospheric pressures prevalent in the model of the present outlet design (figure 14A) were attributed to inadequate aeration resulting principally from improper location of the delivery ends of the air ducts, but due also to the small aeration area. The peculiar shape of the jet beyond the end of the needle tip no doubt contributed to the severity of these pressures. The stream expanded abruptly to fill the conduit at approximately 25-percent opening, with the action continuing throughout the upper range.

Pressures on the needle, using the 1-1/2-inch orifices, were found to be positive for all openings above 23 percent (figure 14B). For smaller openings the pressures on the surface of the needle near its outer edge were severely subatmospheric, indicating that cavitation would occur on the prototype. Since the critical pressure existed over such a small range of opening and damage to the needle could be eliminated by avoiding operations in this region, and since it was impossible to streamline the corner of the plunger sufficiently to relieve this condition without a

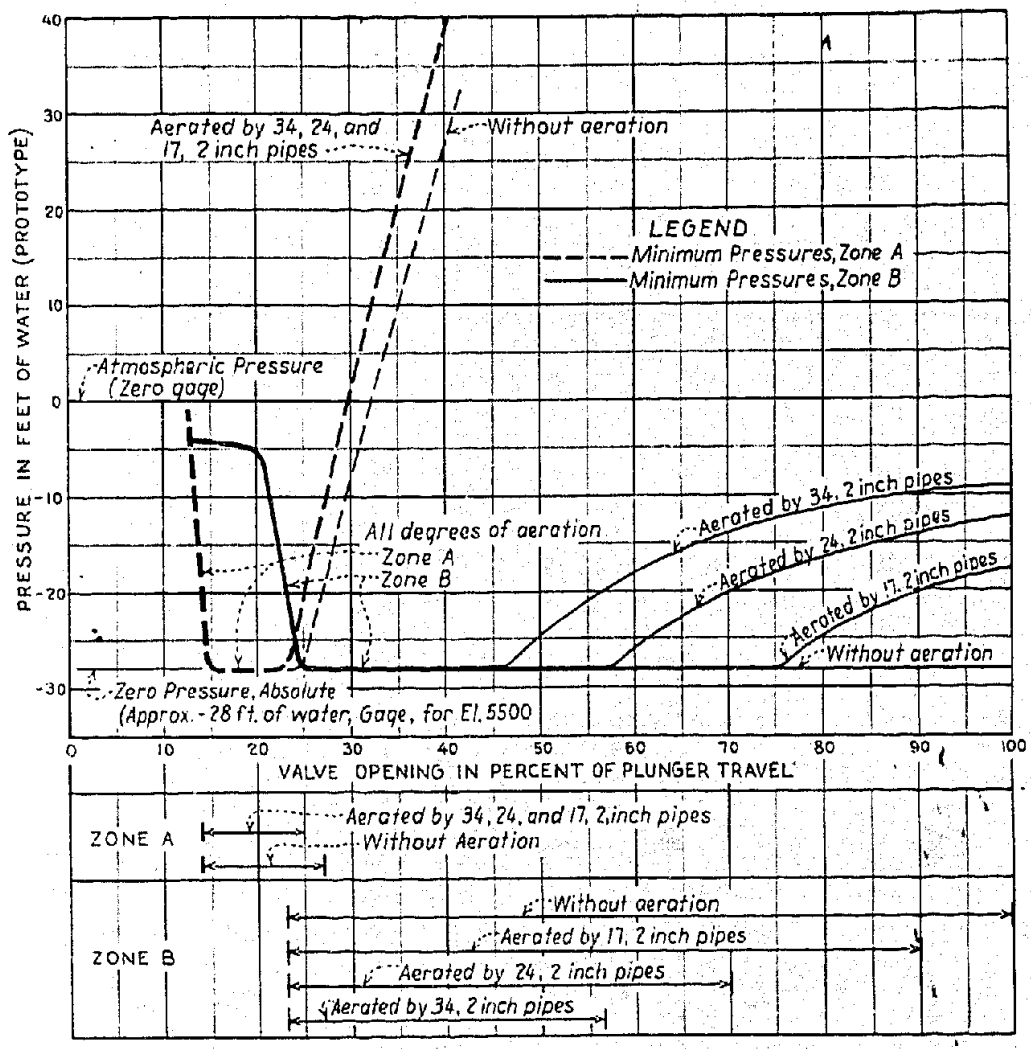
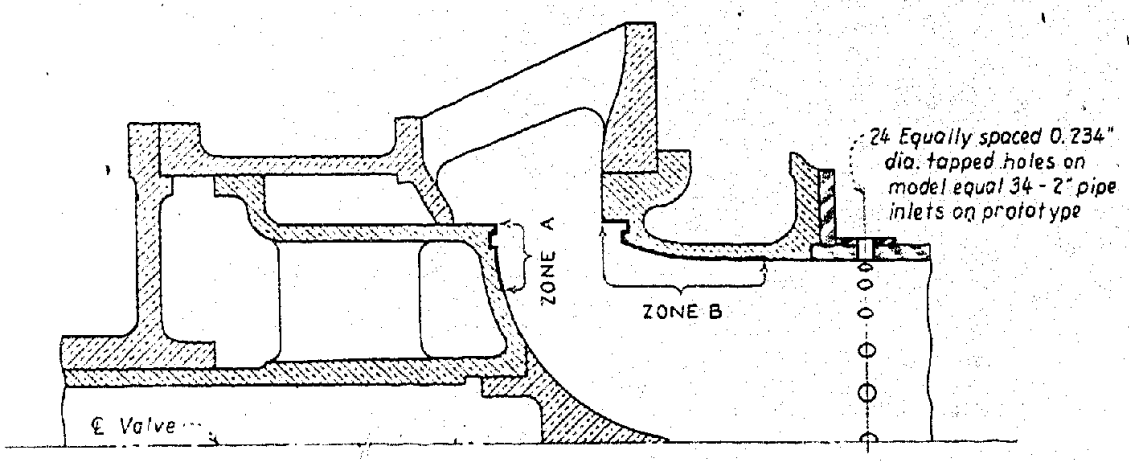
FIGURE 16

Model studies of the present field design indicated that the pitting of the prototype valve needles has been the result of operating at valve openings between 14 and 25 percent and that damage to the conduits resulted between 23 and 70 percent valve opening. No doubt the damage to the conduit at these openings rendered the air-supply system ineffective and aggravated the destructive action for larger valve openings. Discharge coefficients and capacity curves, which will assist the project operating personnel to determine the flow being released by the outlet works before and after the outlets have been revised, were prepared from the model data.

CRITICAL VALVE OPENING RANGE
Based on -20 feet of water gage pressure

SHOSHONE DAM
58" BALANCED VALVE
HYDRAULIC MODEL STUDIES - SCALE 1:8⅔
CRITICAL OPENING RANGE - VARIOUS DEGREES OF AERATION
PRESENT FIELD INSTALLATION
