UNITED STATES
DEPARTMENT OF THE INTERIOR
BUREAU OF RECLAMATION

Laboratory Report No. HYD-231
Hydraulic Laboratory
Written by: C. R. Dawn
Checked by: J. L. Gilliland
Reviewed by: A. J. Peterka

Subject: Failure of heating elements in water heaters.

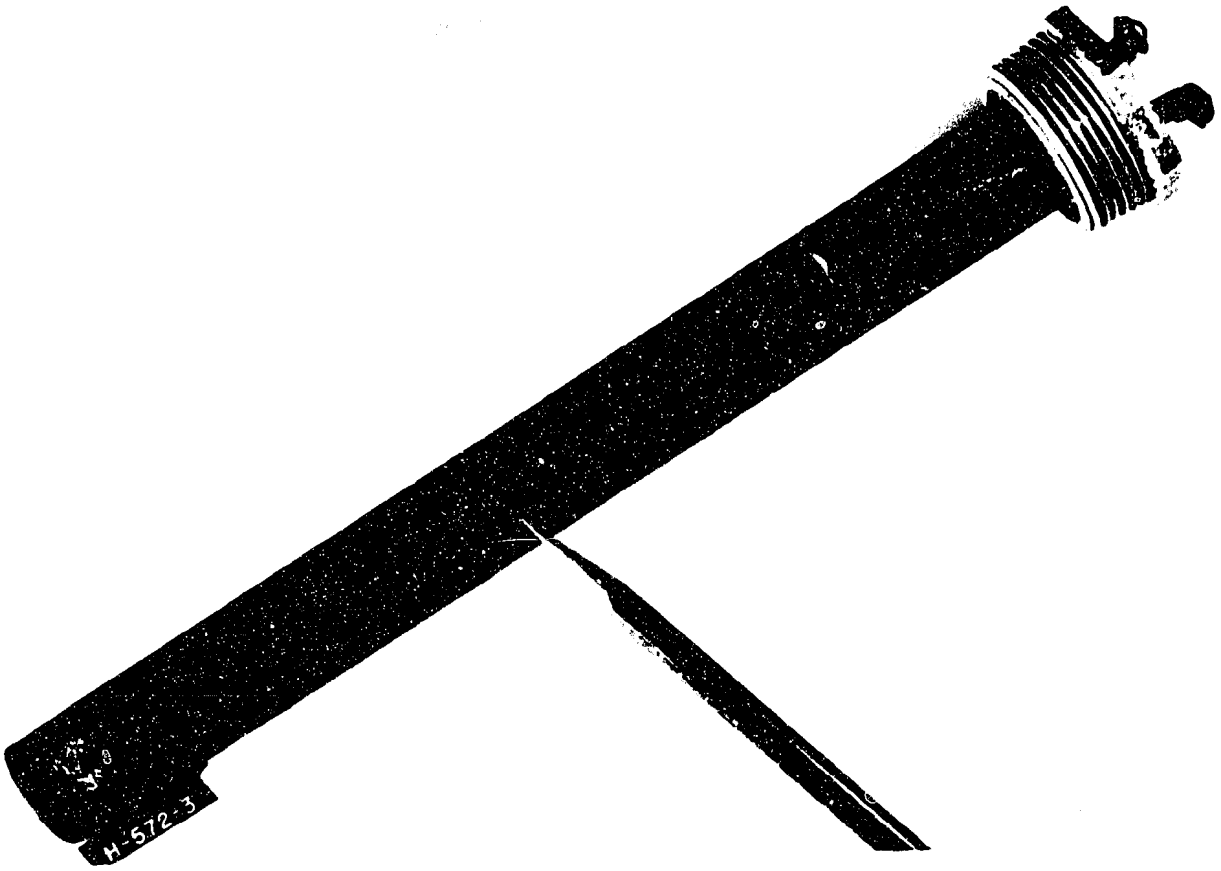
Figure 1

Measurements made on the electrical section of the heating element showed that they met the power requirements stamped thereon. Other tests made on the jacket showed that it was made of ferrous material. Failure of the element was due to corrosion of the jacket which had proceeded to an advanced degree, as shown in Figure 1. Figure 2 shows an enlarged section of Figure 1.

Examination of the water-heater jacket showed no tendency toward a scale deposit. Rather, it indicated that the water at Estes Park is a scale solvent, since the metal surface is deeply pitted with very little scale present. The formation of a protective scale therefore cannot be relied upon to prevent the corrosive reactions from taking place.

The cylinders containing the heating elements in the purchased heaters were found to be installed in a horizontal position approximately 18 inches above the bottom of the tank. The maximum corrosive activity took place on the upper side of the jacket. This would be expected since the flow of water in the immediate region of the jacket is upward due to the temperature gradient. The bubbles of dissolved air liberated from the water on the lower side of the jacket are carried away, while the bubbles on the upper side are protected, and since free air is composed of approximately 21 percent oxygen, the components for continued corrosion are present. As the corrosion

progresses, small crevices hold the air liberated by heating, and the oxidation progresses at an accelerated rate.

Corrosion of heating element jacket.

A jacket made from suitable material would minimize the corrosive activity in this particular case. Copper or high-copper brass is recommended. Copper, being on the negative side of hydrogen in the electrochemical series, would be restrained from going into solution. The use of a copper jacket for the heater element, however, introduces galvanic cell action between the copper and the iron water tank. A slight amount of corrosion would result with the iron of the tank going into solution. The electrical current flow would be minimized in this case since the amount of mineral matter in the water is small. In addition, the area of the copper is small compared to the area of the iron and the galvanic couple should not greatly accelerate the present corrosion rate of the tank. To further eliminate the corrosion due to the galvanic couple, however, an electrical insulator could be used in mounting the heater unit in the tank.
