HYDRAULIC LABORATORY REPORT NO. 42

REPORT ON INSPECTION TRIP TO STUDY OPERATIONS OF OUTLET WORKS - ALCOVA DAM - KENDRICK PROJECT

C. W. Thomas

Denver, Colorado
November 16, 1938

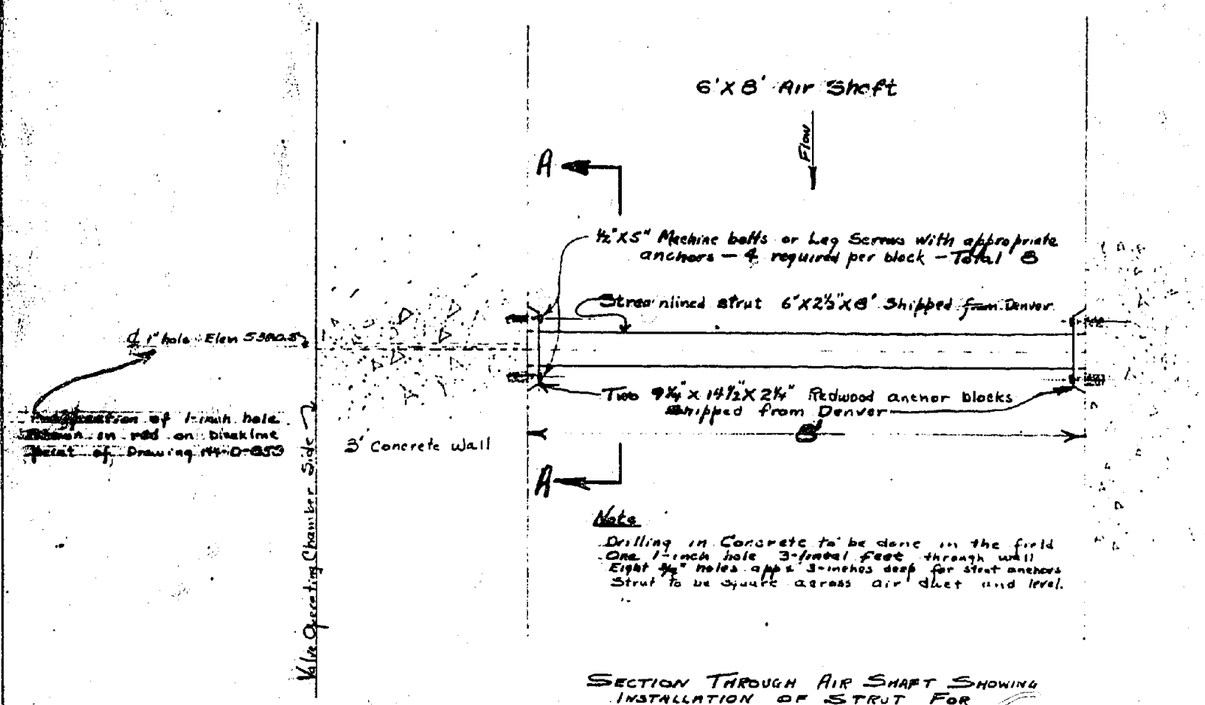
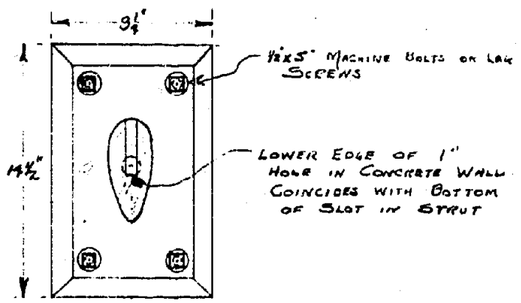
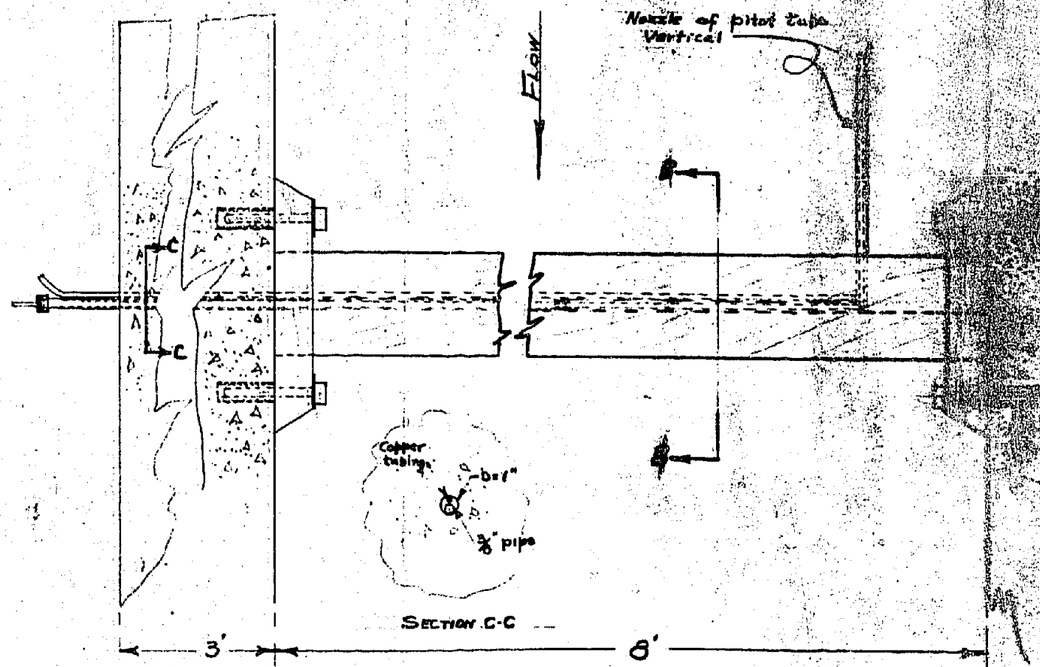
DEPARTMENT OF THE INTERIOR
BUREAU OF RECLAMATION
KENDRICK PROJECT - WYOMING
ALCOVA DAM
OUTLET WORKS
PITOT TUBE INSTALLATION IN 6'X8' AIR SHAFT

4. Previous to the operation of the needle valves for test purposes, the construction engineer had installed, in accordance with drawing no. 144-JEW-101 (figure 1), a pitot tube and supporting strut in the 6-foot by 8-foot air shaft (drawing no. 144-D-1292). A differential gage from the Denver hydraulic laboratory was used to determine the velocity head at the pitot tube. With both needle valves being opened simultaneously, complete pitot tube traverses were made in the 6-foot by 8-foot air shaft at 25, 50, 75, and 100 percent valve openings. These observations showed an excellent velocity distribution. Pitot-tube readings were taken only on the center line of the shaft for the tenth-point valve openings. These readings were corrected to average cross-sectional velocity by a constant derived from the complete traverses. The mean cross-sectional velocity plotted against valve opening is shown in figure 2. The quantity of air flowing into the discharge tunnel plotted against valve opening is also given in figure 2. A study of these curves and pressures taken in the discharge tunnel resulted in a decision to remove the louvers and grill installed at the entrance to the air shaft (drawing no. 144-D-1064). Pitot-tube investigations were repeated for this condition and the results are given in figure 2. Since there was no simple means of further augmenting the air supply to the tunnel, no further air-demand tests were made.

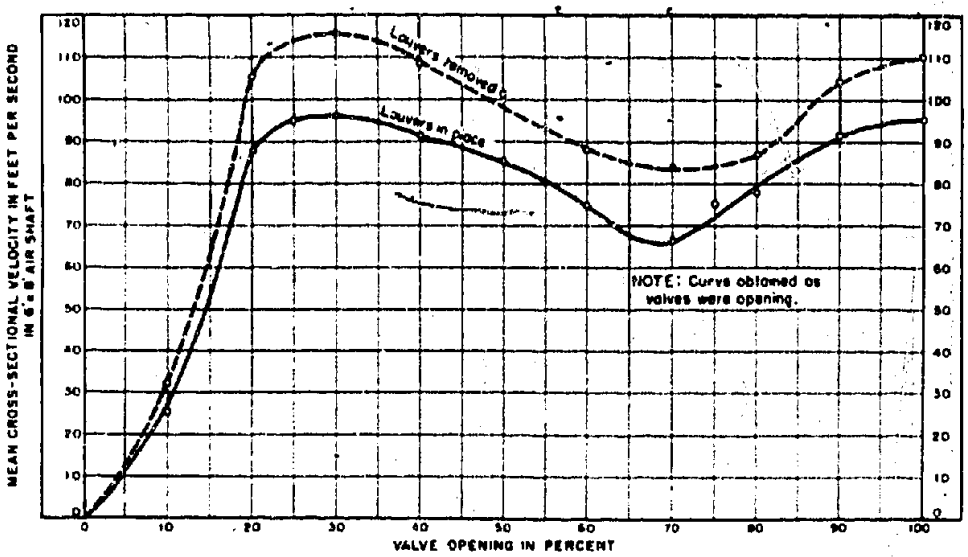
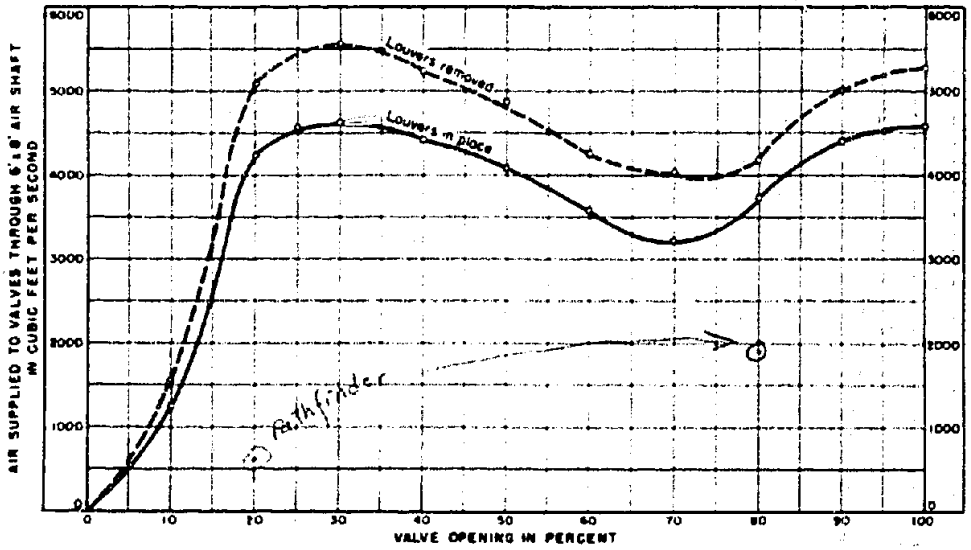
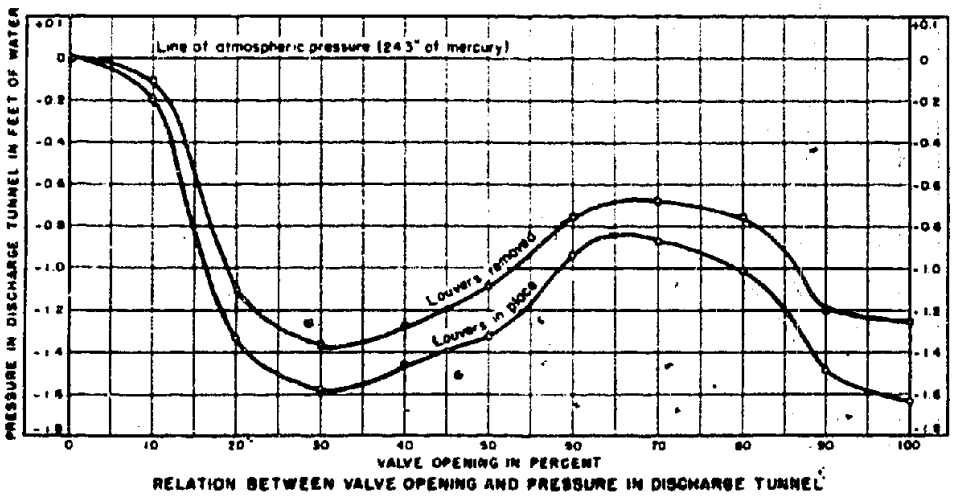
144-D-2902

RELATION BETWEEN VALVE OPENING AND VELOCITY OF AIR IN 6' x 8' SHAFT

RELATION BETWEEN VALVE OPENING AND QUANTITY OF AIR FLOWING THROUGH 6' x 8' AIR SHAFT

RELATION BETWEEN VALVE OPENING AND PRESSURE IN DISCHARGE TUNNEL

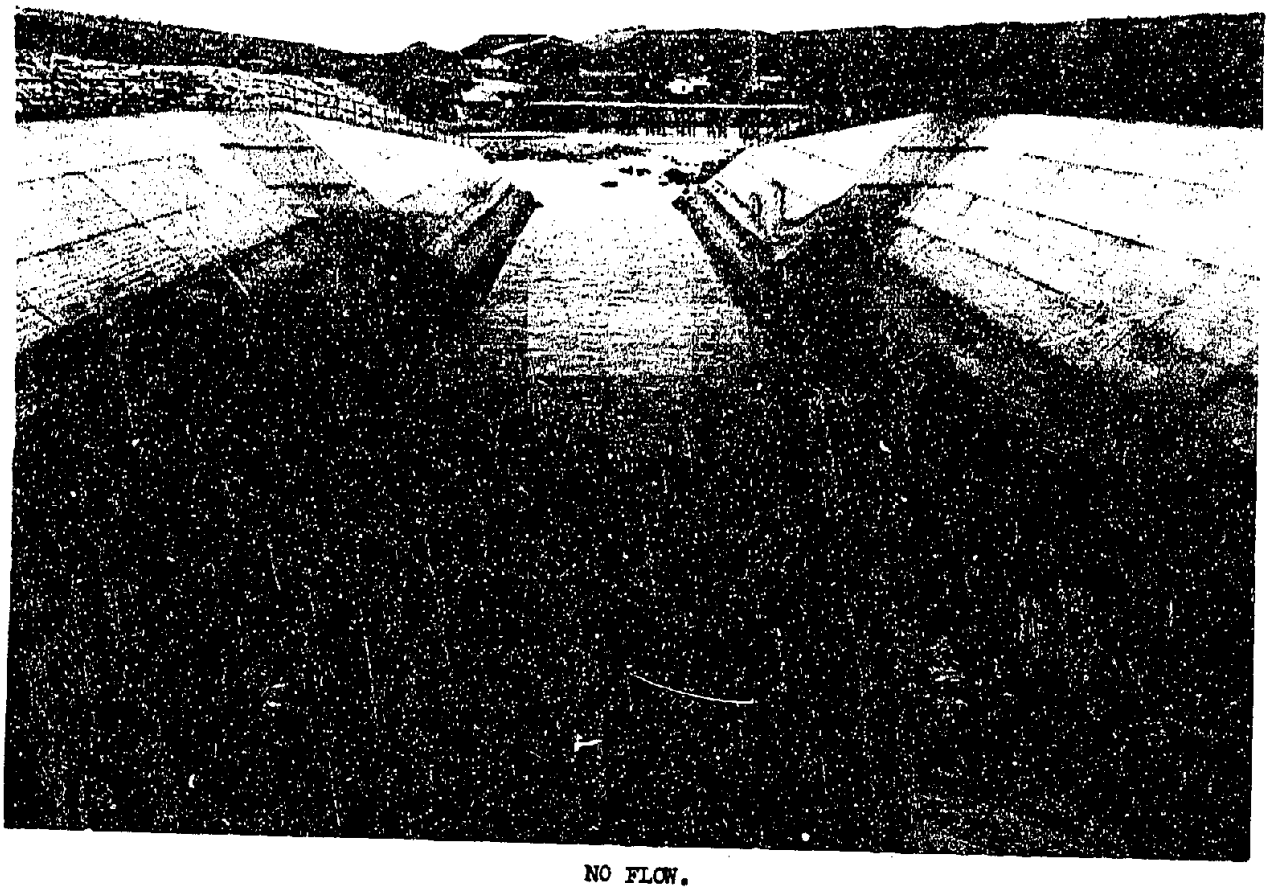
12. Flow conditions in the stilling pool for four valve settings are shown in figures 6, 7, 8, 9, and 10. The hydraulic jump occurs within the tunnel for discharges below approximately 2,000 cubic feet per second, and conditions in the pool are fair. At higher discharges, the pool is very rough and turbulent. At discharges above 2,000 second-feet, there is a return flow along the left pool wall near the tunnel portal that enters the hydraulic jump from the side, thus impairing the stability of this phenomenon, and waves are produced in the pool. These waves overtop the walls of the stilling basin for discharges above approximately 4,000 second-feet. The tunnel did not flow full at any discharge (figures 8, 9, and 10). The flow leaves the lined section of the pool at high velocity (figure 10). The boulder-strewn stream bed downstream from the pool (figure 11) is sufficient protection against erosion in the bed. However, erosion of the right bank at the end of the lining is quite severe and has exposed most of the cut-off wall (figure 11). In fact, some of the large riprap was moved during the relatively short time that the tests were being made. The riprap on this bank was dumped from the top. The left bank shows little or no tendency to erode (figure 11). The difference in stability is due to the fact that the riprap on the left bank was placed and swings back on a long arc from the end of the concrete. If the right bank is allowed to erode until it is similar in plan to the left bank, and then covered with placed riprap, the tendency for erosion in this area should be completely eliminated. The sharp offset in the walls and floor of the stilling pool at station 15+00, causes the flow to leave the walls, and possibly the floor, immediately downstream from the square corner. An expansion joint traverses
