HIGH HEAD GATE SEAL STUDIES

Report No. HYD-582

HYDRAULICS BRANCH
DIVISION OF RESEARCH

MARCH 1968

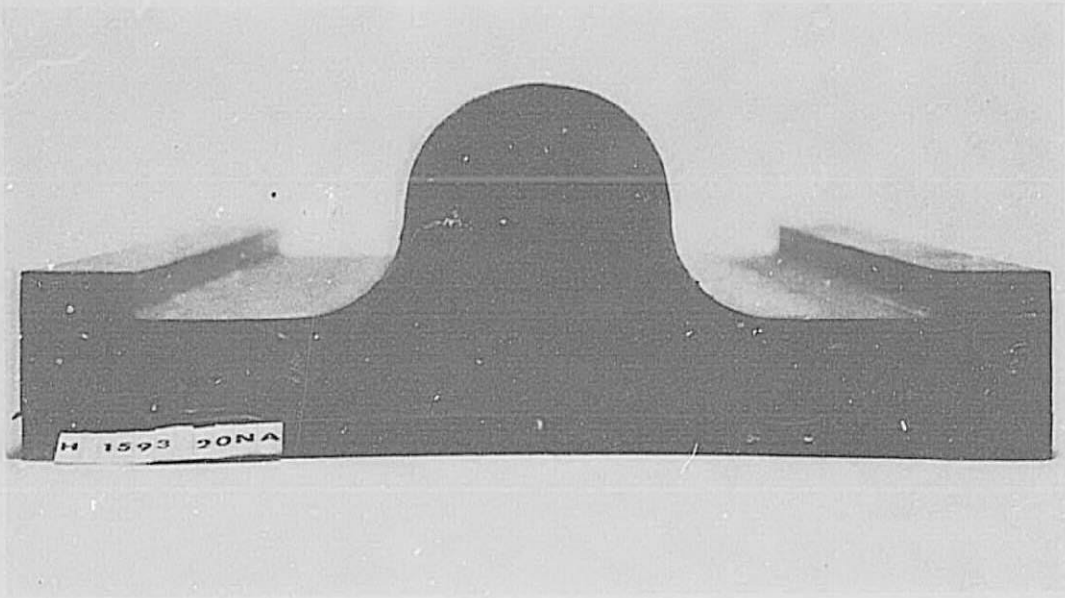
Specimens 1 through 4 were of the clamp-on design having a red fluorocarbon cap bonded to the bulb. The brass backings on Specimens 2 and 3, which had been applied in the laboratory, broke loose from the rubber during testing (Figure 5A); subsequently, all cladding was factory applied and little additional trouble with bonding was experienced. On Specimens 1 and 3, the cap tore loose from the bulb on the lower (high-pressure) side (Figure 5B). As a result, several samples were made with the fluorocarbon extended to cover the lower stem. This design proved to be successful and no major bond breaks occurred on specimens so made. When Specimen 3 was tested with 3/8-inch (9.525-mm) clamp-to-seat clearance (increased from 7/32-inch (5.556 mm)), severe vibrations occurred when the bulb was near the seat. This fact would indicate that increasing the clearance increases the tendency for vibrations to develop. Specimen 4 was tested to 500 feet (152.40 m) of head and sustained an extensive bond break on the upper side of the bulb by pinching during the gate closing cycle (Figure 6B). This was the only specimen tested that had a bond break in this region.

A. Specimen 2 - Brass backing pulled loose from rubber. Photo PX-D-60629

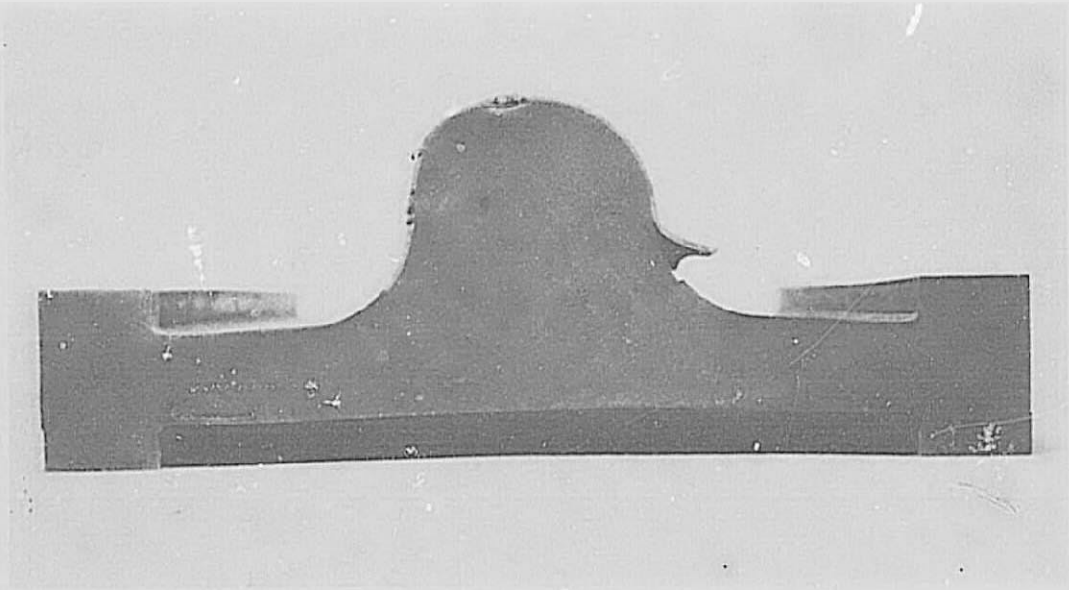
B. Specimen 1 - Fluorocarbon bond failure on high pressure side of bulb. Photo PX-D-60630

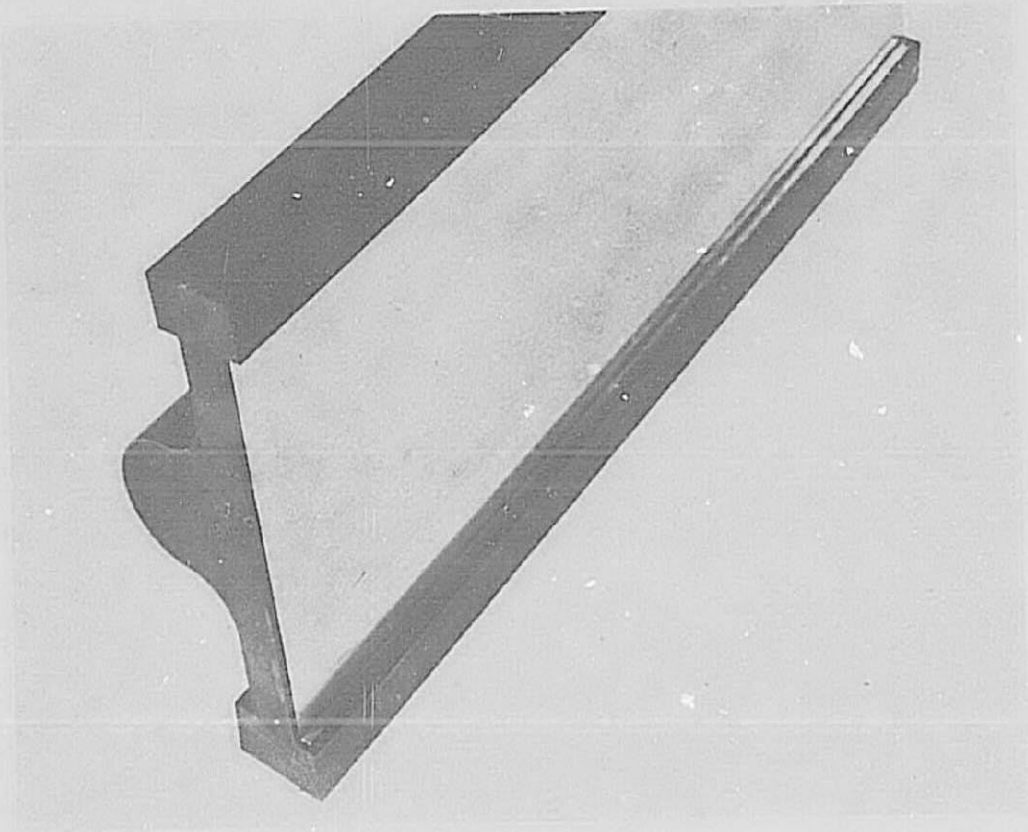
A. Specimen 3 before testing - showing a typical brass backing. Photo PX-D-60631

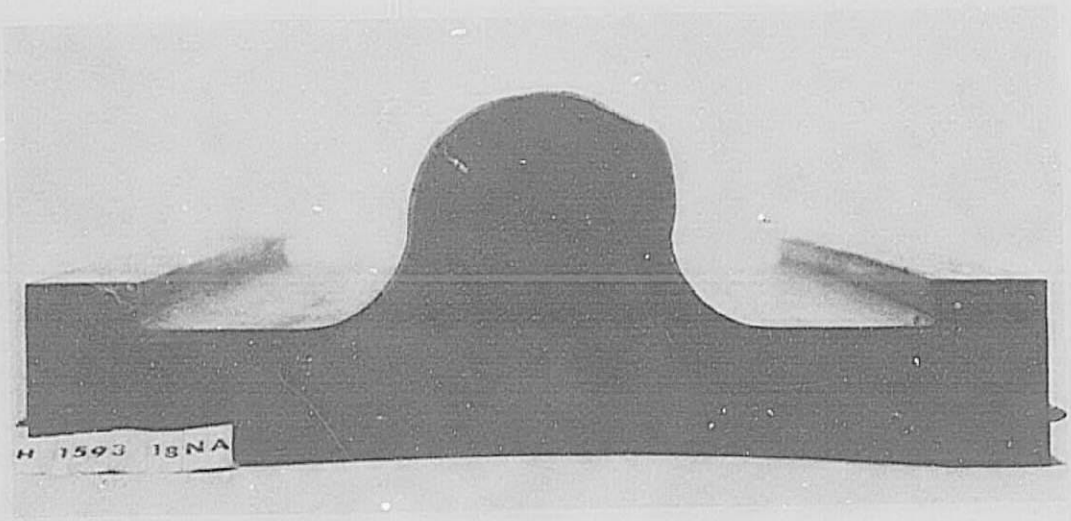
B. Specimen 4 after testing - bond failure on low pressure side of bulb due to pinching between clamp and seat. Photo PX-D-60632

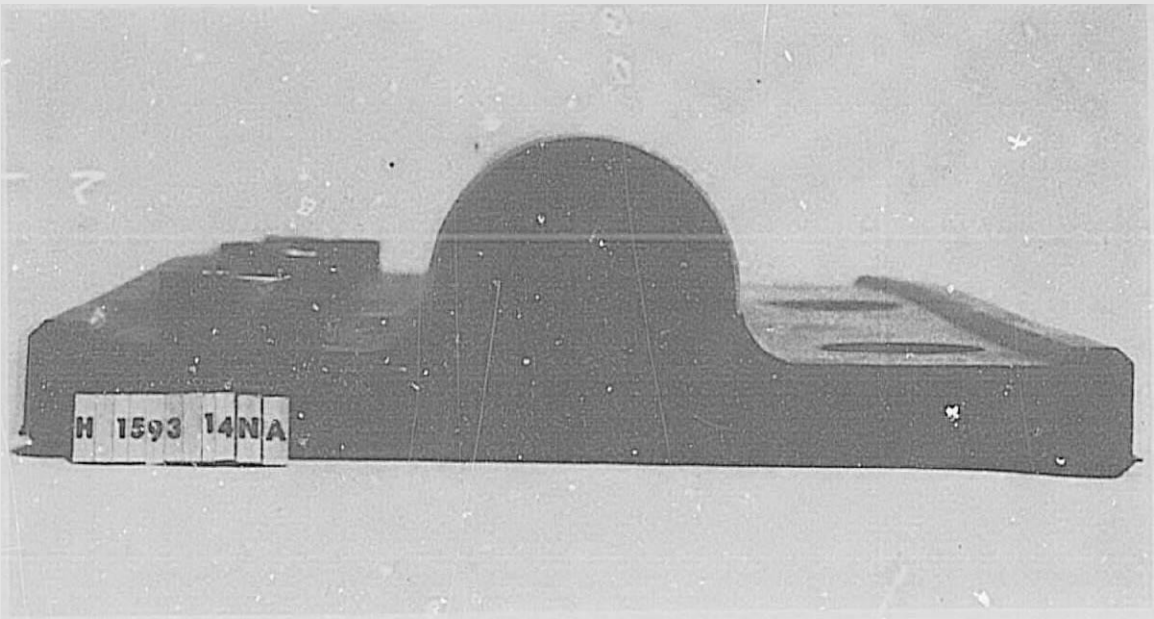
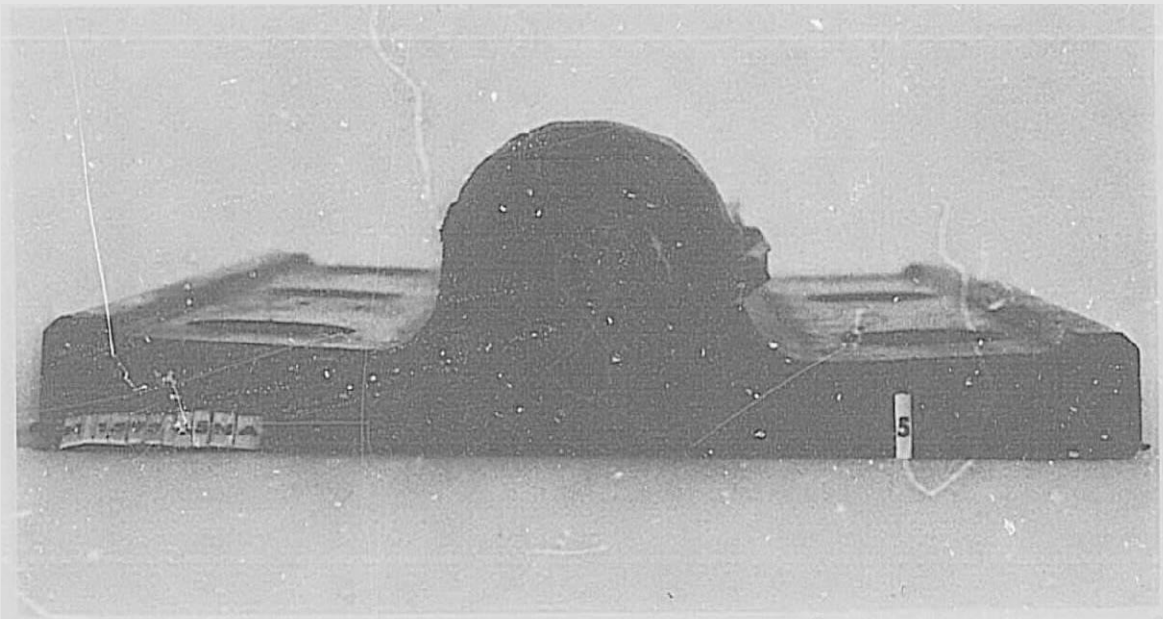
Specimen 5 - Bulb clad with fluorocarbon

Specimens 5 (Figure 7) and 6 were of the bolt-through type and proved to be less satisfactory than the clamp-on type in two respects: (1) the bulbs extended more and pinched during the closing cycle at heads considerably lower than the clamp-on-type (250 and 225 feet [76.20 and 68.58 m], respectively), and (2) very heavy vibrations occurred with the bulb near the seat at heads as low as 150 feet (45.72 m). The greater extension resulted from the seals being restrained positively only at the mounting bolts, whereas the clamp-on seals are restrained continuously along their entire length. In addition, a greater area of unclamped stem existed with the bolt-through seals allowing the stems to stretch more than those of the clamp-on seals. These conditions probably contributed to the vibration problem. To obtain an indication of the severity of the vibrations, measurements of pressure variations in the groove behind the seal were made with an oscillographic recorder. The pressure fluctuated from about plus 90 percent to about minus 70 percent of the head acting on the gate and had frequencies of 7 to 12 cycles per second. It was noted that the pressure in the 8-inch (20.32-cm) supply line fluctuated at approximately the same frequencies and probably initiated the seal vibrations. A similar situation could exist in the prototype, so the tendency for vibrating must be eliminated.

B. After testing to 275 feet (83.82 m).
Photo PX-D-60634

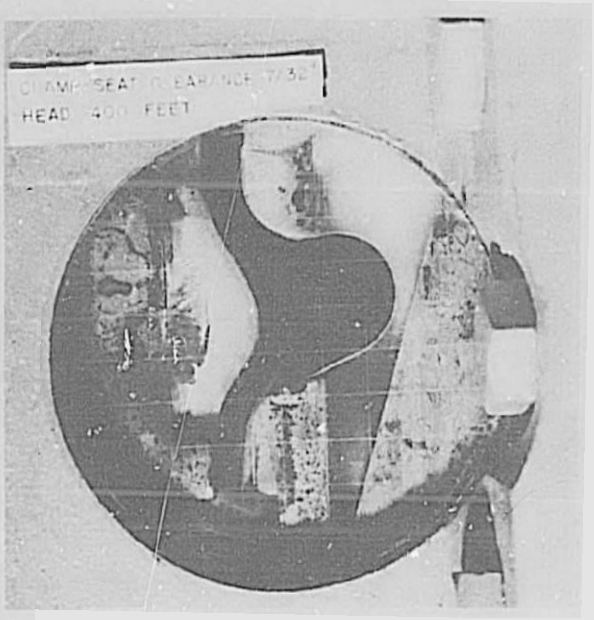
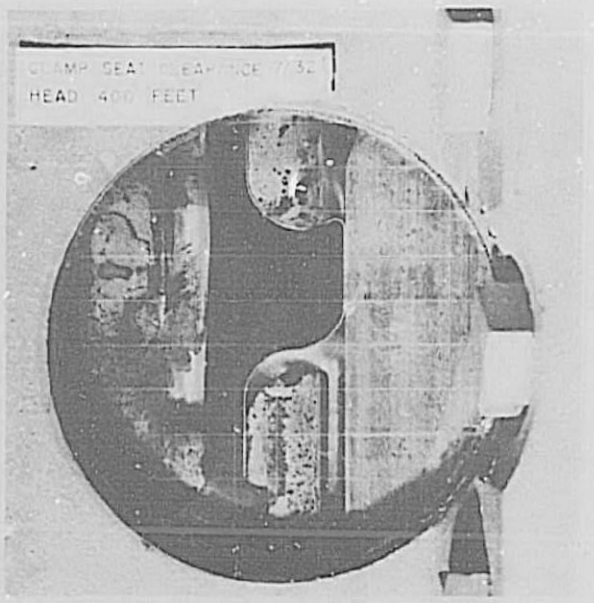
Specimen 7 in Test Rig

Specimens 7 and 8 (Figures 8, 9, and 11) were tested up to 425 and 400 feet (129.54 and 121.92 m) of head, respectively, before the bulbs were pinched enough to put a permanent crease in the fluorocarbon cap. It was noted with each successive run to a higher head that a permanent set was imparted to the seals. (The bulb remained displaced about 0.05 inch [1.27 mm] from its initial position after the pressure had been up to 400 feet [121.92 m] and then reduced). The set was apparently due to stretching the fluorocarbon beyond the elastic limit. The extent of this set is shown in Figure 11B.

A. Seal bulb extended during closing cycle.
Photo PX-D-60635

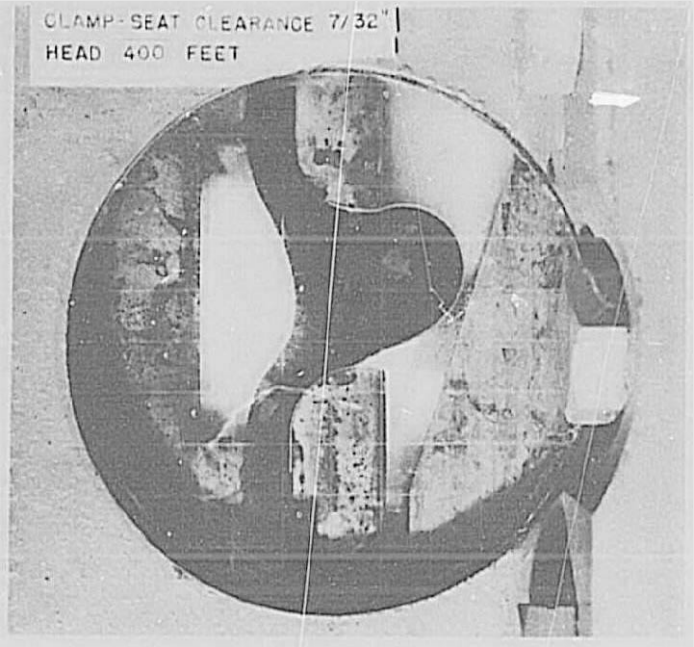
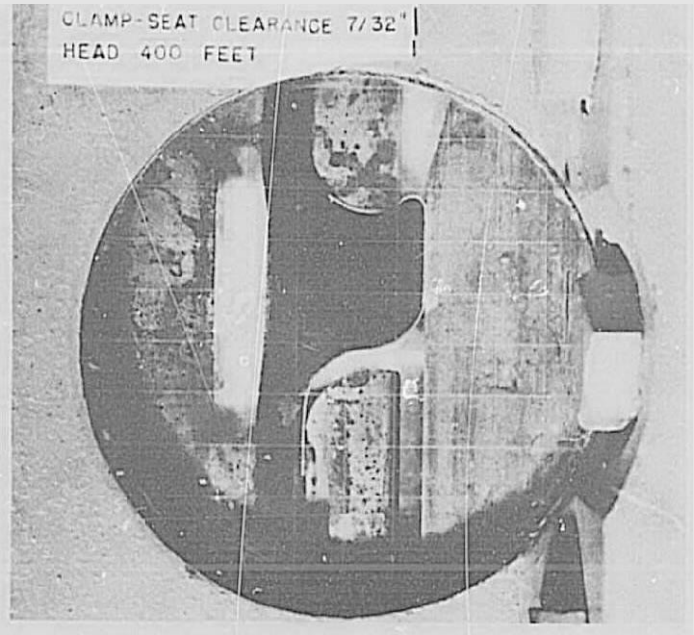
Specimen 8 in Test Rig

A. Seal bulb extended during closing cycle.
Photo PX-D-60637

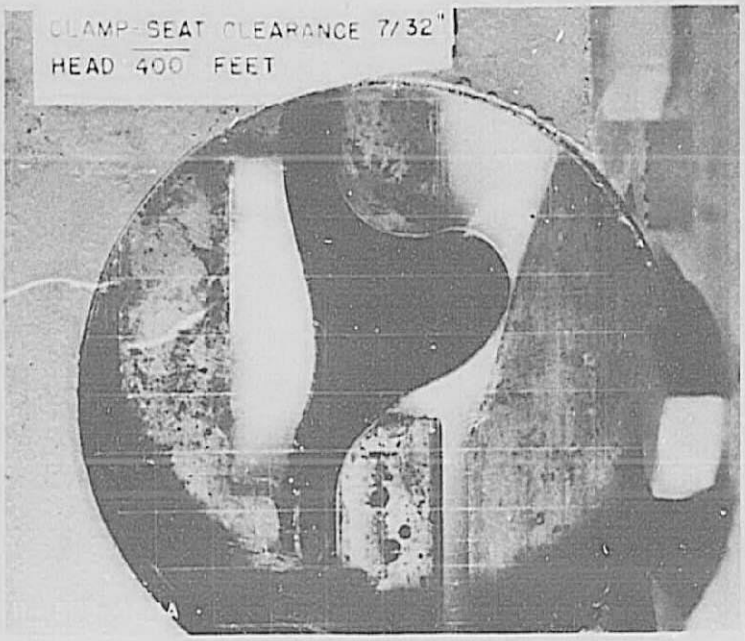
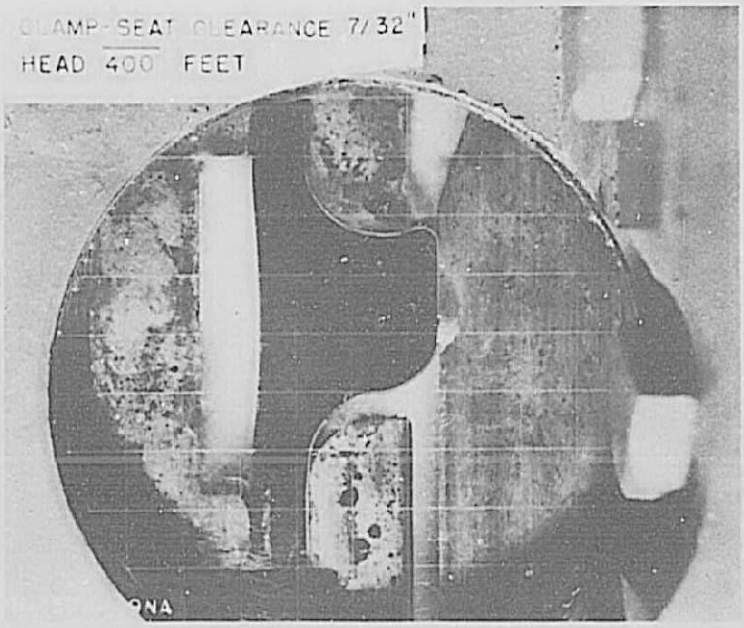
Specimen 13 in Test Rig

Specimen 13 (Figures 10 and 12), with cladding identical to Specimen 10, underwent about 20 gate opening and closing cycles at 600 feet (182.88 m) and was also subjected to tests at partially open gate positions at heads ranging from 60 to 600 feet (18.29 to 182.88 m) for a period of approximately 20 hours without being damaged. The permanent set noted in Specimens 7 and 8 was practically eliminated in Specimens 9, 10, and 13 by the addition of the brass backing (compare Figures 11B and 12B). Protrusion of the bulb between the upper clamp and seat that occurs under high head with the gate closed was somewhat less on specimens having fluorocarbon extended over the upper stem.

A. Seal bulb extended during closing cycle.
Photo PX-D-60639

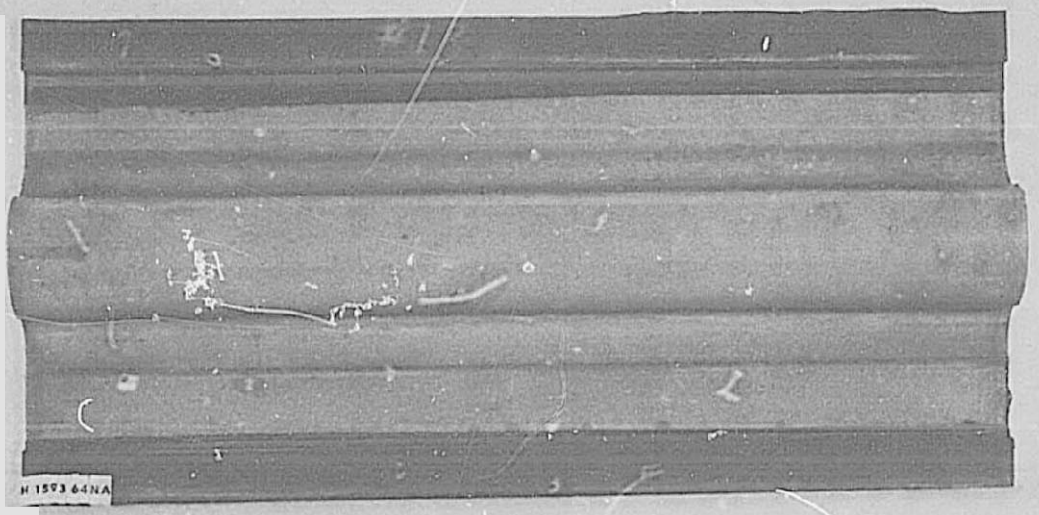
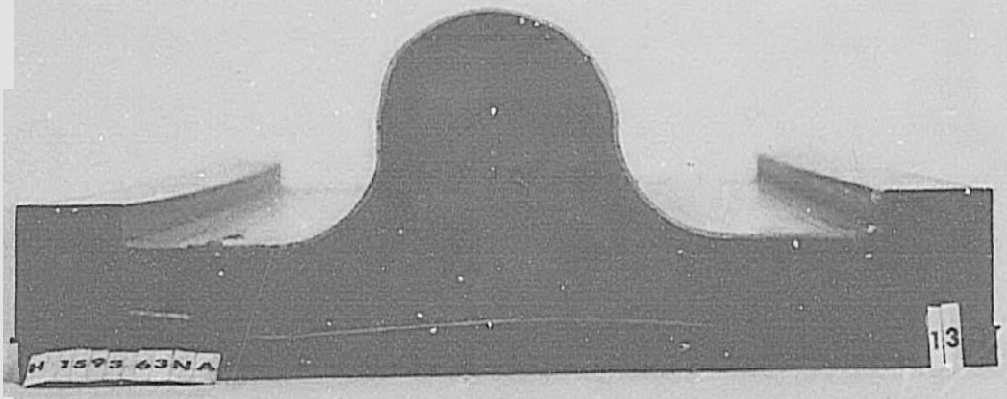
Specimen 13 After Testing to 600 Feet (182.88 m)

Specimen 13 - Green fluorocarbon over bulb and both stems and brass backing – Tested with $\frac{7}{32}$" clamp-to-seat clearance

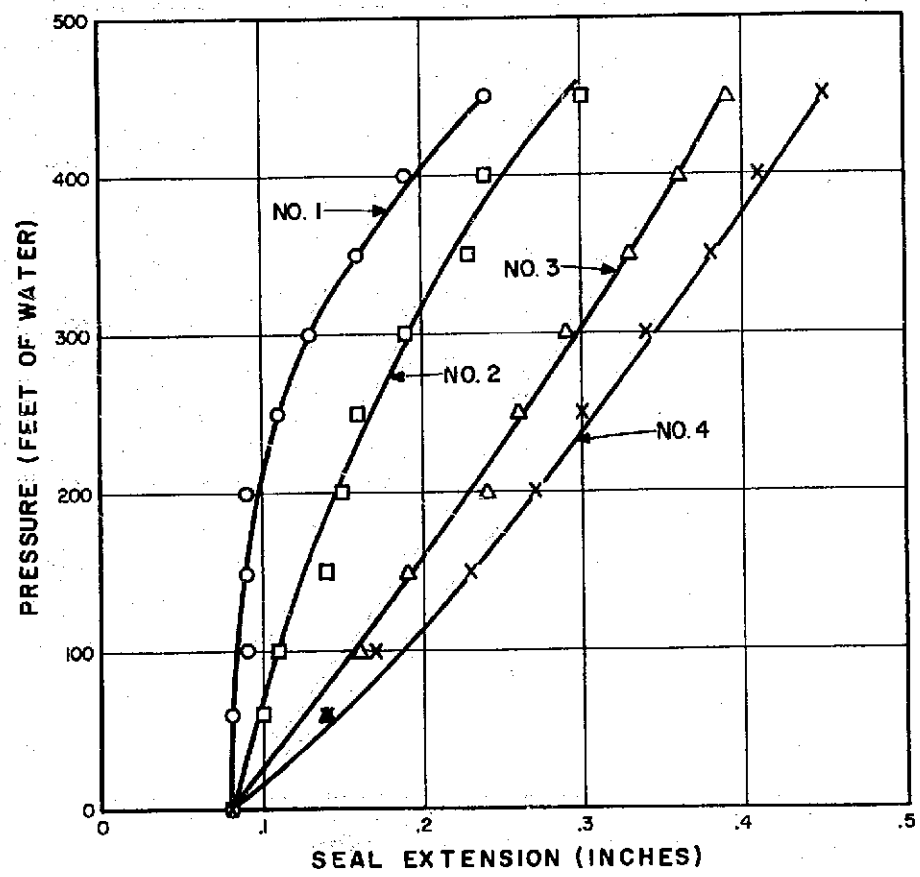
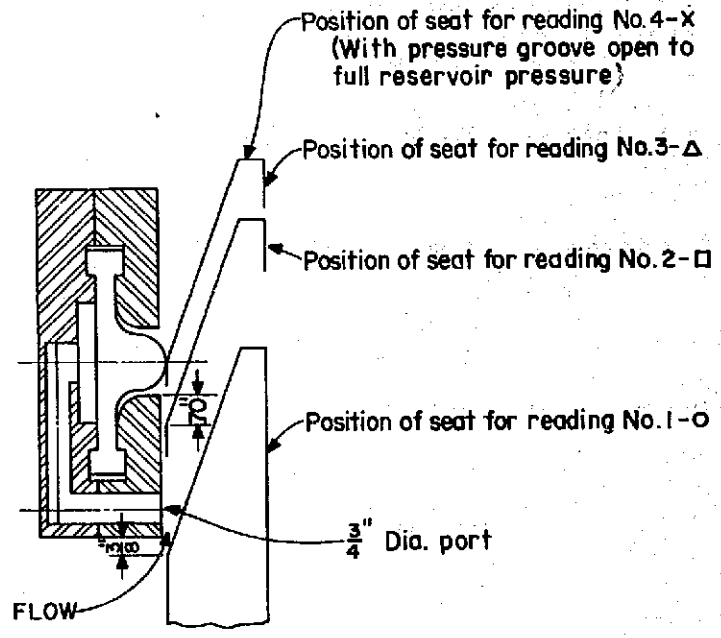
SEAL BULB EXTENSION CURVES FOR SPECIMEN 13-
TESTED WITH THE AUTOMATIC RETRACTION-EXTENSION SCHEME

The first test was run using Specimen 13. Negative pressures behind the seal were obtained in Position 1 at heads up to 300 feet (91.44 m), but the bulb extended slightly rather than retracting. Apparently, the high velocity stream of water, as an undesirable side effect, reduced the pressure in front of the seal even more than the pressure behind it and caused the seal to extend.

When Position 2 was reached, pressures behind the seal were still much lower than reservoir head and extensions were one-half to two-thirds as great as those without automatic retraction; however, before the bulb moved past the sloping surface of the seat, it snapped out to almost maximum extension. Hence, the pinching situation still existed.
