Department of the Interior
Bureau of Reclamation

OPERATION AND MAINTENANCE EQUIPMENT AND PROCEDURES

RELEASE NO. 23

January, February and March 1958

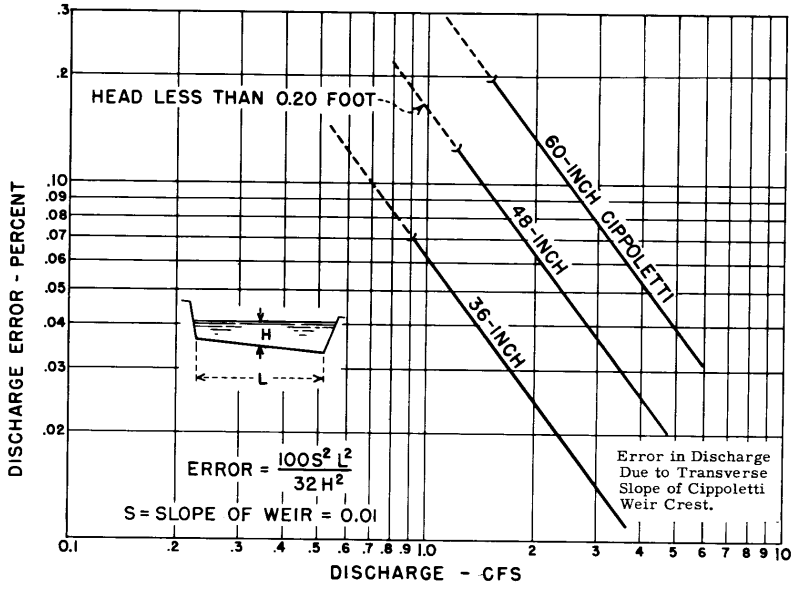
When installing Cippoletti and rectangular weirs in the field, it is necessary to set the crest exactly horizontal. If it is known that the crest is not level, it is common practice to consider the effective head to be the average head on the weir. The error caused by this practice is shown in the figure at upper left.

Actually, a more precise method is to calculate the discharge using the head at the low end and the head at the high end and average the discharge derived from these two calculations. If this is done, the error is reduced to minor significance.

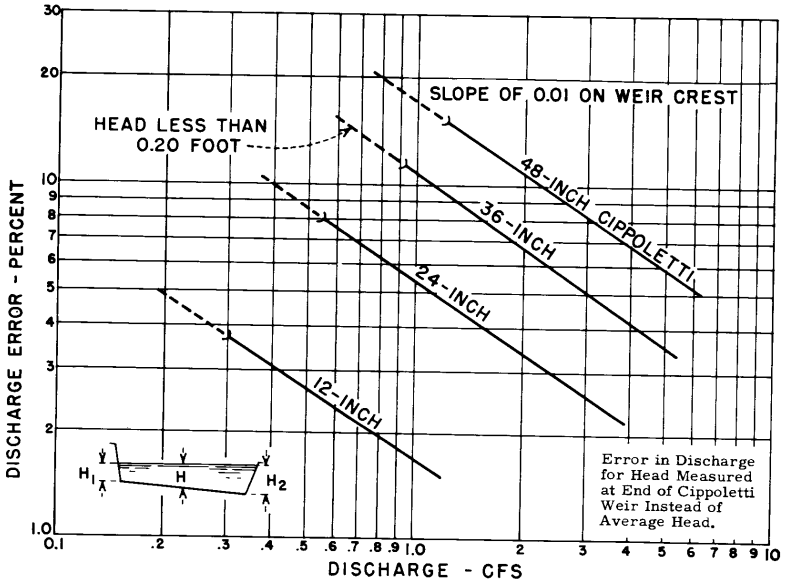
The figure, lower left, shows the magnitude of the error in discharge resulting from measurement of head at either end of 12-, 24-, 36-, and 48-inch Cippoletti weirs, having a transverse slope of 0.01,

instead of using the average head over the weir. An inclination of about 6 degrees will cause an error in the order of 1 percent. An angle of this magnitude should be detectable by eye, and corrective measures taken.

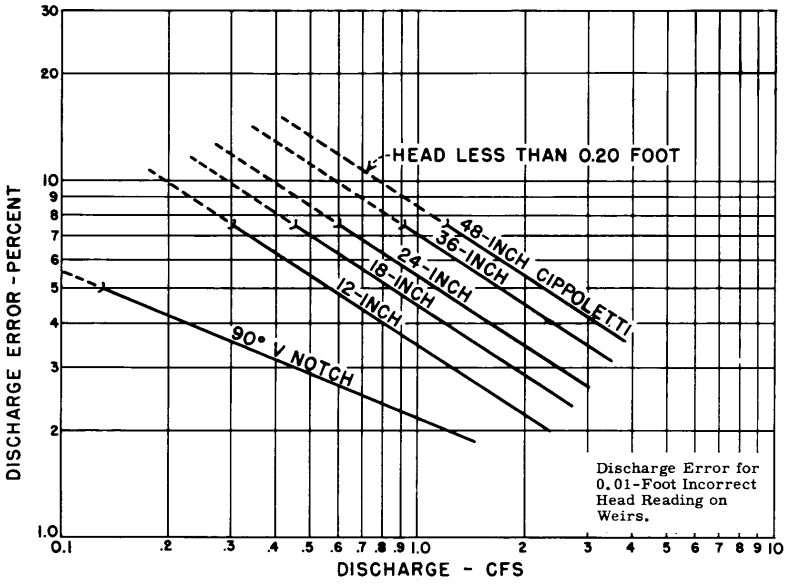
The figure, upper left, shows the error in discharge resulting from a 0.01-foot incorrect head reading on 12- to 48-inch Cippoletti and 90° V-notch weirs. This figure clearly illustrates that even with a small error of 0.01-foot, an error of approximately 7-1/2 percent in discharge results when the lower heads are being measured. For greater heads this error is less. Also, it can be noted that for the longer weirs this slight error in head reading results in quite large errors in discharge measurements.

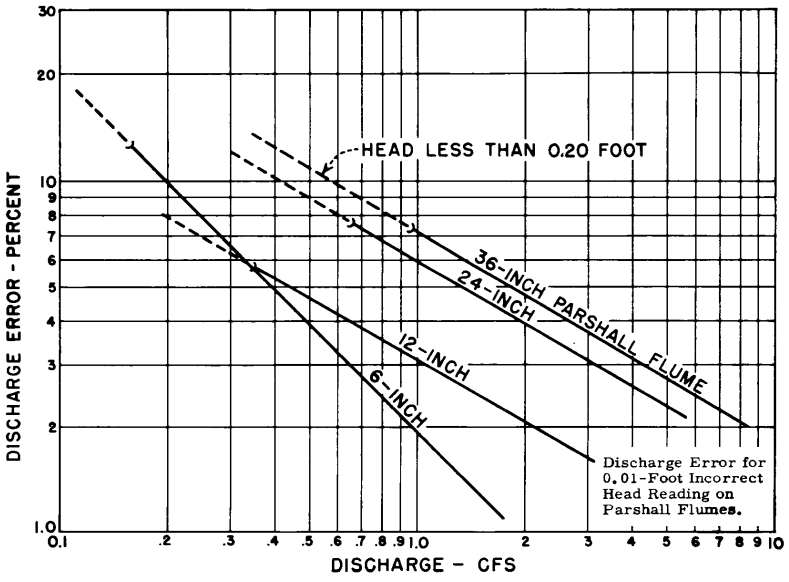
As in the case of weirs, the head at the throat of a Parshall flume is quite easily misread in the field. The error in discharge resulting from misreading the gage only 0.01 foot is shown in the figure at lower left. Parshall flumes of throat widths of from 6- to 36-inches

are shown in this figure. It can be noted that the error in general is approximately the same as for misreading the head an equal amount when weirs are considered.

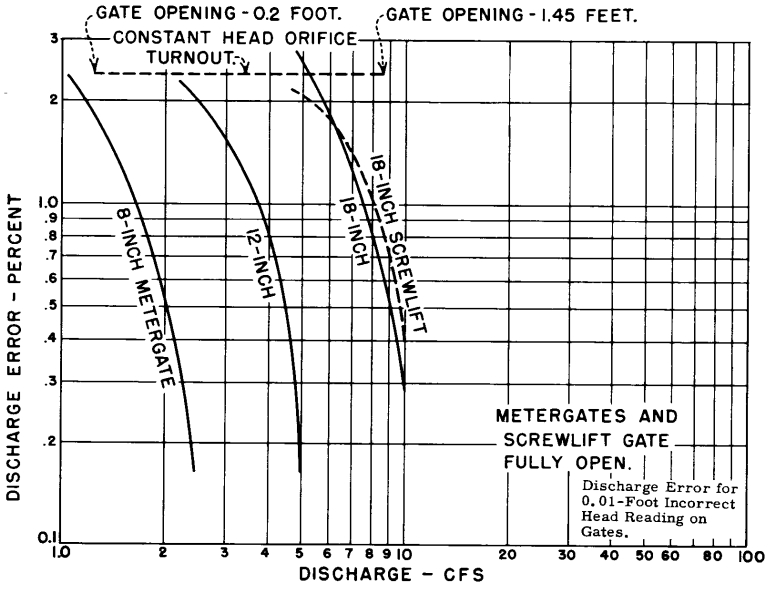
The figure below shows the error in measurement resulting from an error of 0.01-foot in reading the head on 8-, 12-, and 18-inch screw-lift gates. The meter gate has a circular leaf and the screw-lift gate has a rectangular leaf. Included in the figure is the error caused by 0.01-foot incorrect head reading for the constant-head orifice turnout. It should be noted that the percentage error in discharge resulting from misreading the head on an orifice is in general less than the same misreading on a weir.

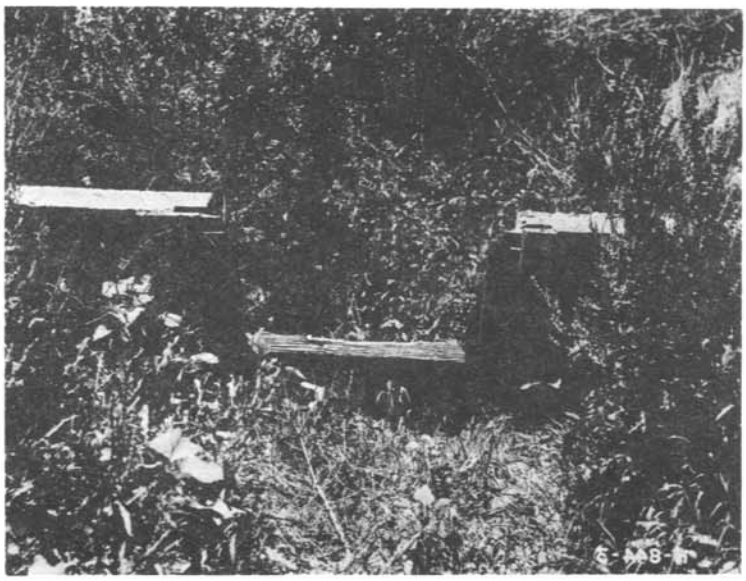
In irrigation practice many of the older weirs were constructed of wood. In this type of construction the original sharp edge of the crest soon becomes rounded. Rust and corrosion also produce a rounding effect on metal weir blades. The effect of this rounding is to cause an increase in the flow rate for a given head when compared to a sharp crested weir. Considerable experimentation has been done to evaluate the effect of the rounding of the crest. The results show that the percentage increase in discharge due to the rounding, decreases as the head increases. For a head of 0.5-foot, an increase of some 2, 3, 5-1/2, 11, and 13-1/2 percent may be expected for roundings having radii of 1/24, 1/8, 1/4, 1/2 and 3/4 inch, respectively. There is a deficiency of data for the higher heads with the longer radius roundings. However, with radii smaller than those given above, the increases become consistently smaller as the head increases. As an example, the increase in discharge of 2 percent, given above for the 1/24-inch rounding at 0.5-foot

head, becomes 0.7 percent at 1.0-foot head and about 0.5 percent at 1.35-foot head. An extreme example of rounding of a weir crest is that shown in the photograph on the preceding page.

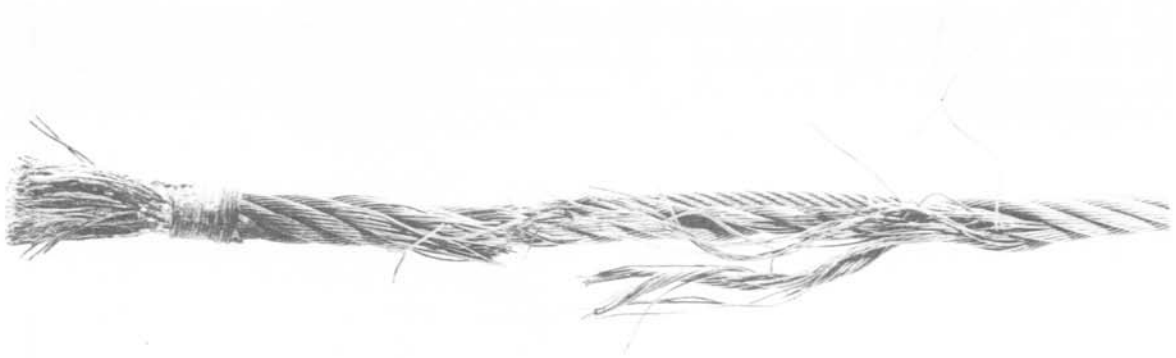
A word of caution is appropriate, however, as pointed up by a recent failure of stainless steel hoisting ropes after about six months of service at a loading of only about one-eighth of breaking strength. The failure occured on an automatic gate and was due to hunting over a range of 2 or 3 inches.

The major break shown above was a few inches above the point of attachment to the gate, where the rope was straight and not subject to bending; but breakage of single wires had occurred all through the rope structure as shown on the more detail photographs on the following page, and particularly where the rope was flexing as it ran on and off the drum.

Stainless steel is very susceptible to work hardening. Military Specifications No. MIL-C-5424 allow a 50-percent reduction in tensile strength after 50,000 bending reversals of 1/4-inch 6 by 9 stainless steel rope. Fewer reversals would be required to produce a similar weakening of larger ropes. Individual wires of a rope are subject to torsional, as well as tensile, stresses when the rope is under straight tension; and each wire twists and untwists if the rope pull is alternately increased and decreased. This explains the failure of the ropes at a point of straight tension.

Stainless steel wire rope should not be used on gates which are likely to hunt and the need for lubrication of stainless ropes should not be overlooked. Keystone wire cable grease is recommended.

We suggest that all stainless steel ropes now in service be examined minutely, at the convenience of operating personnel, for possible breakage of individual wires as shown in the photographs above. If any such breakage is discovered, it should be reported along with the conditions of operation and service. An alarm is not being sounded, as the one case of failure was due to very unusual operating conditions. However, due to the possibility of extensive damage to facilities in case of rope breakage, a careful investigation is warranted; and operating personnel who may be using or considering the use of stainless steel rope should be informed of its inherent work-hardening characteristics, and its limitations under continuous flexing.
