WATER OPERATION AND MAINTENANCE

BULLETIN NO. 85

SEPTEMBER 1973

CHEMICAL GROUT EXPEDITES TUNNEL REPAIR[1]

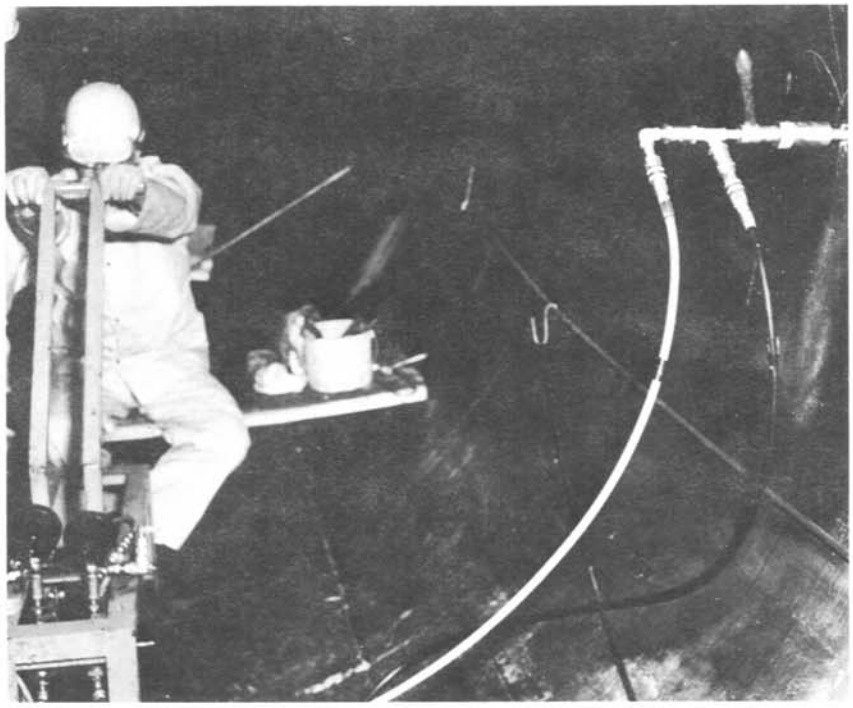
Figure 3 P245-713-5242 NA

In tracing the red dye, grout travel up to 22 feet was observed along the cracks. Travel of 3-5 feet either way from the grout hole was more common. Nine hundred sixteen gallons of chemical solution were pumped into the lining over a total distance of 2,200 feet. Refilling of the tunnel occurred on June 22, 1972. The previous leakage of

80 g.p.m. had been reduced to 2-3 g.p.m. Initial surface leakage from previous seep areas was zero.

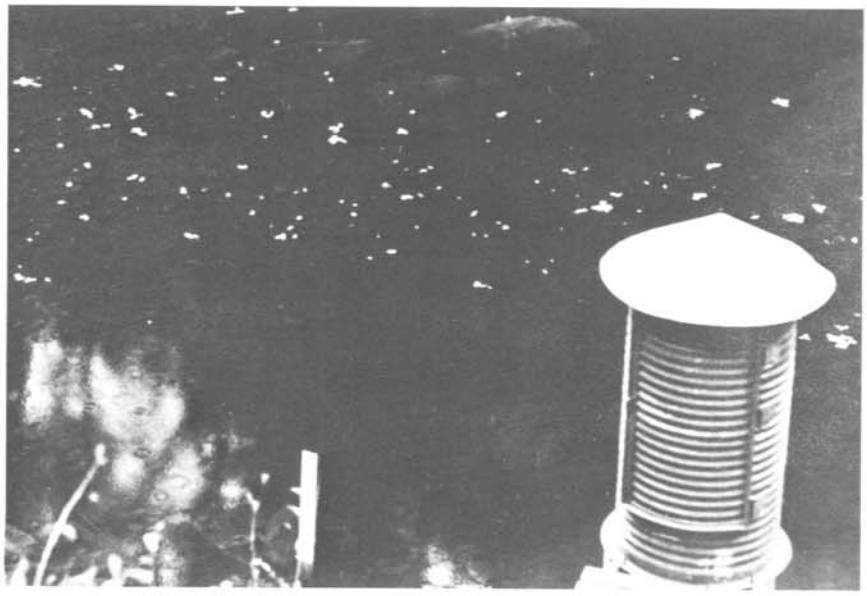
Figure 4 PX-D-54339

The idea presented in this article is designed to protect radio-operated stream gages from gun-toting vandals. Stream gages are an expensive and delicate instrument, and are usually housed in a gaging station made from corrugated steel to protect the recording equipment. See Figure 4 below.

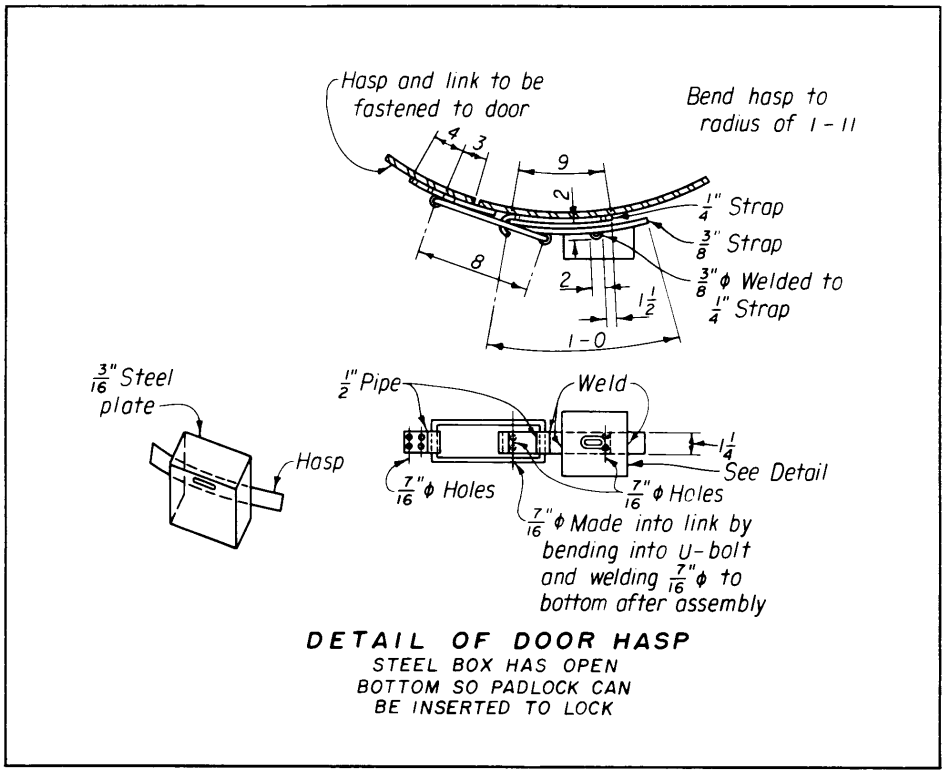
Vandals have no respect for property of any kind when they are bent on destruction, and the doors of some of these current-meter gaging stations have been broken open on numerous occasions and the equipment destroyed. Therefore, to prevent further destruction, maintenance personnel designed a unique steel plate box to cover exposed padlocks, and it has proven instrumental in preventing the locks from being pried open with a bar or tire iron.

The locks take a little longer for authorized personnel to open, but operating personnel overlook this inconvenience because of the effectiveness of this device. A detailed drawing of the protective steel box is shown in Figure 7 below.

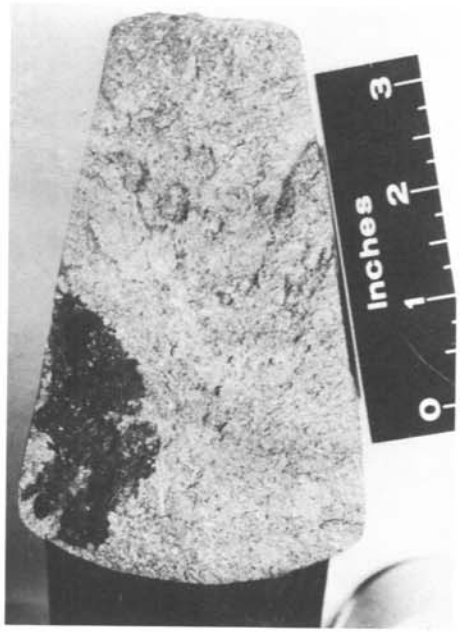
PX-D-73039

The crane hook shown on the following page was in normal use for only a few months when it failed under a partial loading. The two lower pictures are closeup views of the broken ends and graphically illustrate the reason for failure. The two pieces fitted together in the center photograph show the relative failure point.

Similar hook failures can be prevented with a good sound inspection program as outlined in the following regulations.

Section 1910.179, Overhead and gantry cranes (j)(3)(ix): "Crane hooks. Magnetic particle or other suitable crack detecting inspection should be performed at least once each year."

4. Incipient cracks are not always visible. Each hook should therefore be checked annually for cracks by being subjected to a Magnaflux, Zyglo, or some other suitable nondestructive crack detection test. If equipment for these tests is not available in the Region or from local test equipment rental sources, this office will aid in locating such equipment upon request.
