WATER OPERATION AND MAINTENANCE

Bulletin No. 94

DECEMBER 1975

Effective Maintenance Painting
Repairing Aluminum Irrigation Tubing
Safety Tips For Irrigators
Valve Lid Vandalism
A Low-Cost Shutoff Valve
Energy Conserving Enclosure

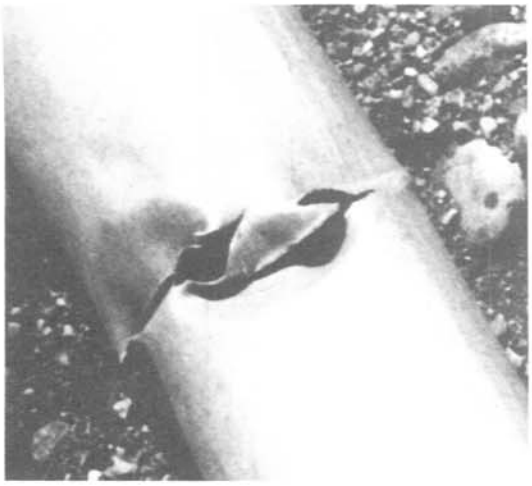
Figure 5

A large hole in a section of four-inch tubing, shown in figure 5, was repaired with fiberglass cloth and polyester resin purchased from a local marine supply company. The dents around the hole were removed, and the hole reshaped by the method previously described for the three-inch tubing. About one foot on each side of the hole on the outside of the tubing was cleaned with emery cloth, as in figure 6.

The hole was repaired by first applying resin to the tubing for a distance of about 10 inches on each side of the hole. After a piece of fiberglass cloth about 18 inches wide and 2 feet long was impregnated with resin, it was centered over the hole and wrapped around the tubing, see figure 7. The patch was secured with masking tape. The appearance of the patch could have been improved if a piece of wide masking tape had been placed over the hole before the cloth was attached. After the resin had cured, the patching procedure was repeated to give additional strength. Some small pinholes allowed leakage through the patch when it was tested. These pinholes could have been prevented by using more care in preparing the tubing and applying the resin and cloth.

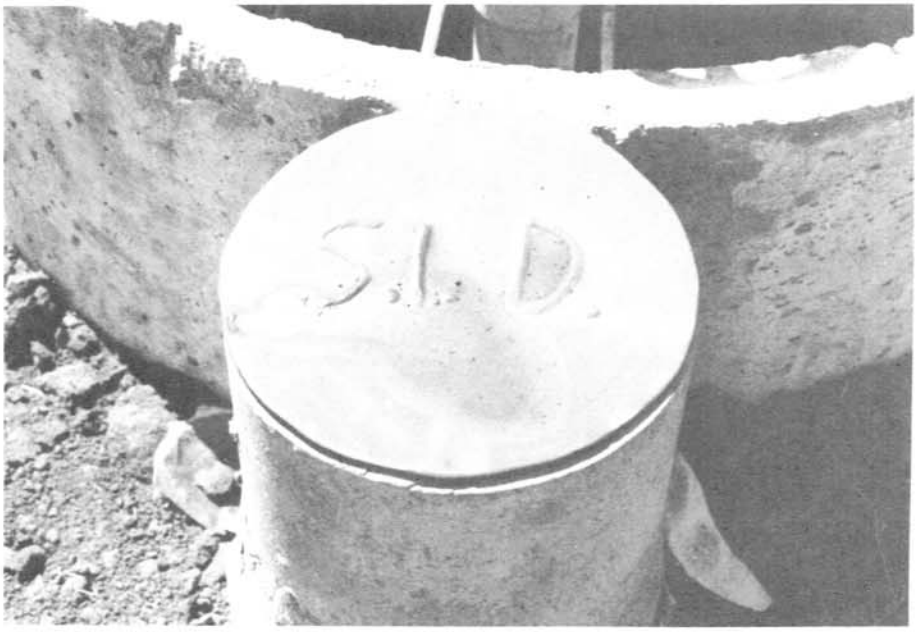
Figure 9

A unique idea to prevent vandalism of valve lids and also covers on air relief valves, etc., now being used by the Solano Irrigation District, Vacaville, California, has proved to be a most worth while project.

The photograph (figure 9) shows a closeup view of an Irrigation Turn-out valve lid with the initials S.I.D. branded on the lid. This branding was done by the shop welder and the District has stated that the branding has practically eliminated vandalism of the covers altogether. The covers were being taken by others who were using them for their own purposes, and the District is now able to keep the valve lids in their proper position.

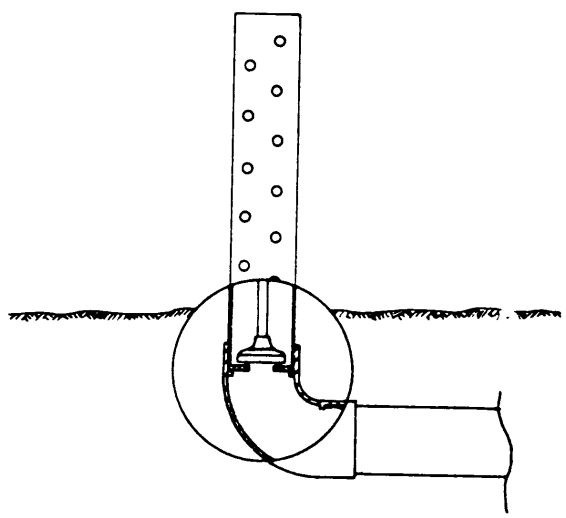
The shutoff valve shown here was made by placing a rubber plunger (plumber's friend) over a orifice plate cemented into a plastic-riser pipe. Figure 10 shows a riser inlet and shutoff used in a feedlot with broad-basin terraces. Slight pressure due to liquid head seals the valve. This valve can be used in inlet risers as a shutoff for each debris basin of a feedlot runoff control facility. The rate of water collection in each basin was recorded during runoff events. The inlet risers in the basins were connected to underground lines for conveying runoff to a holding pond.

The orifice plate was cut from 3/8-inch plastic (Plexiglas) and cemented into the riser pipe. However a thicker orifice plate could be used. The orifice plate was supported by the shoulder of the fitting. Female polyvinylchloride (PVC) fittings including elbows, tees,

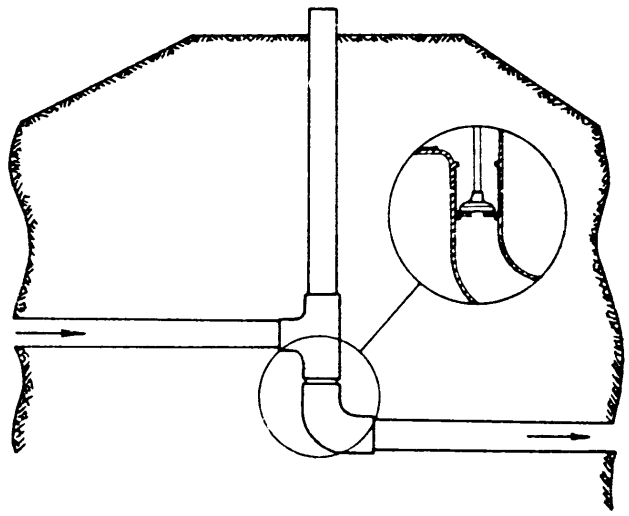
The valve also was used to control gravity discharge of effluent from an animal waste holding pond. Figure 11 shows a cross section of an earth dam and shutoff for draining holding ponds. Located in the center of an earth fill dam the valve consists of an elbow, tee, orifice plate, and the rubber plunger. The open riser to the top of the fill served as an excess port for operating the valve, which could be opened and closed under 7 feet of head. The plunger should be securely fastened to the pull rod. Modification of the plunger would be necessary to operate at greater head or in larger pipes.

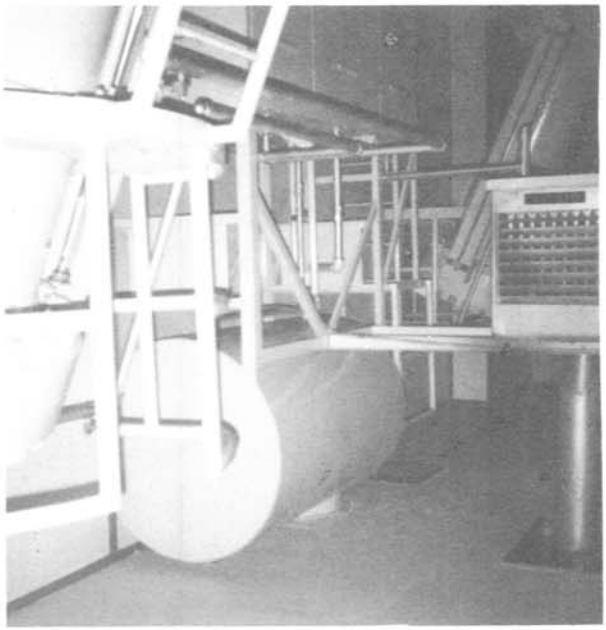
By cleverly sectioning off the space around the ring-follower gates and oil supply tanks with a roof and a wall, the amount of space to be heated was reduced to 7,000 cubic feet - a 75 percent reduction. The wall was built flush with the face of the control panel, allowing easy access to gages and controls shown in figure 12.

Figure 13 shows a clear view of the interior of the enclosure with a "snug fit" around the equipment. Gas heaters can now maintain the proper operational temperature around the equipment with a substantial reduction in the amount of fuel used.
