WATER OPERATION AND MAINTENANCE

BULLETIN NO. 106

DECEMBER 1978

WATER OPERATION AND MAINTENANCE
BULLETIN NO. 106

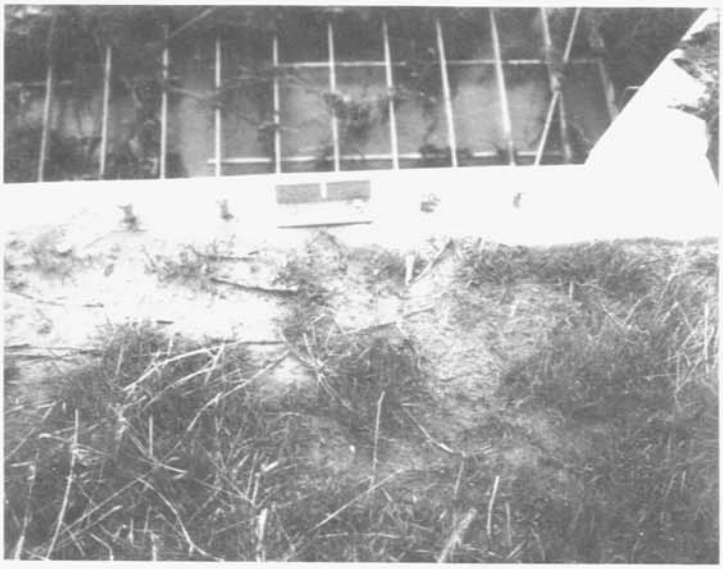
To make sure such a problem did not occur again, the top hinges were removed and placed on the base of the rack. These base hinges were moved far enough away so that the rack could be dropped down without striking the drain top. The racks were fastened in an upright position with a short length of small chain secured in a slot cut in a piece of metal angle, which was anchored to the existing top hinge anchor bolts.

Figure 4.–Slotted angle-iron chain retainer to hold rack in place.

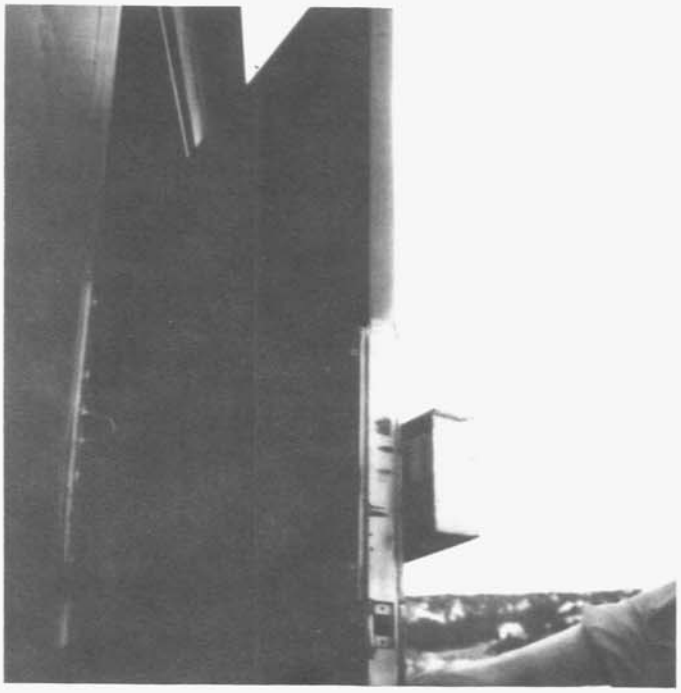
Figure 6.–Door open (hasp visible).

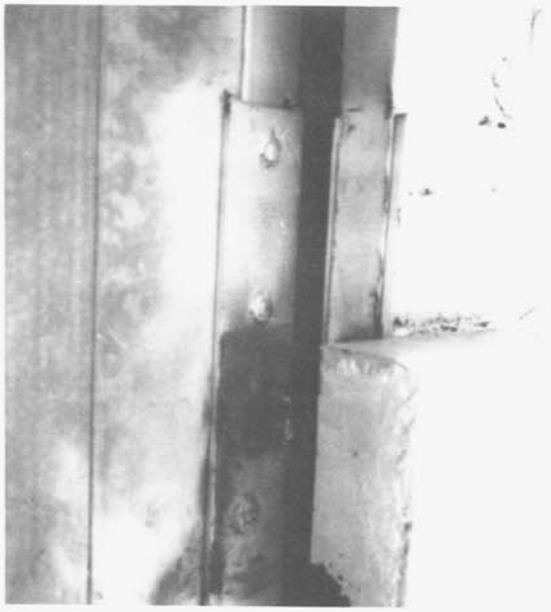
Figure 7.–Door closed (hasp covered).

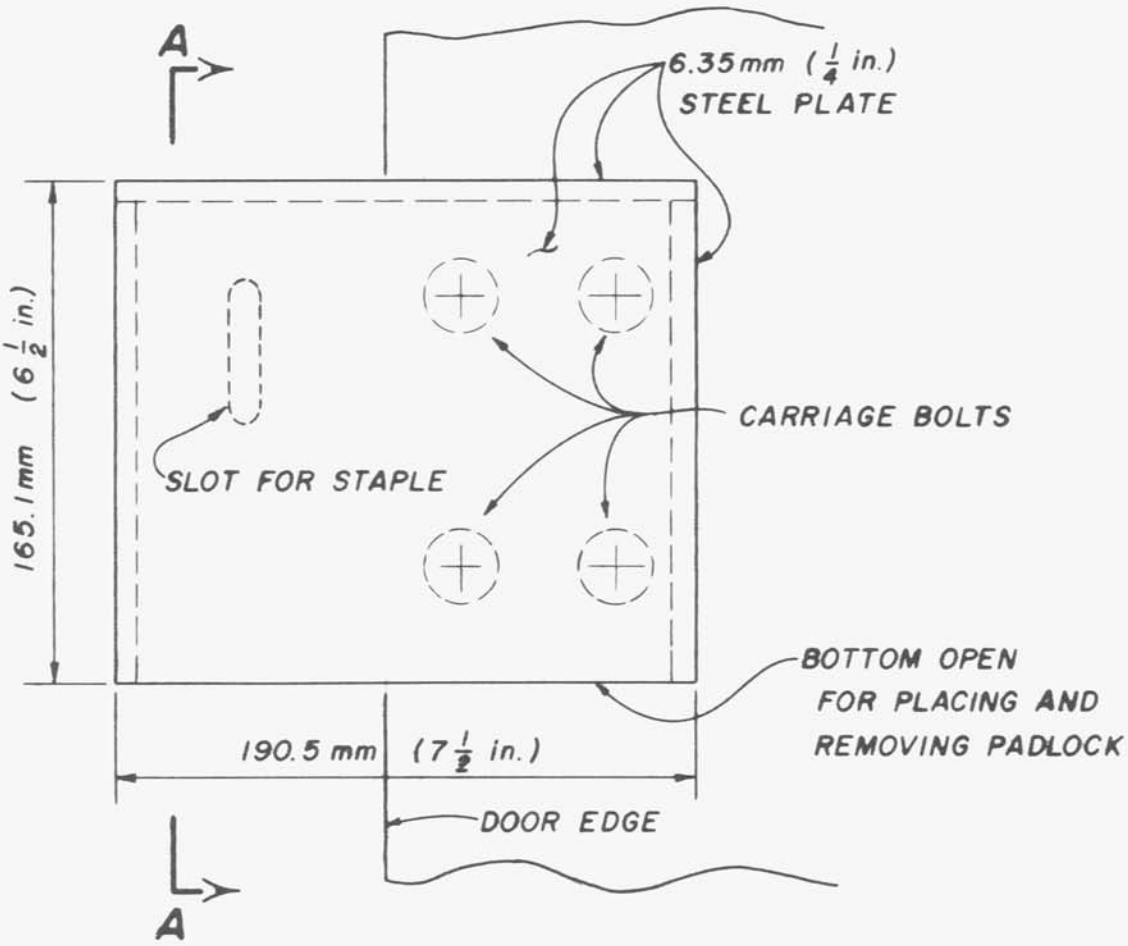
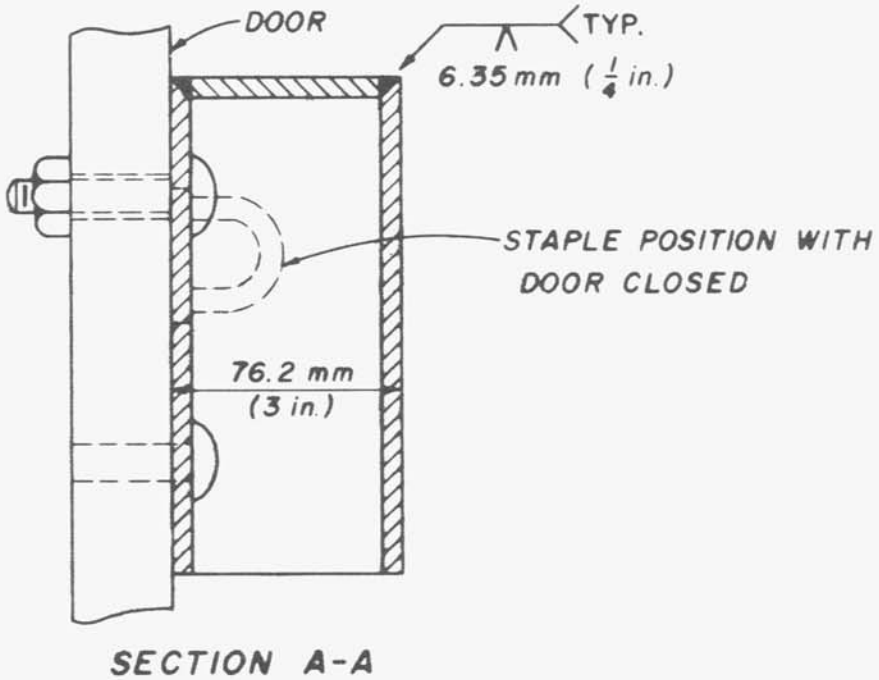
Figure 8.–Padlock cover.

The padlocks used on the doors and hatches or lids at these installations were being battered or broken off by hammers, rocks, screwdrivers, bars, etc. Mr Abe Miller, Plant Mechanic at Alcova, Wyoming, designed and installed covers for these exposed padlocks. These covers can be permanently installed on the doors, or hinged so they can be swung out of the way when not in use. Similar covers can be constructed over built-in door locks that will protect them from external damage.

The material required for these covers is approximately a 0.186 to 0.279 m^2 (2 to 3 ft^2) of 4.76- or 6.35-mm (3/16- or 1/4-in) thick plate steel and can be built and installed for about $15 each. (See drawing on following page.)

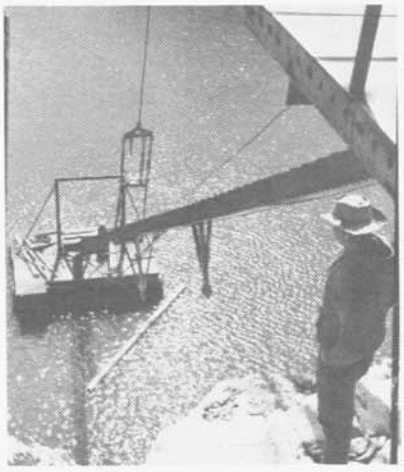
Figure 10.–Ron Rosenberg at the pumping station during low water in April.
