SPOTLIGHT ON GLEN CANYON DAM

POLICY FOR SAFETY RECOMMENDATIONS[1]

CRITERIA[1] FOR THE REMOVAL OF TREES, OTHER VEGETATIVE GROWTH, AND RODENT BURROWS FROM EARTH DAMS, DIKES, AND CONVEYANCE FEATURES (1987)

LEMON DAM–CONCRETE SPILLWAY INLET WALL FAILURE

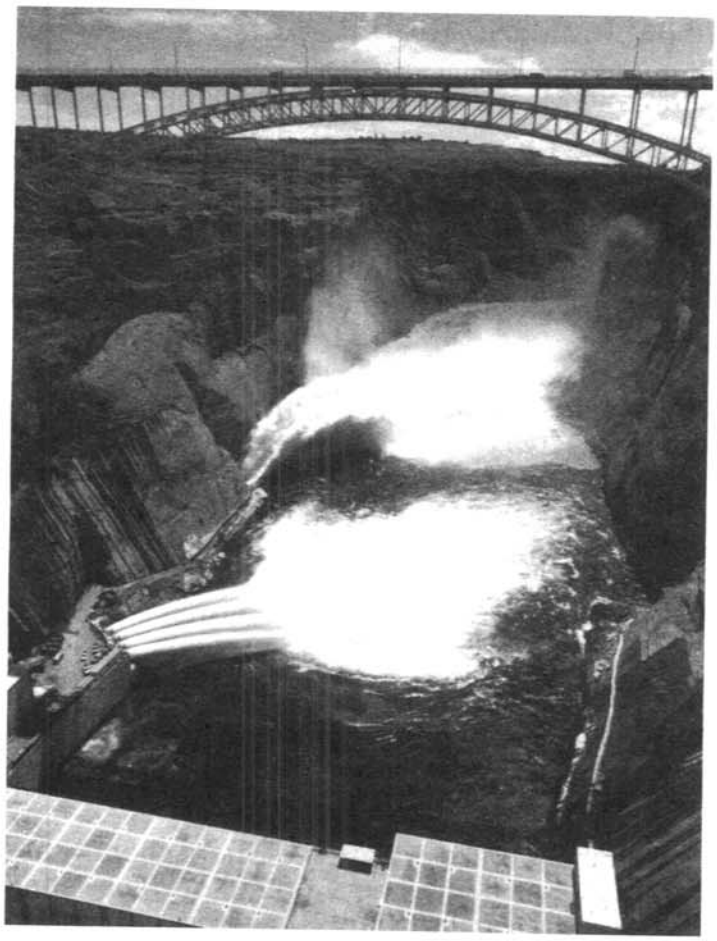
Photo 7. Glen Canyon Dam.

Aerial view of left spillway and hollow-jet valves in operation. 8/12/84

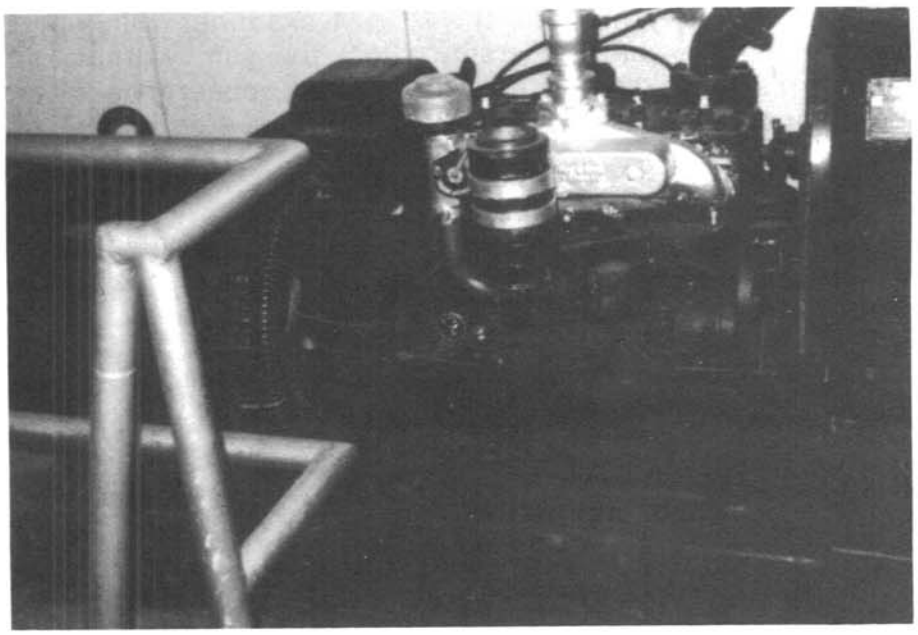
Photo 1. - Potential for gasoline fire or explosion. Carburetor is inoperable and replacement parts are no longer available. Gasoline is poured into engine in order to operate.

Photo 2. Potentially hazaardous intake tower. A safety buoy line should be installed to prevent swimmers and boaters from drifting into intake tower. A sign should also be posted warning recreationists of high-velocity flows.

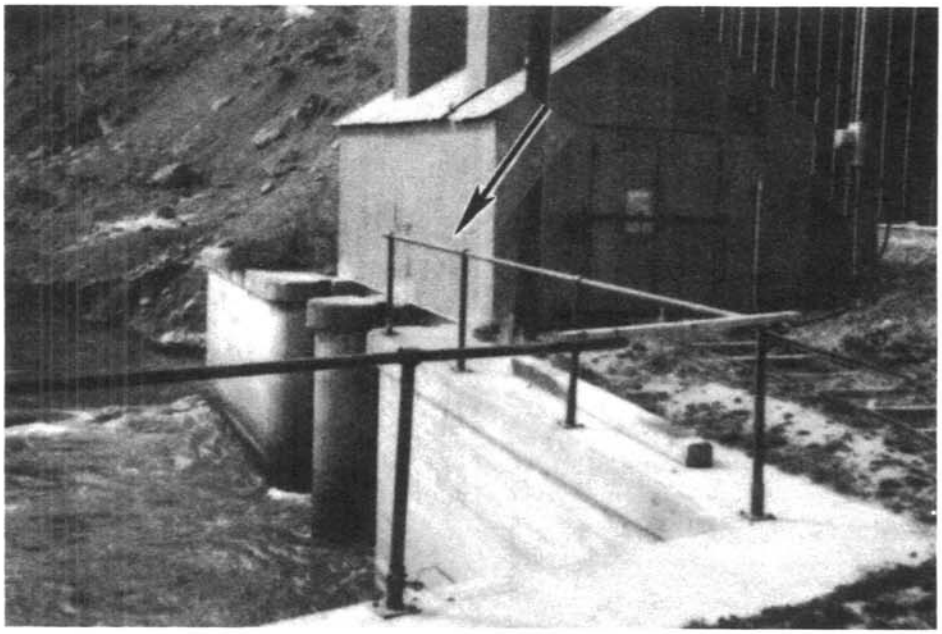
Photo 3. - Broken guardrail has been patched with a timber board and should be replaced with a pipe of original design. Also, the guardrail should be extended to the equipment house to prevent anyone from falling through the opening.

Photo 4. - Closeup view of above photo showing opening.

Photo 5. - Grab bars are needed to allow operating personnel to climb safely through the roof hatch.

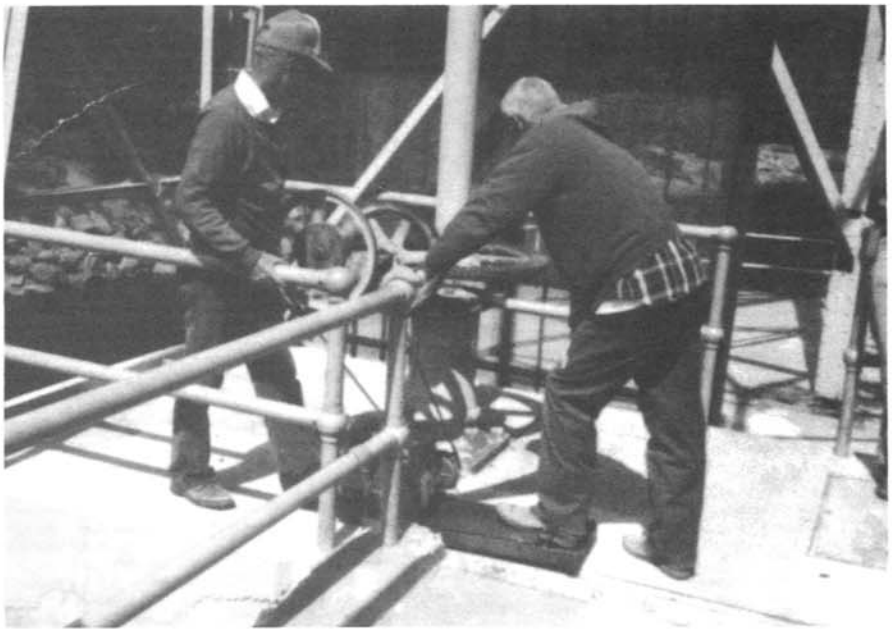
Photo 6. - Unscreened motor-driven gate operator. A rubber fan belt is connected between a 3-hp gasoline engine and a 14-inch-diameter pulley on the handcrank shaft. Tension in the belt is maintained by foot pressure against the engine base. The equipment should be screened because serious injury can result.

Photo 7. The safety screens around the motor-operated gears can protect operators from serious injury.

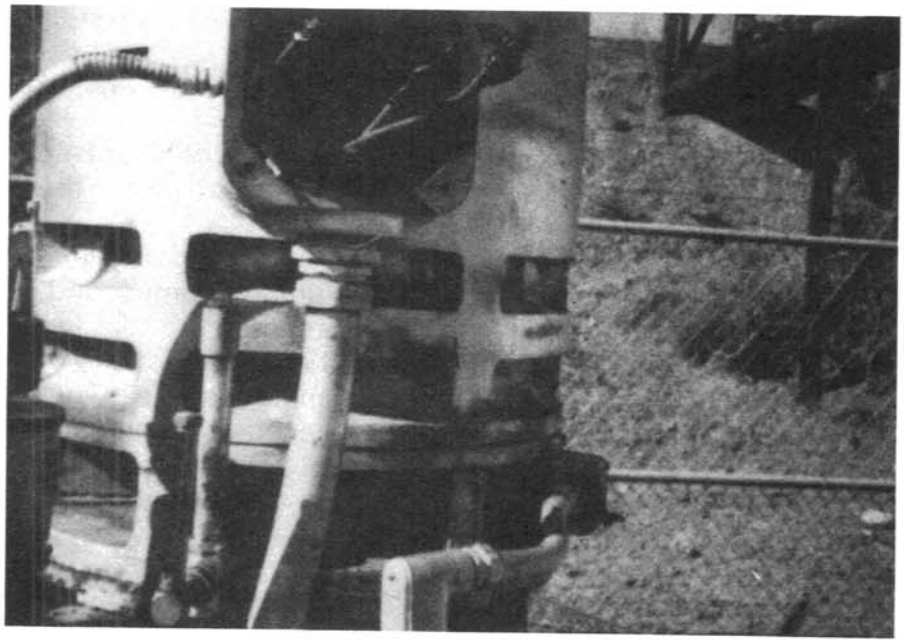
Photo 8. The missing faceplate should be replaced. Exposed electrical wiring on the motor junction box can cause serious injury to operating personnel.

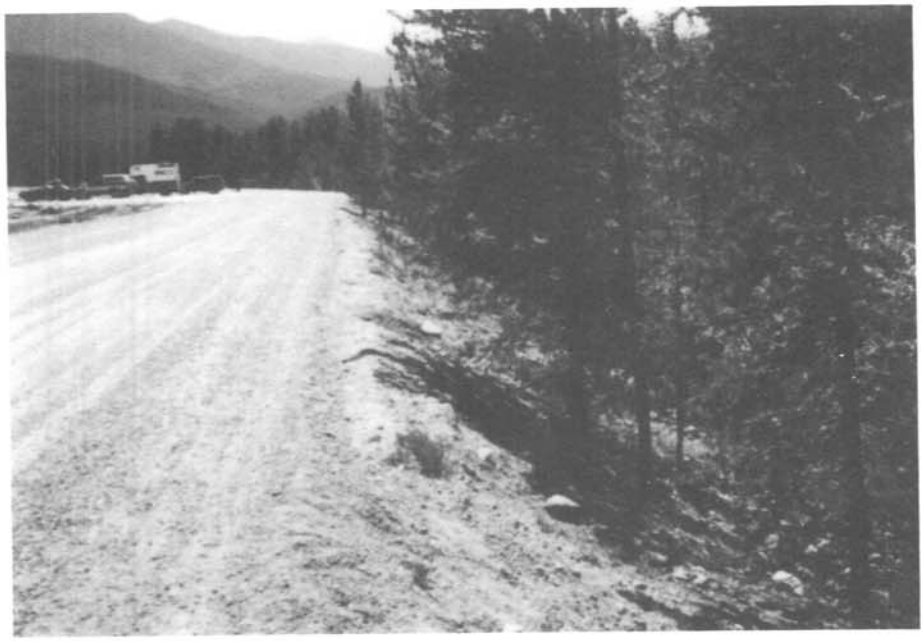
Photo 10. - Conifers have established themselves on the downstream face of this saddle dike and can conceal evidence of any problems in this area.

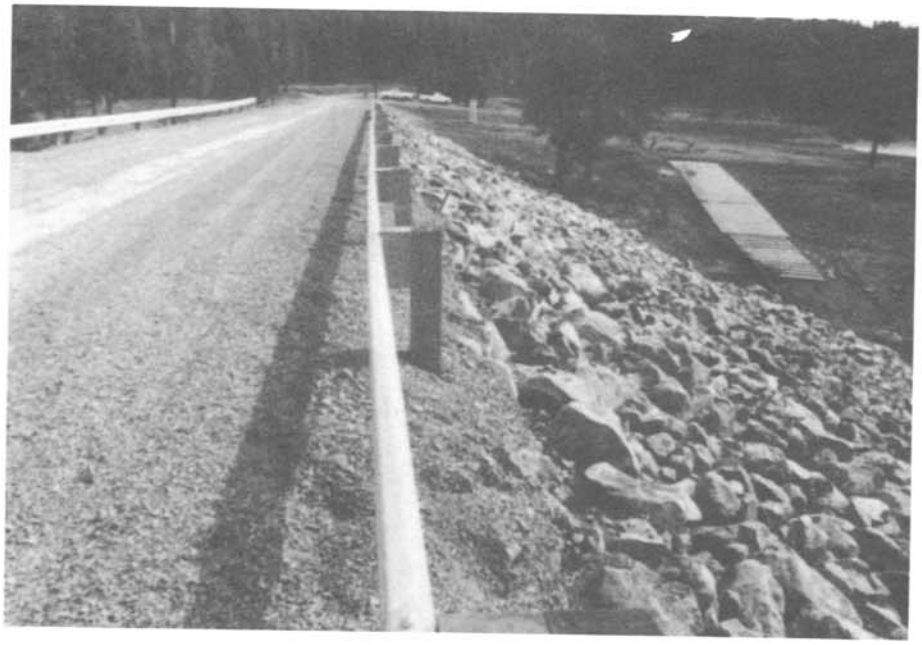
Photo 11. - Mature conifers have established themselves on both the upstream and downstream faces of this low saddle dam. Surveillance of rodent habitats and structural problems is difficult to perform.

Photo 12. - The two conifers near the right upstream abutment can provide annual seed stock for more conifers and result in the spread of undesirable growth in this area.

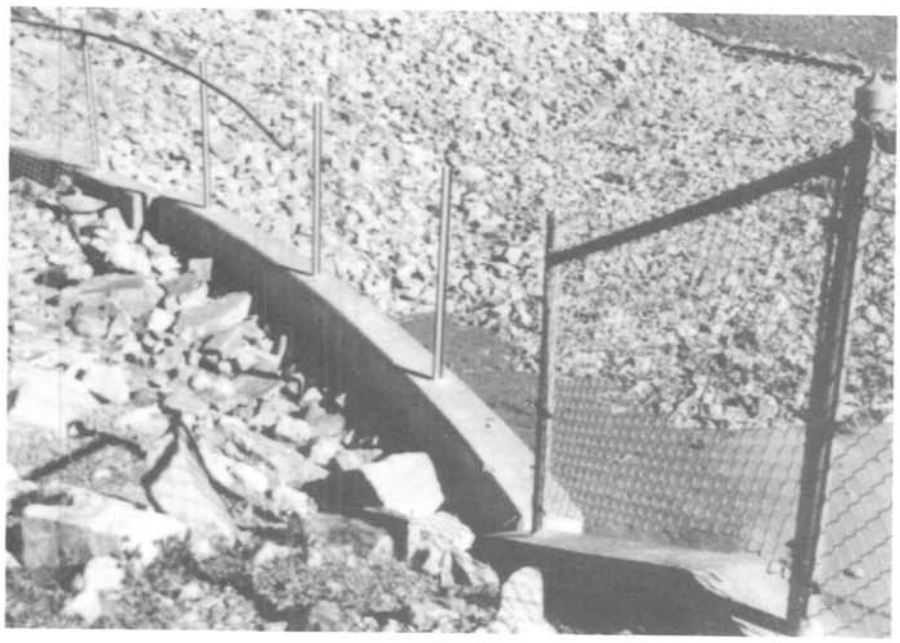
Photo No. 1. - Lemon Dam

Right wall of spillway approach channel. Deflection of the wall damaged the fence.

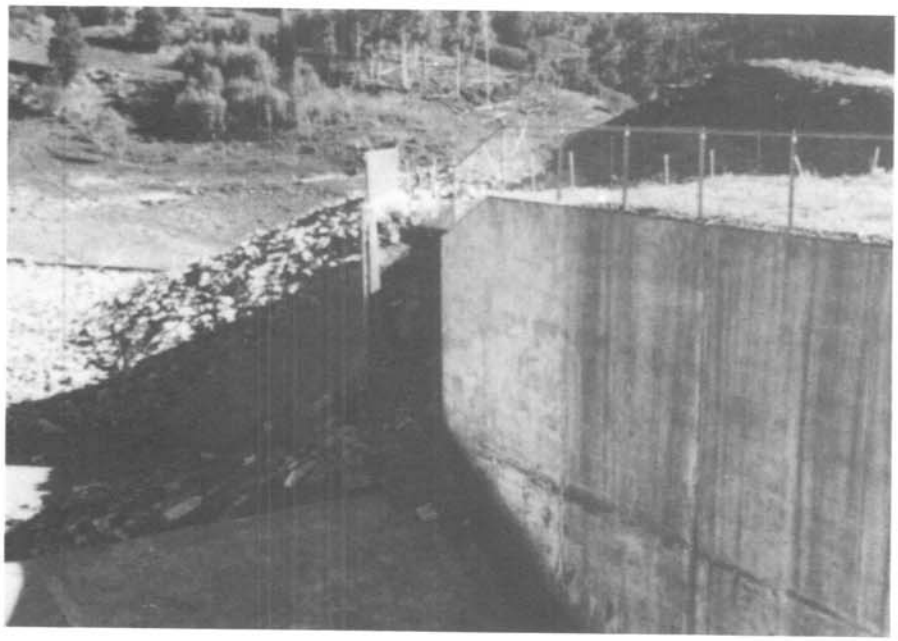
Photo No. 2. - Lemon Dam

Incident: Beginning in 1966, progressive deflections were noted in both concrete spillway inlet walls. By 1973, deflections as much as 12 inches were apparent; and on May 14, 1973, the left wall failed and fell into the spillway. The incident did not cause any operational problems.

Upon examination of the exposed reinforcement at the base of the wall stems during the reconstruction, it was discovered that only one-third of the required face wall movement reinforcement extended into the footings. In addition, for the left face wall that had overturned, only stubs of moment reinforcing bars protruded above the footing, and only two or three of these showed the characteristics of tension failure. It appeared that most of the bars did not extend continuously into the face wall, and two-thirds of the bars did not extend into the wall footing. Lack of proper reinforcement was probably the major cause of the failure of the spillway entrance walls.

Left wall of spillway approach channel. Failure was result of repeated cycles of frost action on saturated fill.

Remedy: Since it was determined the deflections were caused by freezing action in the impervious soil blanket behind the concrete walls, a portion of the backfill was excavated and a pervious blanket of soil was placed beneath a layer of impervious soil. Several pipe drains extending to the base of the wall penetrated the pervious backfill. Insulation board, 1-1/2 inches thick, was placed between the back face of the walls and the pervious backfill. Seepage wells to collect the pipe drainage and heaters were installed at the base of the walls to allow drains to operate through the winter months. The curved inlet walls were replaced with adequate reinforcement anchoring the walls to the footings.
