FILL SLOPE REPAIR USING SOIL BIOENGINEERING SYSTEMS[1]

THE SLUICEWAY FAILURE OF RIVERSIDE DIVERSION DAM

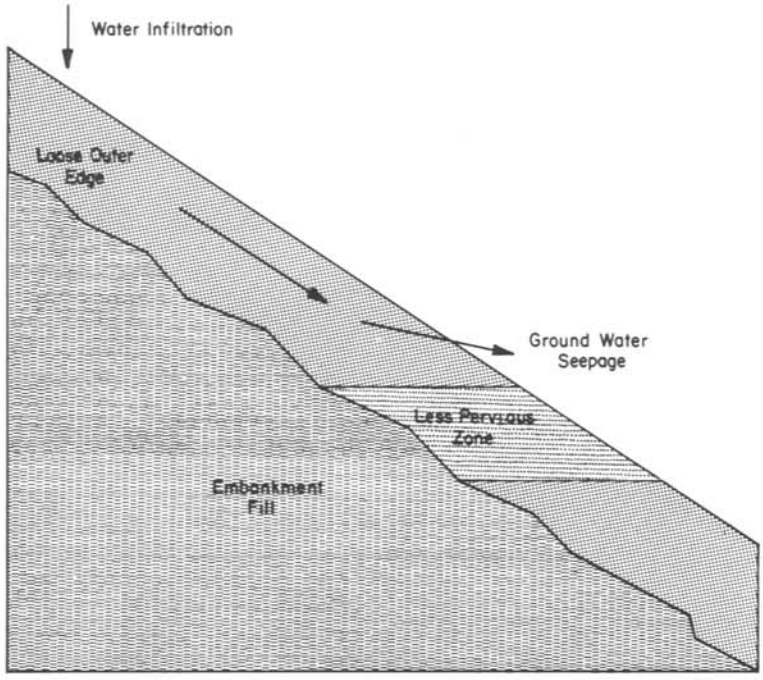
Figure 1. – Schematic illustrates variables controlling shallow slope failures in compacted fill slope.

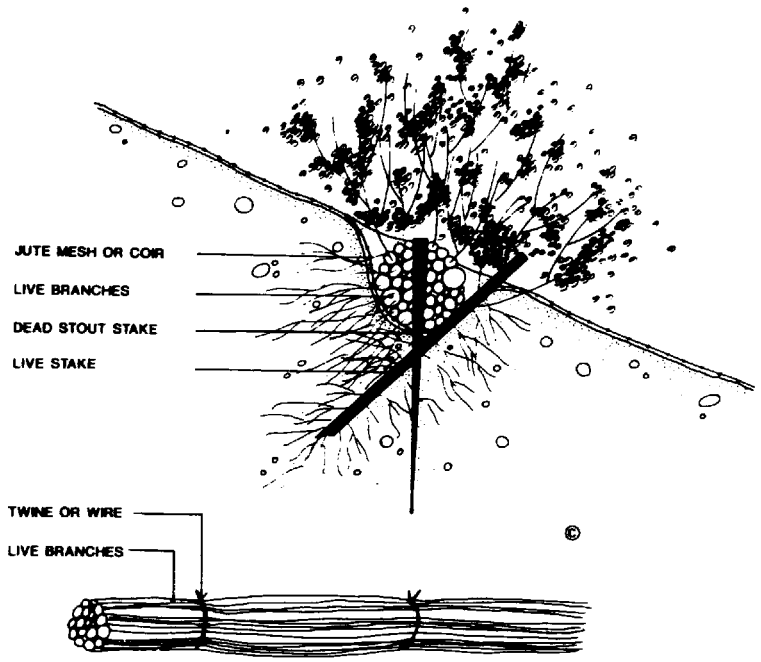
Figure 2. – Live fascine with jute or coir. Rooted/ leafed condition of the living plant material is not representative at time of installation.

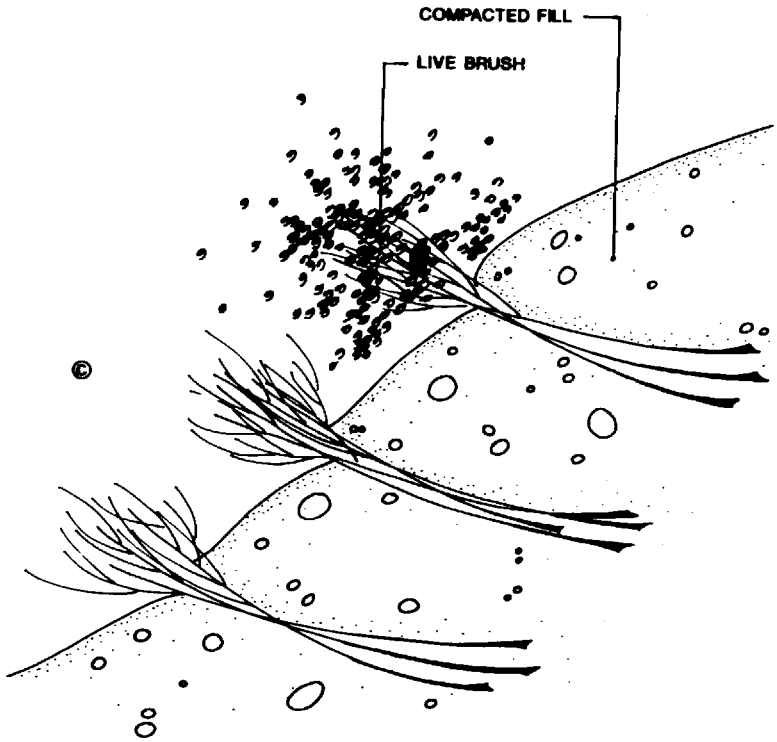
Figure 3. – Schematic representation of a brush-layer fill installation.

Brushlayering system.–This system (figure 3) includes brushlayers cut into a slope and those used in a new or repair fill that abuts the slope face. The branches are placed as the fill is raised in the latter case. This system works very well as porous filter units to control surface erosion from heavy rains during and after construction. This filtering action was observed during construction when 4.5 inches of rain fell in a 3-day period. The brushlayers prevented erosion of the outer edge of the loosely compacted fill material placed in the fill brushlayer system in Area 2. Those areas of the slope where such systems had not been installed experienced large soil flows and earth failures.

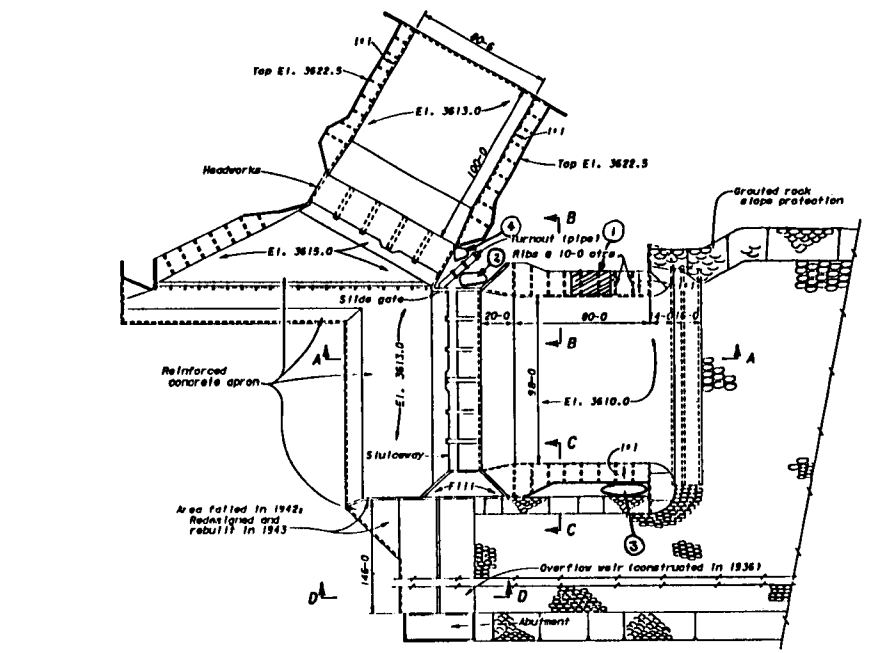
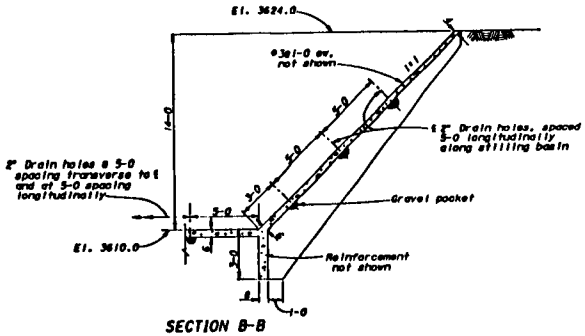
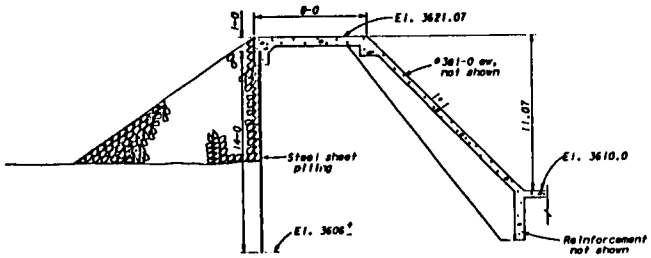
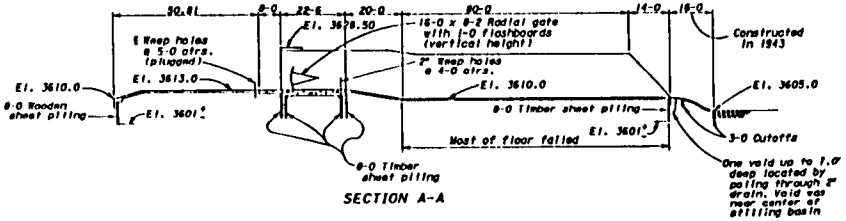
Figure 2

1. A section of left downstream side slope failed at 6:30 to 7 a.m.
2. Most of side slope failed by 9 a.m. (photograph 2).
3. Closed sluice gate on left side by 10 a.m.
4. Upstream sinkhole, near headworks, started by 10 a.m. to noon.
5. Crack in left upstream sluiceway abutment noticed at noon (photograph 3).
6. Filled upstream sinkhole with concrete.
7. Dumped rock in failed embankment area.
8. Excess flow from Caballo Dam stopped.
9. All sluiceway gates raised to lower upstream water surface.

1. Another sinkhole developed near the right abutment of headworks.
2. Right downstream abutment of sluiceway failed.
3. Sluiceway gates were raised and diversions were stopped.
4. Excess riverflows were reduced.

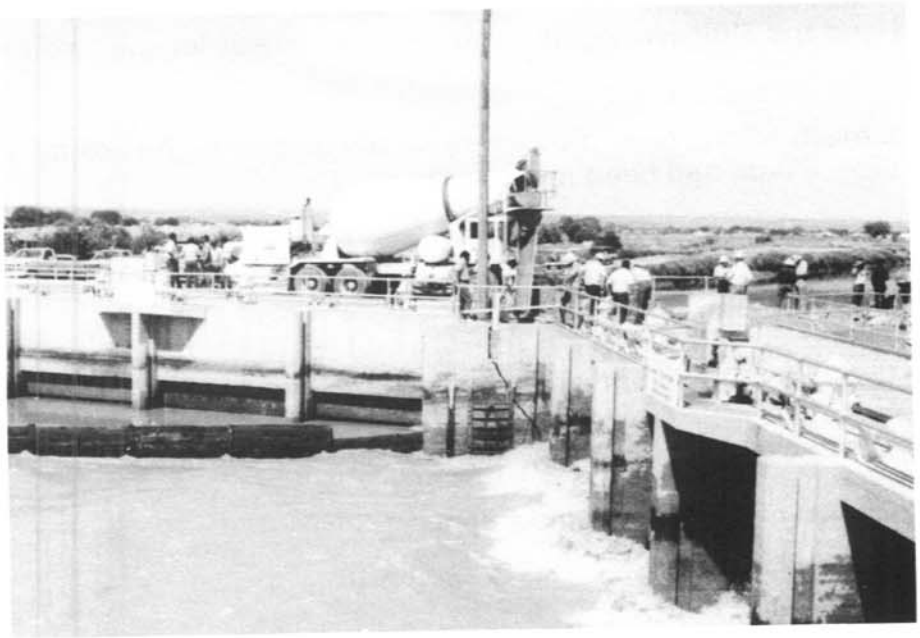
Photograph 3. - Riverside Diversion Dam. Notice crack in left upstream abutment wall of sluiceway. 6/9/87

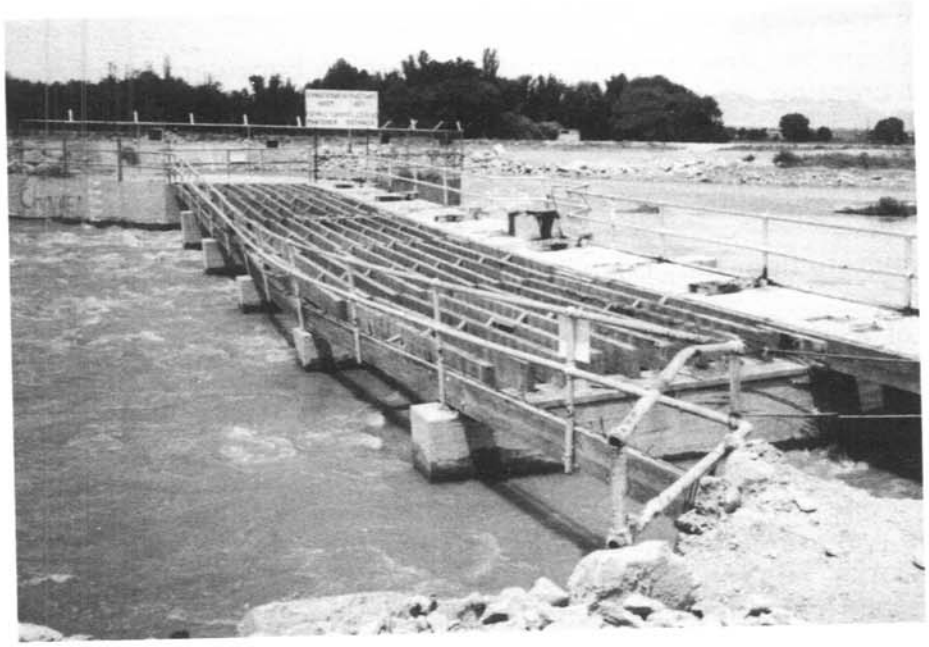
Photograph 6. - Riverside Diversion Dam. Dismantled sluiceway structure from left abutment after the failure. 7/15/87

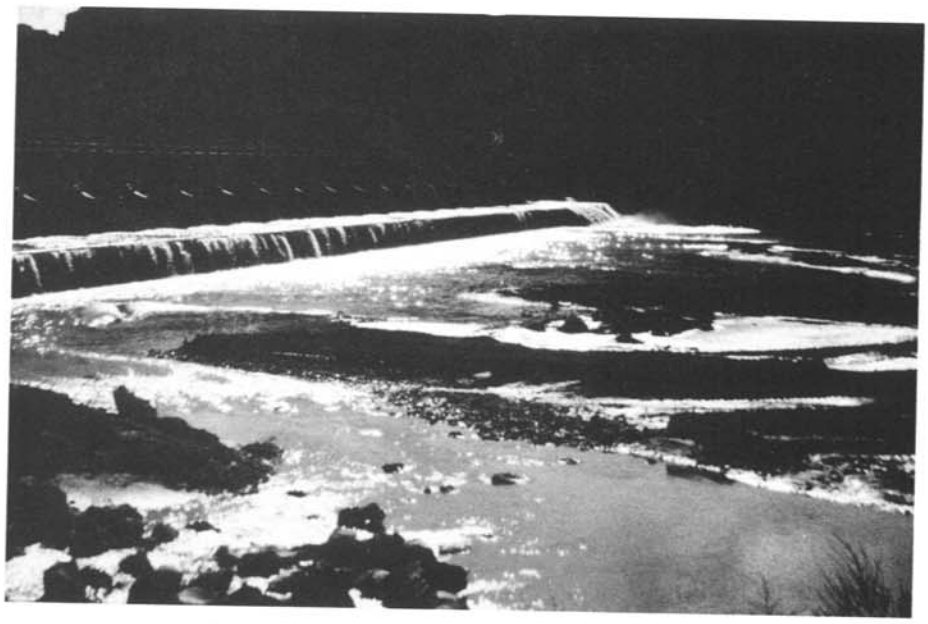
The average riverbed elevation, the summer of 1988, was 6 to 10 feet below the dam's concrete apron, with localized scour holes of 18 feet immediately downstream of the dam. After an RO&M (review of operation and maintenance) examination, the threat of foundation erosion resulted in a Category 1 recommendation for correction. This meant repairs were critical for stability of the structure and must be completed prior to the 1989 runoff season.

Figure 2. – Downstream view of San Acacia Diversion Dam showing depth of scour prior to rehabilitation. 11/88

Repair work consists of placing riprap, bedding material, and geotextile for a distance of 65 feet downstream of the dam along the entire 700-foot width to an elevation of 7.5 feet below the apron elevation. The riprap is held at the downstream end by a line of sheet piles driven up to 28 feet below the top of the riprap and capped with concrete. The riprap is part of a filter system which consists of a 5-foot-thick layer of 3/4-yd^3-size riprap placed over a l-foot thickness of 6-inch-size riprap which was placed over a 1-foot layer of gravel. Geotextile was placed between the gravel and the underlying fine sand material. To accomplish this work, most of the 1,000 to 1,800 ft^3/s riverflows were diverted through the adjacent Low Flow Conveyance Channel for approximately 2 miles. The conveyance channel and river levee were breached at this point to return flows back to the Rio Grande. A minimum flow of 150 ft^3/s was required to be passed through the dam to support an endangered species of fish. Storage was not required at upstream reservoirs.

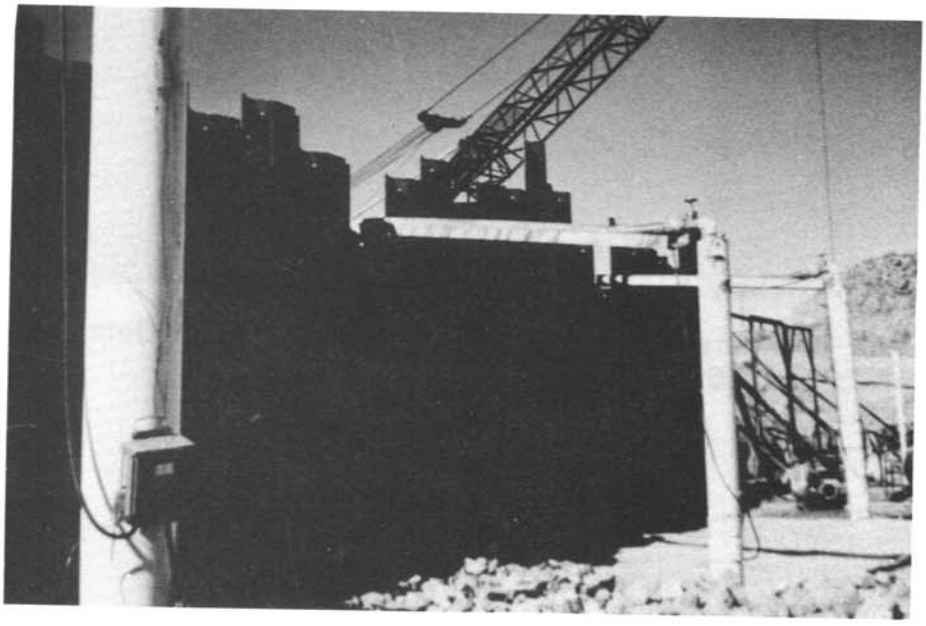
Figure 3. – Work area showing the dewatering wells just upstream of the steel sheet piling. 7/27/89

Dewatering of the work area was accomplished with 40-foot-deep 800-gal/min wells spaced as close as 30 feet. The dewatering operation lowered the water table in the riverbed 21 feet, allowing the 17-foot excavation to be done under dry conditions. Hydraulic jetting methods were used successfully in constructing the dewatering wells in the riverbed material. The ease in constructing the wells by this method allowed successful installation of wells outside of two-thirds of the excavation. Having the dewatering wells installed outside the excavation and still maintaining ground water at the design level significantly accelerated construction.

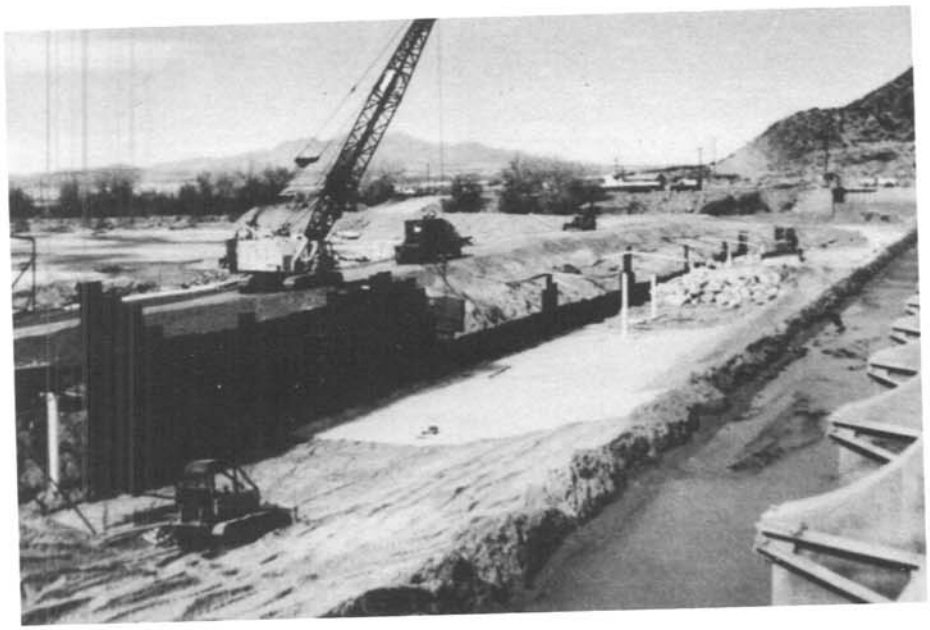
Figure 4. – Work area as viewed from the diversion dam. Some dewatering wells have been relocated to allow for geotextile placement and bedding material (center of photograph). 7/27/89
