WATER OPERATION AND MAINTENANCE

BULLETIN NO. 158

December 1991

Research and Development for Better Trash Screening and Cleaning Devices
The Importance of Proper Operation of Air Valve Assemblies
Trouble From the Sun
Recent Experience With Excitation System Upgrading in Hydroelectric Powerplants
Intake Tower Replacement for Bumping Lake Dam
Personal Computer Maintenance Management System
Water Banking — Minidoka–Palisades and Boise Projects
Water Conservation Program — Casper–Alcova Irrigation District and City of Casper
Savage Rapids Diversion Dam

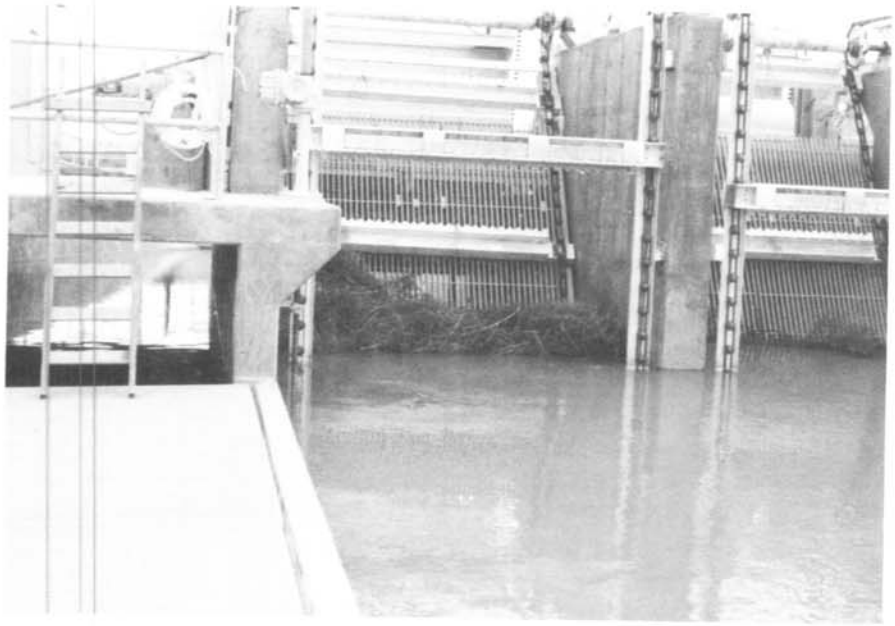
Figure 1. – A typical catenary-type trash rake located on the Government Highline Canal near Grand Junction, Colorado.

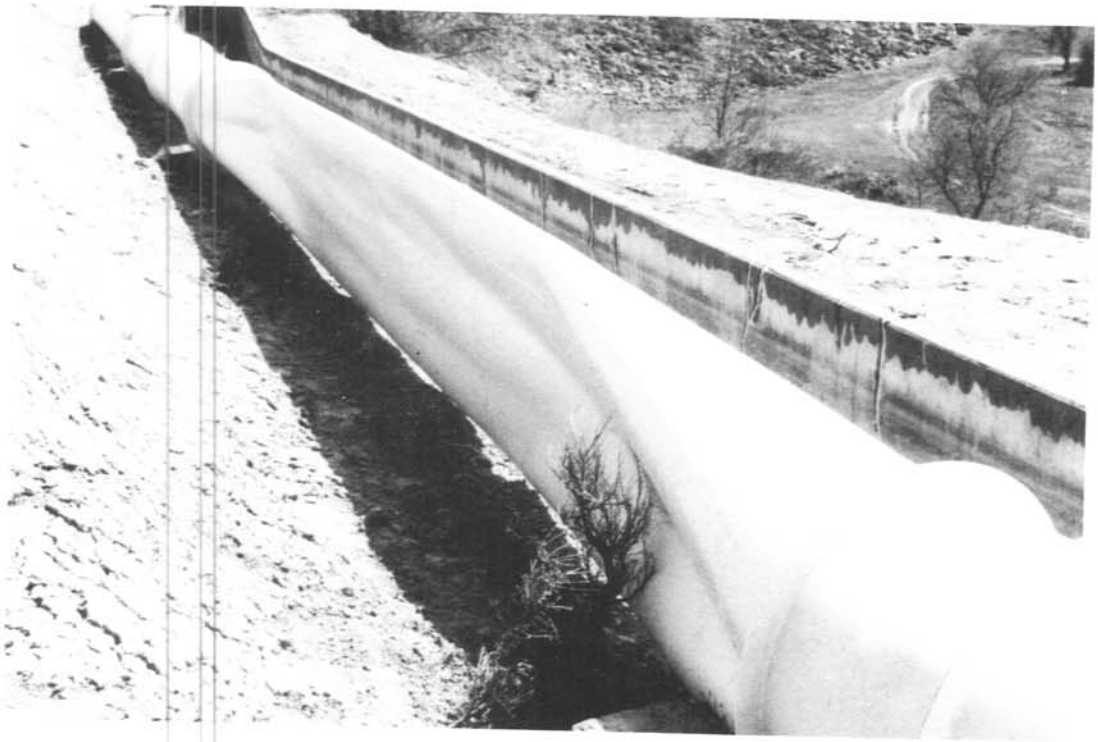
The consultant filled the penstock to check for any leakage in the pipe. After charging (filling) the pipe, he closed the regulating gates at the dam, closed the guard isolation valve (gate valve) located below the air vacuum/air release valve, and closed the pump turbine gates. He assumed that the penstock would remain full of water. But the pump turbine gates leaked sufficiently to create a vacuum in the pipe. The vacuum was enough to lead to the collapse of a 40-foot section of pipe.

Since the pipe collapse was caused by the consultant's operating error (the closing of the guard isolation valve), he obtained a replacement pipe section from Salt Lake City to be welded in place at Hyrum Dam.

Photo 2. - Hyrum Dam, Utah—Collapsed pipe viewed from west. 4/18/91

Two air valve assemblies will be installed by the consultant downstream of the regulating gates for the Hyrum Dam outlet works because there is about 400 feet of 34-inch-diameter penstock between the existing air valve assembly and the regulating gates. Gate seats for the pump turbine gates will be replaced to eliminate leakage when the system is not being operated.
