WATER OPERATION AND MAINTENANCE

BULLETIN NO. 159

March 1992

AMPHIBIOUS EXCAVATOR RESTORES RIO GRANDE[1]

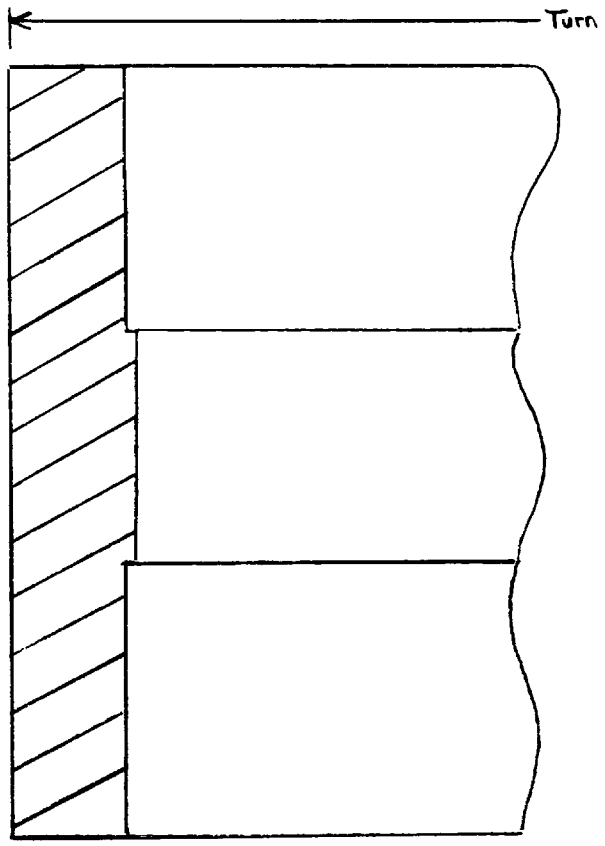
Typical rotating seal ring design — shrink fit.

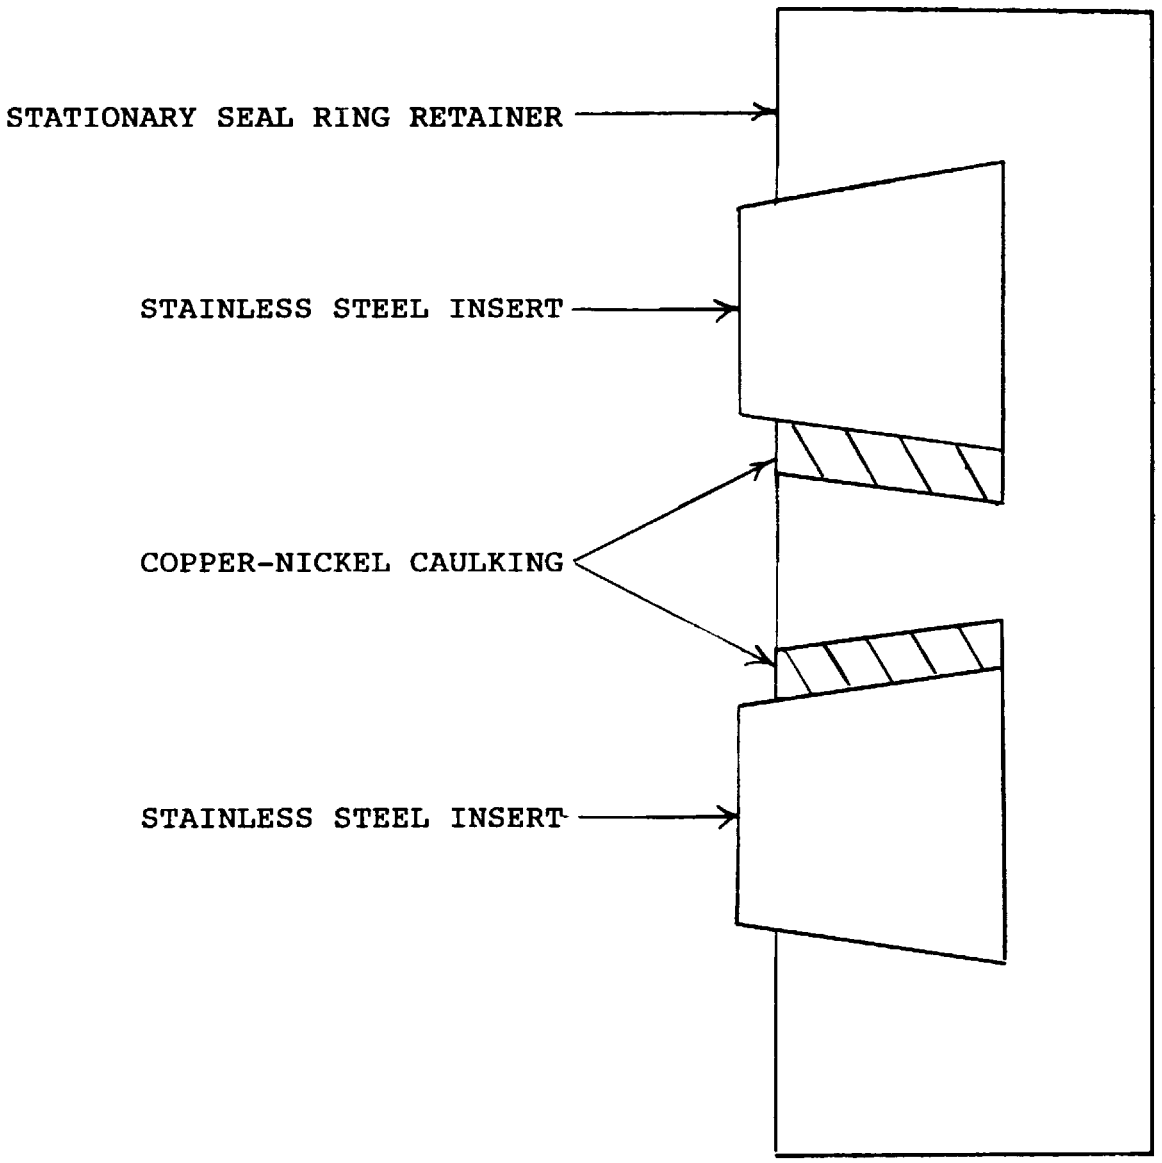
Inspection revealed that the caulking for the stationary seal inserts was severely eroded and the seal inserts were worn to the level of the steel retainer. The sealing effect of the turbine seal rings is based on the shearing forces generated between the two surfaces being greater than head pressure exerted across the gap between the wearing rings. As turbine seal ring clearances increase to 200 percent of the manufacturer's initial design, we can expect up to a 2 percent turbine efficiency loss. The optimum radial seal ring clearance for a 100,000 hp Francis turbine which turns at 180 r/min in the 400-500-foot head range is 0.035 inch. In replacing the seal rings we decided to modify the design to incorporate the material selection and design practices discussed previously.

Typical caulked-in seal ring design.

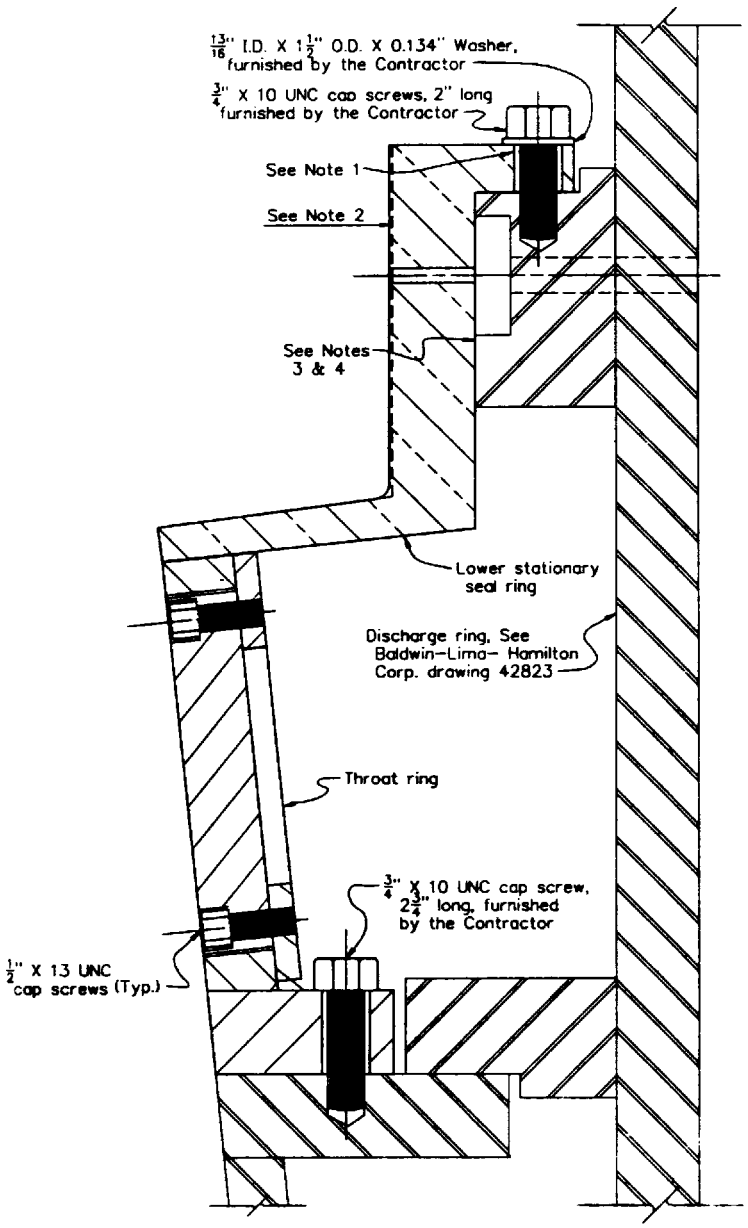
ASSEMBLY SECTION

New integral stationary seal ring and retainer design.

To improve the stationary seal ring design, we changed materials to nickel aluminum-bronze UNS C95500 or C95800. Whenever possible we decided to make the rings as a single piece by sand casting, centrifugal casting, or ring rolled forging. If the ring must be made in several sections, each section is usually cast. Single-piece rings are shrunk in place. If fasteners are required, they are made from Nitronics 60 gall-resistant stainless steel. On some units the steel seal retainer and seal ring assembly have been replaced with a single-piece, nickel aluminum-bronze casting.

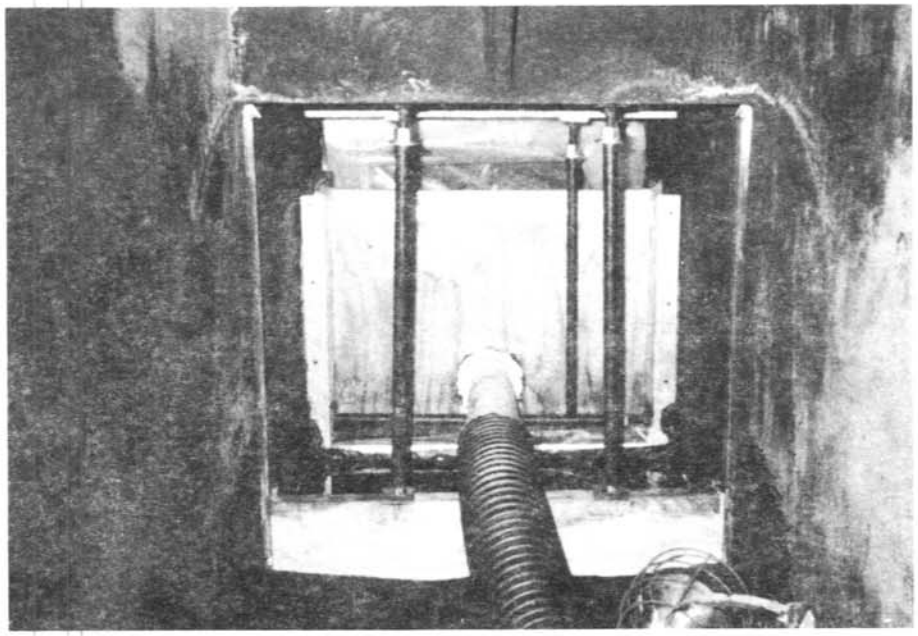
Photo 1. — Lemon Dam - Cavitation repair - Bulkhead installed in right outlet conduit between the regulating and emergency gates to control all leakage during repair work. 4/24/88

Mr. Ey devised a temporary bulkhead to afford dry conditions in the work area and not break the district's repair budget. A fiberglass shield was placed immediately downstream of the guard gates to deflect gate leakage. A wooden framework covered with a heavy plastic sheet was then placed in the 2.25- by 2.25-foot gate frame to stop any overspray. An aluminum and plywood bulkhead was also installed using silicone and large truck inner tubes for gasket material and screwjacks to compress the gasket material to the gate frame. A 4-inch irrigation flexi-hose was inserted through the bulkhead to convey all accumulated gate leakage away from the work area. Minor leakage past this bulkhead at the left gate body was controlled by using an additional set of screwjacks, a 2 x 4, and caulking downstream of the bulkhead. This system was successful in completely drying the areas needing repairs.

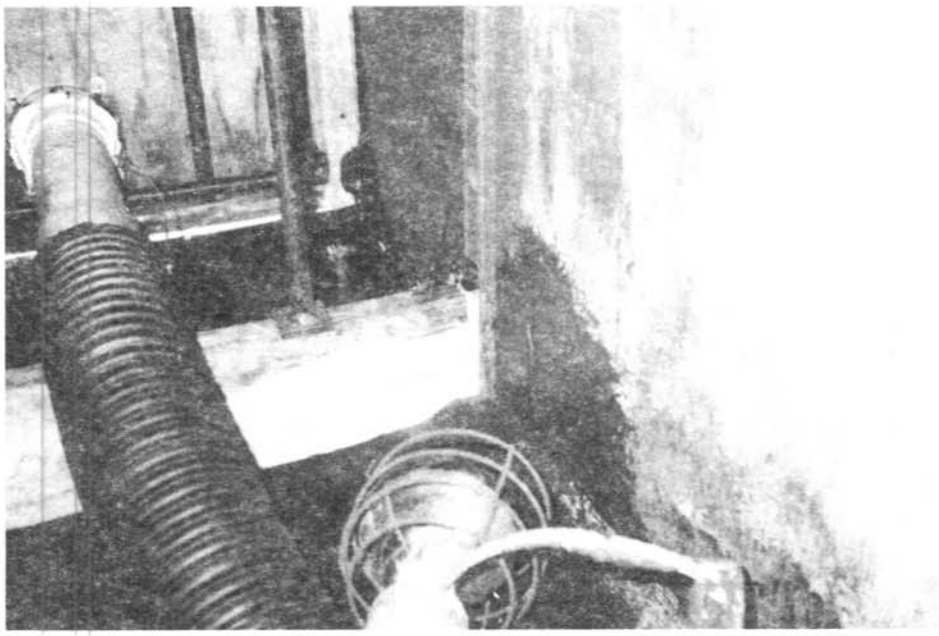
Photo 2. — Lemon Dam - Devcon ceramic metal repair to gate body below left regulating gate. 4/24/88

Cavitation damage on the gate frame immediately downstream of the regulating gates was repaired with a Devcon ceramic metal applied in thin layers and cured with a heat lamp between applications. Heat lamps were important to the repair process since the work was accomplished in April 1988 at elevation 8000 feet. The repairs to the concrete floor downstream of the left regulating gate were performed with Probond, an epoxy-concrete material manufactured by the Protex Company. The repaired areas are inspected each fall with additional repairs made as needed. The reason the repairs have been so successful at Lemon Dam can be attributed to Durango Projects personnel's and Mr. Ey's contacting the manufacturers of the repair materials for proper application procedures in the Durango area.

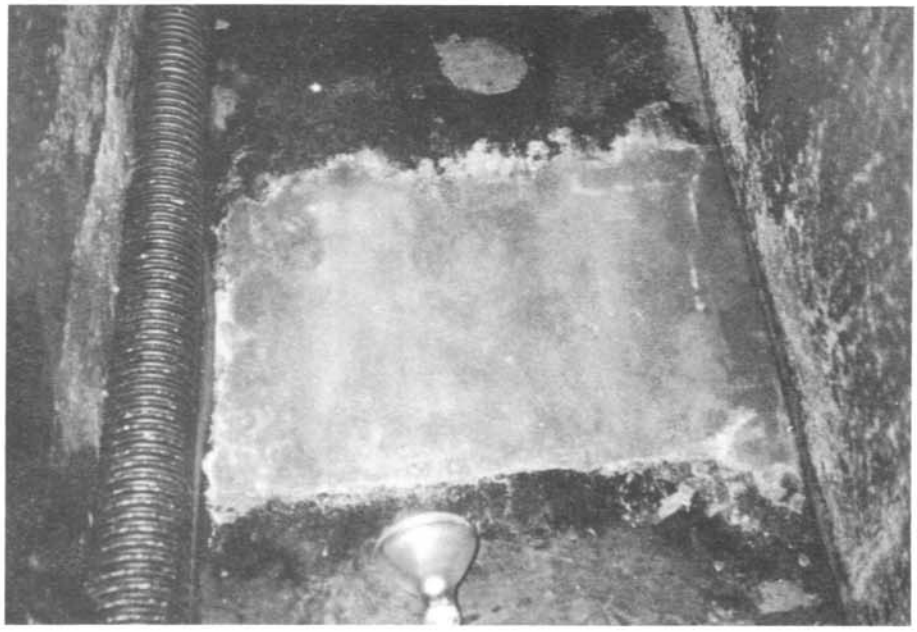
Photo 3. — Lemon Dam - Cavitation repair. Protex Probond epoxy concrete repair to the floor of outlet tunnel downstream of the regulating gate. 4/24/88

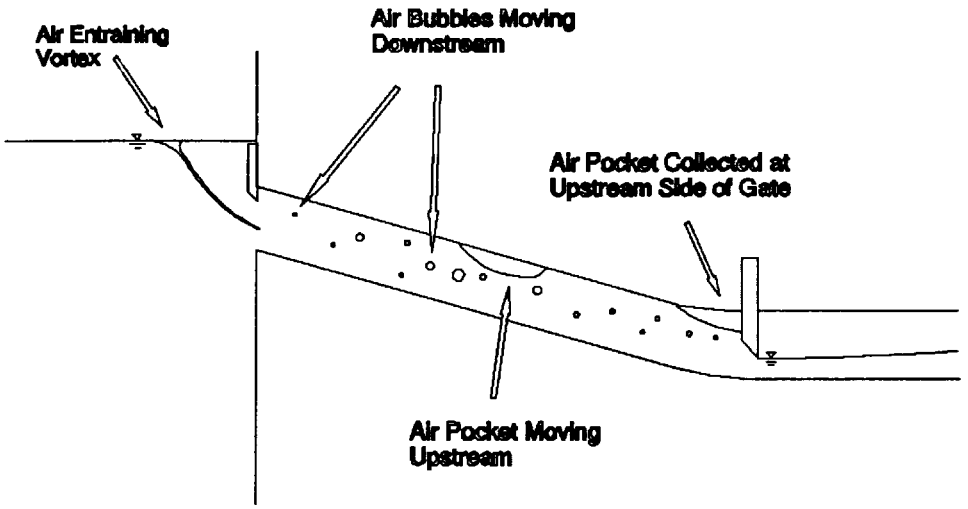
Figure 1. — Conditions that cause blowback.

Blowback is the release of air back through the intake of a closed conduit. Figure 1 shows the conditions that combine to cause blowback. At low reservoir levels, air enters partially submerged intake structures, or may enter shallowly submerged structures via air entraining vortices. When air bubbles are small, they have little buoyancy relative to the drag forces acting on them, and are carried downstream by the flow. However, as bubbles collect at discontinuities in the pipeline (such as the upstream side of control gates), they combine to form larger air pockets. As the air pockets grow larger, their buoyancy increases faster than the flow forces acting to carry them downstream. Under certain flow conditions, these air pockets will begin to move upstream against the flow, though smaller air bubbles are still carried downstream. In a downstream inclined conduit, as the large air pockets move upstream, the pressure head is reduced and the volume of the air pocket increases. Eventually the air pocket may occupy a large part of the cross section of the conduit, so much so that the flow is affected. This causes surging flow and pressure pulsations in the conduit. Eventually the air pockets may move all

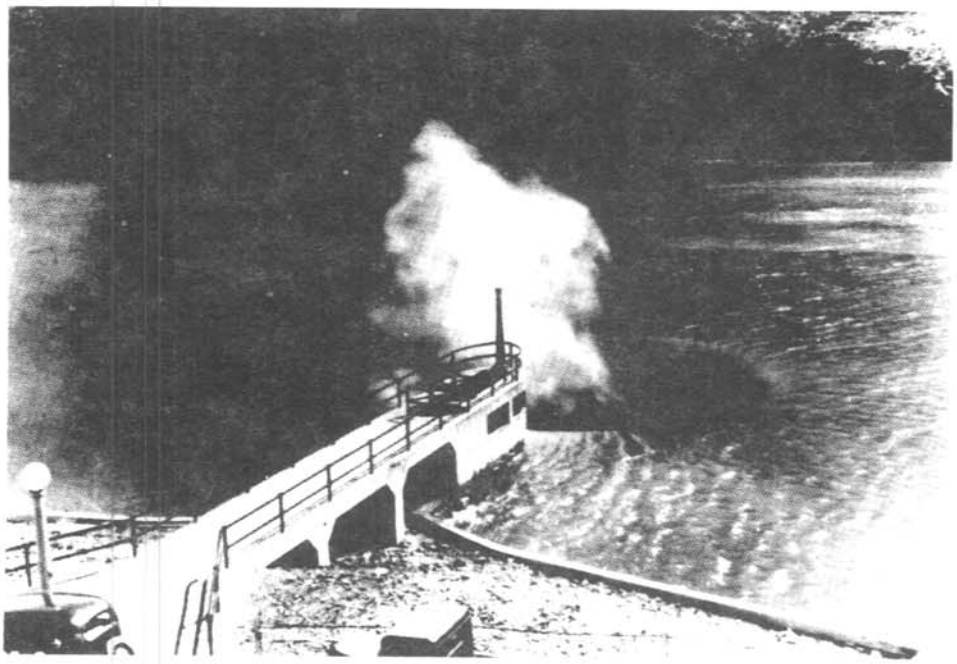
Figure 2. — Observed air blowback in morning-glory spillway at Owyhee Dam, Oregon.
