MYTHS AND REALITIES OF SURFACE-TOLERANT COATINGS FOR BRIDGES[1]

ICE MELTERS AND CONCRETE DAMAGE: ARE THEY RELATED?[1]

SILICA FUME CONCRETE REPAIRS ON THE SAN JUAN-CHAMA PROJECT

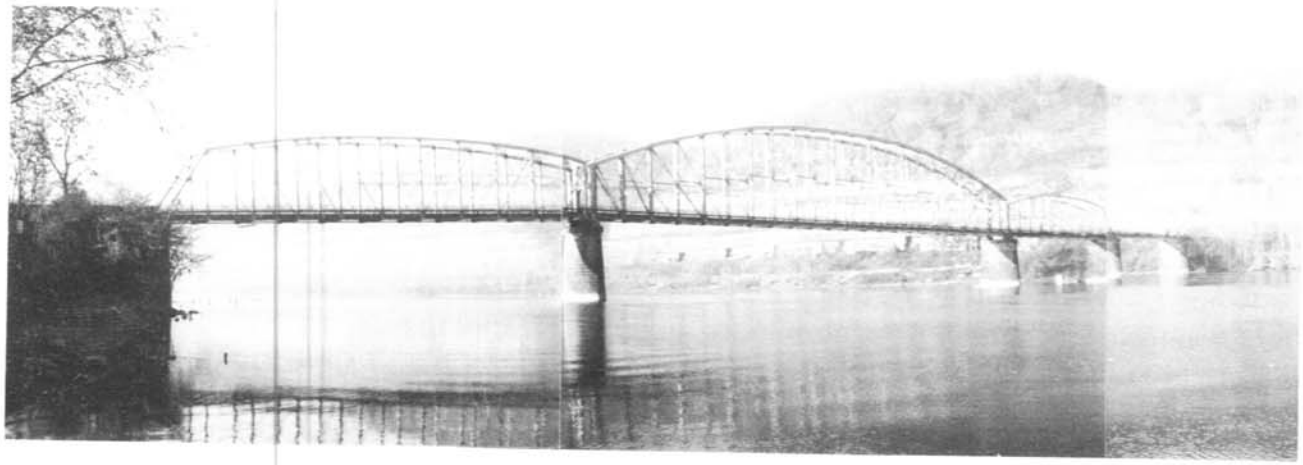
The Hulton Bridge near Pittsburgh PA before recent removal of lead-based alkyd (commercial blast) and recoating with an epoxy mastic primer and urethane topcoat. (Picture courtesy of Pennsylvania Department of Transportation, Pittsburgh, Pennsylvania.)

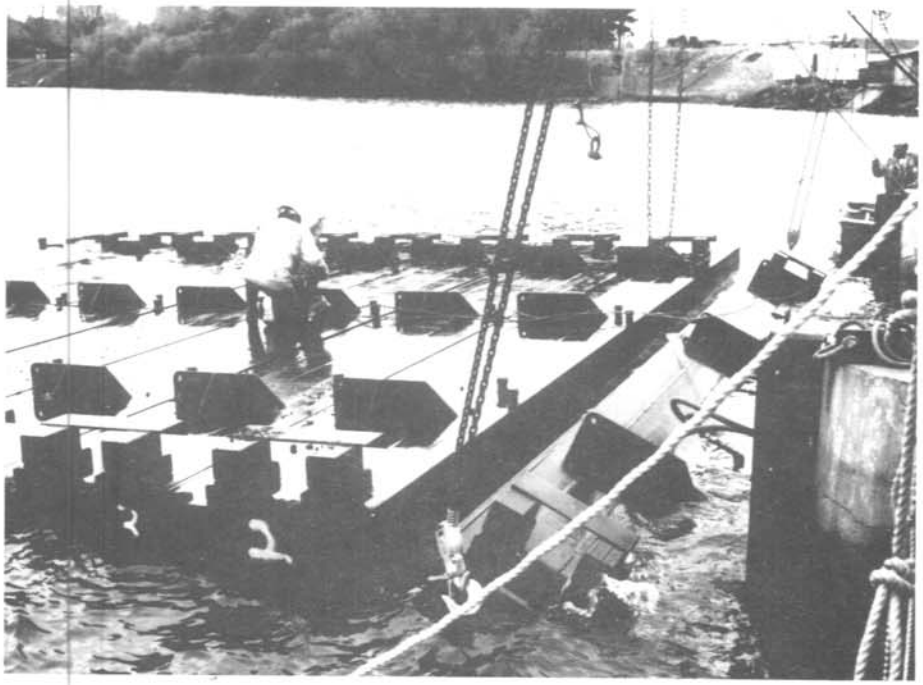
Photo 1.–Filling of caissons for sinking the bulkhead–Wissota hydroplant intake, 1987.

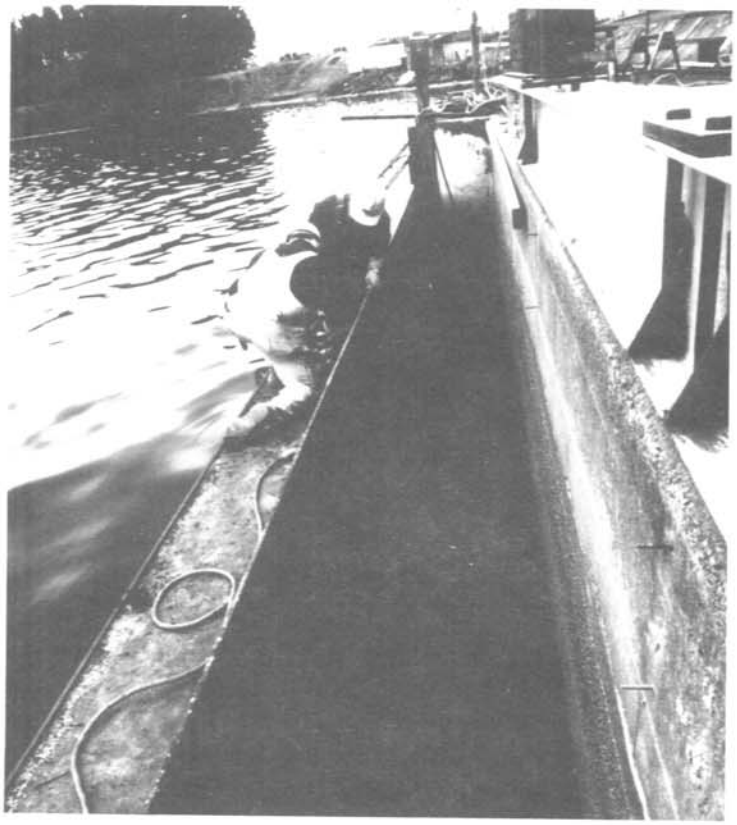
Photo 2.–Bulkhead installed and headrace dewatered–Wissota hydroplant intake, 1987.

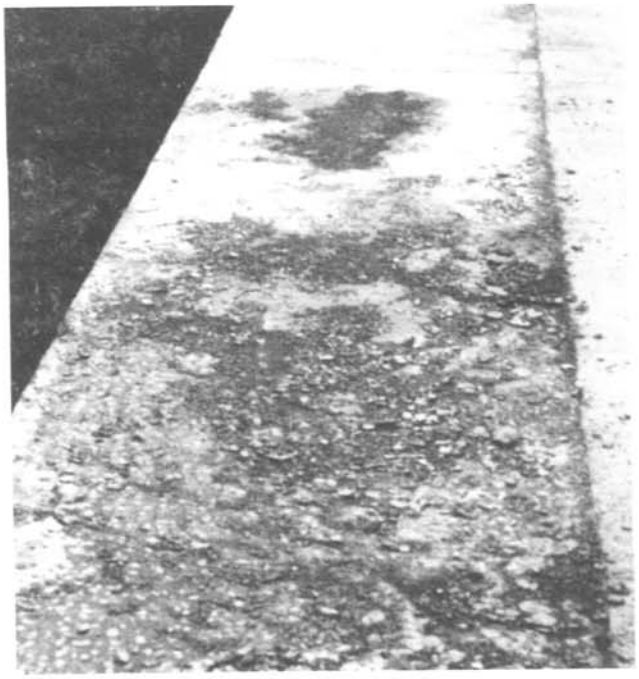
Flaking and peeling of surface mortar is usually caused by internal pressure created when water freezes within the concrete, not by corrosive chemical action.

If damage occurs during the first frost season, or if the concrete is poor quality, a breathable surface treatment should be applied to the dry concrete to help protect against further damage. ACI and PCA recommend adding a penetrating sealer made with boiled linseed oil, silane, siloxane, and/or breathable methacrylate. Non-breathable formulations should be avoided as they may accelerate scaling conditions.

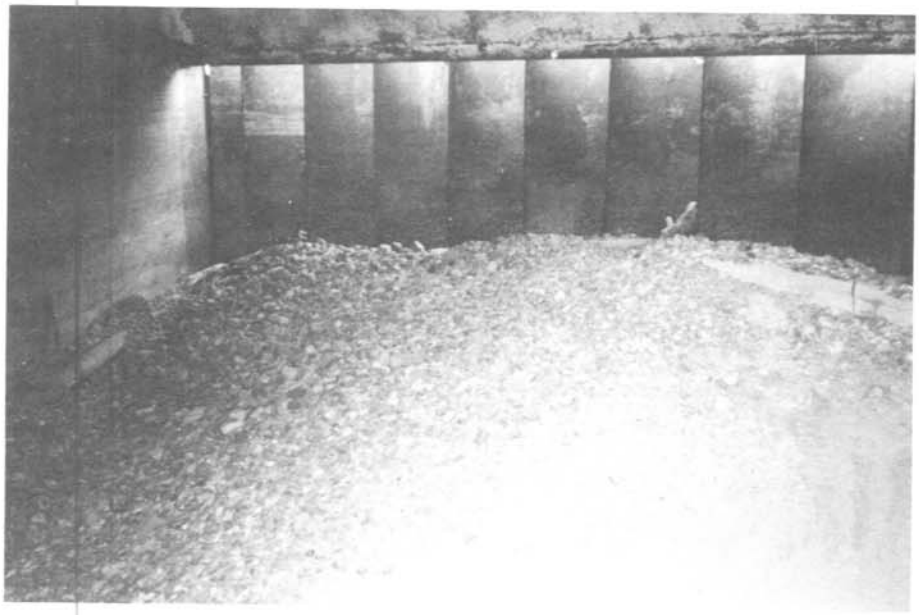
The system was designed with sluiceways at each diversion dam to pass the gravelly sediment load carried by the mountain streams. Personnel in the Southwest Regional Office (which office has since been abolished) ordered a halt to the sluicing operations in the late 1970's due to complaints from the Colorado Department of Water Resources and downstream irrigators as those operations were creating a maintenance burden to irrigators and affecting fisheries downstream of the diversion dams. Over several years of operation, the gravelly sediment caused severe wear to the inverts of the tunnels.

Typical sediment load–Blanco. 10/22/91

1.10-foot-deep hole in Azotea Tunnel invert. 10/22/91

silica fume mixes are more expensive, Project personnel will use such mixes at the portal areas where exposure to the high altitude weather would be more detrimental. Inside the majority of the tunnel, the air temperature remains near 50 °F, so standard concrete mixes with 1-1/2-inch aggregate should endure against the sediment load.

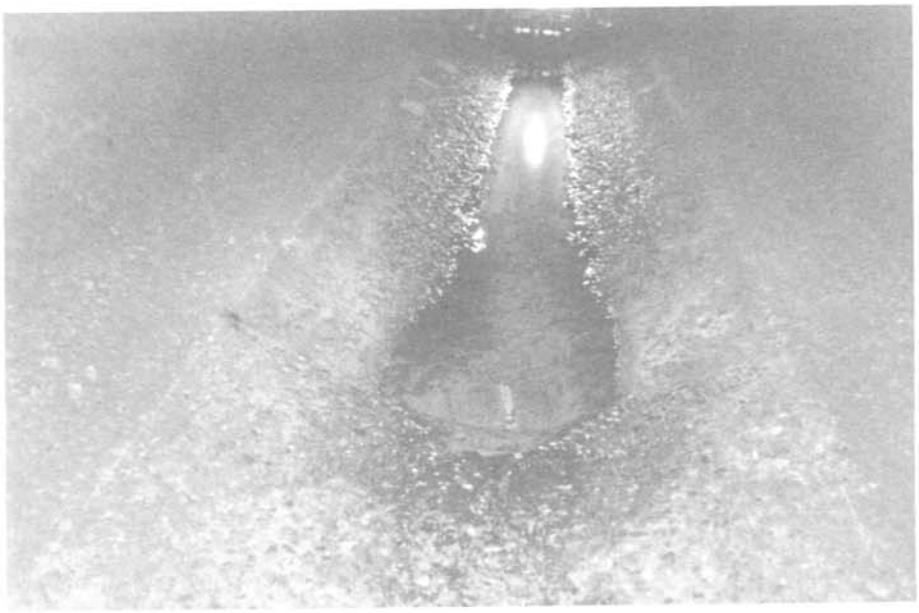
0.7-foot-deep hole in Azotea Tunnel invert. 10/22/91
