WATER OPERATION AND MAINTENANCE

BULLETIN NO. 170

December 1994

DESCHUTES CANAL LINING DEMONSTRATION - CONSTRUCTION REPORT

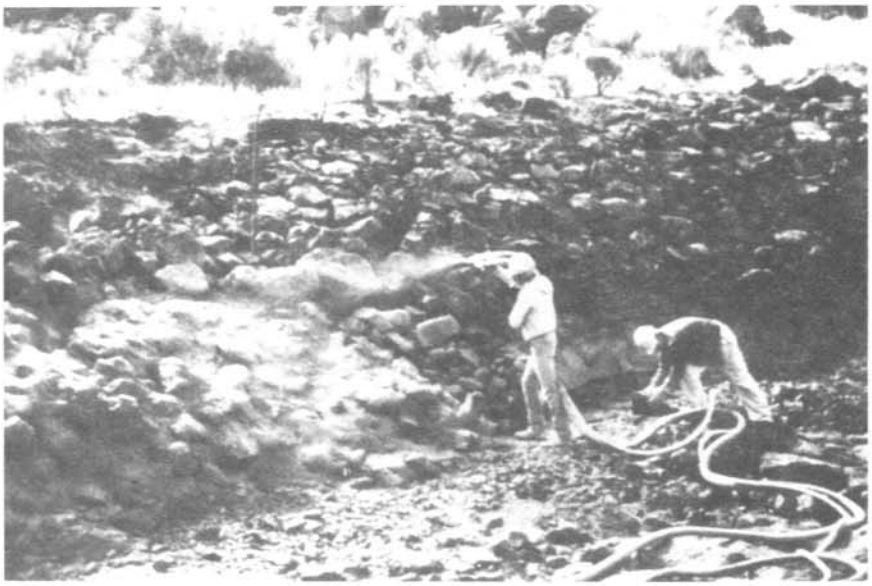
Figure 6.—North Unit Canal test sections 3 and 4. Application of protective coating to geotextile.

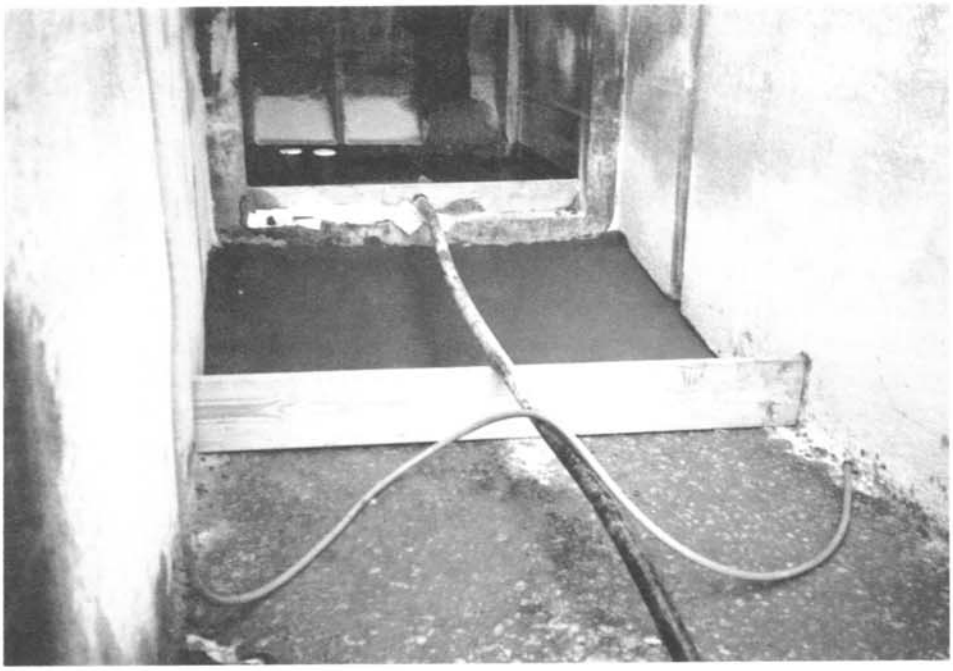
When the Mirdan Canal headworks first went into operation, no one anticipated that cavitation damage could occur downstream from the two 5- by 6-foot-high pressure slide gates. The Designers' Operating Criteria cautioned minimum gate openings of 1 inch to reduce the possibility of cavitation damage. The Twin Loups Irrigation and Reclamation District personnel strictly adhered to this minimum gate opening criteria. In spite of the strict adherence to the operating criteria, erosion of the floor concrete and cavitation damage were observed immediately downstream from the gates after the second season of use. Rather than repair the area with materials that could be periodically removed by the cavitation process, the District personnel opted to eliminate the potential for the cavitation process to occur.

Damaged concrete removed from downstream canal invert. Pipe is to divert gate leakage away from work area.

Concrete placement in downstream canal invert.

The impact area downstream from the gate made a 1-foot vertical drop from the gate sill. The eroded concrete was removed, and a smooth transition was created in the concrete floor from the sill to the Mirdan Canal invert 8 feet downstream.

Ron Wolf, the District Manager; Dave Ritchie, the District Superintendent; and their staff developed a steel air slot to be installed in the vertical corners adjacent to each gate. The air slot consists of steel plates bent to form a tube that fits the gate frame corner. The tube is attached to the concrete with anchor bolts. Openings for the anchor bolts are fitted with steel plugs to allow removal of the air slot if necessary. The air slot stops 6 inches short of the top and 3 inches short of the bottom of each side of the gate frame. This design allows air to be drawn from the top air vent above each gate corner, through the air slot, to the bottom portion of the gate frame. Negative cavitation pressures cannot occur with the atmospheric air flow coming through the air slot.

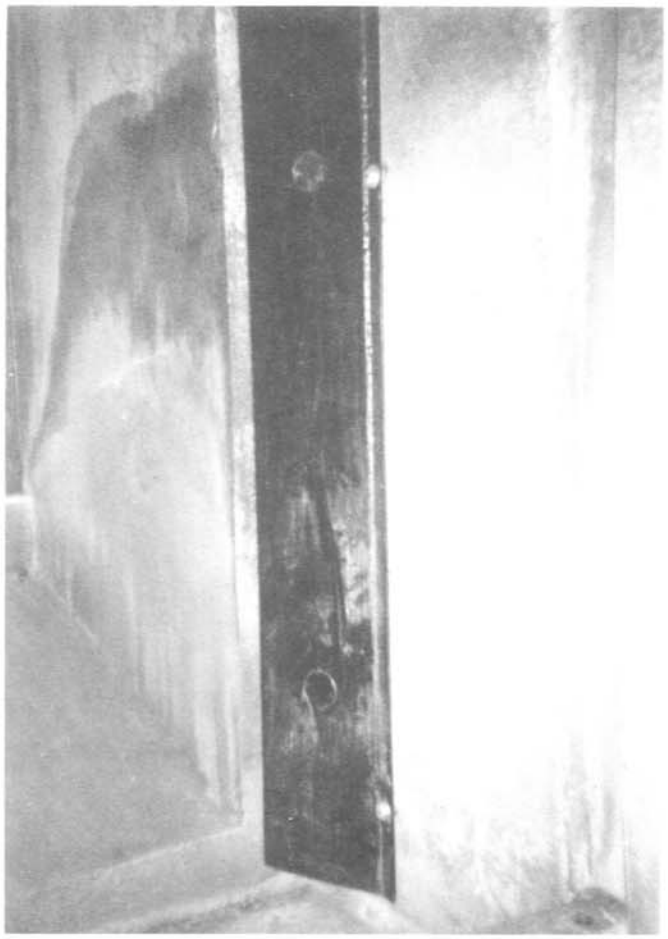
Top portion of air slot. Note air vent above air slot.

Bottom portion of air slot.

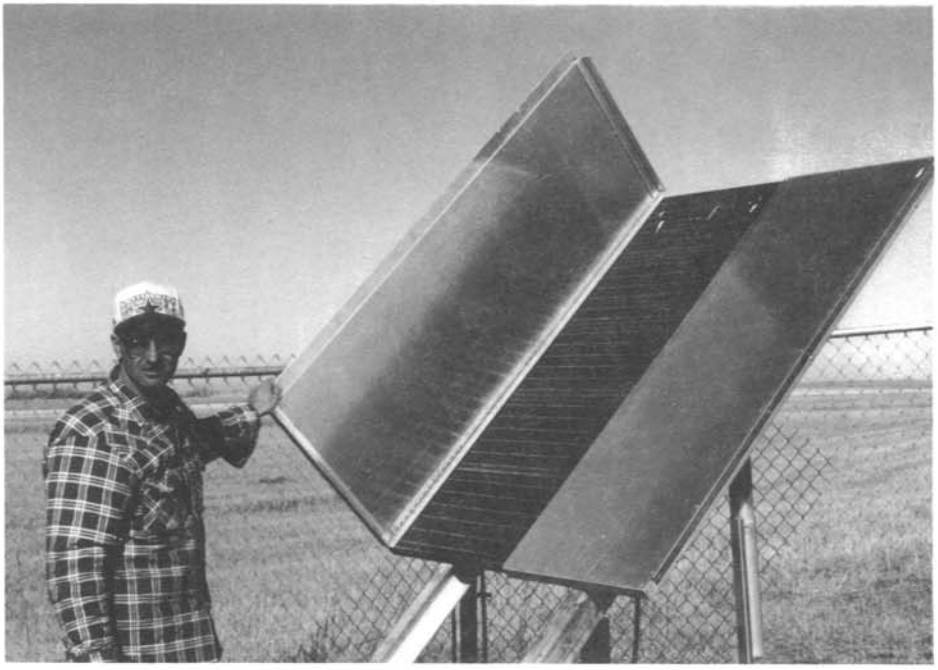
Kevin Morris flips back covers from solar panel.

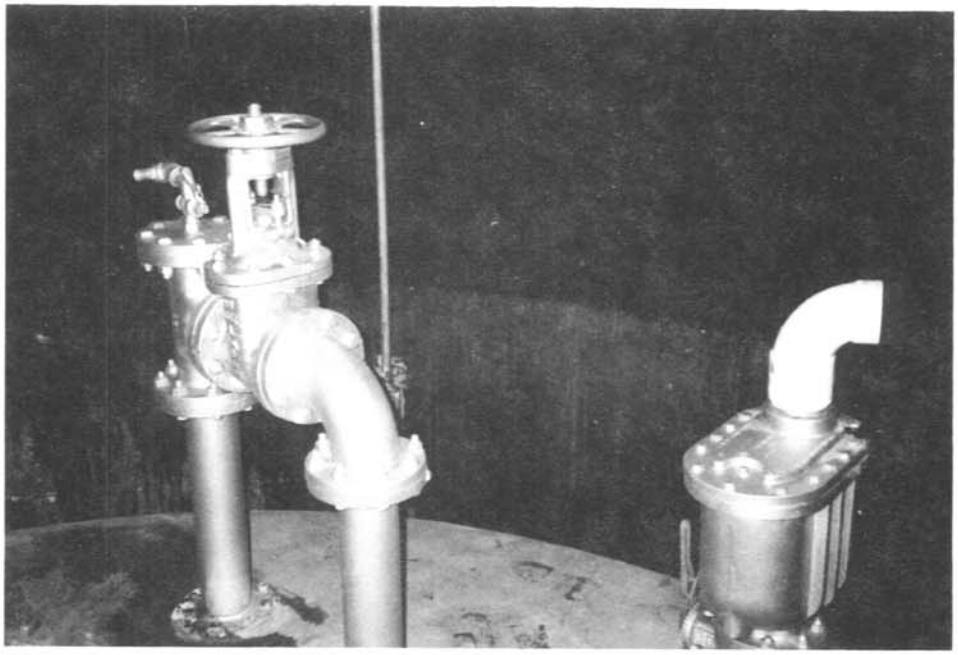
The air release/air vacuum valve assemblies in the upper gate chamber of the outlet works were modified to protect surrounding metalwork. During filling of the outlet works pipe, the valve assemblies tended to "burp" when releasing trapped air in the pipe. Some air assemblies are designed so water would sometimes spray upward through the valve assemblies and hit the deflector plate during filling operations. Once deflected, the water could shoot out in a circular path, getting surrounding metalwork wet. The air assembly supplied for Medicine Creek Dam did not have an outlet pipe to divert excess water.

Plastic elbow installed on valve assembly.

To reduce wear on the metalwork protective coatings, a plastic elbow was installed by the McCook Field Office to deflect dispelled water. The plastic elbow directs any water to the concrete chamber wall, where it falls harmlessly into the gutter. The plastic elbow has a slip joint for easy removal.

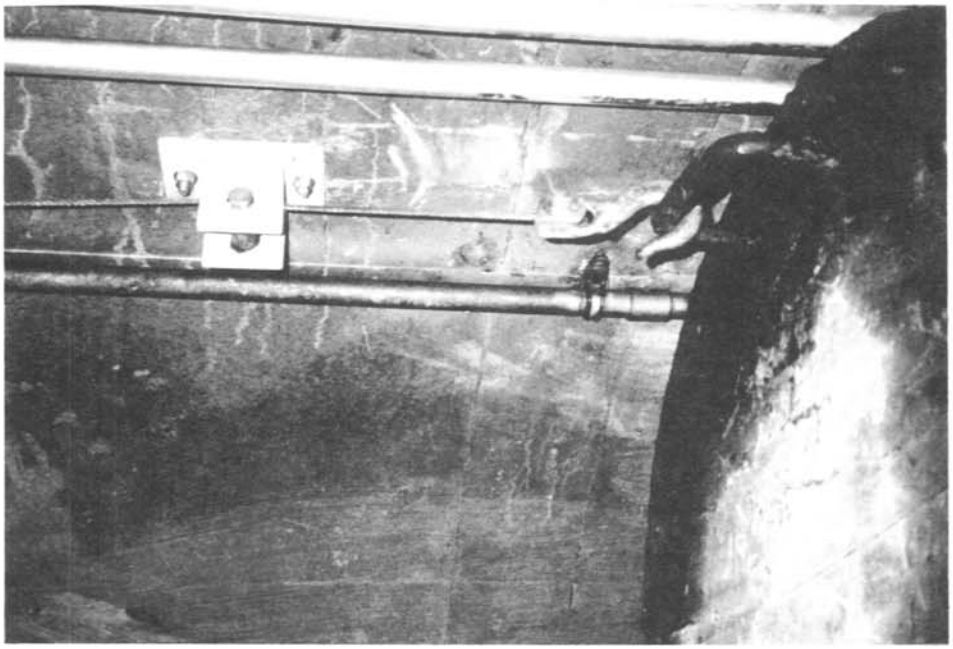
View of "come-along" and support brackets attached to ceiling.

View of "come-along" hook attached to access hatch on right.
