WATER OPERATION AND MAINTENANCE

BULLETIN NO. 172

June 1995

REPAIR AND REHABILITATION OF PRESTRESSED CONCRETE PIPE AT THE CENTRAL ARIZONA PROJECT

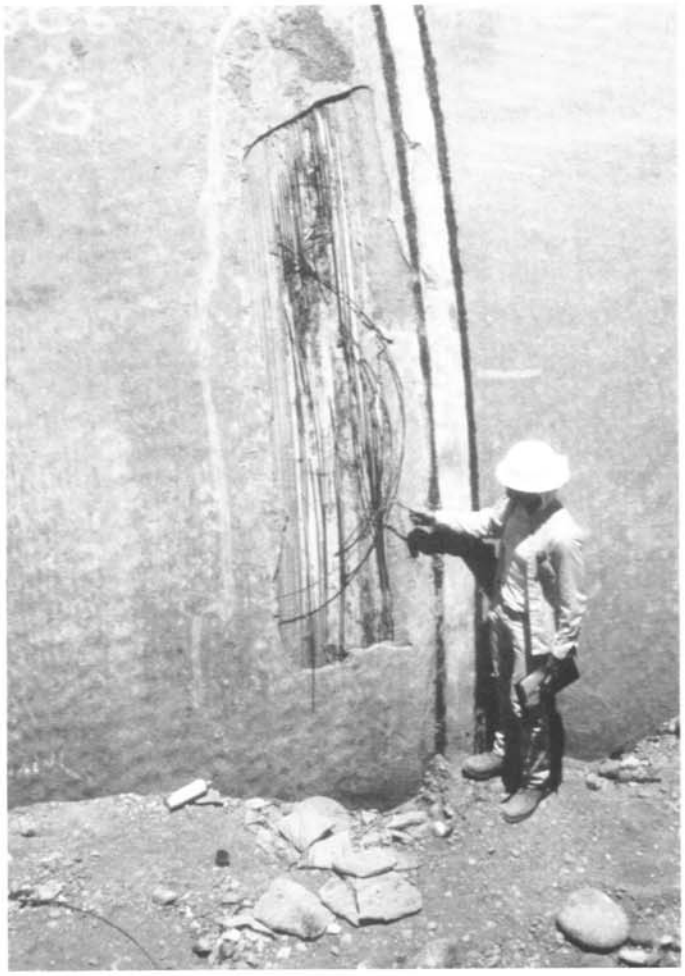
Pipe distress in the form of degradation of the mortar coating and the prestressing wire (i.e., corrosion) ranged in intensity from minor to extreme (figure 3). In many cases, the mortar coating had disbonded to expose the underlying prestressing wire. In other cases, sounding of the pipe by hammer tapping revealed hollow or drummy areas where the mortar coating had delaminated but had not completely disbonded. Visible coating cracking was sometimes apparent. Drummy areas commonly continued to expand or grow with additional exposure. Although inspection by hammer tapping proved to be fairly successful in pin-pointing delaminated coating, mortar coating continued to disbond in certain instances, even in areas that had been previously inspected and thought to be sound.

Figure 3.—The pipe distress ranged in intensity from minor to extreme.

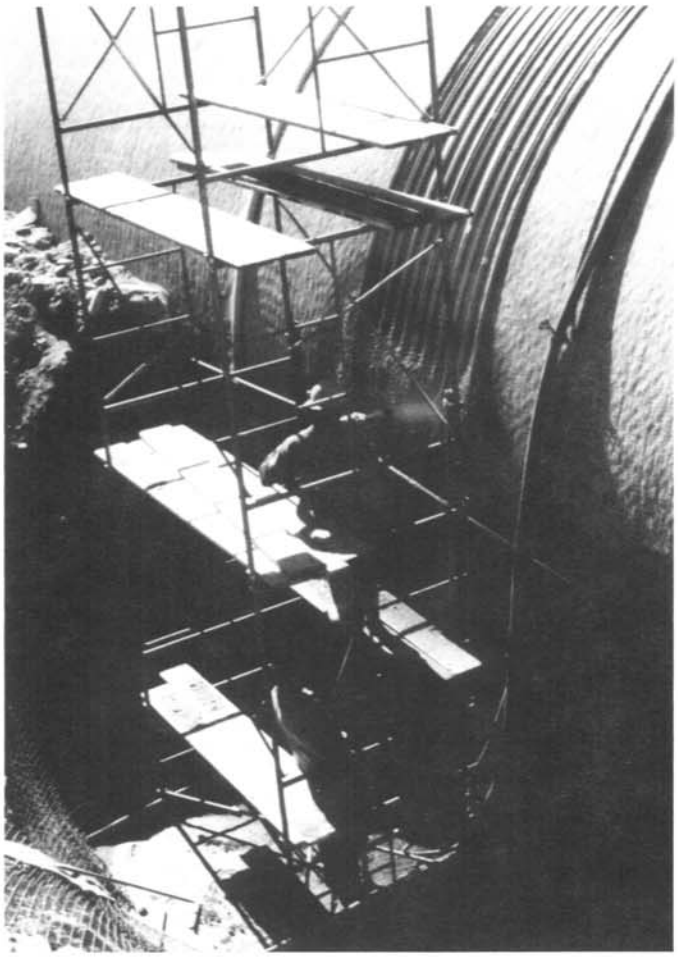
Figure 7.—Shotcrete application over the tendons.

to 8 gallons of water to provide a design strength of 3,200 pounds per square inch in 3 days. The shotcrete was applied to a minimum thickness of 1 inch over the tendons and anchorage assemblies and at least 3 feet beyond the end of each repair area. The process consisted of applying shotcrete from the soil-cement interface to the ends of the tendon overhang (figure 7). Thereafter, the anchorage assemblies and tendon overhangs were also encased.

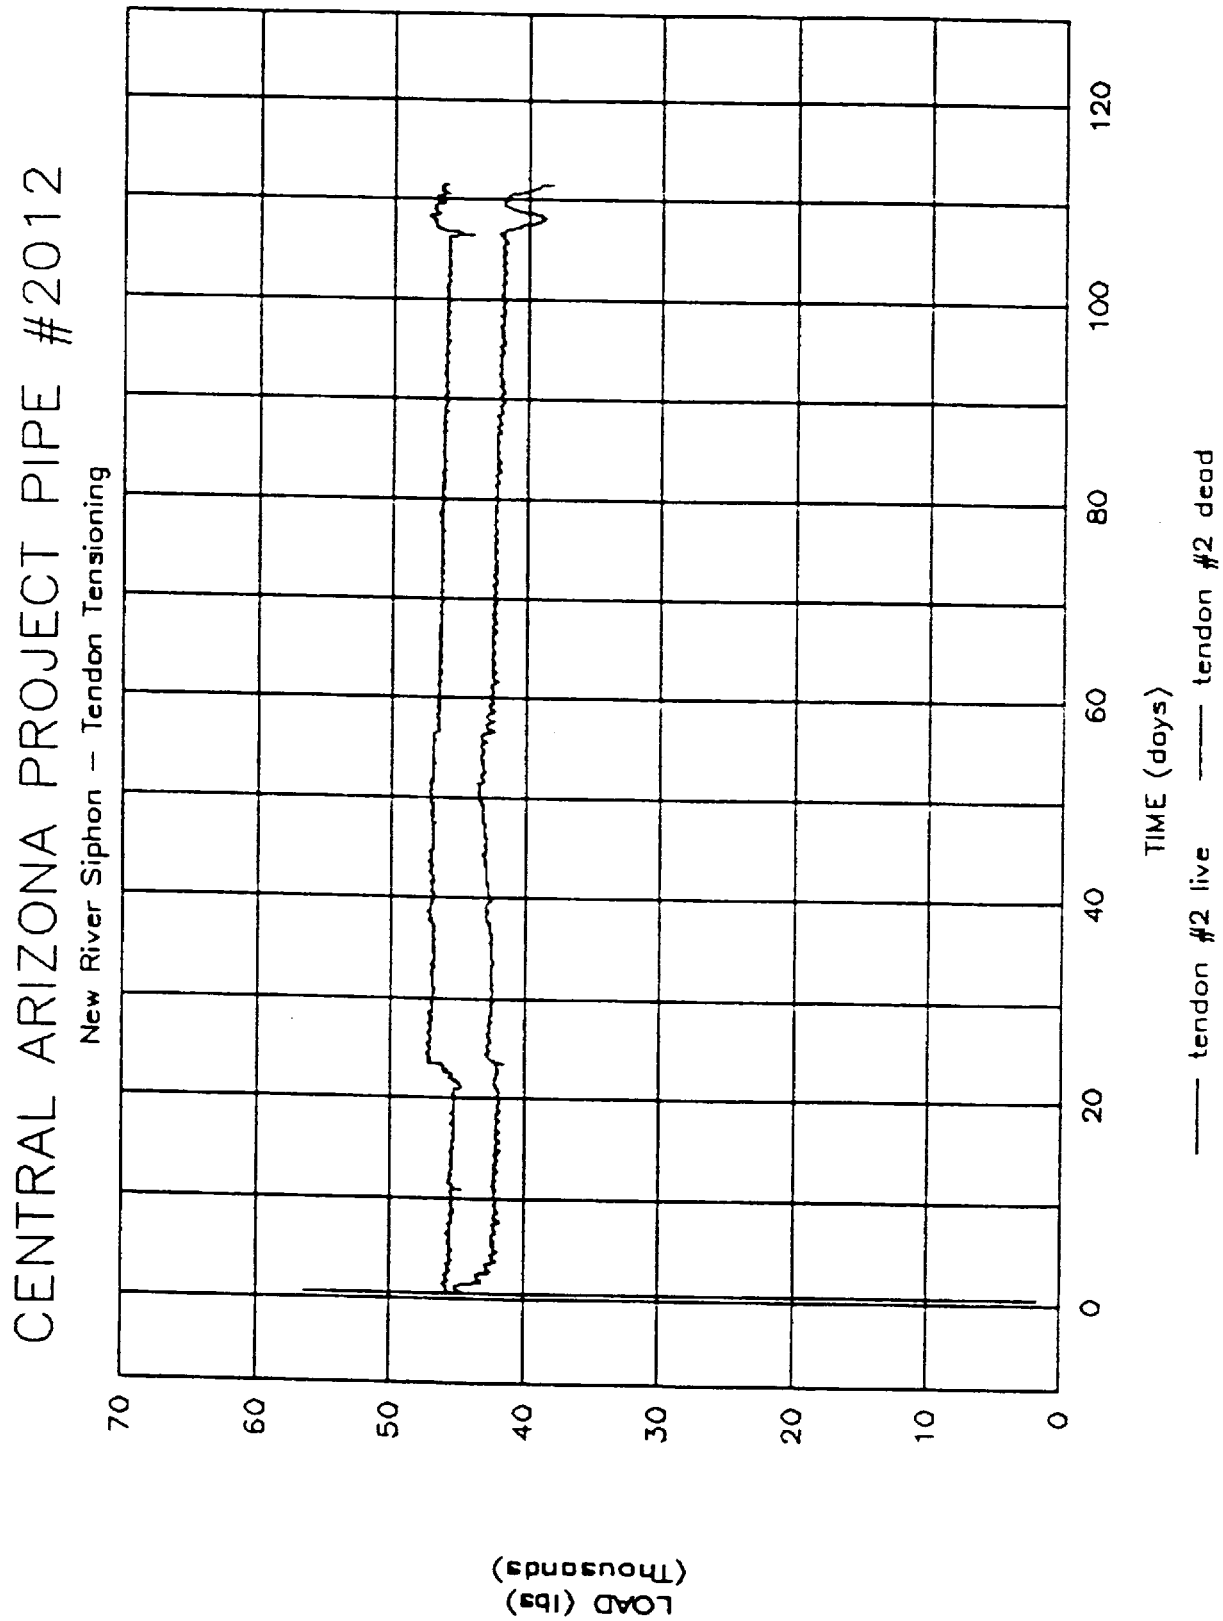
Figure 8.—A typical load versus age curve for a type 1A repair on pipe 2012 of New River siphon.

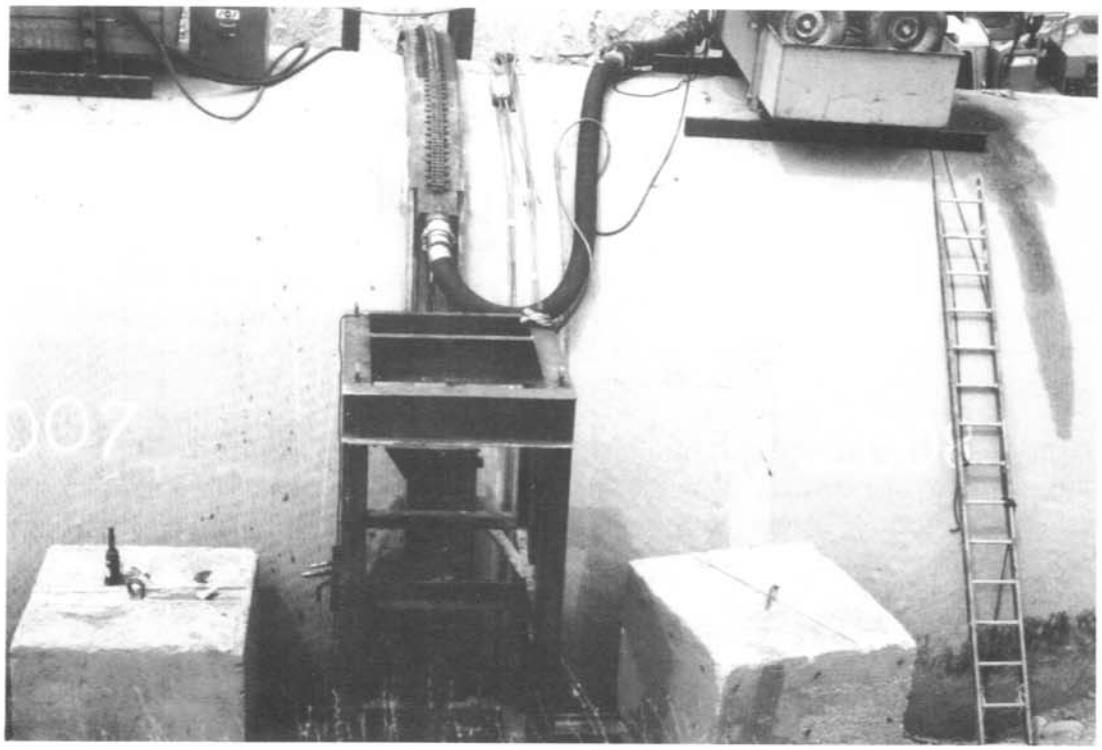
Figure 10.—When pipe was repaired in service, tendons were installed over mortar coating and corroded and broken prestressing wire through the narrow annulus beneath springline.

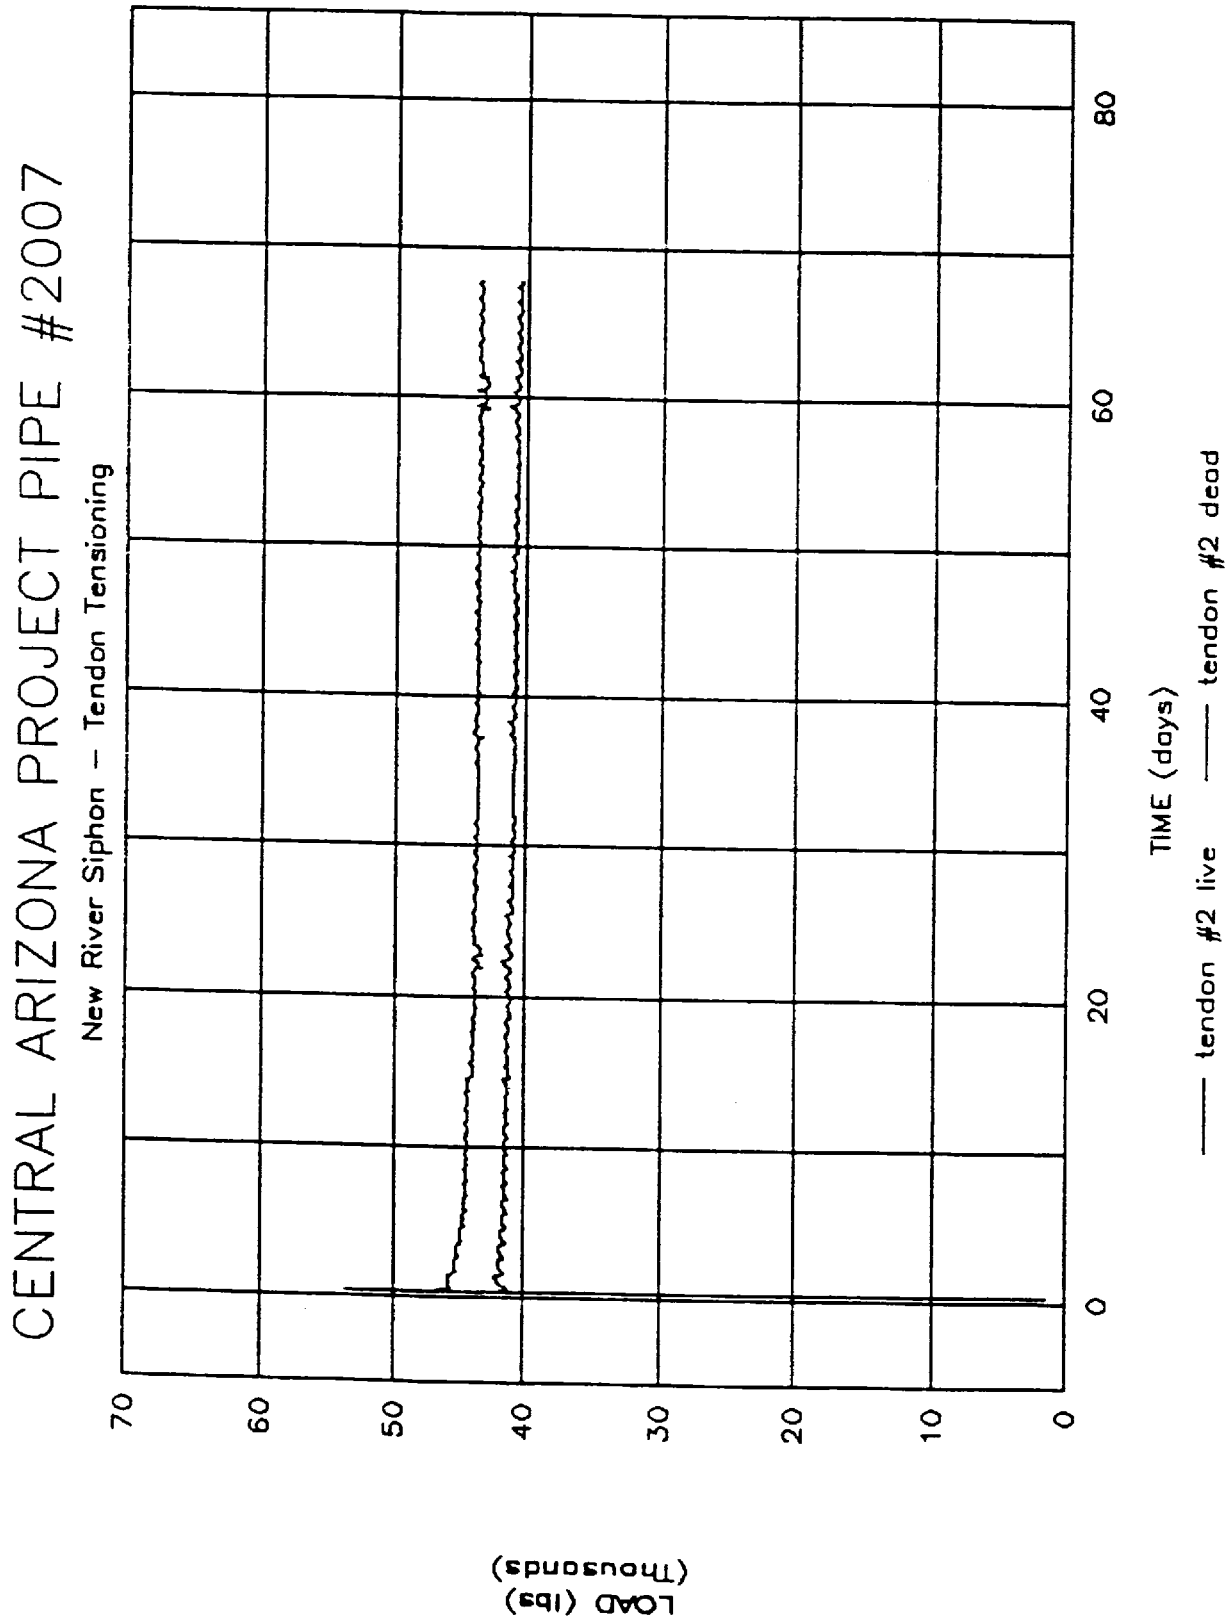
Figure 11.—A typical load versus age curve for a type II repair on pipe 2007 of New River siphon.

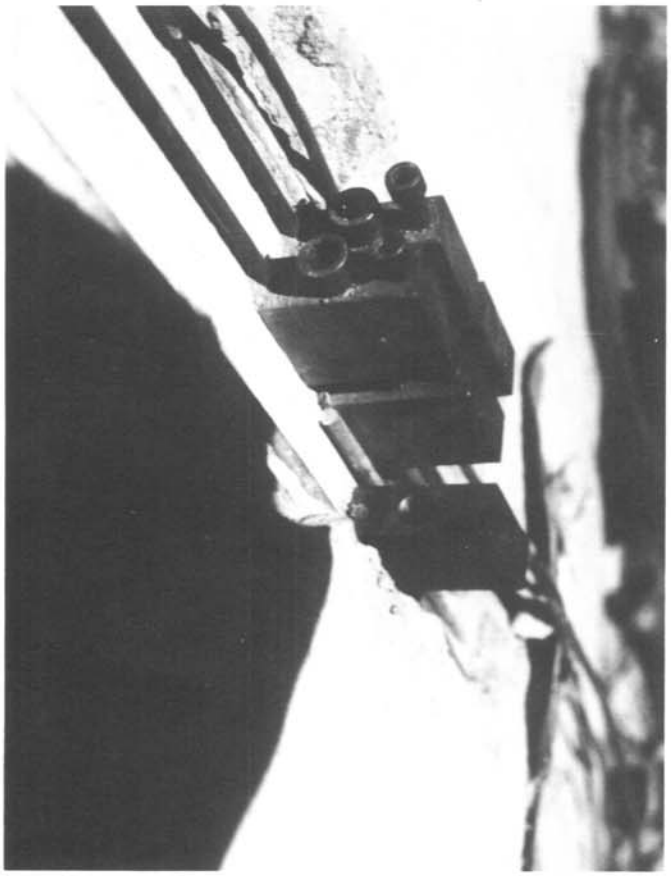
Figure 12.—Anchor blocks of a type III repair were fastened by hammering their teethed grooves onto the prestressing wire at splice juncture points. The anchor blocks also contained set screws as well as holes and threads for connecting bolts.

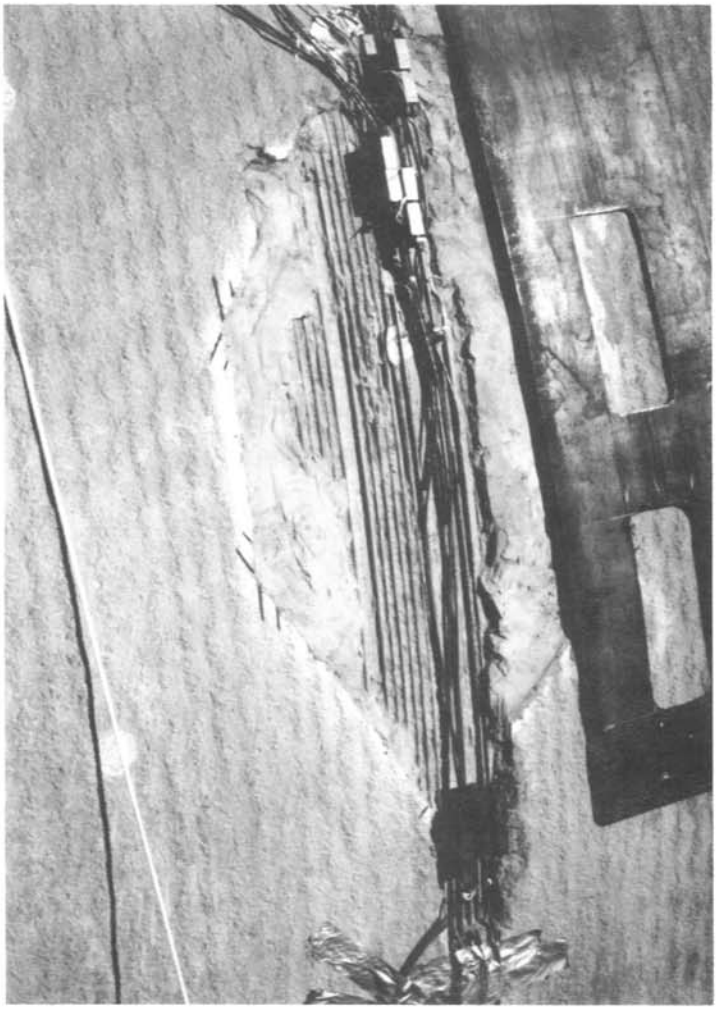
Figure 14.—A type III repair.

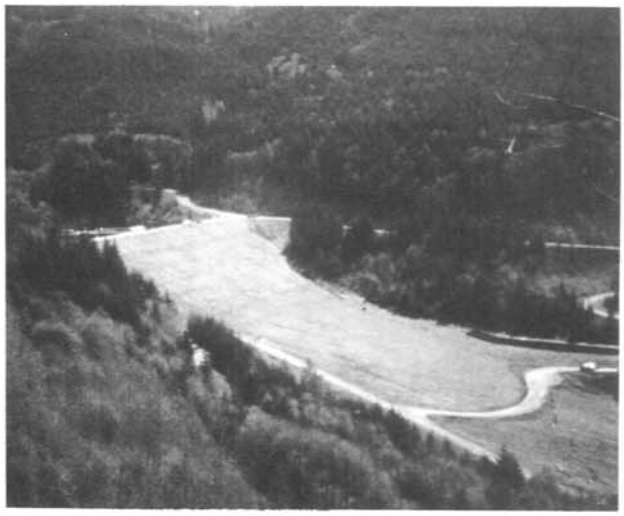
Tolt Dam.

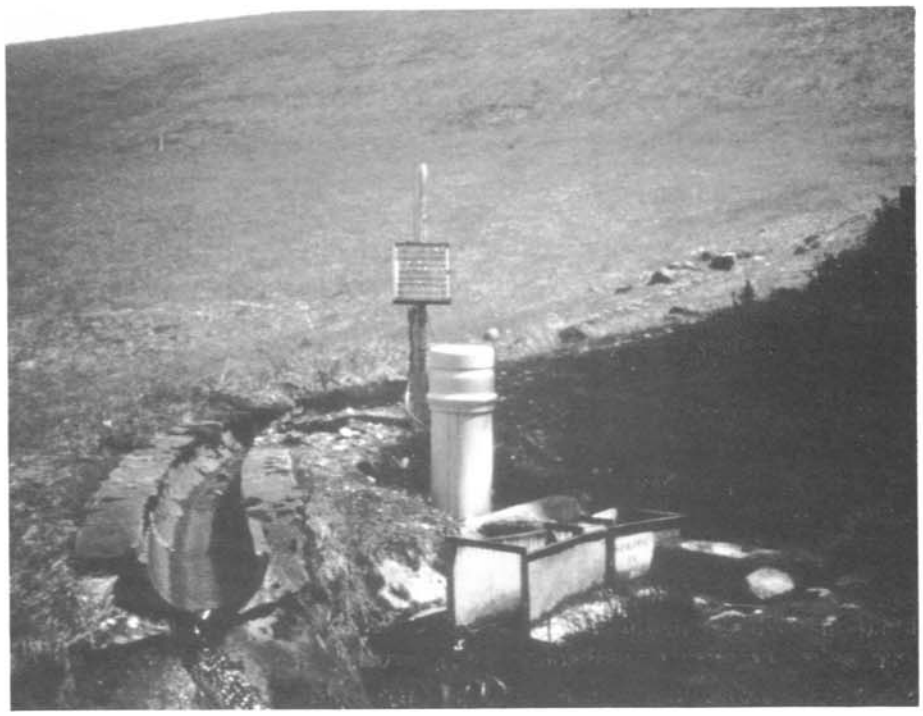
Typical seepage gauge installation.

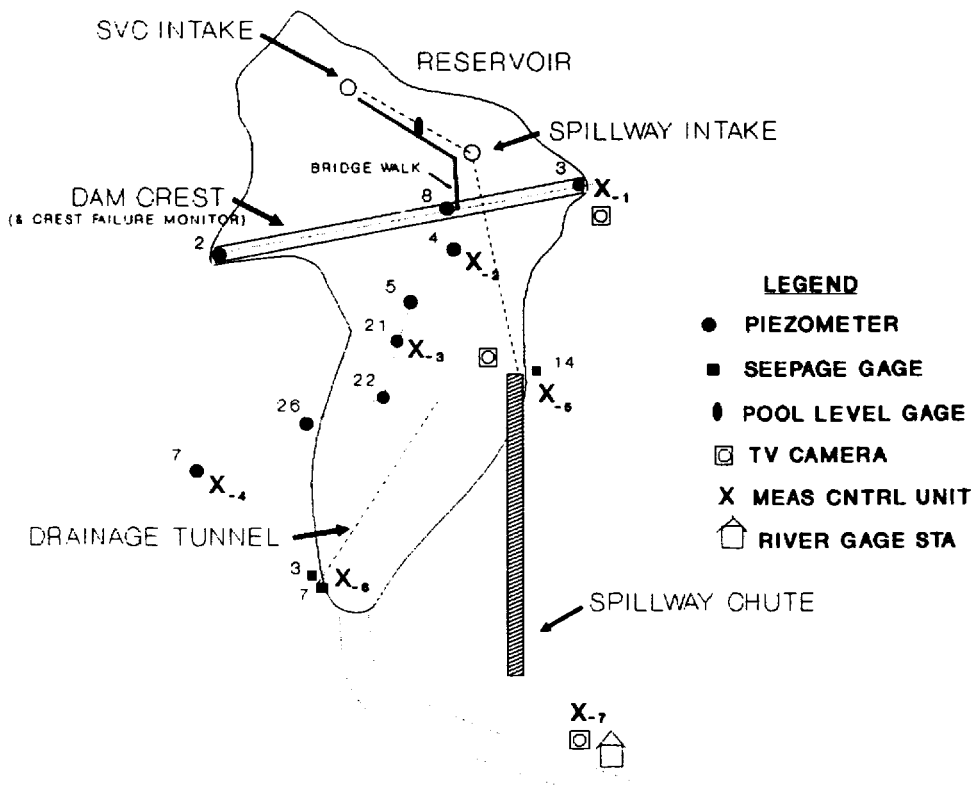
The instruments were connected to local Measurement Control Units (MCU's), which are microprocessor-controlled data acquisition units. The MCU houses signal conditioning equipment to operate up to six vibrating wire instruments. The MCU operates off a solar-charged battery power pack (or a-c power, available at two locations) and has radio transmission equipment to communicate with other MCU's, or to send data and alarms, via the "Gateway" MCU No. 1, back to the Network Monitoring Station (NMS), located about 8 kilometers (5 miles) away in the water treatment plant. A total of eight MCU's were installed to serve the widely spread array of ADAS instrumentation at the dam and along the river. See figure 15 for a plan of the ADAS instrumentation layout.

Figure 15.—Plan of instrumentation layout.

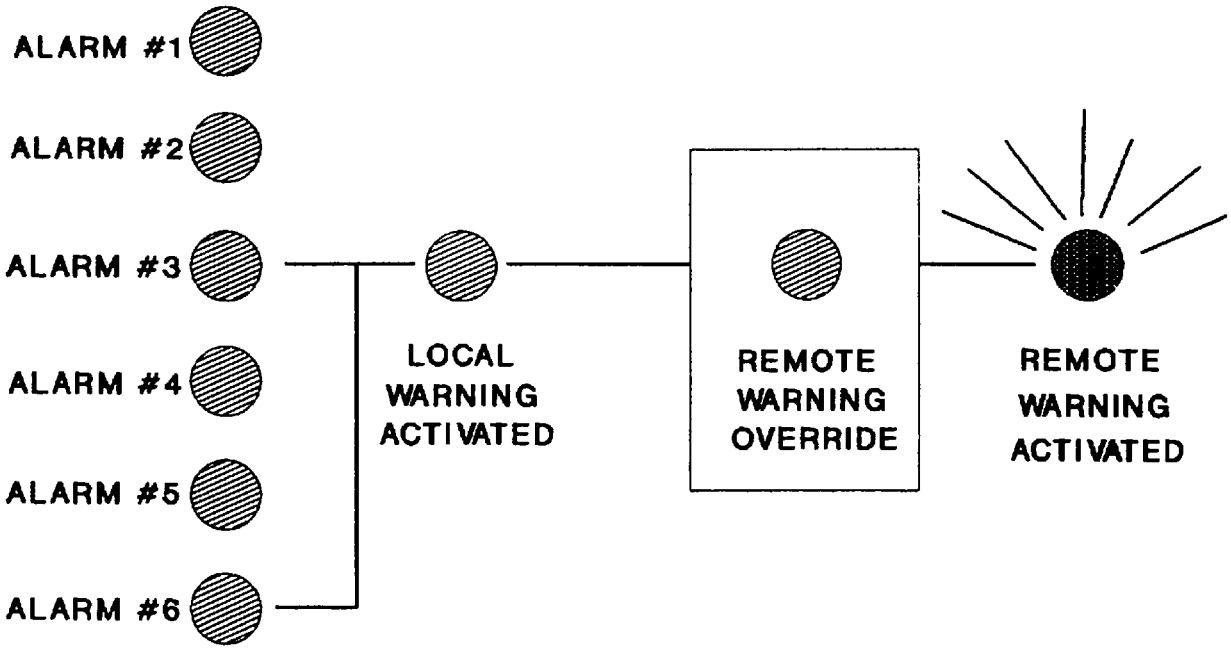
The alarm criteria developed for the Tolt system attempts to balance the need to provide early warning to the public with the need to detect the possibility of instrument failure and spurious alarm conditions. The alarm signal console, located with the NMS in the water treatment plant, is shown in figure 16. Low and mid-level alarms 1, 2, 4, and 5 indicate developing problems or hazardous situations. Alarms 1 and 2 identify situations dealing with the river downstream from the dam, and alarms 4 and 5 alert operators to situations with the instruments on the dam face. When these lights illuminate, a quick reference to the NMS computer will indicate the exact problem. If the upstream or downstream river gauge exceeds its established maximum threshold limits, the crest monitor instrument shows a failure condition, or the pool level shows a greater than allowable pool drop, then

Figure 16.—Alarm console diagram.

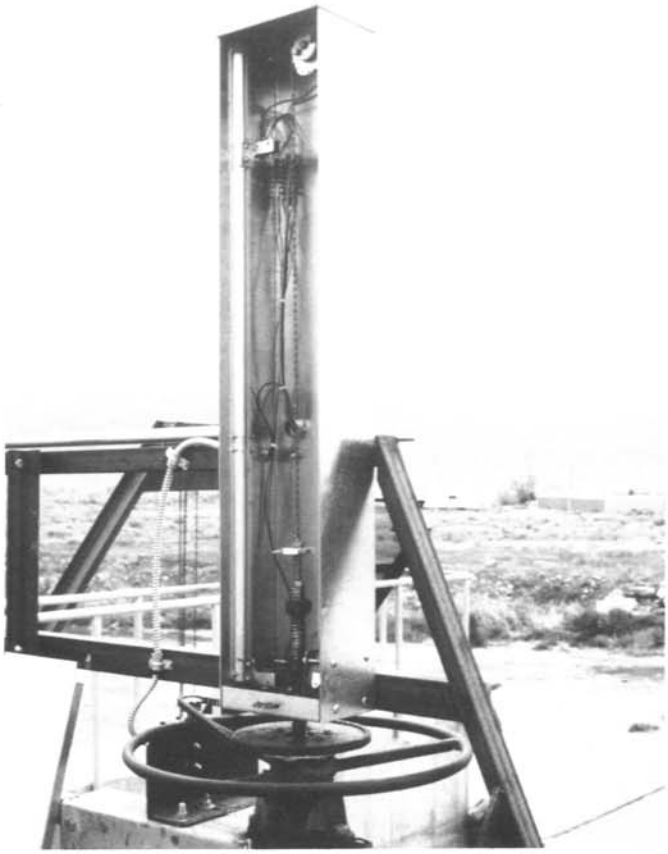
Figure 18.—Drive installation with position and limit switches.

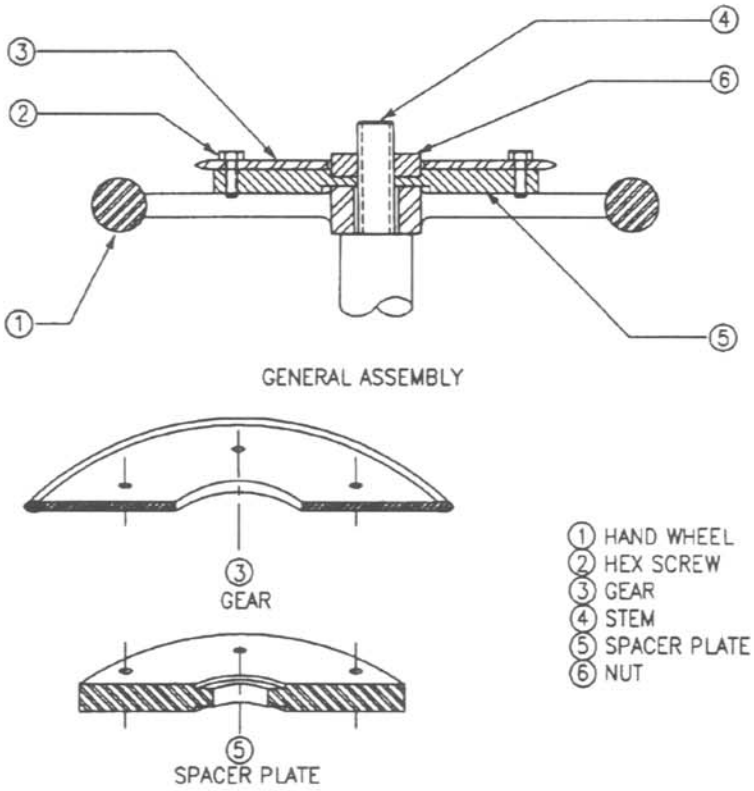
A spacer plate, as shown in figure 19, is used to attach a gear to the gate handwheel. The spacer plate also aligns and centers the gear on the handwheel. Additionally, the adapter provides spacing between the handwheel and gear for clearance between the chain and handwheel. Figure 20 is a typical rising stem slide gate installation. The gear motor is attached to the gate frame with a bracket that allows adjustment of the chain. Idler sprockets should not be used.

Figure 19.—Gate handwheel adapter assembly.

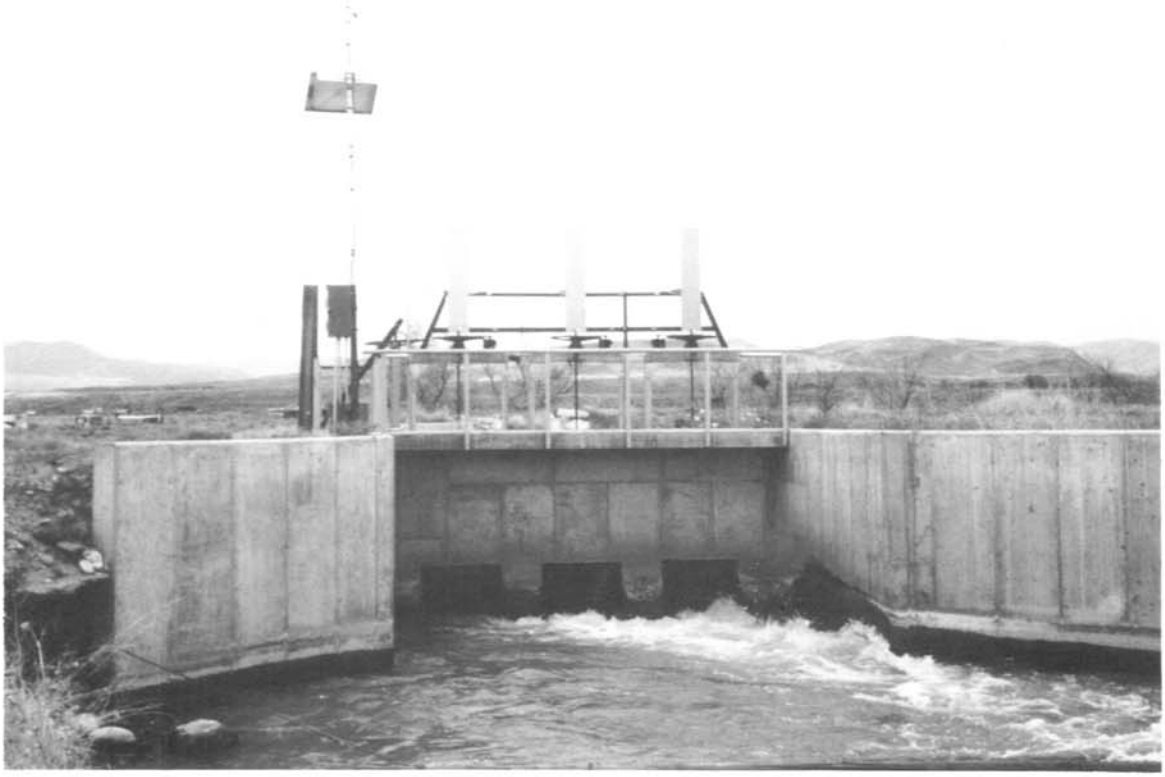
Figure 20.—Typical installation.

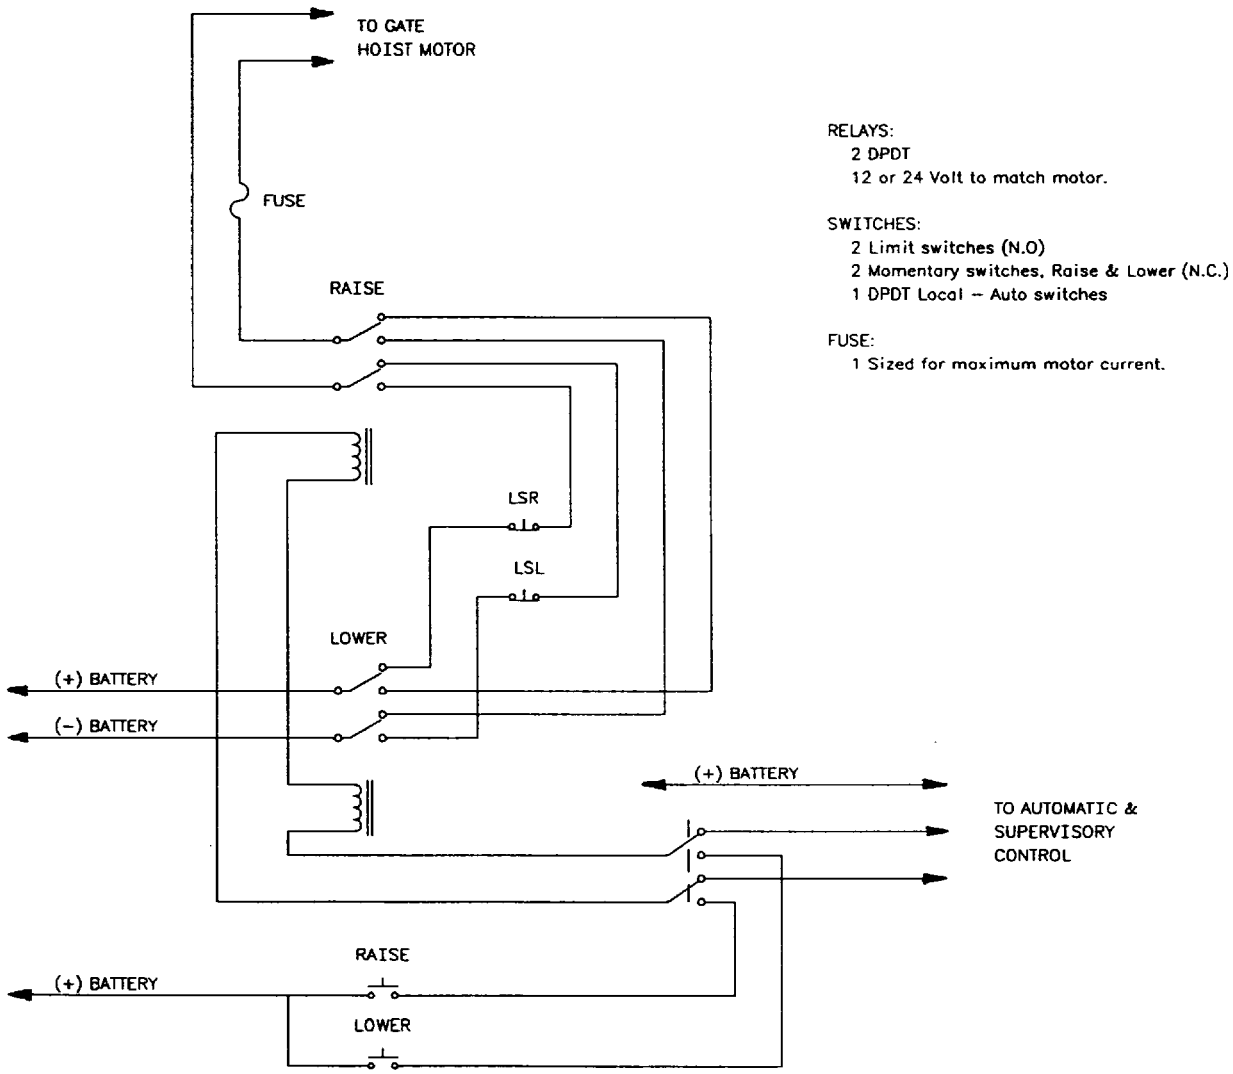
Figure 21.—Motor controller schematic.

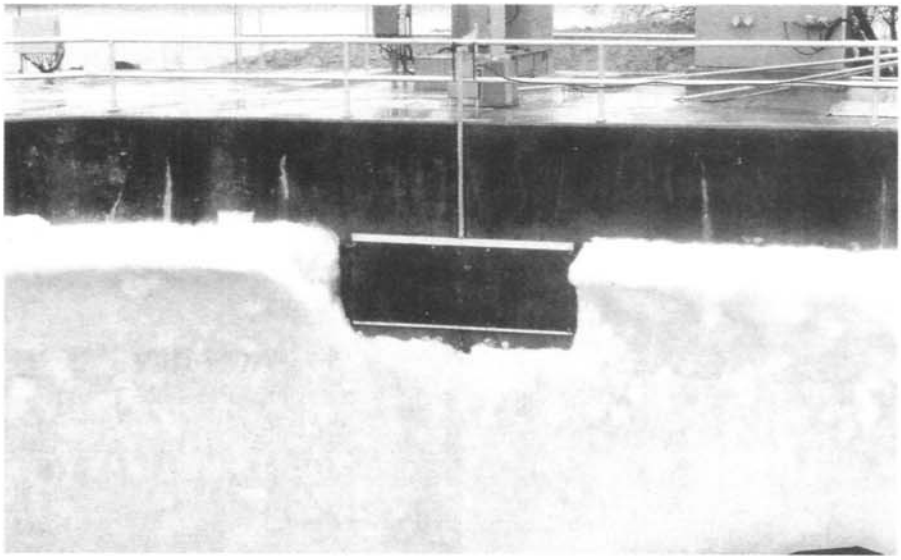
The use of panel water heaters to control and minimize icing in miter gate recess areas is an effective solution to the icing problem at Starved Rock Lock and Dam on the Illinois River. A panel heater was installed at this location in December 1993, just in time for one of the worst winters of the decade. The panel was bolted onto the concrete wall in the miter gate recess area (figure 22) and was very successful in keeping the wall ice free (figure 23).

Figure 22.—Closeup of the panel.

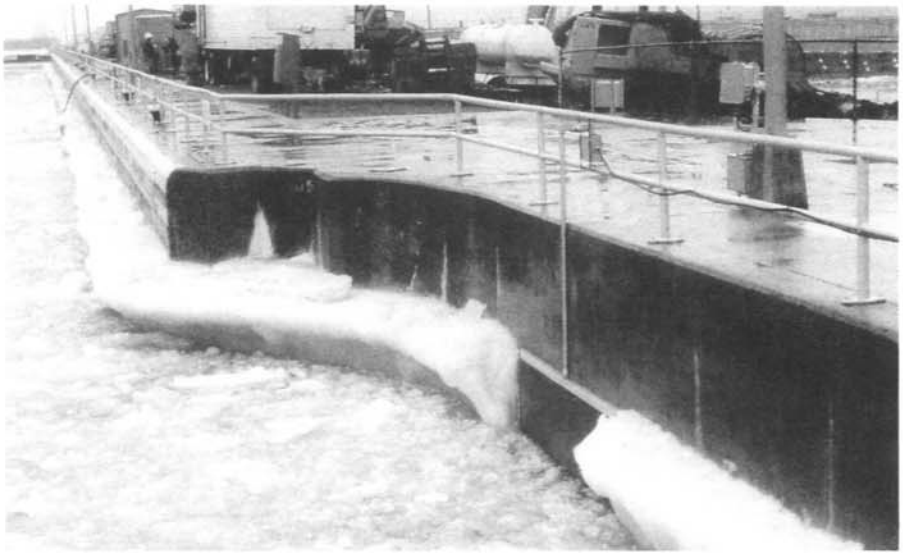
Figure 23.—Longer perspective shot of the panel from the side.
