BUILD AND OPERATE A CLATHRATE DESALINATION PILOT PLANT

FINAL TECHNICAL REPORT

Water Treatment Technology Program Report No. 31

May 1998

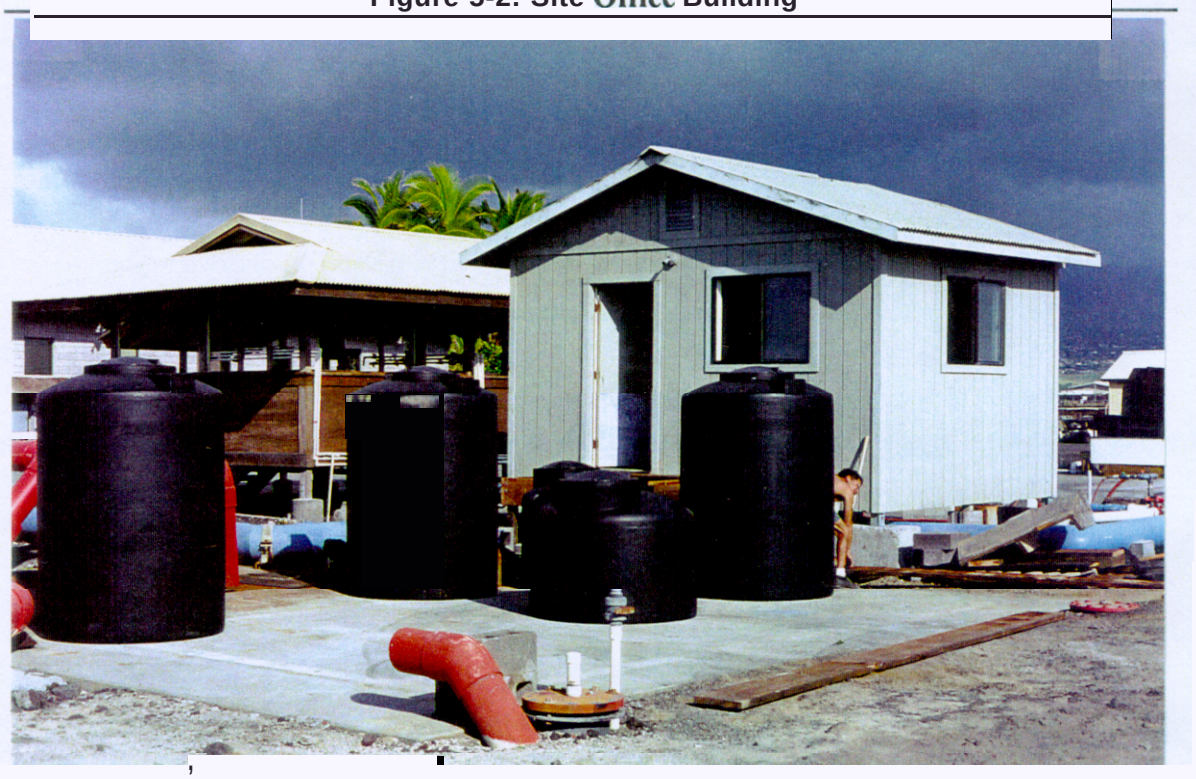
Figure 5-2: Site Office Building

A small frame building was moved adjacent to the East side of the concrete pad, as shown by the photograph in Figure 5-2. This building served as the site project office, and also housed the plant control system and data acquisition system. The photograph was taken after delivery and temporary staging of the HDPE tanks on the concrete pad.

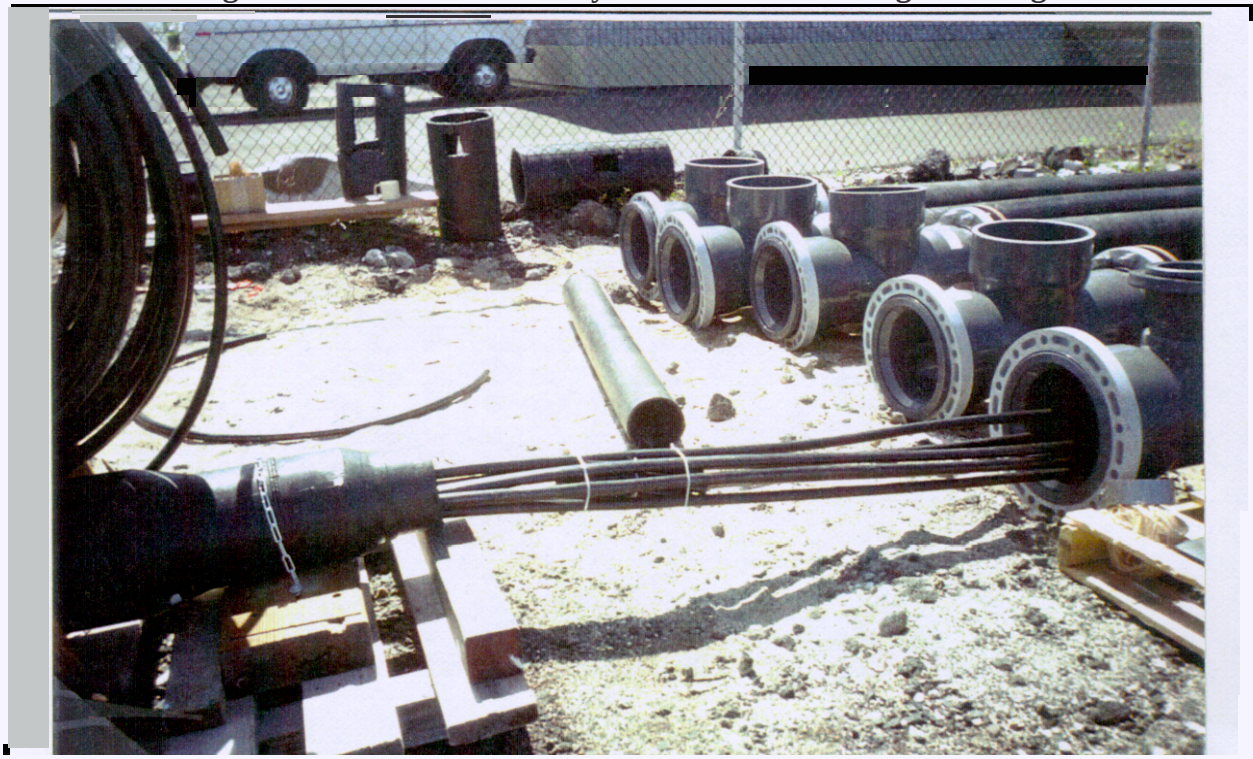
Figure 5-8: Tube Bundle Pattern

The tees were inverted and the stems of the tees were connected in a short vertical loop formed with 45-degree ells. At the near end CHX-2 and CHX-3 were connected as shown in the Figure 5-7 photograph This photograph also shows the connection to the NELH deep seawater cooling supply, the pipe extending horizontally to the inlet of the CHX-1 tee. The line from CHX-4 to the drain is also shown (Figure 5-7) at the right but is somewhat obscured in this view. At the far end CHX-1 and CHX-2 were connected with a similar vertical loop, as were CHX-3 and CHX-4. These connections are depicted in Figure 5-8.

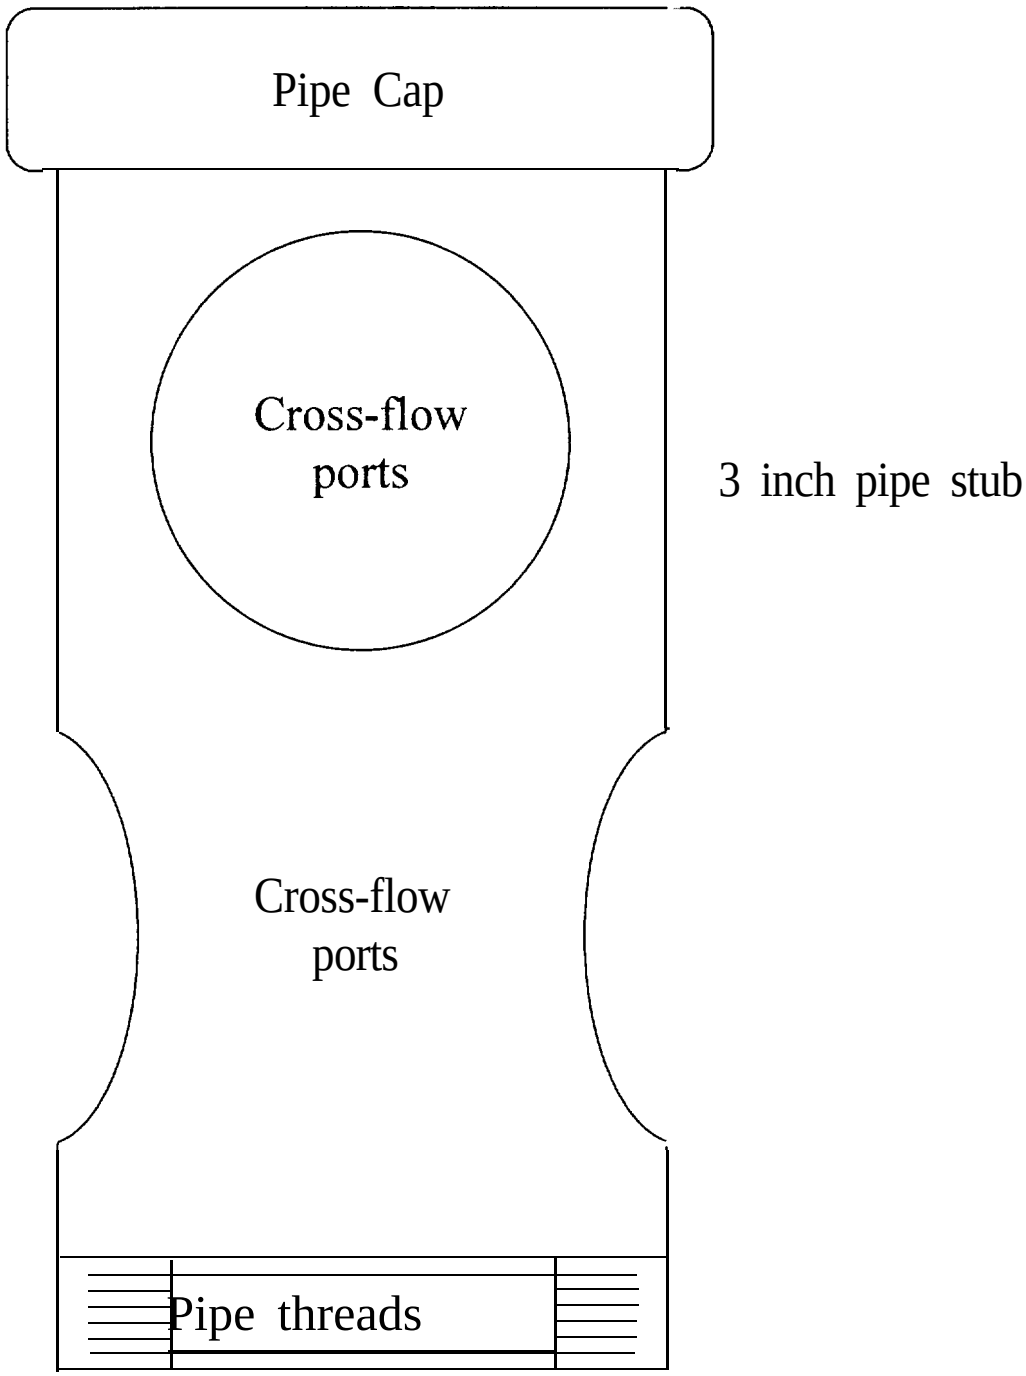
Figure 6-2: Modified Wash Column Inlet

uniform vertical velocity, and lessen the tendency of a central "jet" to break through the forming ice pack.

The production of clathrate crystals began with the system in a recirculation mode, with a small makeup seawater flow. Clathrate crystals were produced but the modifications to the wash column inlet did not produce the desired result. The wash column again failed to perform as intended. The drain holes plugged and a coherent ice pack did not form, again resulting in an overflow of seawater from the wash column into the product water storage tank.

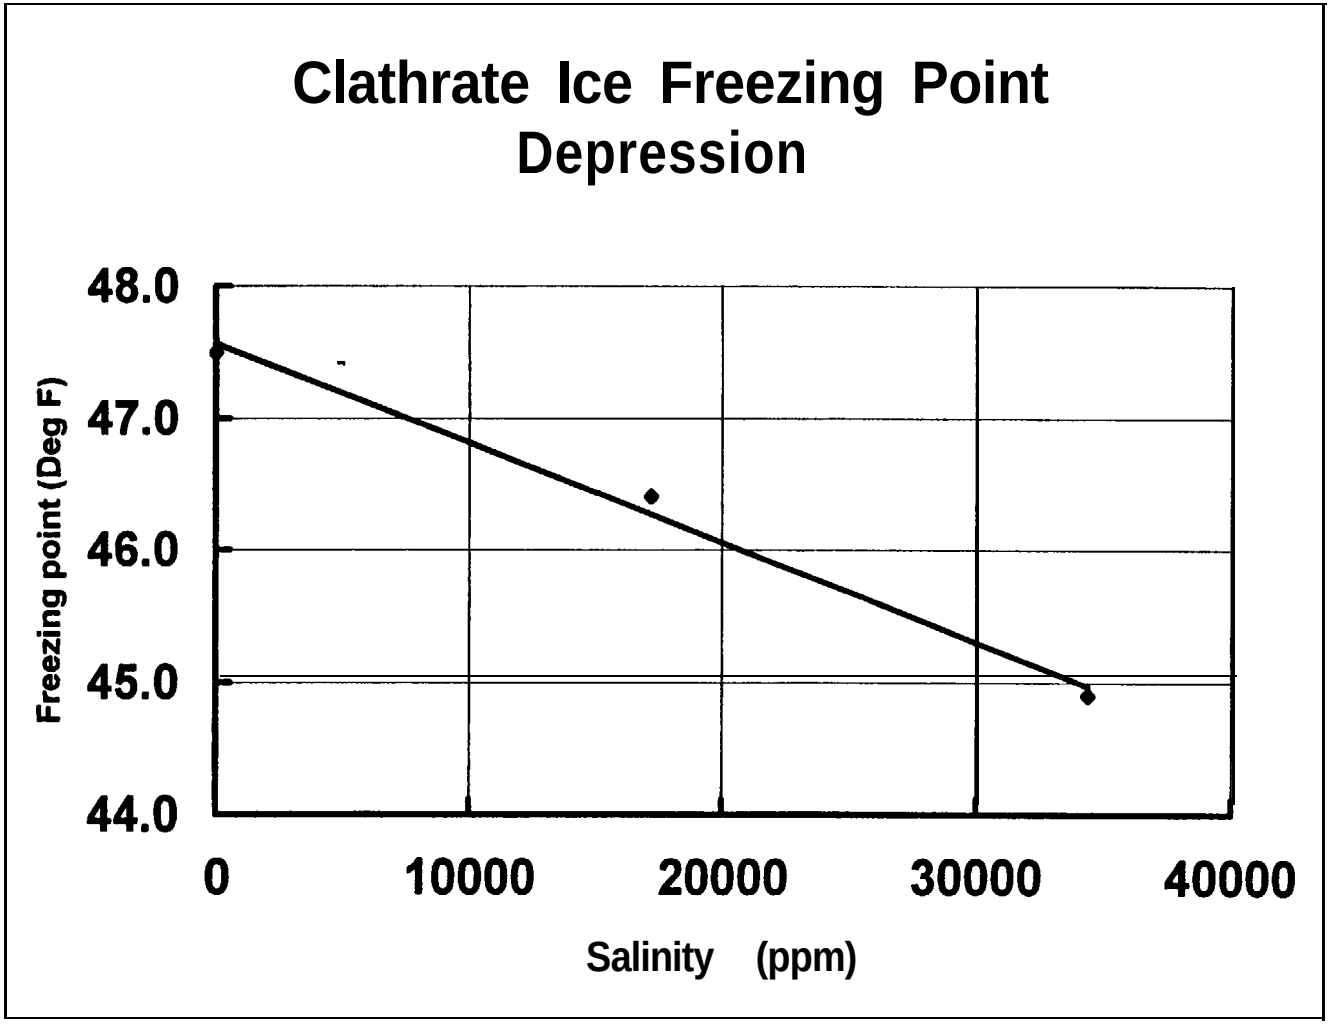
Figure 6-3: Clathrate Freezing Point Depression

During the attempts to operate the plant, the effect of salinity on freeze temperature was evaluated with bench tests. Three salinity levels were examined, a sample of deep-sea water having a salinity of about 34,400 ppm, a 50 percent seawater-SO percent potable water mixture with a salinity of about 17,200 ppm, and potable water with negligible salinity. The results of this work are given in Figure 6-3.

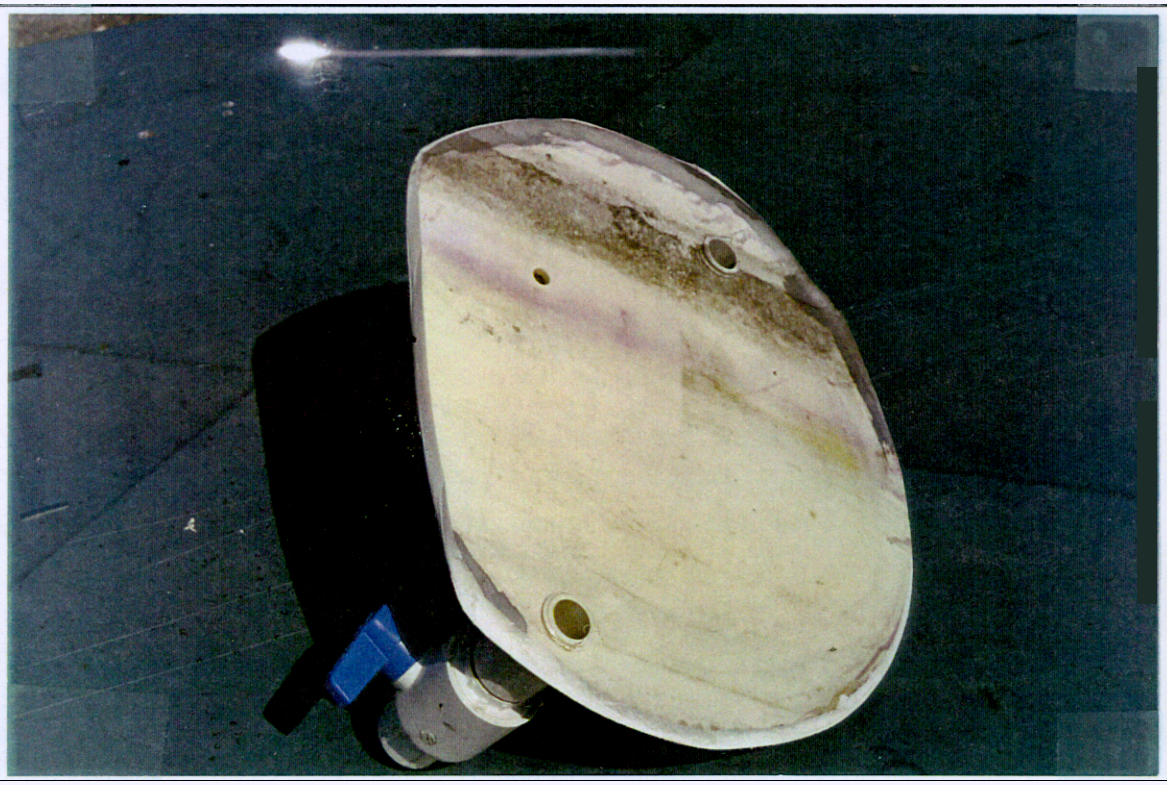
Figure 6-4: Crystallizer End Cap Rupture

In this instance, the overflow was detected in time to make adjustments so that clathrate crystals production could continue while an attempt was made to flush the seawater from the product water storage tank. During the cleanup, a catastrophic failure of the CHX-1 return end cap occurred, requiring shutdown of the system. The end cap failure, shown in Figures 6-4 and 6-5, resulted in the loss of much of the inventory of the recirculating clathrate crystals and R14 1 b/seawater mixture.

A decision was made to attempt a second temporary repair in order to avoid having to shut down the plant. However, during the attempt to make the temporary repair, the end cap completely fractured, rendering the plant inoperable. The product side flow was shut off to avoid losing any additional R141b, and to permit installing a replacement end cap. The original end cap was replaced with a Schedule 80 end cap but in the interim, with no product side flow, the balance of plant warmed up enough to prevent immediately resuming operation.

The end cap was repaired as quickly as possible with fiberglass reinforced plastic (FRP) resin, and an attempt to continue operation was made. During the repair and curing of the FRP, circulation through the balance of the plant piping and storage tanks was not possible.

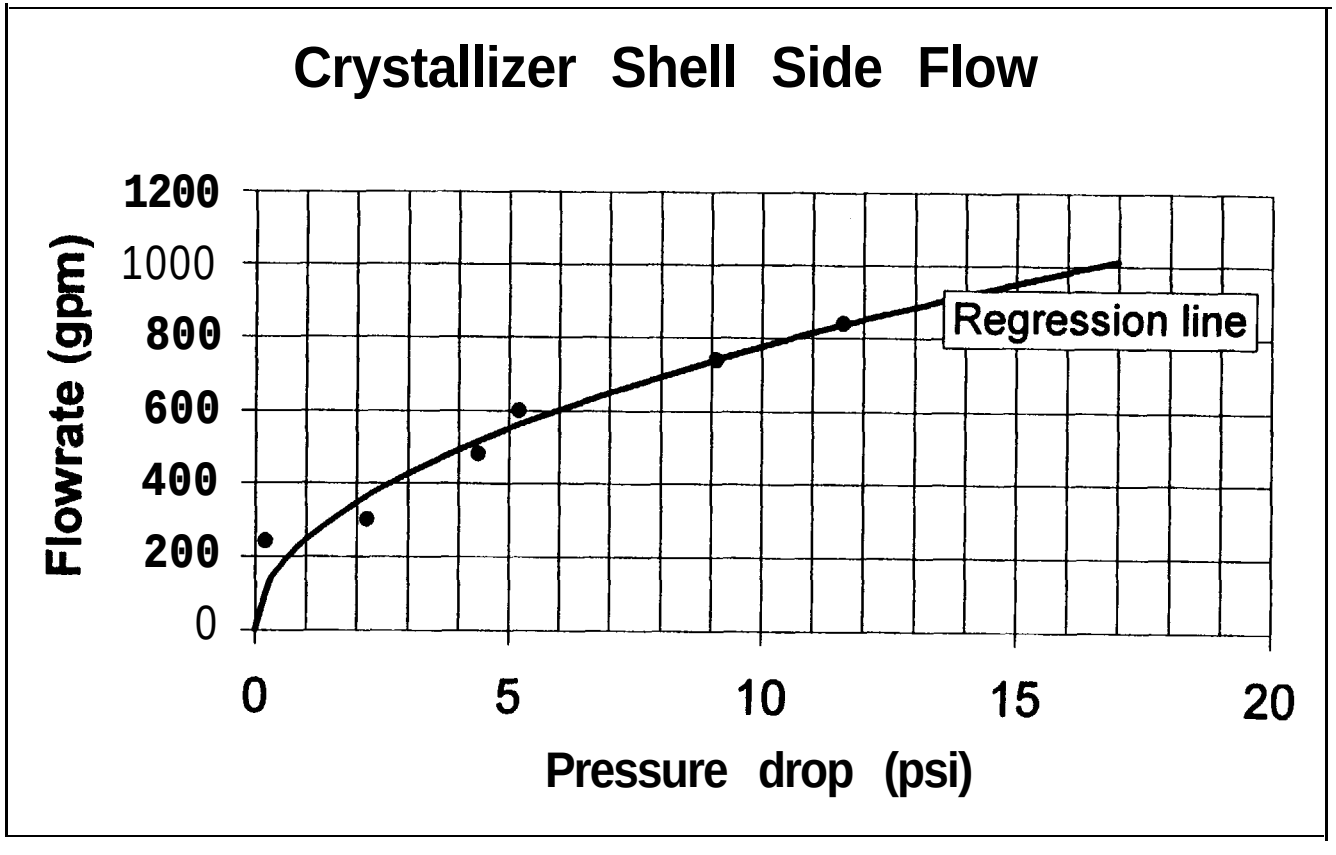
Figure 6-8: Crystallizer Shell Flow and Pressure Drop

The pressure at the outlet is somewhat less than atmospheric after the air is evacuated, about -23.4 kPa (-3.4 psig) at 3 100 liters (800 gallons) per minute. If the NELH system pressure were increased to 82.7 kPa (12 psig), the outlet pressure might increase to -17.2 kPa (-2.5 psig). If so, the pressure drop would be about 100 kPa (14.5 psi) and the expected flowrate would be about 3,640 liters (940 gallons) per minute. The apparent flowrate limiting of Figure 6-7 seems to be an artifact of measurement error: pressure, flow, or a combination of errors. It appears that the crystallizer pressure drop limits the flow with the available NELH

pressures to about 3,640 liters (940 gallons) per minute. A potential solution for this is to place a pair of the crystallizers in parallel, with each taking 1940 liters (500 gallons) per minute. This would increase the flow as needed and allow the use of the same NELH supply and drain lines.

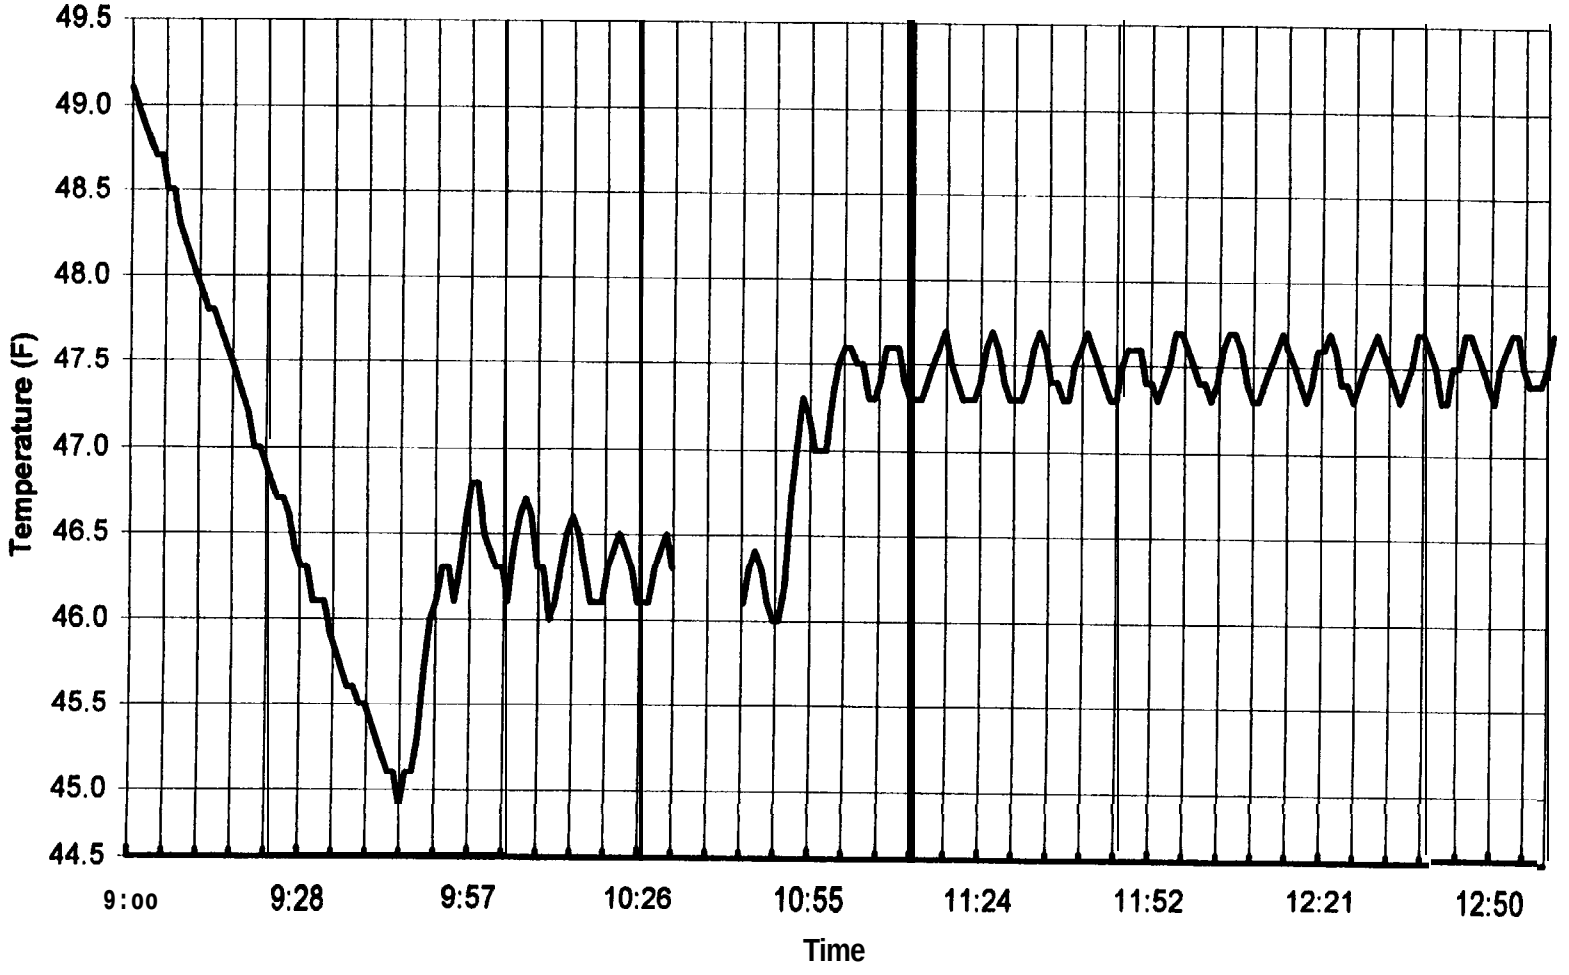
Figure 6-9: Startup System Response

At about 10:46, R141b was added to the startup system. The temperature immediately increased and began oscillating between about 8.5°C (47.3°F) and 8.7°C (477°F).

The evident cause of the observed increase in average exit temperature was crystal formation on the inside of the tube walls. This would also constrict flow, and cause the higher observed pressure drop. The temperature in the chiller side of the heat exchanger oscillated between limits controlled by the chiller thermostat. Crystals forming on the inside of the tube added

resistance to heat flow, and increased the exit temperature from the heat exchanger to near the clathrate formation temperature.

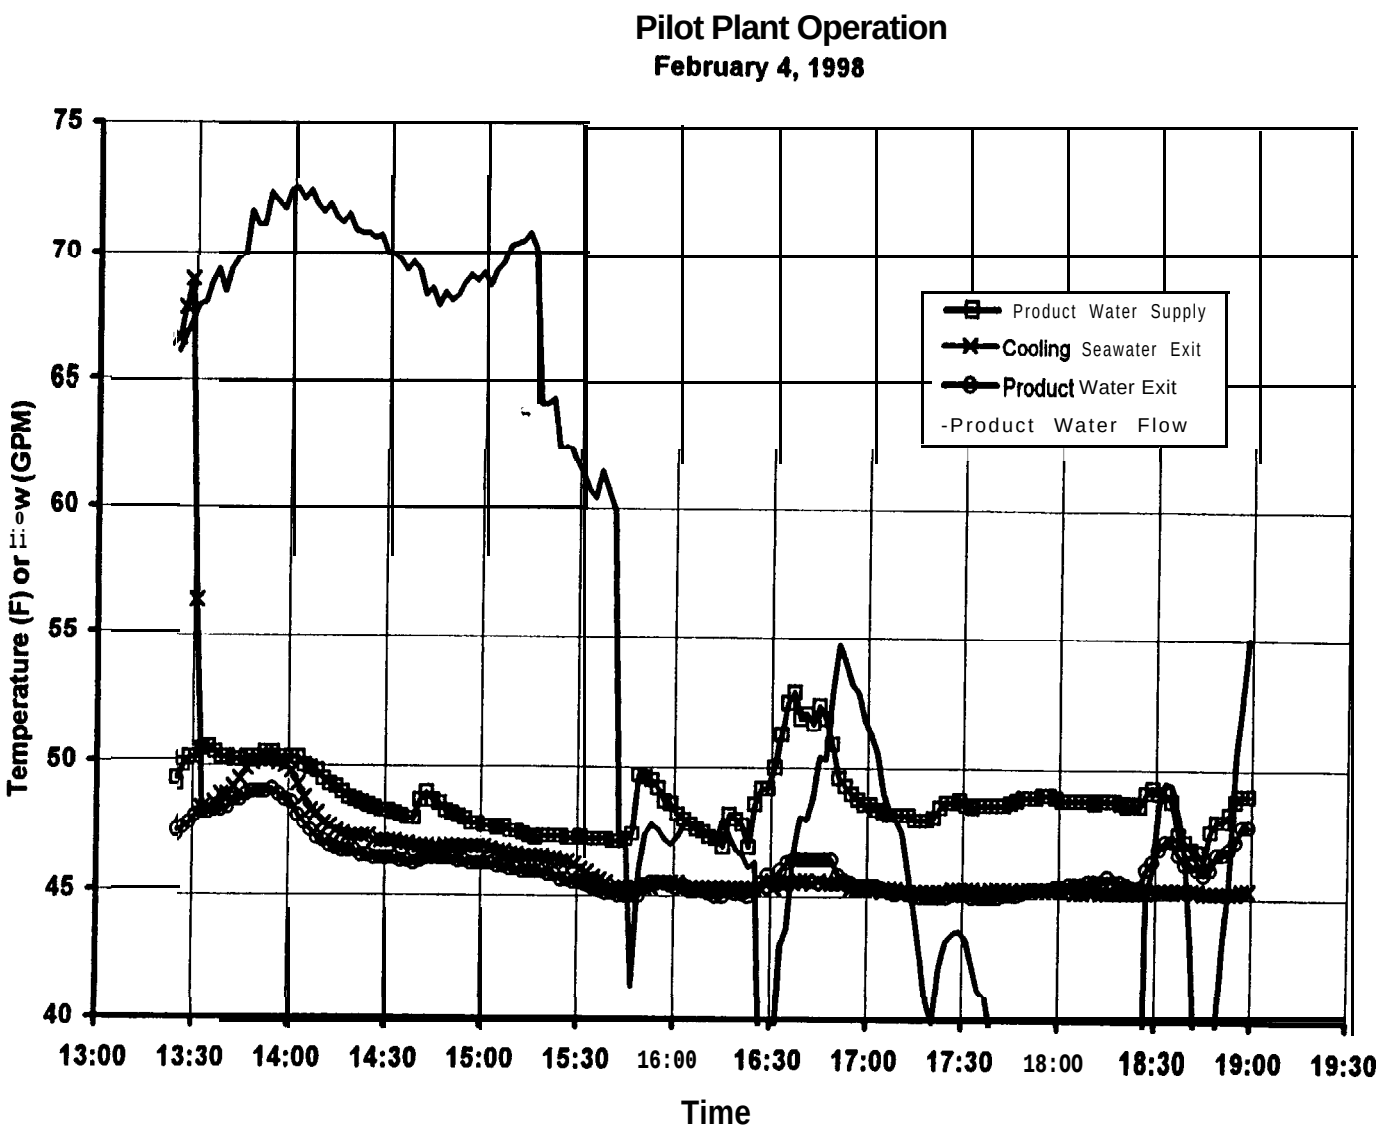
Figure 6-10: Pilot Plant Operation on Feb. 4, 1998

The intial cooling of the system occurred with a cooling flow of approximately 580 liters (150 gallons) per minute. During the cooldown, which began at about 15:00, the product side flowrate was somewhat erratic at about 230 liters (60 gallons) per minute. The product exit temperature from the CHXs decreased steadily until 16:21, at which point the temperature began to increase. The temperature increased for about 16 minutes and then began to decrease again, indicating the release of the heat of fusion as clathrate crystals were formed. The flowrate through the system decreased as the temperature increase occurred, indicating an accumulation of clathrate crystals in the crystallzers. The temperature decrease signaled the depletion of available R141b for forming clathrate.

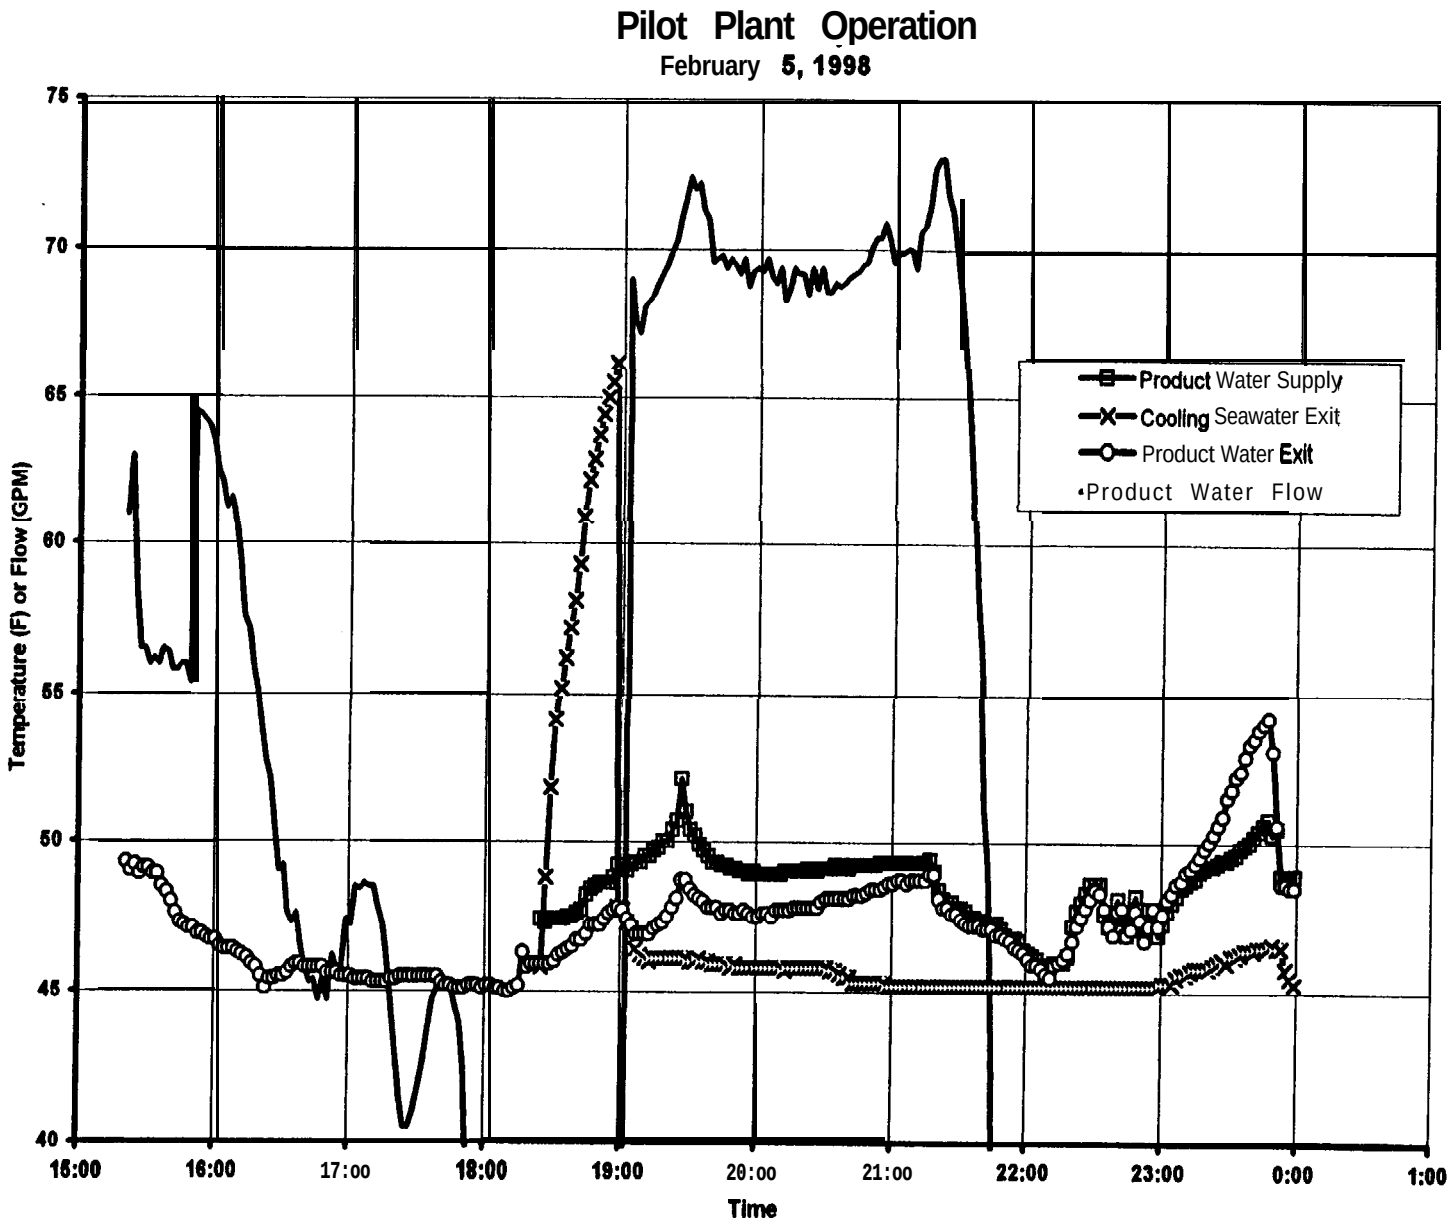
Figure 6- Pilot Plant Operation on Feb. 5 998

increase, followed by a temperature decrease. The indicated flowrate again decreased, dropping to zero at about 18:00. Because of the apparent freezing that had occurred the night before, severe occlusion of the CHXs was suspected. Consequently, it was decided to shut off the cooling water at about 18:25. With the cooling seawater flow shut off the indicated exit temperature in the stagnant section quickly increased to about 18.3°C (65°F). The system valve lineup was changed to permit placing the startup pump in the product loop.

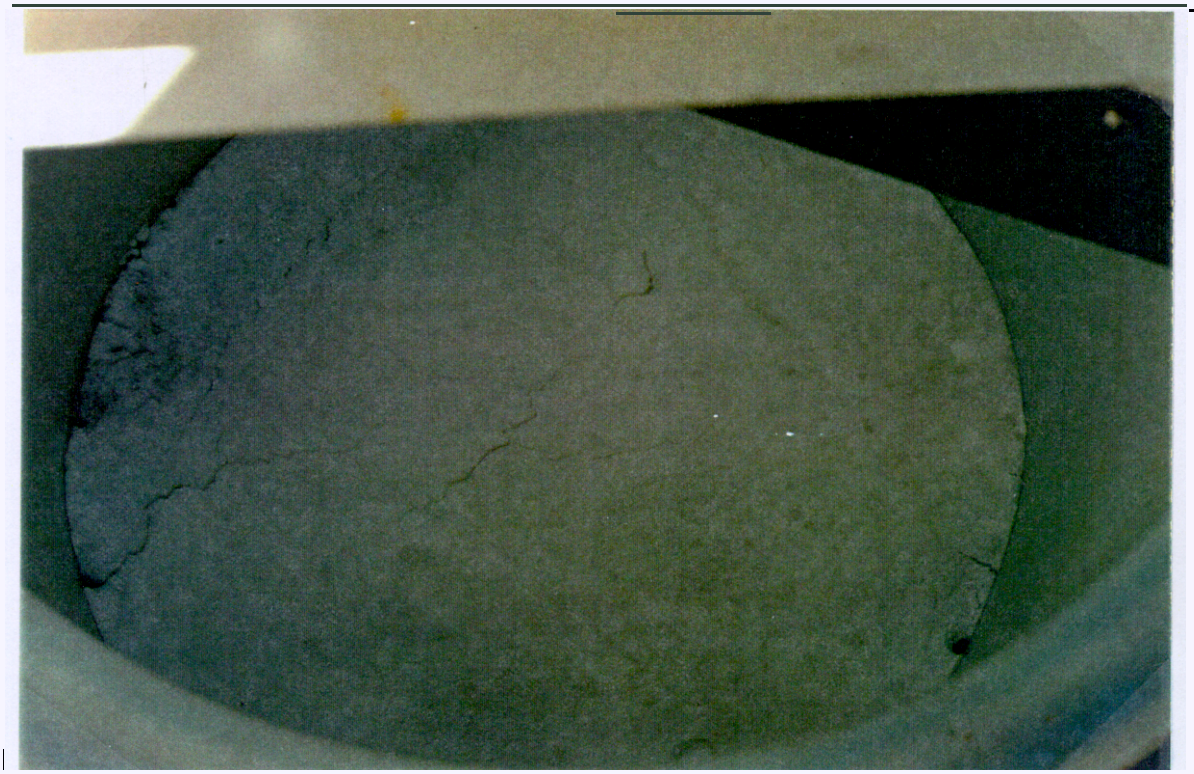
Figure 6-12: "Ice Pack" formed in Wash Column

Although the clathrate ice pack appeared on visual inspection to be coherent, when flow was restored, fissures in the pack appeared and the slurry flowed through the pack and again filled the inner tank until it was necessary to reduce the flow into the wash column. The pack did not appear to move vertically, but grew thicker as additional material was deposited on top of the ice pack. This process was repeated several times until the pack was estimated to be about 0.6 meters (2 feet) thick. The pack remained permeable and drained readily, changing in appearance from translucent to snow-like (see Fiie 6-12) as it drained. Catch tests done at 9: 15 and 9:42 established the drain rate as about 7.2 liters (1.9 gallons) per minute, substantially less than the design value of 94.6 liters (25 gallons) per minute, indicating the degree to which the drain holes were occluded. It is not known if increasing the number of drain holes would suffice to make the wash column operate as intended, but the lack of upward movement seems to indicate that it is unlikely.
